**Church of St Dionysius, Church Square,
Market Harborough, Leicestershire:
An Archaeological Watching Brief**

Archaeology & Built Heritage

Report Number: R-0076

Project Reference: ABH-2017-23

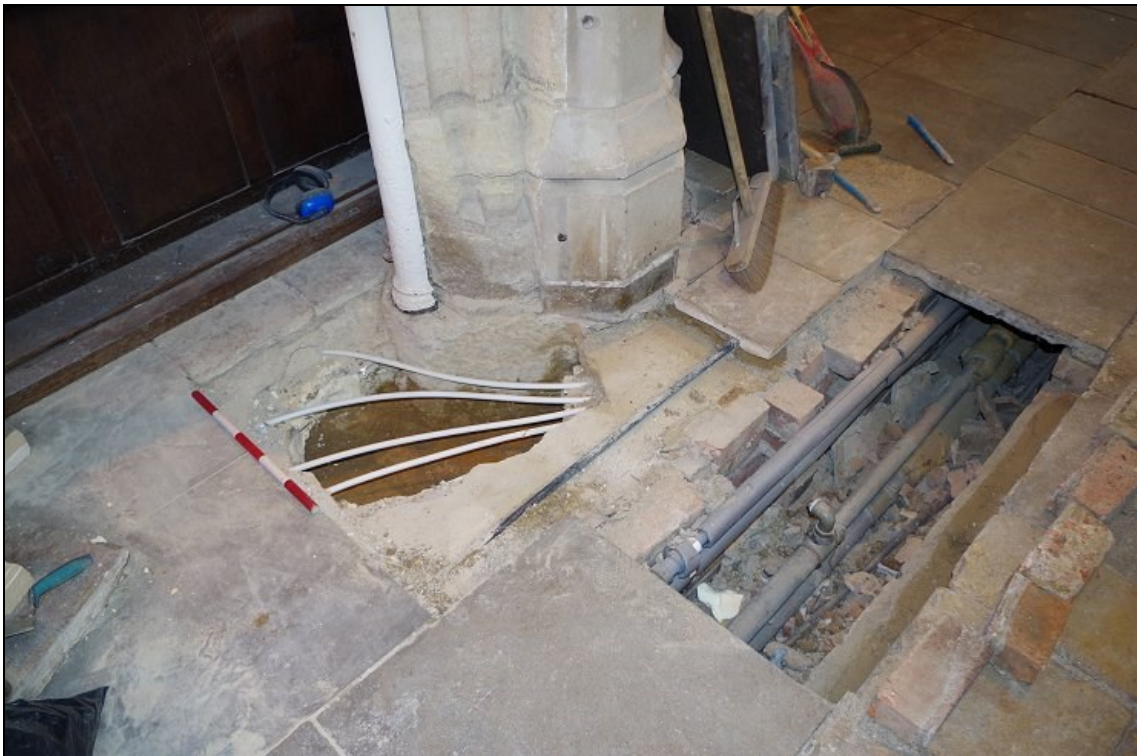
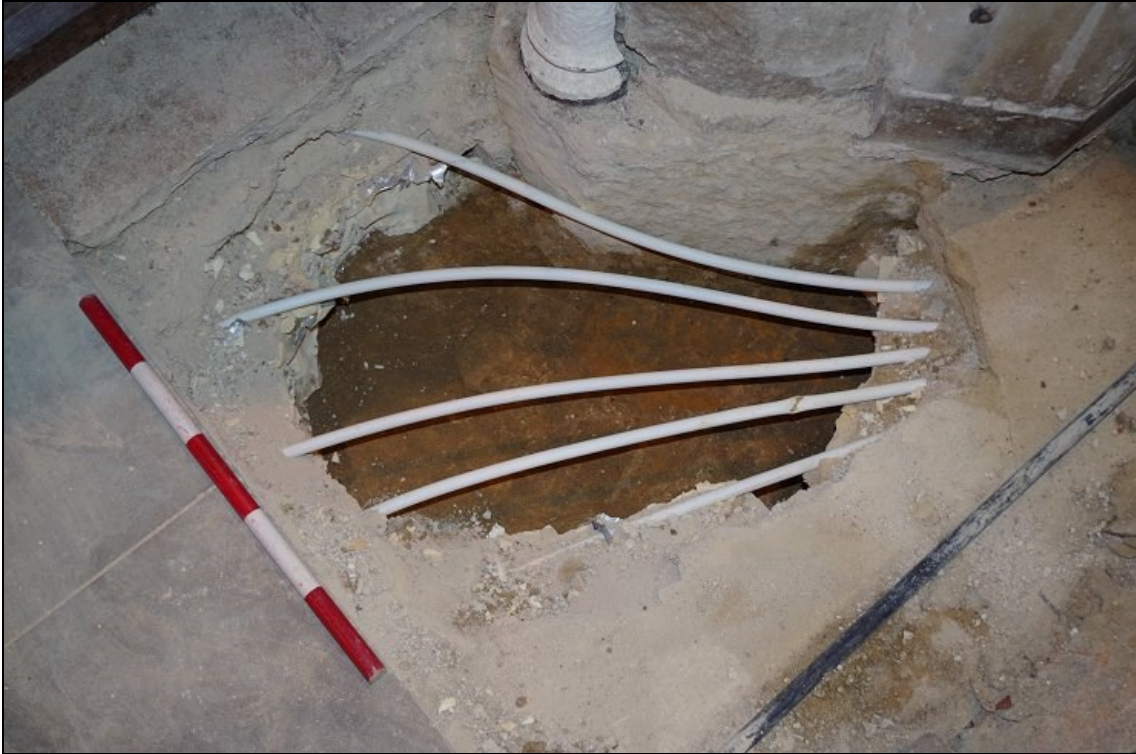
Intervention 1 (Photos 4-5; Figure x)

- 8.2 Trial pit located towards the west end of the nave, adjacent to the westernmost pier of the north arcade. Two adjacent 600mm square and 50mm thick concrete paving slabs were lifted to expose the heating duct below. The brick-lined heating duct, on a north-south alignment, was 400mm wide and 550mm deep. The test pit was subsequently extended to the east, partially exposing a massive mortared ironstone foundation on the north side of the pier base, at a depth of 300mm below finished floor level. The deposits overlying this foundation were recent in date and included sheet insulation of expanded foam type.

- 9.1 Two trial pits were excavated inside the nave of the church (Interventions 1 & 2). No evidence was seen in either of these for earlier floor levels, although the extent of undisturbed ground that was exposed was limited. A substantial mortared ironstone foundation was partly exposed within one of these trial pits (Intervention 1), at a depth of 300mm below floor finished level. This may have been a footing for the adjacent pier of the north arcade. The full extent and depth of this foundation could not be determined within the constraints of the trial pit.

Photo 4. Intervention 1: Showing heating duct & stone footing below pier base, looking SE.

Photo 5. Intervention 1: Detail of mortared ironstone footing below pier base, looking SE.

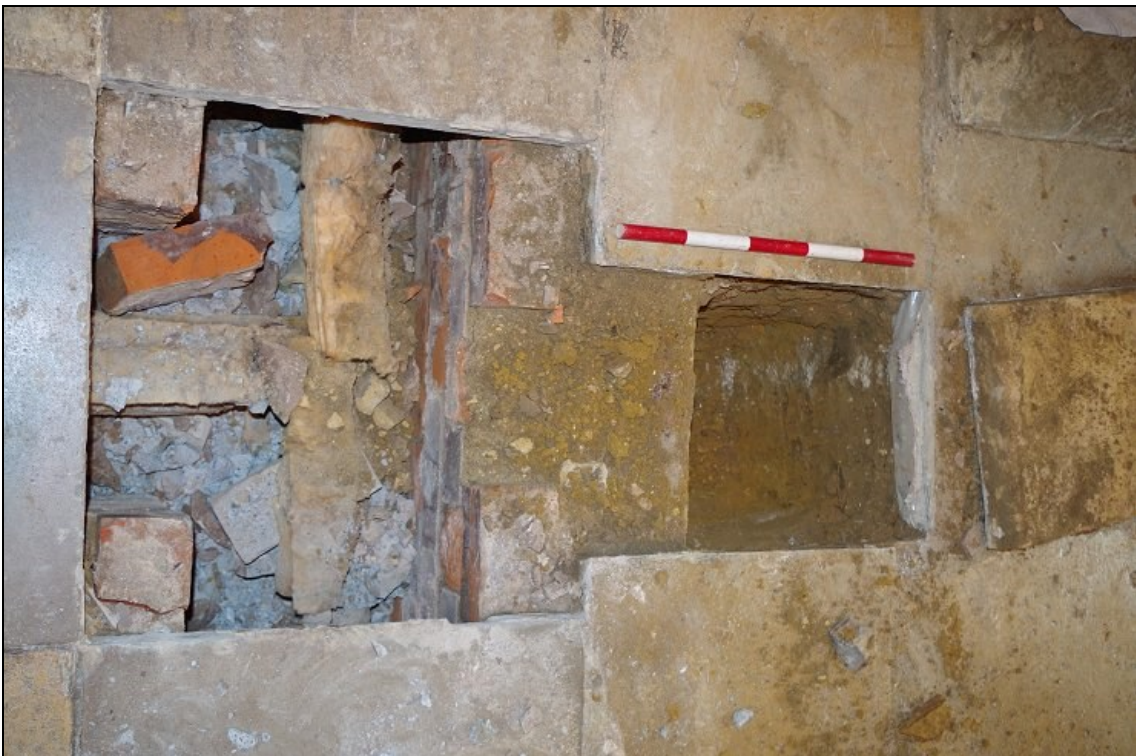
Intervention 2 (Photo 6; Figure x)

- 8.3 Trial pit located on the central axis of the nave towards its east end, 1.24m west of the chancel arch. A 600mm square and 50mm thick concrete paving slab was lifted, exposing an east-west aligned heating duct with a branch off to the north. The heating duct was 370mm wide and 460mm deep. The test pit was subsequently extended to the south with the removal of a stone floor slab measuring 550mm x 370mm x 75mm thick. A 350mm square sondage 500mm deep was excavated within this area. The deposit sequence consisted of a sand bedding for the slab to a depth of 200mm below finished floor level, beneath which was an orange-brown sandy clay with inclusions of chalk and unmodified flint fragments, which appeared to be the geological natural ground.

Photo 6. Intervention 2: Heating duct (left) and geological natural ground (right), looking E.

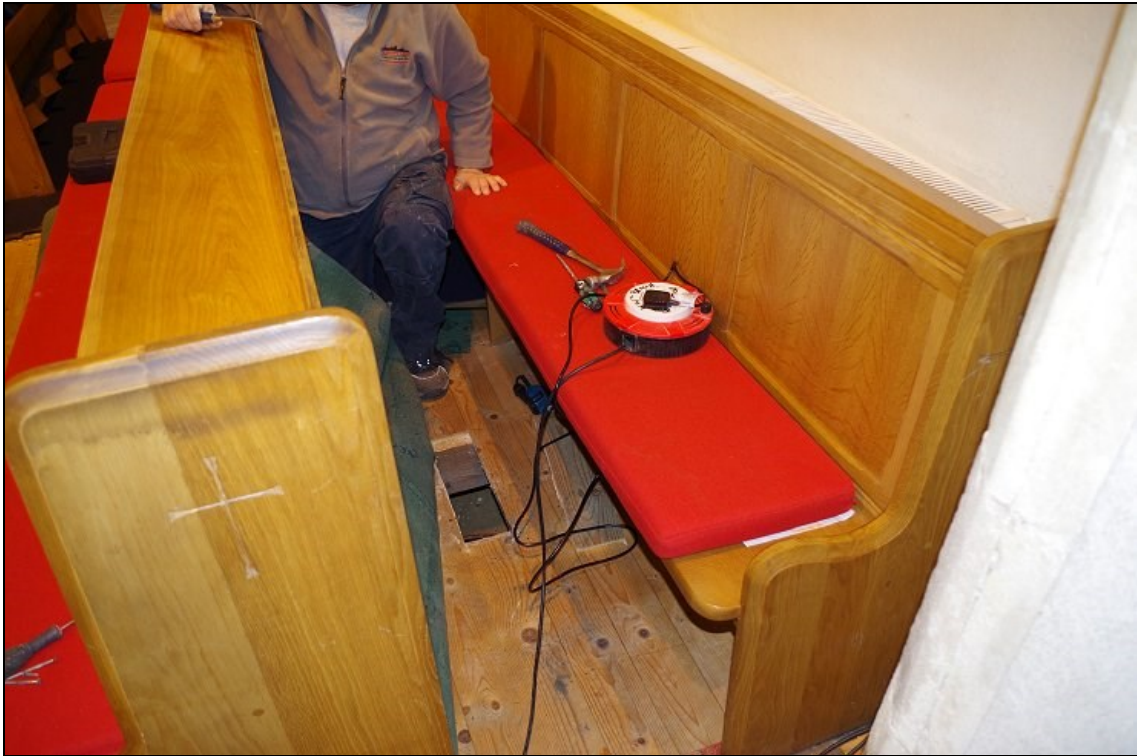
Intervention 3 (Photo 7).

- 8.4 A c.300mm x 100mm section of the tongue and groove timber boarded floor of the choir stall on the south side of the chancel was cut out using an electric saw. The stone-paved floor terminated at approximately 1.8m north of the south wall of the chancel. To the south of this was a void to a depth of 360mm below the level of the stone floor (460mm below the level of the timber floor of the choir stall). The exposed ground was a clean orange coloured sand, possibly the geological natural ground.

- 9.2 Intervention 3 determined that the stone floor of the chancel terminates c. 1.8m west of the internal face of the east wall. This may reflect the position of earlier choir stalls that were narrower than the extant stalls.

Photo 7. Intervention 3: Opening in floor of choir stalls on south side of chancel, looking SE.

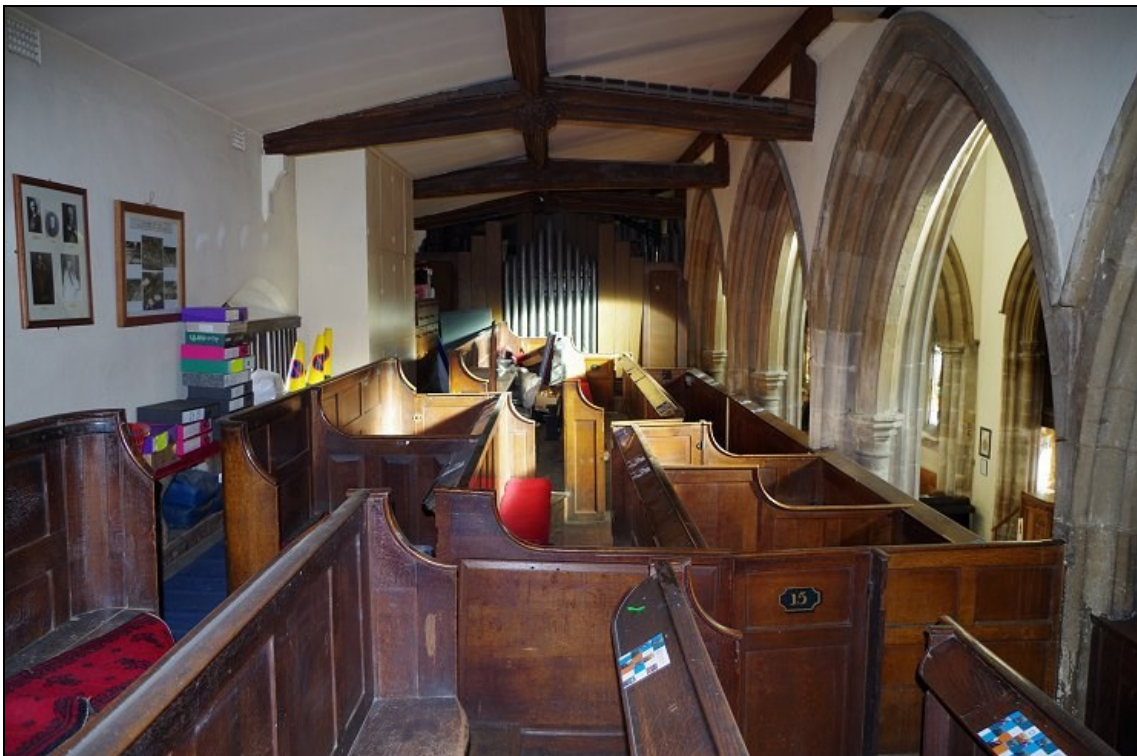
Intervention 4 (Photo 8)

- 8.5 To determine the size of the trimmer supporting the front (south) side of the north gallery and the detail of its fixing to the arcade piers, it was examined from above (Intervention 4) and below (Intervention 5). Intervention 4 also served to expose the joists supporting the gallery and confirm the extent of previous remedial repairs. Loose floorboards were lifted to expose the trimmer and joists from above; this had no adverse impact on historic fabric.

- 9.3 Interventions 4 & 5 served to clarify details of the construction and fixing of the north gallery. According to Pevsner the galleries within the north and south aisles were installed in 1836 and extended to the east in 1844 (Pevsner and Williamson 1992, 306). The delicate gallery staircases are presumably also of 1836. Conversion of the north gallery into a multi-use meeting room/creche will involve removal of the box pews which are also attributable to 1836 and/or 1844 (Photo 8).

Photo 8. Box pews in N gallery, looking E. Intervention 4 involved lifting loose floor boards.

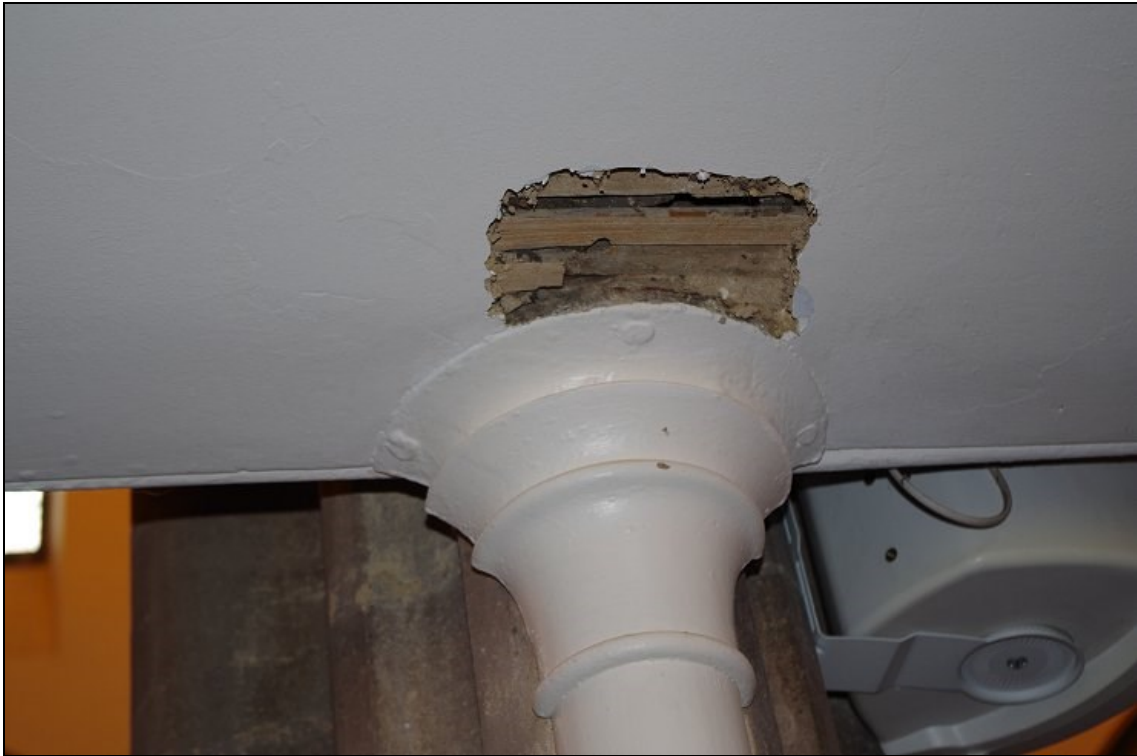
Intervention 5 (Photo 9)

- 8.6 A section of the ceiling to the underside of the gallery, measuring 160mm x 100mm, was removed adjacent to the second pier from the west end of the north arcade, in order to expose the junction of the trimmer supporting the front of the gallery and the pier. The ceiling at this point consisted of lime plaster on lathe. It was apparent from Intervention 4 that a large part of the ceiling below the gallery had previously

been replaced with plasterboard, when iron strengthening plates were inserted from below to support the gallery floor joists.

Photo 9. Intervention 5: Plaster removed from ceiling below N gallery, looking S.

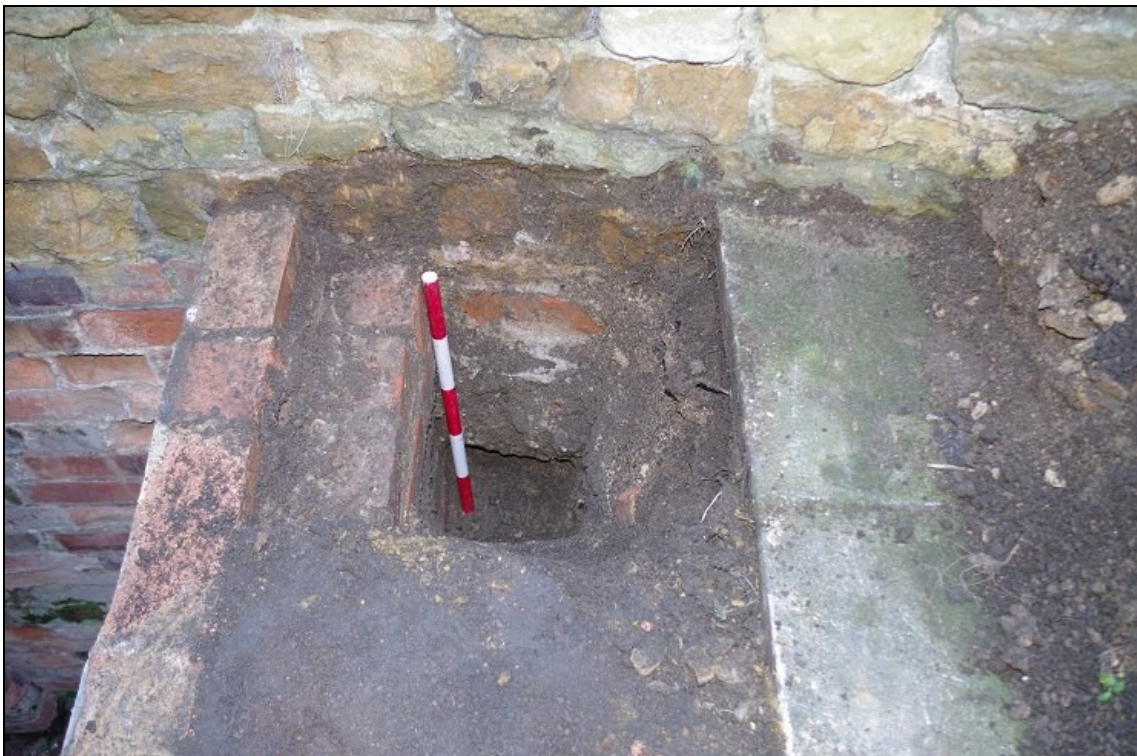
Intervention 6 (Photo 10; Figure x)

- 8.7 Trial pit located against the inside (southern) face of the stone-built boundary wall enclosing the external staircase to the boiler house on the north side of the church. Measuring 500mm x 400mm x 700mm deep, its long axis aligned north-south. This trial pit was intended to determine the foundation depth of the wall along the northern boundary of the church property. A 600mm square and 50mm thick concrete paving slab was lifted against the internal face of the wall. Below this was a mid-brown sandy clay deposit containing stone, brick and mortar fragments, including bricks stamped 'Phorpress', which were manufactured by the London Brick Company (LBC) between 1910 and 1974. This deposit was deeper than the trial pit, which was excavated to a maximum depth of 700mm. The ironstone boundary wall has a brick-built foundation, the base of which is 550mm below the level of the concrete slab floor of the area it encloses.

Photo 10. Intervention 6: Trial pit excavated through 20th century made ground, looking N.

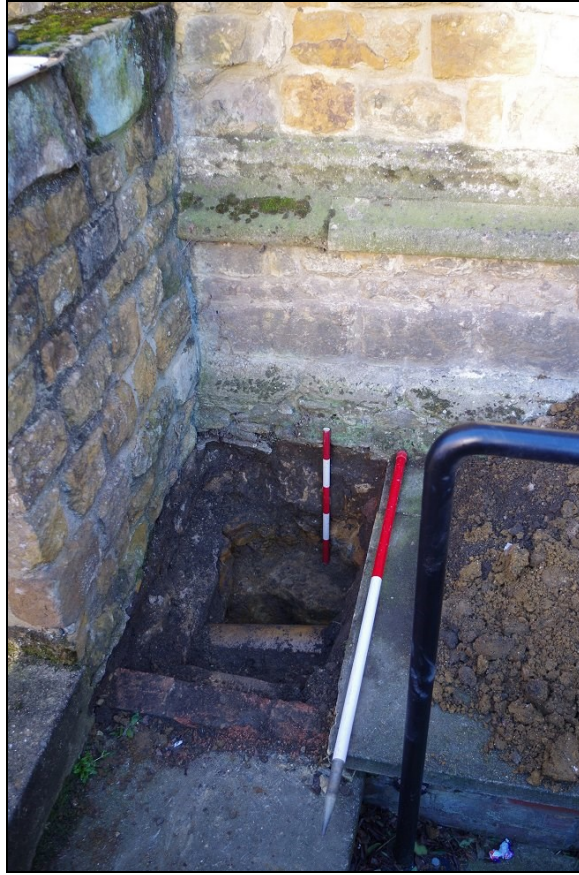
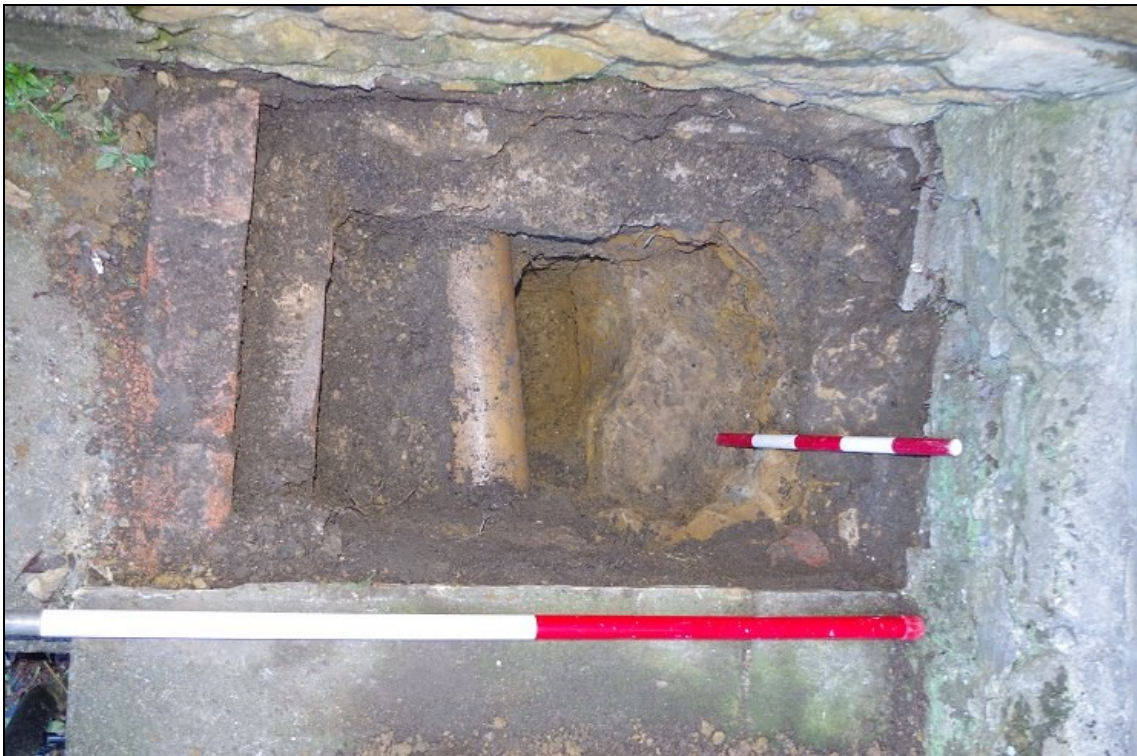
Intervention 7 (Photos 11-12; Figure x)

- 8.8 Trial pit located against the external face of the north wall of the north aisle, intended to determine the foundation depth of this wall. The trial pit measured 800mm x 550mm, its long axis aligned north-south. Below the concrete slab surface was a dark brown sandy clay soil, within which was a 5" ceramic drainage pipe of 20th century date. At a depth of 250mm below ground level the footing of the north wall was encountered, projecting out from the wall face by 350mm. This consisted of clay bonded ironstone. The base of the footing was at 680mm below ground level. Beneath this was an orange brown sandy clay with inclusions of chalk and unmodified flint fragments, apparently the geological natural ground.

- 9.4 Two of the external trial pits (Interventions 7 & 8) served to clarify the depth of the north and east wall foundations of the north aisle, which are relatively shallow. The bottom of the north wall foundation, exposed in the Intervention 7 trial pit, was 1.30m below the underside of the ogee-shaped string course that runs around the north aisle. The bottom of the east wall foundation, as exposed in the Intervention 8 trial pit, was 1.06m below the underside of the same string course. No buried archaeological remains were encountered in either of these trial pits, with recent deposits directly overlying the geological natural ground in both.

Photo 11. Intervention 7: Trial pit against exterior of north wall of north aisle, looking S.

Photo 12. Intervention 7: Detail showing stepped footing to north wall of north aisle.

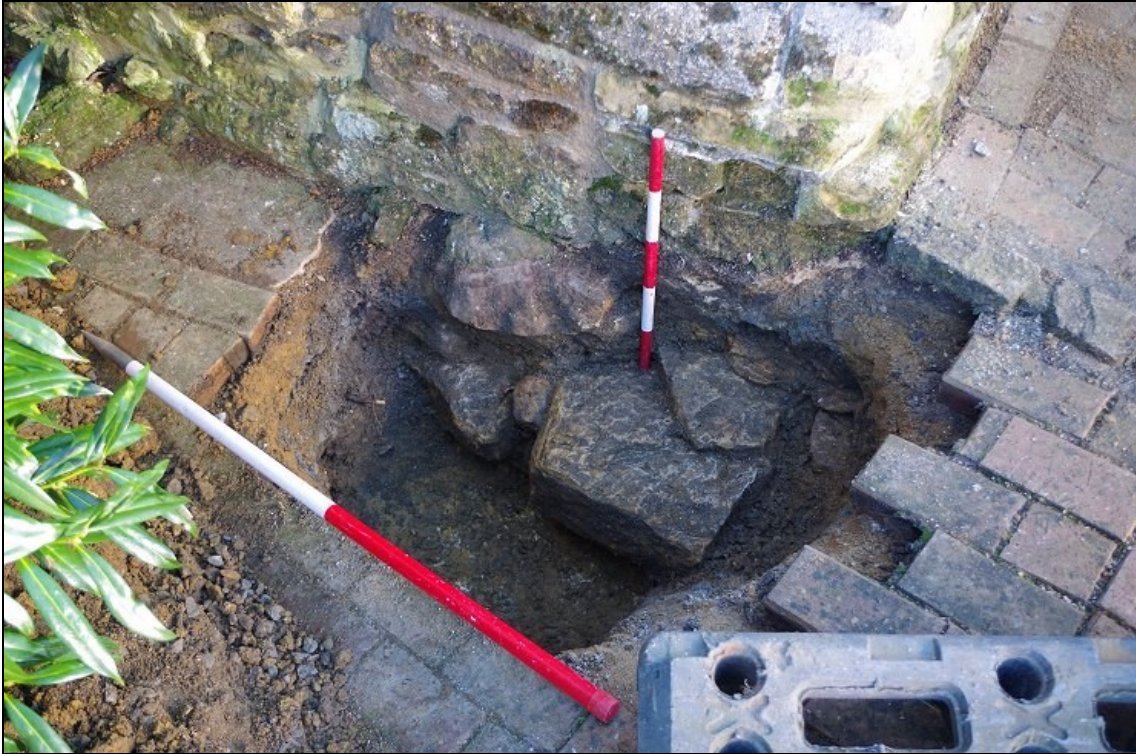
Intervention 8 (Photo 13; Figure x)

- 8.9 Trial pit located against the external north-east corner of the north aisle, intended to determine the foundation depth of the wall at this point. The trial pit measured 950mm north-south by between 550mm and 700mm east-west; its maximum depth was 700mm. The deposit sequence consisted of modern block paving on a sand bed to a depth of 200mm, below which was granite mill waste to a depth of 500mm below pavement level, beneath which was an orange-brown sandy clay, apparently the geological natural ground. A projecting ironstone footing to the east wall of the north aisle was exposed at 350mm below pavement level, the base of which was at 0.65m below pavement level. The clay-bonded footing consisted of a large, roughly squared block of ironstone at the corner of the buttress, with smaller, less-regularly shaped pieces above and to the south of this. Further to the south, the foundation courses of the east wall of the north aisle are exposed above the level of the block-paved surface.

Photo 13. Intervention 8: Footing exposed at north-east corner of north aisle, looking SW.

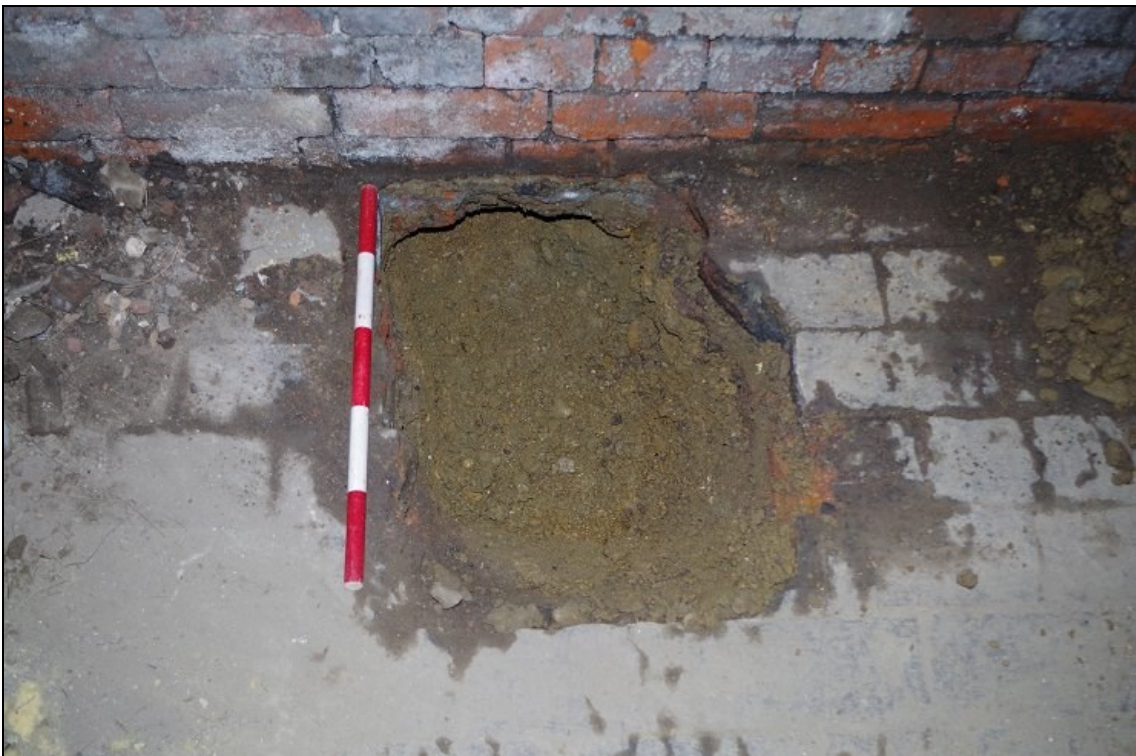
Intervention 9 (Photo 14)

- 8.10 Trial pit located within the boiler house, towards the north-west corner, intended to determine the foundation depth of its brick-built north wall. The trial pit measured 500mm north-south x 300mm east-west x 250mm deep. The excavated deposit

sequence consisted of blue brick paviments 75mm thick laid on a thin levelling bed of clinker, directly overlying the geological natural ground, consisting of a yellow brown coloured clay gravel. The bottom of the north wall of the boiler house was 110mm below the internal floor level.

Photo 14. Intervention 9: Geological natural ground exposed within boiler room, looking N.

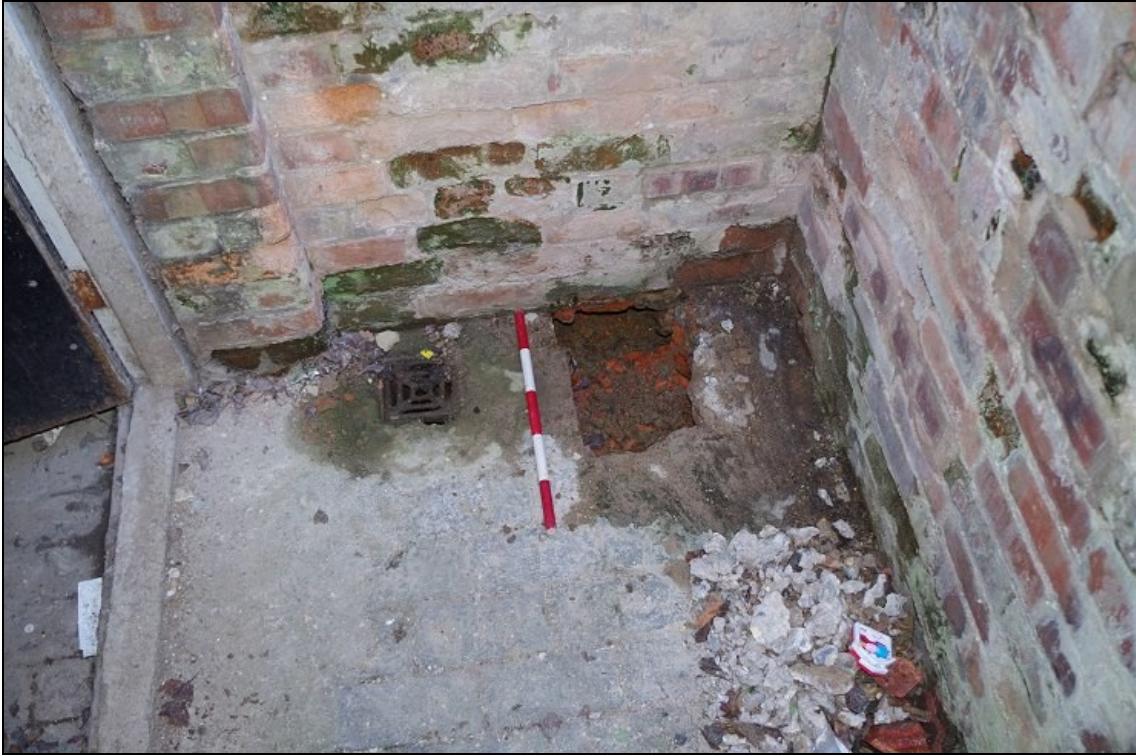
Intervention 10 (Photo 15)

- 8.11 Trial pit located against the inside (southern) face of the brick-built retaining wall at the base of the steps down to the boiler house, intended to assess the foundation depth of this wall. The trial pit measured 350mm x 300mm x 250mm deep. Beneath blue brick paviments 75mm thick was a cast iron drainage gulley, below which was clinker make-up/bedding. No archaeology was encountered and the geological natural ground was not exposed in this trial pit. The base of the retaining wall was at 150mm below ground level, corresponding with the level of the same wall in Intervention 9 (above).

Photo 15. Intervention 10: trial pit looking N.

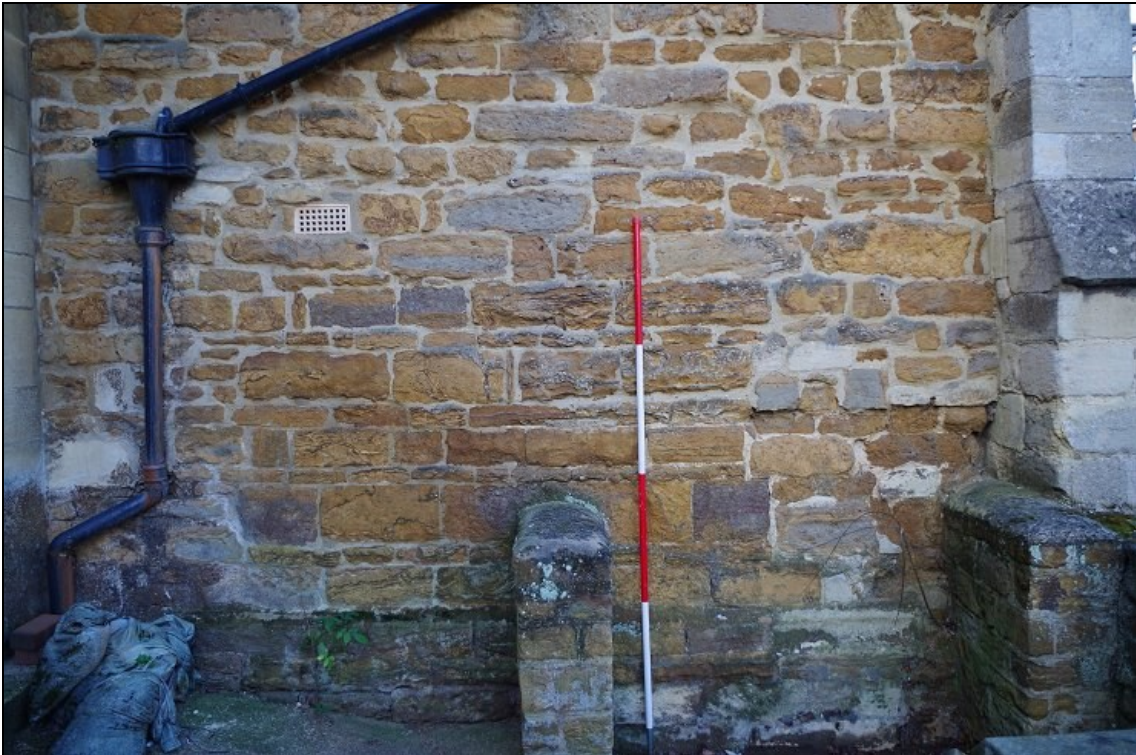
Intervention 11 (Photo 16)

- 8.12 The thickness and construction of the east wall of the north porch was assessed, where it is proposed to form a new doorway opening into the new kitchen extension. This intervention, which involved drilling through the wall to determine its thickness, was not monitored but the external face of this wall was examined and photographed (Photo 16). The internal face is lined with plasterboard and is not visible. The wall is constructed from squared, coursed ironstone rubble and there are no historic architectural features such as windows, doors, string courses, etc., in the area where it is proposed to form the new door opening.

- 9.7 The proposal to form a doorway in the east wall of the north porch will not impact on any features of particular historic architectural significance (Intervention 11). Similarly the proposal to form a new doorway in the south wall of the south aisle, opening into the room above the south porch, will not impact on any features of particular historic architectural significance (Intervention 12).

Photo 16. External face of east wall of north porch, looking W.

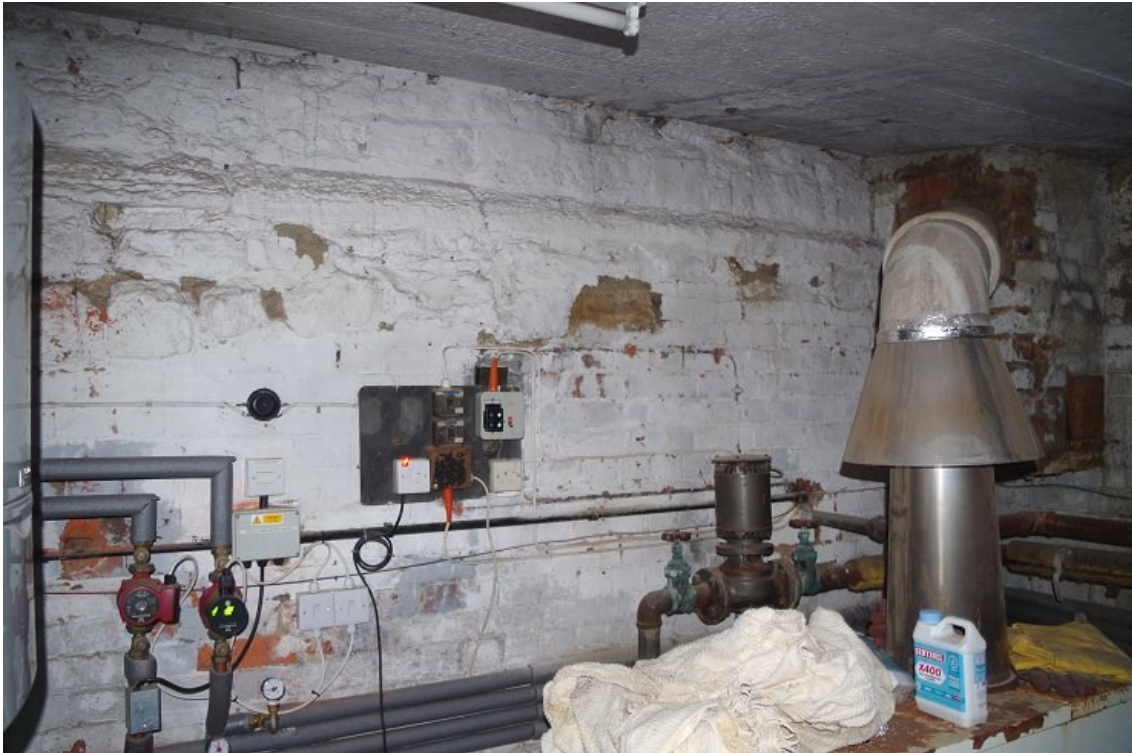
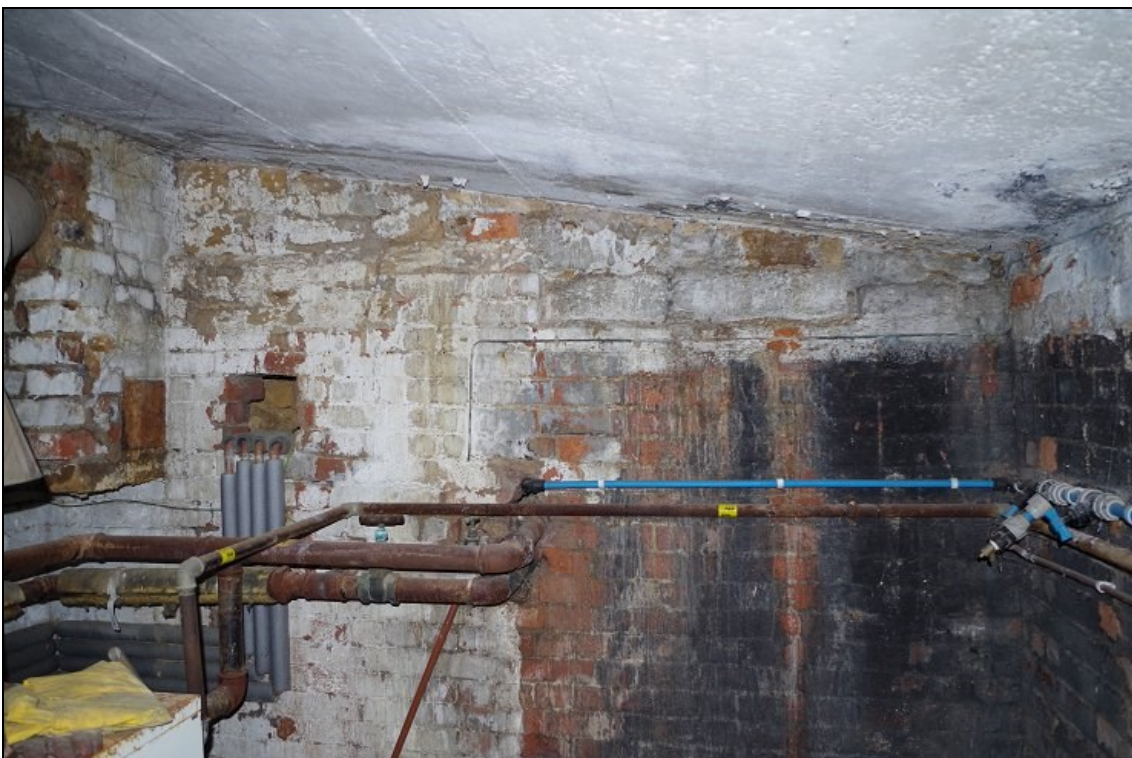
- 9.5 The depth of the north wall foundation of the north aisle and east wall foundation of the north porch are also apparent from within the boiler house, where these walls are underpinned by the brickwork of the later boiler house walls (Photos 17-18).

Photo 17. Brick-built south wall of boiler house underpinning stonework of north wall of north aisle, looking SW.

Photo 18. Brick-built west wall of boiler house underpinning stonework of east wall of north porch, looking W.
