CHURCH OF ST MARY THE BLESSED VIRGIN, SWAINSWICK

Report on the Archaeological monitoring of drainage works

Prepared March 2018 for

The PCC of St Mary the Blessed Virgin, Swainswick

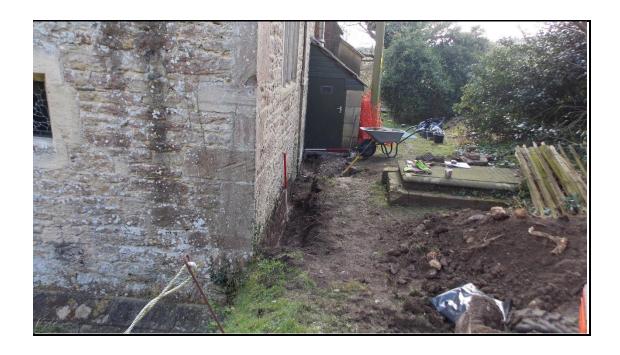
The photograph on the cover shows the excavated area: facing S.

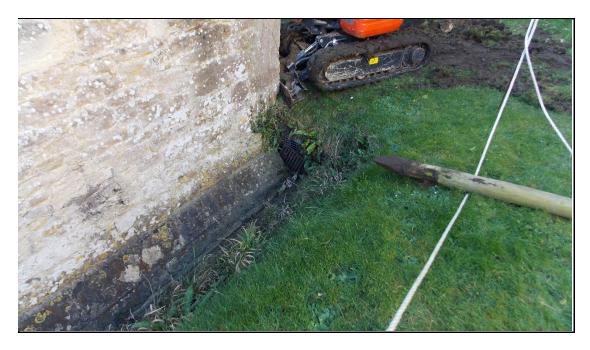
The stone lined drainage channel on the north side of the church was up to 750mm below the existing ground surface in the proposed area for the new drain. The west end of this drain could be seen disappearing into a vegetation covered void (Fig. 1).

Figure 1. Existing stone drainage channel & vegetation covered void.

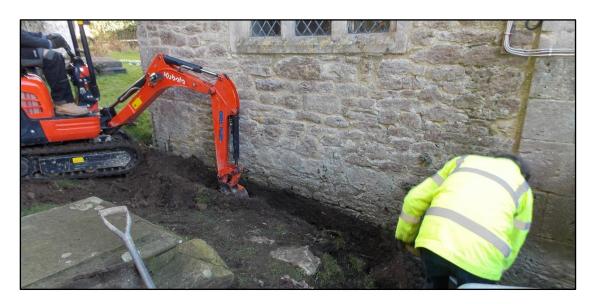
A trench approximately 2.8m long, 450mm wide and up to 700mm deep was excavated in a grass covered area on the west side of the church starting 350mm south of the drain on the north side of the church. The trench was excavated using a mini-digger and

Figure 2. New drainage channel under excavation.

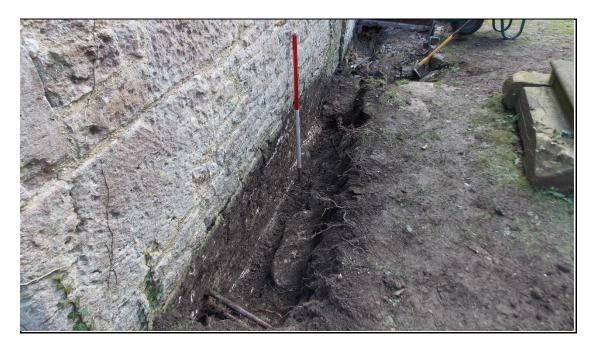
In the west side of the trench a stone capped culvert was uncovered at a depth of between 350mm and 500mm (Fig, 3). This feature appeared to be constructed from a combination of local limestone and Bath Stone slabs, between 100mm and 140mm high and at least 300mm wide. The full width and depth of this feature were not seen during these works as it was possible to fit the new drainage system around the east side of the culvert without causing any further disturbance.

The chamfered offset church footings were also revealed at a depth of 550mm in the east side of the trench and were seen to protrude up to 100mm away from the church wall (Fig. 3). Again, these were not disturbed as it was possible to locate the new drain in between these and the culvert.

Figure 3. Stone capped culvert in W side of trench: facing S, 1m scale.

Although no exact dating evidence for the culvert was found during these works it is assumed to be associated with the restoration works carried out in the 19th Century. The access along this side of the church is very narrow and perhaps it was decided that is was safer to underground this section of drainage rather than have an open deep channel. Grave stones were also visible approximately 1m west of the church in this area so there is also the possibility that the ground surface may have been raised to accommodate more burials?

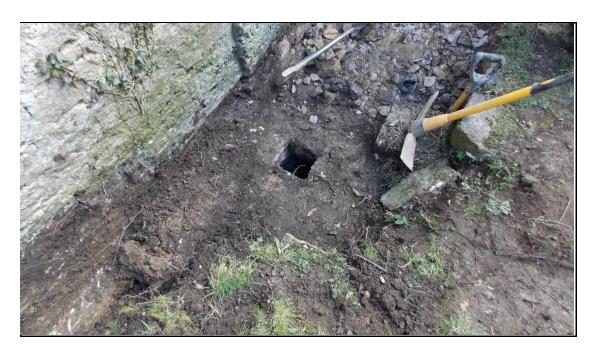
Removal of the slabs surrounding the existing water spout drain and concrete slab to the south of the drain revealed a modern, loose rubble deposit (Figs. 4 & 5) which had been used to infill behind an existing retaining wall, located 1m west of the church wall. This feature was of drystone construction and comprised of roughly faced limestone blocks and was at least 500mm high (Fig. 6). Three courses were exposed, and each course was up to 120mm high, the full depth and width of this feature was not exposed during these works, but it would appear to be modern.

Figure 4. Existing drain: facing SE.

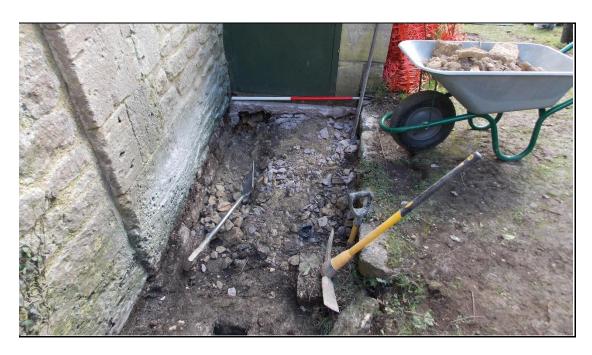
Figure 5. Rubble deposit: facing S, 1m scale.

The rubble deposit at the south end of the area would appear to be recent and is probably associated with the construction of the boiler room.

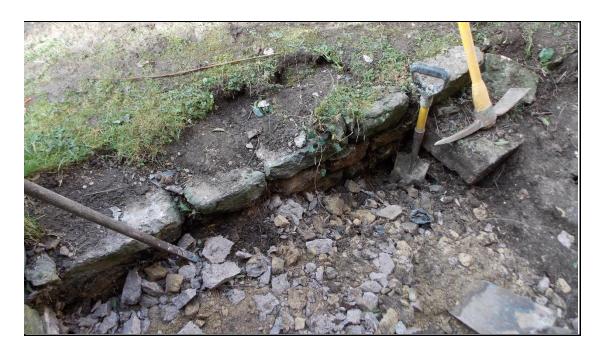
Figure 6. Retaining wall: facing NW.
