# St Peter's Church

## Roof condition

Heritage Crafts & Building Skills Centre Ltd

The purpose of the roof survey was to establish the condition of the roof slope of the Church of St Peter's. A total of 6 areas were opened to check the condition of the fixing's and the design of the slating and roof structure.

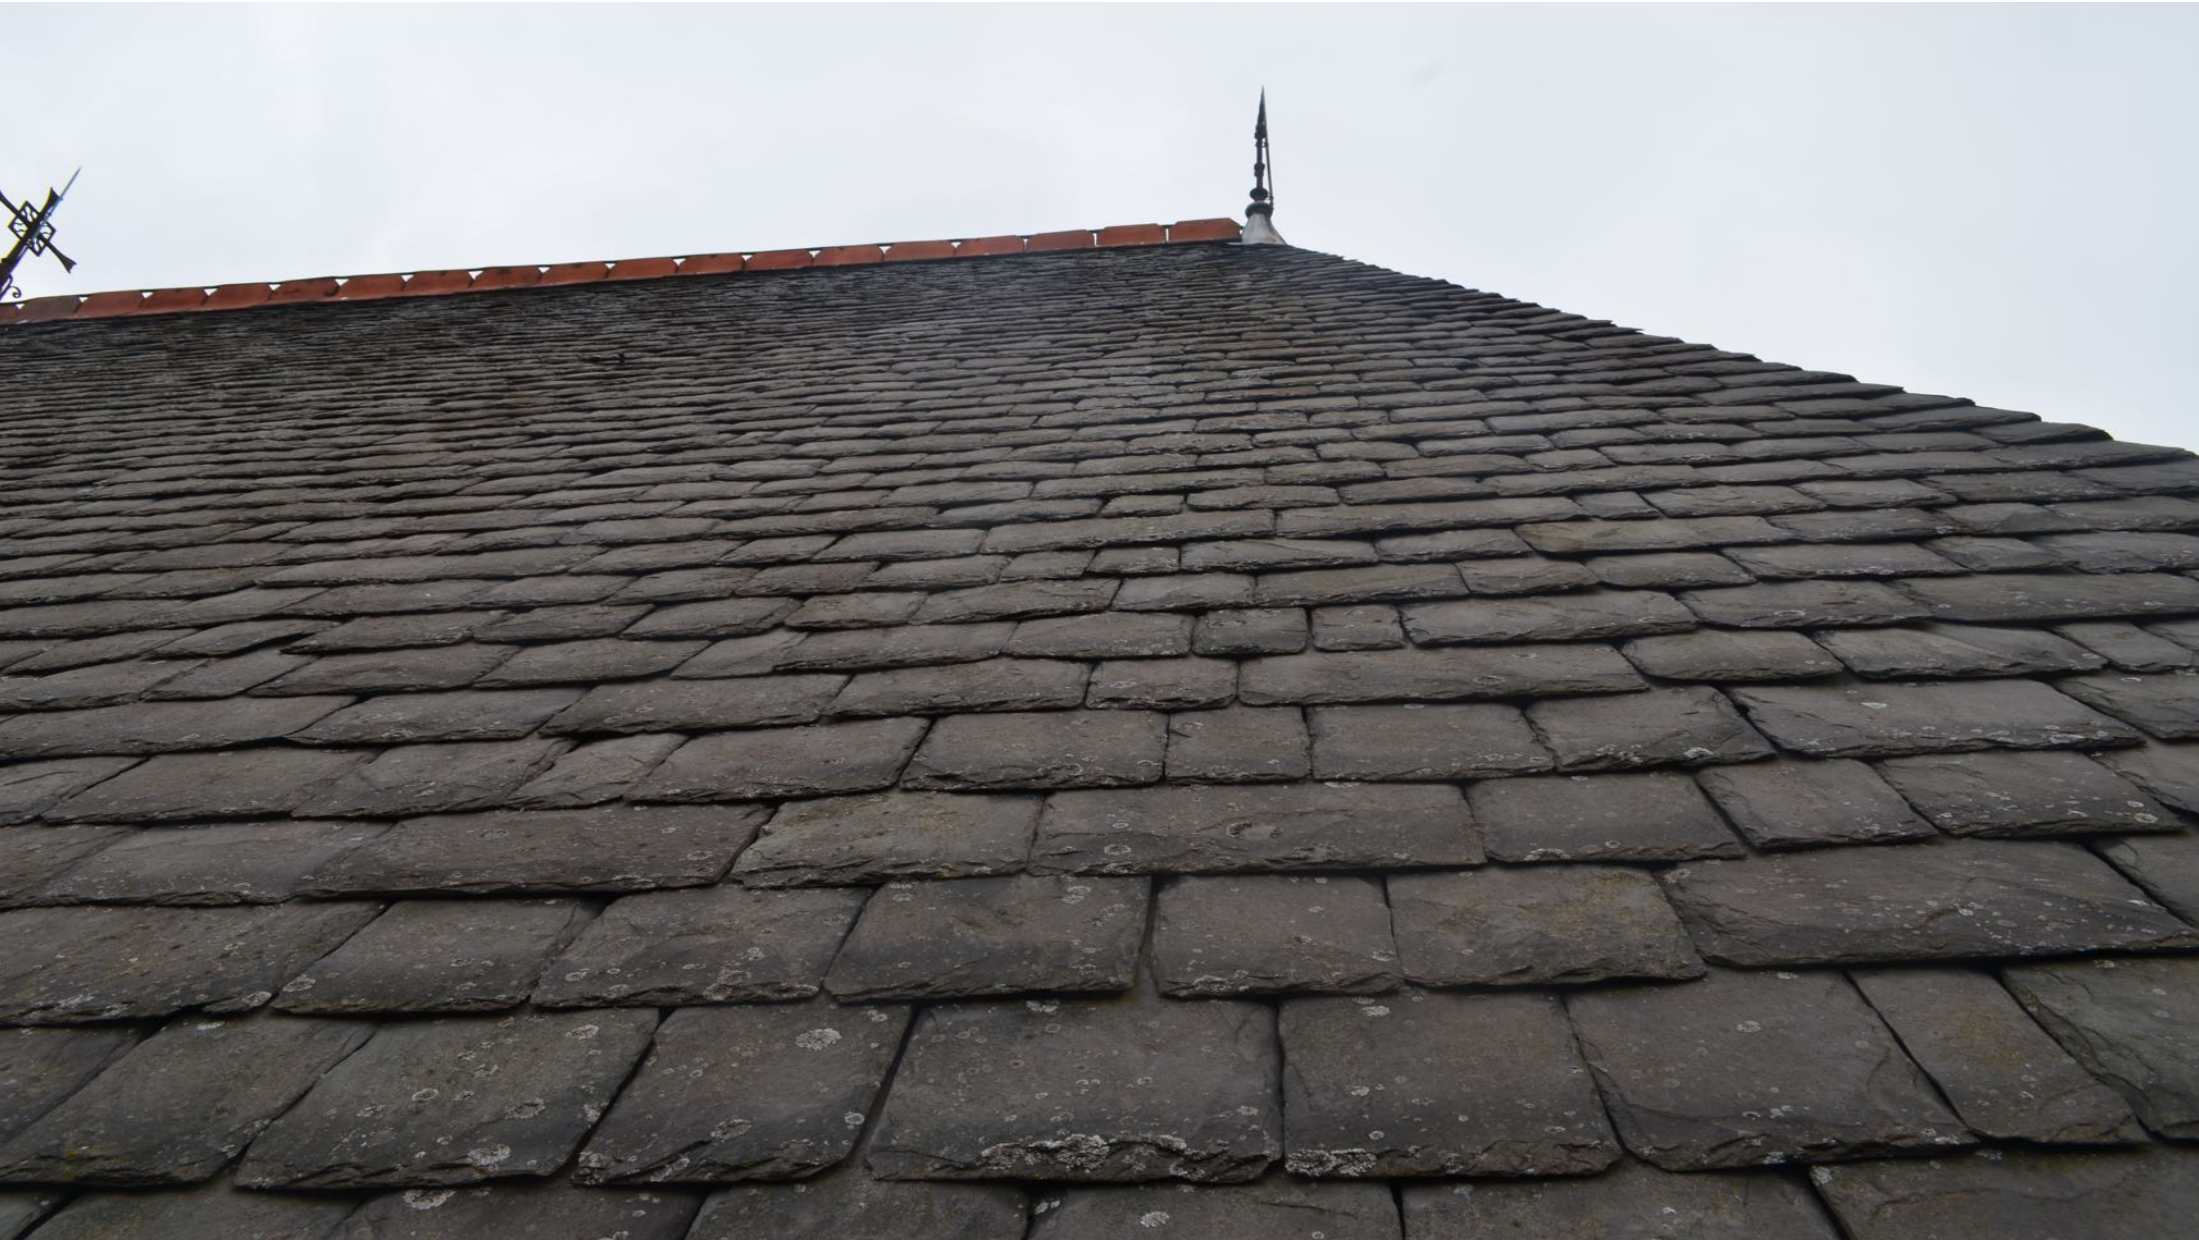
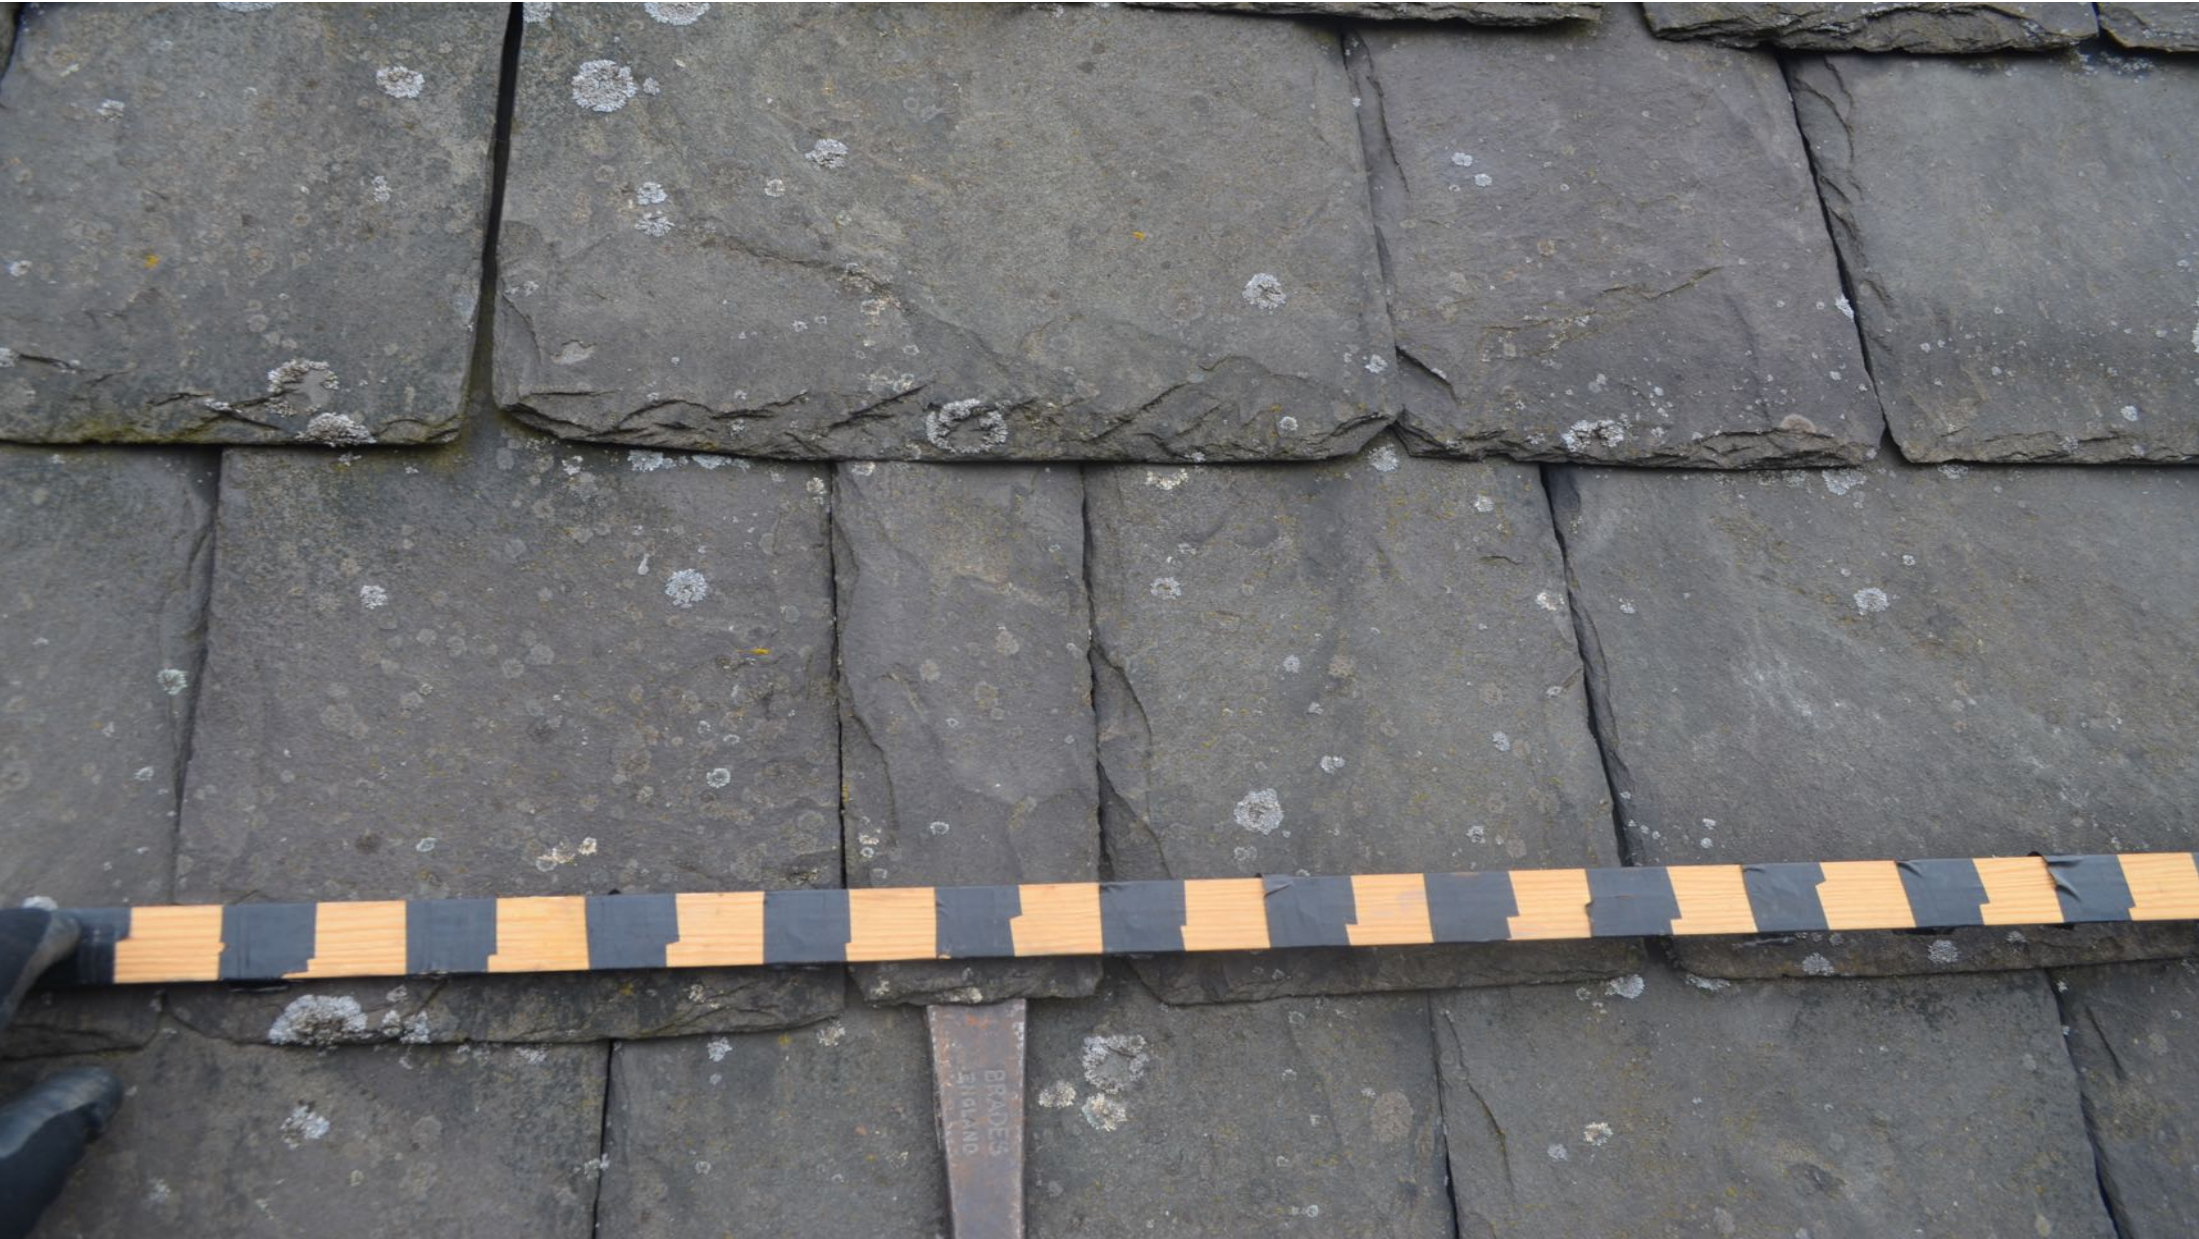
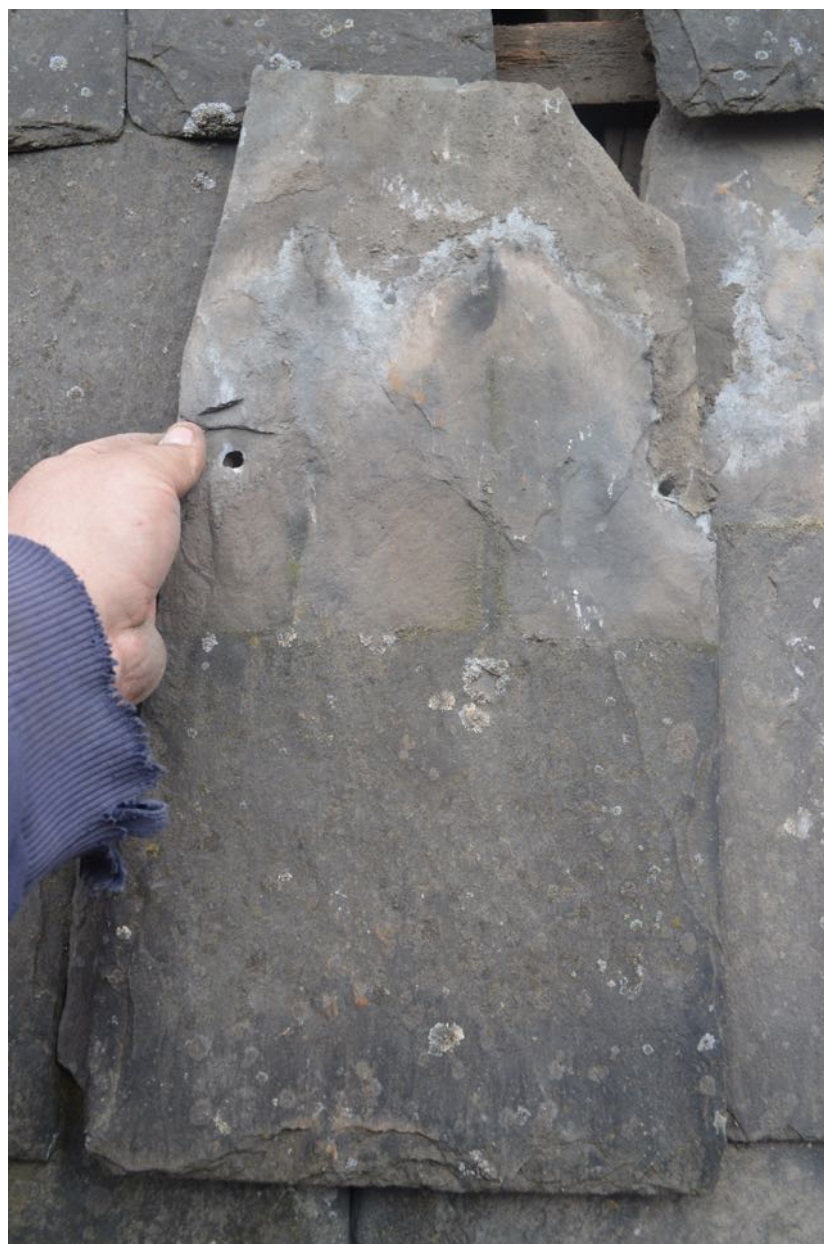
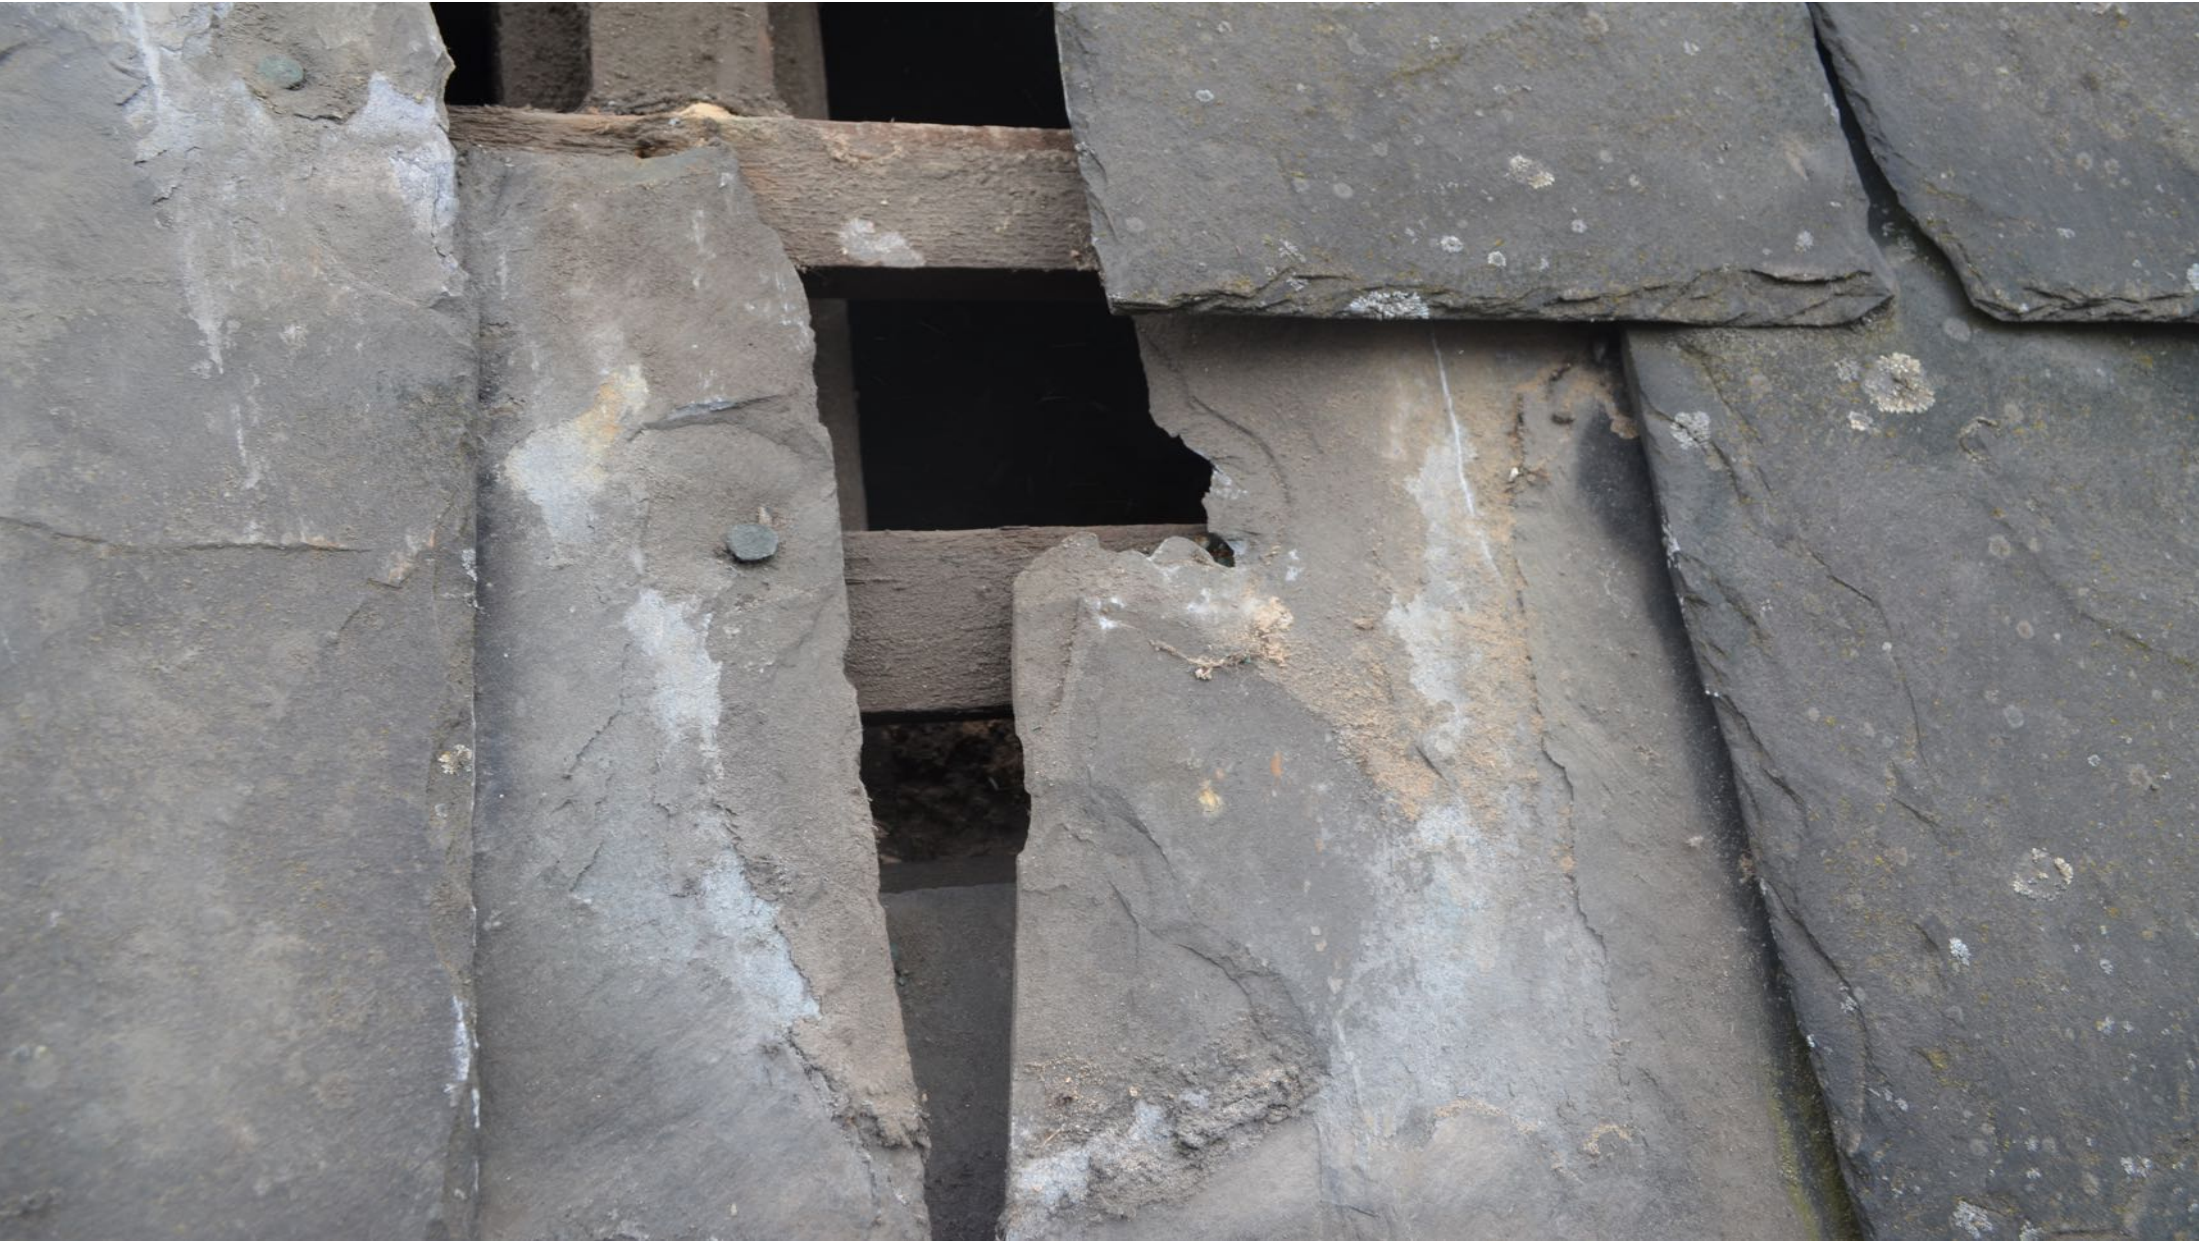
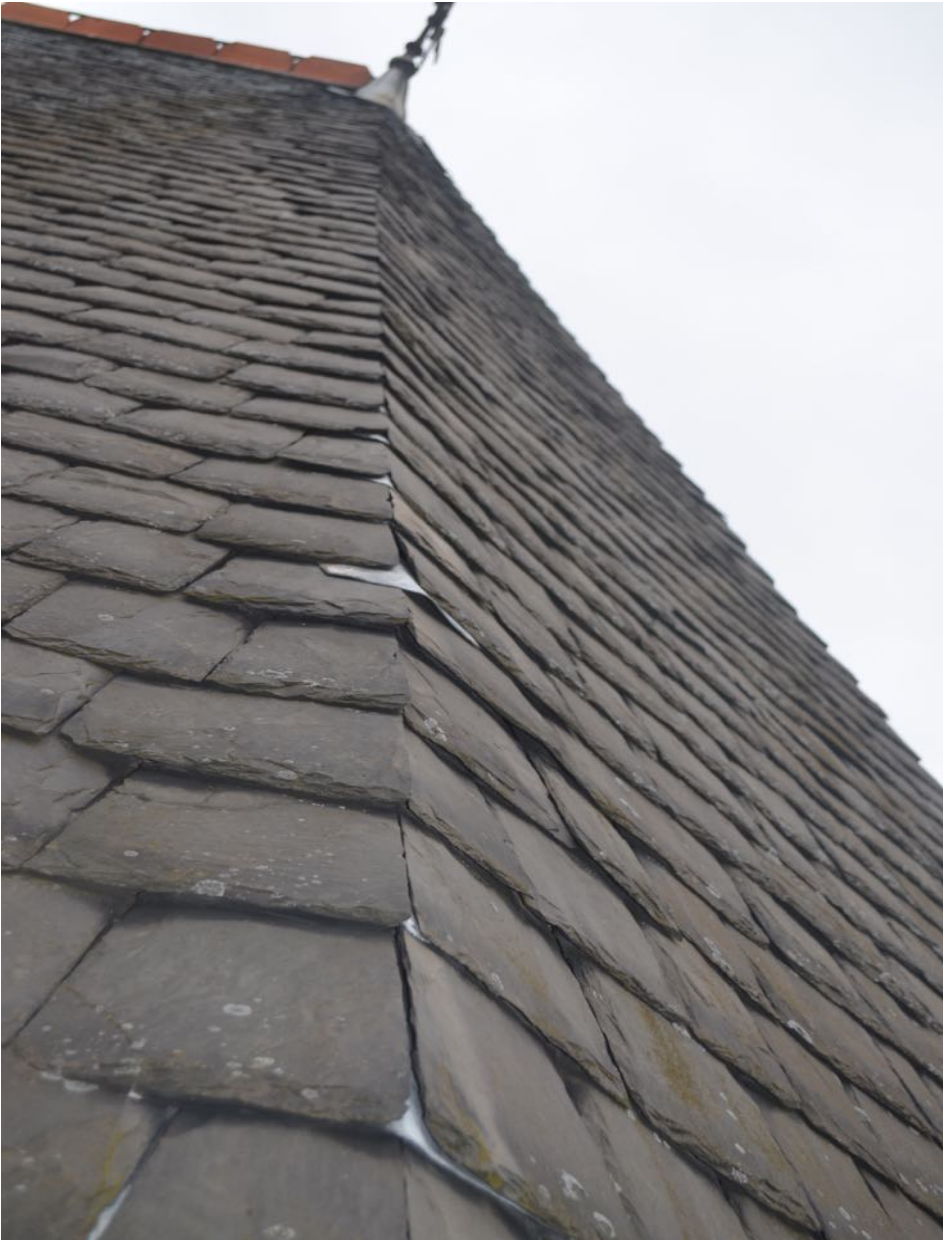
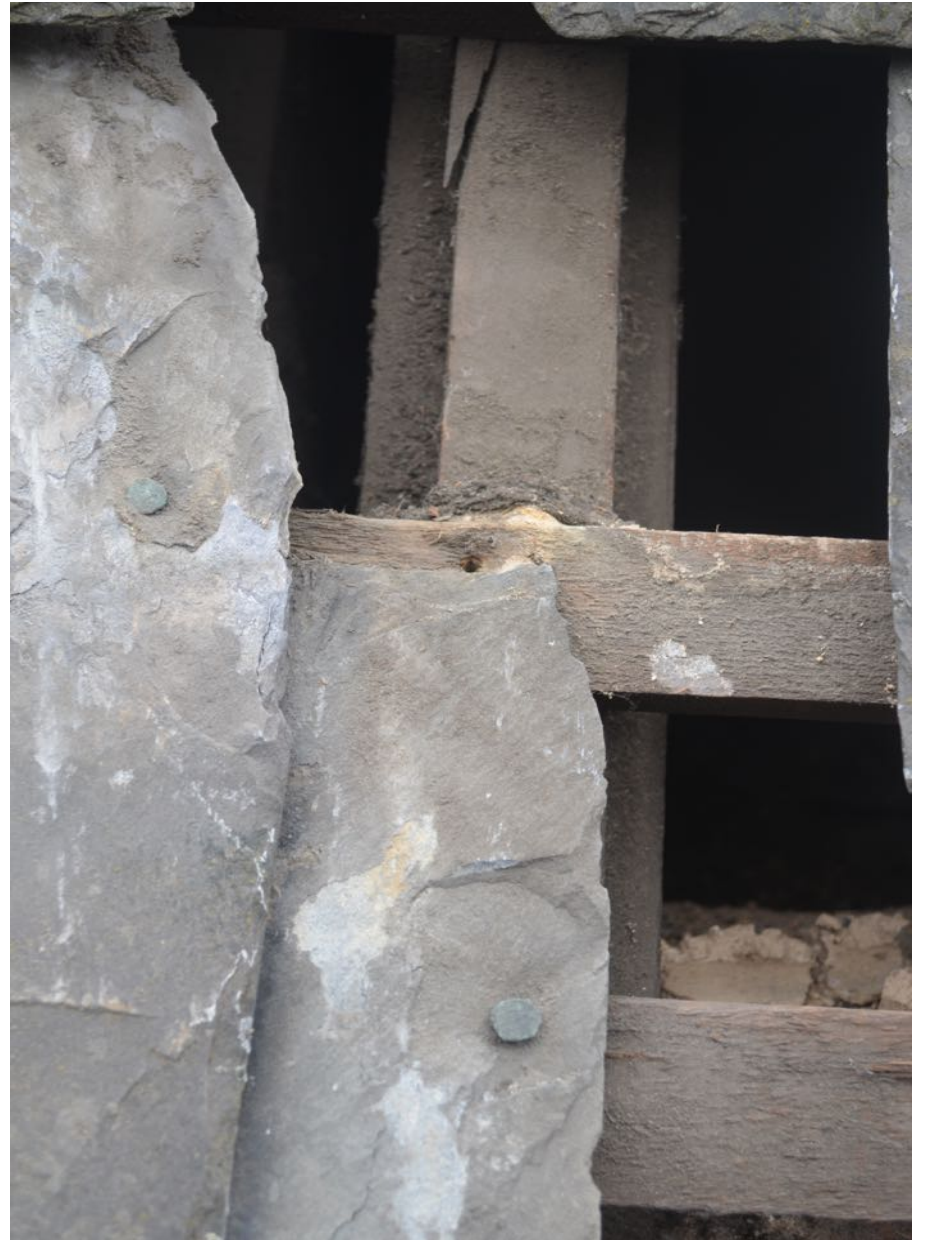
The Chancel has a apse end with close mitred hips. The roof coverings on the chancel are Swithland slates and were opened up from course 4 down. The slating lay well and tight across the whole area. The slates were centred fixed using 2 large copper nails per slate, with the head of the slates cut to form a 4 sided cut slate. This is not typical of Swithland slates which are generally head fixed over lath or shoulder fixed nailed to boards. The slate batten was nominal 2" x 1" fixed to a 3.5"x 3.5" rafter with a 1.25" x 1.75" counter batten placed on top of the rafter. The batten and counter batten were fixed with steel nails.

The longest slates were 24.5" on the over eave slate dropping to 19" on course 4. the widest slate was around 12" and the narrowest slate was around 3". The pitch of the roof was 55 degrees and the slates had minimum 2.75" to 3" head lap

There was no lime mortar bedding or torching to this area of the roof.

**The Chancel** should be repaired using Swithland slates taken from areas of the church that will need replacing and that are hidden from the main view. I recommend the slopes on the North side of the church.
