# St Peter's Church

## Roof condition

Heritage Crafts & Building Skills Centre Ltd

The purpose of the roof survey was to establish the condition of the roof slope of the Church of St Peter's. A total of 6 areas were opened to check the condition of the fixing's and the design of the slating and roof structure.

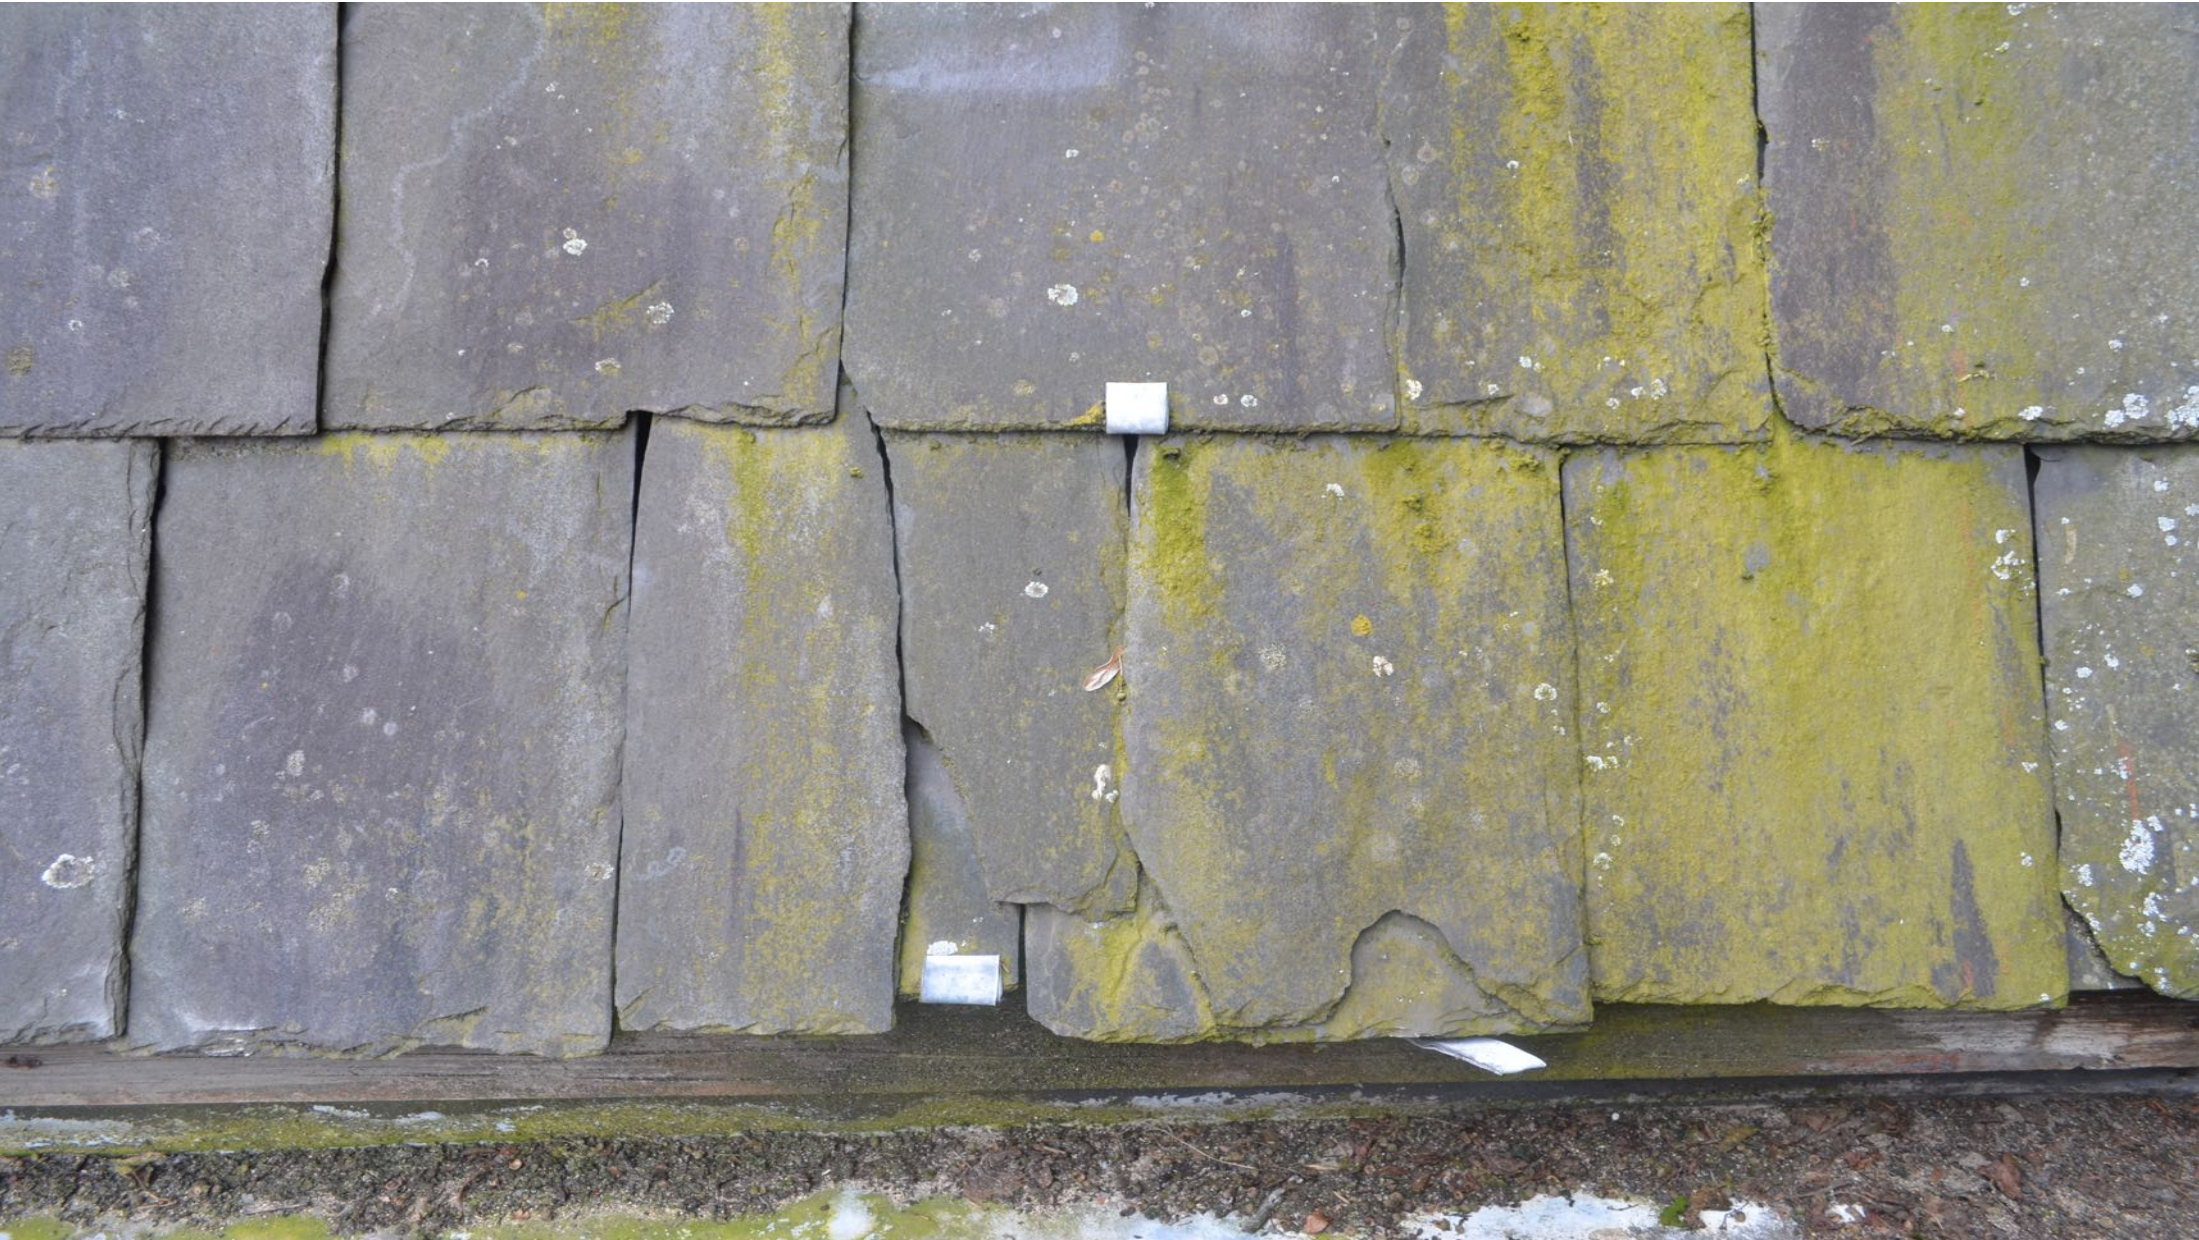
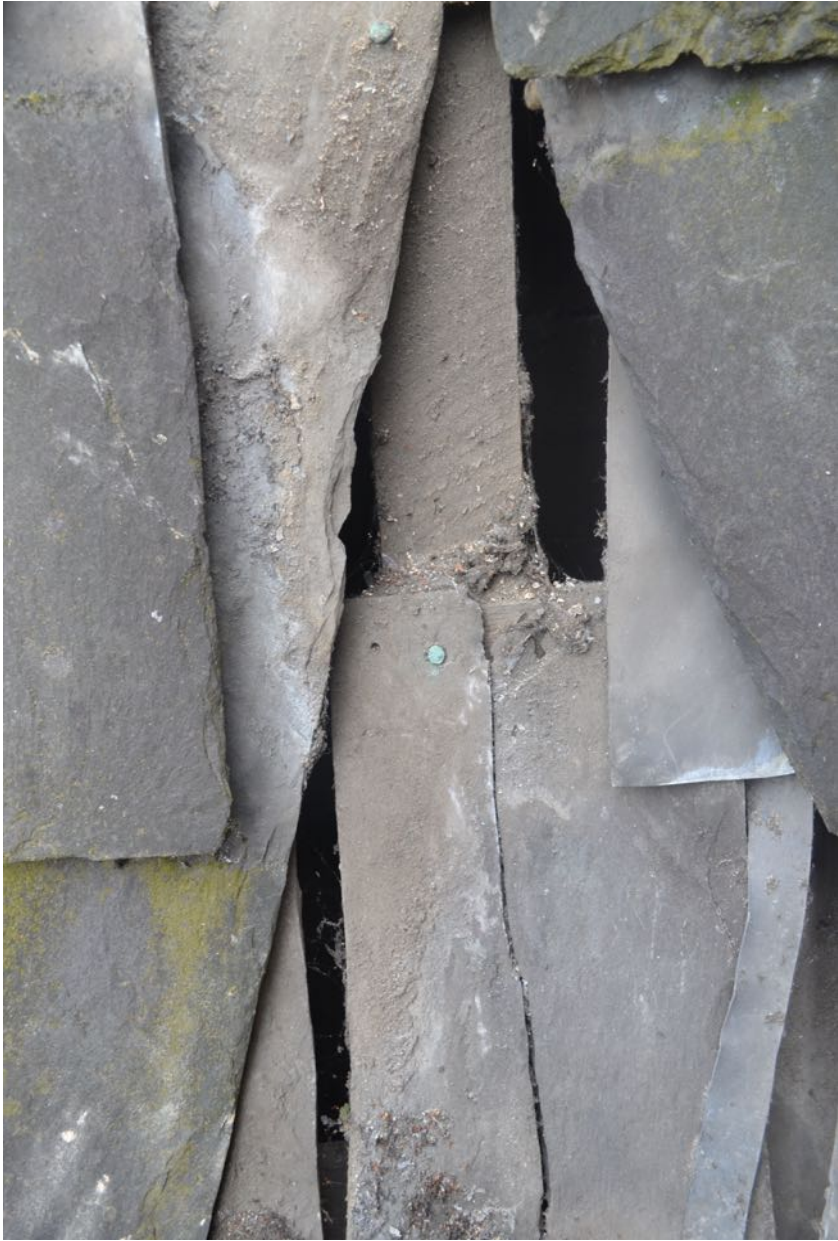
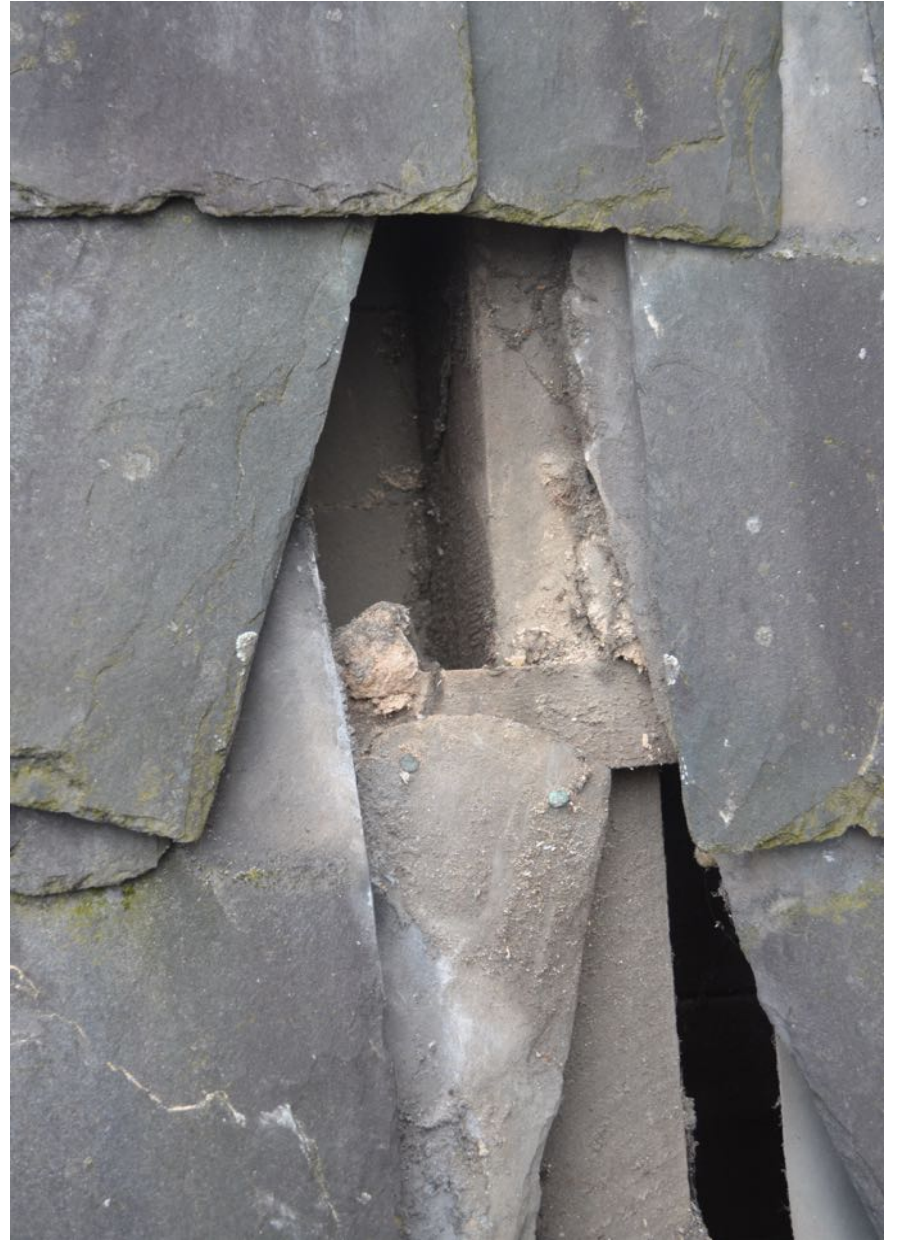
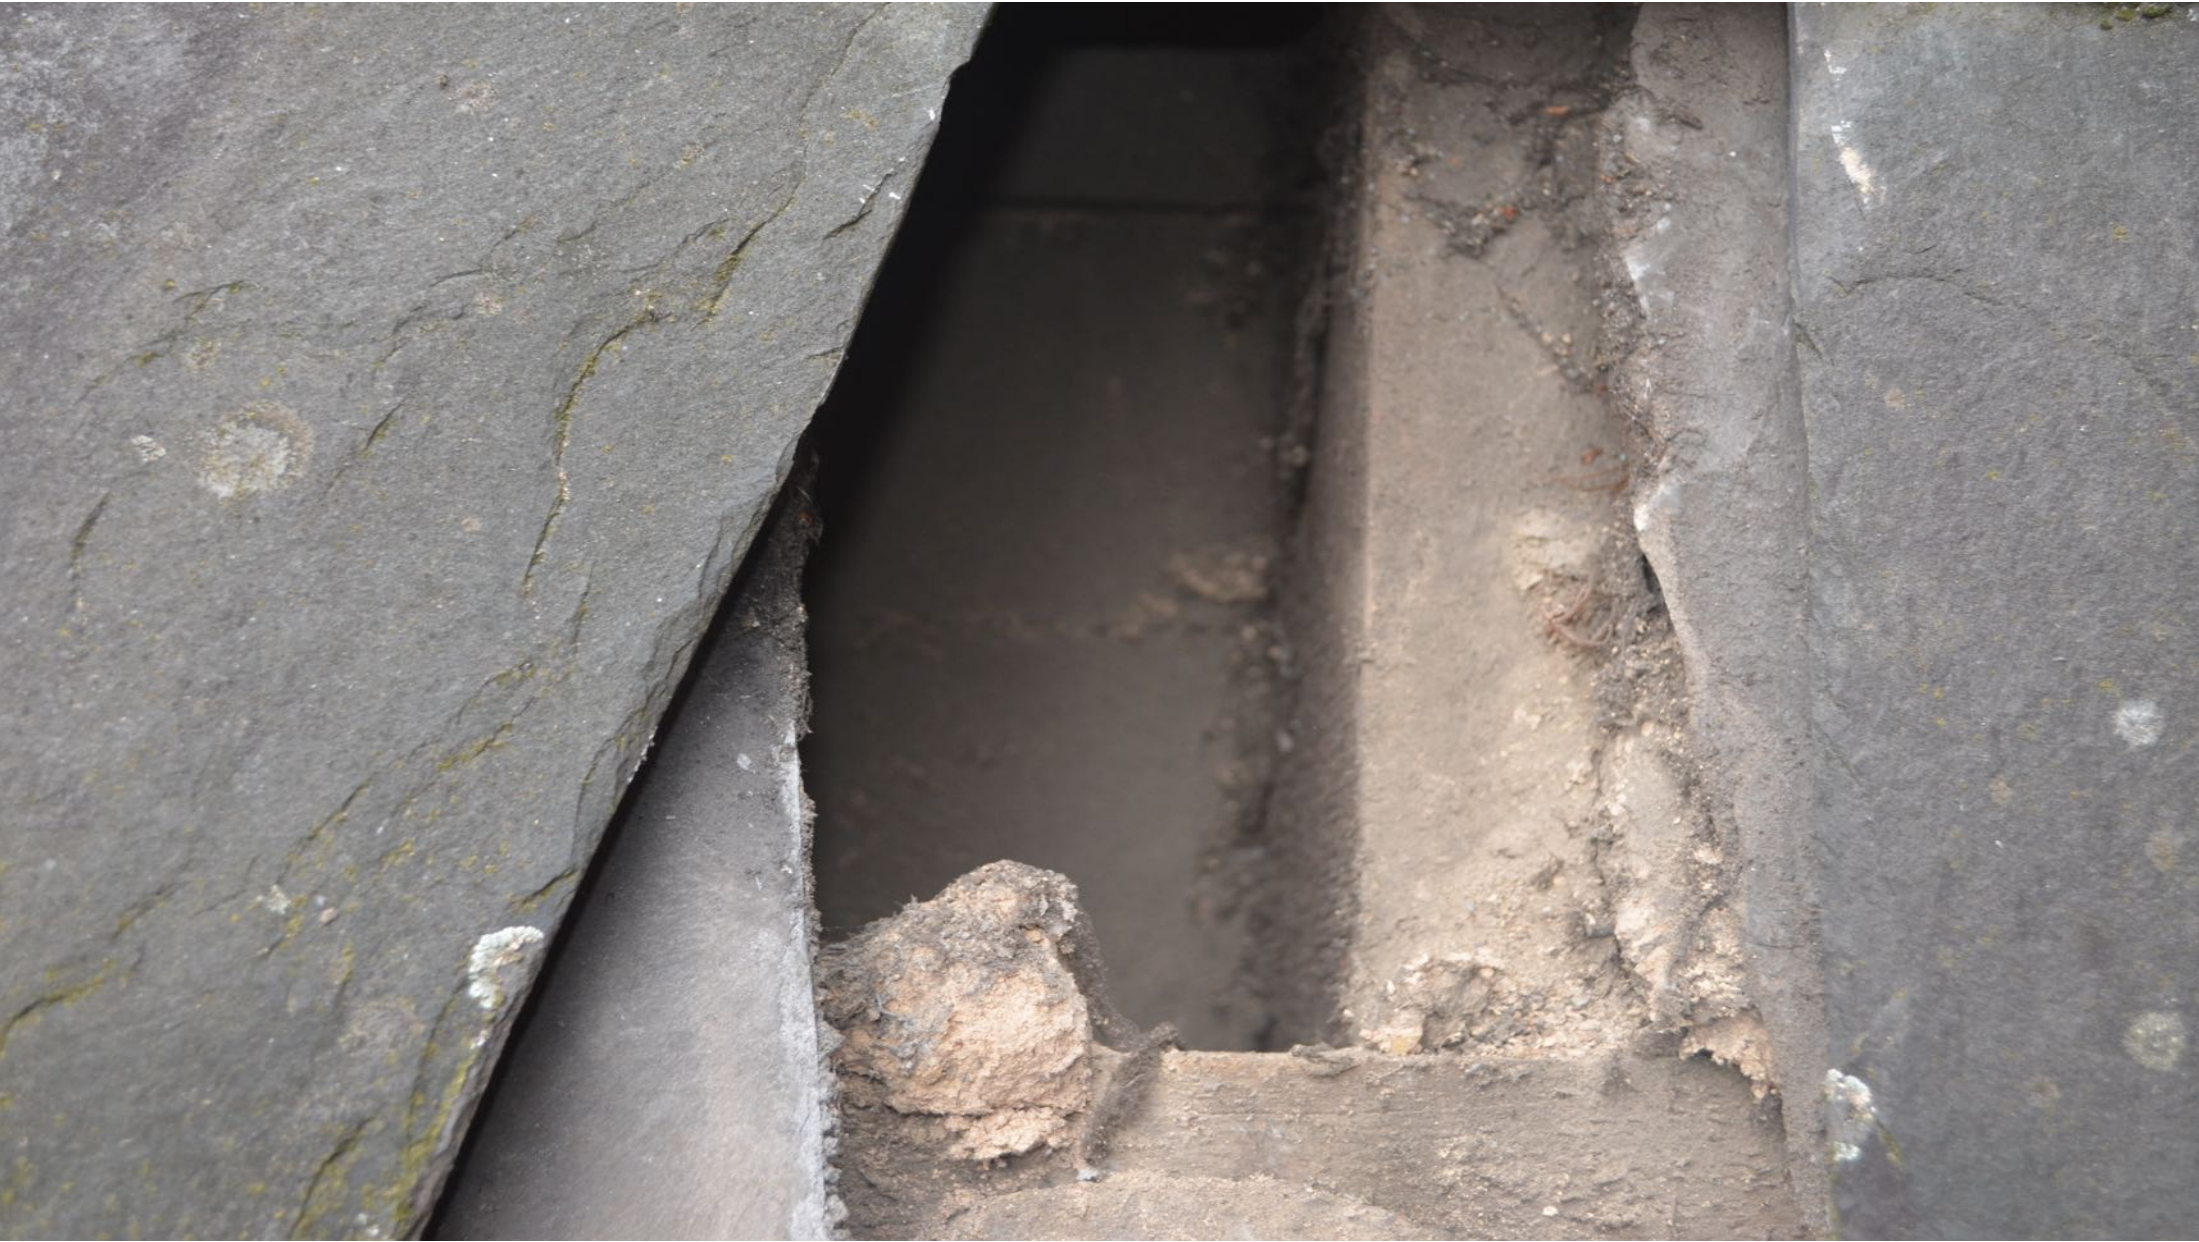
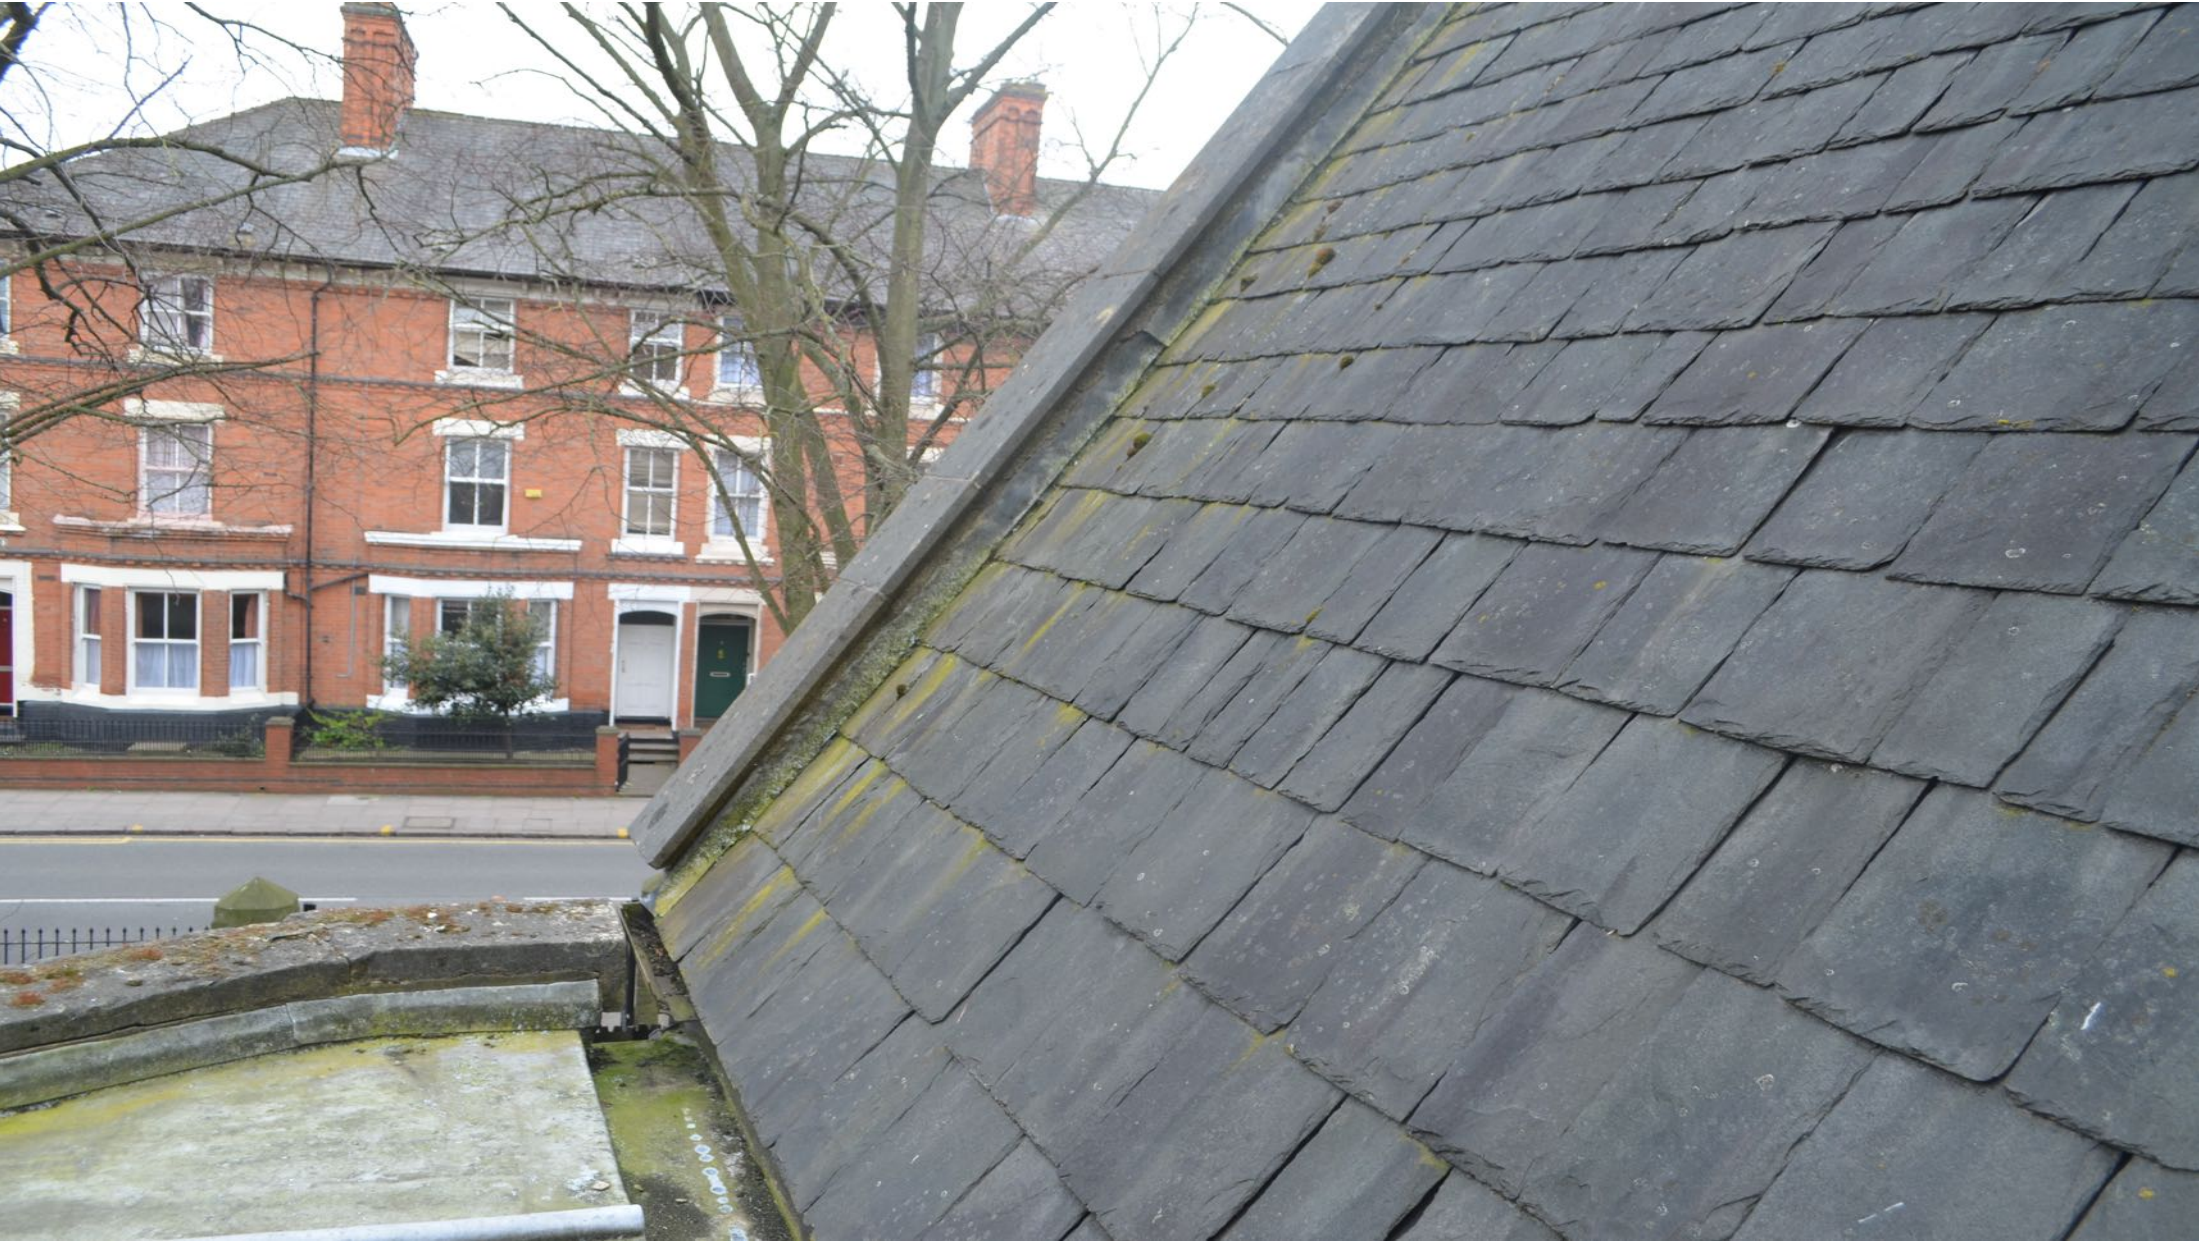
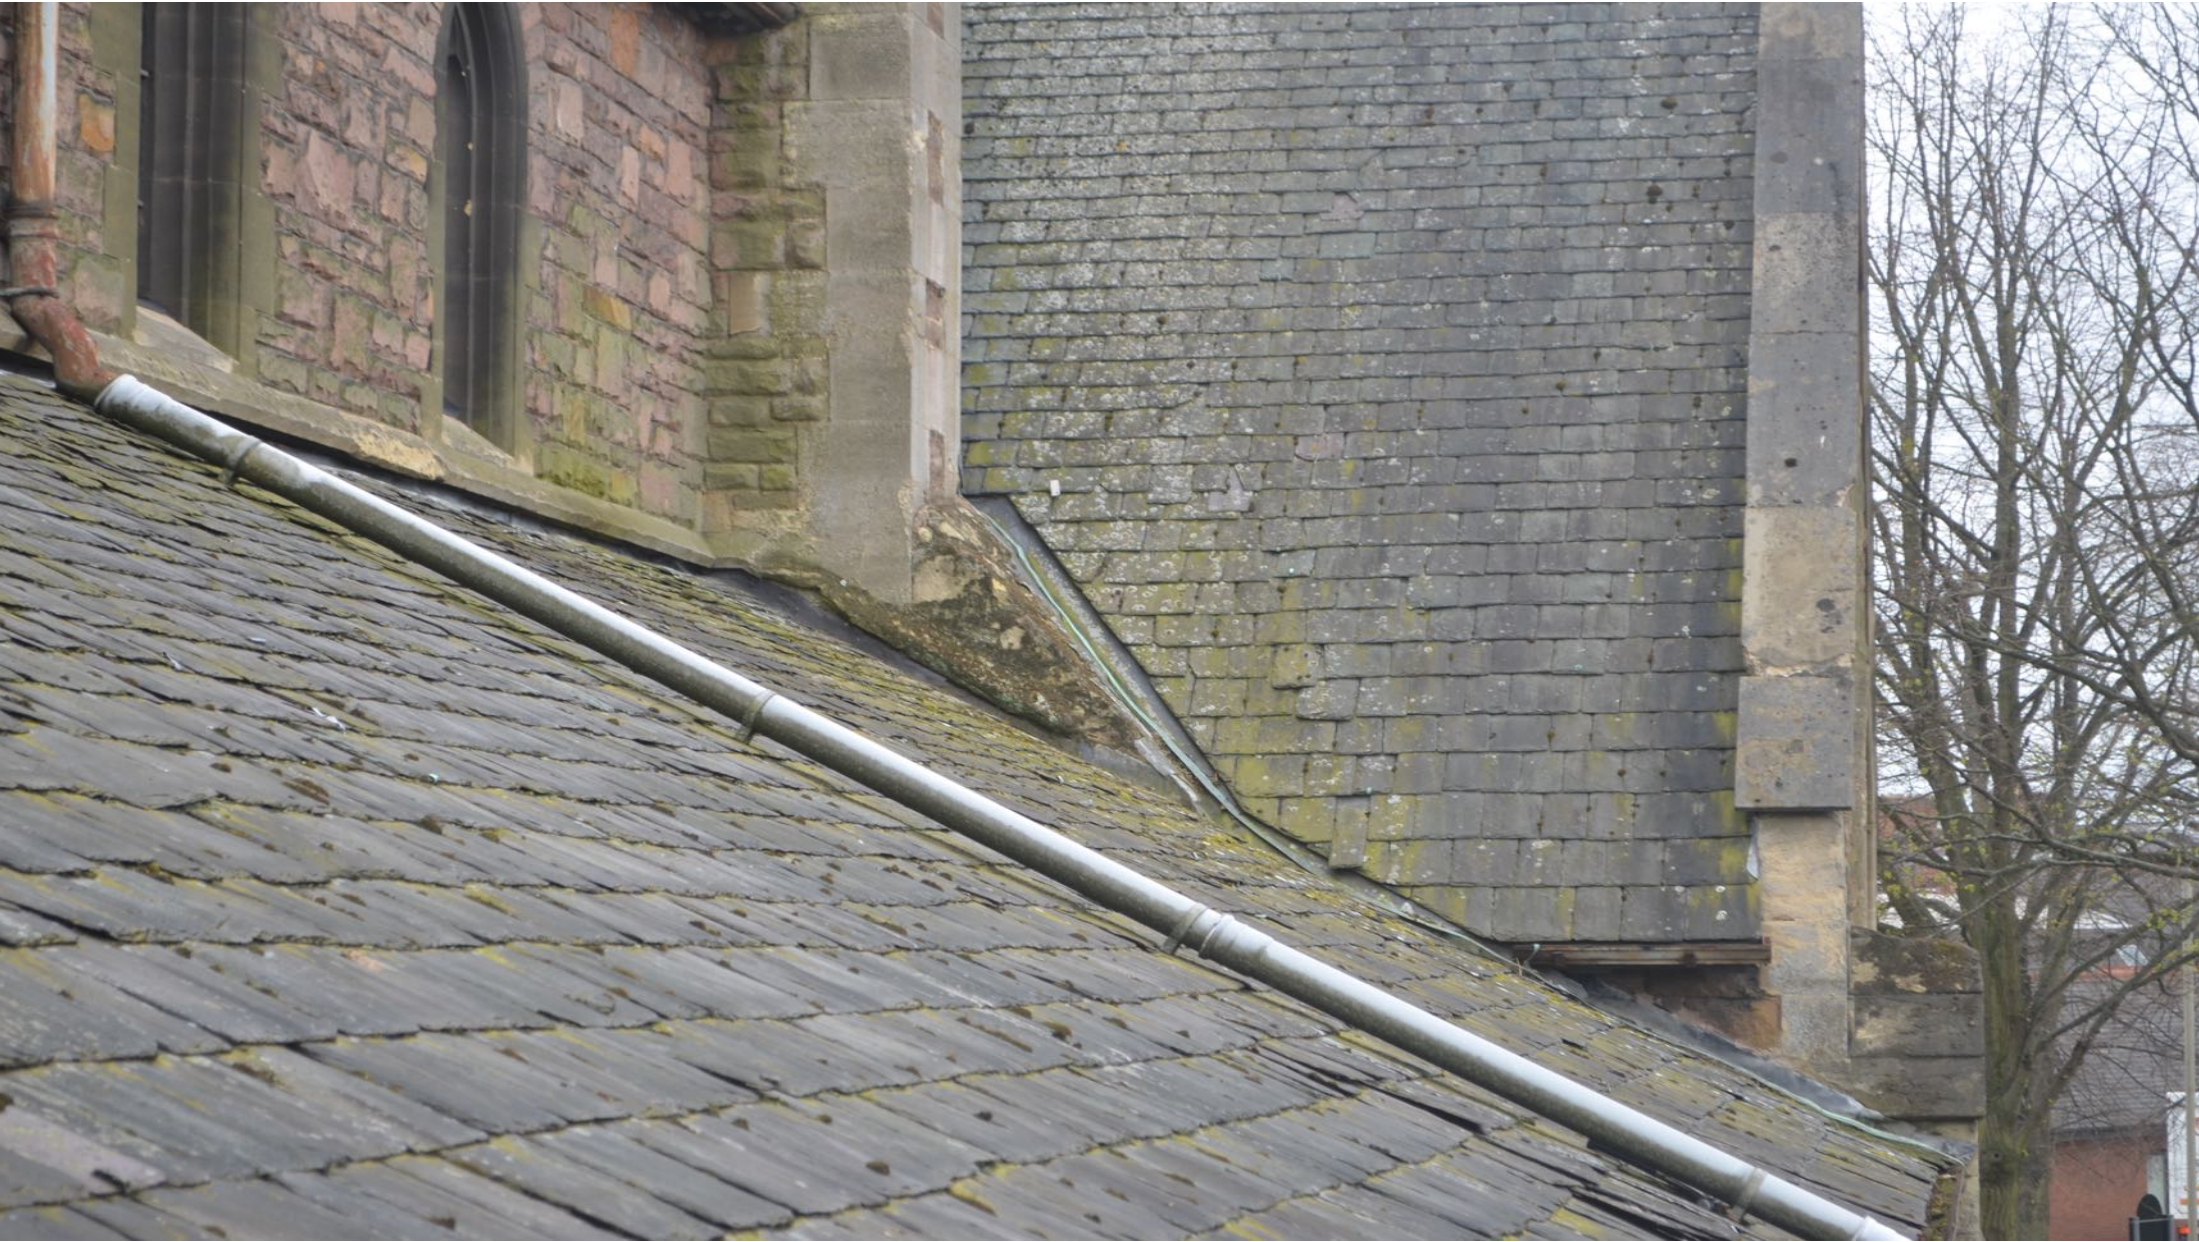
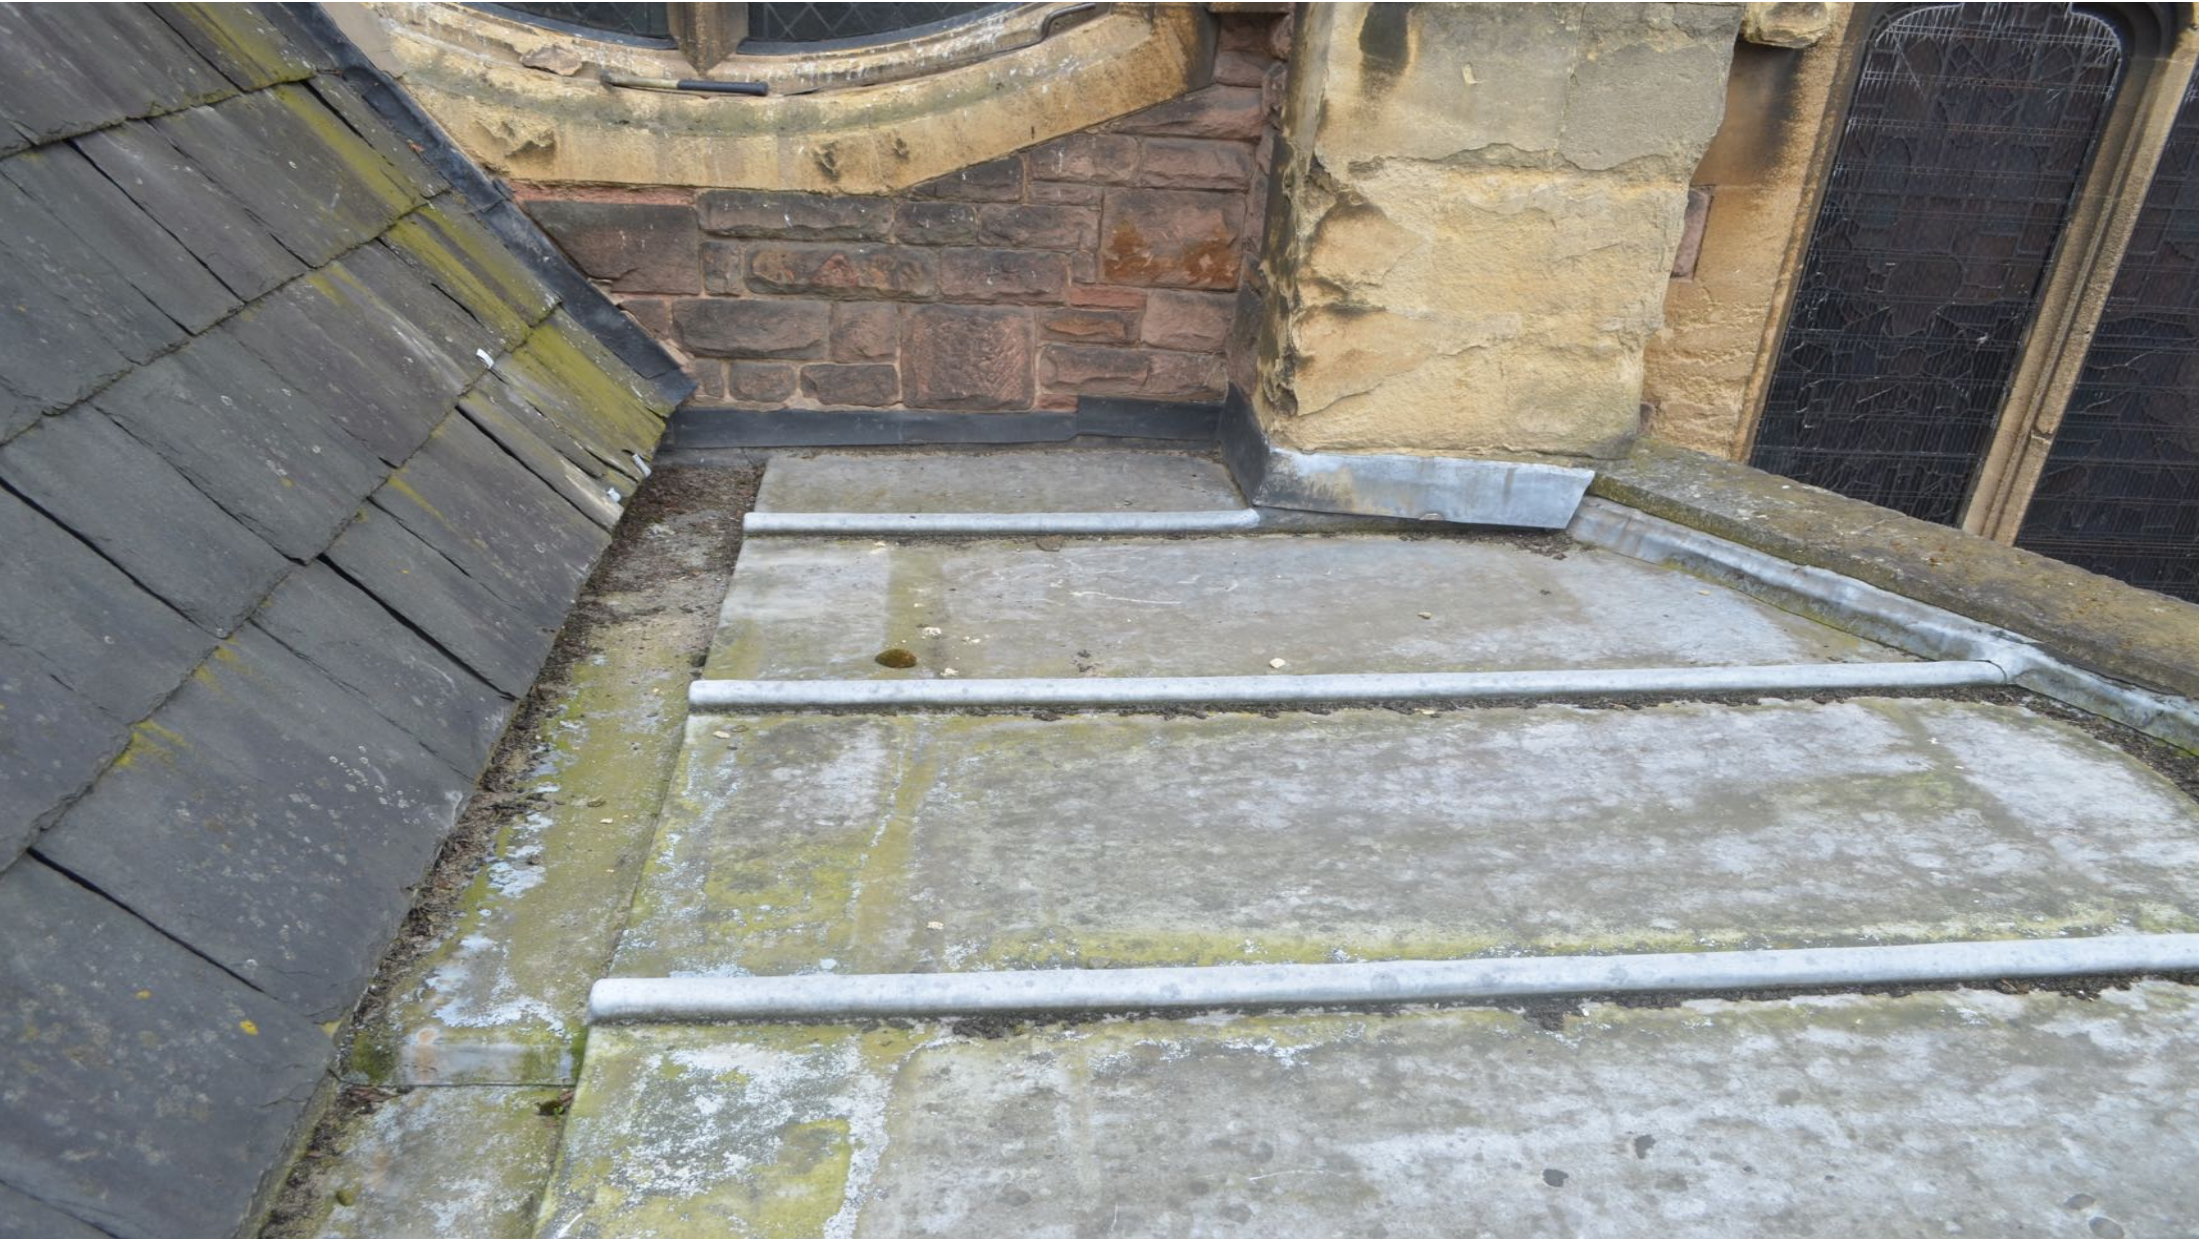
# The South Transept

The roof coverings on the South Transept are Swithland slates and were opened up from course 4 down. The slating did not lay as well across this area with repairs being carried out around the eaves to various standards. The slates were head fixed using 1 large copper nail per slate. This is typical of Swithland slates which are generally head fixed over lath or nailed into the batten. The slate batten was nominal 2" x 1" fixed to a 6"x 3" rafter and boarded from the underside of the rafter. The battens were fixed with steel nails. There was signs of lime mortar over the rafter in between the slate batten and a small amount of torching.

The longest slates were 32" on the over eave slate dropping to 26" on course 4. the widest slate was around 14" and the narrowest slate was around 4.5". The pitch of the roof was 55 degrees and the slates had minimum 2.75" to 3" head lap.

**The South Transept** should be repaired using Swithland slates taken from areas of the church that will need replacing and that are hidden from the main view. I recommend the slopes on the North side of the church.
