# St Peter's Church

## Roof condition

Heritage Crafts & Building Skills Centre Ltd

The purpose of the roof survey was to establish the condition of the roof slope of the Church of St Peter's. A total of 6 areas were opened to check the condition of the fixing's and the design of the slating and roof structure.

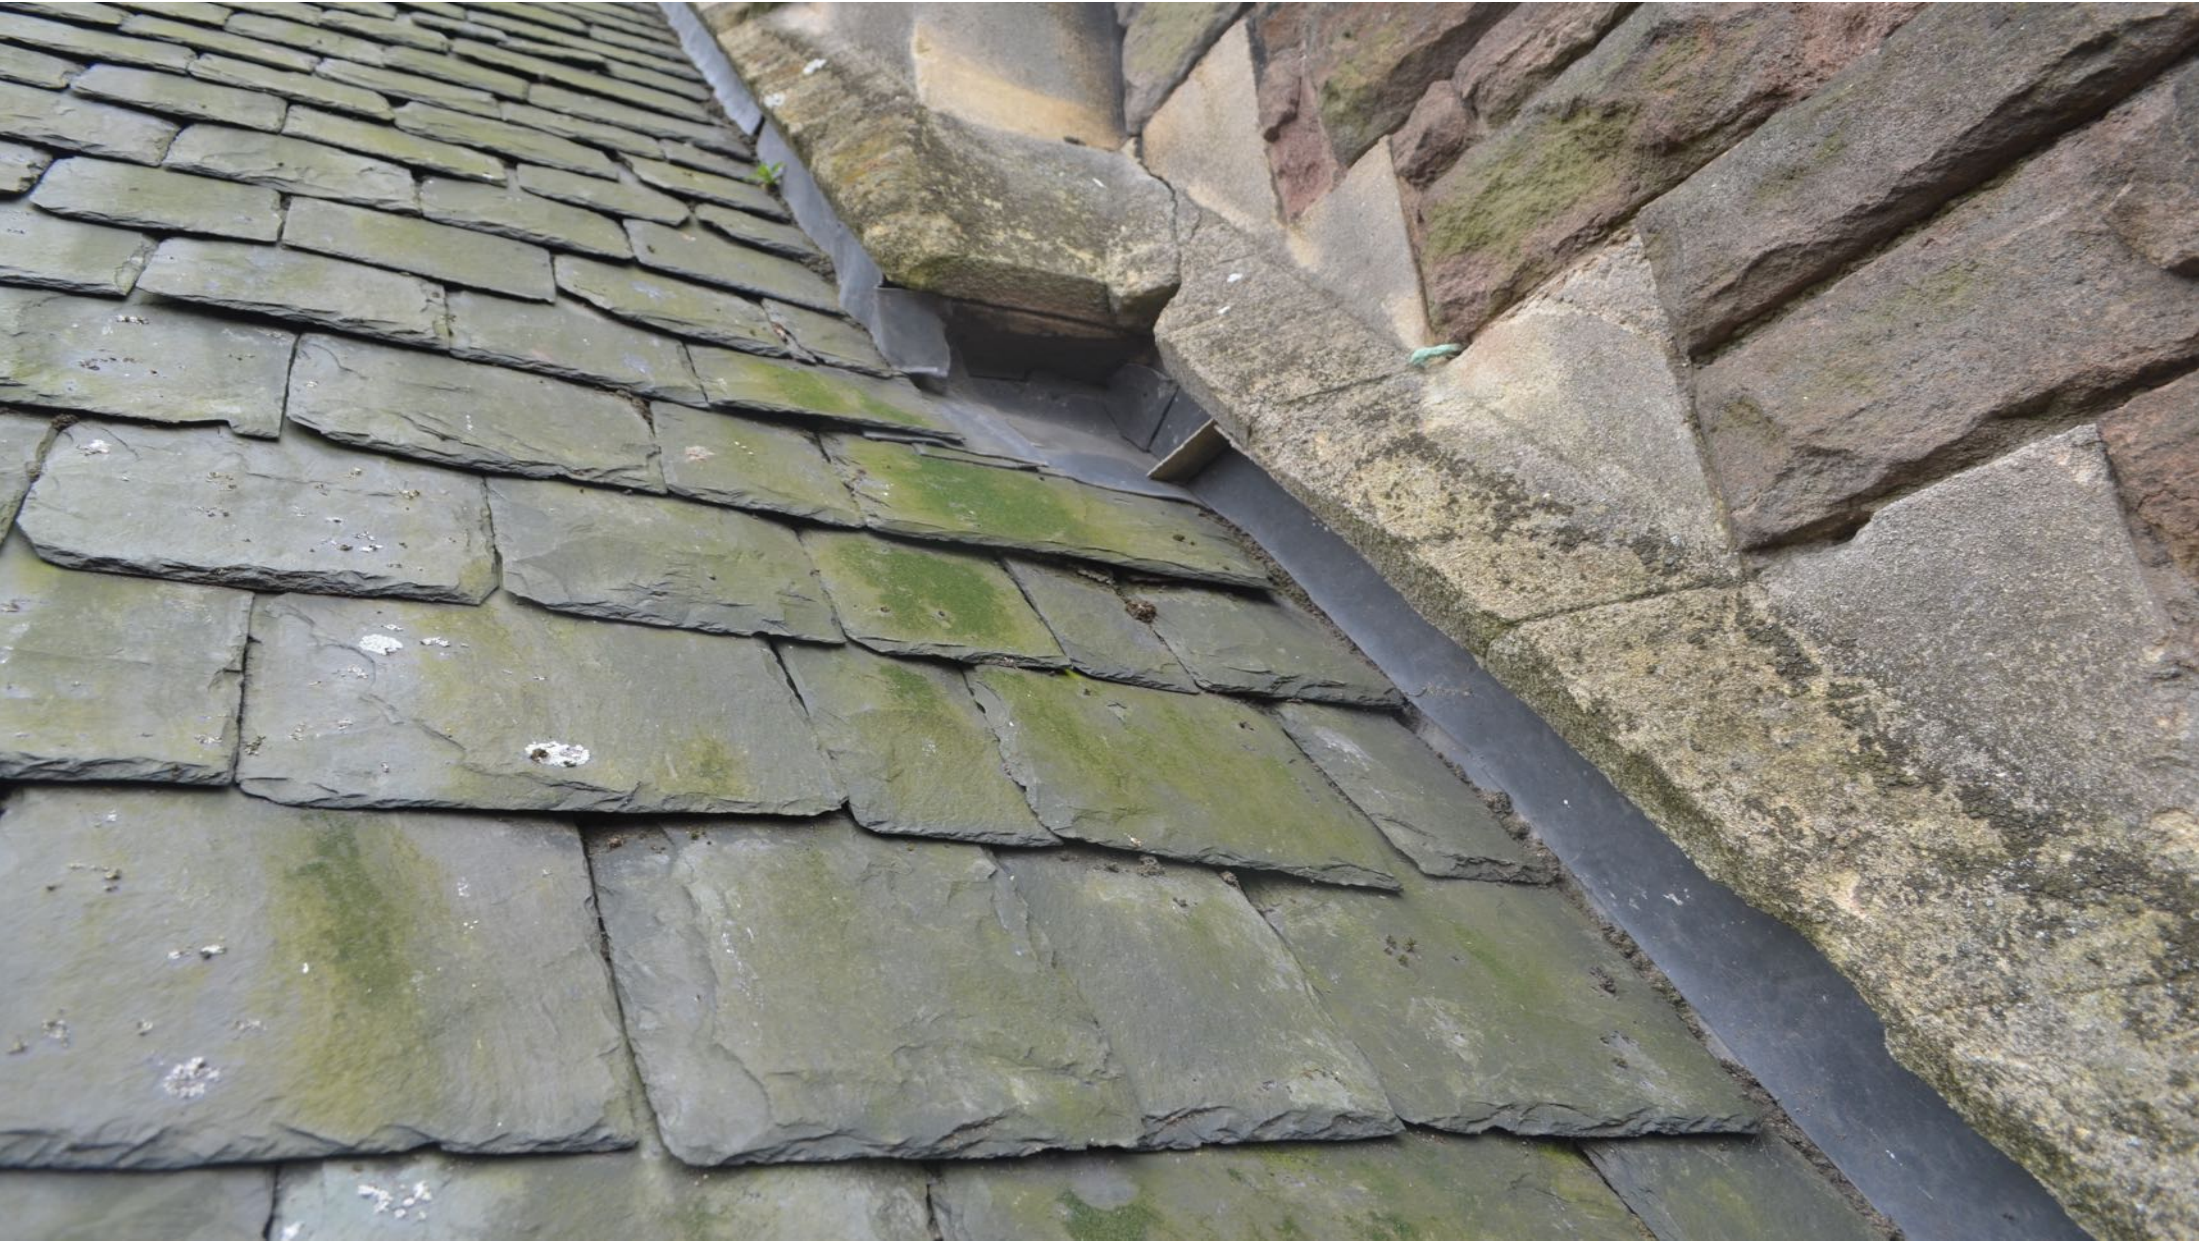
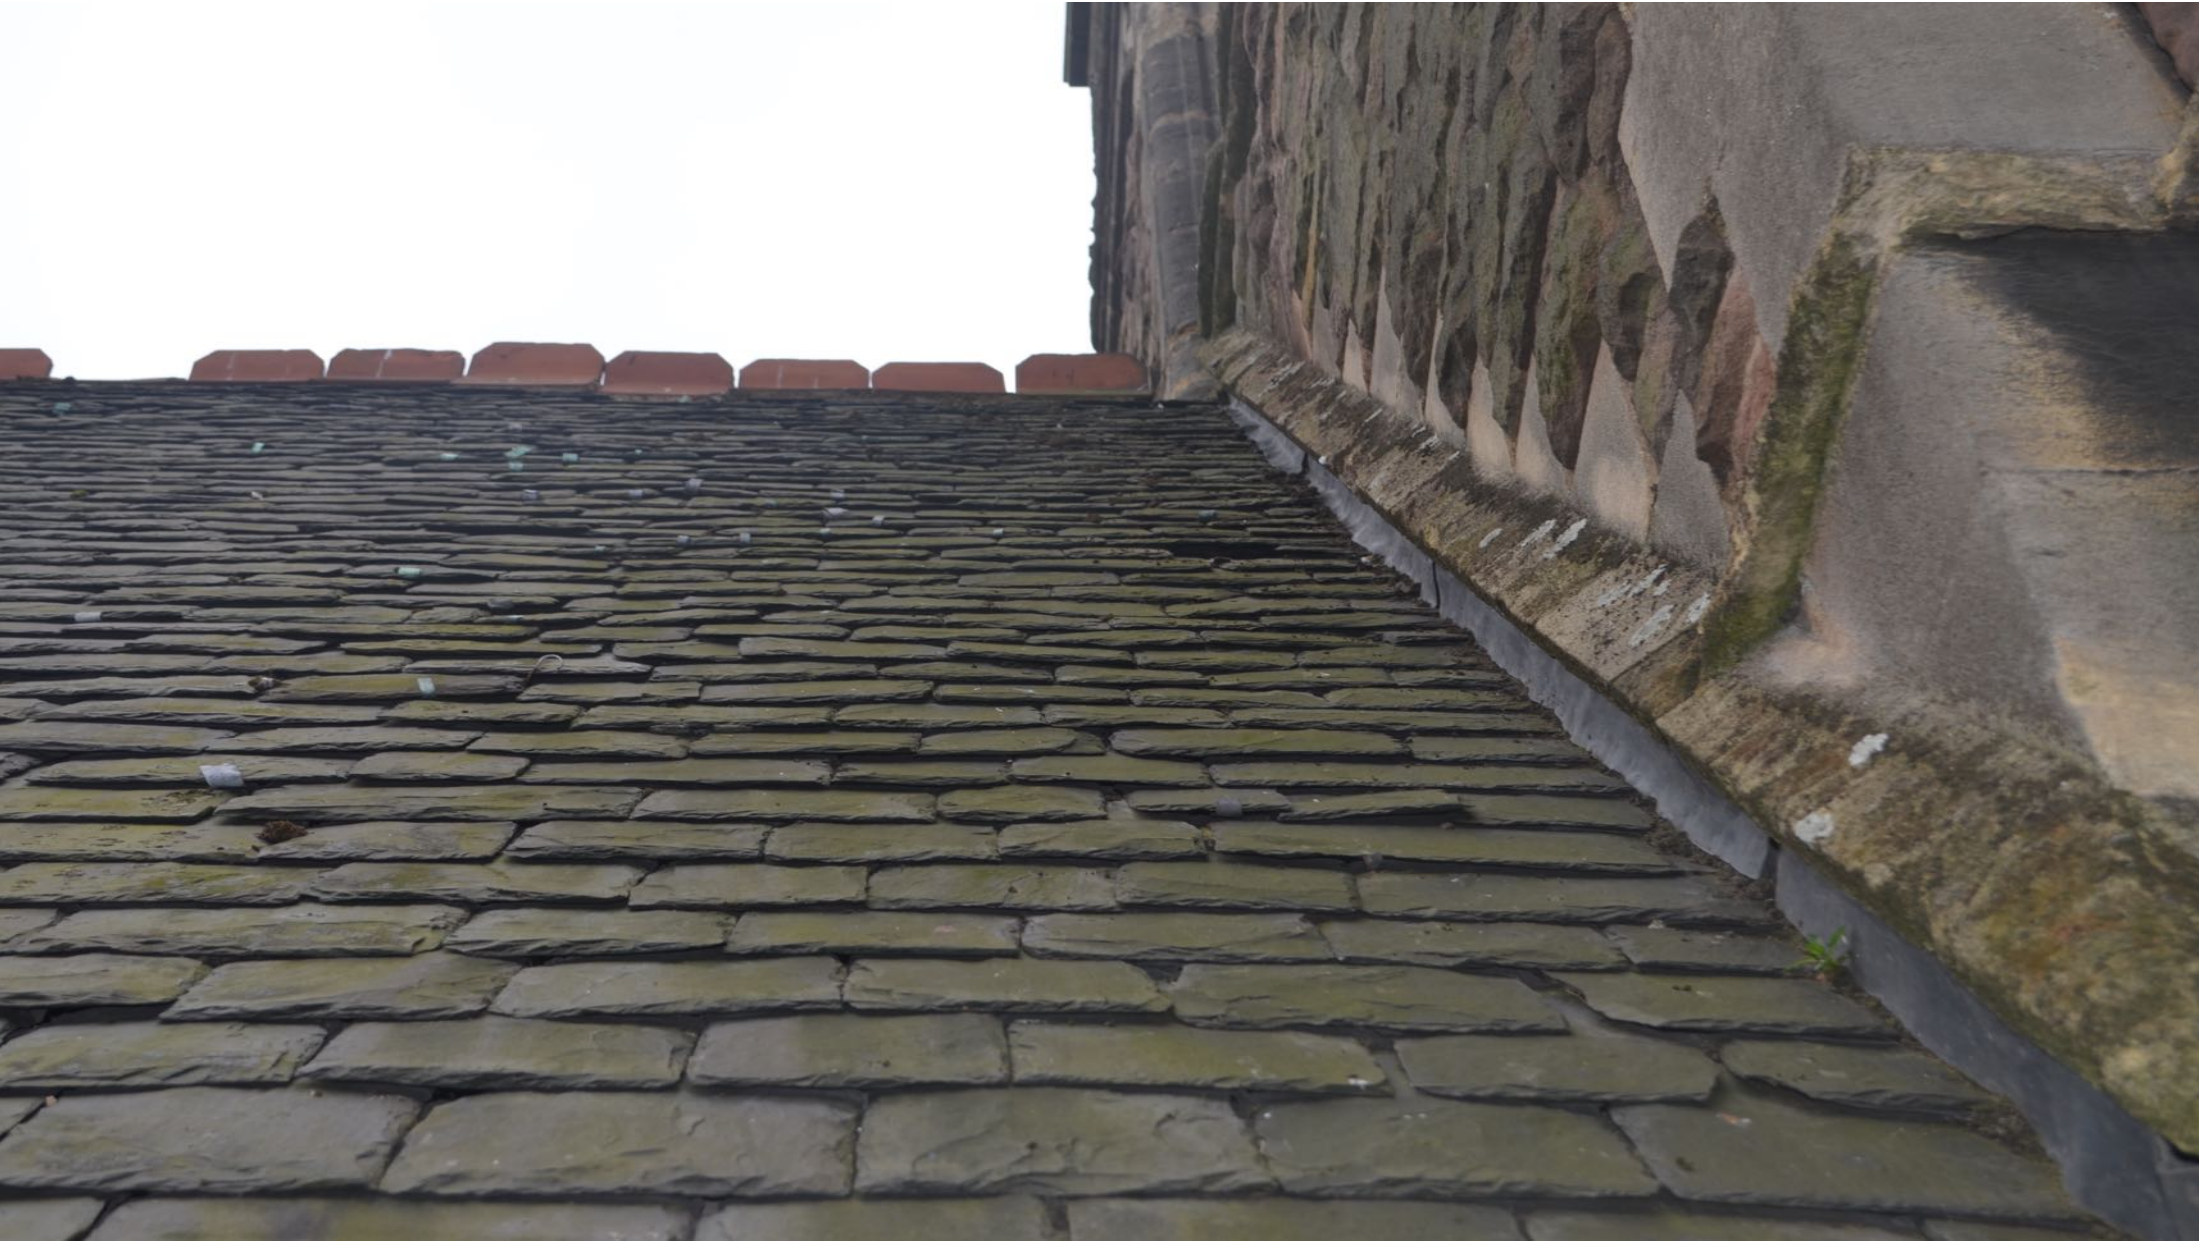
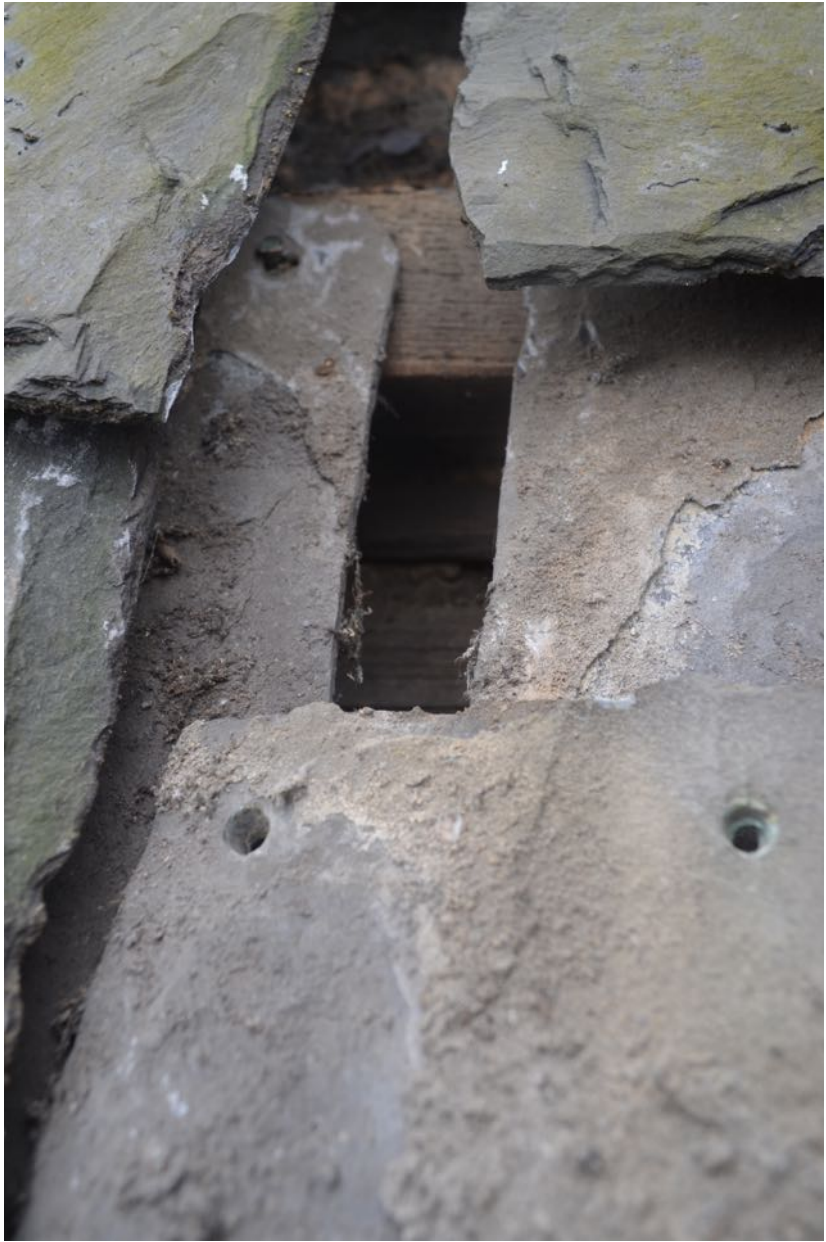
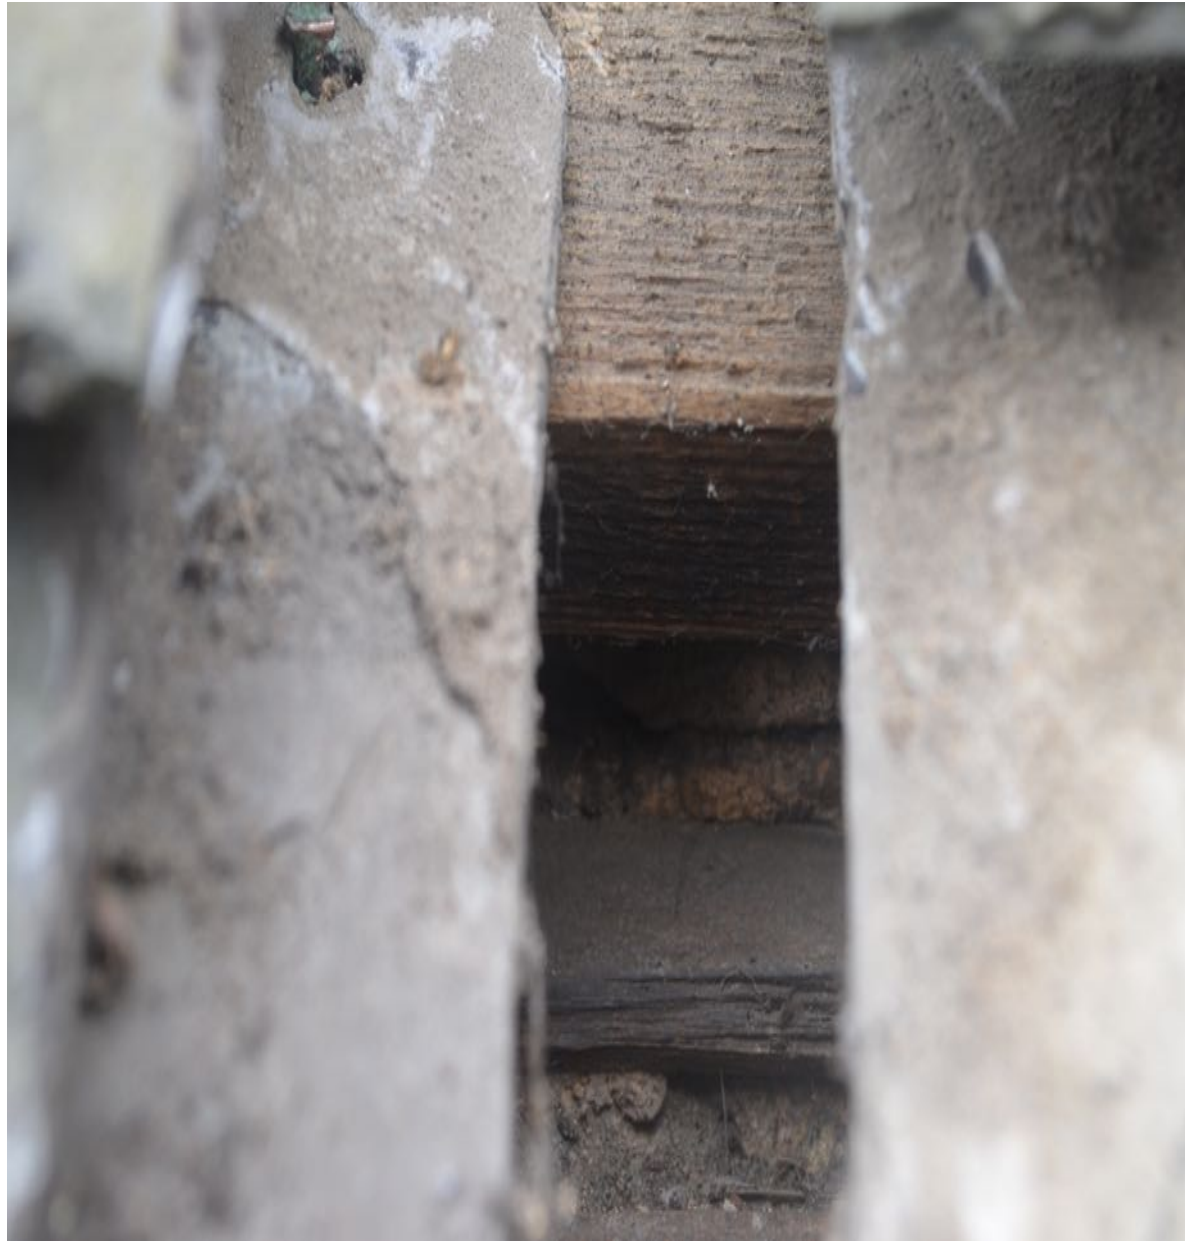
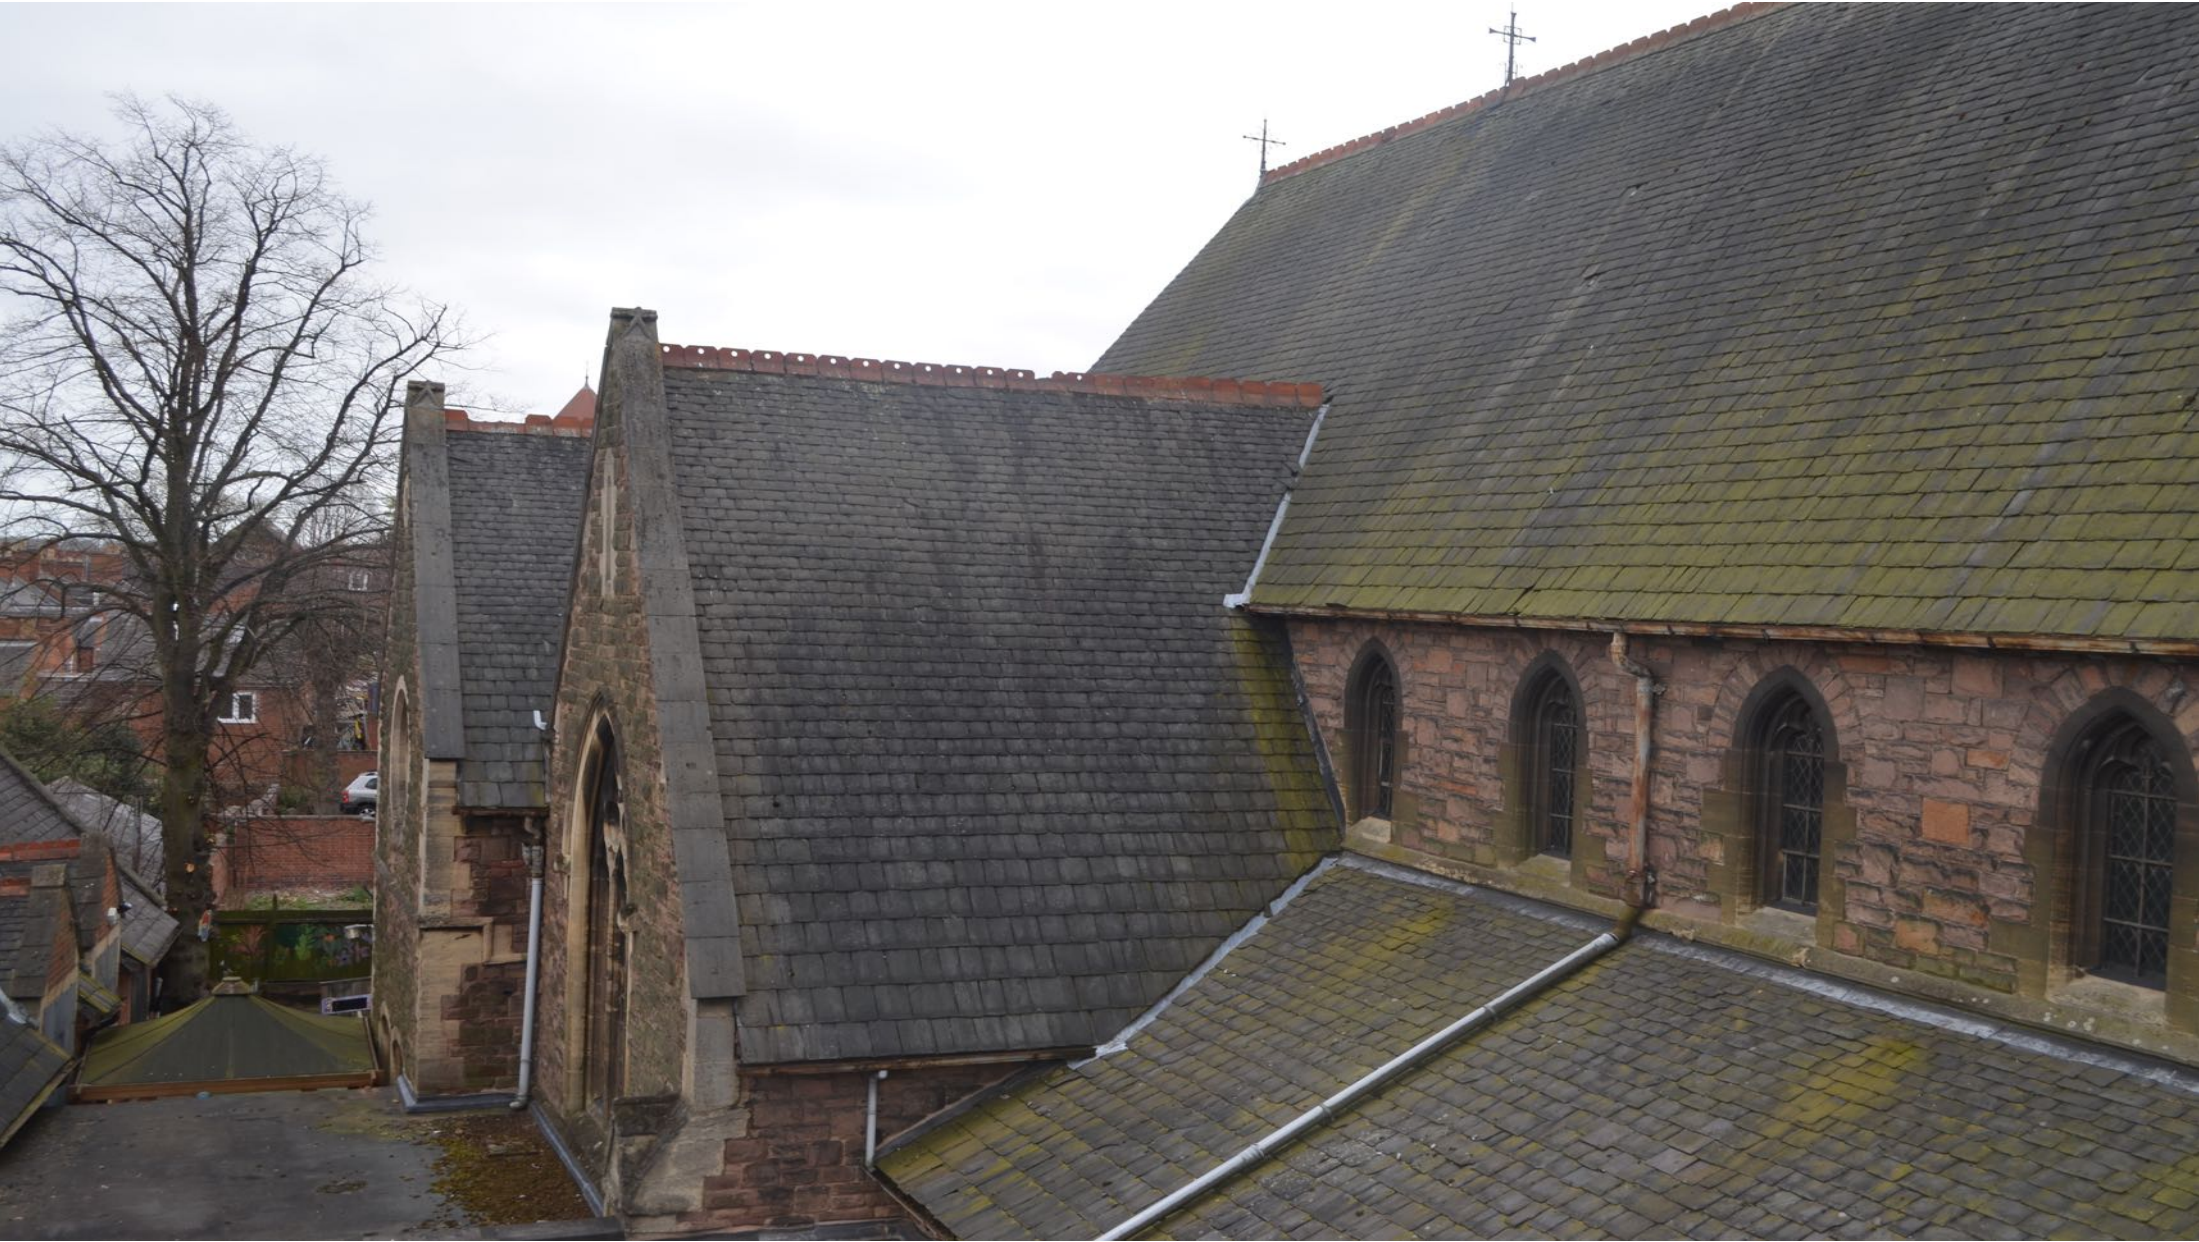
The Nave

The roof coverings on the Nave are Swithland slates and were opened up from course 2 down. The slating did not lay as well across the area and also against the tower (approx 4m from the tower) repairs had been carried to various standards and quality. The slates were shoulder fixed using 2 large copper nails per slate. This can be typical of Swithland slates but generally nailed into boards not batten. The slate batten was nominal 2" x 1" fixed over a thin counter batten which appears to be fixed over the plaster laths which are laid over the rafters. We could not gain access to measure the rafters. The battens were fixed with steel nails. There was no lime mortar in this area.

The longest slates were 24" on the over eave slate dropping to 22" on course 2. Care should be taken when using Swithland slates as the length and width does not calculate when using BS5534 for Pitched Roofing, it is the skill of the craftsman to understand how these slates with work through knowledge and understanding. The pitch of the roof was 55 degrees and the slates had 2.5" head lap. This construction is not un common, but the chance of loosing the plaster ceiling whilst work to the slating is carried out is highly likely. A internal scaffold deck will be required for both health & safety whilst working on the roof and to gain access for checking the plaster ceiling.

Once away from the tower area there are some slipped and damage slates but in general the slating looks good.

**The Nave** In the main this can be repaired using Swithland slates taken from areas of the church that will need replacing and that are hidden from the main view. I recommend the slopes on the North side of the church. The areas on both the North and South side of the Nave and approximately 4-5 metres from the tower should be stripped and relayed to the original batten which could be re-fixed with screws if the nail has failed. The shortfall of slates should be made up from the North slopes of the church.
