# St Peter's Church

## Roof condition

Heritage Crafts & Building Skills Centre Ltd

The purpose of the roof survey was to establish the condition of the roof slope of the Church of St Peter's. A total of 6 areas were opened to check the condition of the fixing's and the design of the slating and roof structure.

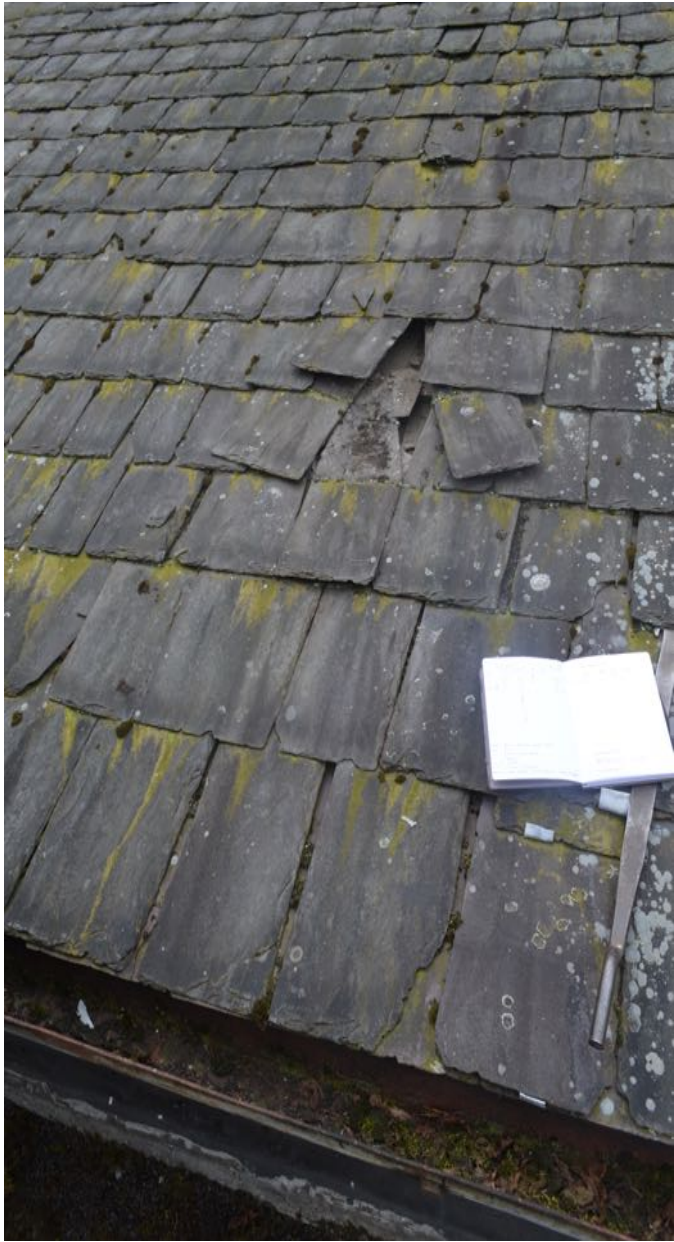
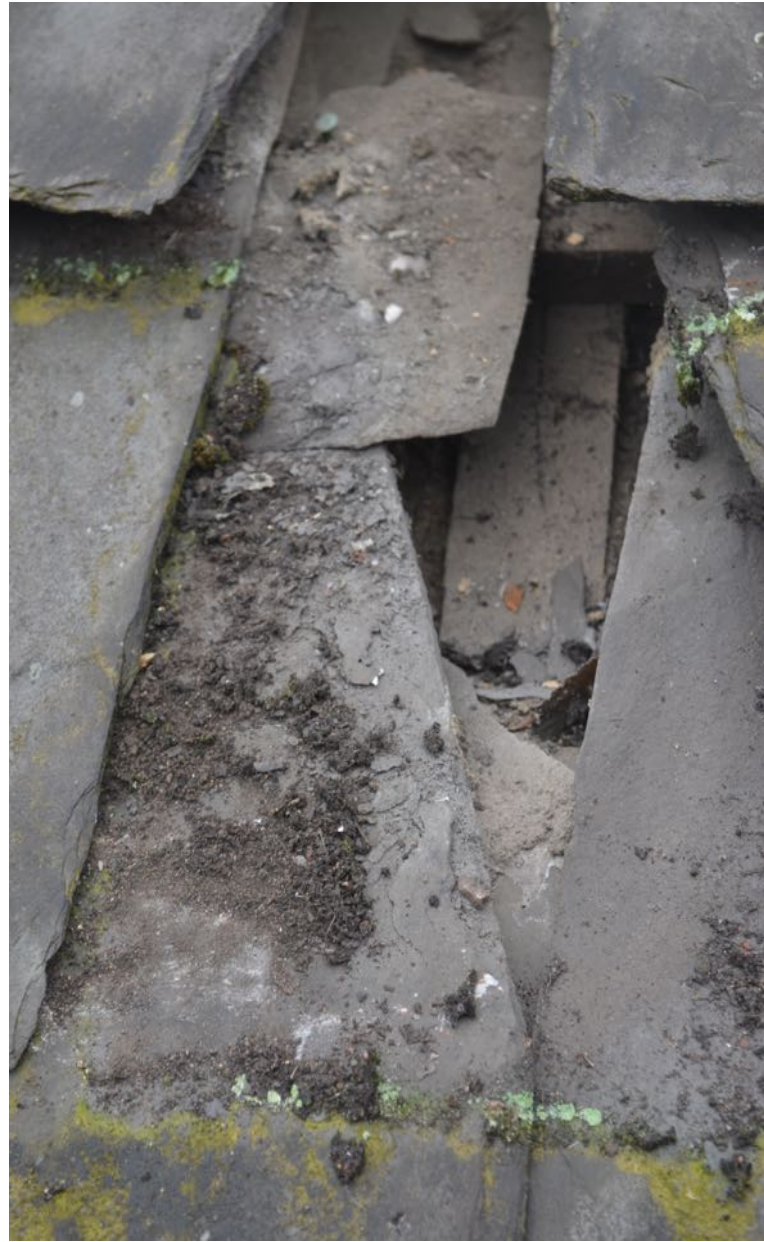
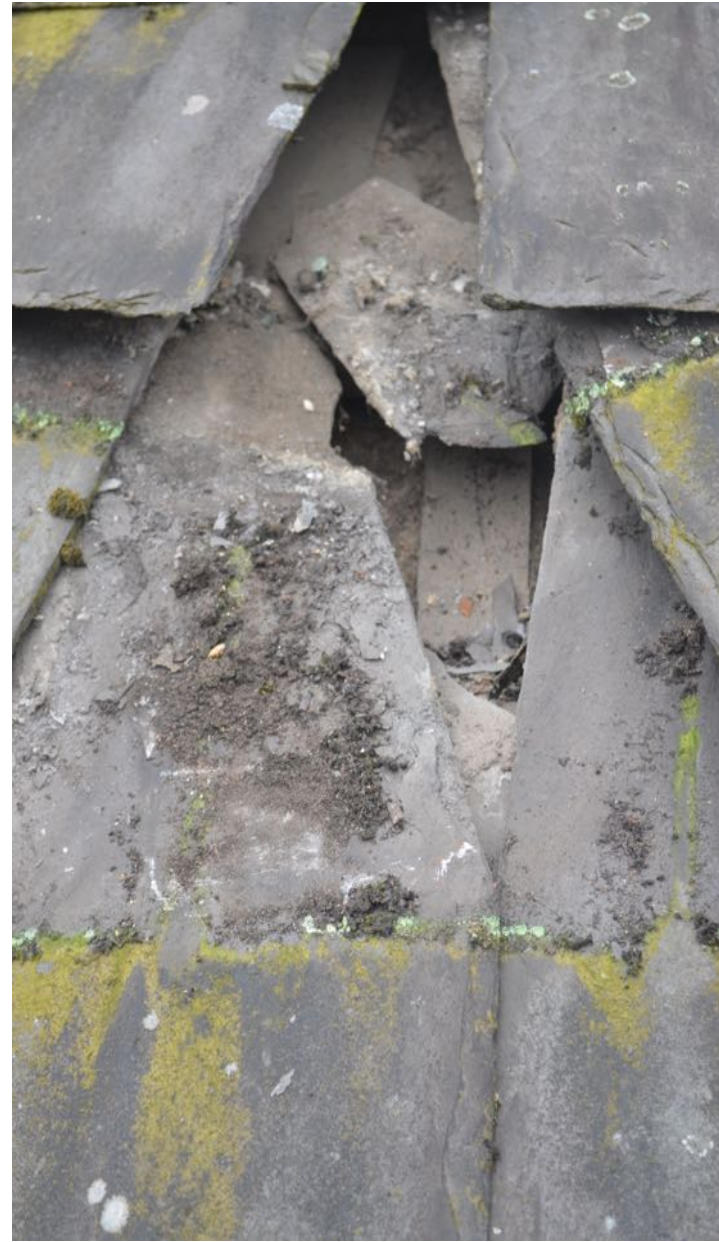
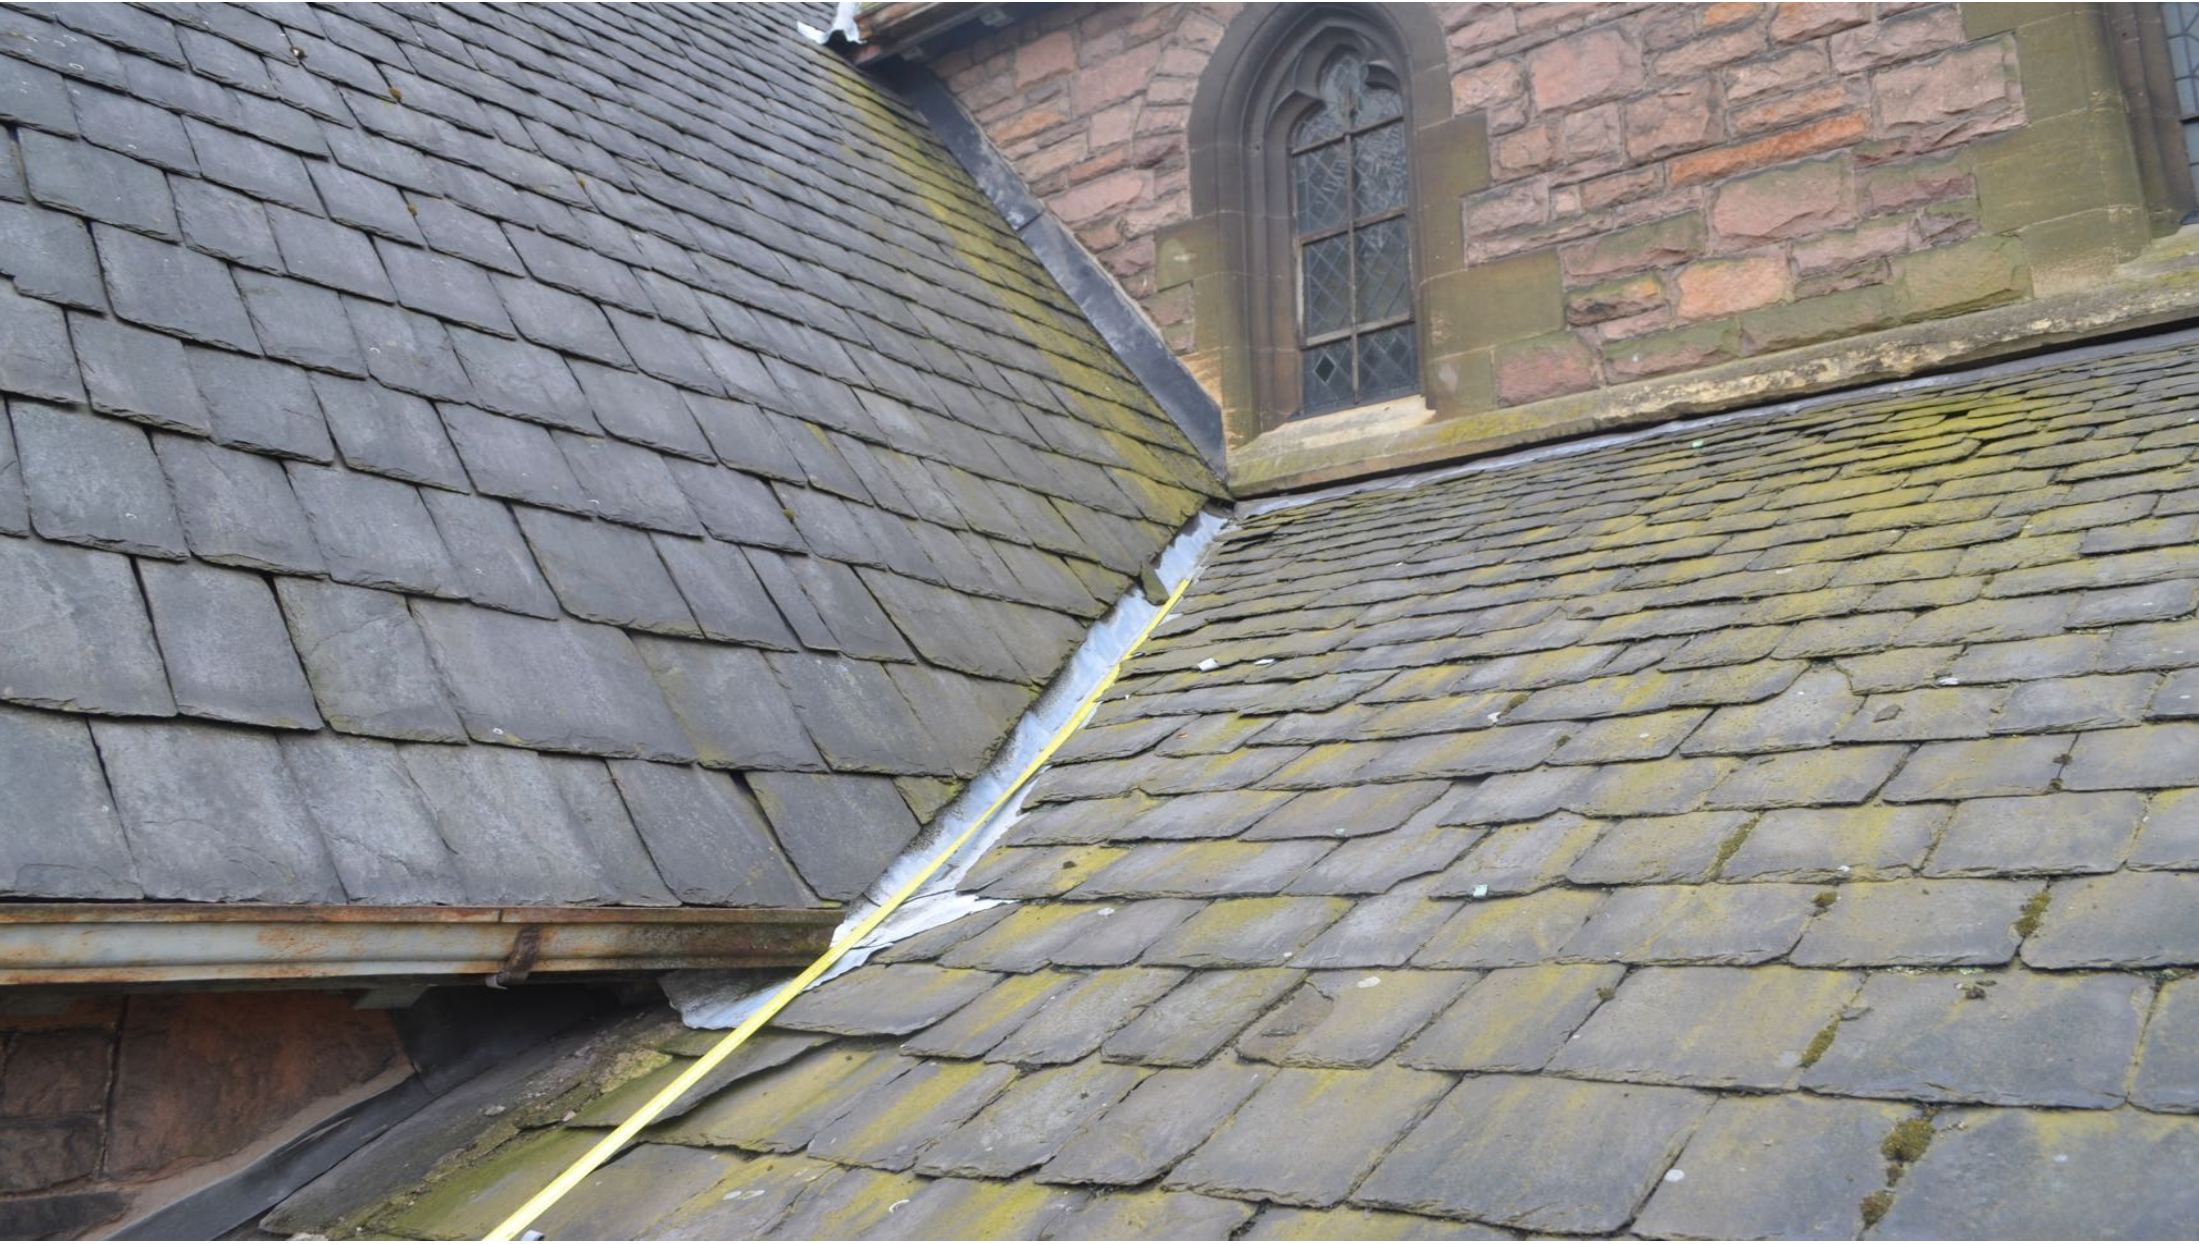
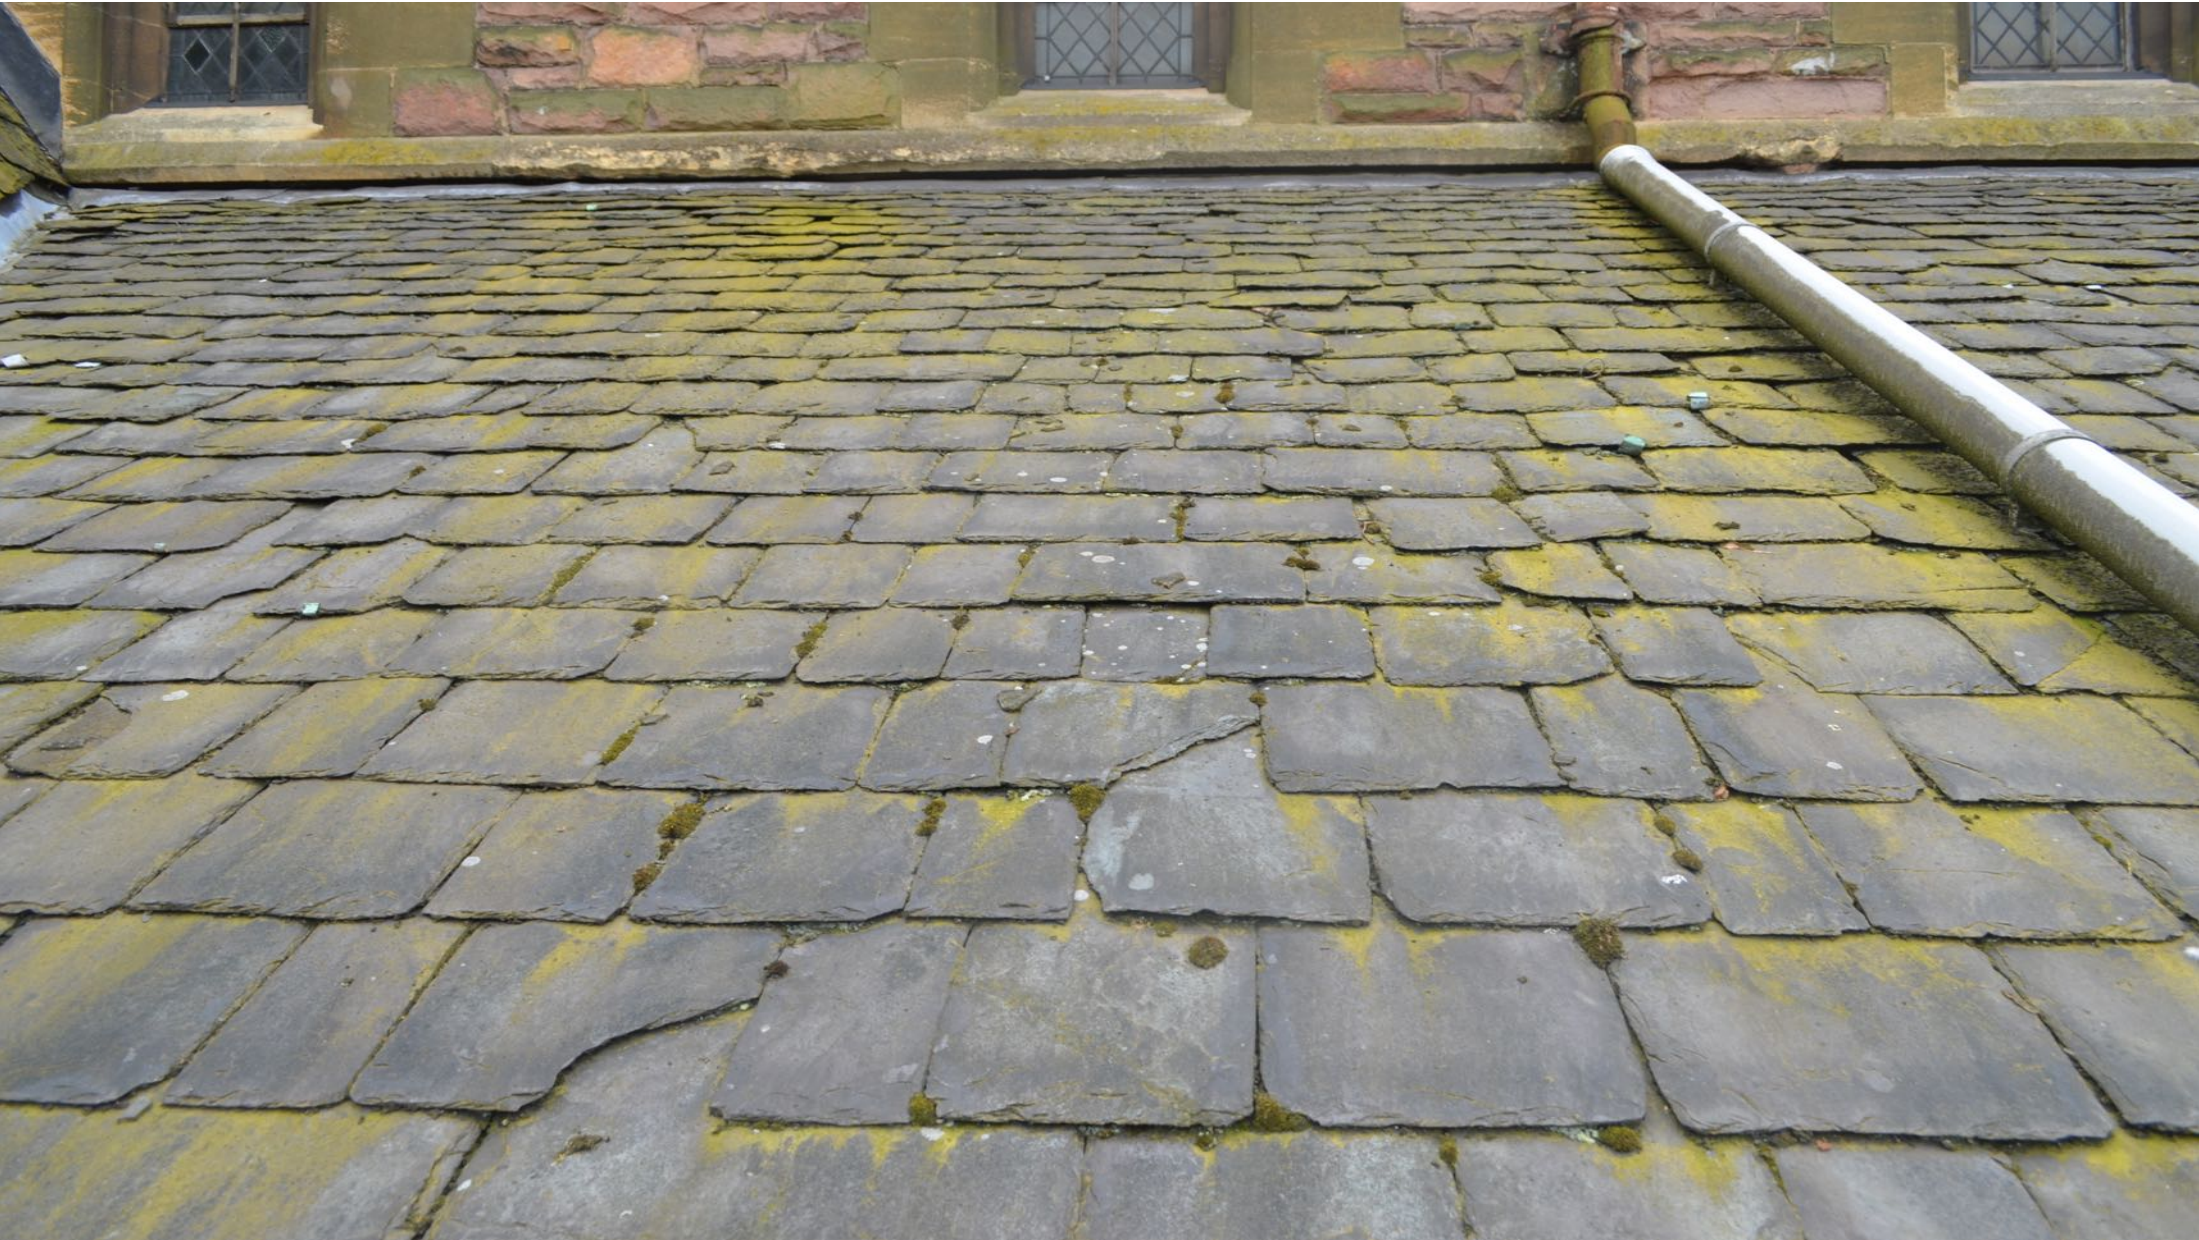
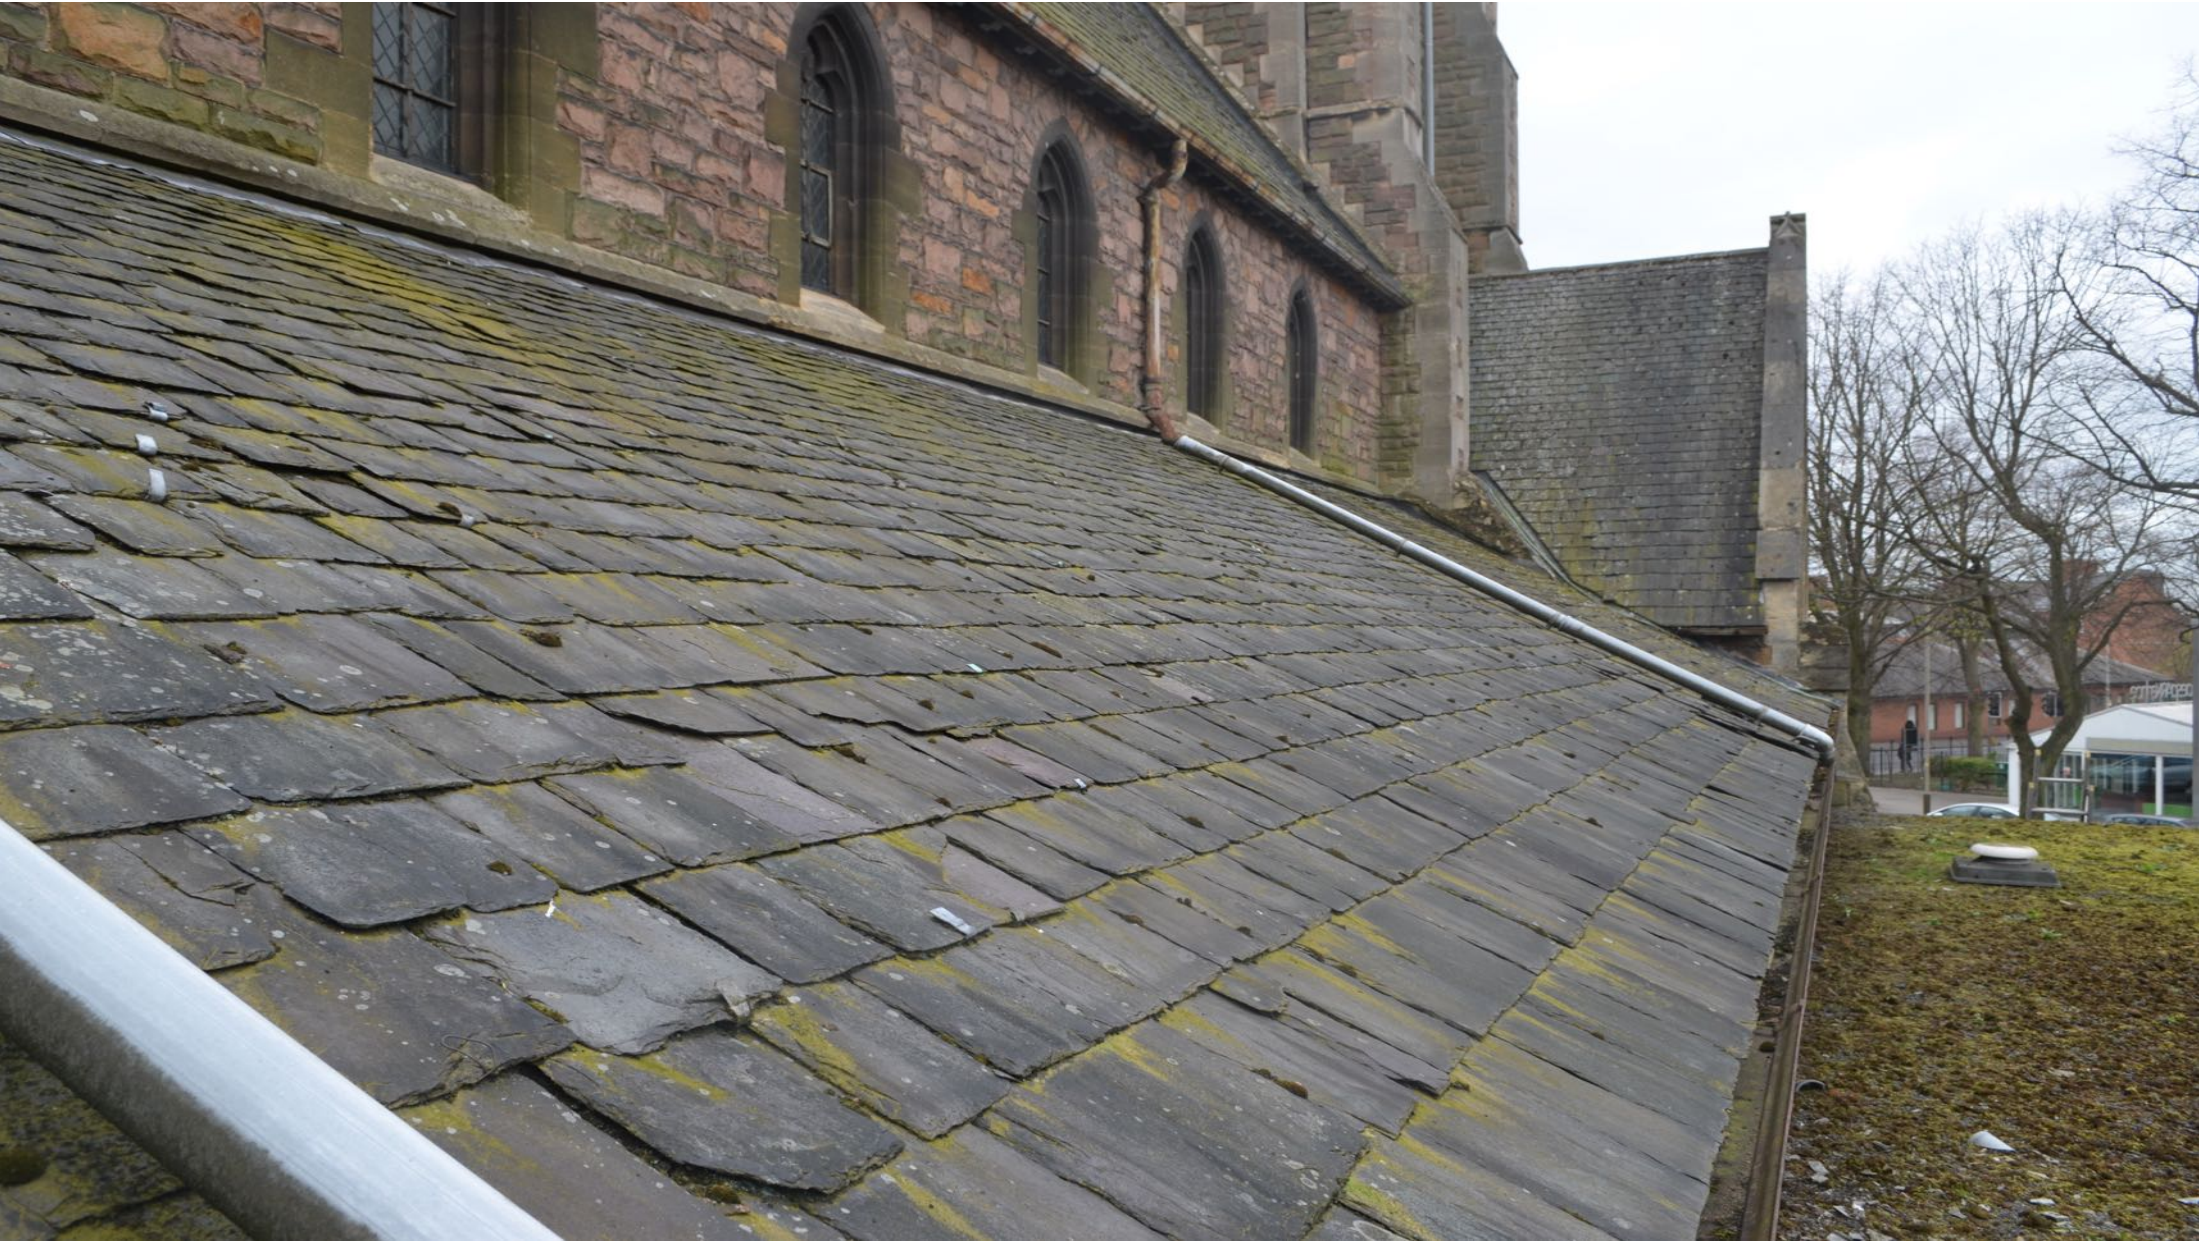
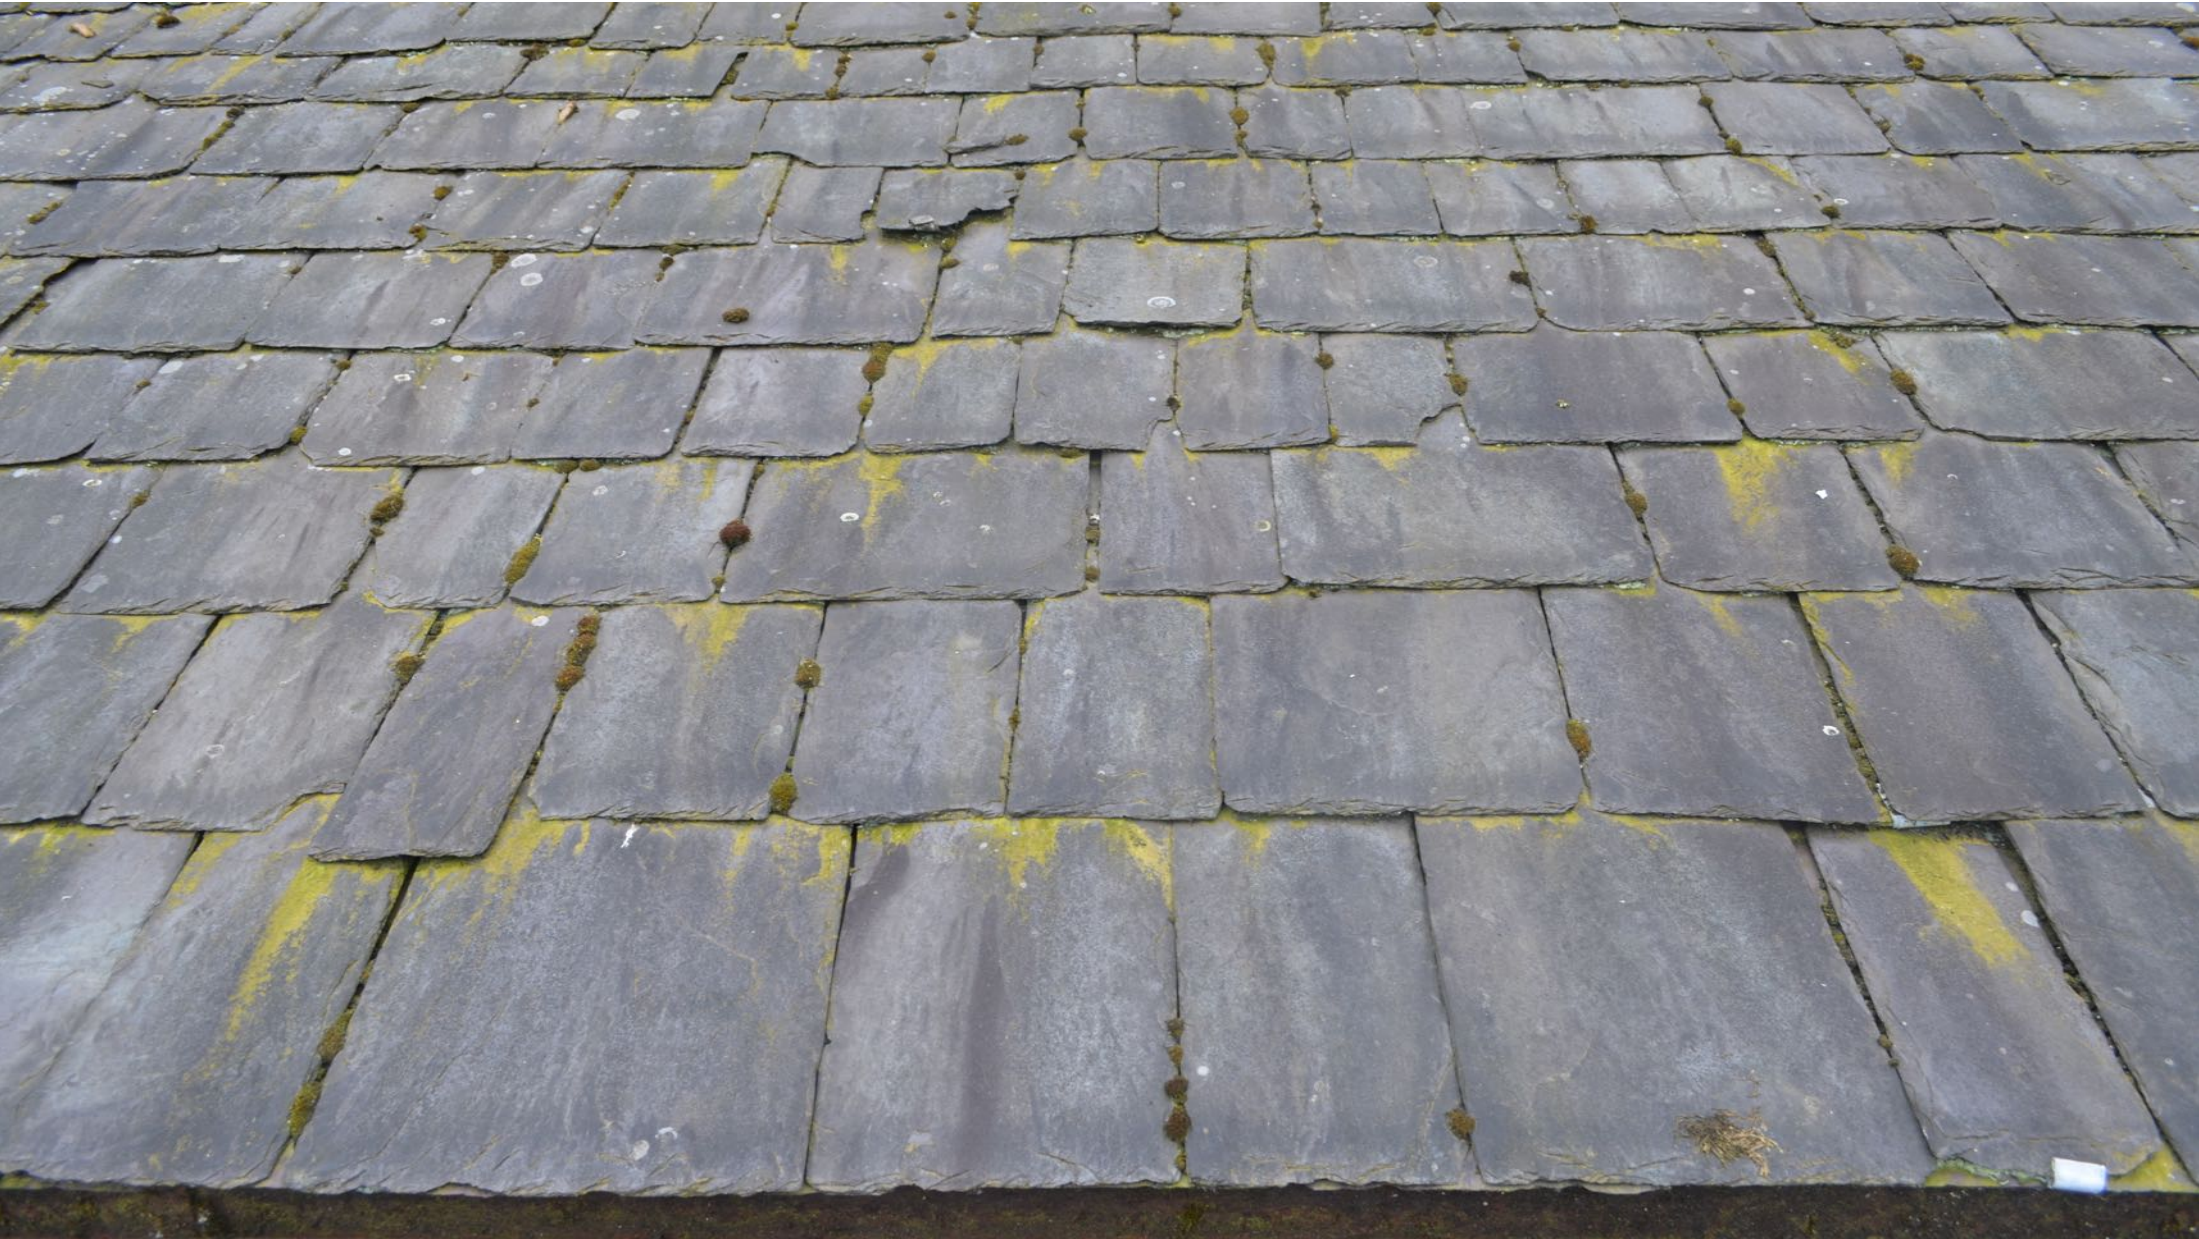
The North Aisle

The roof coverings on the North Aisle are Swithland slates and were opened up from course 5 down. The slating did not lay as well across the area and repairs had been carried to various standards and quality. The slates were head fixed using 1 large copper nail per slate fixed directly into the batten. This is typical of Swithland slates. The slate batten was nominal 2" x 1" fixed over a 2" x 1" counter batten which appears to be fixed over a ceiling which was laid over the rafters. We could not gain access to measure the rafters. The battens were fixed with steel nails. There was no lime mortar in this area.

The longest slates were 30.5" on the over eave slate dropping to 26.5" on course 2. Care should be taken when using Swithland slates as the length and width does not calculate when using BS5534 for Pitched Roofing, it is the skill of the craftsman to understand how these slates will work through knowledge and understanding. The pitch of the roof was 35 degrees and the slates had between 2.75" & 3.75" head lap. I feel that the head lap should be increased slightly due to increase deluge rain. Some slate head laps had shale placed over them to increase the head lap and this technique was very common, but most modern day's roofers think this is unnecessary. Care must be taken not to miss a weak head lap and not adding a piece of shale. Increasing the head lap will help in this instance.

**The North Aisle** This area should be stripped and recovered using New slates to match as close as possible. The batten and slate fixing details should be kept as original.
