# St Peter's Church

## Roof condition

Heritage Crafts & Building Skills Centre Ltd

The purpose of the roof survey was to establish the condition of the roof slope of the Church of St Peter's. A total of 6 areas were opened to check the condition of the fixing's and the design of the slating and roof structure.

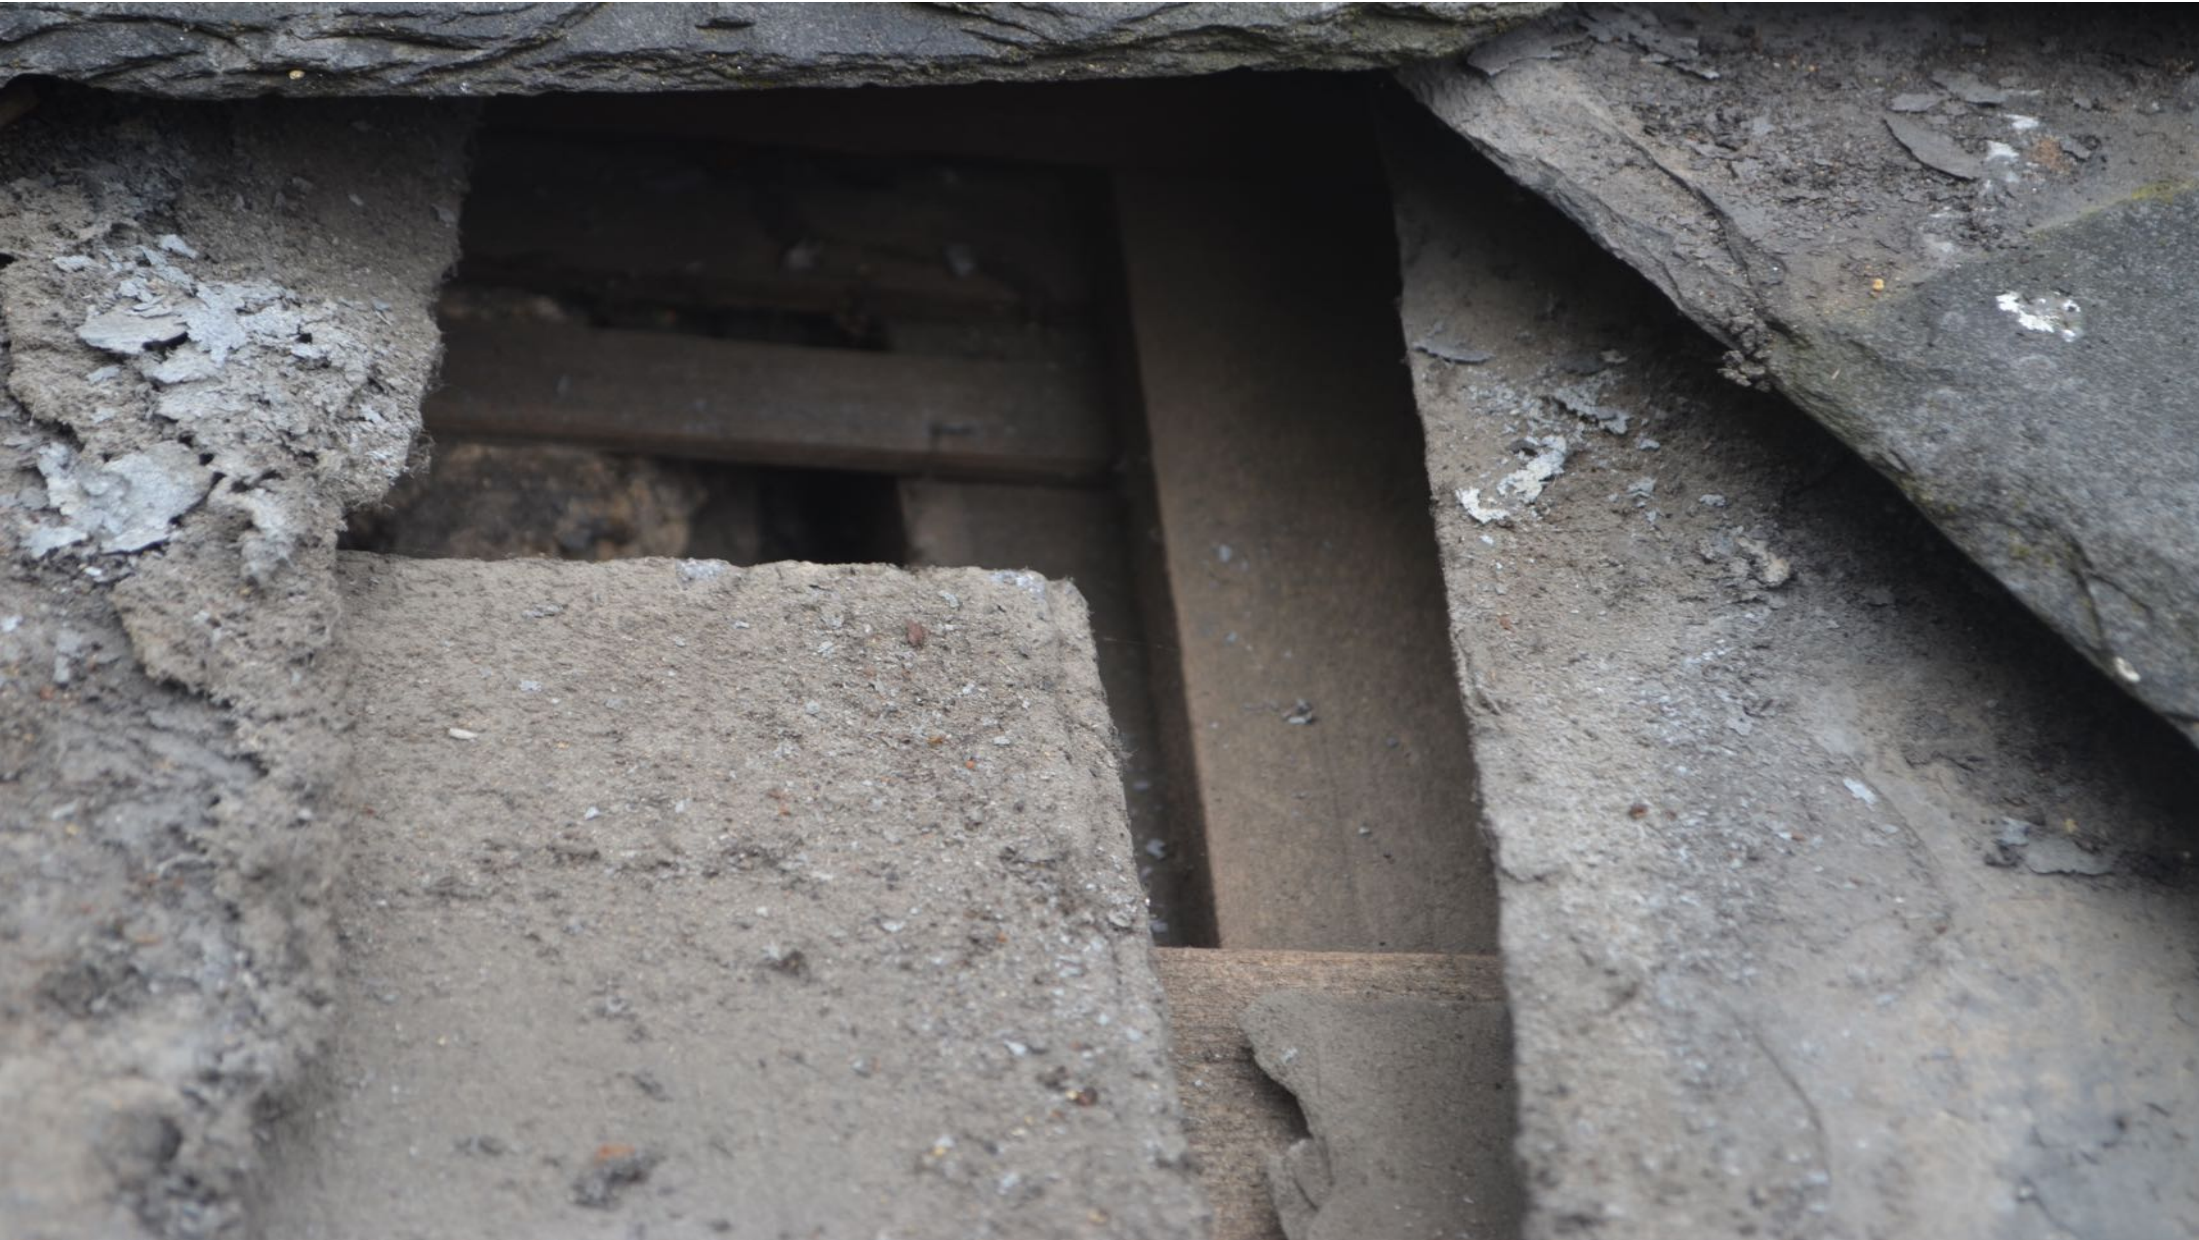
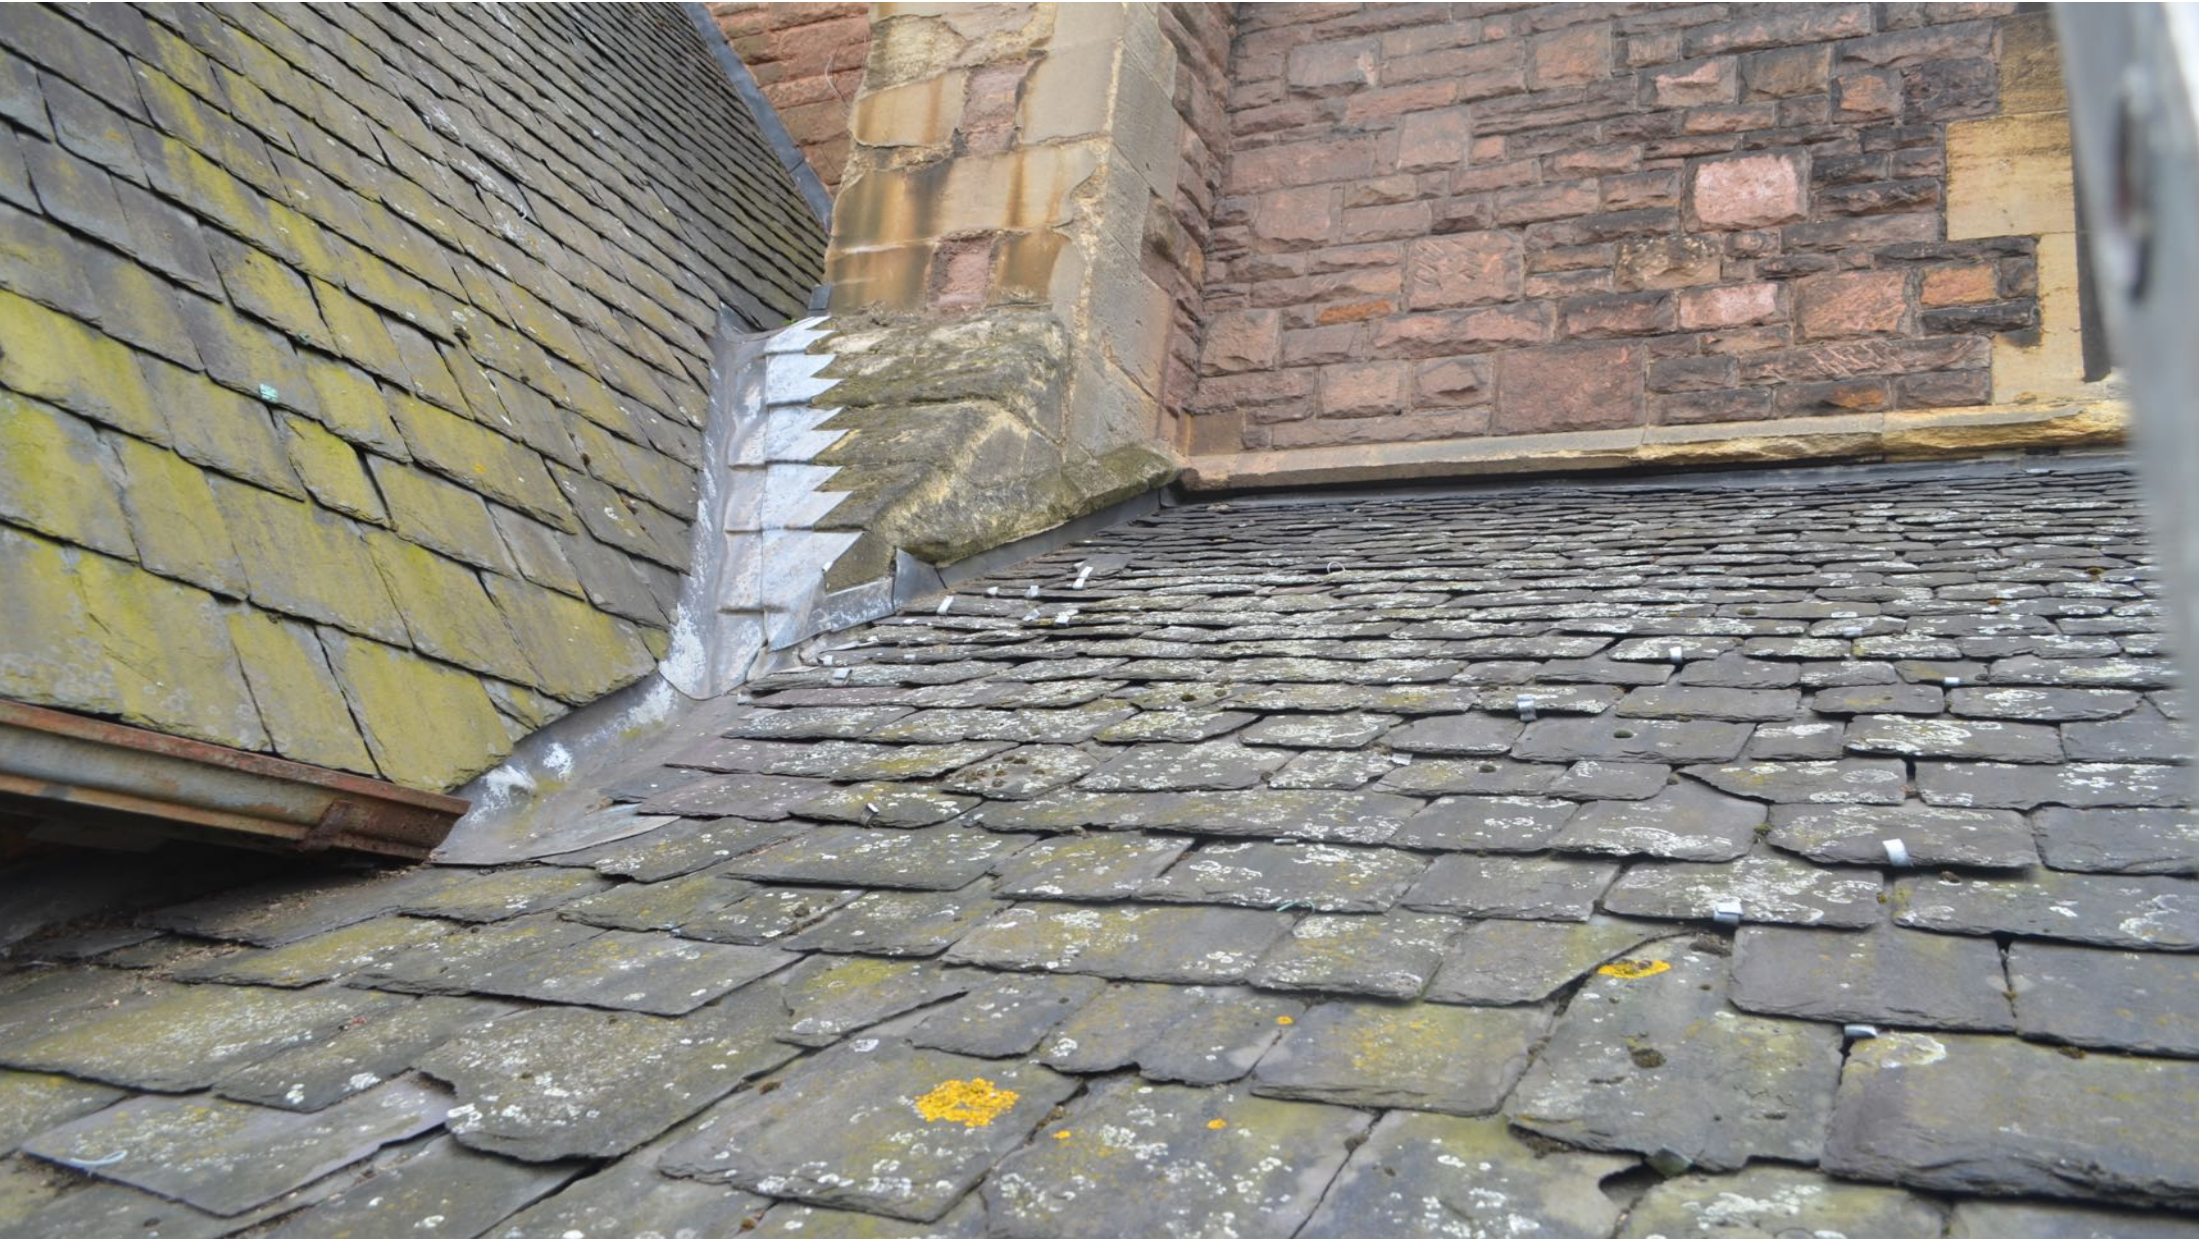
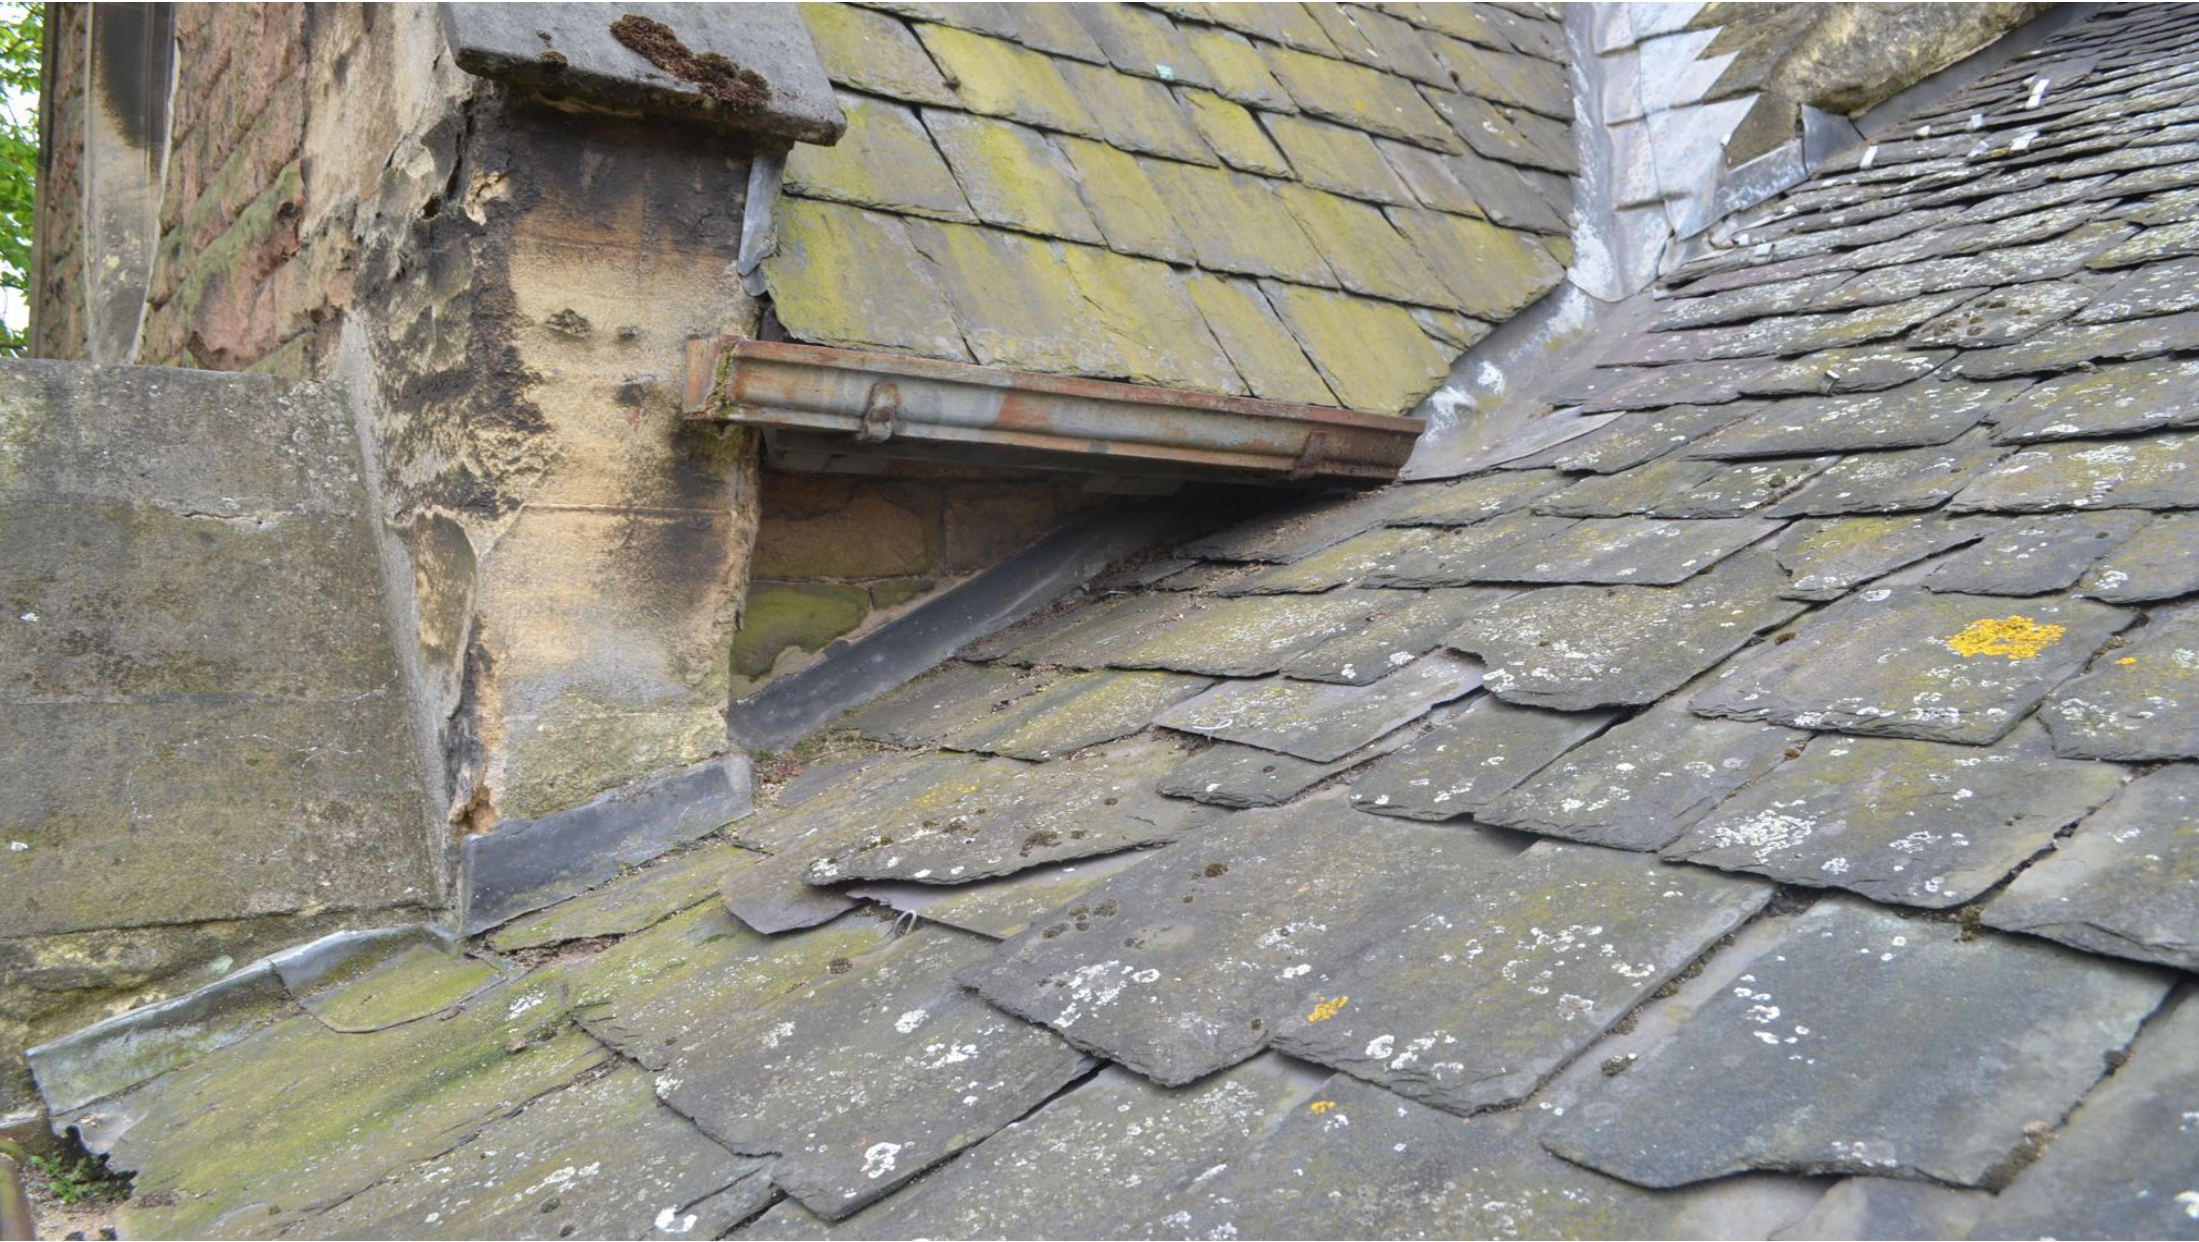
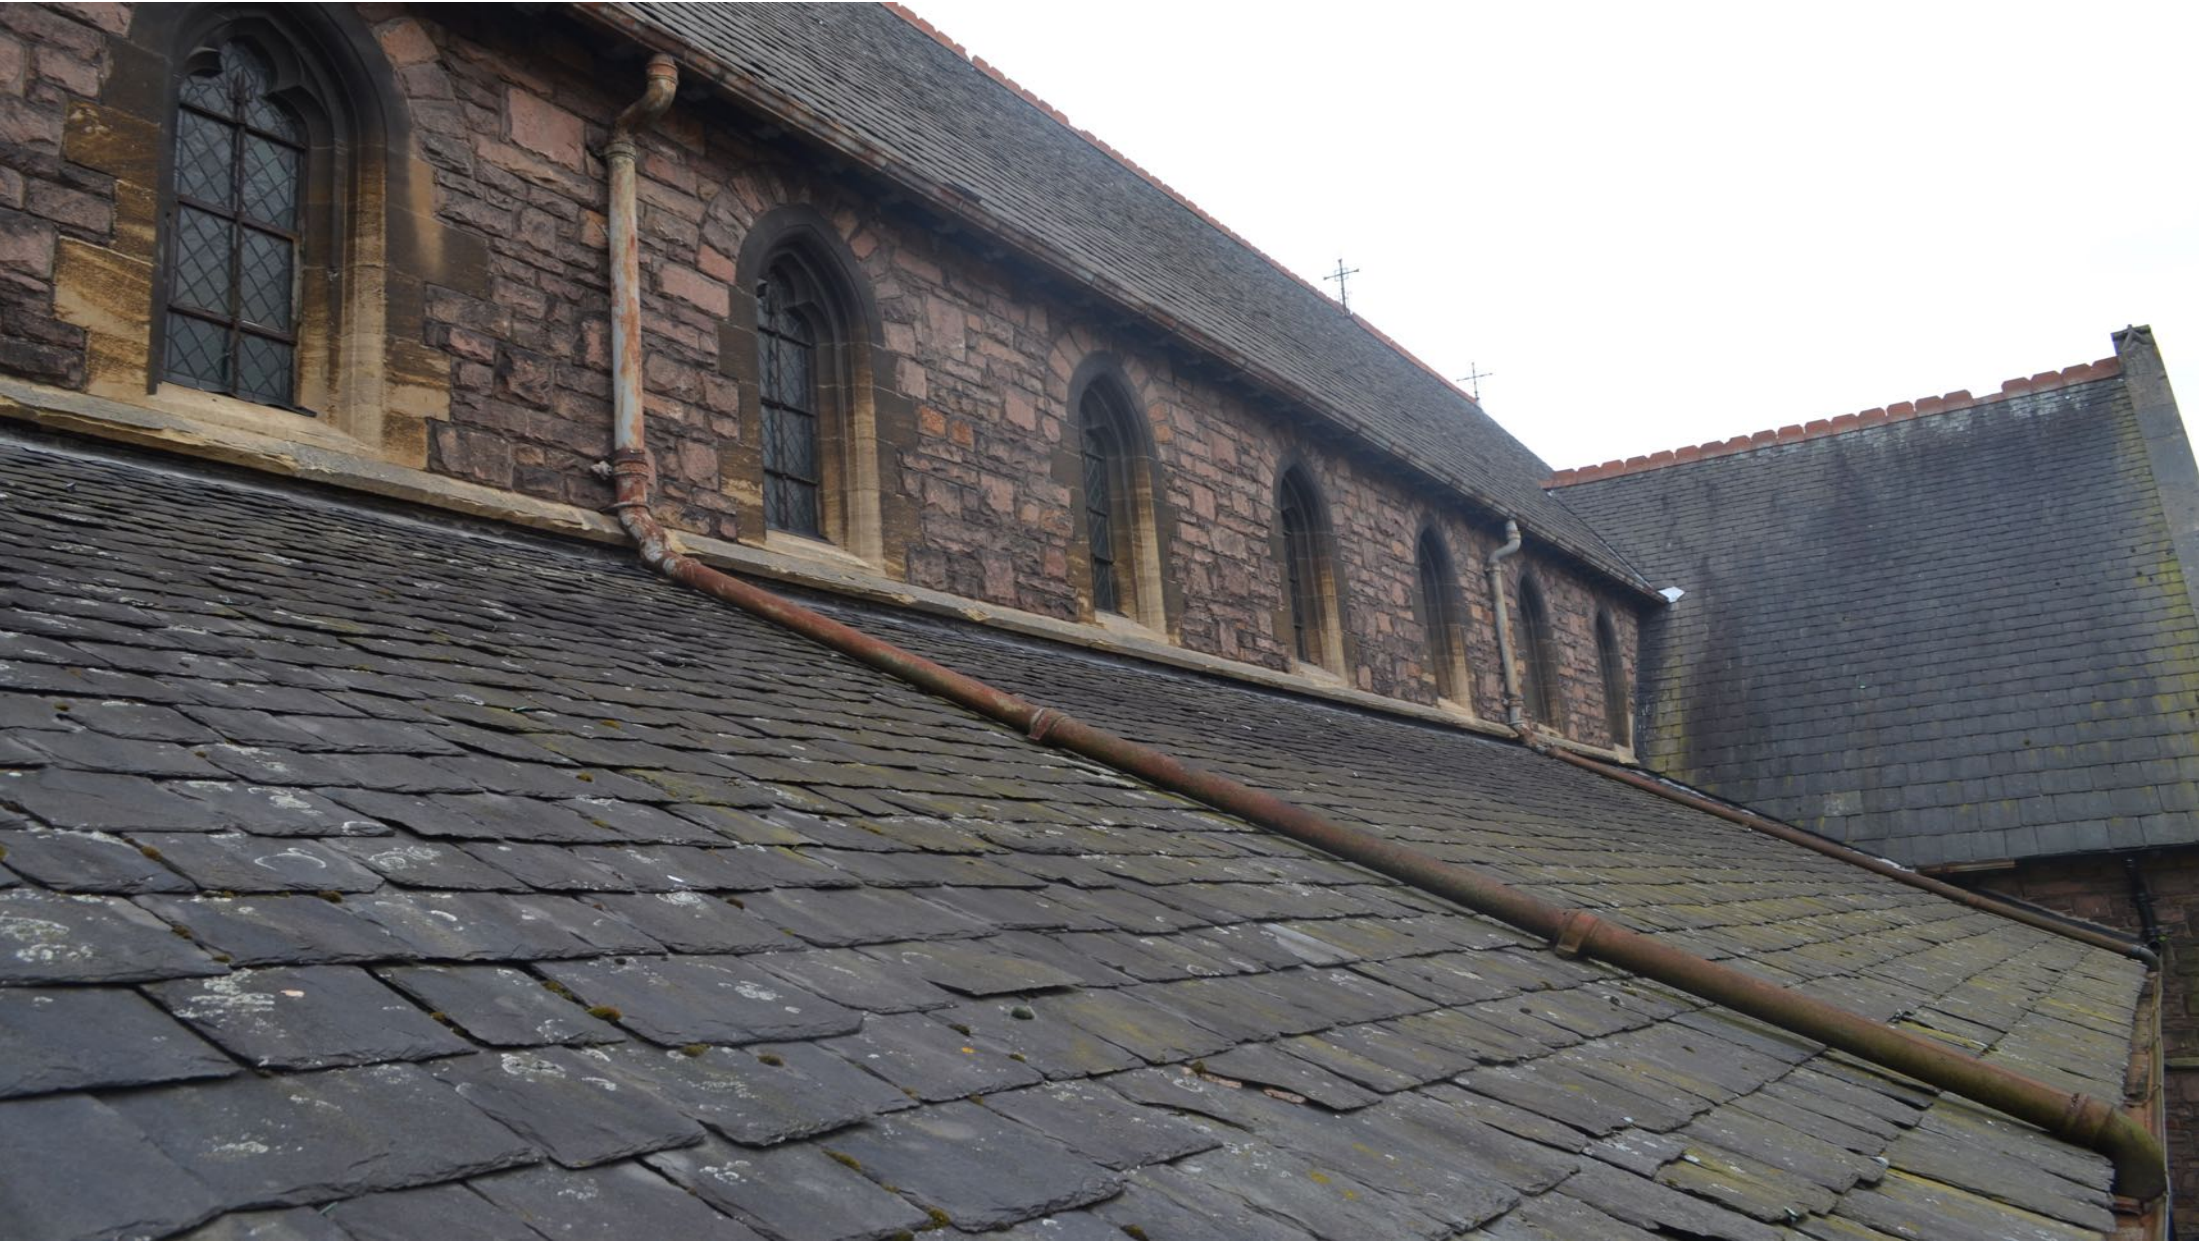
The South Aisle

The roof coverings on the South Aisle are Swithland slates and were opened up on course 2. The slating did not lay as well across this roof area and repairs were carried out to various standards and quality. The slates were head fixed using 1 large copper nail per slate. This is a typical way of fixing Swithland slates. The slate batten was nominal 2" x 1" fixed over a 2"x 1" counter batten which is fixed over the plaster laths, which are laid over the rafters. We could not gain access to measure the rafters. The battens were fixed with steel nails. There was no lime mortar in this area. The pitch of the roof was 35 degrees and the slates had 2.5" head lap. This construction is not uncommon, but the chance of loosing the plaster ceiling whilst work to the slating is carried out is highly likely. An internal scaffold deck will be required for both health & safety whilst working on the roof and to gain access for checking the plaster ceiling.

**The South Aisle** This area should be stripped and recovered using slates from the North slopes of the church to make up the shortfall of slates. The batten and slate fixing details should be kept as original.

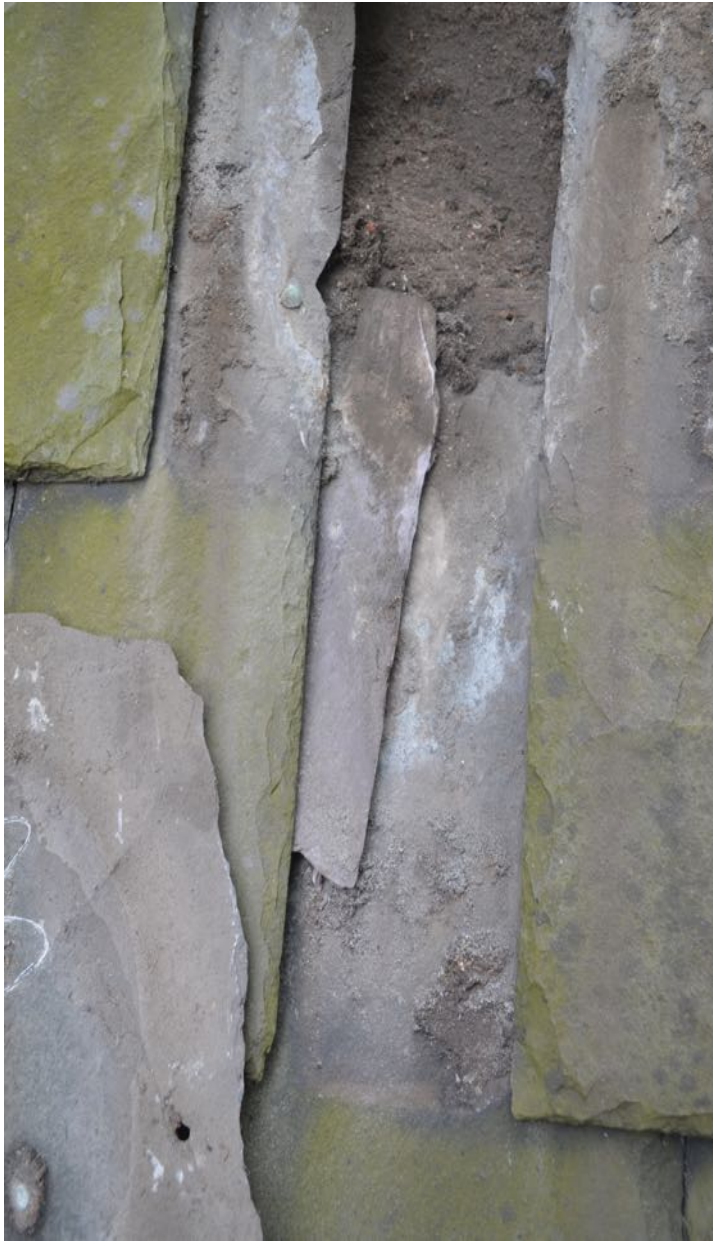
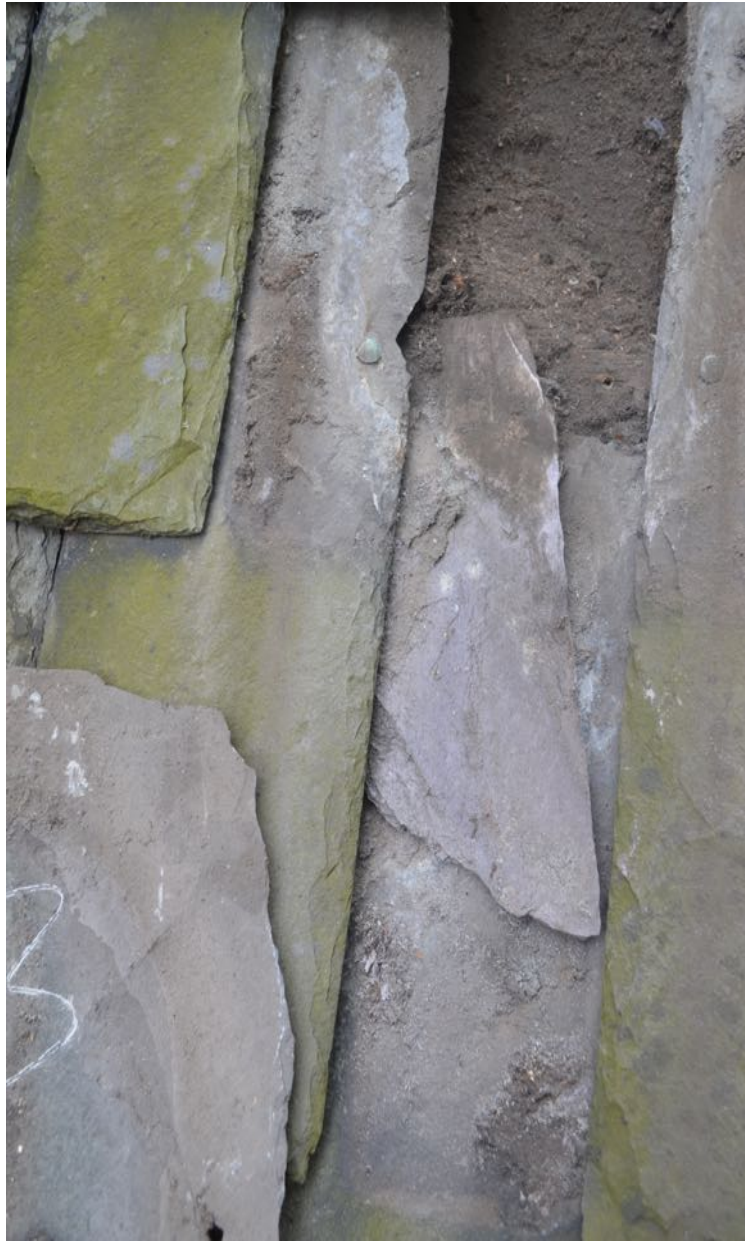
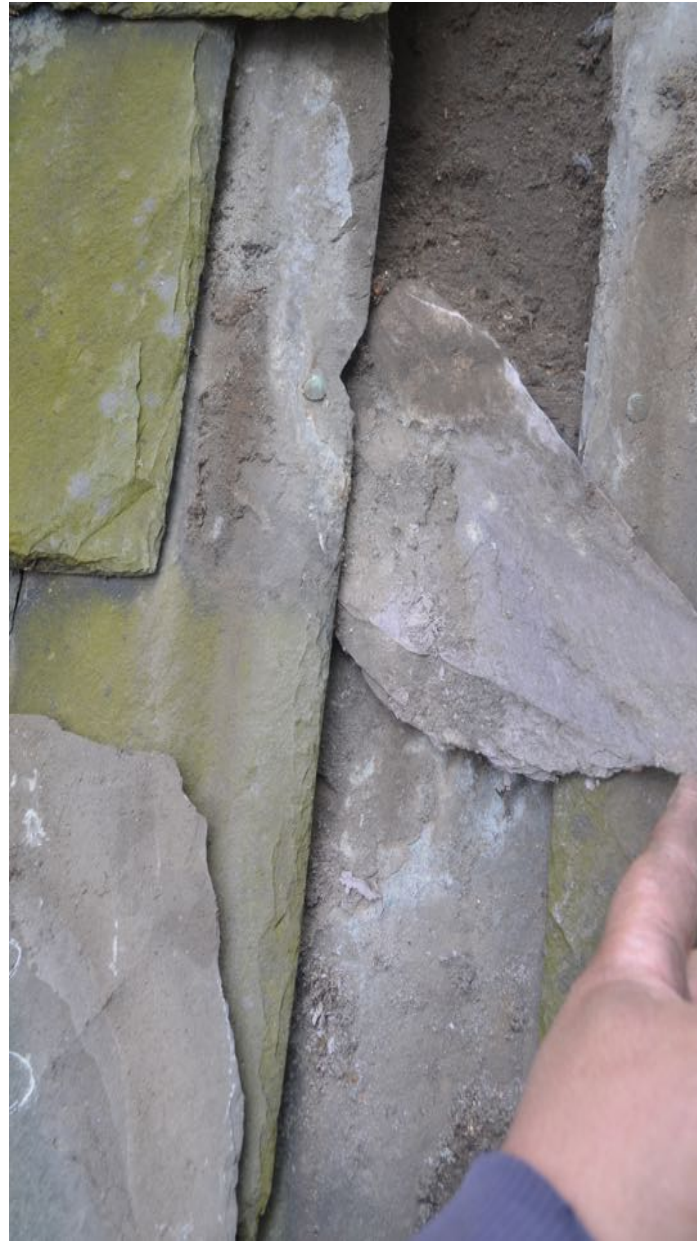
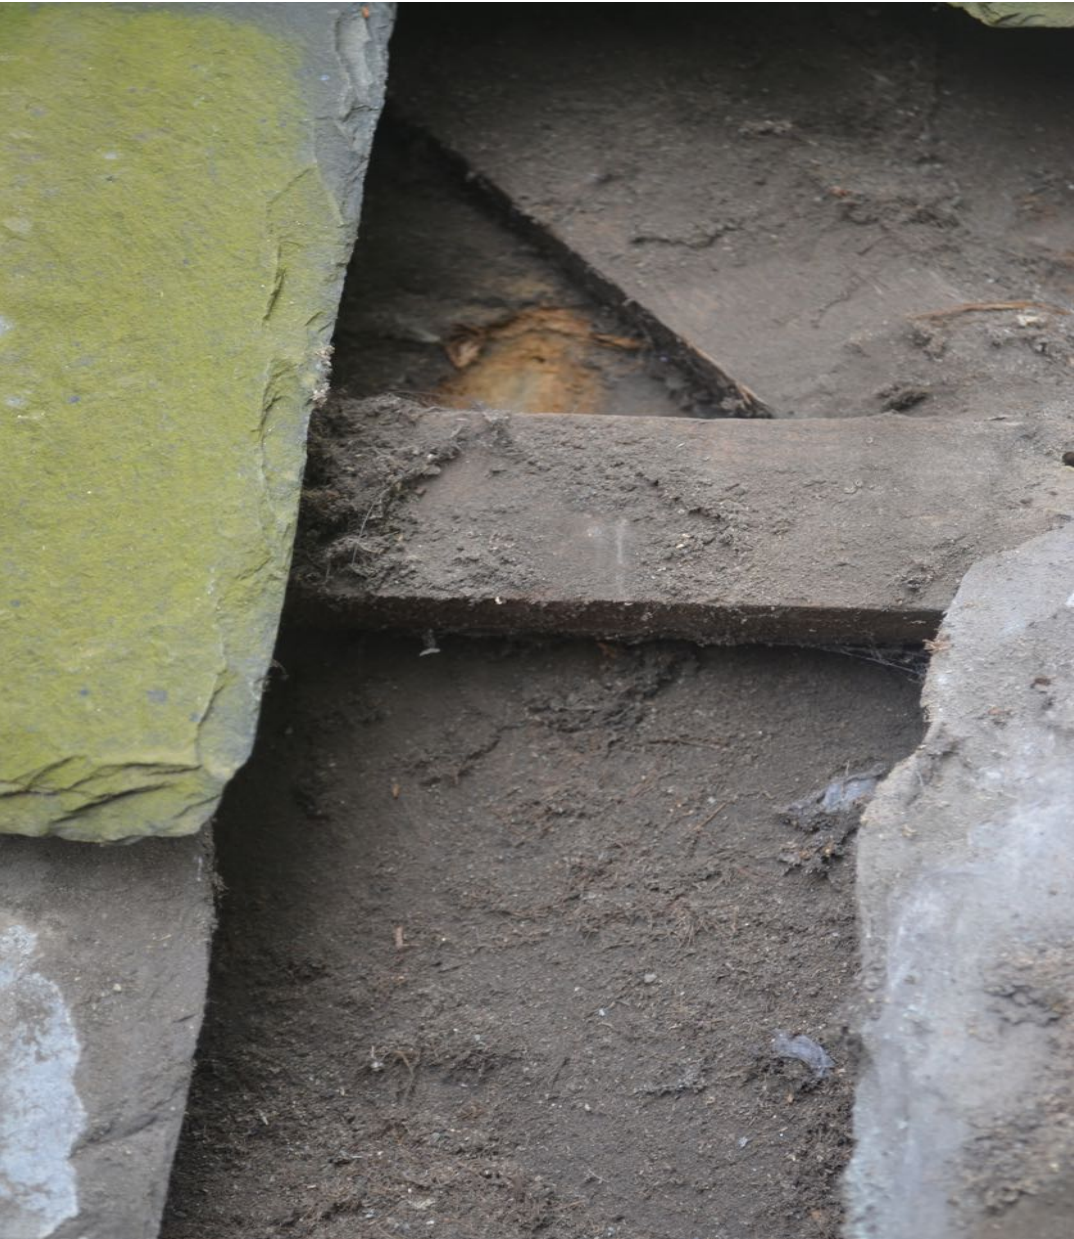
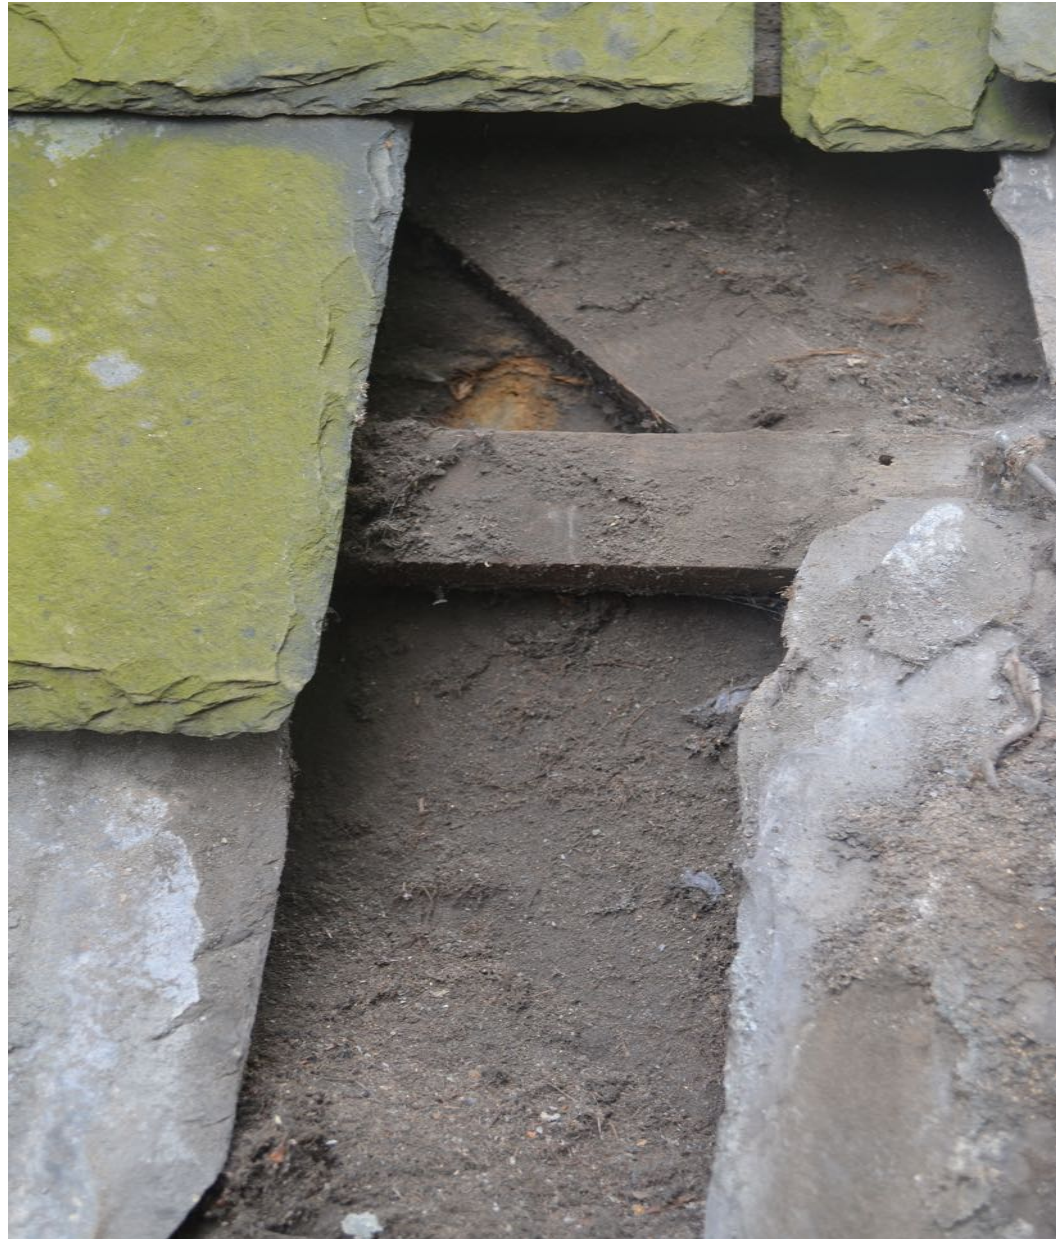
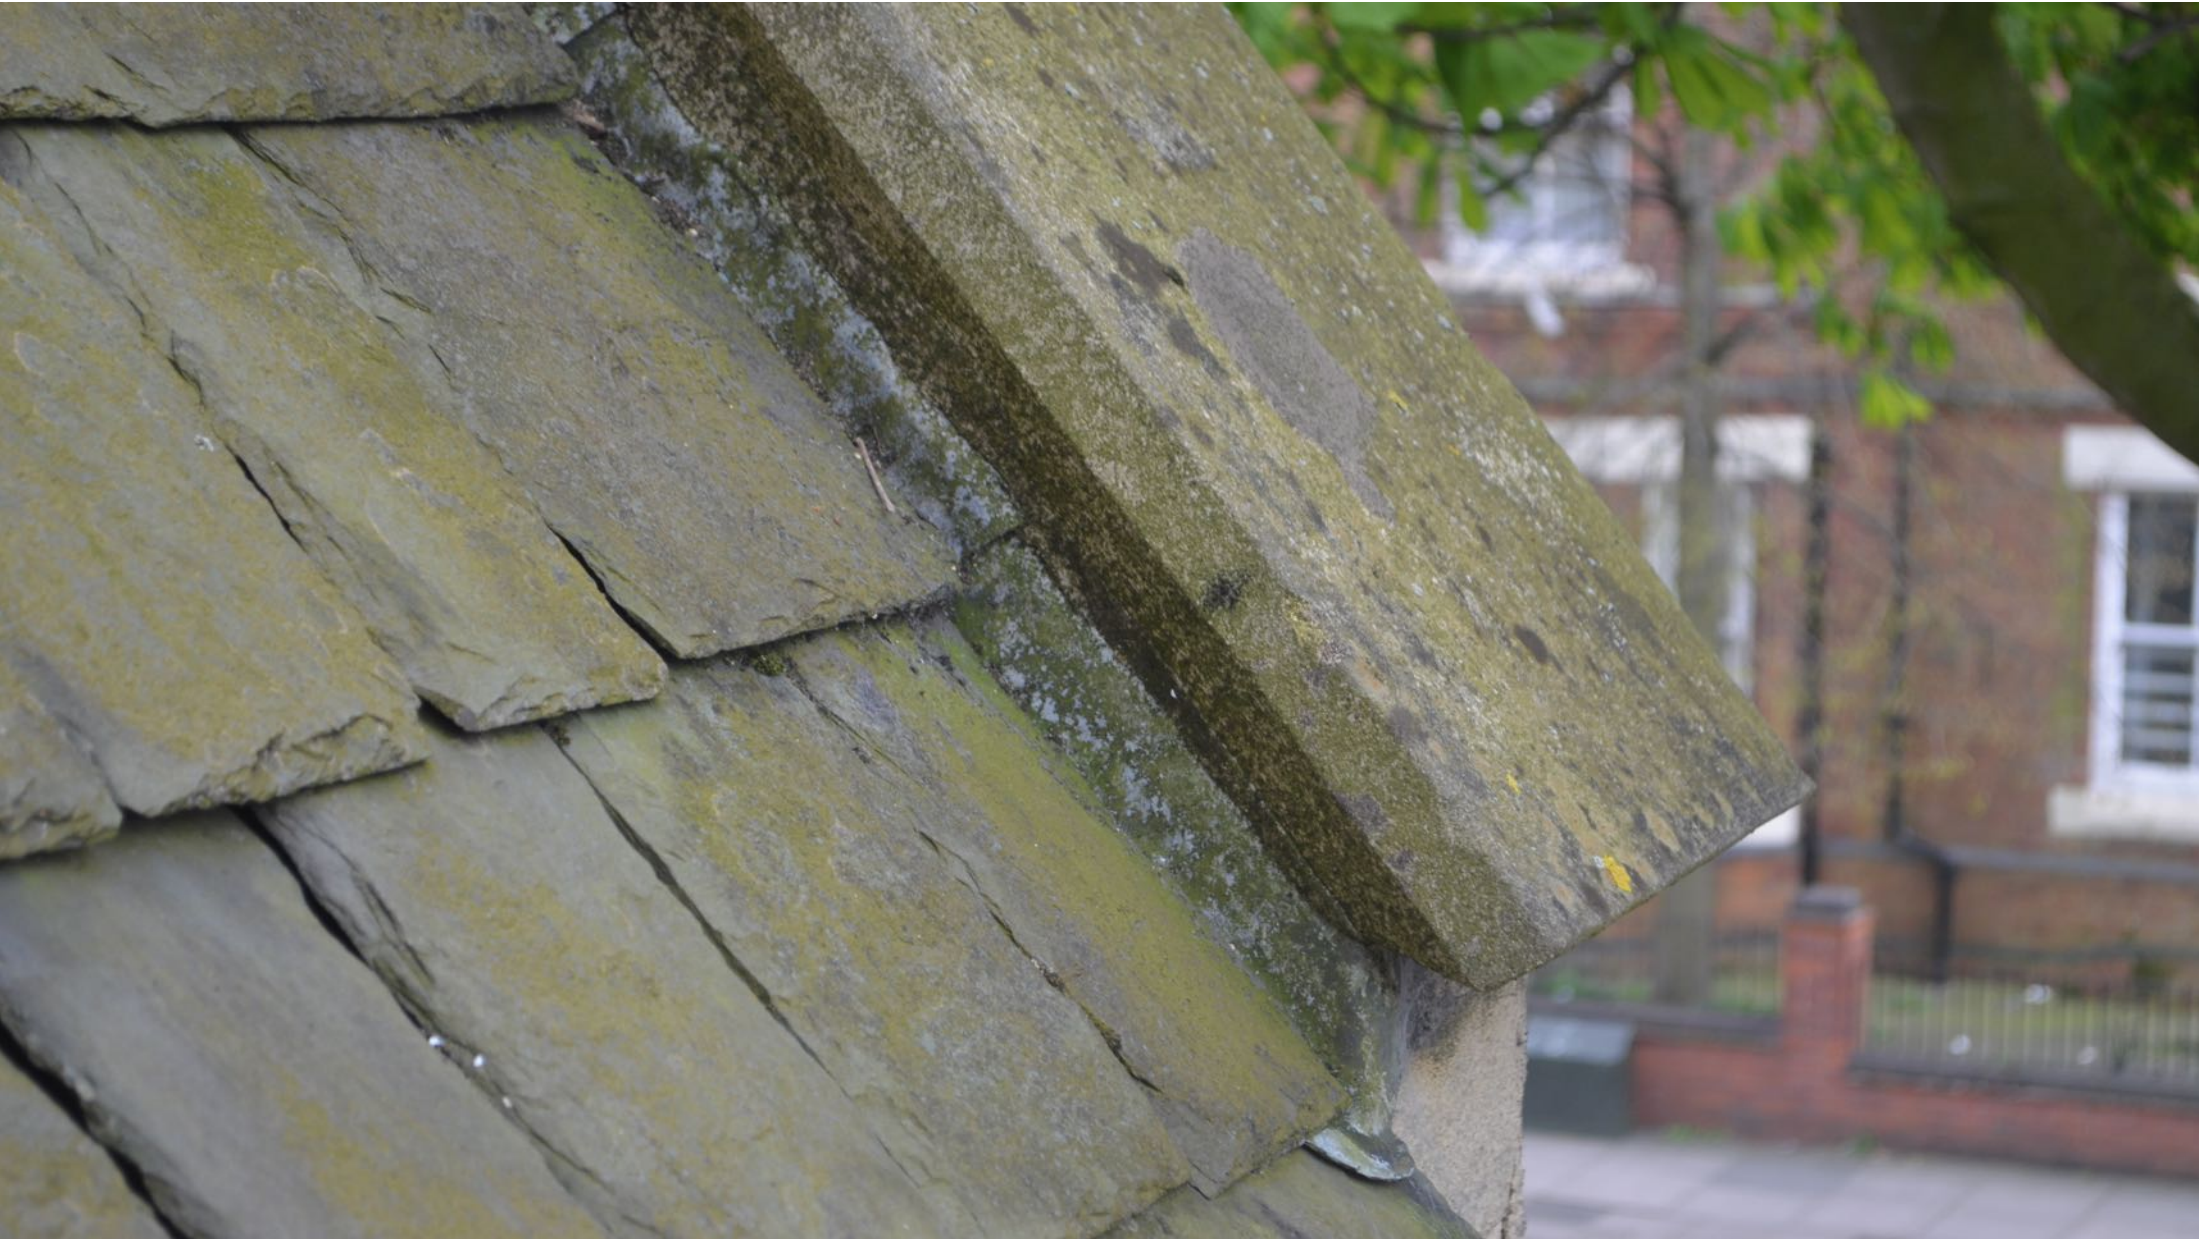
# The South Porch

The roof coverings on the South Porch are Swithland slates and were opened up on course 3 & 2. The slating did not lay as well across this roof area and repairs have been carried out to various standards and quality. The slates were centred fixed using 2 large copper nails per slate, with the head of the slates cut to form a 4 sided cut slate. This is not typical of Swithland slates which are generally head fixed over lath or shoulder fixed nailed to boards. The slate batten was nominal 2" x 1" fixed to a 2" x 1" diagonal counter batten placed on top of a type of horse hair felt laid over a boarded roof construction. The batten and counter batten were fixed with steel nails. The longest slates were 24" on the over eave slate dropping to 21" on course 3. The pitch of the roof was 55 degrees and the slates had 3" head lap. There was no lime mortar bedding or torching to this area of the roof.

**The north and South Porch** This area should be stripped and recovered using slates from the North slopes of the church to make up the shortfall of slates. The batten and slate fixing details should be kept as original.
