# St Peter's Church

## Roof condition

Heritage Crafts & Building Skills Centre Ltd

The purpose of the roof survey was to establish the condition of the roof slope of the Church of St Peter's. A total of 6 areas were opened to check the condition of the fixing's and the design of the slating and roof structure.

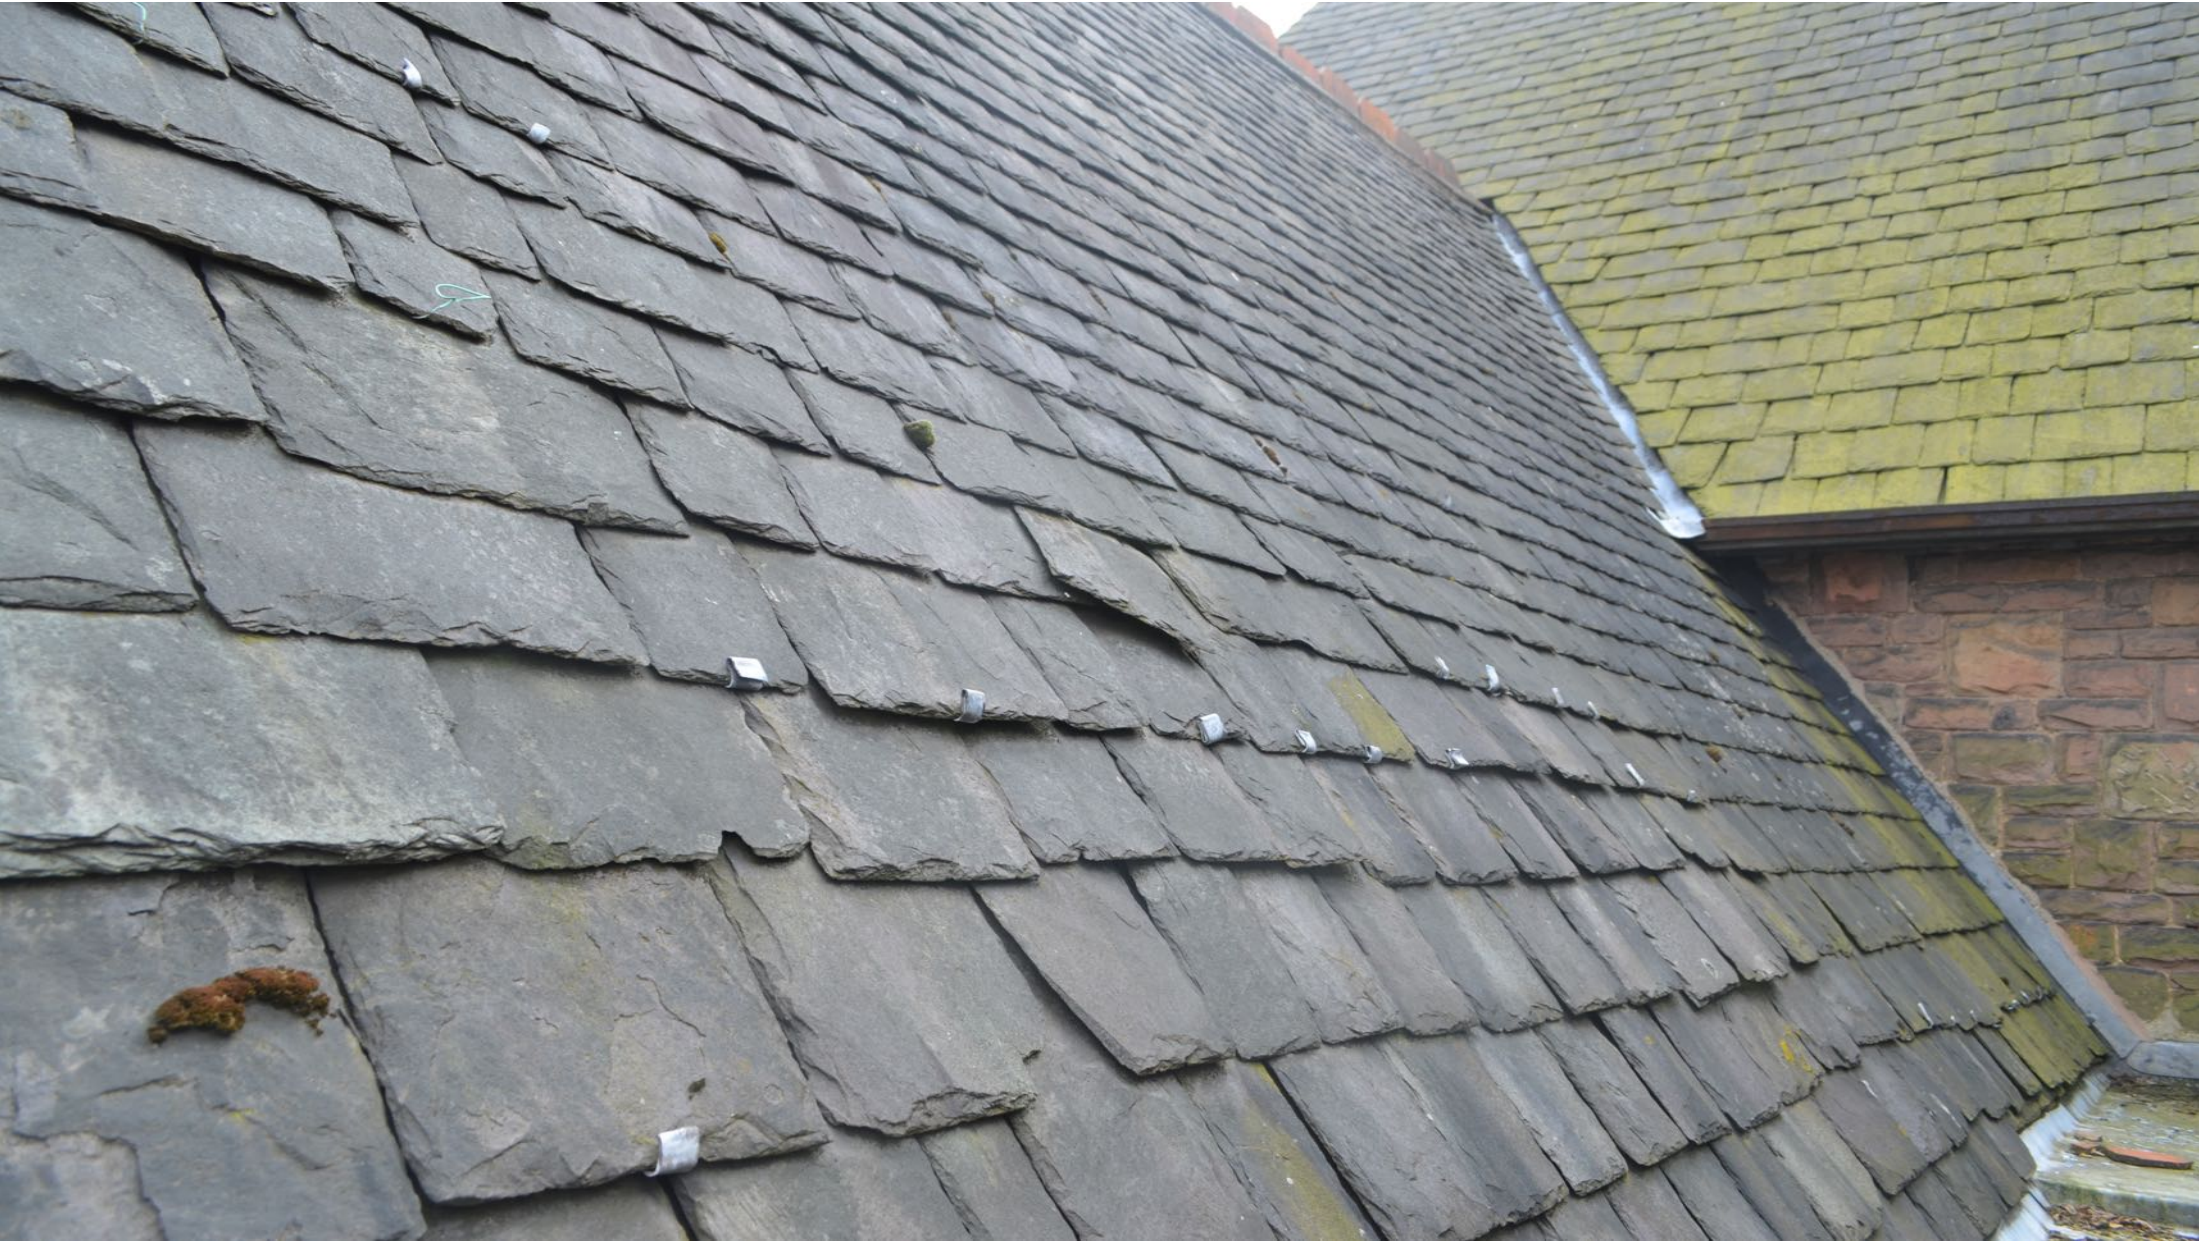
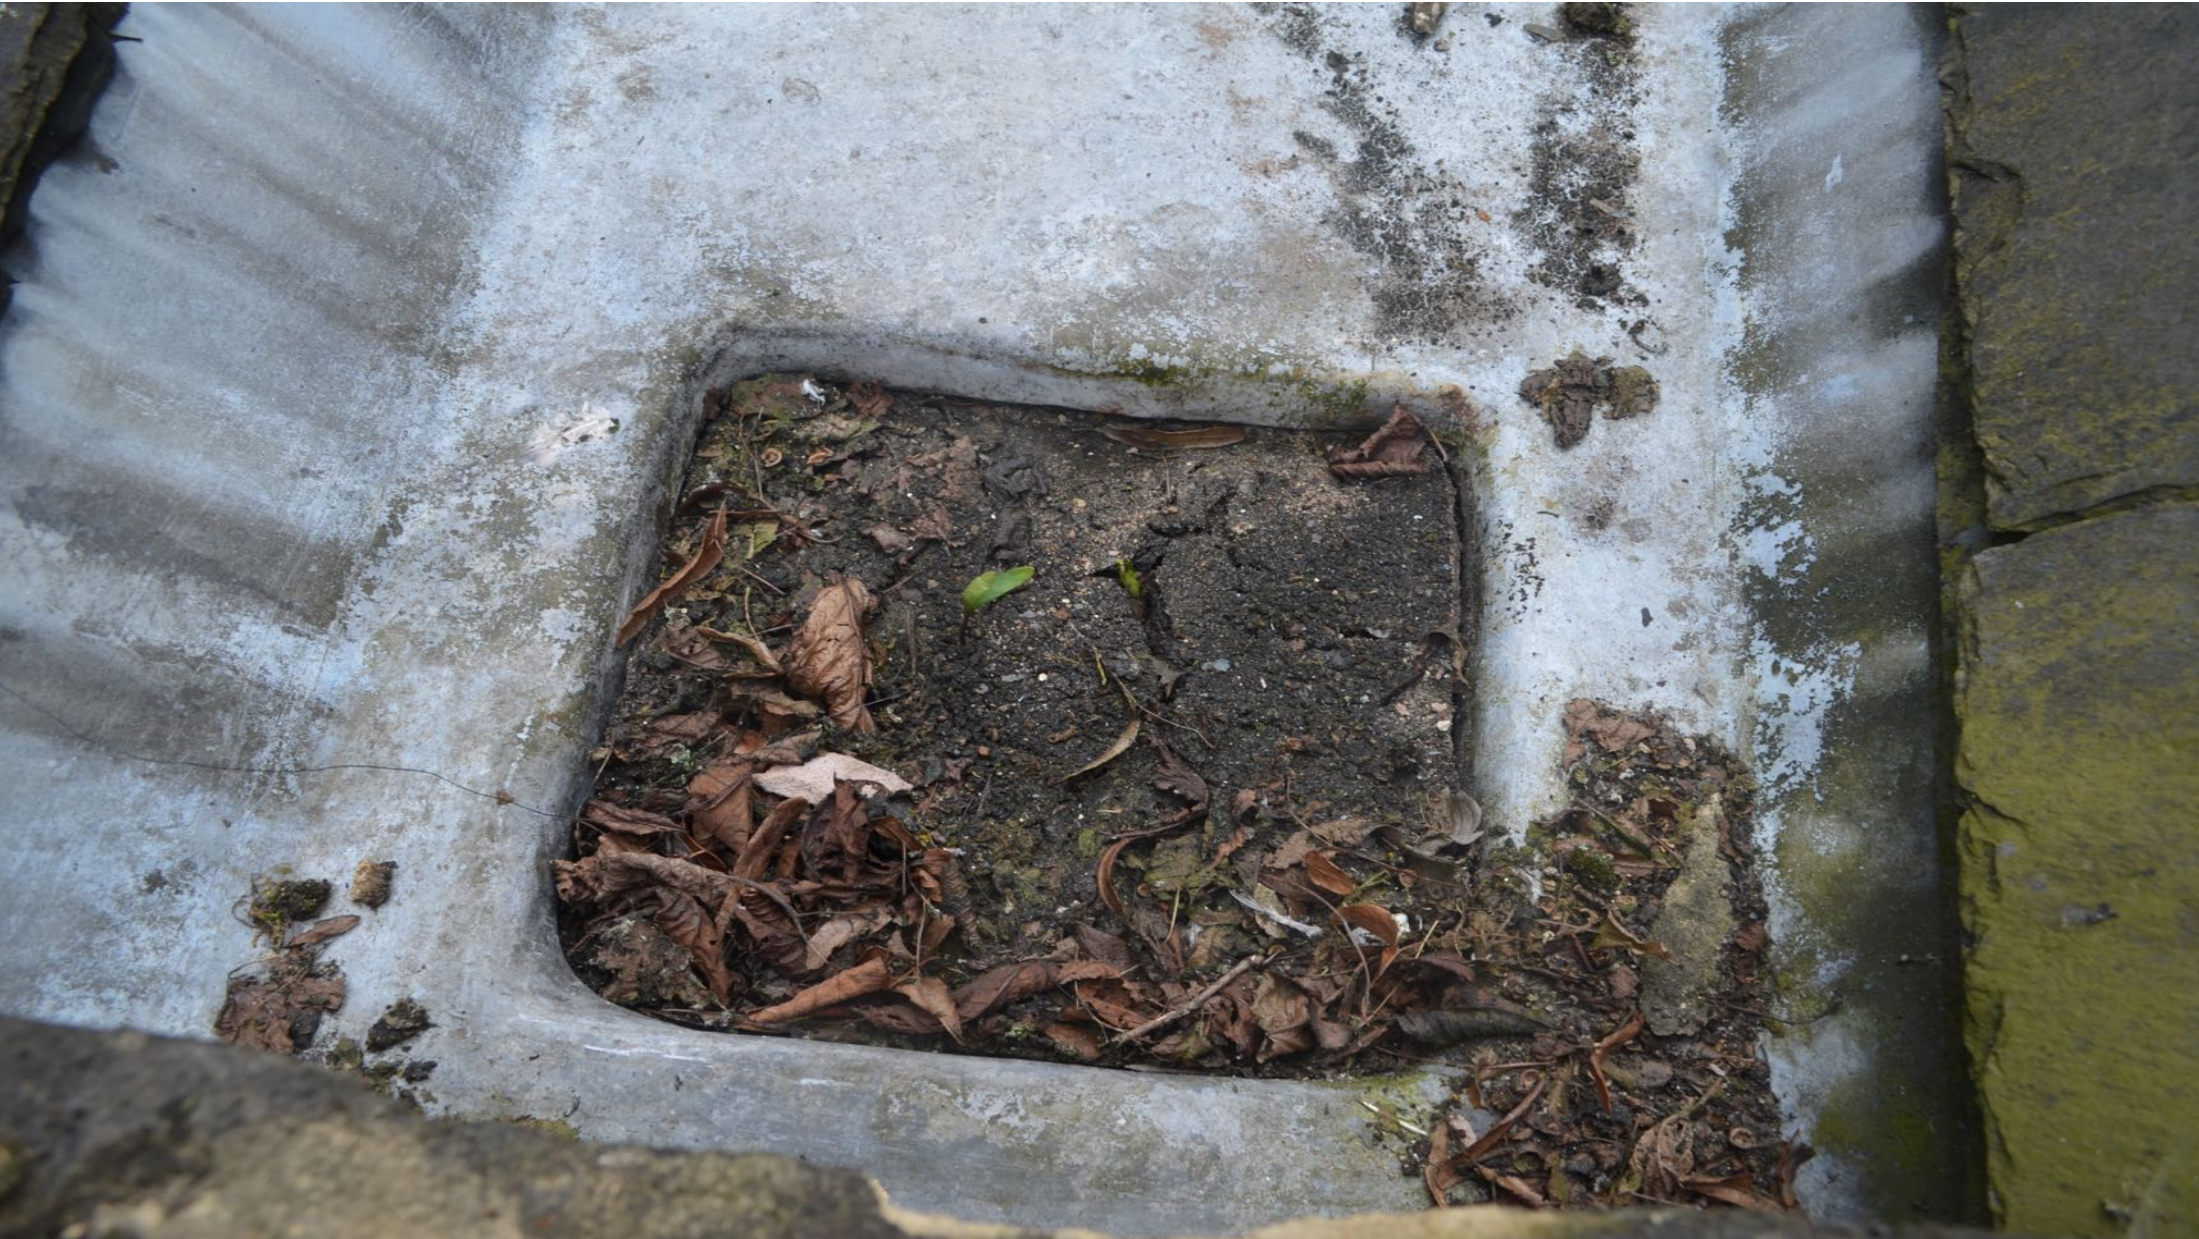
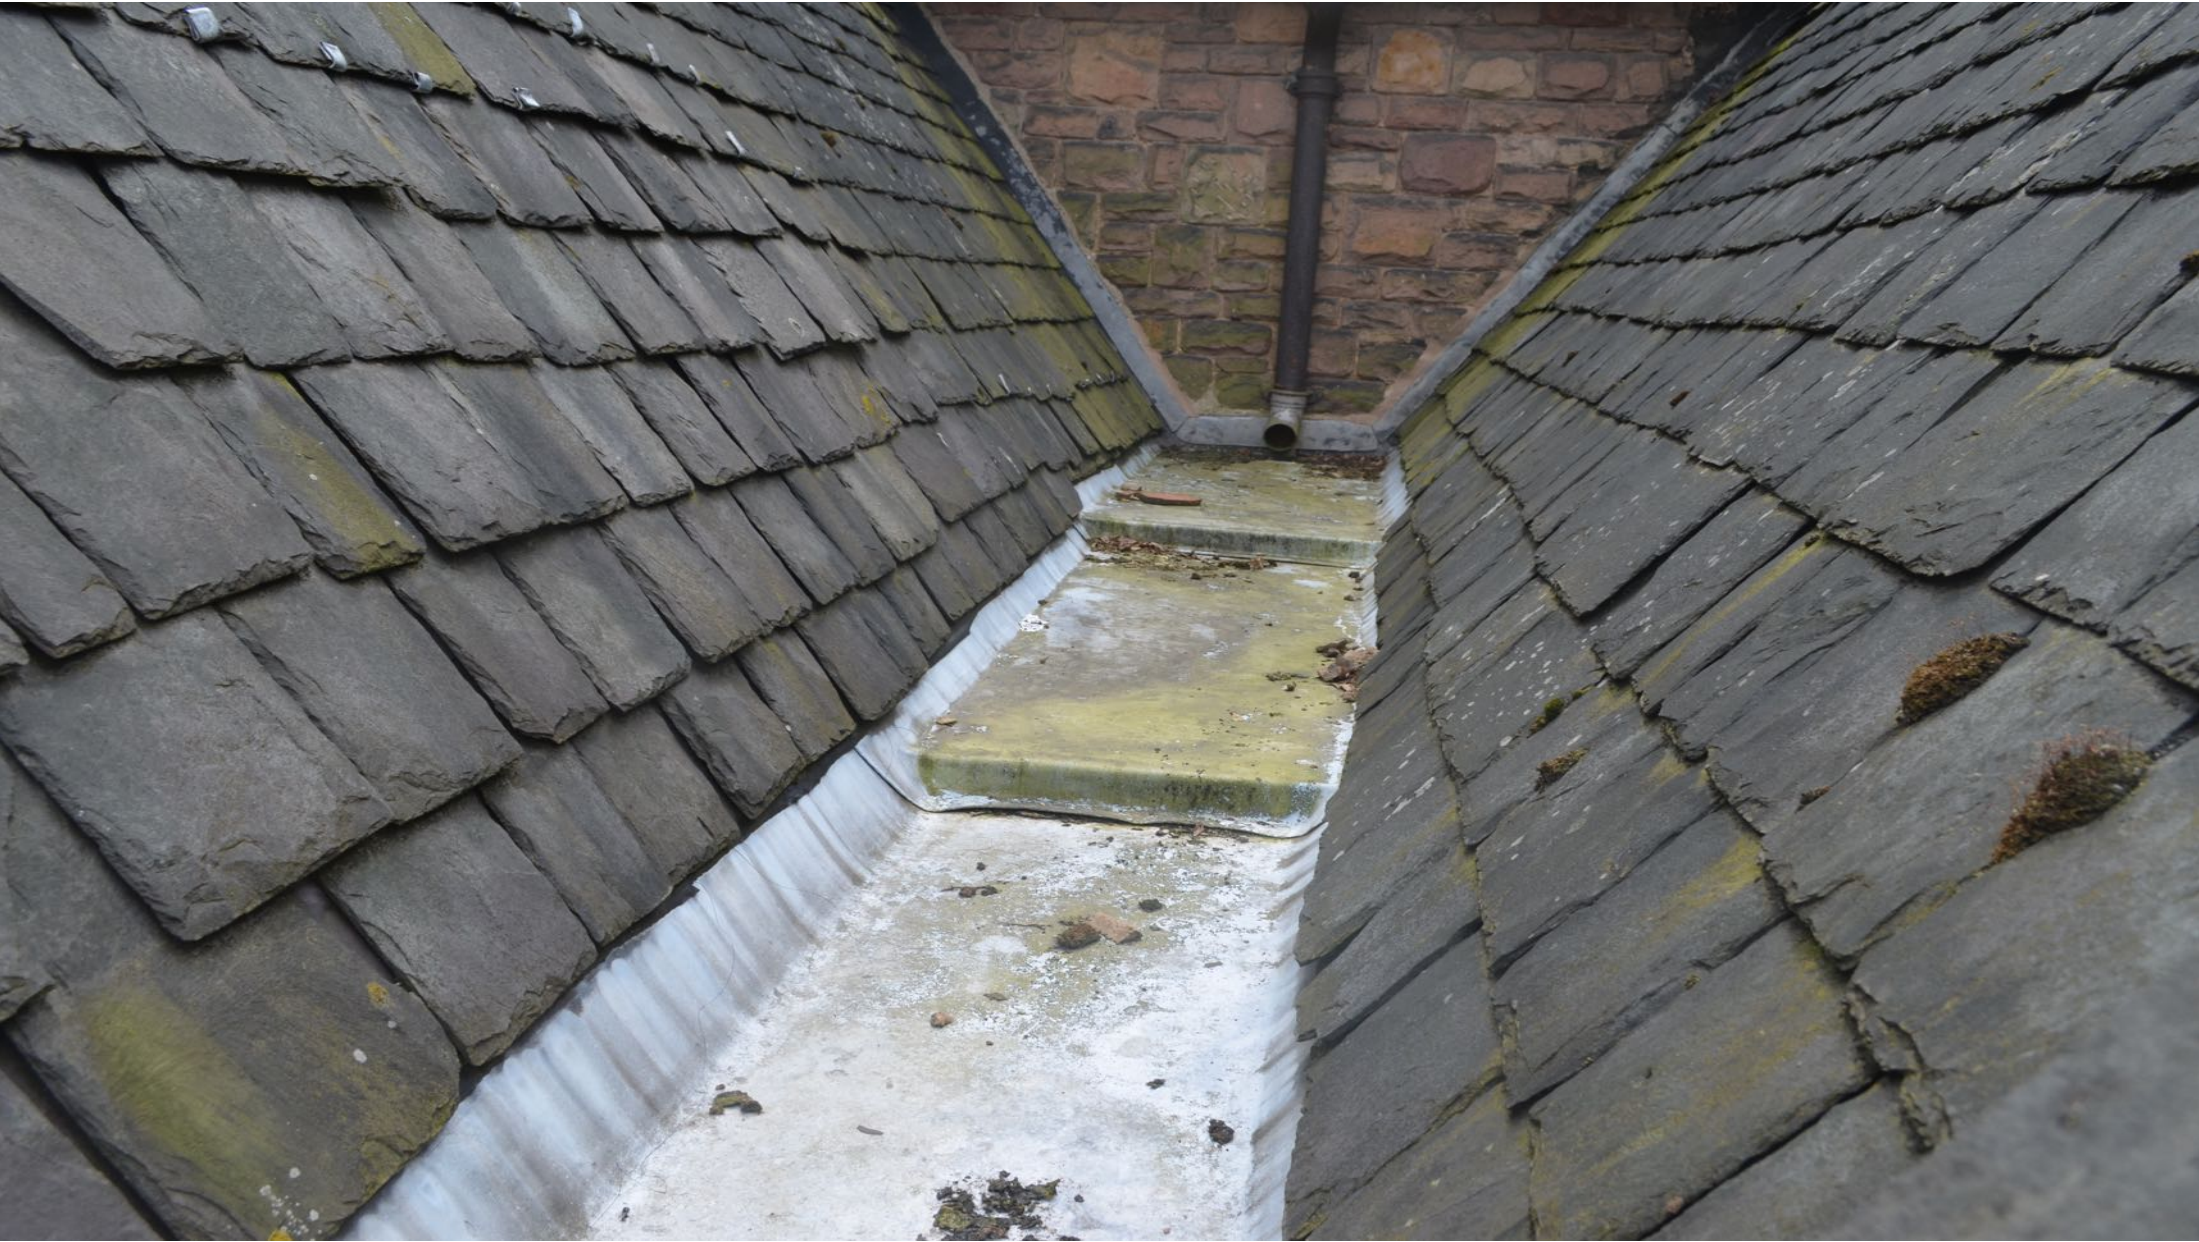
# The North Transept

The Roof of the North Transept and Vestry has Swithland slates laid to a pitch similar to the Nave. The slates come down into a horizontal lead gutter. Work has been carried out to the gutter (not Recent) and the slates have been fixed back using lead tingle. The slating to these areas are in poor condition compared to the Nave. We did not remove slates from these areas and have no idea of construction.

\* **The North Transept and Vestry** This area should be stripped and recovered using new slates to match as closely as possible. The batten and slate fixing details should be kept as original.

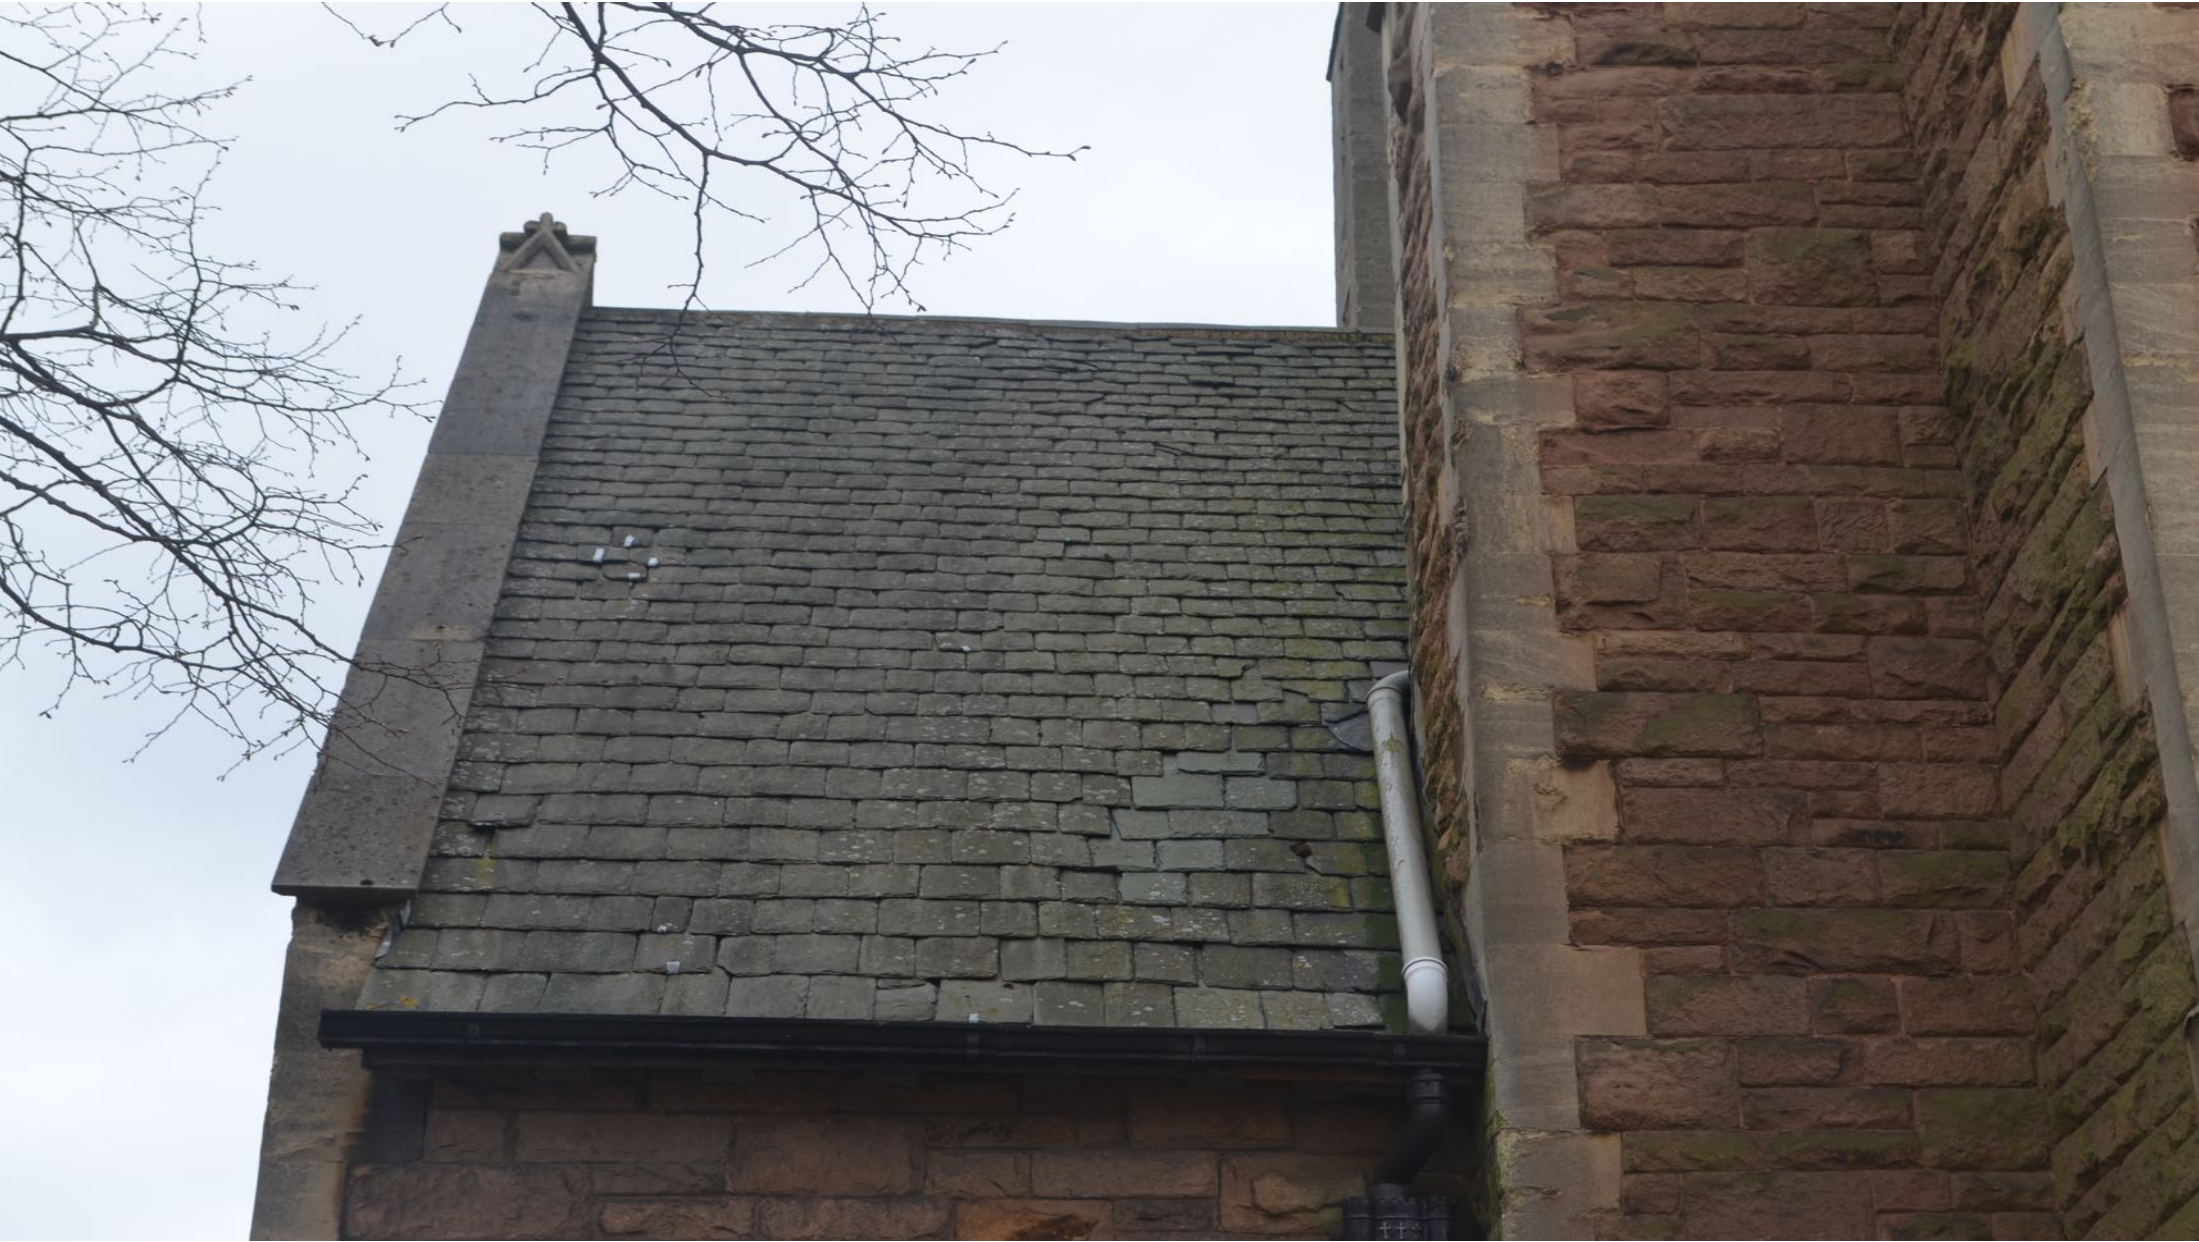
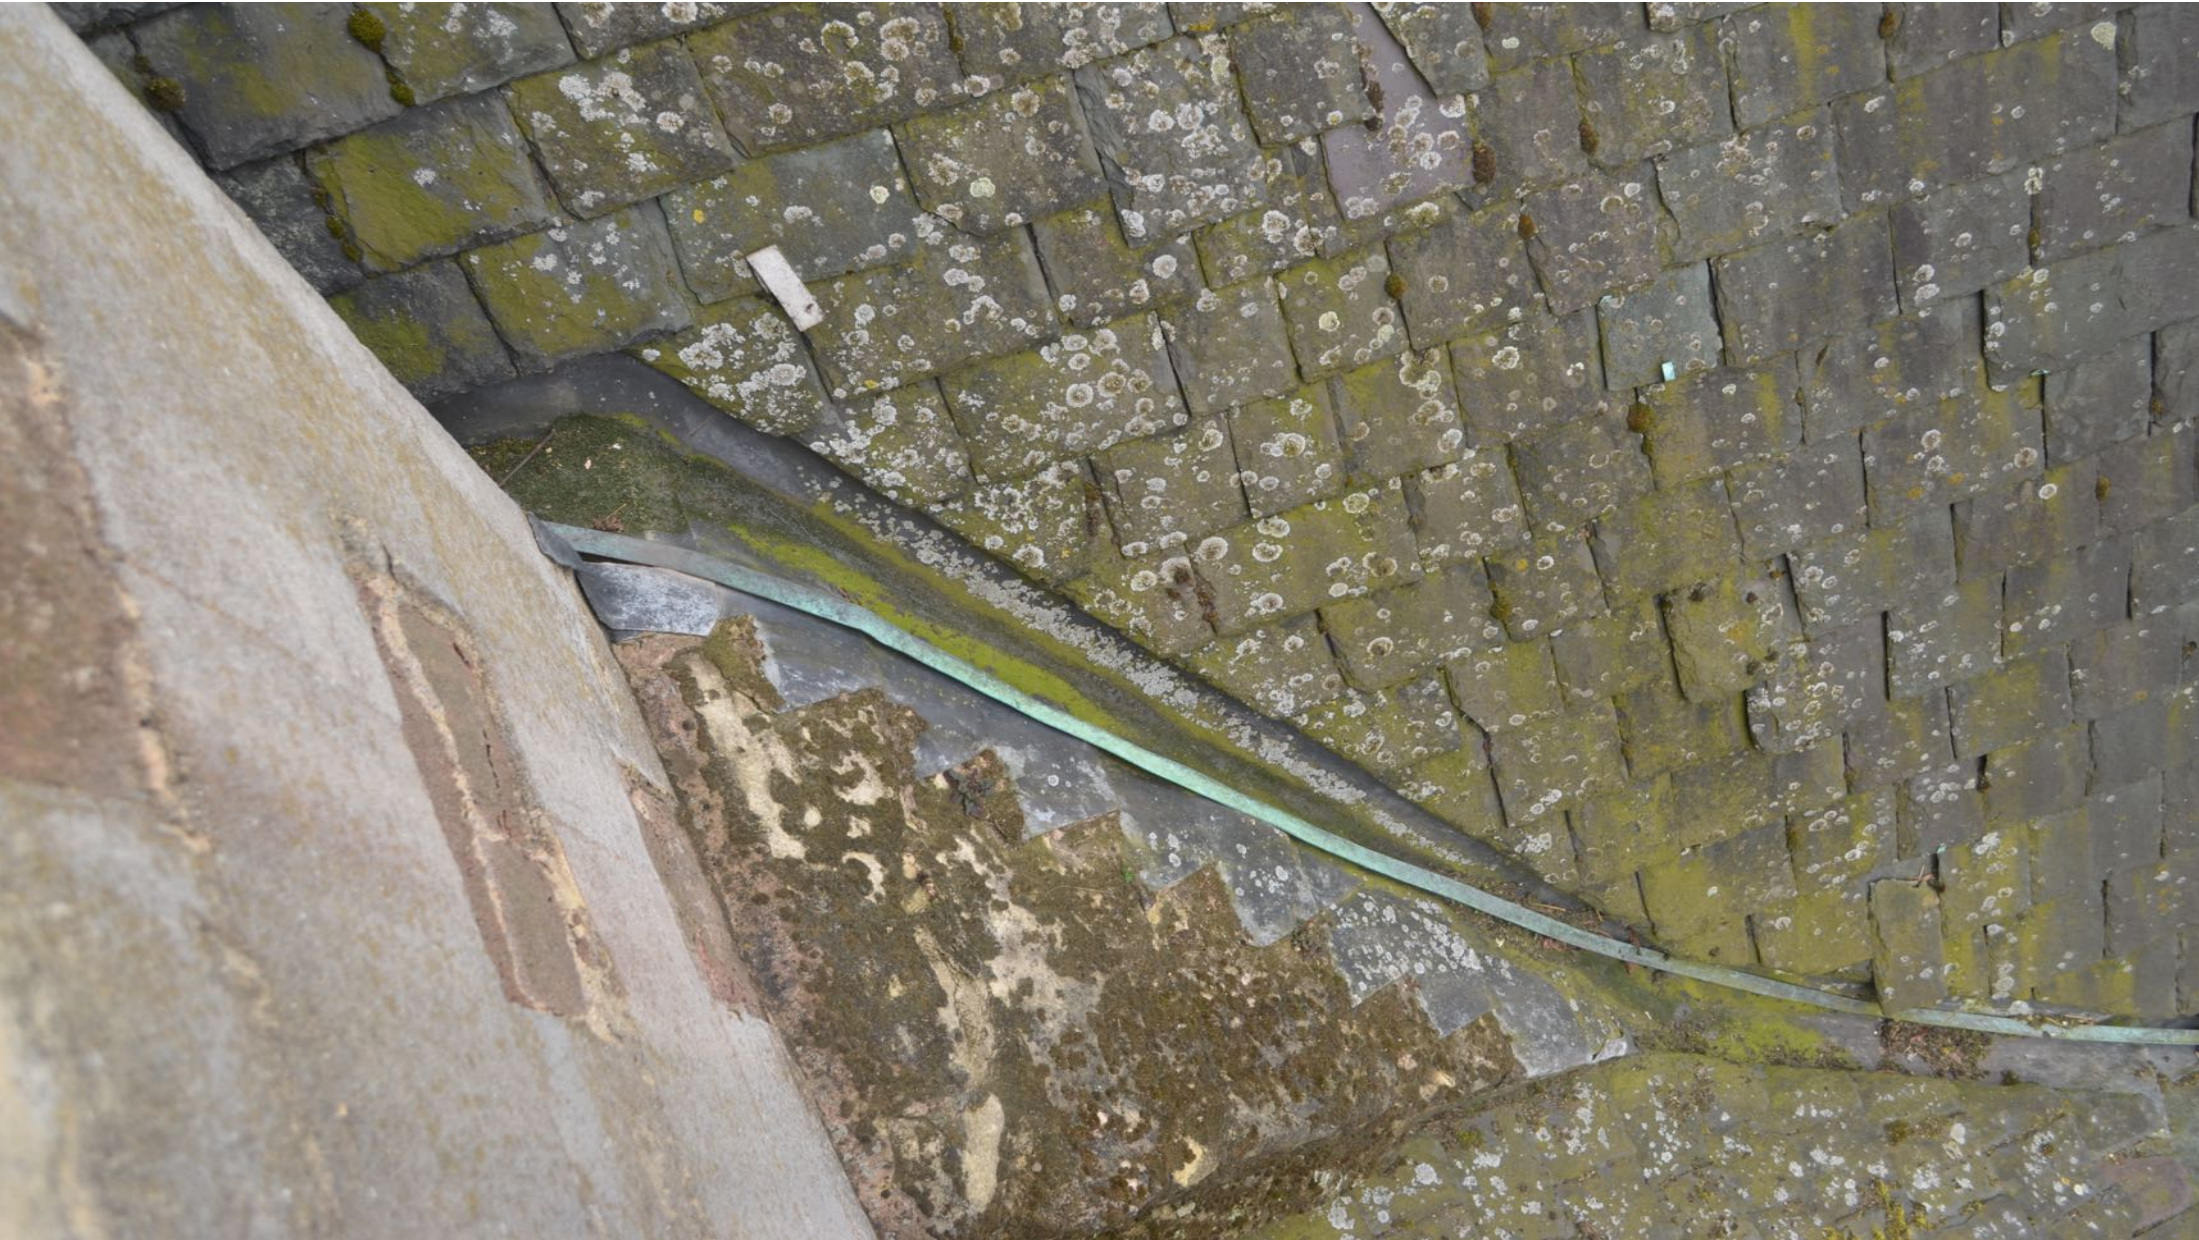
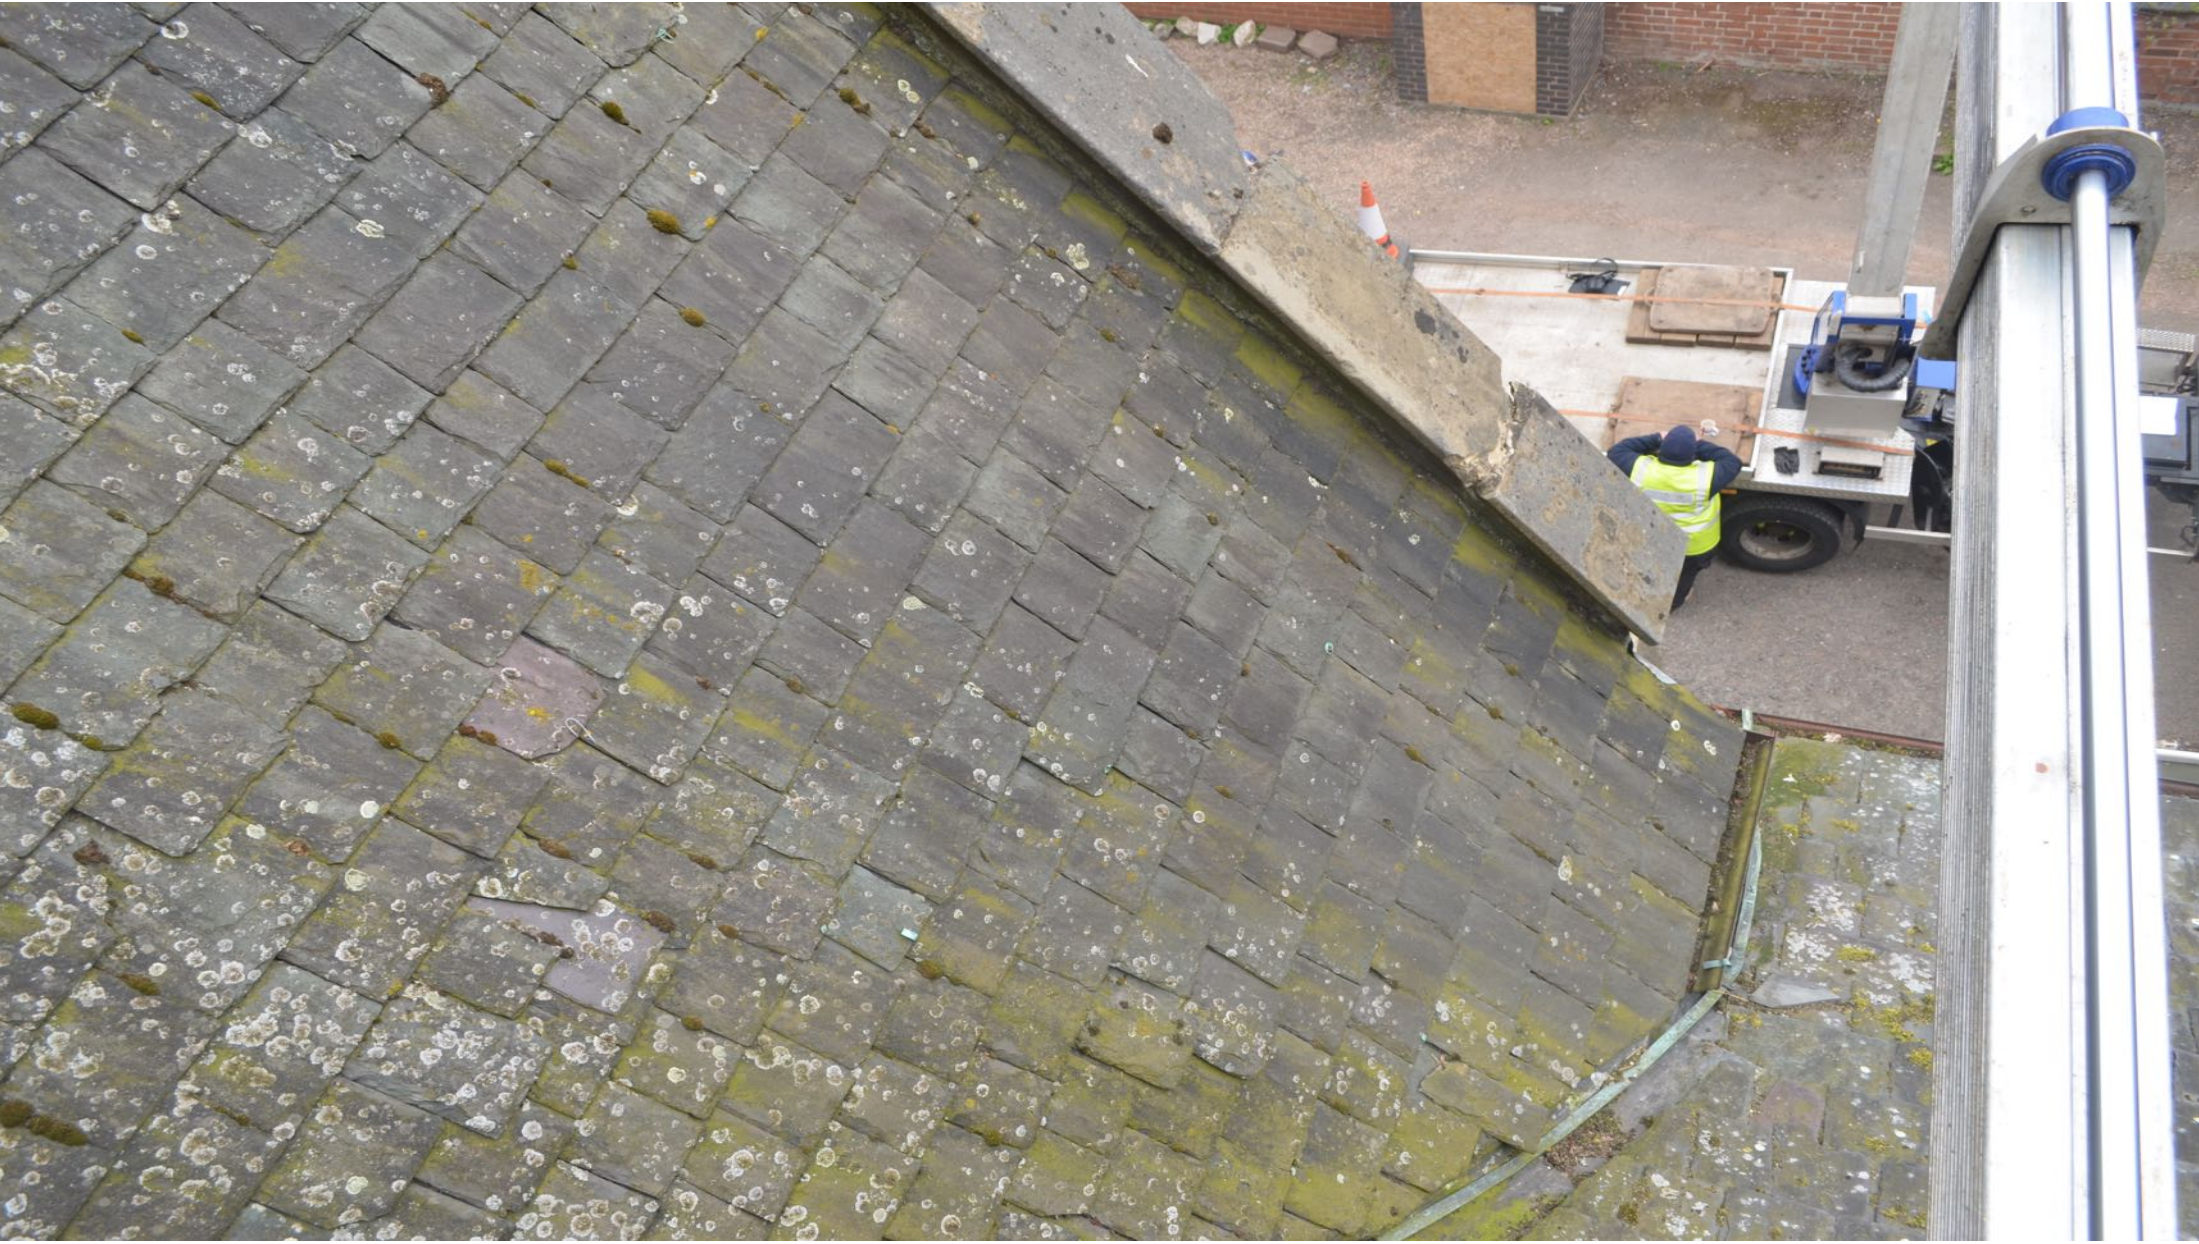
# The North Porch

The Roof of the North Porch and has Swithland slates laid to a pitch similar to the Nave. The slating in this area is not great compared to the Nave. Repairs were carried out at various locations on the porch but vary in standard, quality and types of slates used. We did not remove slates from this area and have no idea of construction.

**The north and South Porch** This area should be stripped and recovered using slates from the North slopes of the church to make up the shortfall of slates. The batten and slate fixing details should be kept as original.
