<b>Ref:</b>	2017-011568	<b>Church:</b>	Coddington: All Saints
<b>Diocese:</b>	Southwell & Nottingham	<b>Archdeaconry:</b>	Newark
<b>Created By:</b>	Ms Susan Lovell	<b>Contact Tel.:</b>	01636 676707
<b>Status:</b>	Faculty granted, awaiting Practical Completion

Certificate of practical completion of works authorised by faculty

# Conservation Unit Laboratory Record Card

Object Name: Alms box sign

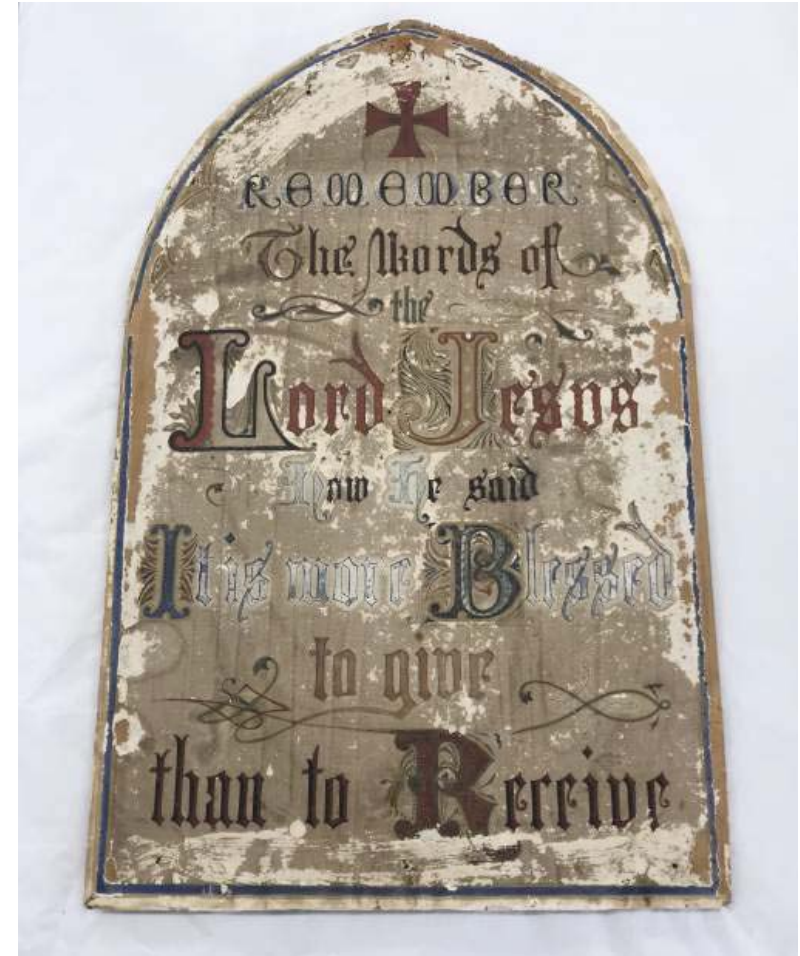
Fig 1. Painted sign, paper on pine board, frame removed, before treatment

- The frame is stable
- Physical damage caused by pinholes is visible in the frame and in the panel. Some of the push pins had been left in place.
- Pins had corroded leaving residue and discolouration on the paper, which could be damaging to paint.
- Damage caused to the structure of the paper caused by pests (silverfish) selectively destroying areas around the various paint colours which contain poisonous pigments.
- Pine panel has been attacked by woodworm around the edges.

- Object covered in cobwebs, loosely adhering dust and dirt embedded into the surface.
- Paper and decoration has been disfigured by pest damage and there are areas of loss of the wording, which is also disfiguring.
- Decoration has suffered light damage and fading, and the dark background is believed to be ingrained dirt gathered over time.

- The sign was vacuumed using museum vacuum and a soft bristle brush to remove transferable surface dirt. A stiffer brush was used for the back of the pine panel as this surface was rougher and dirt more ingrained.

- Japanese tissue paper coated with a starch paste made from a mixture of Tylose powder and wheat starch was used to fill the areas of loss of the sign. A small rotating knife was used to accurately cut out the shape of the fills on transparent Melinex foil placed over the lacunae, then the Japanese tissue fill was dampened using a paintbrush and distilled water, which reactivated the adhesive mixture. Layers of tissue were built up to compensate for the lost material to the level of the original paper.

- Once the Japanese tissue had been left to dry fully, colour matching and in-painting was completed. Using powdered pigments, in an acrylic binding medium (Golden Acrylics Porcelain Restoration glaze) and a natural sponge, the background colour was built up in layers. More detailed in-painting of the edges and the lettering was completed using Golden Acrylics paints and fine paintbrushes.
