STATION 14: ST MICHAEL AND ALL ANGELS CHURCH, ABINGDON

CONSERVATION TREATMENT REPORT

September 2018

Report No: BMSAC0218 Date: 4 September 2018 Author: Bianca Madden, Conservator of Wall Painting and Sculpture, The Garden Flat 5 Rawlinson Road Oxford OX2 6UE; T: 07789067364/01865 513144; E-mail: bianca@biancamadden.com

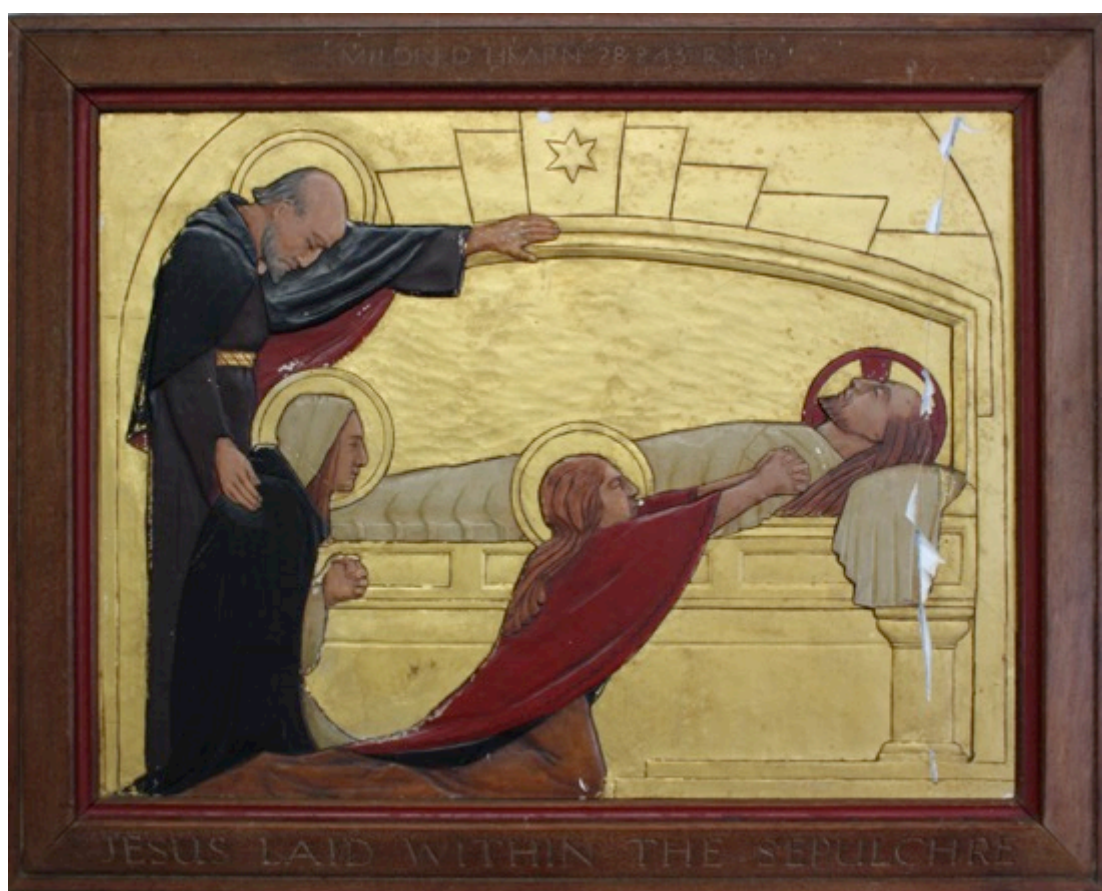
The panel was damaged by accidental dropping, which resulted in a long vertical break running the height of the panel at the right-hand side. The break exposed the internal armature, and appeared to run along it. The break resulted in the loss of a certain amount of material along the fracture line, as well as shattered and loose sections of plaster. A number of hairline cracks radiated from this break, across the surface of the panel, with additional loss of material along them. A large chip at the top off the panel appeared also to be associated to the fall.

The polychrome of the panel appears to be generally in sound condition and is well adhered to the surface, with the exception of some localized areas of loss, in particular across areas of raised relief, which are likely be related to dusting or cleaning attempts and abrasion rather than a break down of the adhesion of the polychromy to the underlying layer. Aside from the areas damaged in the accident, the plaster substrate appears in stable and sound condition, and there is no evidence of rust or expansion of the metal armature within. The wooden frame is in sound condition.

Above: the condition of the panel before treatment

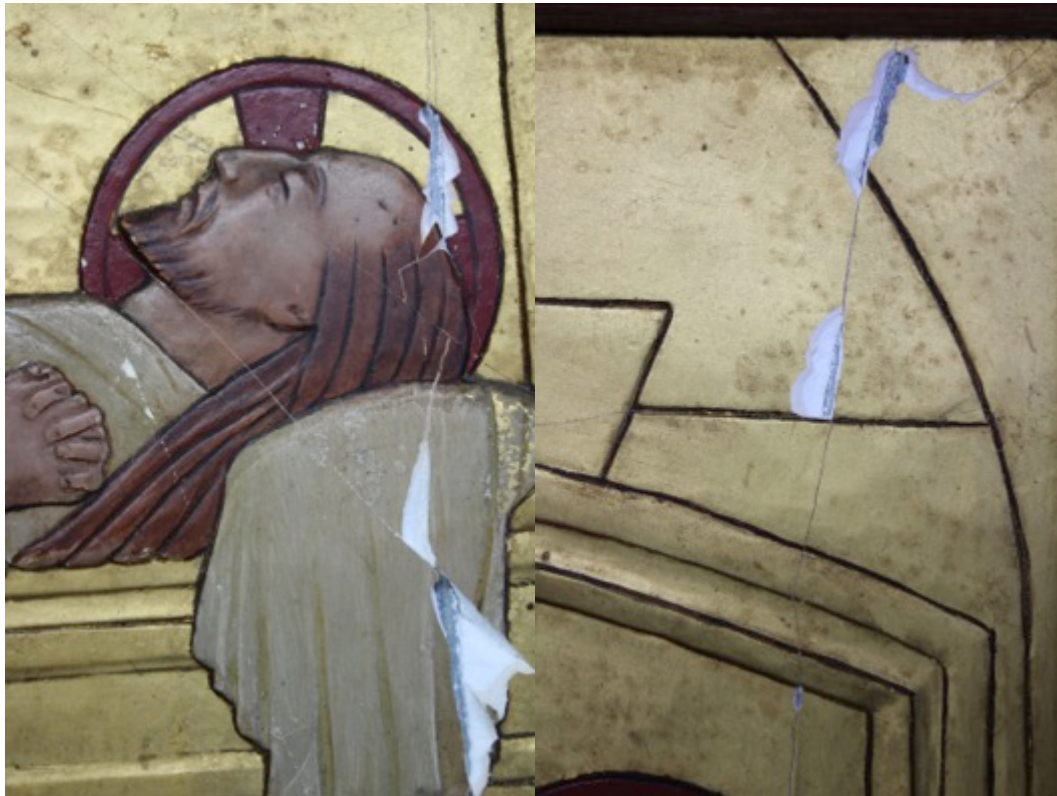
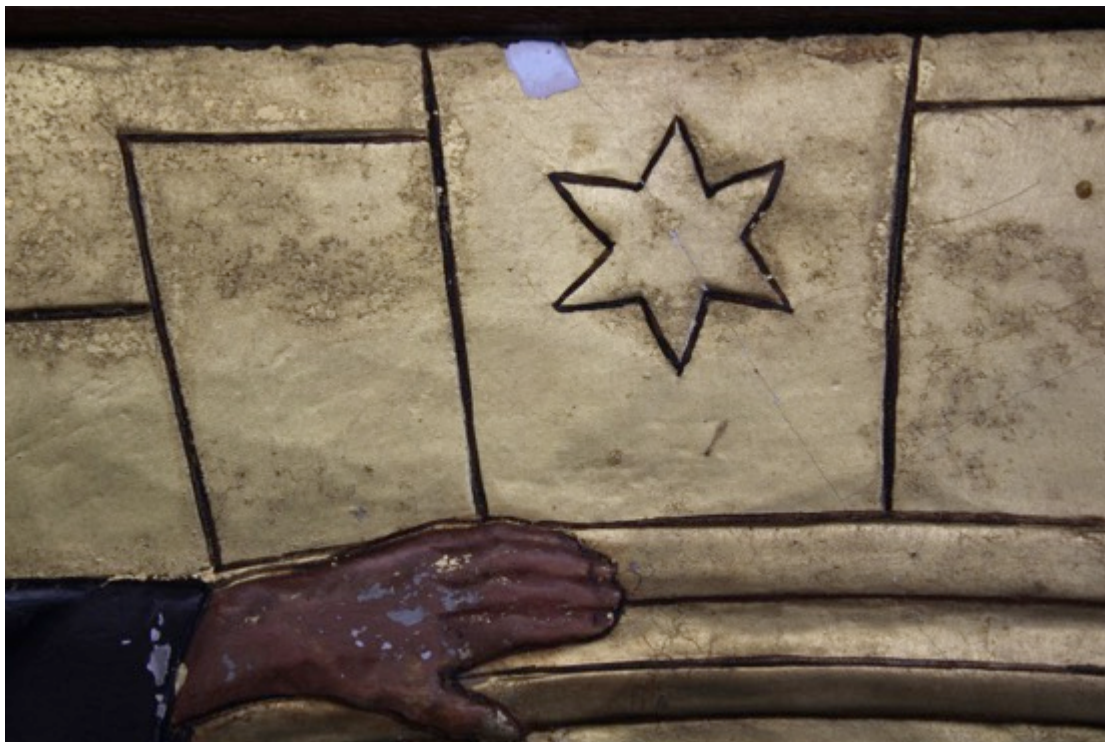
Above top: details of the loss and fracture, with gold evident under the painted layer on the cloth under Christ's head. Above: abrasion of paint layer across the hand and sleeve, with evidence of the gold layer beneath the paint layer on the hand. A large chip is visible at the top of the panel, as well as a crack with associated losses across the star.

The cracks and losses were consolidated, and the detached elements reattached, by application of Paraloid B72 (acrylic resin) at concentrations of 10-20%, as appropriate, in acetone. The exposed metal armature of the panel was also coated with Paraloid to protect it from rust associated to exposure to moisture.

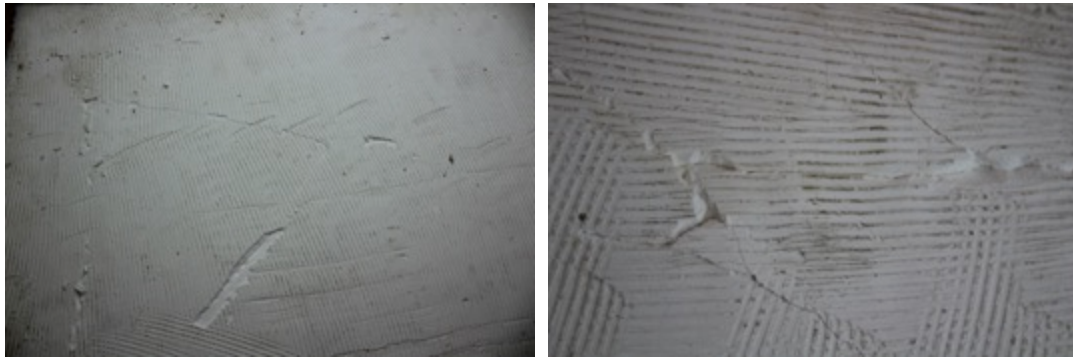
Once the face of the panel was secured, and all loose elements reattached, the panel was turned over. On removal of the backing board, it was revealed that the cracks had, in places, extended right through the depth of the panel. These cracks were rejoined and consolidated using Paraloid resin, as those on the panel face.

Details of damage and cracking on the reverse of the panel

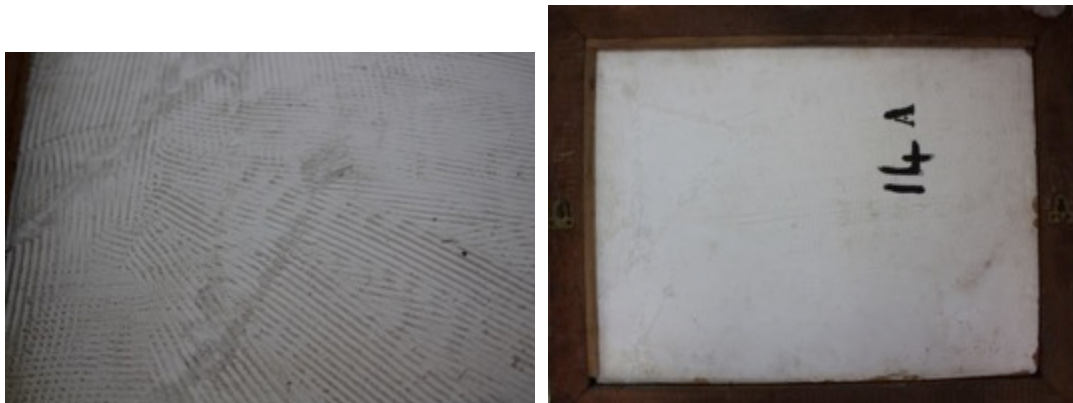
Above: a detail of the filled cracks, left, and an overall view of the reverse of the panel after filling

Working on the reverse of the panel the losses associated to the cracks at this side were then filled using Paraloid B72 resin at 35-40% with a glass micro-balloon bulking agent. This filler provides a light, inert, and reversible conservation grade fill, which has good adhesive qualities to further support the damaged area.

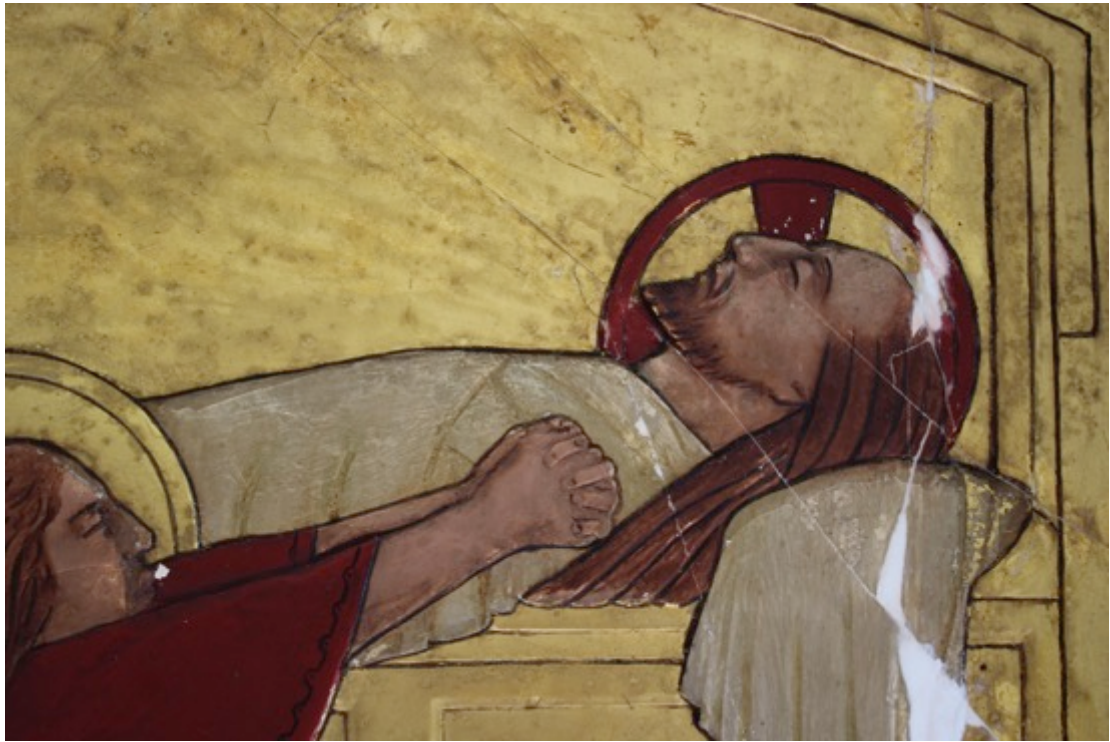
Above, detail of filling before retouching on the face of the panel

Once the reverse was supported and repaired, the original backboard was replaced and the panel turned over again. The same Paraloid and glass micro-balloon filler was then used to fill and support the losses on the face of the panel.

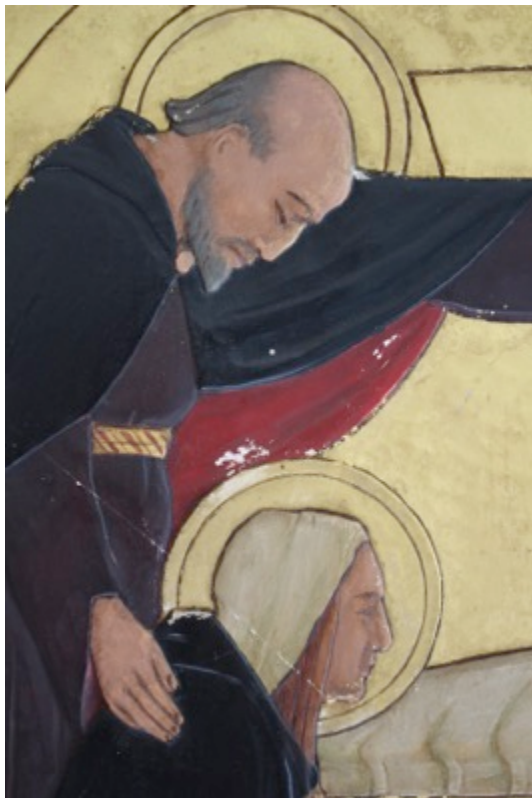
Above: detail of the left-hand side of the panel before retouching

Losses to the paint layer were retouched using light stable, conservation grade acrylic colours.

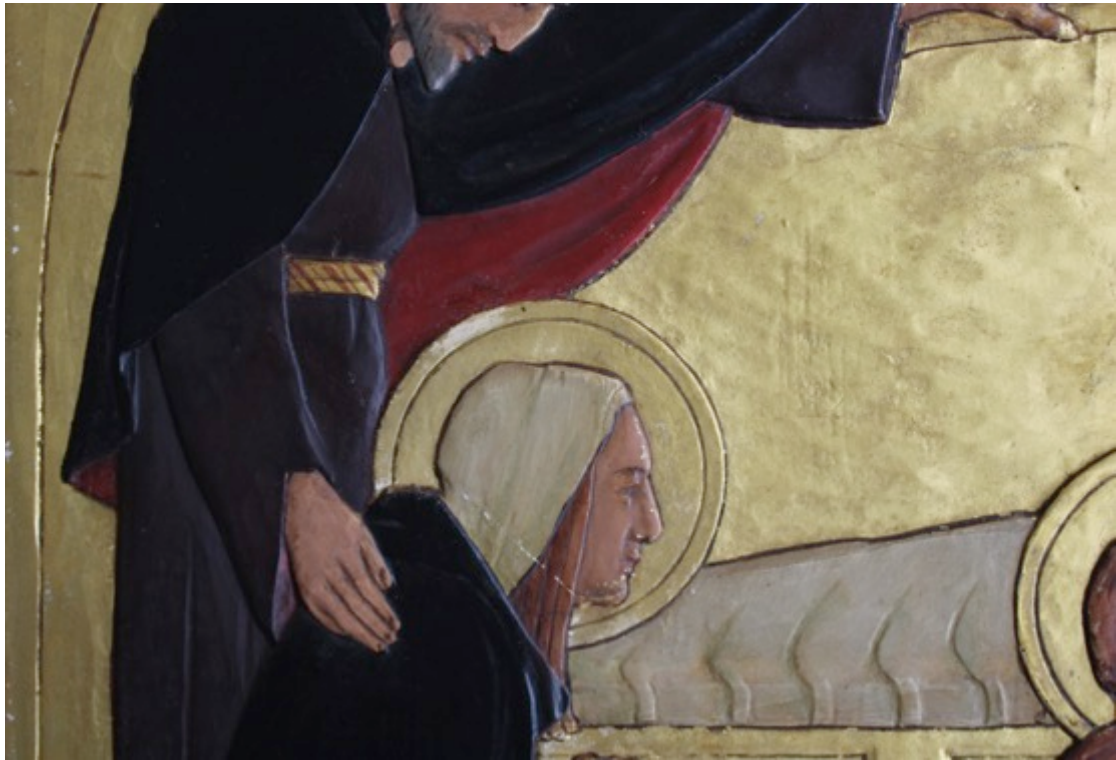
Above: detail, during, retouching losses of the paint layer

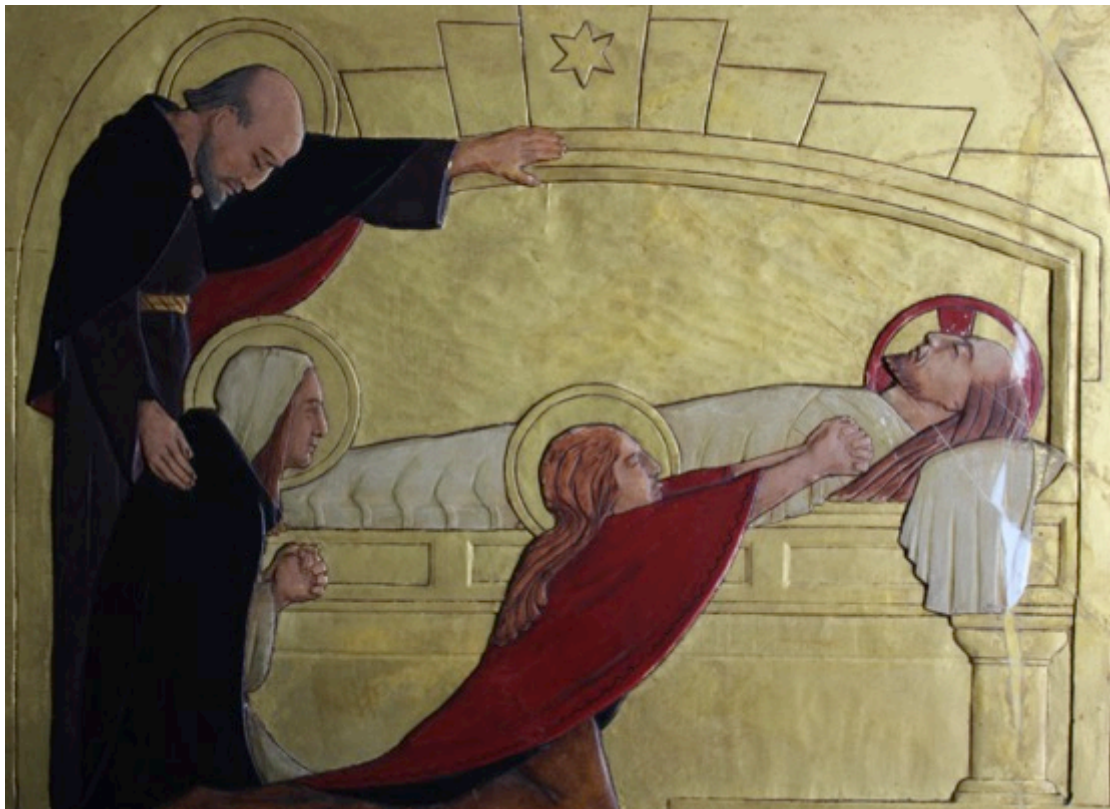
Above: the reintegration of the gilded areas

The filled areas within the gilding were reintegrated by re-gilding, over a yellow ochre acrylic ground, using 23-carat loose leaf gold applied with an acrylic size. The new gold was then toned using a range of light stable acrylics to reintegrate the new areas and repairs to the surrounding gold surface.

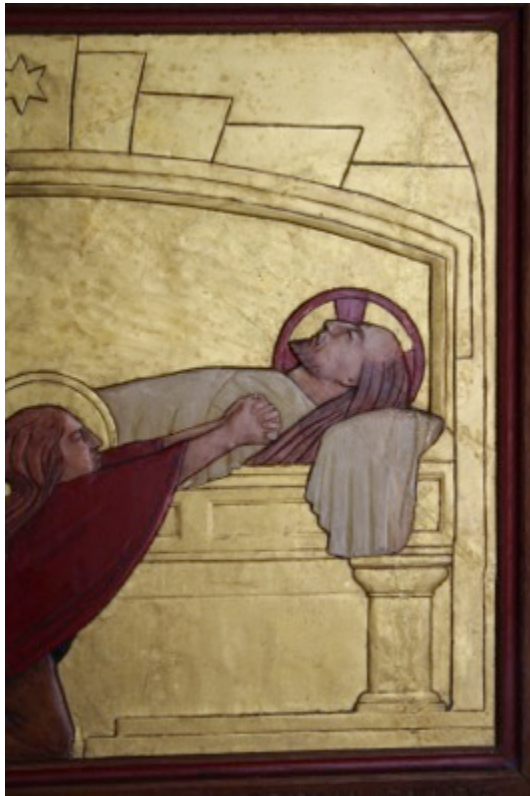
Above: after retouching the paint layer and the regilding and the reintegration of the new gold

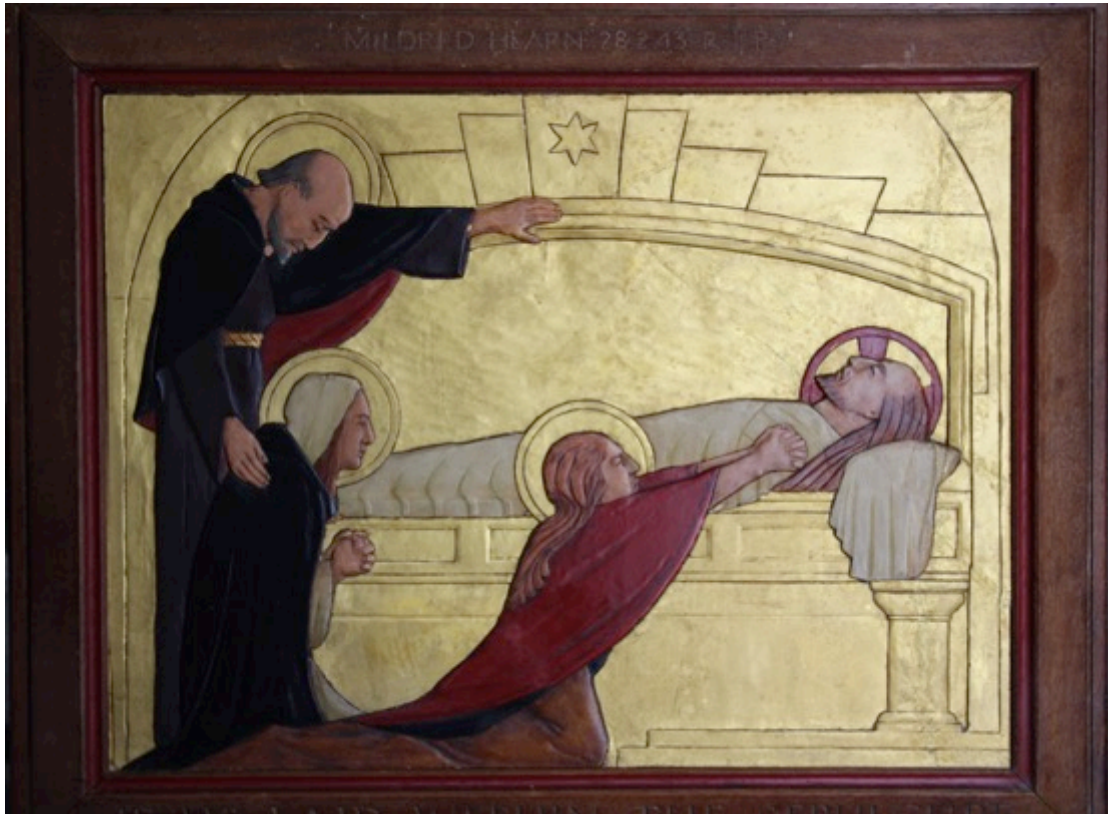
Station 14 after conservation

Station 14 is now repaired, retouched and stable. But it should be noted that the wooden frame which houses it, and is in good condition, plays a significant part in protecting and holding the panel. The panel would be very vulnerable if removed from the frame. Fortunately, the panel is also built around a metal armature, which gives it further structural support, but it remains a delicate object due to the brittleness and weight of the thick plaster of the panel.

The reintegration of the gilded layer has been carried out under daylight lighting at my studio, but as I have mentioned to the churchwarden, Peter Squire, I can undertake further toning of the new repairs if necessary once it is replaced in the church in situ as the appearance of the toning of the newly gilded areas varies according to lighting conditions and angles.
