Tresungers Cross, St Endellion – Repair and Conservation

Details of Restoration

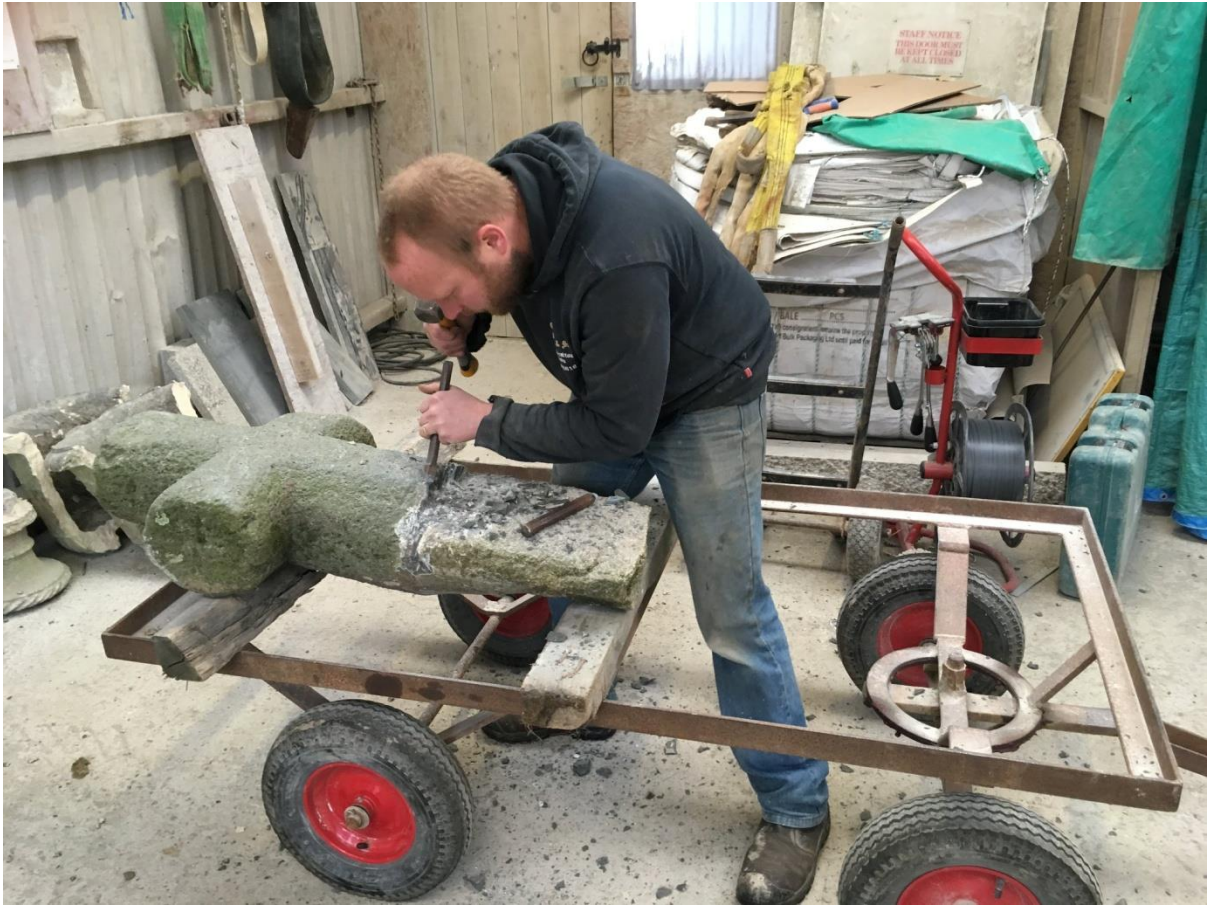
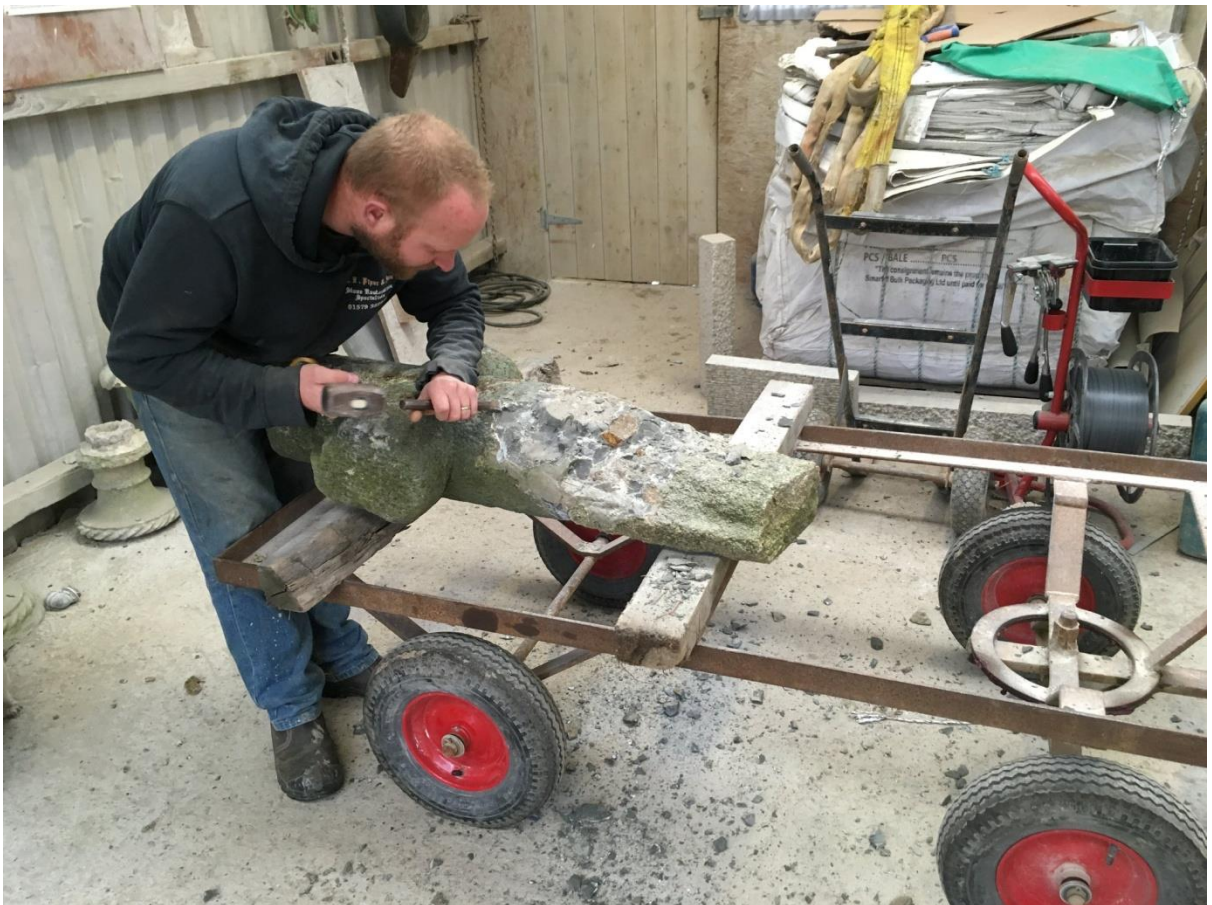
Until recently, the cross was located under a large conifer. However, during storms in the early part of 2014, branches from the tree fell on the cross, which was knocked to the ground, breaking the granite shaft on which it was mounted. Part of the granite shaft remains in the ground.

On 11th October 2018, Mr Piper carefully chipped away the cement mortar that had been smeared over the joint between the granite mullion and the cross itself, revealing the full shape of the cross and demonstrating how awkwardly it had been set on the mullion. Not all of the cement was removed however in order to keep the two stones stable. It was never the intention to detach the two completely, but to keep enough of the granite mullion to allow it to be sunk into the new base and keep as much of the original cross visible as possible. .

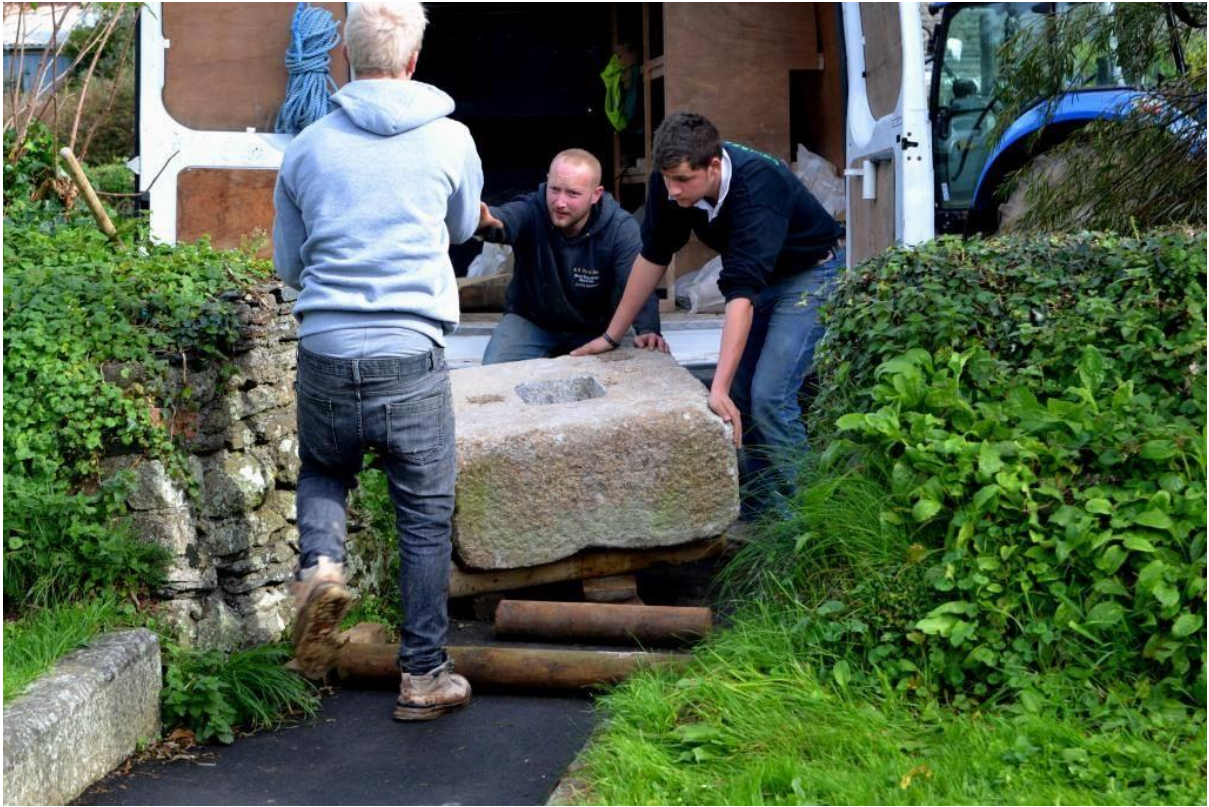
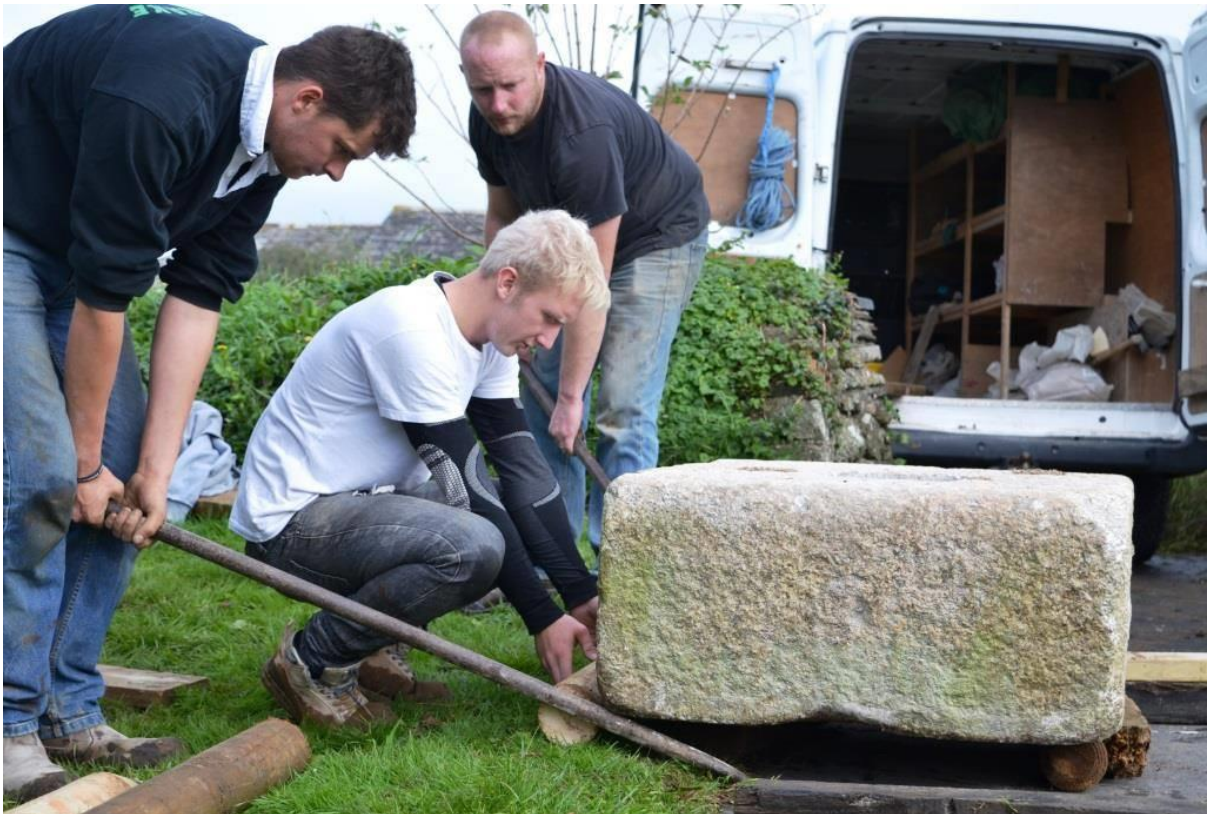
Some damage to the bottom of the cross shaft was revealed and here only the top centimetre of cement was removed. This was replaced with a dark green lime-based mortar from Mason's Mortars, which is used for the conservation repair of church windows in Cornwall made from Polyphant Stone. Polyphant is a local greenstone of similar appearance to Catacleuse Stone.

An approximately 20cm length of the mullion was cut off to enable it to be slotted into the mortice of the new base.

At the same time, a mortice 20cm deep and 30 x 20 cm across was cut into a large block of reclaimed weathered granite measuring 90 x 80 cm across and 30 cm high, acquired specially for the new base of the cross.

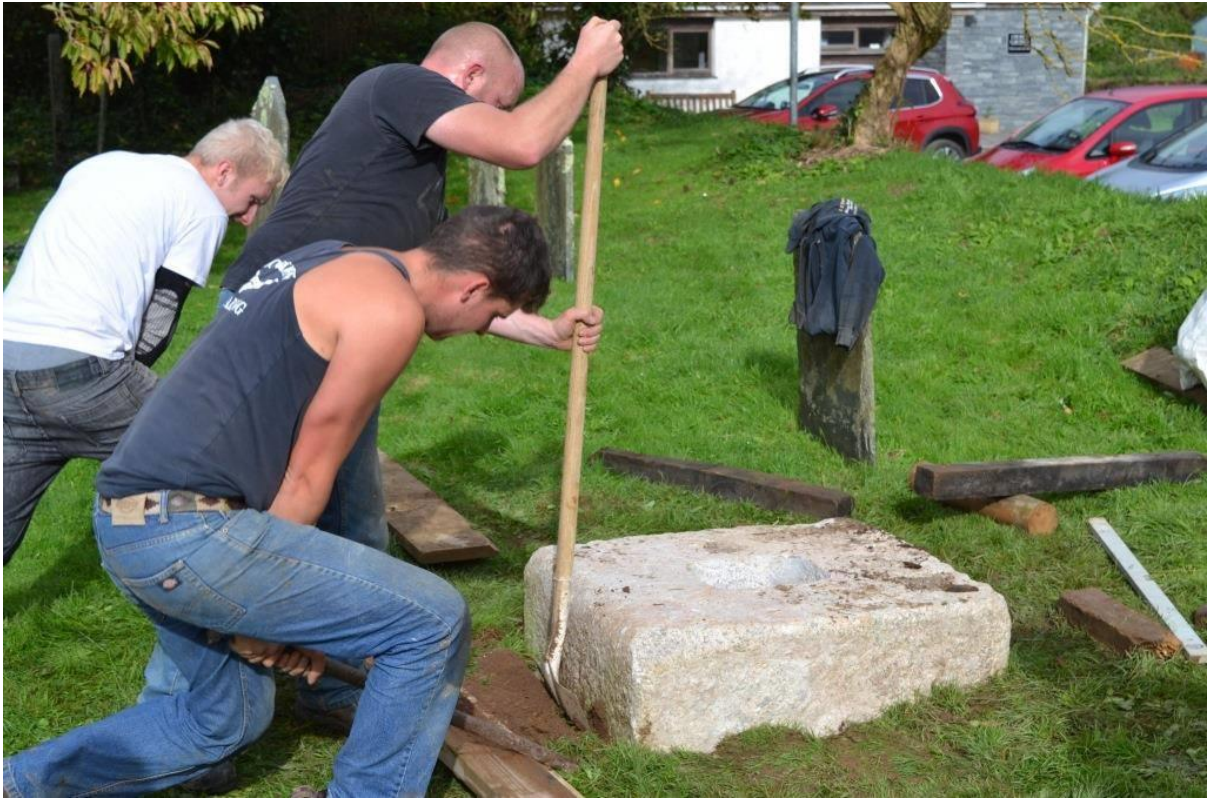
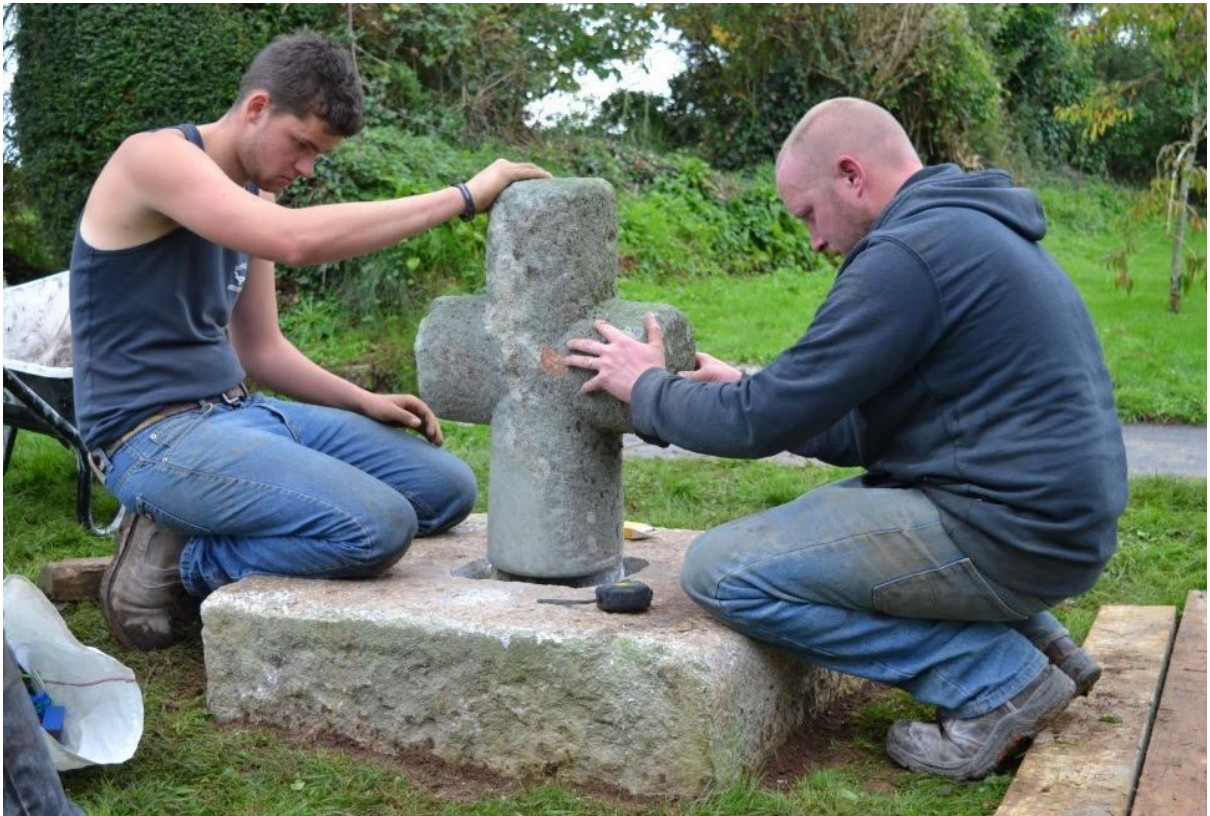
An area of turf was removed measuring 95 cm x 85 cm x 20 cm deep, 5 cm larger than the cross-base all around, to minimise ground disturbance. The ground was checked but consisted only of a medium brown shillety soil with much rubble in it. There were a few pieces of clear bottle glass, fragments of slate and mortar. No bone was noticed and no graves disturbed.

The cross-base was moved from the van to its new position entirely by hand, using wooden rollers to manoeuvre it. It was extremely heavy and took a good deal of effort to get it into position, after which it was carefully levelled.

The cross was then brought into the churchyard, set into the base, centred, levelled, and mortared into place with a dark gritty lime-based mortar.

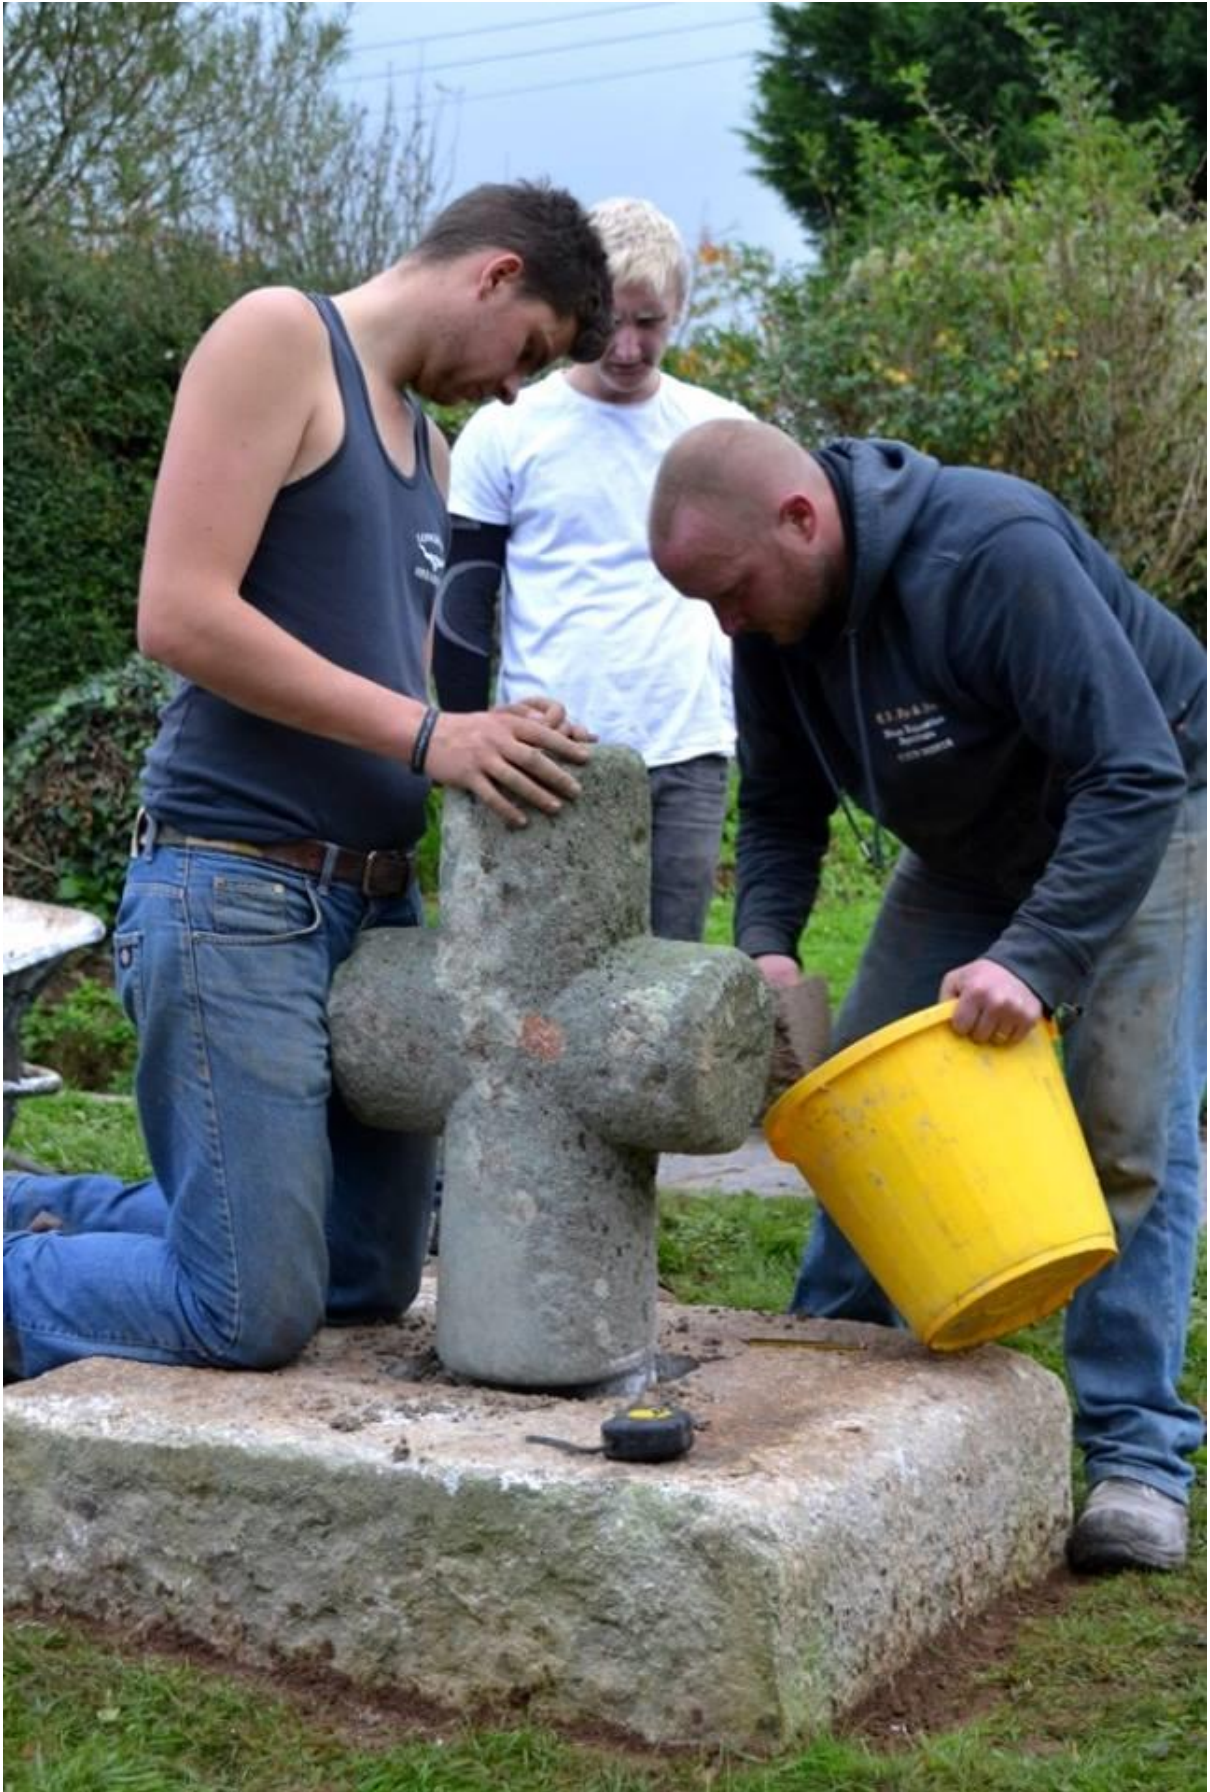
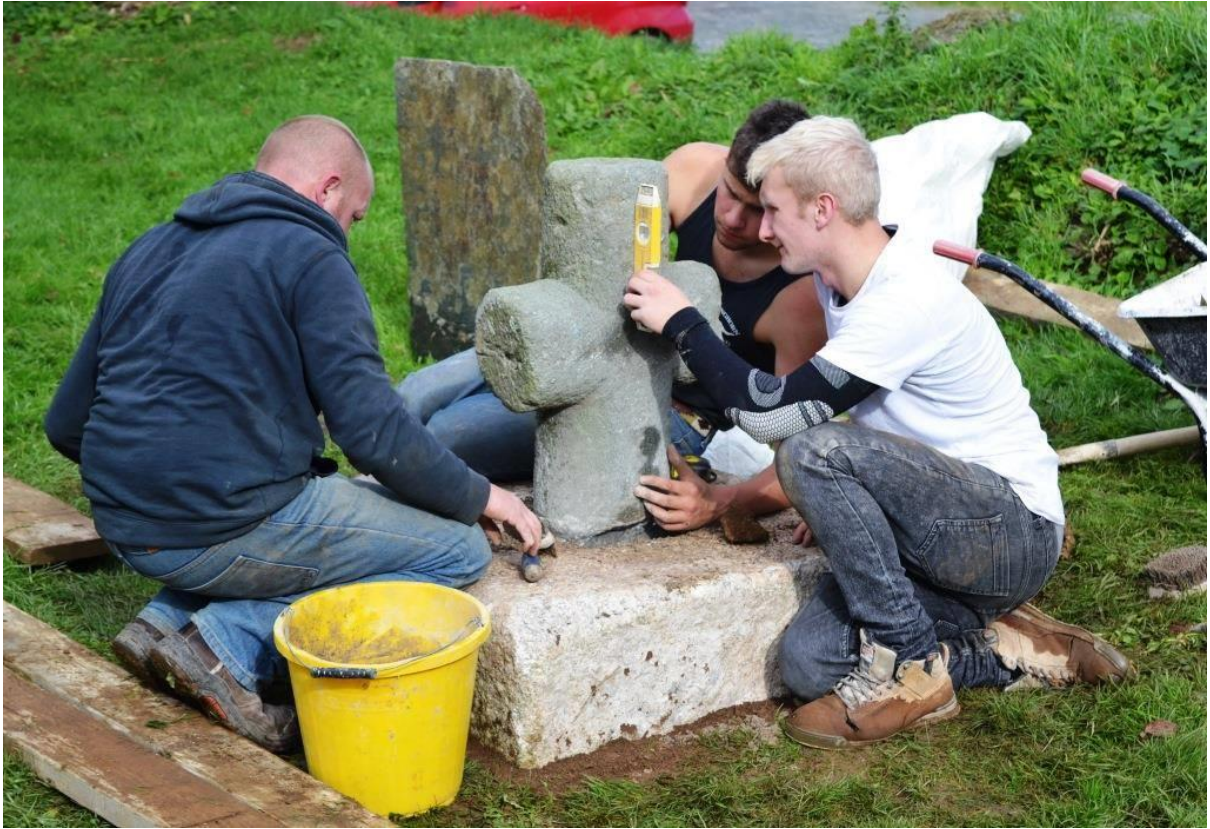
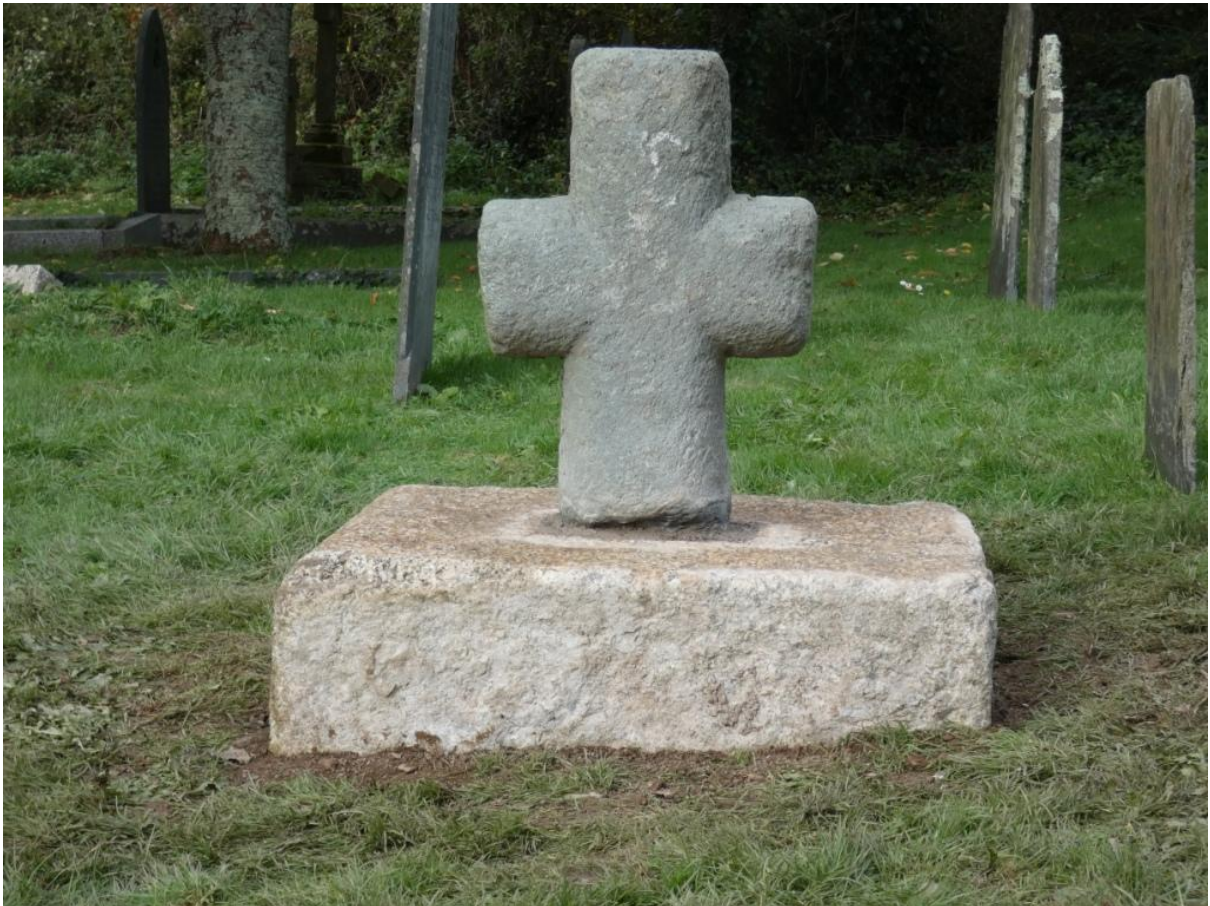
The cross was set into the base, so that all of the old part of the stone is exposed, but the modern mullion 'stem' remains hidden.

The Polyphant repair to the broken part of the cross shaft blends remarkably well with the colour of the original monument.
