Padiham St Leonard (Diocese of Blackburn)

**Condition report and recommendations for
restoration of south aisle east window
(John Hardman, 1870)**

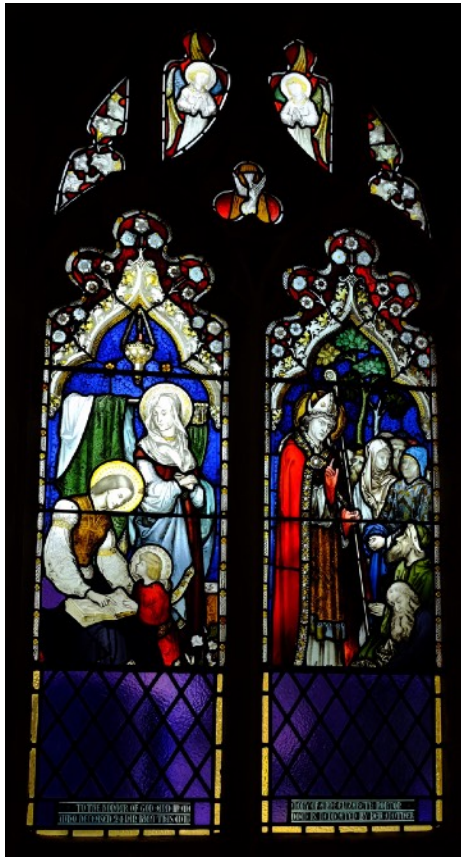
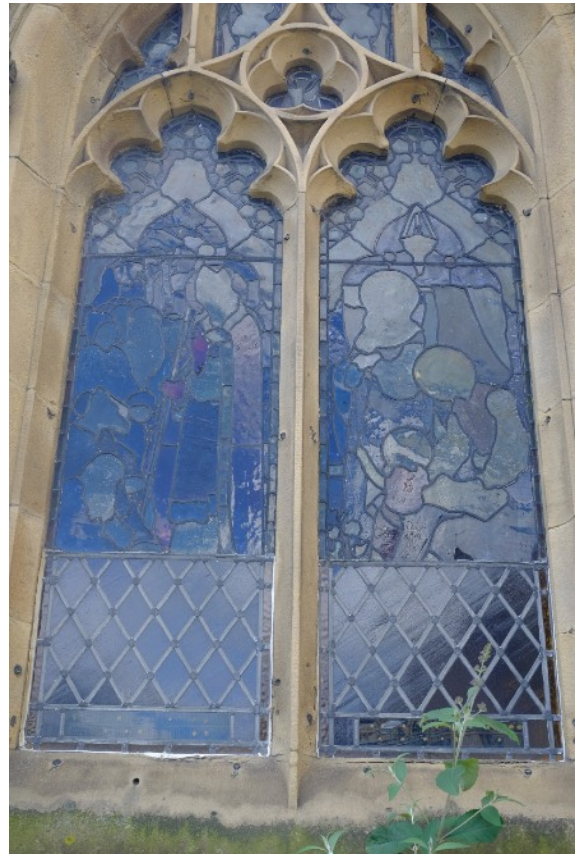
south aisle east window

1870 date, weakened by previous intervention, particularly in the areas directly above the division. Most ties are holding and no fractured solder joints were visible in reflected light. Leaded light cement is beginning to fail, and has a 'frilly' appearance at the edge of the lead came.

In what is now panel 2a, there is a significant distortion from the plane. One factor in this is that the panel appears to be rather oversized, and is tight within the groove. The mortar creeps beyond the glass line on both mullion and jamb side of a light. This should be acknowledged in the method of removal. The distortion has probably been aggravated by the rather brutal treatment to which the panels were subjected.

interior

In order to restore the lower part of the window to approximate to the original intention, given the condition of the current panels 2a and 2b, it will be necessary to remove these panels for partial releading, some flattening and joint strengthening, for consolidation of fractured glass, replacement of the unpainted repair, as well as to integrate the new painted pieces into a well constructed matrix of leads. The small head panels, currently 3a and 3b, are sound and could remain in place: a good division seal should be achievable, with care. Our recommendation is therefore to restore the original two panel lights.

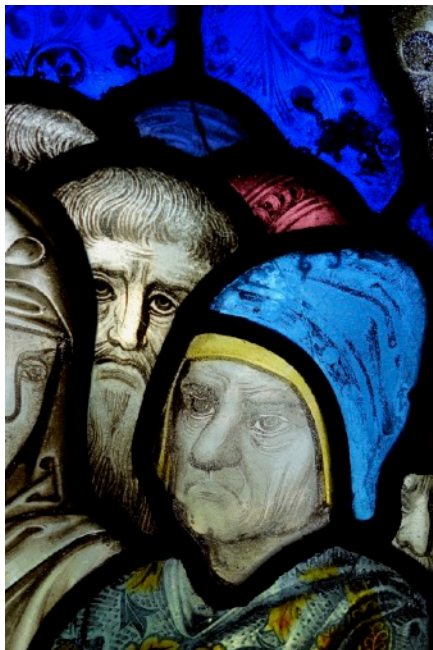
the mild steel bars are surface corroded, and there is evidence of damage to masonry at bar sockets.

exterior

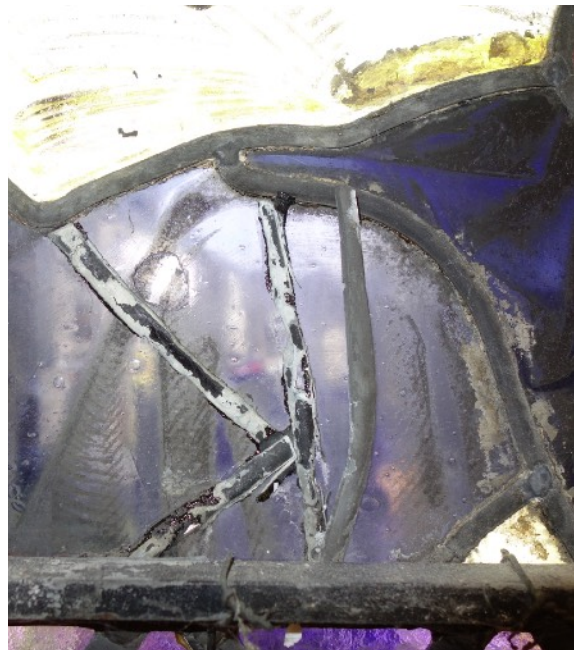
there is some evidence of past damage from condensation in the form of visible pigment loss, and the painted pigments should be treated as unstable. The condition of the decorated surface is variable from one piece to another.

Some pressure fractures were noted throughout both lights, and further breakage, with an unpainted *in situ* repair, and inferior failed leaf lead repairs, above the lower division to the purple glass forming part of Eunice's purple skirt. Other than this area of repair, associated with the modification of the window, no other interventions were noted.

details: variable pigment loss, fractures/ failed repairs

Consolidation of fractured pieces: suggested use of conservation grade silicone

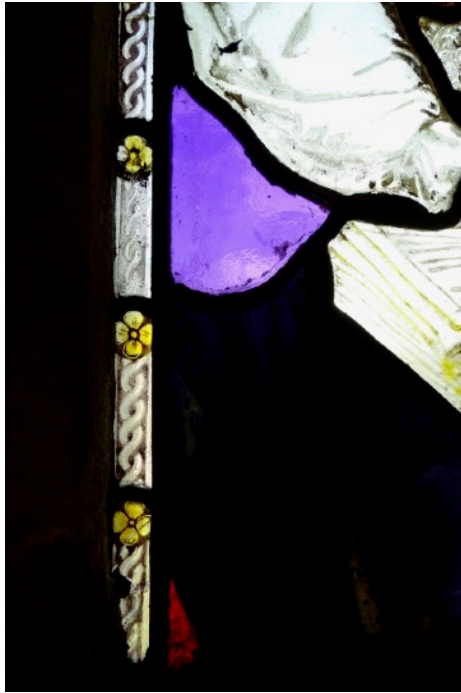
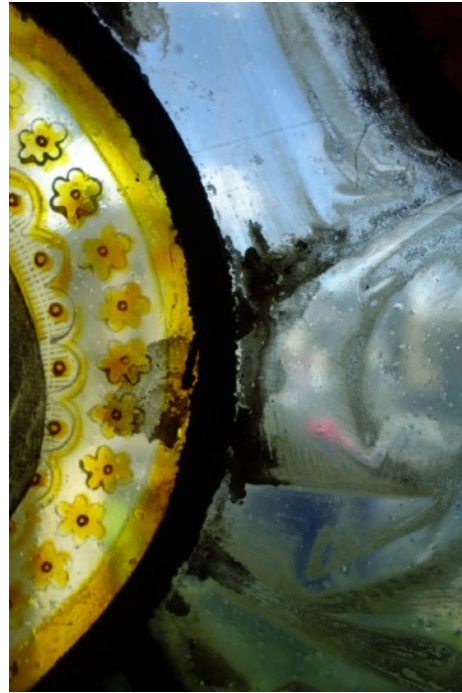
On the internal surface, there is a fine layer of dust, and some leached leaded light cement deposits.

details: unpainted repair/ leached leaded light cement

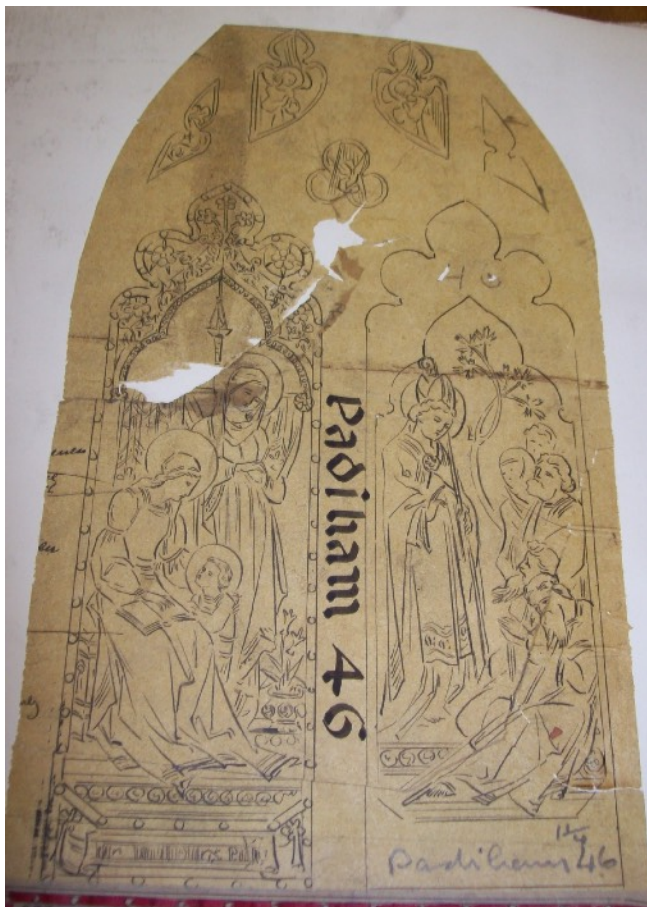
- i) the intention of a stylised pedestal at the base of each scene with commemorative scroll
- ii) the lower termination of the main subjects, including disposition of the draperies
- iii) the continuation of the delicate outer border above and beneath the pedestal

sketch design 1870
from the Hardman Archive
