Date: 24th October 2018.

Re: Percolation Testing – All Saints Rotherby.

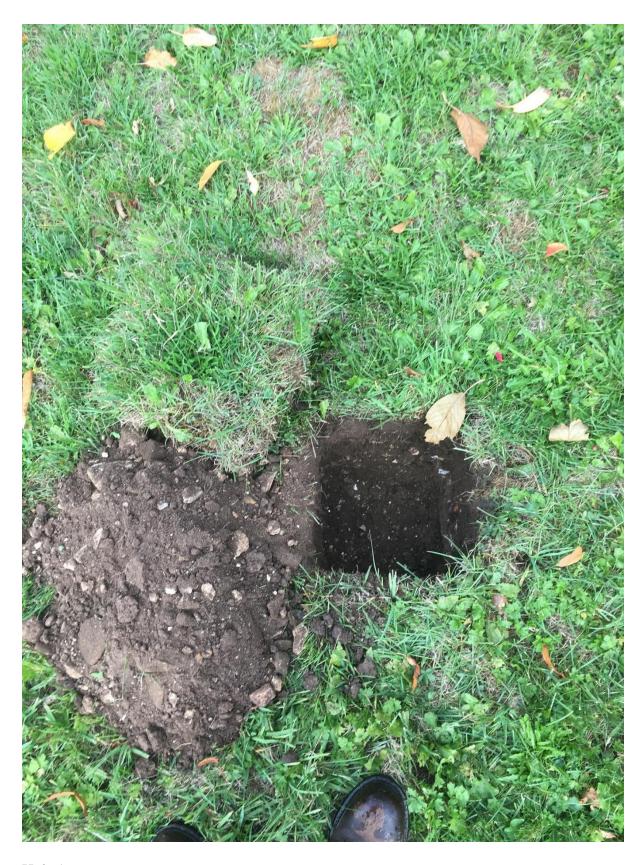
Hole 1.

Hole no. 1 – located at 5.5m away from the South West corner of the tower. Following complete drain away of the first water fill the hole was filled with water and drainage timing commenced at 12.00.30. The water had completely drained by 12.11.15 giving a drain time of 10 minutes 45 seconds.

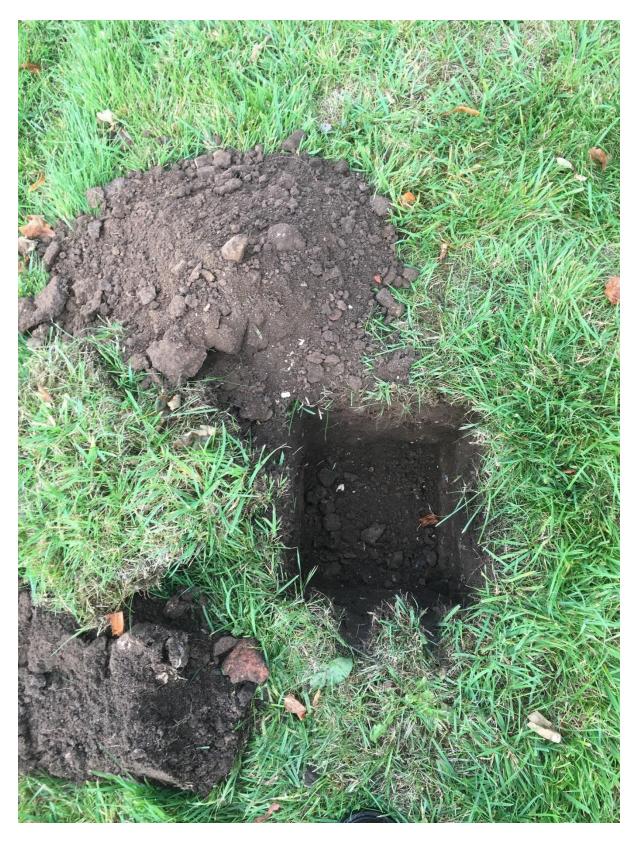
Hole 2.

<u>Hole no. 2 – located at 9.0m away from the South West corner of the tower.</u> Following complete drain away of the first water fill the hole was filled with water and drainage timing commenced at 12.06.15. The water had completely drained by 12.30.40 giving a drain time of 24 minutes 25 seconds.

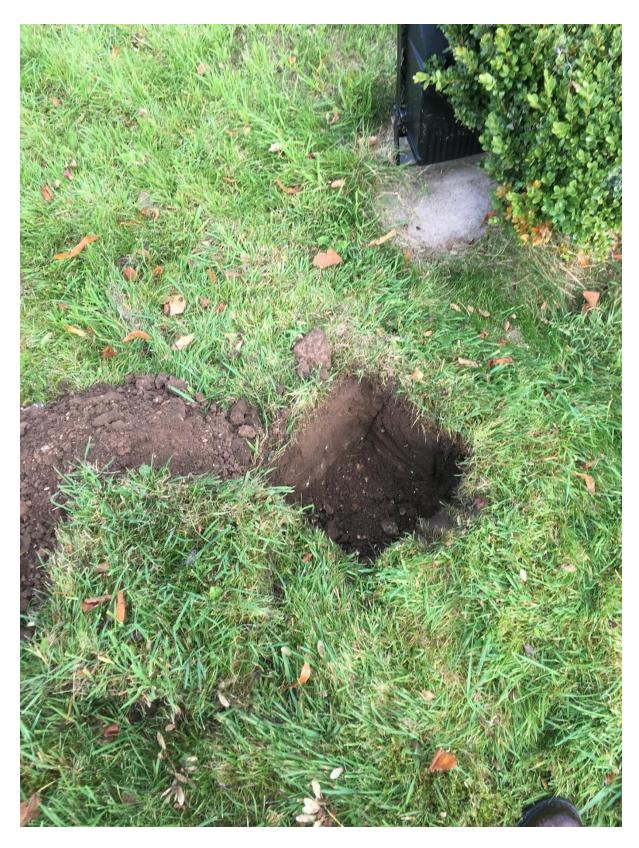
Hole 3.

<u>Hole no. 3 – located at 12.0m away from the South West corner of the tower.</u> Following complete drain away of the first water fill the hole was filled with water and drainage timing commenced at 12.07.15. The water had completely drained by 12.44.00 giving a drain time of 36 minutes 45 seconds.

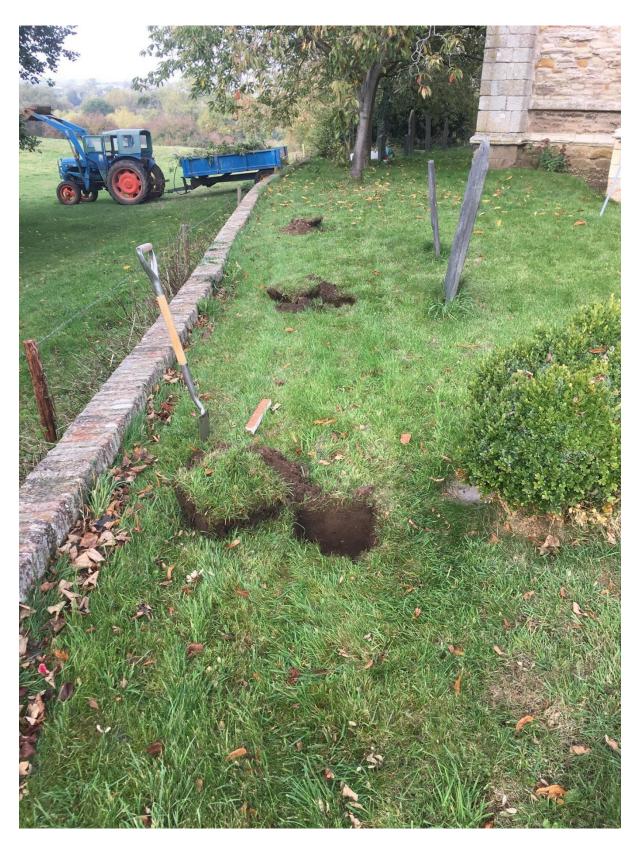
Three holes.

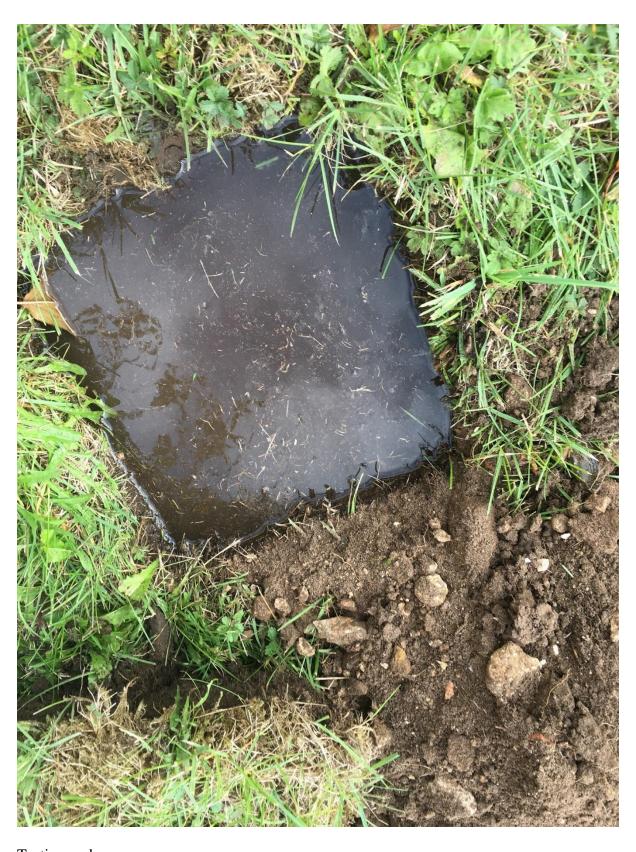
Testing underway.

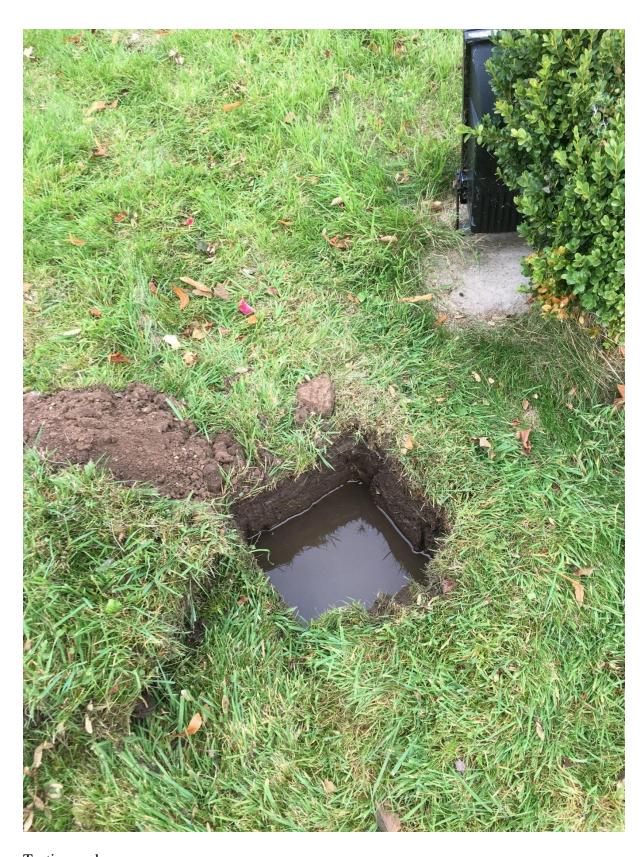
Testing underway.

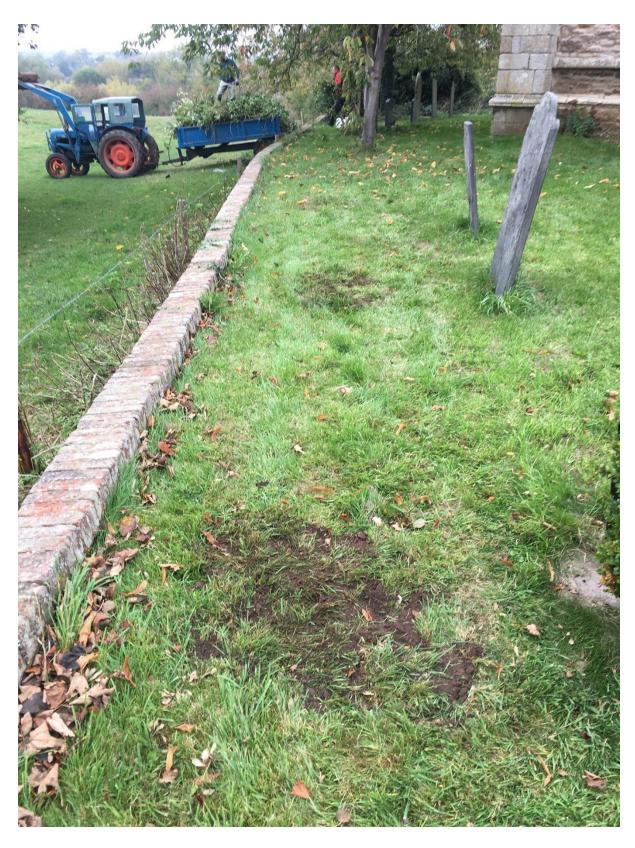
Holes backfilled on completion.
