## Stained Glass condition and conservation report

<b>Object Title:</b> Bilton in Ainsty St Helen's Church, window nll (Vestry)	
<b>Window removed by:</b> Daniel Thomas and Alison Gilchrist	<b>Date:</b> 16 October 2018
<b>Conserved by:</b> Keith Barley, Liam Bradley, Alison Gilchrist, Charlotte Roden, Daniel Thomas and Rose Waits	<b>Location:</b> Barley Studio, York
<b>Reinstated by:</b> Daniel Thomas and Alison Gilchrist	<b>Completion date:</b> 15 January 2019
<b>Owner / client:</b> Susie Pilling on behalf of PCC St Helen's Church	
<b>General Description:</b> 3 light window of diamond quarries, with inset medieval shield at head of centre light and opener panel below.	
<b>Iconography:</b> The medieval shield dates to the late fourteenth or early fifteenth century and bears three fleur-de-lys on a white (or silver) band over a red background. It was recorded in St Helen's Church by Nathaniel Johnston in 1670:

<b>Object Title: Bilton in Ainsty St Helen's Church, window w1 (West oculus)</b>	
<b>Window removed by:</b> Daniel Thomas and Alison Gilchrist <b>Date:</b> 16 October 2018	<b>Recorded by:</b> Alison Gilchrist <b>Date:</b> 6 November 2018
<b>Conserved by:</b> Alison Gilchrist

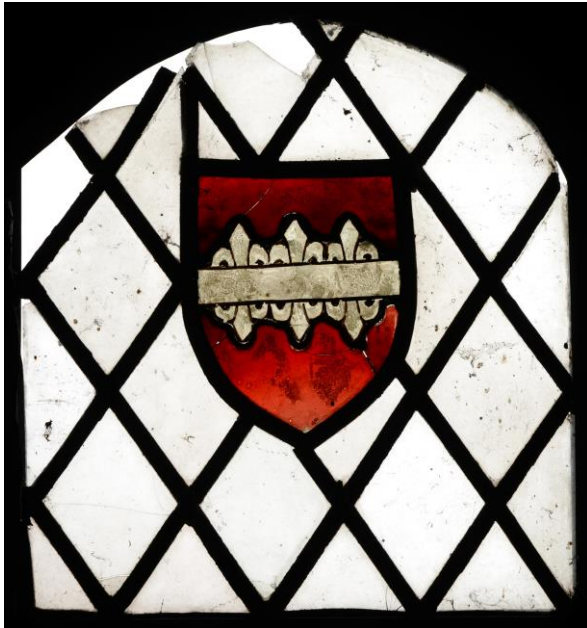
Within medieval shield, antique glass in clear and red, with several breaks and significant corrosion of the internal surface. The external surface is in good condition. Much surface dirt, with evidence of insect infestation.

The surrounding quarry panes and quarry panel from the opener frame are of thin crown sheet glass, generally in good condition with no corrosion but many breaks and missing areas.

Red-brown pigment for both tracelines and shading. Surface corrosion has caused almost complete loss of the shading layer, leaving only the tracelines on the white glass evident.

3/8" flat profile milled lead (post-medieval, probably dating to late C18th) in quarry panels; generally in weak condition with several lead fractures.

*Panel 3b before conservation, transmitted light*

The quarry panels were carefully dismantled, keeping the medieval shield section intact. The clear crown glass pieces were cleaned with deionised water on microfibre cloths. Broken pieces were replaced with reclaimed historic crown glass. In order to introduce both environmental and mechanical protection for the shield panel, a new piece of laminated glass (2+2 float glass) was cut to take the place of the shield within the quarry panel.

The medieval shield was carefully cleaned by dusting with a soft brush, and then swabbing with deionised water on cotton wool buds. Where possible, fractures were edge bonded using CAF3 silicone adhesive (Elkem).

The quarry panels were re-leaded in 3/8" width flat profile extruded lead (Heaps, Arnold and Heaps) to match the original leadwork.

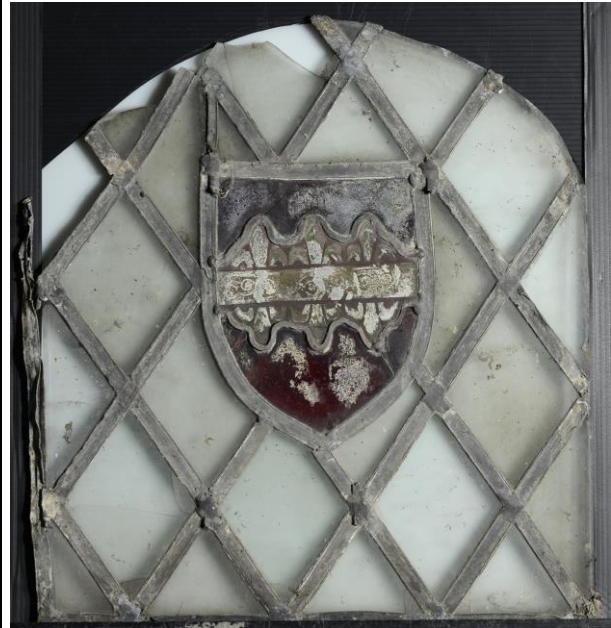
1/8" round profile cast medieval lead within shield; sound condition.

*Panel 3b before conservation, reflected light – note glass corrosion and surviving medieval lead within shield*

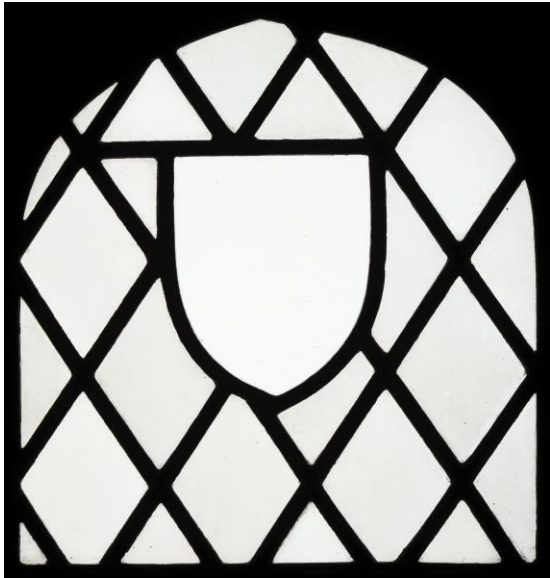
*Head panel with laminated glass protection in place of shield*

Ties in 1.25mm soft copper wire were soldered to the head panel in appropriate positions for the support bar. A 10BA brass bolt was drilled through one quarry joint and soldered into place on the reverse side.

The head panel was reinstated with a 3/8" x 1/4" square section bronzed brass support bar and pointed in with lime mortar.

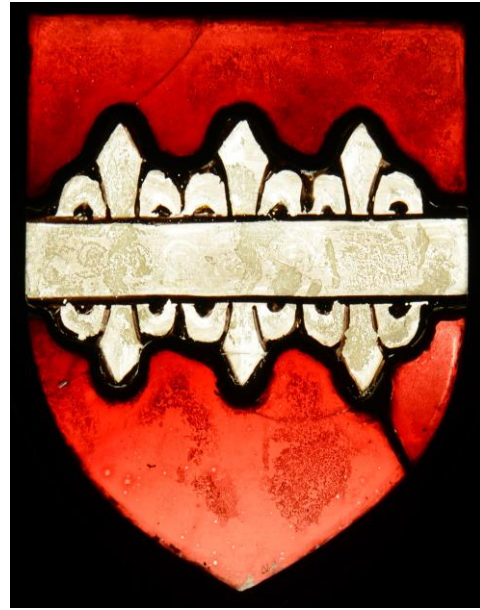
*Shield panel after conservation*

The medieval lead within the shield was retained; one mending lead added in 1/8" round profile extruded lead and new perimeter leads added in 5/16" flat profile extruded lead (Heaps, Arnold and Heaps).

The shield panel was framed in manganese bronze 10 x 12 x 2 mm U-section bars. Holes were drilled in the top bar to allow screw fixing into the support bar of the quarry panel behind. An additional bolt fixing to the leadwork below the shield was fixed to the frame side with a copper rivet.

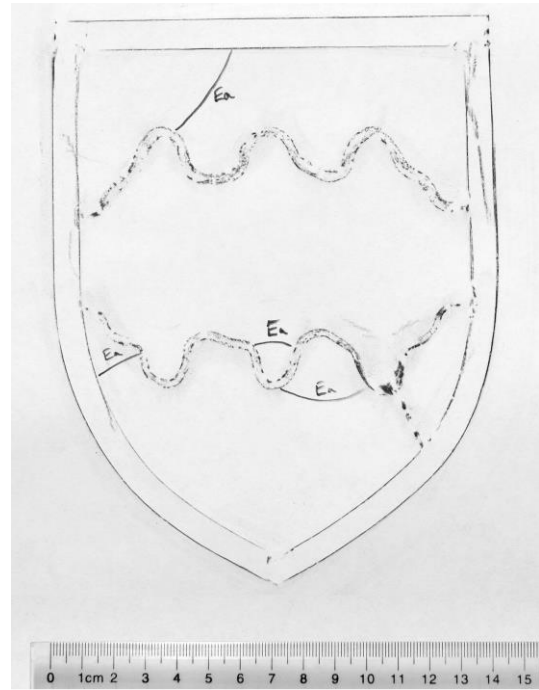
*Record of interventions to shield panel  
Ea = edge bond, silicone adhesive*

A new full-size rubbing of the shield panel was taken and marked up with our interventions (edge bonds).

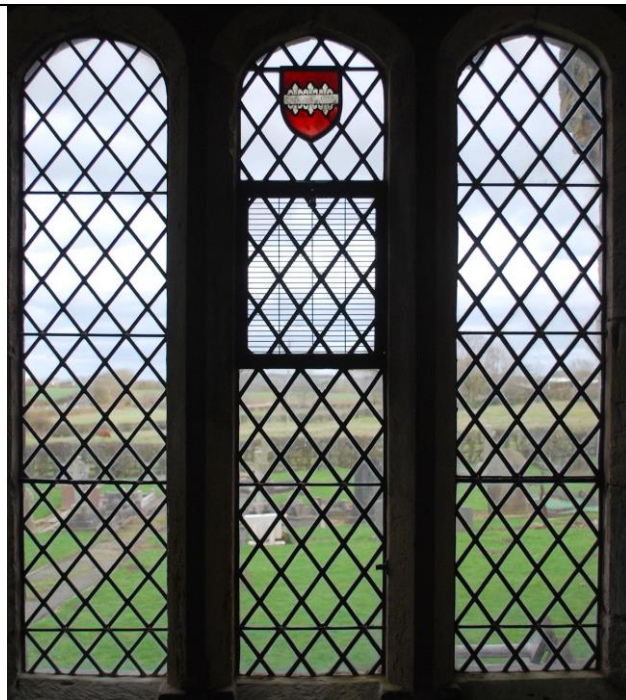
*window nll after conservation*

The remaining panels of the window were cleaned in situ with deionised water on microfibre cloths.

Existing support bars were rubbed down and painted with smooth black rust-inhibiting paint (Hammerite). Two additional support bars in 5/16" round profile bronzed brass were added to light a to match the positions of those in light c. New copper ties were stitched through the leadwork to re-attach the panels to the support bars.

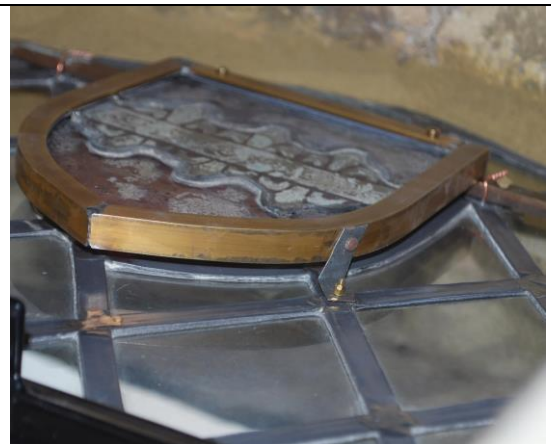
*Detail of shield, showing frame, fixing and ventilation interspace*

The framed shield panel was screw fixed to the support bar and fixed to the 10BA brass bolt using 10BA brass washer and nuts.

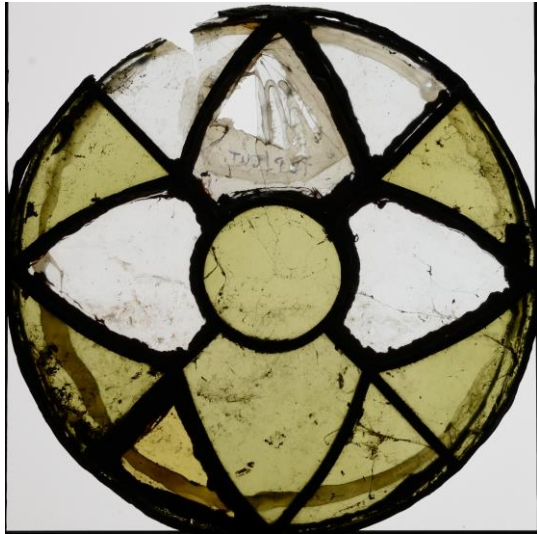
<b>Materials and condition:</b>
<b>Glass:</b> Antique glass in green tint and clear white (previous repairs). No surface corrosion but several fractures. Very dirty, with sealant from previous outer pane and remnants of insect infestation.
<b>Paint Layers:</b> None
<b>Lead:</b> 5/16" flat profile milled lead (probably dating to C19th), weak condition with much damage from previous repairs.
<b>Support:</b> None.

*wl oculus before conservation,  
transmitted light*

The panel was carefully dismantled, setting aside all undamaged original glass for re-use (central circle and piece below). The glass was cleaned with deionised water on microfibre cloths.

New glass to replace broken pieces and previous repair pieces was cut from antique glass of matching green tint and texture.

The panel was re-leaded in 5/16" width flat profile extruded lead (Heaps, Arnold and Heaps) to match the previous leadwork, with a 1/2" flat profile perimeter lead.

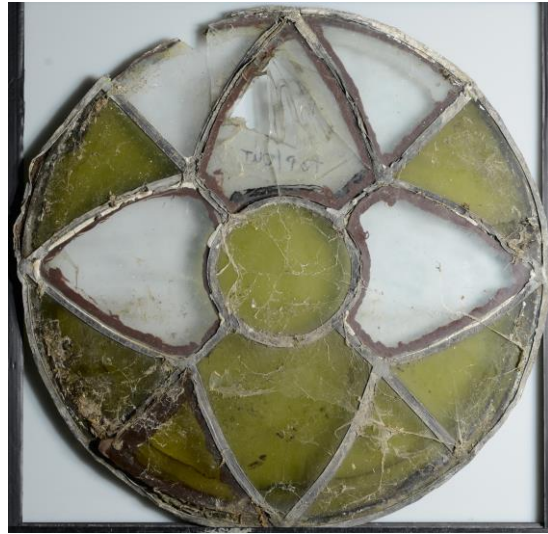
*wl oculus before conservation,  
reflected light*

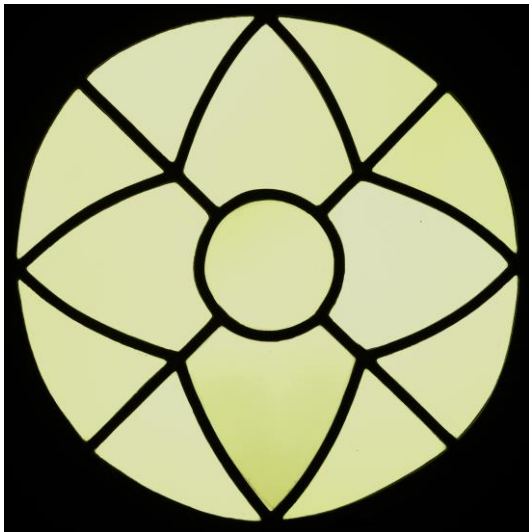
*w/ oculus after conservation,  
transmitted light*

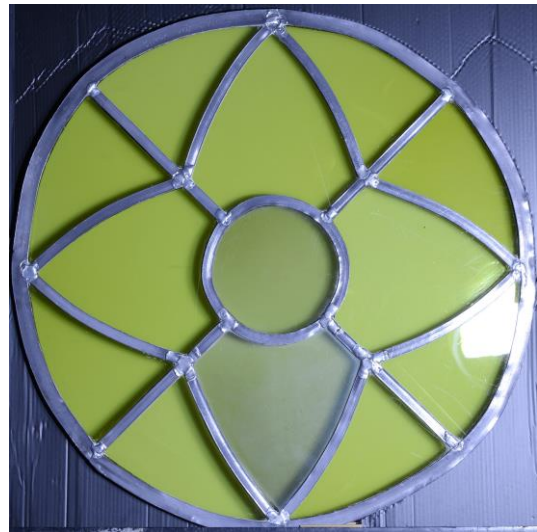
*w/ oculus after conservation, reflected light  
(note darker patina of original glass in  
centre circle and piece below)*

The previous cement mortar was left in place to the interior to form a rebate to fix the panel against. A bead of neutral curing black silicone (Silfix U9, Hodgsons Sealants) was added around the perimeter of the panel to seal it to the existing cement mortar. The panel was fixed in position from the exterior using marine grade stainless steel screws into drilled and plugged holes, and pointed in with lime mortar.
