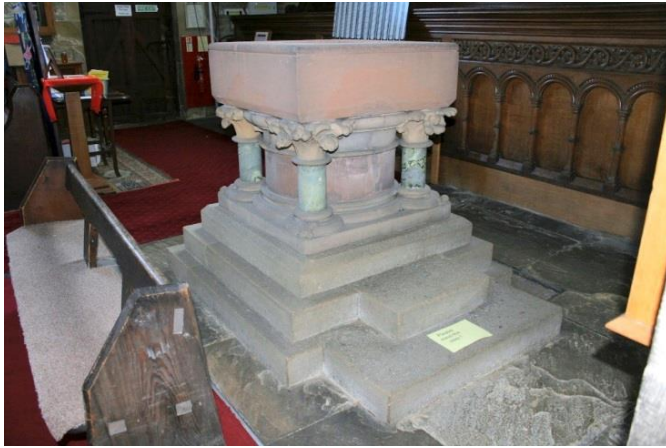
The font and stepped-base prior to any treatments. Note its un-helpful proximity to the entrance to the toilets (to the right and out of shot) the door of which was once the main door into the church, before building of the tower opposite.

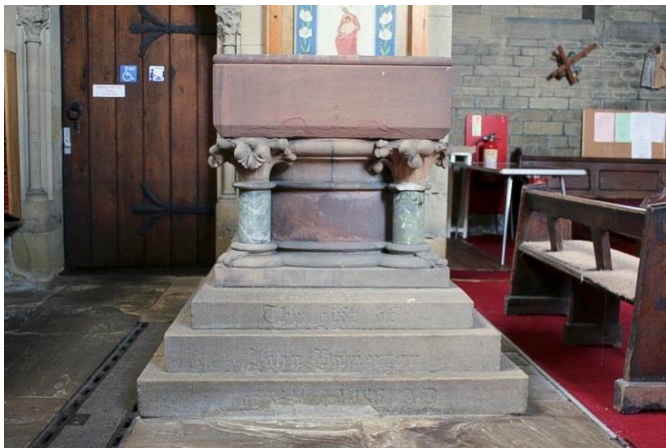
The font before any treatments with the hardwood door, the original entrance into the church, to the left. The font sat in front of the kitchen and welfare facilities.

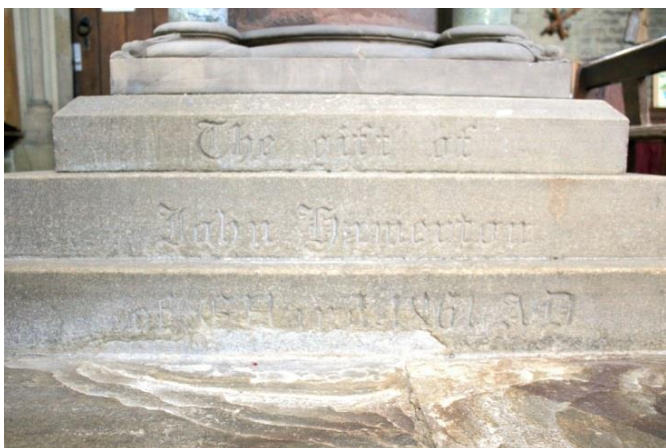
A detail of the historic efflorescence in the paving beneath the bottom step of the plinth, which has adversely affected the upstand of the bottom course. There was little point de-salinating this course, which is likely to have exacerbated the problem with long-standing soluble salt activity and created a very different cleaning differential with other courses.

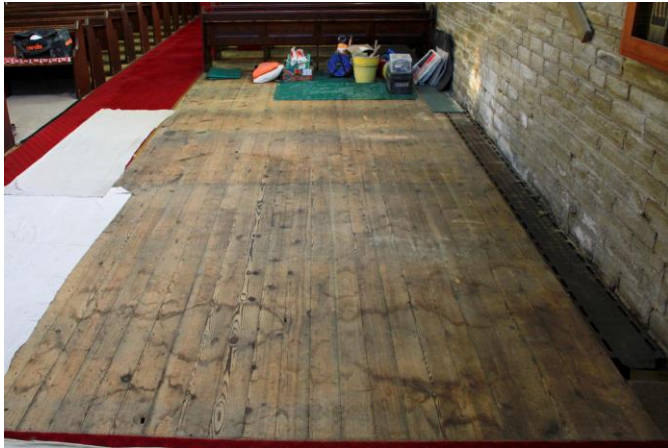
The new location prior to opening-up works, with soft-wood floorboards overlying substantial timber joists. There is a supporting wall running along roughly the same line as the right-hand edge of the dust-sheets.

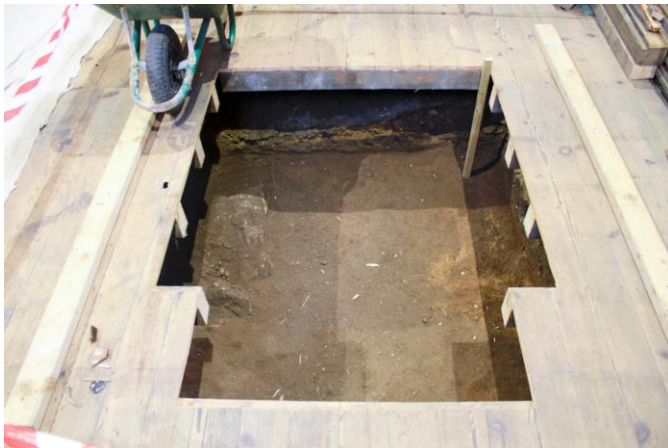
The hole has been formed down to the required depth and a solid base, following the footprint of the font exactly. There were no items of archaeological interest save for a few nails and a pencil. The joists on top of the floorboards were secured to strengthen the underlying joists during these works.

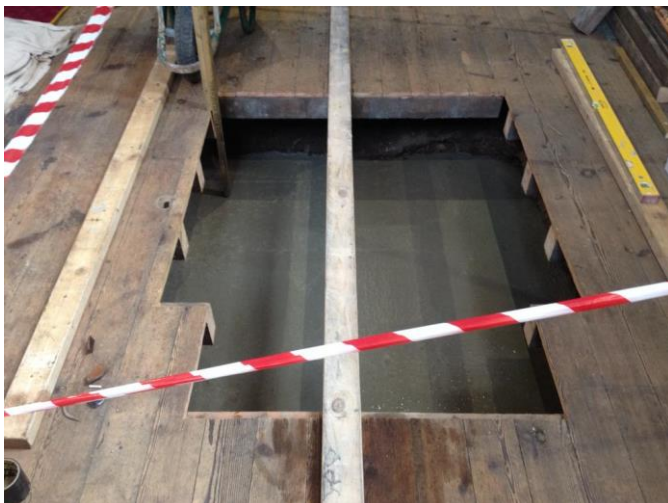
The concrete pad was poured level and to the required height, with a layer of re-enforcing mesh incorporated midway in the slab. This was allowed several days to harden, before building commenced.

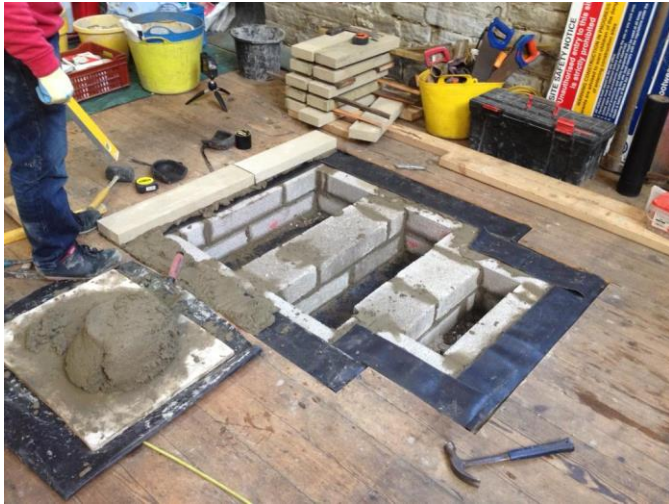
The block-work beneath the timber joists supporting the flooring, with an additional layer of damp-proof membrane beneath the new sandstone plinth course.

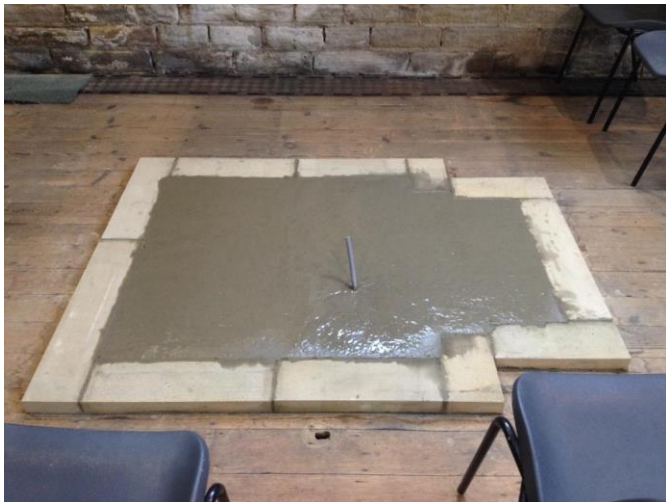
The final layer of lean concrete just after application, with the underfloor heating pipe cast into the concrete, which they are usually. Note the concrete was brought up to the same plane as the new sandstone perimeter at the recommendation of Inspecting Architect, to make a solid and even base to spread the load of the whole font, which weighs in excess of a ton.

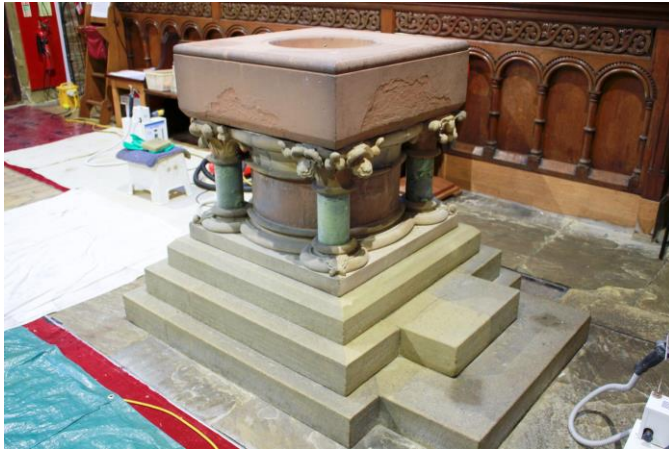
Cleaning in progress, whilst the opening-up works take place in tandem.

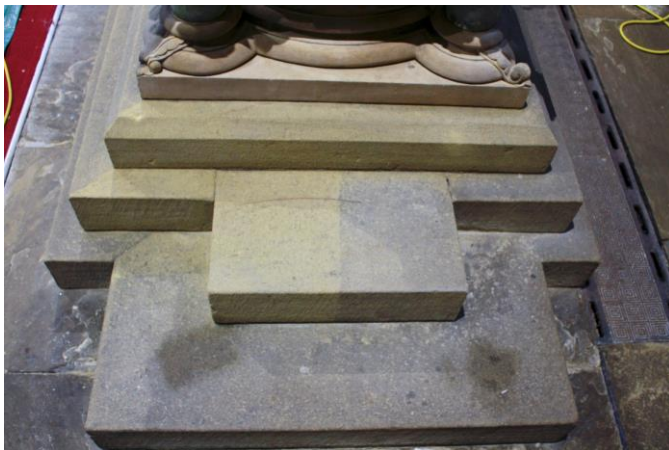
A cleaning contrast to the middle step, showing the subtle level of difference in cleaning achieved, whilst removing decades of accumulated airborne dirt/debris.

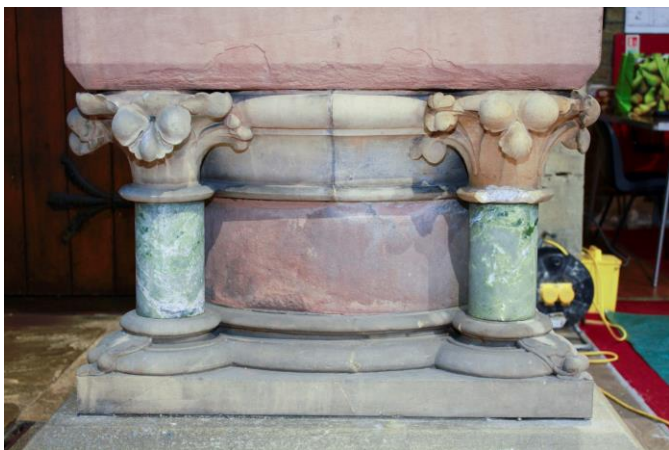
A cleaning contrast showing the right-hand capital and everything above having been cleaned. The vulnerable faces of the font bowl were cleaned with paper-towelling compresses as they were not up-to low-pressure steam cleaning.

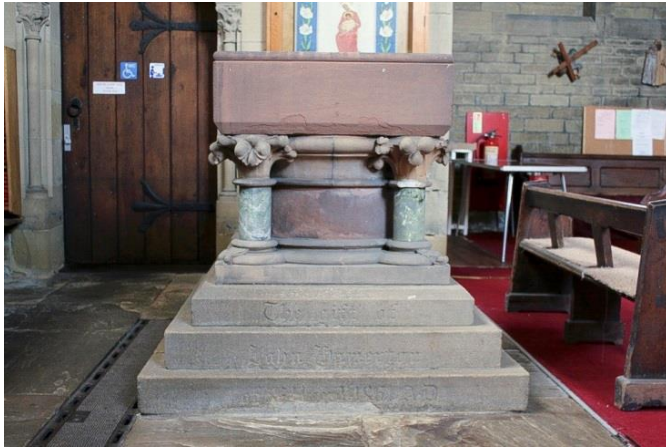
The font before cleaning, note how it was uniformly dirty, particularly the lower four courses.

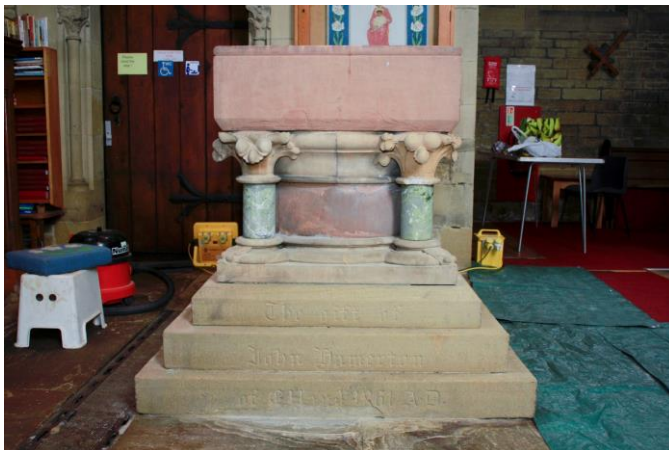
The font after all cleaning processes, note the more obvious difference in colour and texture between the different materials and paving in the foreground.

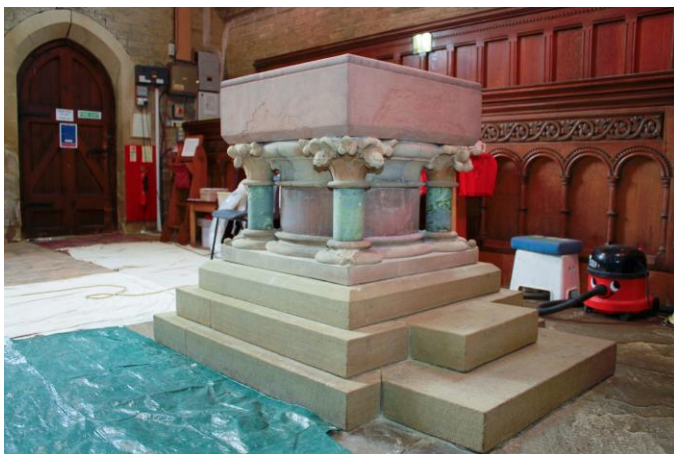
Another view of the font after all cleaning processes. The font received direct (albeit diffused) sun from the tall windows to the south. This would have meant repeated heating and cooling cycles over the decades, perfect for soluble salts in which to flourish. It is shielded from the sun in its new location and its proximity to the nearby south wall.

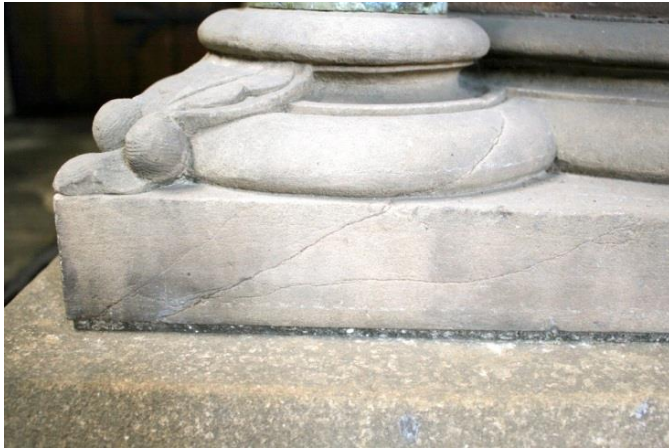
Some of the inherent transverse fractures through the moulded-base course, which would have been particularly vulnerable to lifting despite being strapped horizontally.

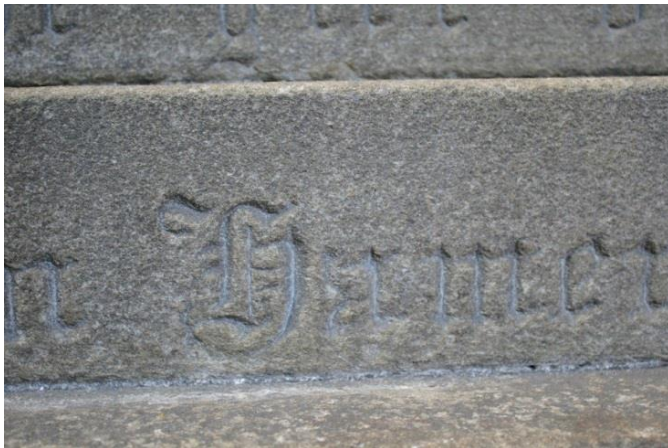
The relative tightness of the original jointing mortar which were difficult to remove prior to dismantling, even with very thin scrapers/chisels, as the very-hard material was well bonded to the coarse, open-textured sandstone.

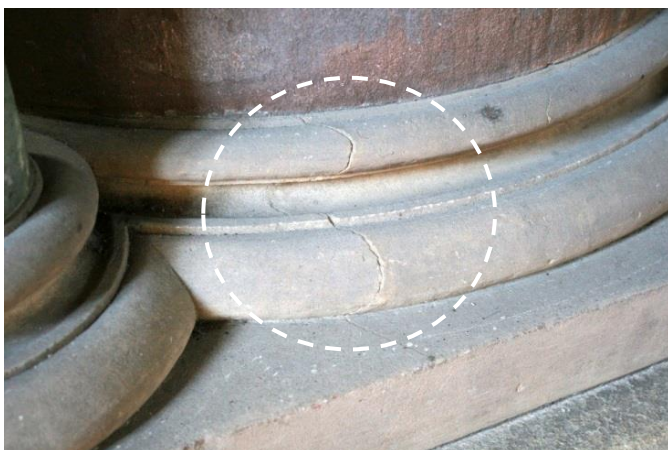
Another inherent fracture through the moulded-base course (indicated) which was by far the worse in terms of structural integrity. As a result the decision was taken not to disassemble these three courses for fear of avoidable damage, no matter how carefully planned and executed.

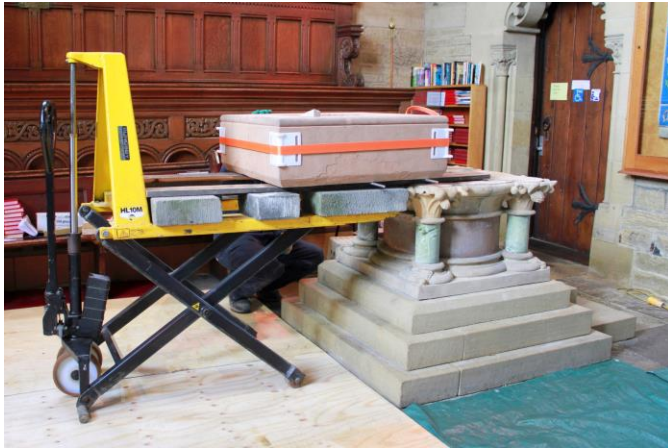
The font bowl being rolled horizontally onto the pallet-truck. There was no room for even thin endless-slings (for lifting) between the foliate decoration of the capitals and the chamfered bottom edge of the bowl.

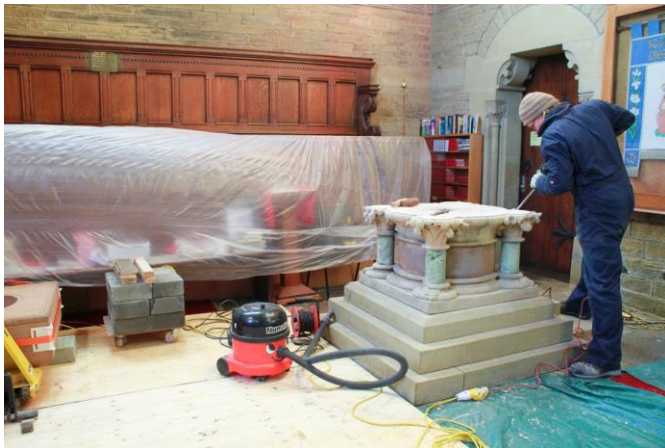
Removing the remains of the very hard mortar from the top bed of the moulded capital course, which was in four uniform pieces. Leaving the very hard mortar in place would have made final positioning of the font bowl problematic.

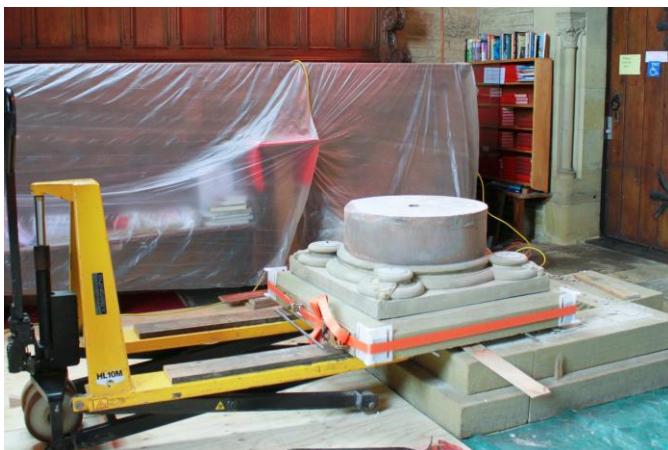
Removing courses 3 – 5 horizontally on steel dowelling, to prevent exploiting the inherent fractures, which lifting/lowering (twice) is likely to have done. The bottom of the three courses was the single biggest block of stone and strapped as a result with additional protections at the corners. There was a crude vertical drill-hole for drainage, which had burst the bottom bed off. The underling courses were made-up of several pieces.

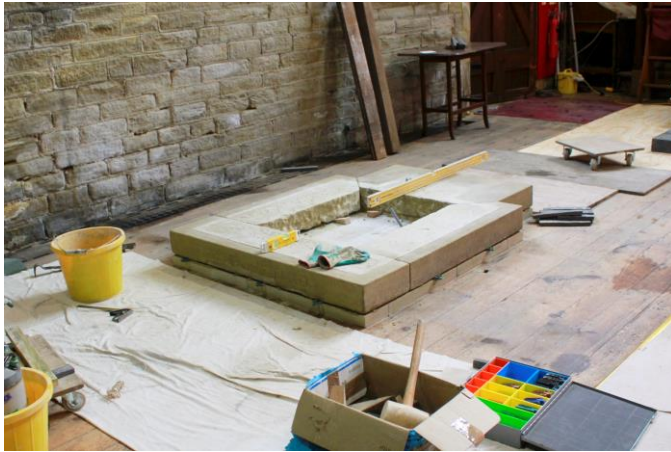
The bottom course of the stepped base, with the additional new sandstone plinth recommended by the architect to raise the whole font upwards, due to the likely addition of under-floor heating within the church in the future. Shims of the correct thickness were used to maintain neat uniform joints whilst the mortar between the heavy units hardened sufficiently for the next course.

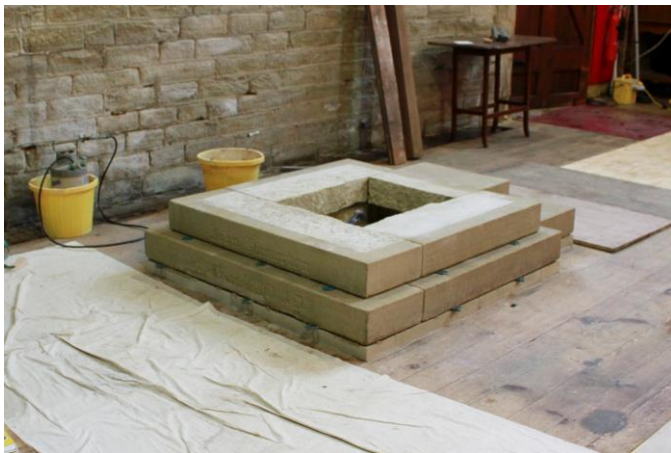
The bottom two courses of the stepped base in-situ. Note the regular void in the centre which was covered completely with the next composite course.

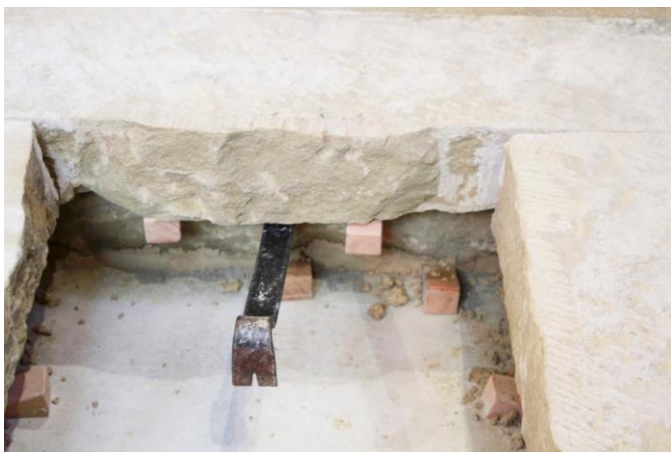
Hardwood wedges were used to maintain level front to back, whilst the bedding mortar hardened. These were removed once the mortar had hardened sufficiently. The crow-bar was used to achieve perfect level before wedging.

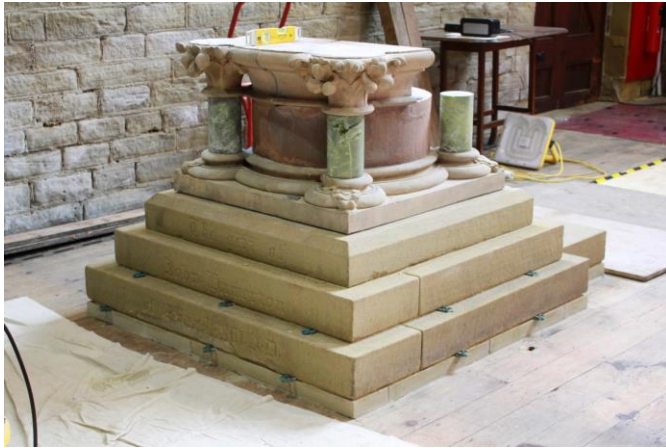
Two of the four moulded capital blocks in place. There were no fixings in this course and we made the four separate units solid by using a casting plaster, whilst maintaining a sufficient gap for the necessary drainage pipe.

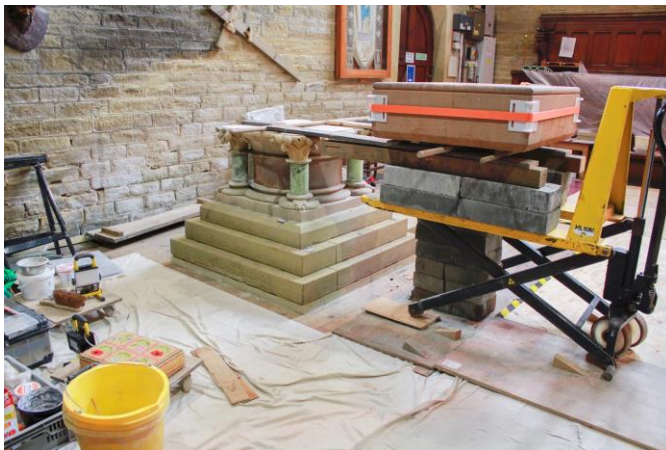
Re-instating the font bowl horizontally onto the underlying courses. The correct height and bedding had been determined beforehand by using stacks of lead shims of different heights, to achieve a level across the different stacks with a spirit level. With the bottom bed of the font bowl being worked smooth.

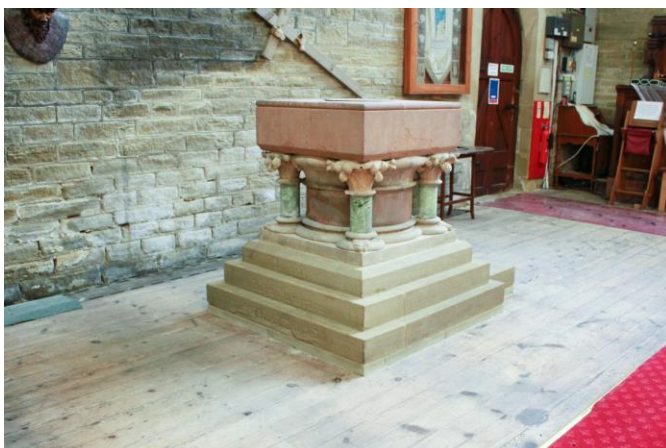
The font-bowl in correct alignment, note once again the different colours at play in what must have been the original intention of the designer/architect.

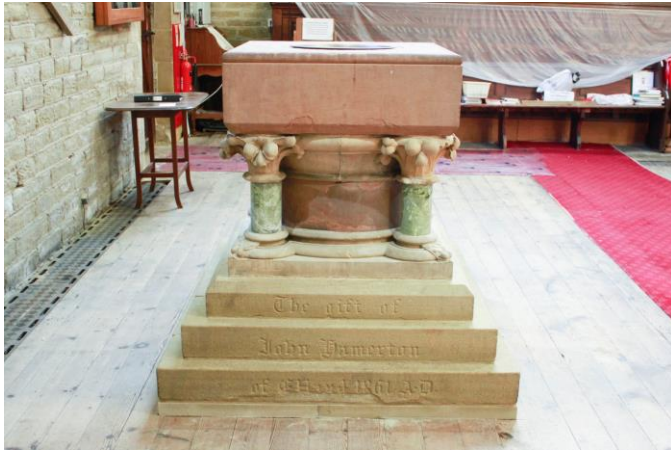
A context view showing the incised inscription to the bottom three courses of the stepped base. Note the lustre on the green marble columnettes which no longer appear dull and lifeless.

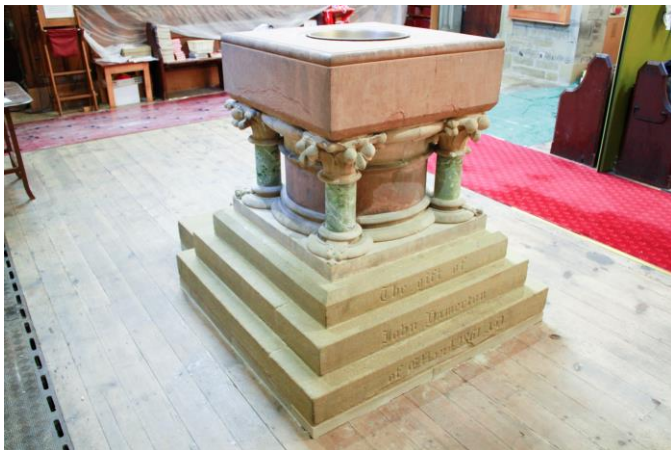
A three-quarter view of the font complete with new copper bowl within the sandstone bowl, which fits perfectly.

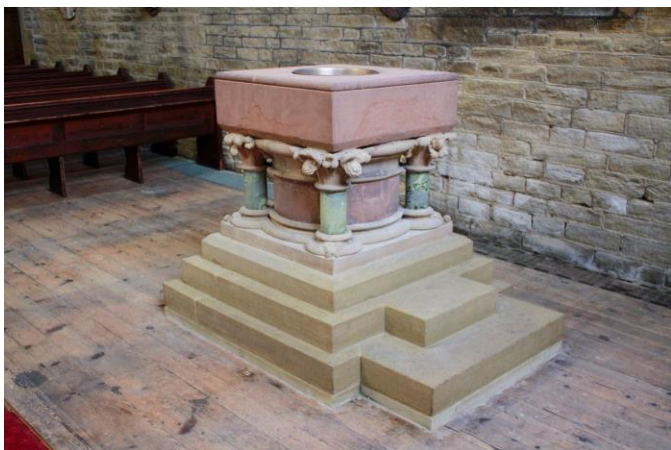
Another three-quarter view showing the historic, chronic soluble-salt activity in the masonry in the background. The new sandstone plinth blends in well with the bottom bed of the stepped base, but is likely to be obscured by future composite layers of under-floor heating.

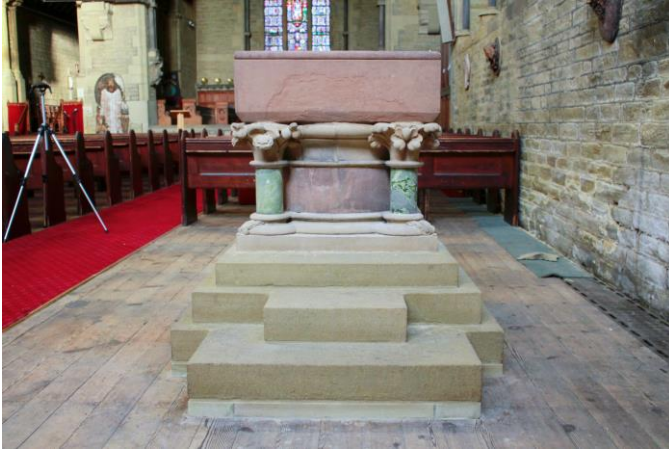
A view from the 'front' of the font, you can just make out support fillings to the vulnerable edges on the vertical face of the font bowl on this elevation.

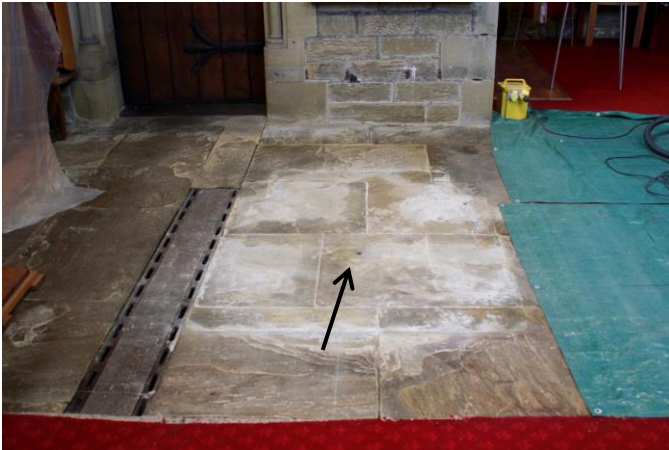
The location from which the font was removed, showing the remaining level of efflorescence in the laminar sandstone paving after vacuuming. Vulnerable laminations were rationalised to prevent being a trip hazard. The small diameter drainage hole can just be made out (indicated) in the centre of the paving. The defective joints were raked-out and re-pointed and left with a sponged finish.
