St John's Church, Ivybridge, Devon (Diocese of Exeter)

Jane Phillips monument

Conservation Report

May 2019

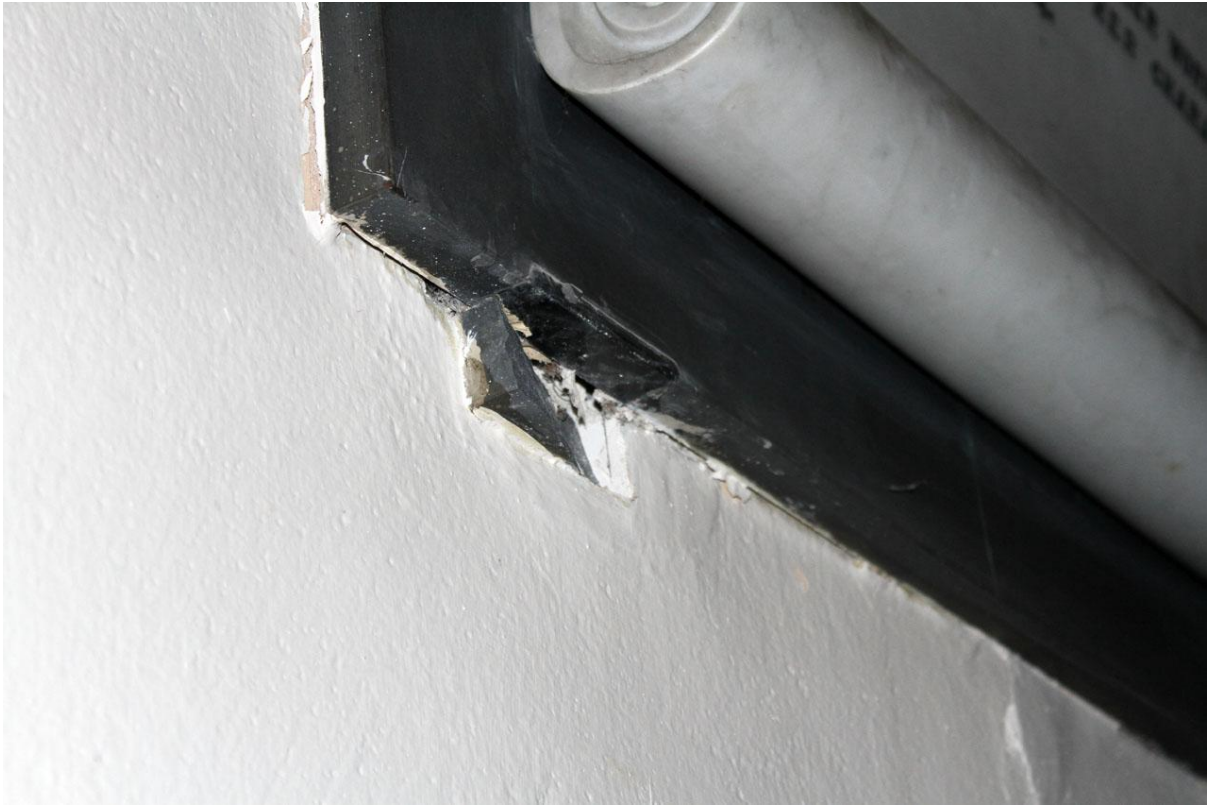
The monument was structurally unstable owing to the fracture of both corbels, the faces of which had broken away leaving the large plaque above vulnerable to collapse. The cause of this problem was not immediately clear (but see below).

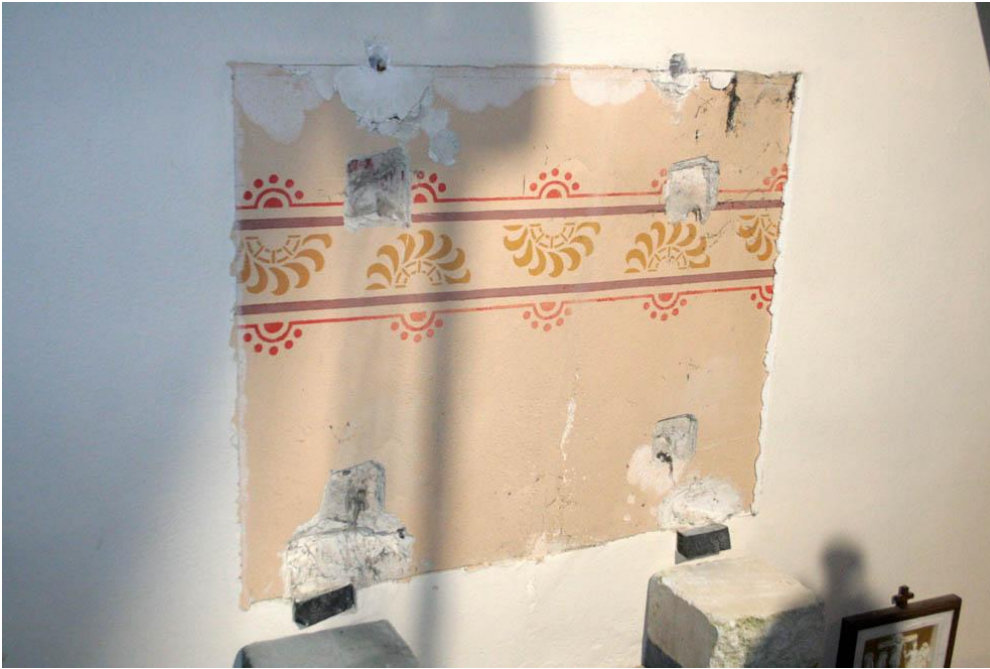
The removal of the monument revealed two things. First, there was a stencilled pattern on the wall behind, which had been obliterated by new paint layers since the monument was erected. Second, a large steel pipe was buried in the wall, passing down directly behind the monument, and had at its lower end rusted and expanded, forcing the monument forward and putting pressure on the corbels.

Above: stenciled decoration found behind the monument

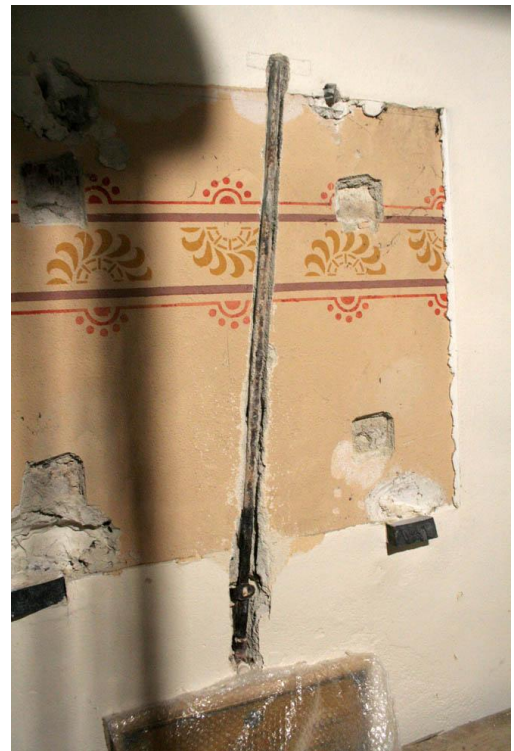
Owing to the rebated design, the monument was unable to push forward and had therefore fractured the corbels.

Right: the steel pipe found buried in the wall behind the monument

This steel pipe was cut with a grinder and removed. The wall was then made good with hydraulic lime mortar.

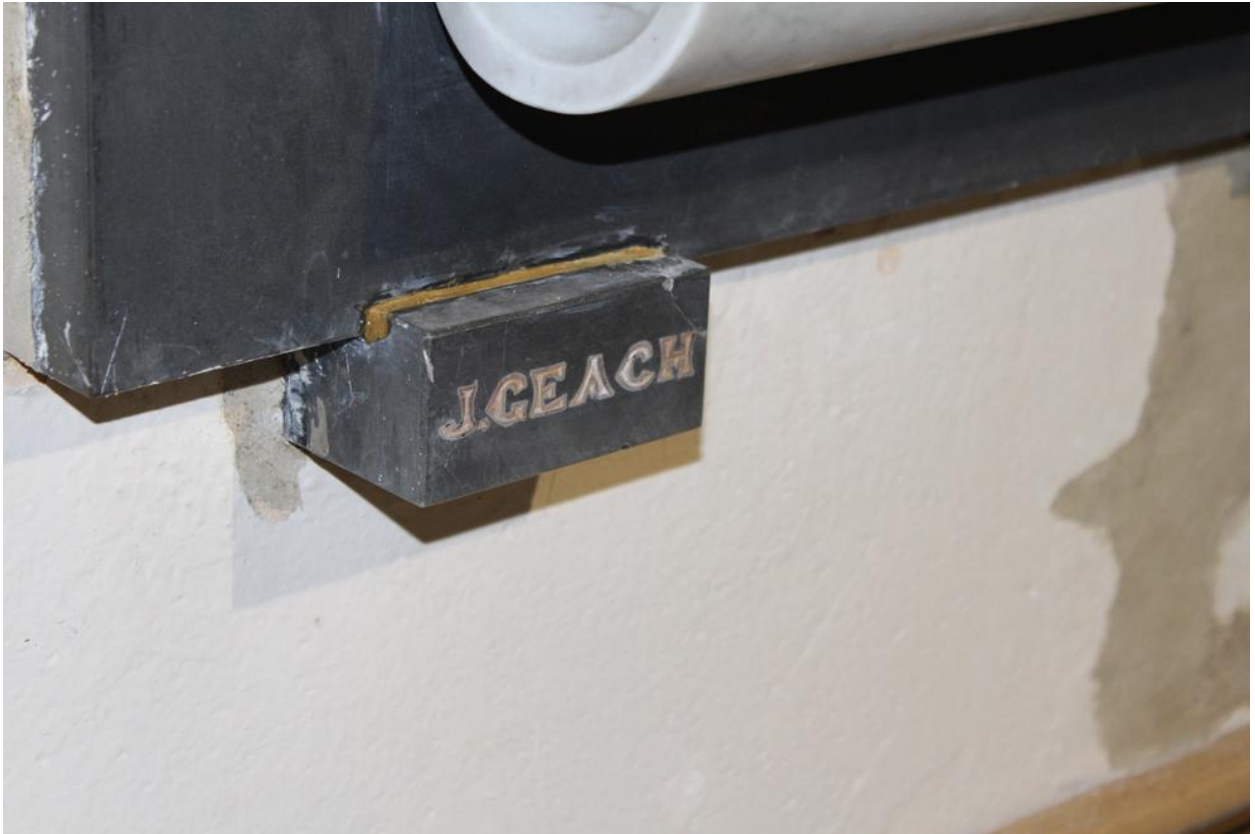
Signature of the monumental mason, retained with the repaired west corbel

The fractured front face of one of the corbels survived and this corbel was therefore repaired with a stainless steel threaded dowel and polyester resin.

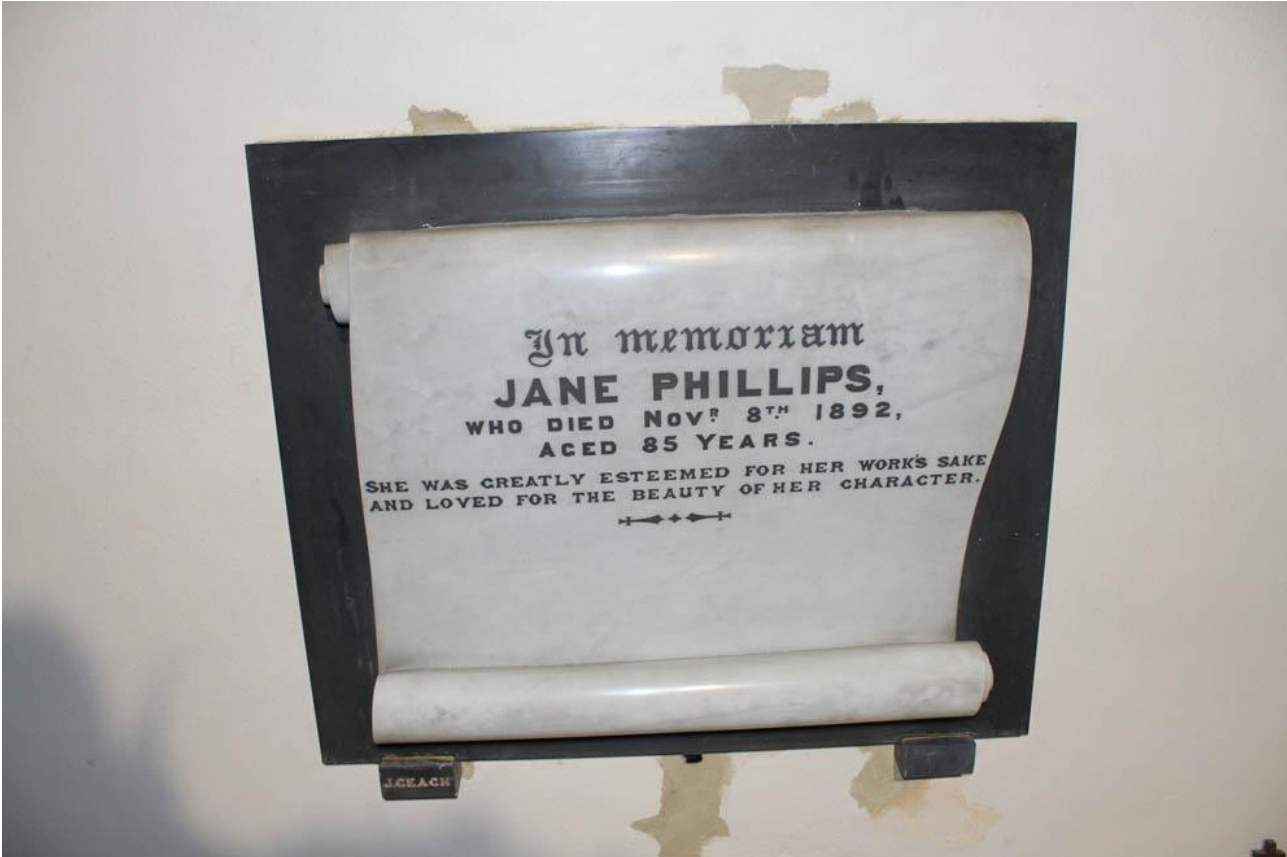
The monument after work was completed

Both corbels were then returned to the wall and built in using natural hydraulic lime mortar. To ensure that the monument would be fully supported, a steel bar of 20mm by 12 mm gauge was inserted in the centre to alleviate load on the corbels and fixed with polyester chemical mortar.

The monument was then returned to its position and fixed with two stainless steel cramps to retrain it to the wall. The edges were pointed with lime mortar and the scaffold struck.
