Skillington Lack

Accredited Conservator - Restorers of Monumental Brasses

MONUMENTAL BRASSES IN ST. AGATHA'S, BRIGHTWELL-CUM-SOTWELL, OXON

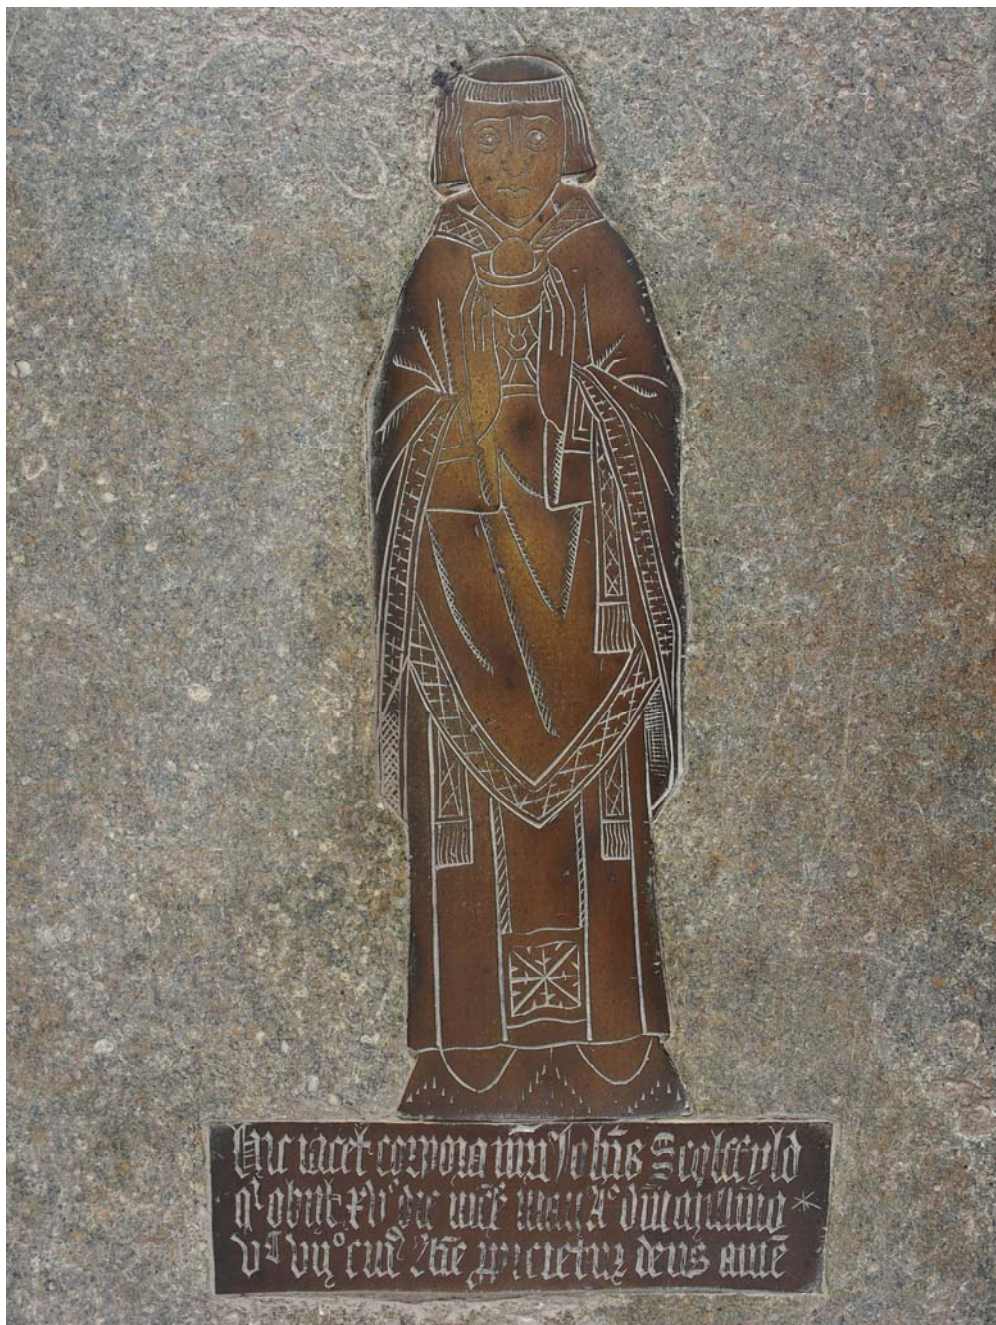
LSW.I. John Scolffyld, 1507. This brass, comprising an effigy in mass vestments with chalice and wafer (466 x 138 mm, mean thickness 4.8 mm (varying from 4.5 to 5.0 mm)) and a three-line Latin inscription (75 x 273 mm, mean thickness 4.9 mm (varying from 4.6 to 5.5 mm)), was removed from the original Purbeck slab (1380 x 670 mm) in the south aisle (photo 1).

LSW.I. The brass is shown before conservation in photos 1 and 2. After cleaning new threaded studs were fitted, three M8 to the effigy and one M7 and two M8 to the inscription (photos 3 and 4).

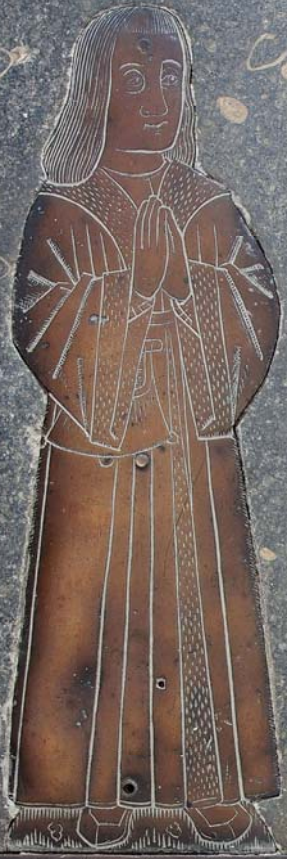
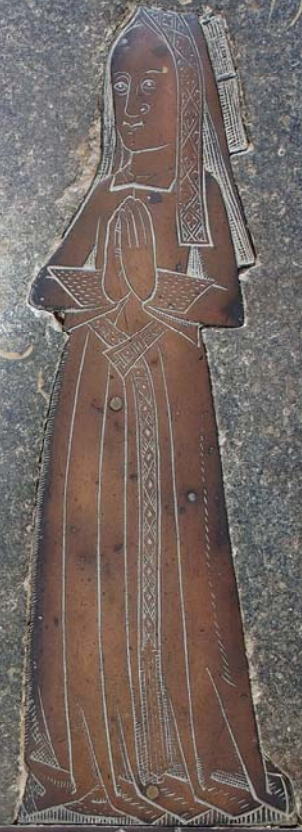
(varying from 2.2 to 4.7 mm)) and a three-line English inscription (98 x 669 mm, mean thickness 4.5 mm (varying from 4.2 to 4.8 mm)), was removed from the original Unio-Purbeck marble slab (2050 x 930 mm) in the nave (photo 5). There is an indent for a lost son (195 x 75 mm). The male effigy had come loose previously and was kept in the church safe. Photo 5 shows the male effigy temporarily replaced in the slab.

LSW.II. The brass is shown before conservation in photo 5. After cleaning new threaded studs were fitted, one M7 and two M8 to the male effigy, two M7 and two M8 to the female effigy and three M7 to the inscription. A small hole in the lower part of the male effigy was blanked with a soldered backing-plate. The new rivets and repair can be seen in photos 6 and 7.

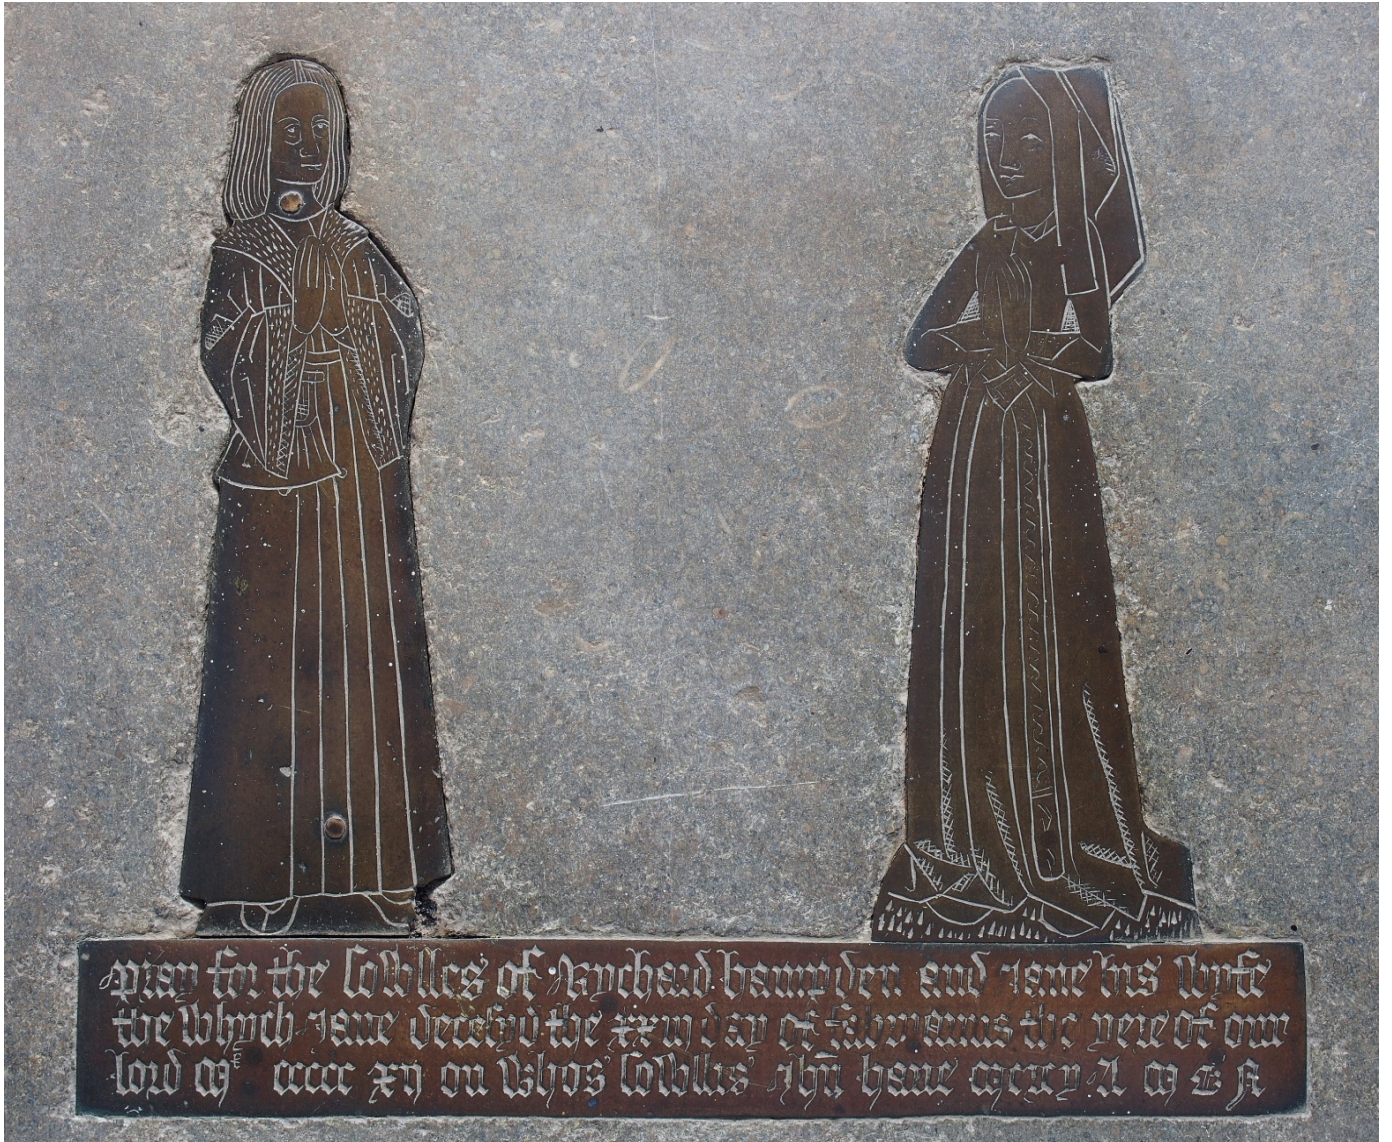
LSW.III. Richard Hampden and wife Jane, 1512. This brass, comprising a civilian effigy (389 x 120 mm, mean thickness 4.0 mm (varying from 3.6 to 4.8 mm)), a female effigy (390 x 147 mm, mean thickness 3.7 mm (varying from 3.1 to 4.8 mm)) and a three-line English inscription (78 x 545 mm, mean thickness 4.4 mm (varying from 4.0 to 4.7 mm)), was taken up from the original Purbeck slab (1610 x 865 mm) at the west end of the nave (photo 8). The male effigy had come loose previously and was kept in the church safe. Photo 8 shows the male effigy temporarily replaced in the slab. The inscription proved to be palimpsest, the reverse showing eight almost complete Latin verses, probably wasted work (photo 9).

LSW.III. The brass is shown before conservation in photo 8. After cleaning a resin facsimile was made of the palimpsest revers. New rivets were fitted to the brass, three tapered-head to the male effigy, two M8 threaded to the female effigy and two M8 and two M10 threaded to the inscription (photos 10 and 11).
