St Nicholas Church, Hardenhuish

Treatment Report
October 2019

Ricardo Monument

TREATMENT REPORT

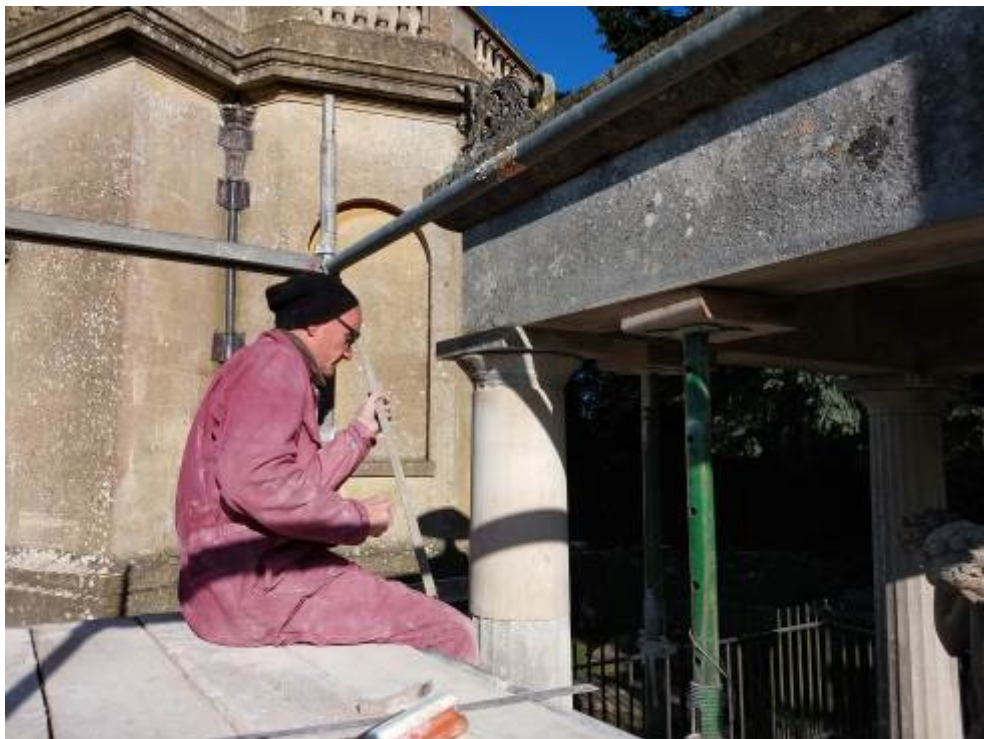
Column section in position, marking up for fluting

A new section of column was fitted and the fluted decoration cut to match the original, the stone selected following consultation with the local Conservation Officer was Portland Whitbed. The cracked and damaged capital to the south east column was removed and a complete new capital installed. Two sections of frost spalled stone on the east side were cut out and new stone pieced repairs made. On the lower plinth, to the west side, an area of cracked and frost damaged stone was removed. A new stone 'piecing in' was installed. All open joints were cleared of debris and repointed with a colour matched mortar bound with Natural Hydraulic Lime mortar (NHL 2).

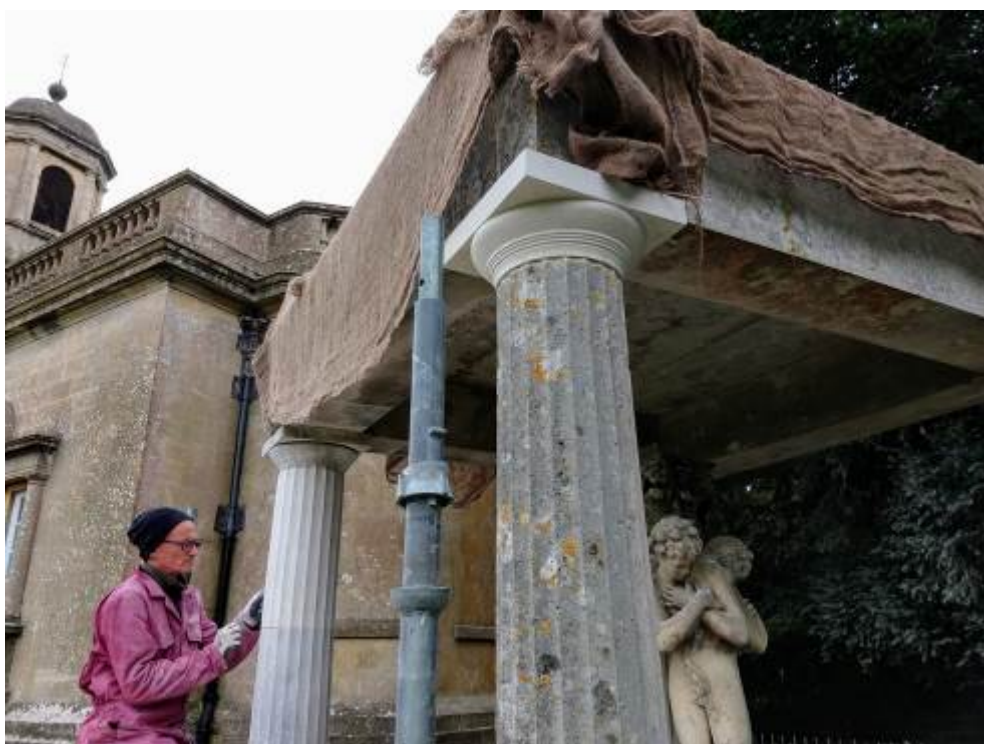
Column section fitted, flutes cut

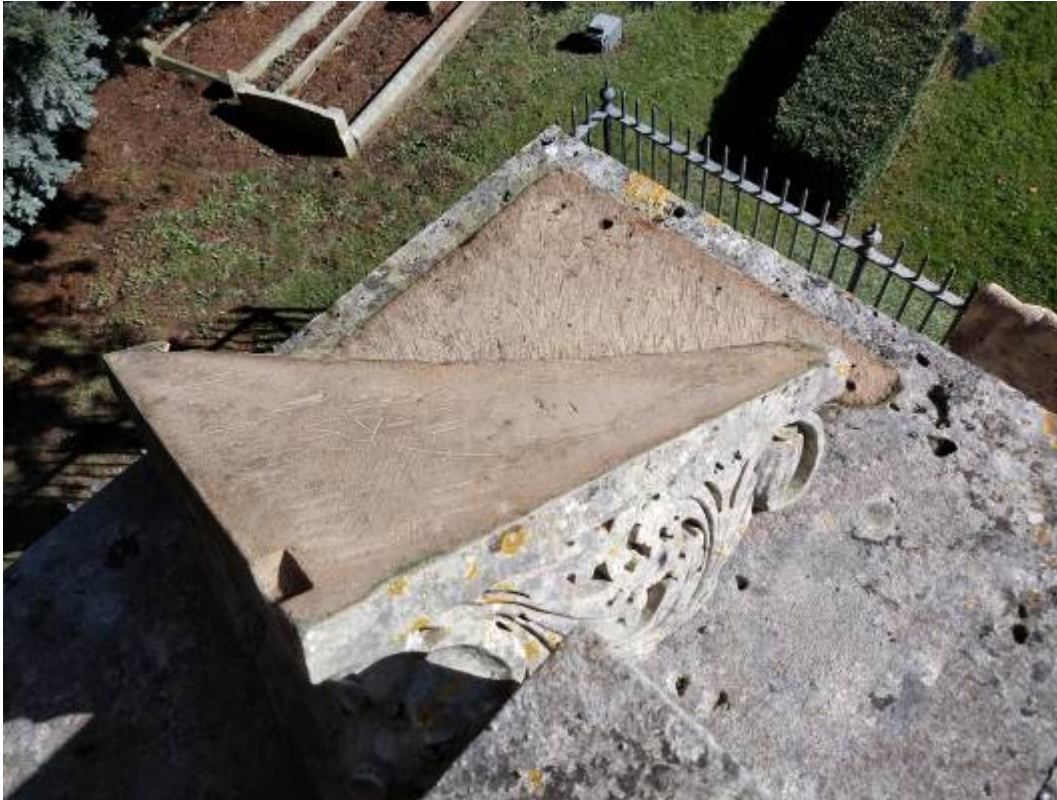
Acroterion lifted prior to re-setting

The four acroterion on top of the monument were lifted to allow the removal of vegetation and re fixed on new beds of lime mortar. During this stage of the work an inscription was found on the base of one of the acroterion, the name 'W. PITT'.

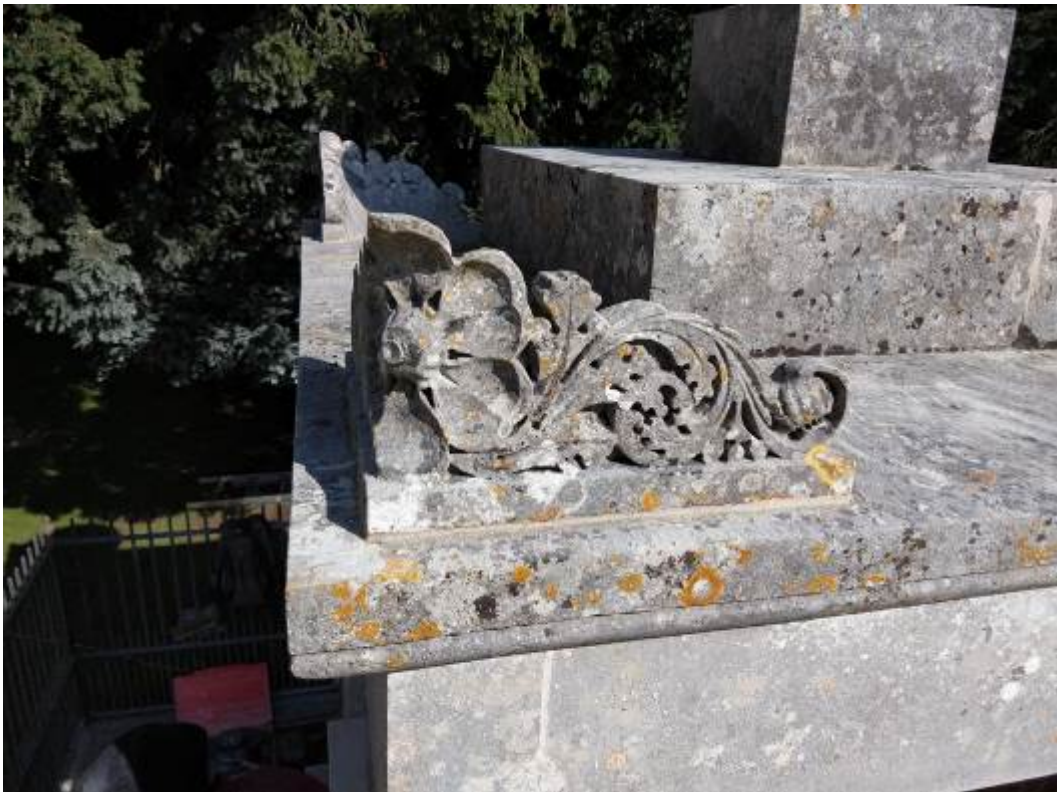
Acroterion re-positioned and bedded

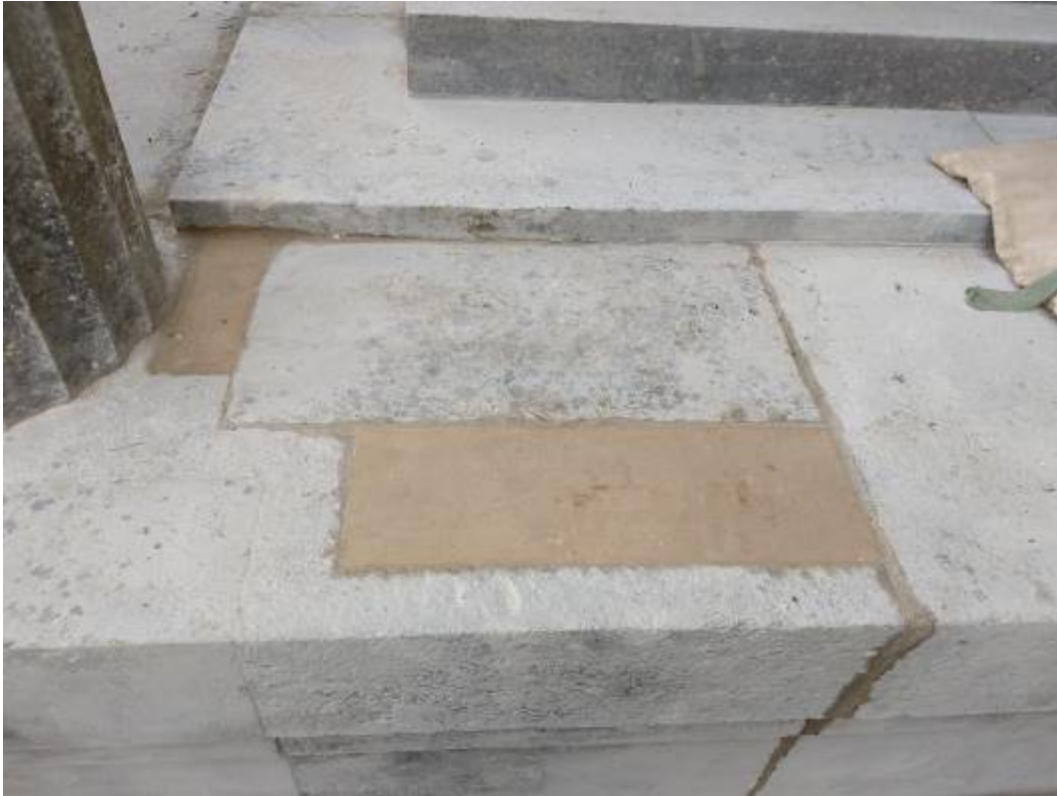
New stone fitted to base of monument

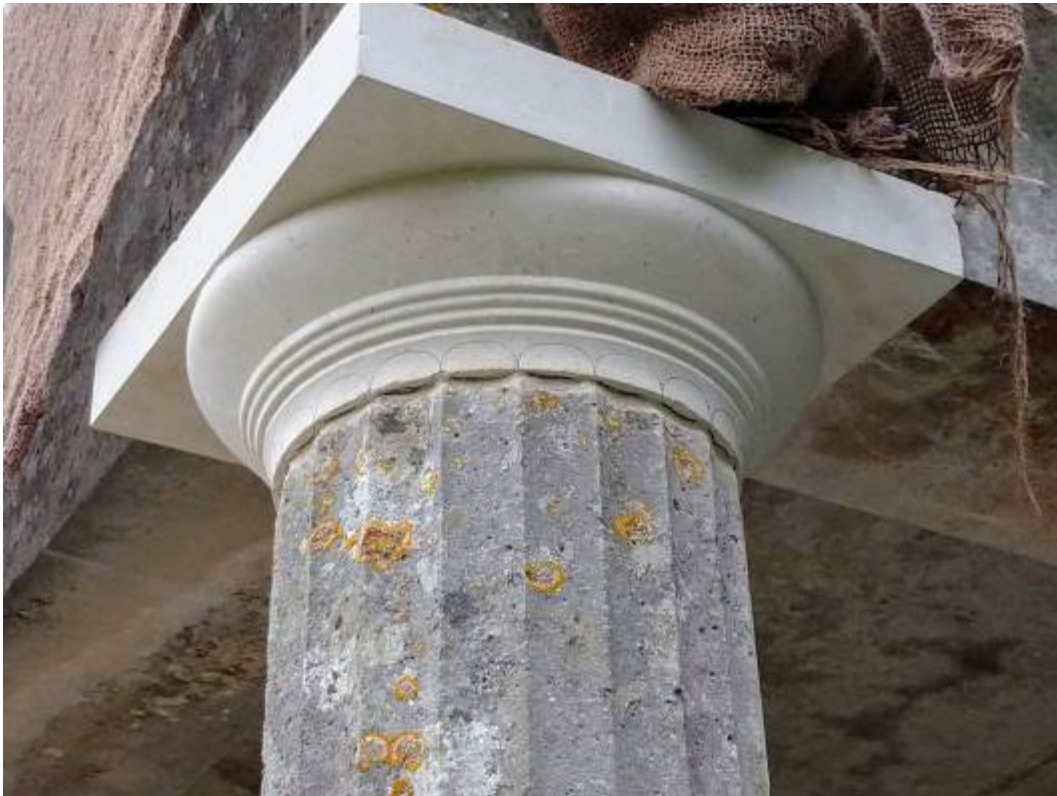
New capital fitted prior to trimming in of flute 'stooling'.

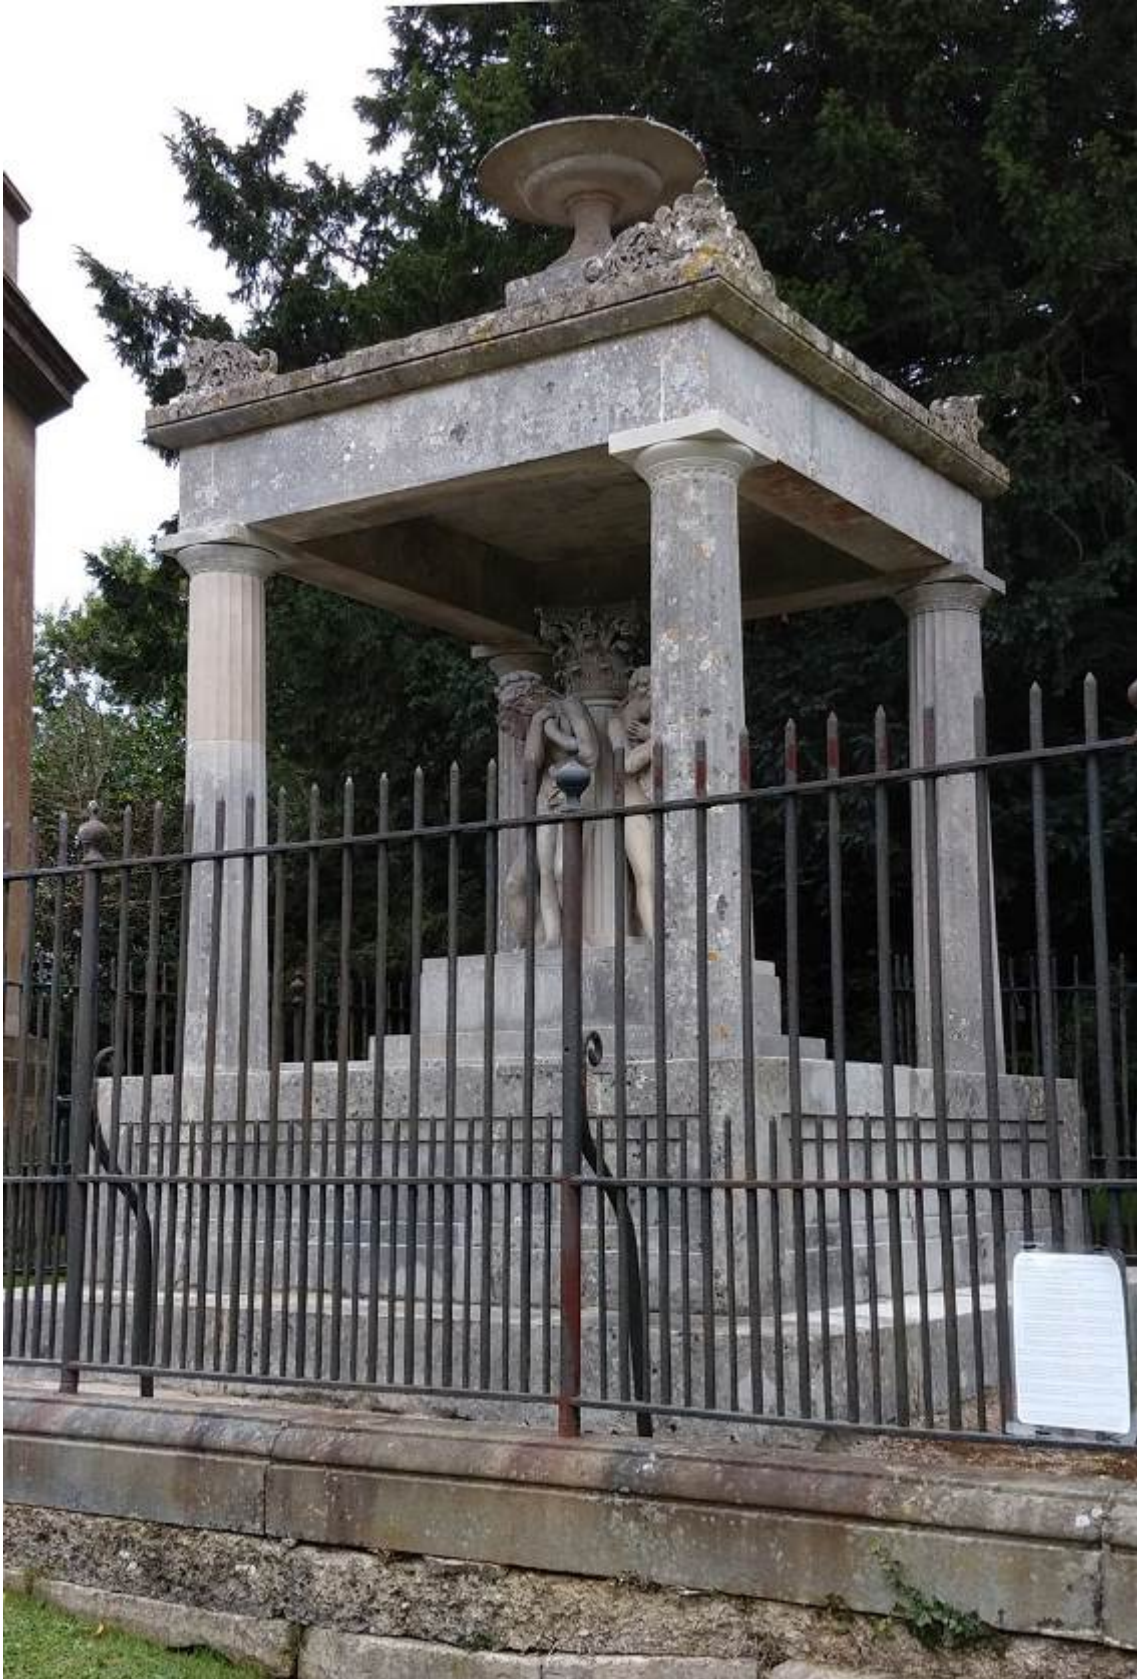
Works to monument completed, new stone trimmed in
