St Peter's Thornbury (Devon – Diocese of Exeter)

Tomb of Elizabeth Johns

Conservation Report

December 2019

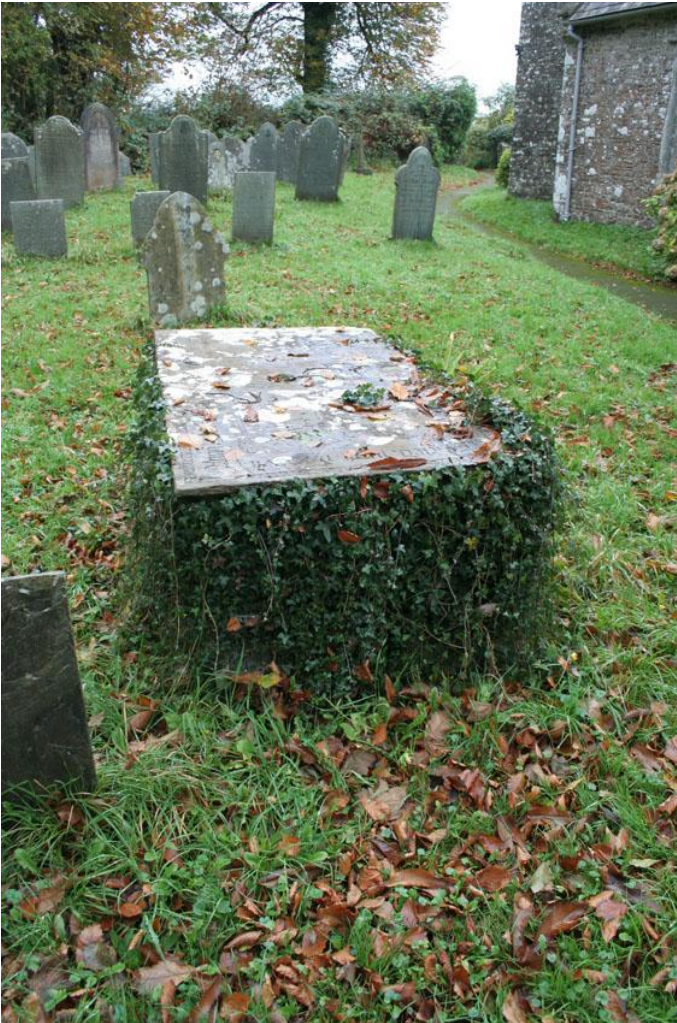
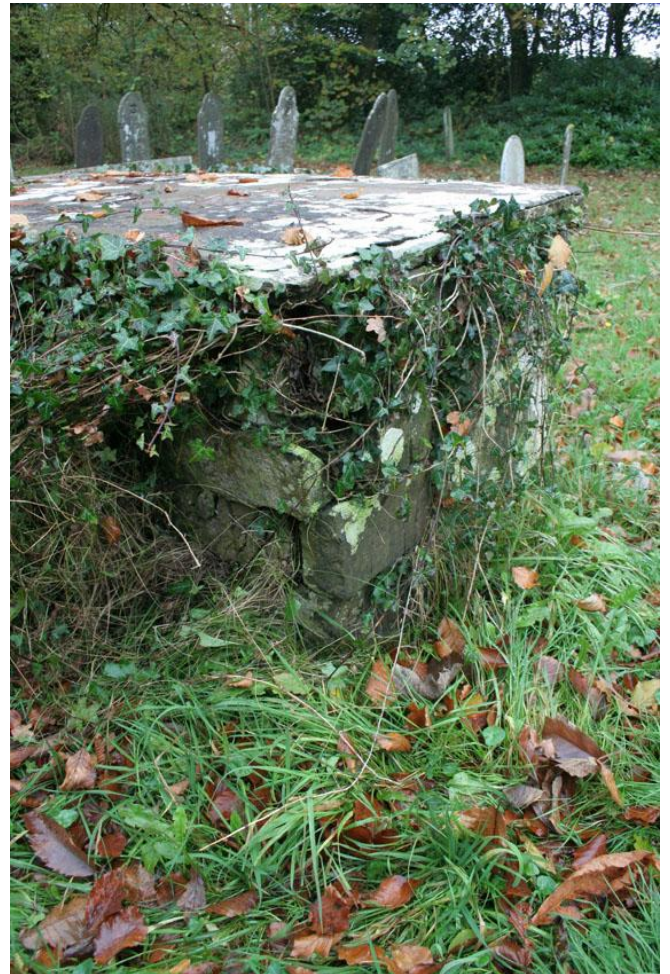
1 and 2.

The tomb chest was variously undermined by the penetration of ivy and other plants, the loss and failure of mortar and of poorly executed old repairs, and some settlement. *See photos 1-4*

Views of the tomb before work, from the east end and, below, from the north west corner

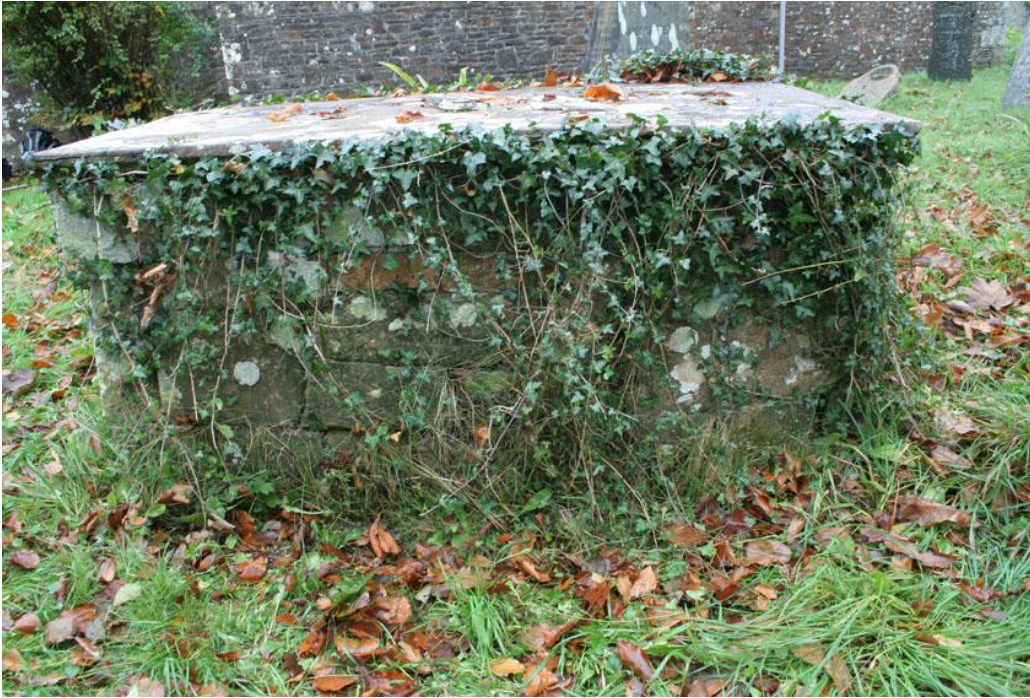
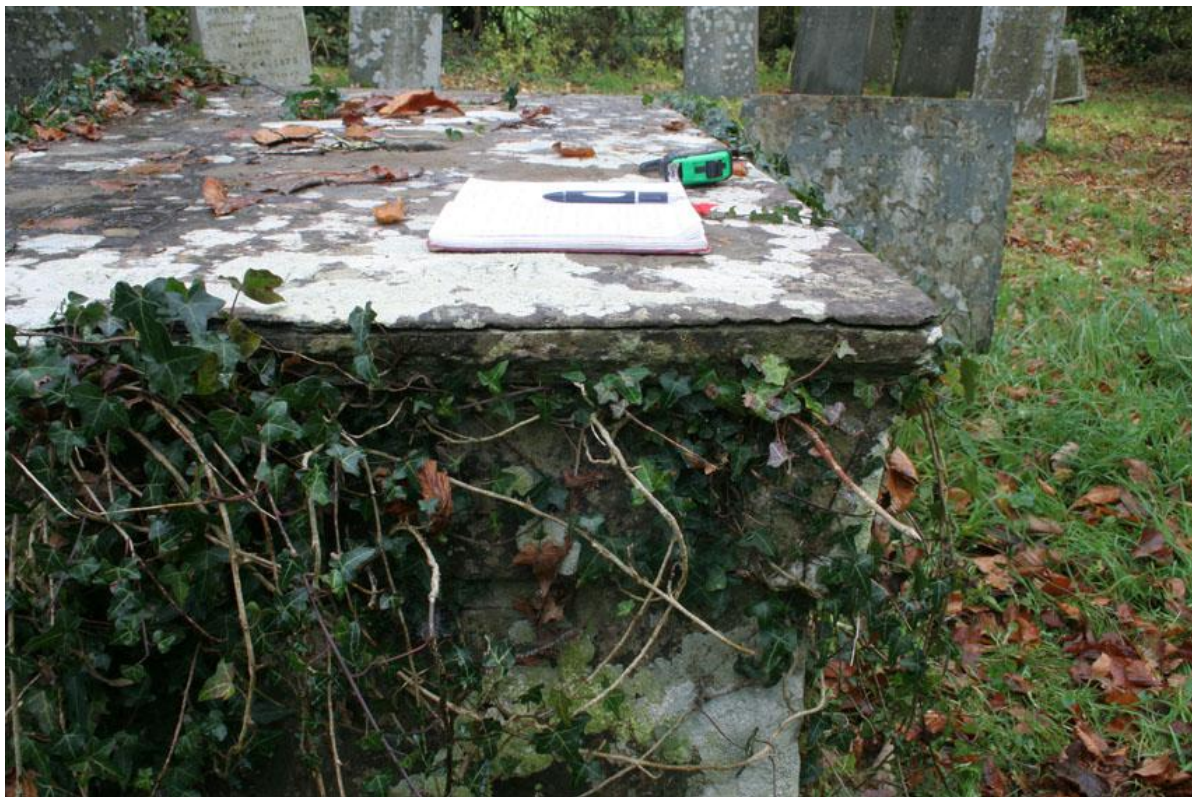
3 and 4.

There were significant laminations all around the edge of the slab, where the strongly fissile stone had begun to open up under pressure from water penetration and associated frost damage. *See photo 4* Further small areas of superficial lamination had led to the loss of some areas of the inscriptions, although the majority of the carved detail survives in remarkably good condition. Some flakes of surface stone of many different sizes were, however, under threat of loss.

Further views of the tomb before work; from the south and below, serious laminations in the slab

Laminations in the edges of the slab were, as necessary, injected with Sika resin and filled with a fine mortar of natural hydraulic lime matched to the surrounding stone. This work has successfully filled the cracks and ensured that for the foreseeable future, water penetration will be limited.

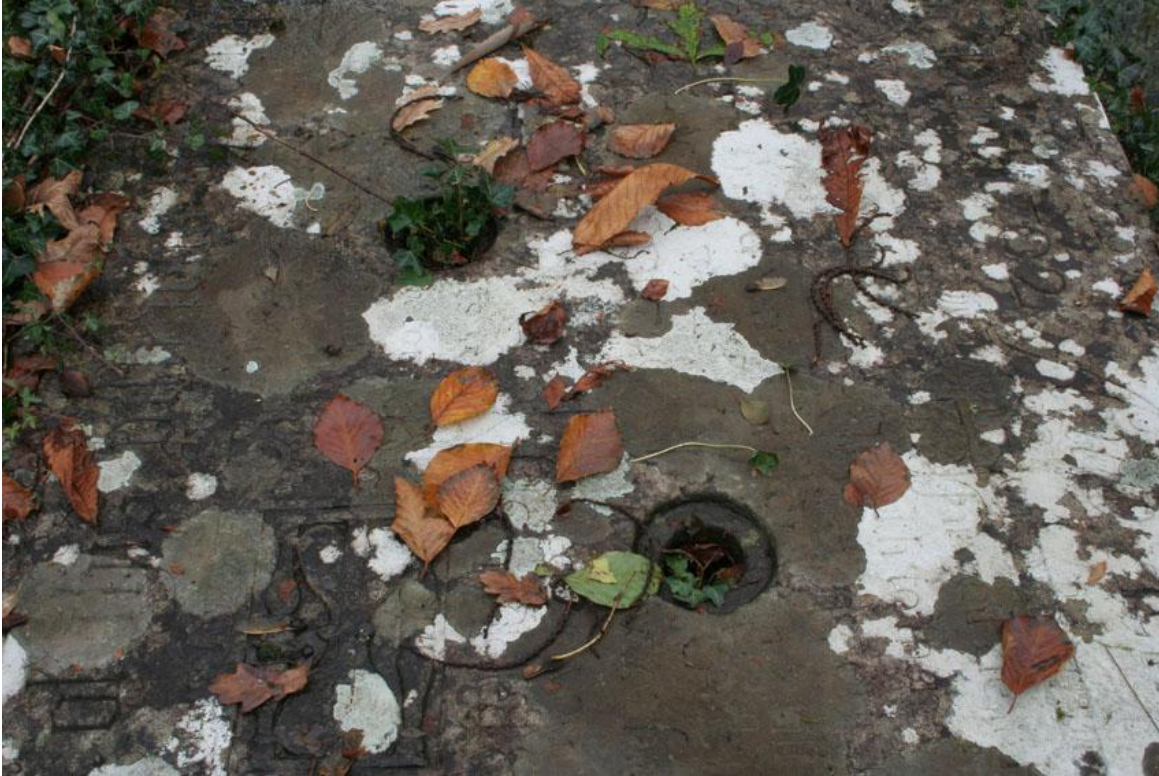
Two curious and rather perfect circular holes had been cut in the slate top slab. *See photo 5* They did not appear to relate to the original design and in fact cut into the lettering of the epitaph inscription, but they were very deliberately – and rather skilfully cut with a recessed centre, suggesting that they were made for some definite purpose as opposed to accidental or vandalistic interventions. What that purpose was, however, is unclear. In any case, they formed holes into the central structure of the tomb chest into which light and water could penetrate, encouraging growth. There was ivy growing out of these holes when we arrived.

There were also the two large perfectly circular holes cut in the slab, with a recessed rebate within each. The reason or purpose for these is still unknown, but it may be that the slab was reused in some way and then later reinstated in its current location.

5 and 6. The circular holes in the slab, with ivy emerging from them; and below, distortion of the slab made clear with timbers

The two large circles were filled with circular stone indents spot-fixed with resin and filled with hydraulic lime mortar. A riven faced stone was used for these infills, to match as closely as possible the weathered surface of the slab itself, and prevent the new pieces catching the eye so readily. *See photo 30*

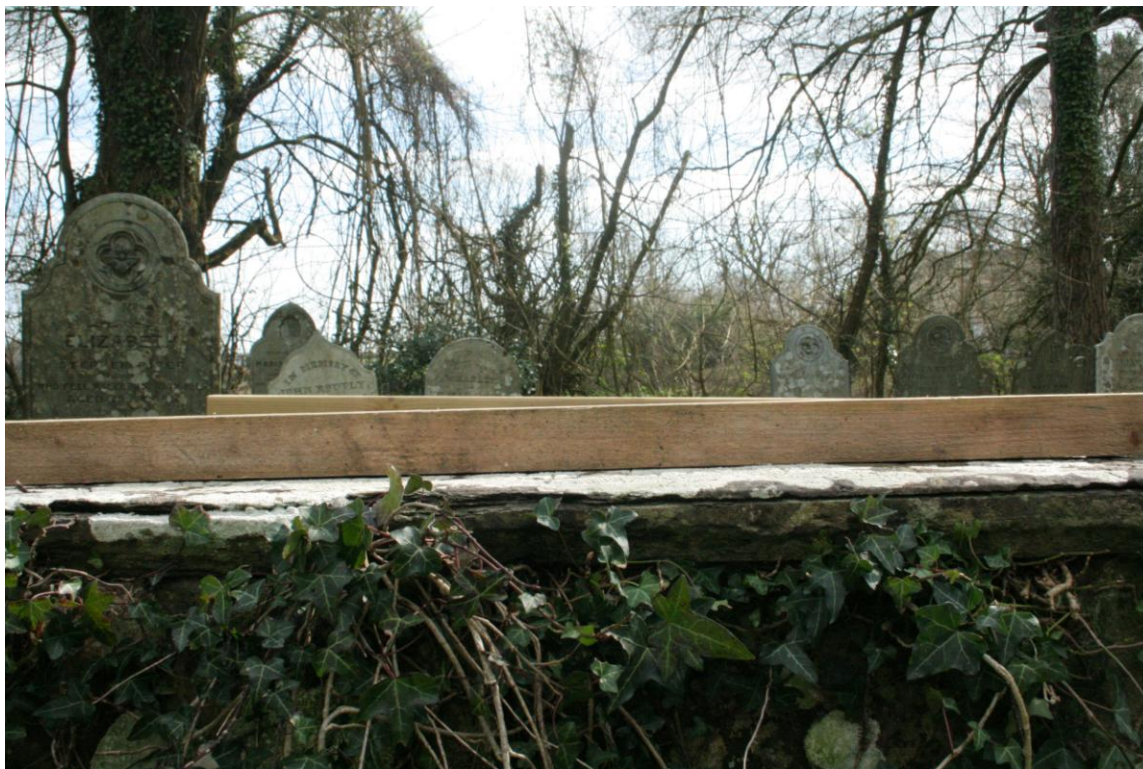
The slab had a number of problems associated with damage, weathering and neglect. The long crack mentioned above was probably the greatest immediate threat to its integrity; it was not clear until the slab was removed to the workshop how far this crack extended across the width of the slab but it clearly required attention. The slab as further distorted and twisted over its length, partly due to the crack and partly to lack of support in some areas (this is not unknown - marble slabs in particular are known to bend and distort under pressure). *See photo 6*

The large transverse crack at the east end of the slab was repaired and strengthened by the introduction of two 8mm gauge threaded rods of 316L grade austenitic stainless steel set into two grooves cut in the underside of the slab and fixed in place with Sprint Iridium® epoxy resin. *See photo 22* The crack was further repaired with a limited amount of crack injection using Sikadur 52® crack injection resin, to penetrate into the finest cracks, and then filled with hydraulic lime mortar matched as closely as possible to the colour of the surrounding stone.

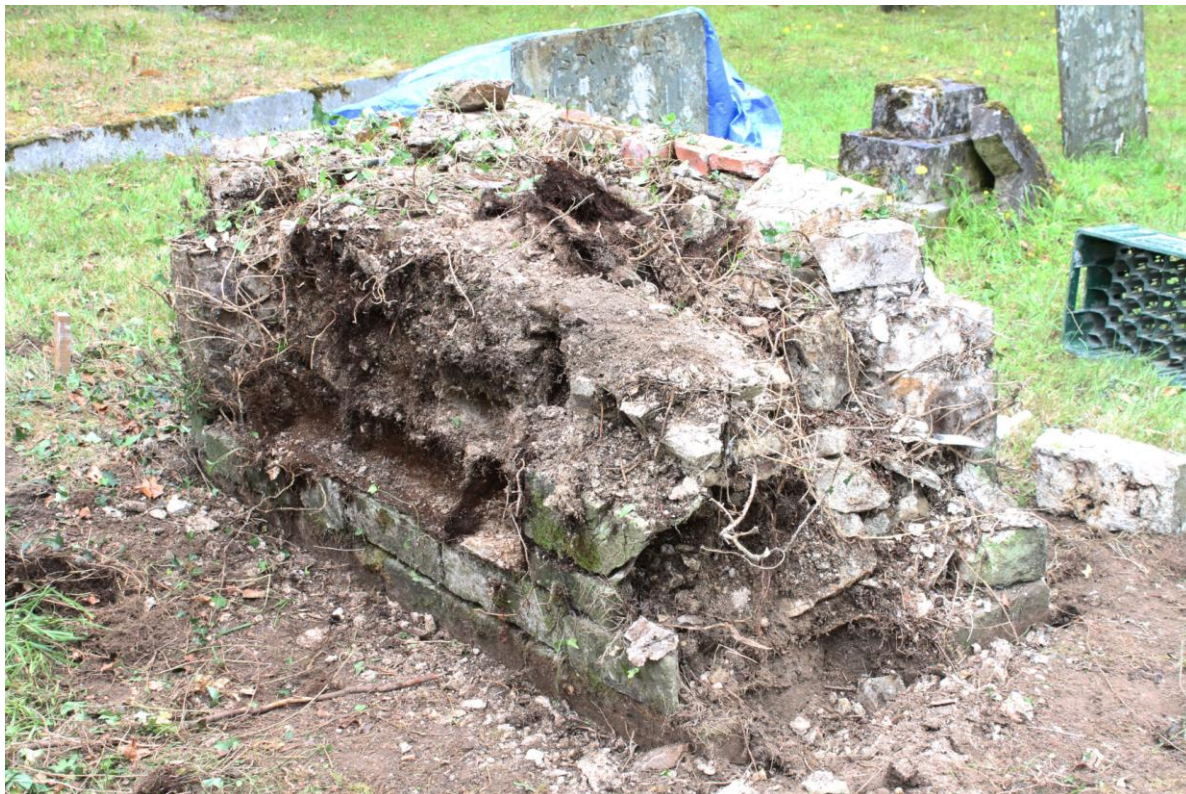
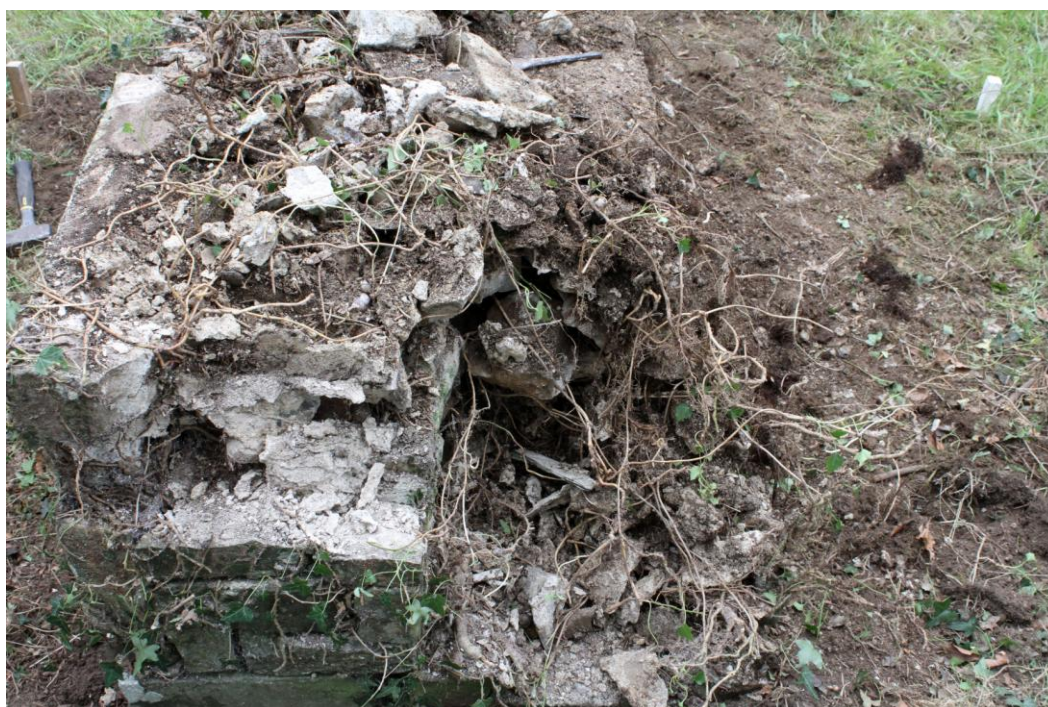
11 and 12. Two shots of the rubble infill within the chest as dismantling progressed

Internally, the chest was inappropriately filled with a selection of random rubble, old mortar, soil and earth, and some brick. *See photos 11 and 12* Interestingly, some of the infill from the base of the interior of the chest was Victorian brick with some glass fragments that appeared to be late nineteenth century in origin; this suggests that the tomb was re-built at least once in its time. One might speculate that it was at this time that the curious circles were cut in the slab – was it once used for something else in another location?

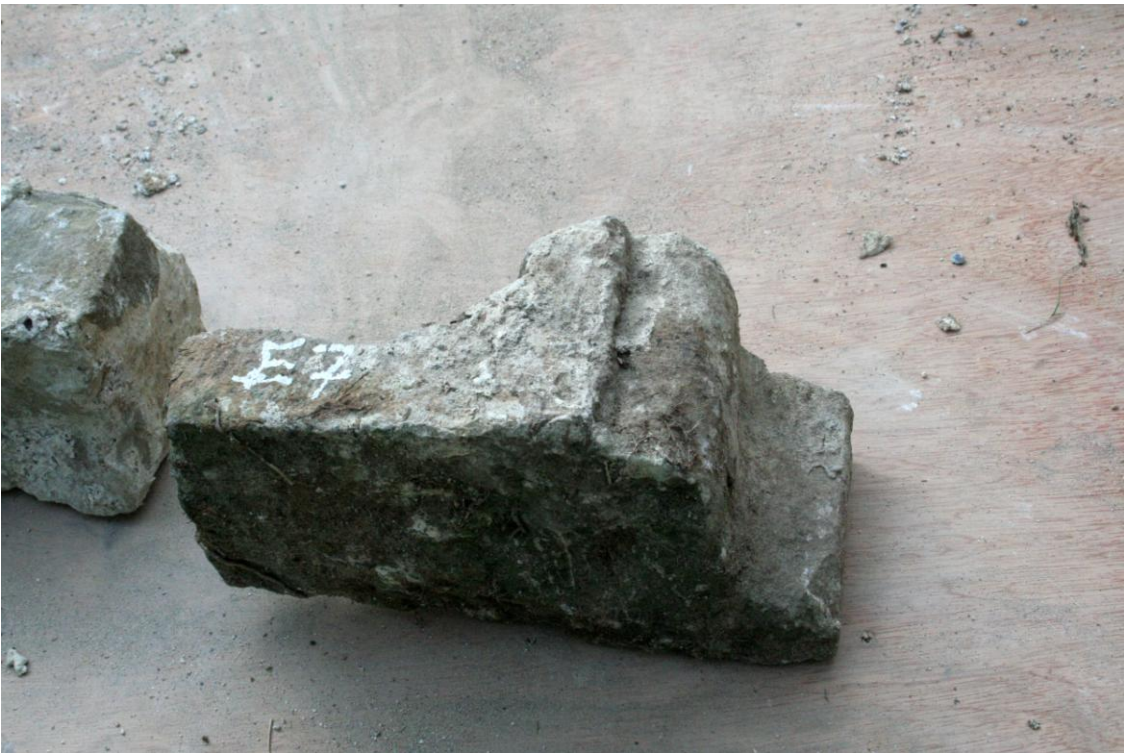
The internal rubble, soil and mortar fill was also broken up; a few pieces of carved architectural moulding were found amongst the rubble *see photo 14* and these have been retained in the new internal structure; the small rubble and fill was discarded as a better support to the walls of the chest and the slab was required.

13 and 14. Numbered stones from the chest laid out and bottom, a moulding revealed on the rear face of one of the stones

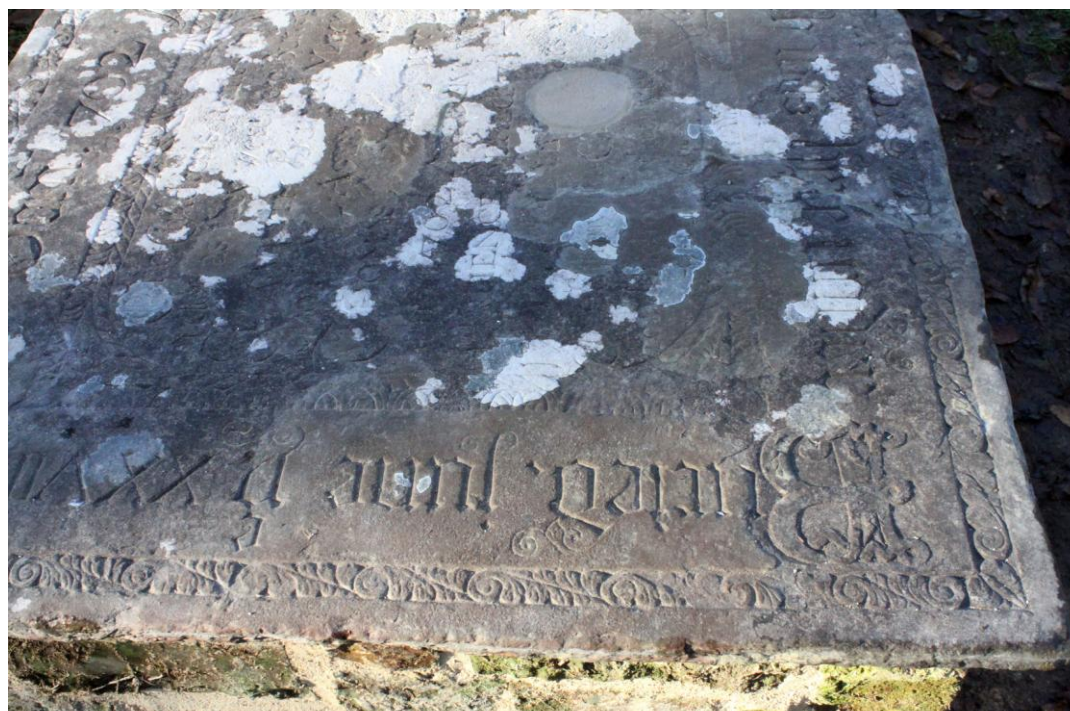
25 and 26. Repointing the slab and bottom, the transverse crack repaired and filled
