CHURCH OF ST WINWALOE

EAST PORTLEMOUTH

REPORT ON THE CONDITION OF THE BELLS, BELL-FRAME AND FITTINGS

Inspection carried out on Tuesday 11th February 2014, on behalf of the Devon Church Bell Restoration Fund, by Ian Smith and Ian Campbell (Trustees of the Fund), met and accompanied by Andy Coton (Fabric Committee Chairman) and Gerry Gurney (Local Ringer). Ian Smith and Ian Campbell are also Bells & Belfries Advisors to the Guild of Devonshire Ringers. This report also includes some of the findings of the late Prebendary John Scott, former Bells & Belfries Advisor to the Diocese of Exeter, from his visit in November 1995.

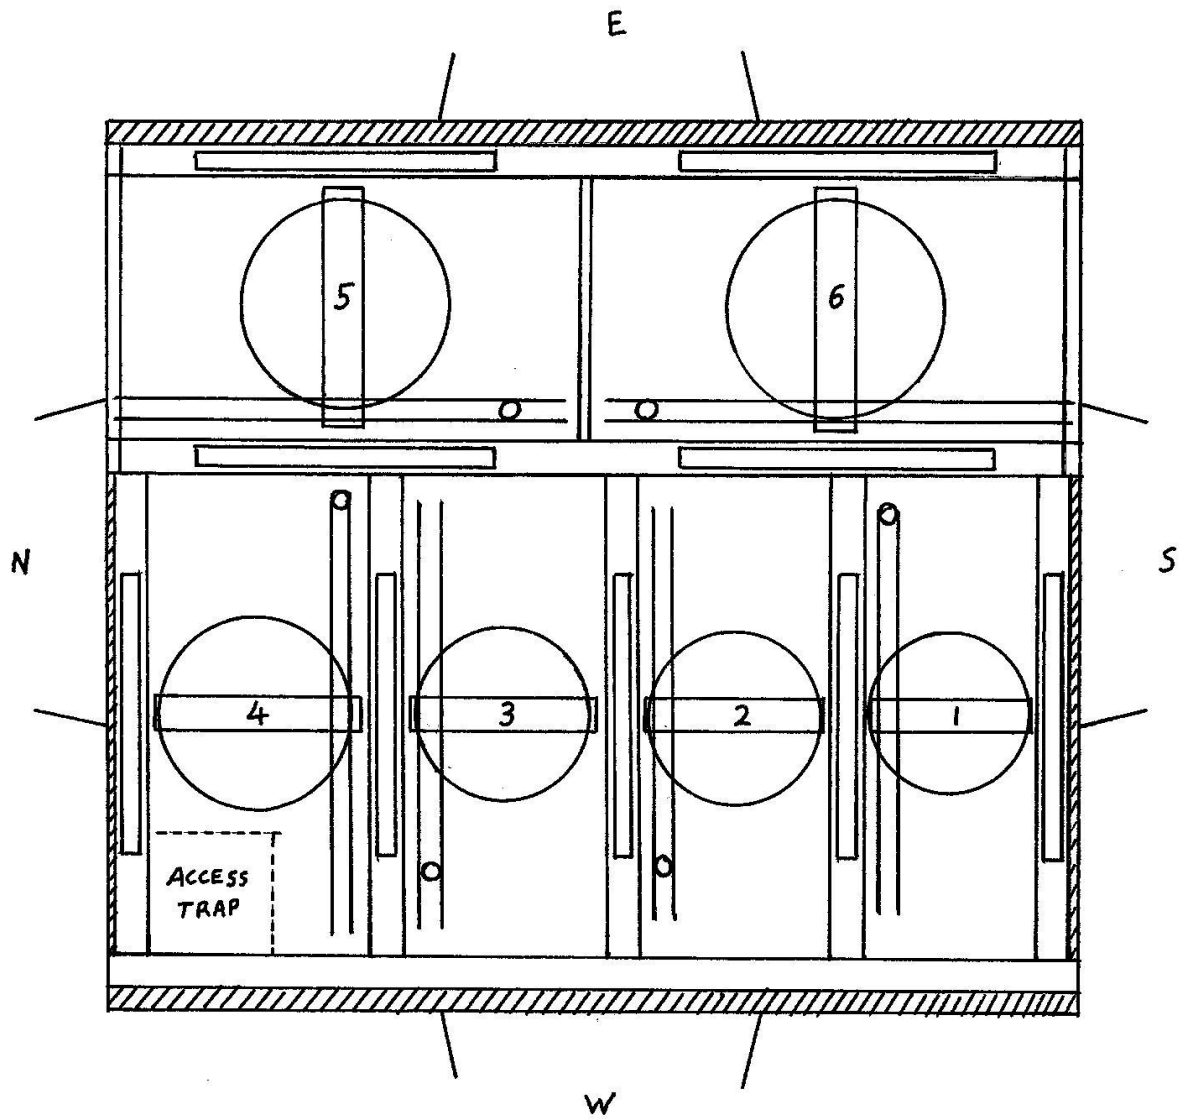
EAST PORTLEMOUTH BELL-FRAME LAYOUT

The **Bell-Frame** is supported on a grillage of 12 inch by 5 inch rolled steel joists, three spanning the tower N/S and built into the walls at their ends. Five subsidiary RSJs run E/W between the two most westerly N/S RSJs. The outer joists are resting on the tower offset, the concern being that the space between the joists and the tower walls has been in-filled such that they are not well ventilated and a full inspection of their integrity is not possible. We did however note that an exploratory hole had been drilled through the web of the most easterly N/S RSJ in order to ascertain its thickness.

We understand that, about ten years ago, the grillage was thoroughly cleaned down, descaled, and painted with a zinc or aluminium-rich primer. This has clearly arrested much of the corrosion, though fresh corrosion is now taking place where the joists are in contact with the tower walls, and some of the metal is now very thin in places. More rubbing down now needs to be carried out on these areas and a fresh coat of similar paint applied. As a precaution steel brackets have been inserted underneath the grillage, three on the E side and one on the S in case the grillage should drop. Metal wedges and packing pieces have been inserted between the brackets and the RSJs.

5. Sand off the heads of the nails securing the shrouding to the soles of the bell wheels and apply a dab of paint to prevent further corrosion.
6. Rub down and repaint any corroded areas of the supporting grillage, firstly with a zinc-rich primer, eg “Galvafroid”, and then with either a machine enamel or good quality exterior gloss top coat.
