St John the Baptist, Bishop's Tawton, Devon (Diocese of Exeter)

Wall monuments

Conservation Report

January 2020

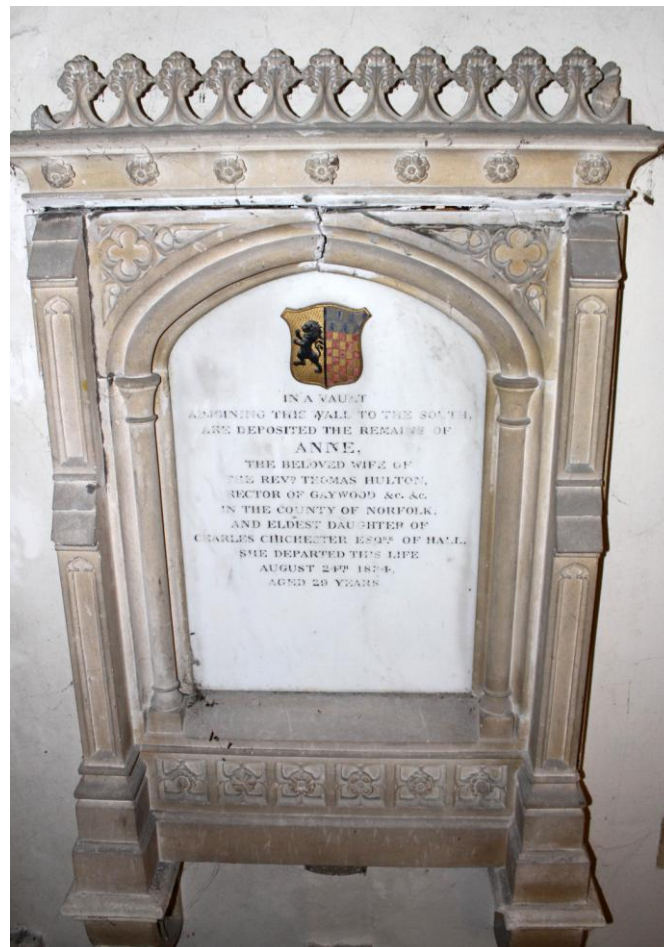
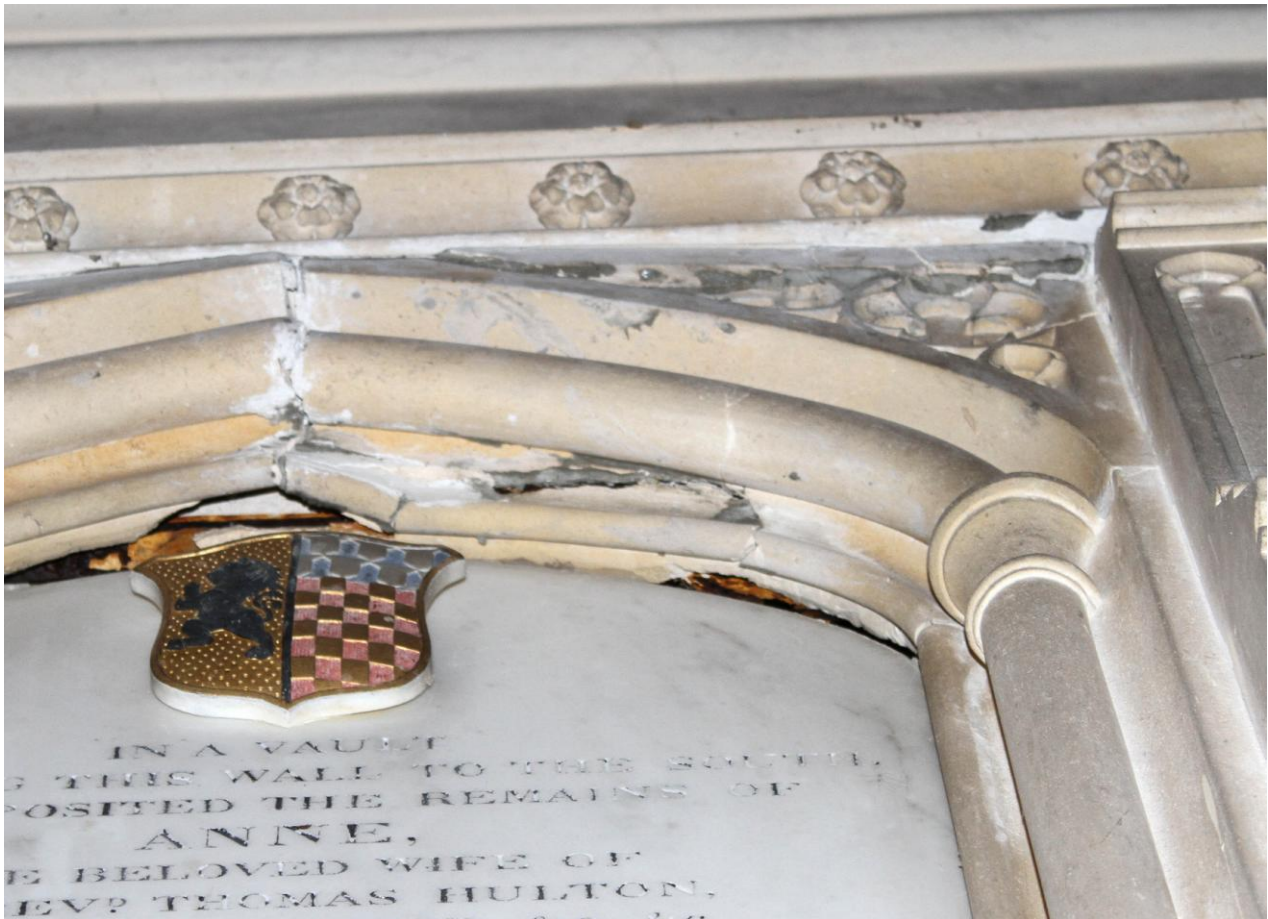
Structurally, the monument was unsafe and close to a collapse of its upper sections. Large fixings and repair cramps of mild steel had been inserted in an apparent earlier phase of repair and these had then corroded, expanded and shattered the surrounding stonework. The arch section above the inscription was broken into many fragments and these had then been unsympathetically repaired with dark grey Portland cement. The lower portion of the monument was apparently stable. The eastern side pilaster was fractured into four fragments and had possibly been dropped during a previous phase of repair work.

The Hulton monument before work: note cracking in joints

The arch sections had suffered widespread fracturing from the corrosion of metal repair cramps; all metal elements were removed and the shattered fragments dowed together with stainless steel pins and cramps set in epoxy resin. Gaps and losses were filled with lime mortar matched in colour and texture to the surrounding stone.

The monument was then reassembled and fixed back in place with stainless steel cramps set in polyester resin. Joints were bedded and pointed in lime mortar.

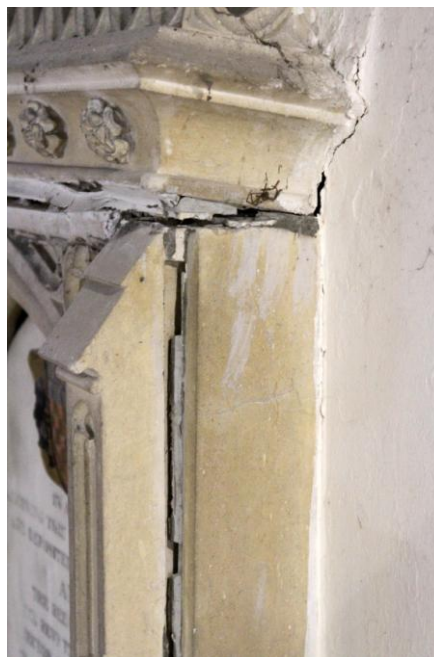
Closer views of the cracking in the structure

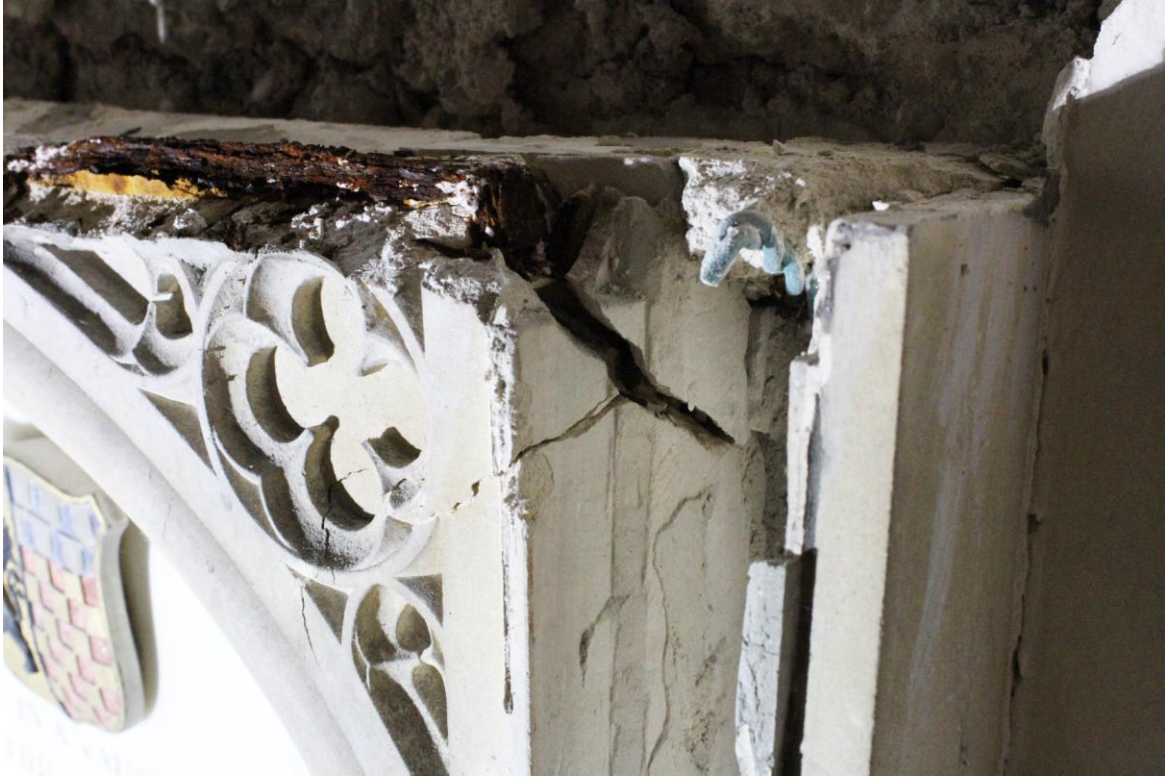
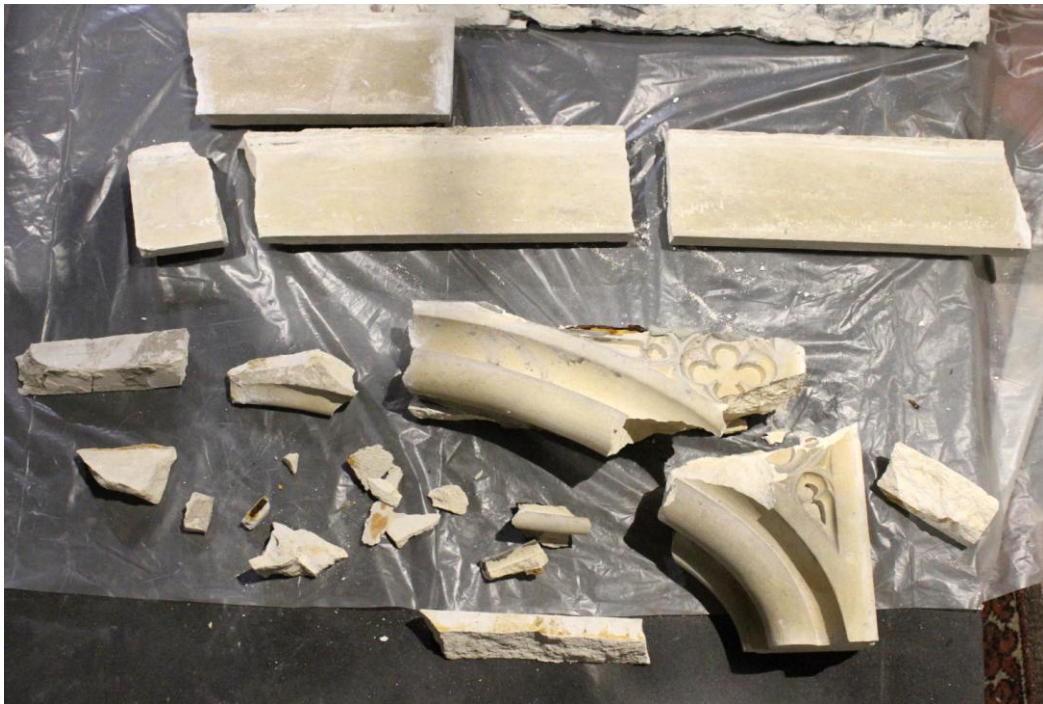
Top photo: dismantling in progress, showing large iron clamp; below, fractured stones laid out before repair

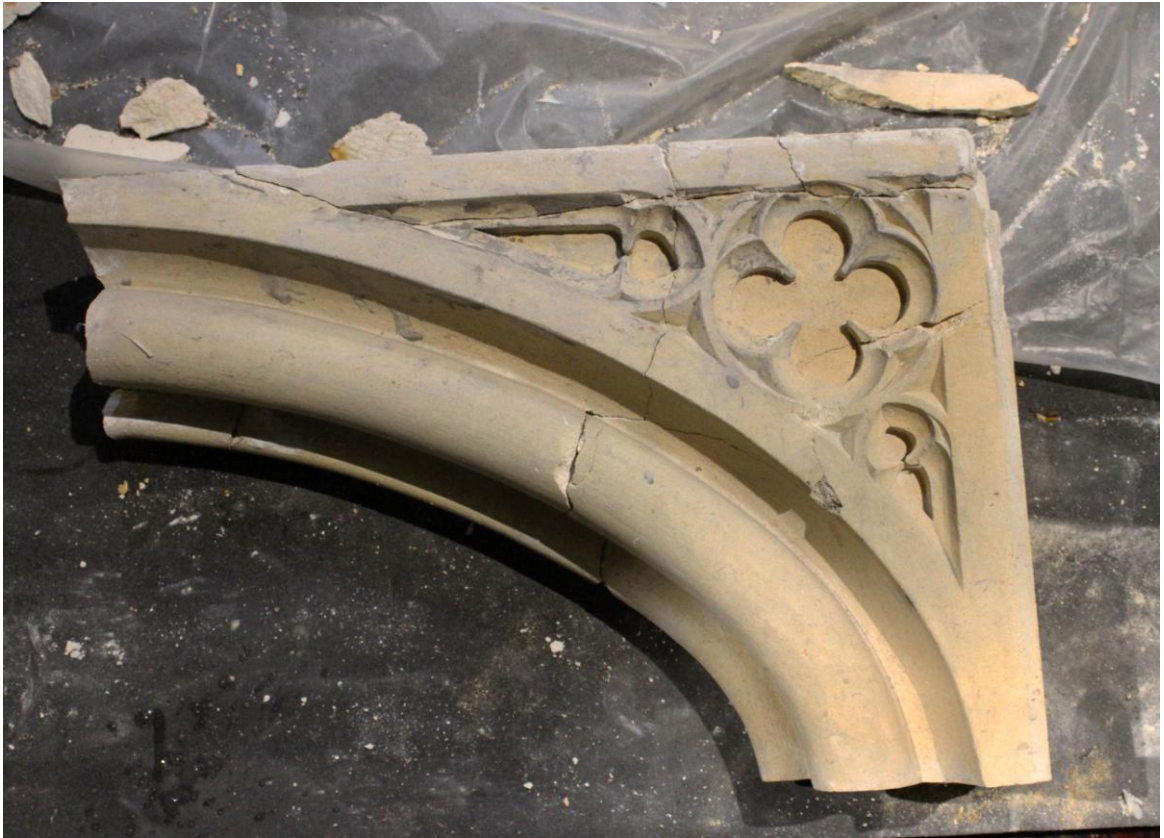
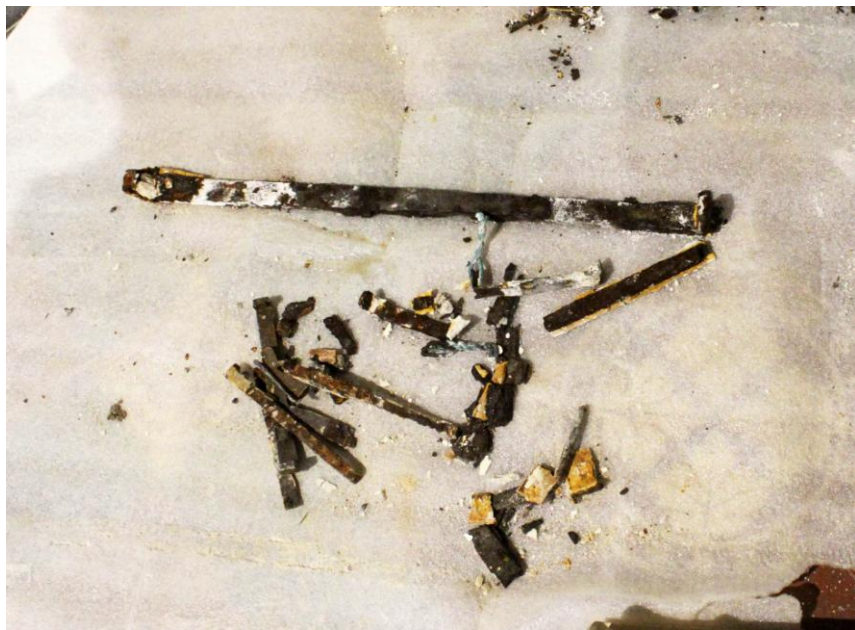
Top: arch section being repaired. Bottom: the iron elements removed from the monument

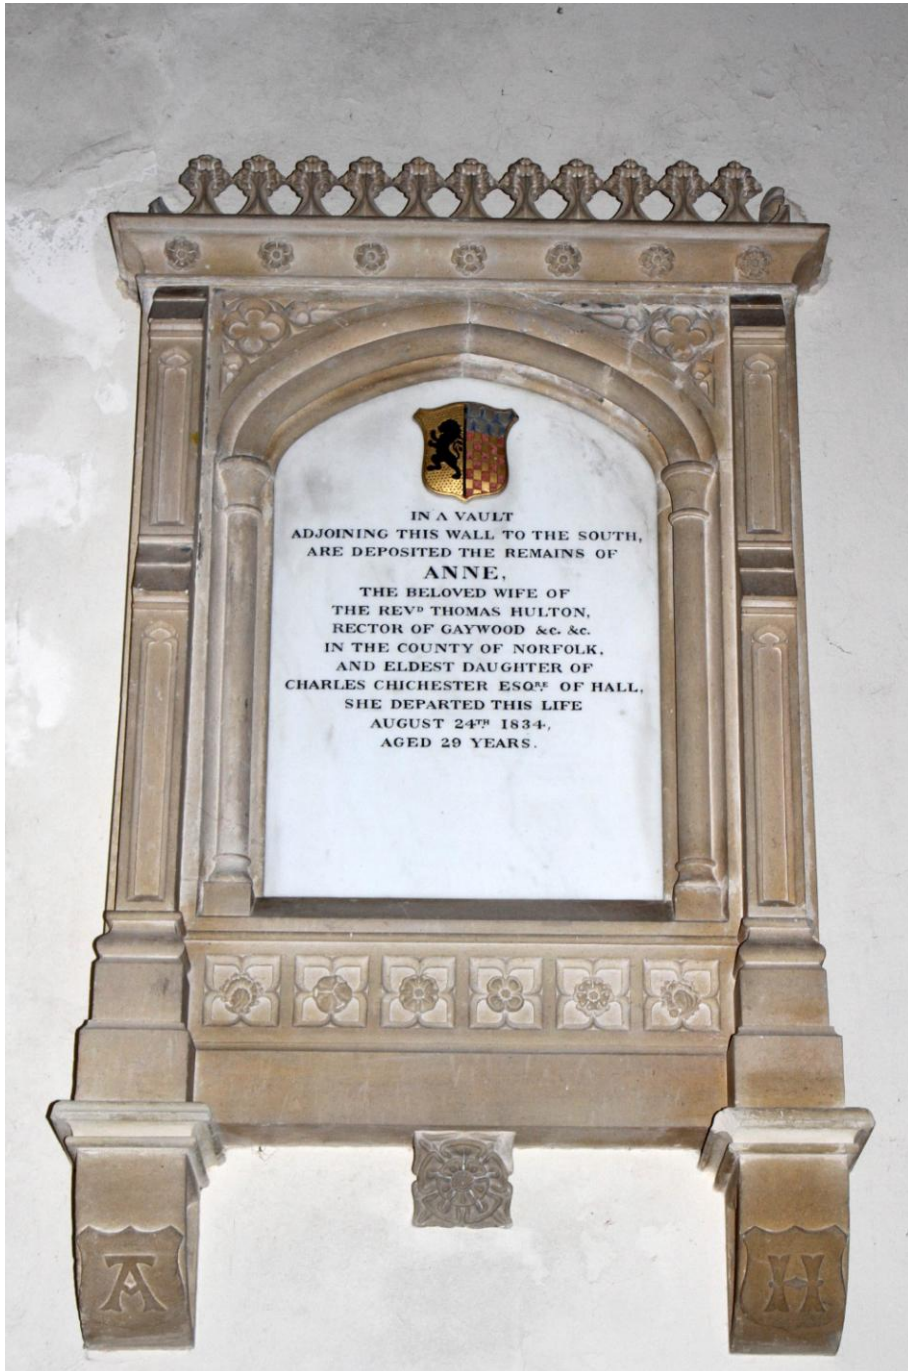
The Hulton monument after work

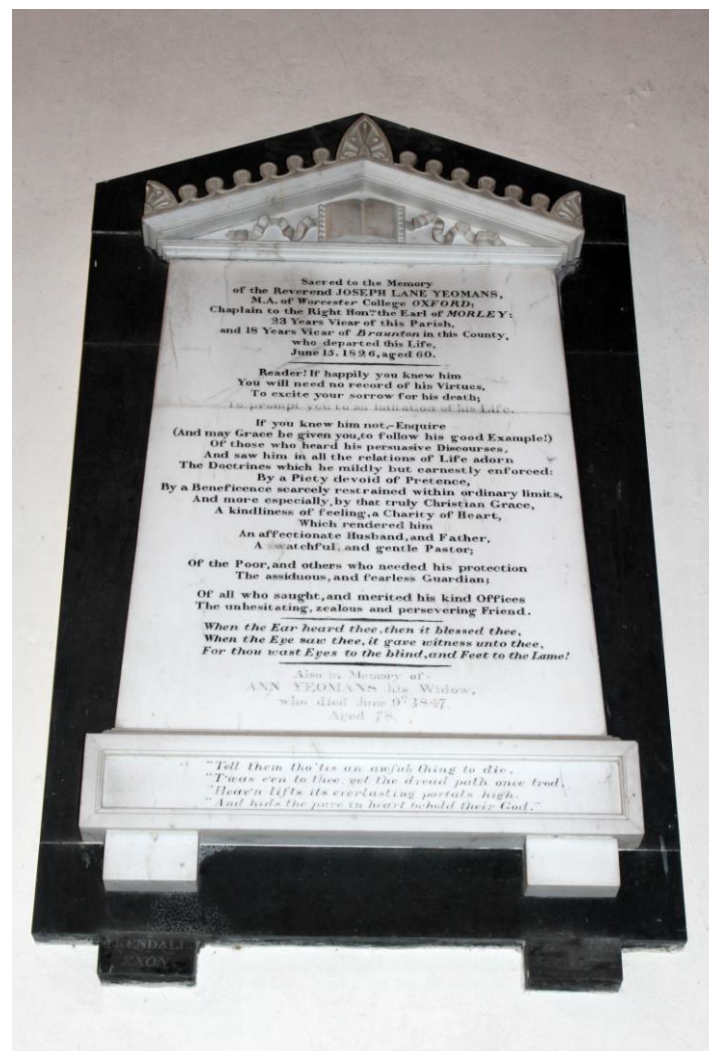
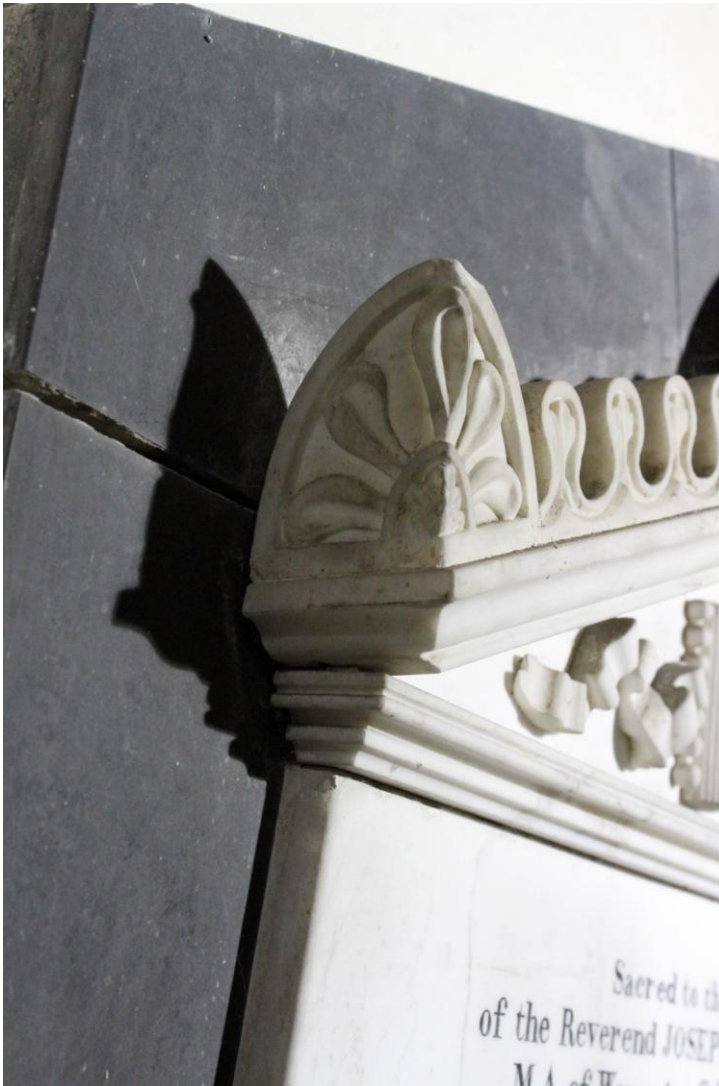
The monument had a sizeable crack down the rear joint with the supporting wall, and further open joints in the upper part of the structure. Surveys with a metal detecting instrument revealed ferrous metal in the lower part of the monument as well, necessitating its removal, as it was clear that corrosion was already advanced.

The Yeomans monument before work began

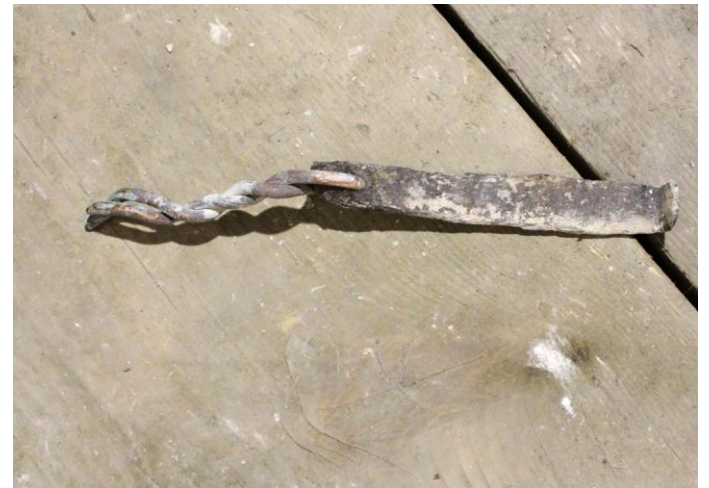
Dismantling revealed that the major failures were in the upper part of the monument, where the black point to the obelisk had been backed on to a piece of Portland stone, itself repaired with several large iron cramps. These were all in a very poor state and had fractured the stone around them.

Above: open joints in the structure, caused by corrosion of fixings

Iron elements and old fixing stubs were removed from both the wall and the monument, and shattered stones were pinned together with stainless steel dowels and epoxy resin. The thin black limestone sections of the obelisk point were then reattached to the Portland stone backing with plaster.

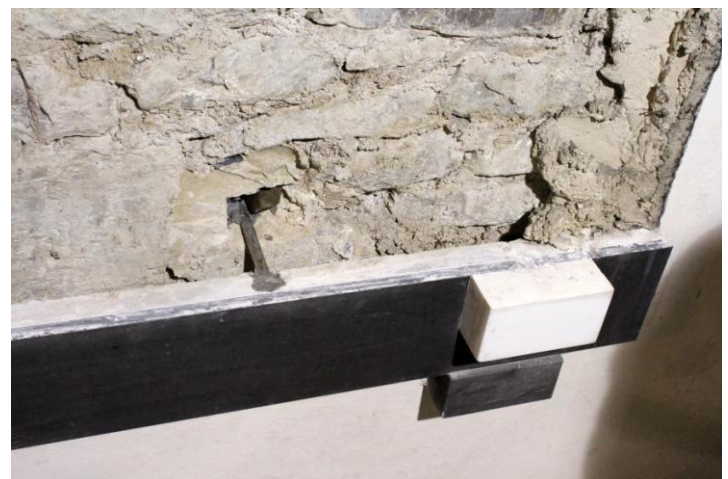
found to be of interesting design - the section of the fixing buried in the wall was of iron, but this was then attached to a twisted bronze wire fixing that returned into the monument to restrain it. In this way, the original builders ensured that the iron staining that rusting would have caused in the white marble was avoided, but unfortunately they were unable to avoid the expansion and disruption caused by the iron section of the fixing in the wall.

Top right: one of the original composite cramps, part iron and part bronze

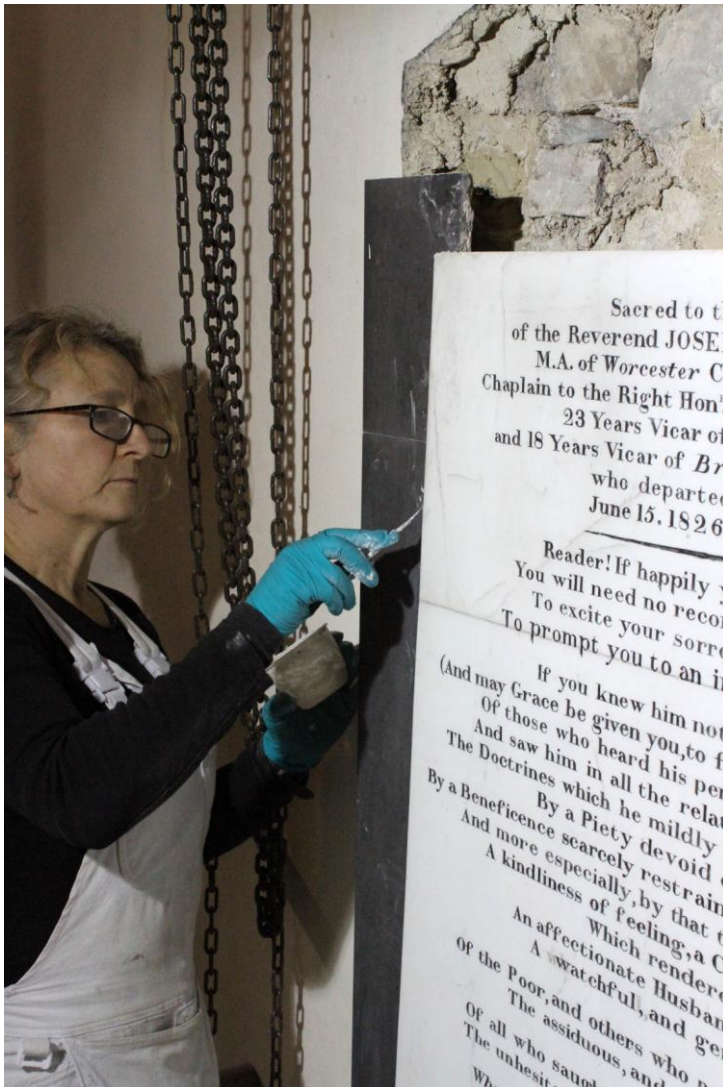
Lower right: a new stainless steel cramp inserted

The monument was then re-erected using stainless steel cramps, polyester resin for wall anchors, and lime mortar or plaster for bedding and pointing, as appropriate.

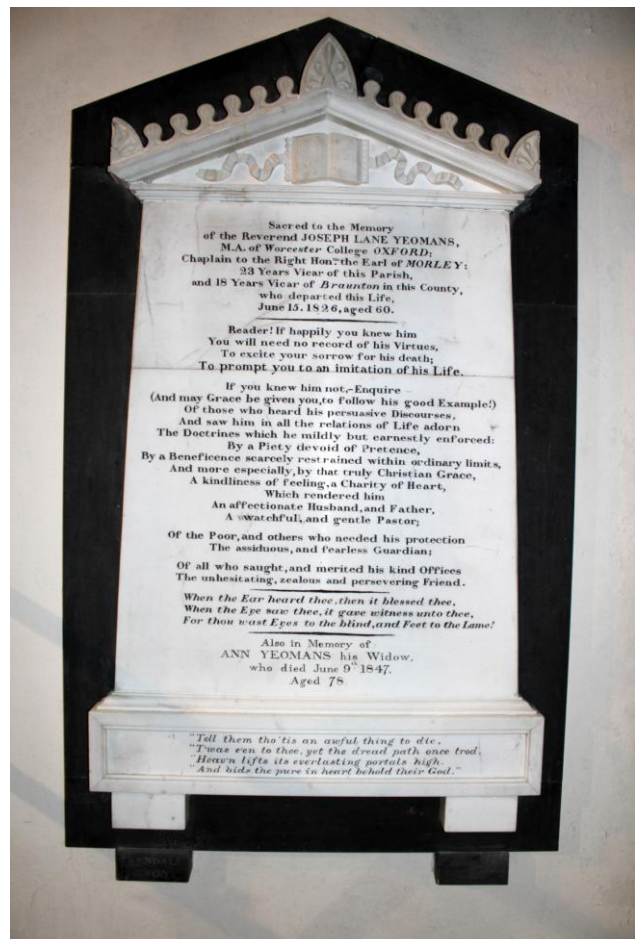
Left: rebuilding in progress

Below: the Yeomans monument after work

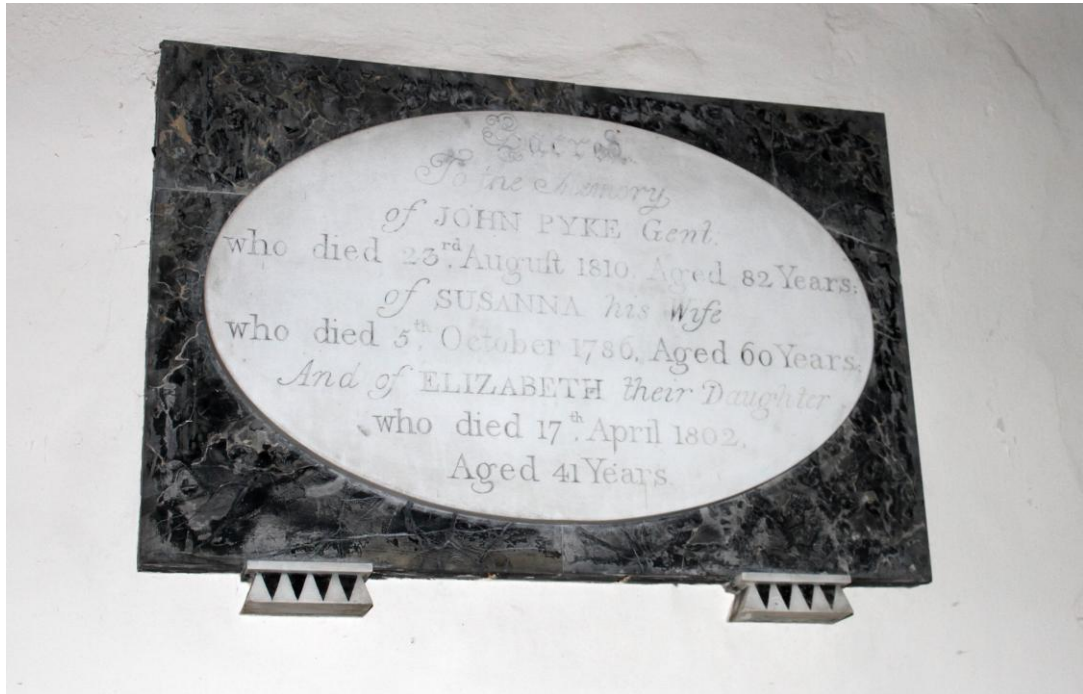
The monument was well supported on its built in marble corbels, but had been fixed together with small ferrous cramps, and these had corroded, damaging the surrounding stone and opening up the joints in the structure. Dismantling revealed also iron fixings holding the monument to the wall, and iron nuts in the rear, tying the oval inscription to the Portland stone backing section. One section of the ornamental marble surround had been displaced from its backing.

The Pyke monument before work began

A small mobile scaffold tower was erected to allow removal of the plaque from the wall. The plaque was recorded with working drawings and digital images. It was then released from its main fixings and removed from the wall. All iron cramps and other fixings were removed with fine drills and replaced with stainless steel cramps of similar form, fixed in epoxy resin. Cramps were overfilled with lime mortar and toned in to match the surrounding stone.

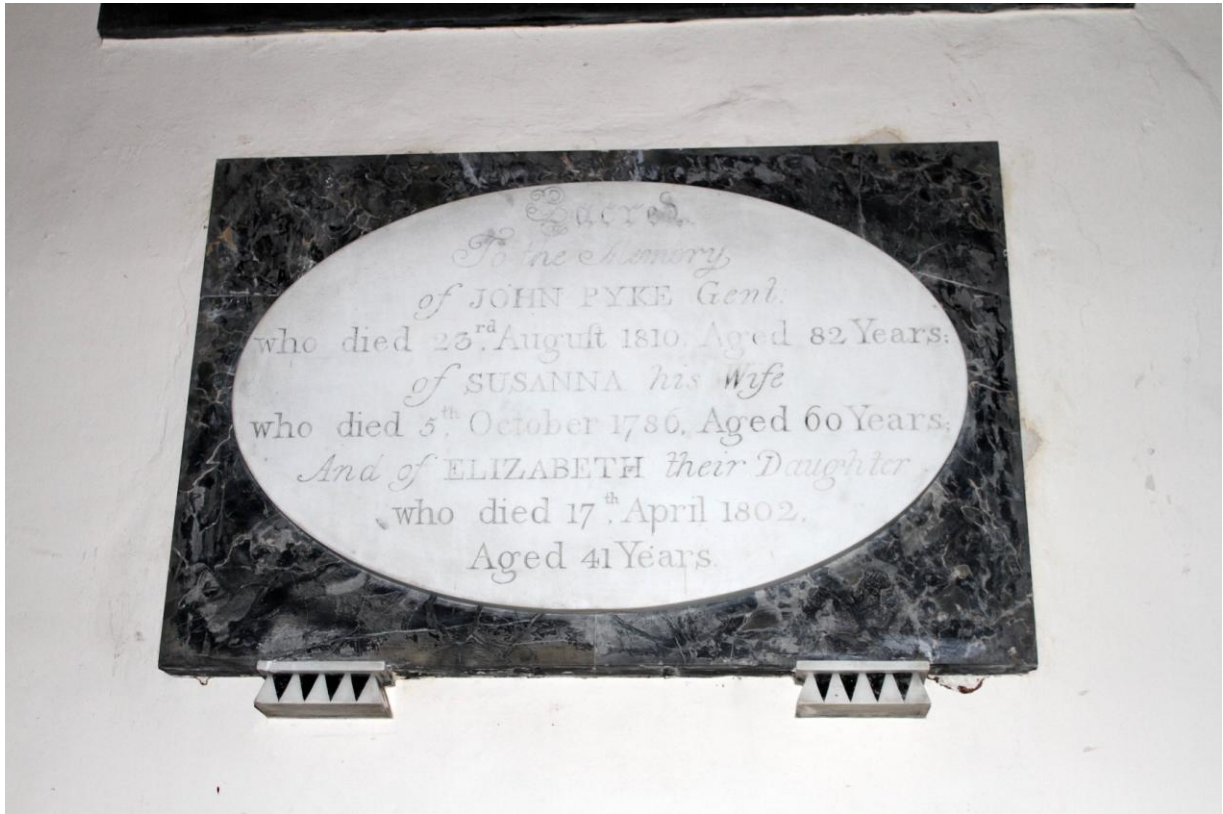
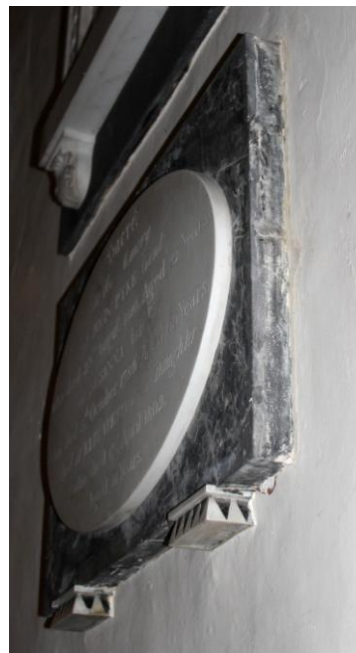
Above: the Pyke monument after work and right, the west side of the monument

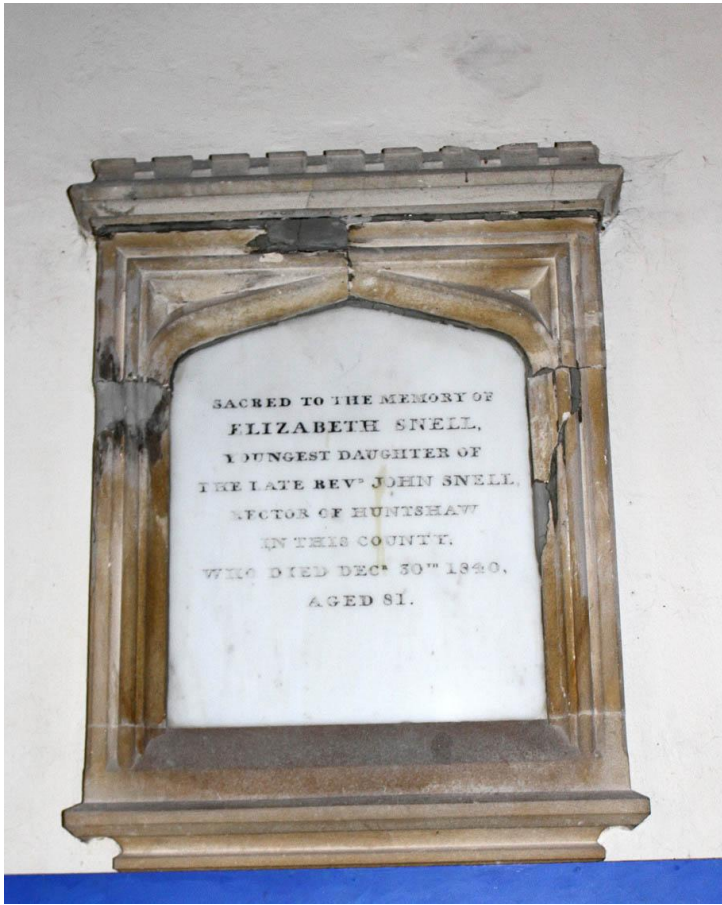
The monument had endured extensive cement repairs, indicating a longstanding problem of structural disruption. Further disruption and cracking of these repairs and adjacent stone was evident, the result of iron corrosion.

Above: the Snell monument before work

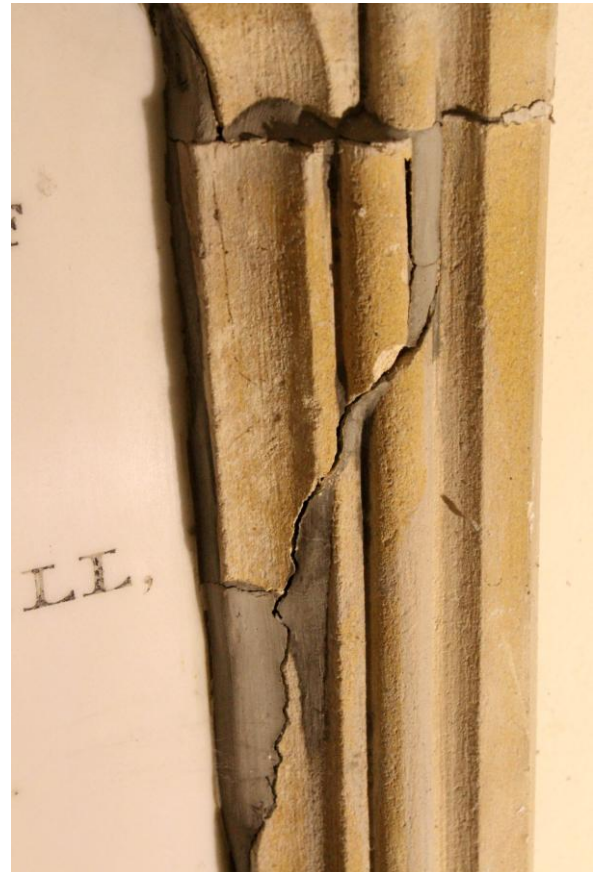
Right: the cracking and old cement repair showing a longstanding problem of deterioration

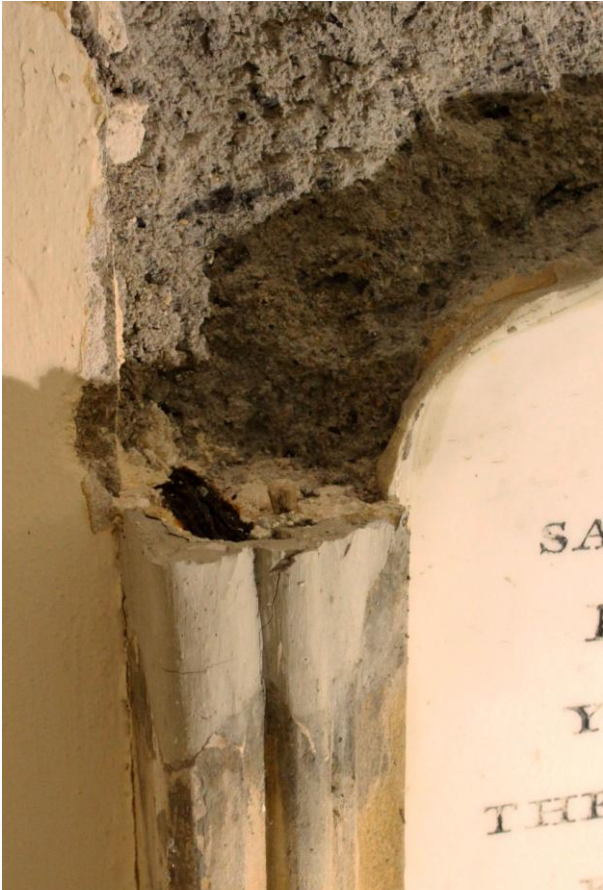
Left: iron cramps buried in the structure

A small mobile scaffold tower was erected to allow removal of the monument from the wall. The monument was recorded with working drawings and digital images. It was then dismantled as far as the base section, which itself was sound and stable. Cement repairs and all iron elements were removed from both the monument and the supporting wall. Surfaces were cleaned with deionised water or V and A mix on cotton swabs as appropriate, and varnish and paint dribbles were removed with solvents.

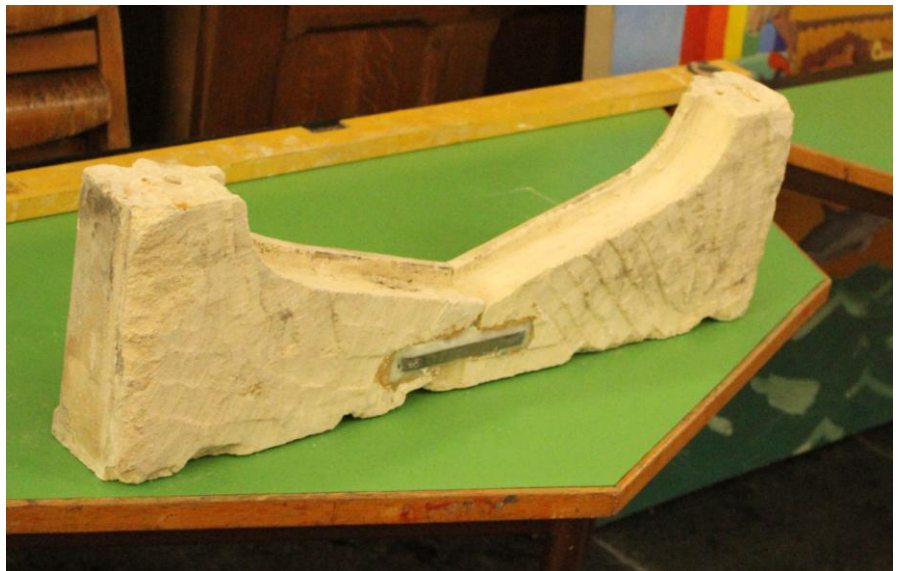
Below: the arched section of the monument under repair

The monument was then re-erected with stainless steel cramps, polyester resin for wall anchors and lime mortars for bedding and pointing. Losses were filled with lime mortars matched to the colour and texture of the surrounding stone.

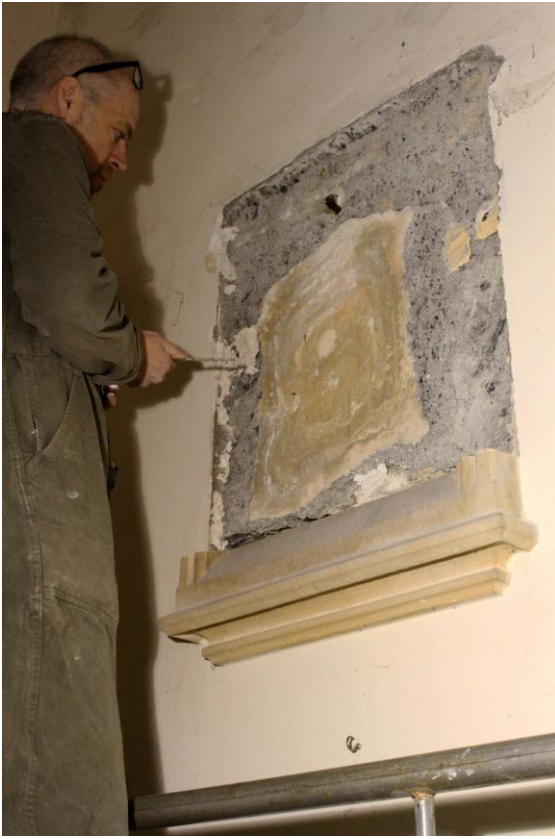
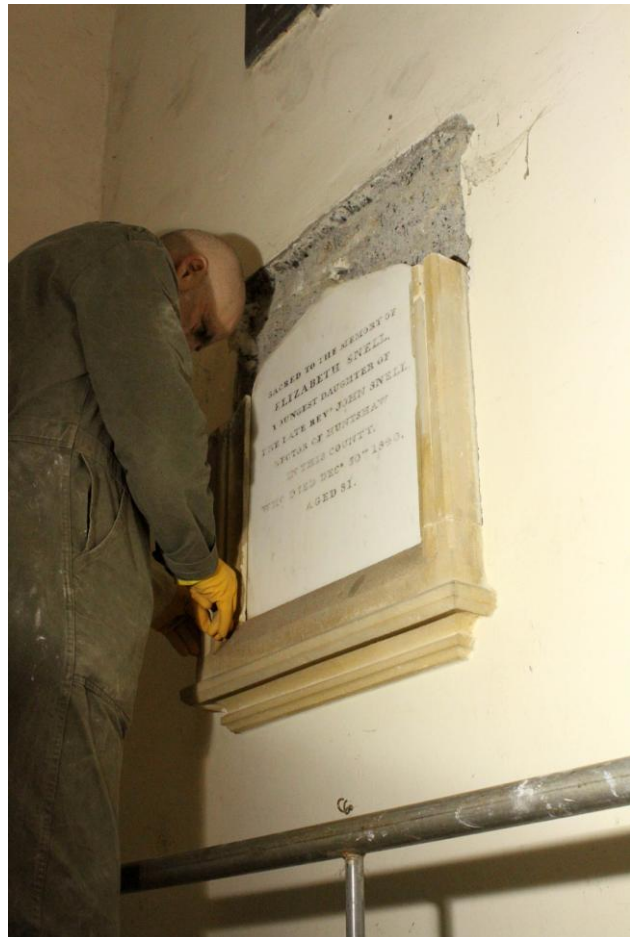
Work in progress: left, dismantling and below, re-erection

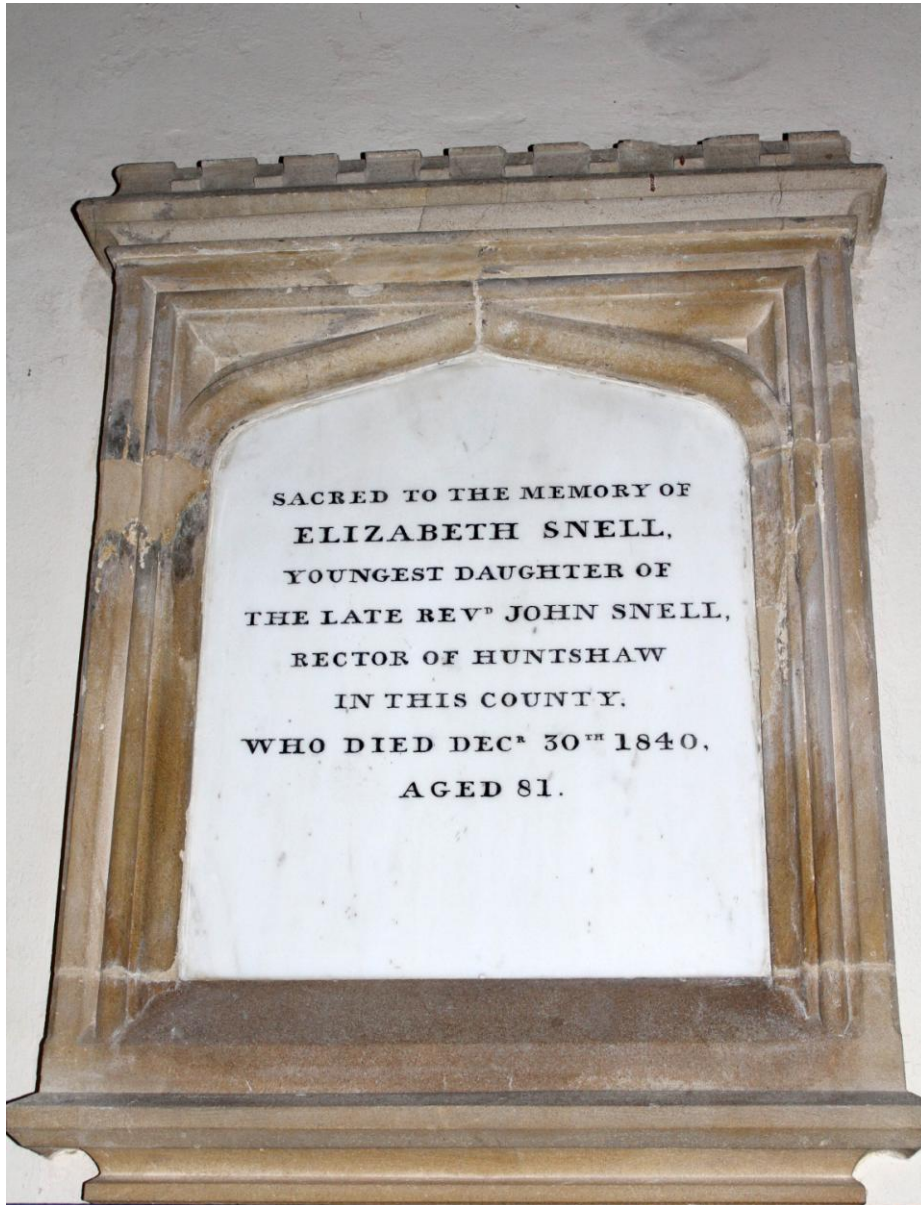
The Snell monument after work was completed

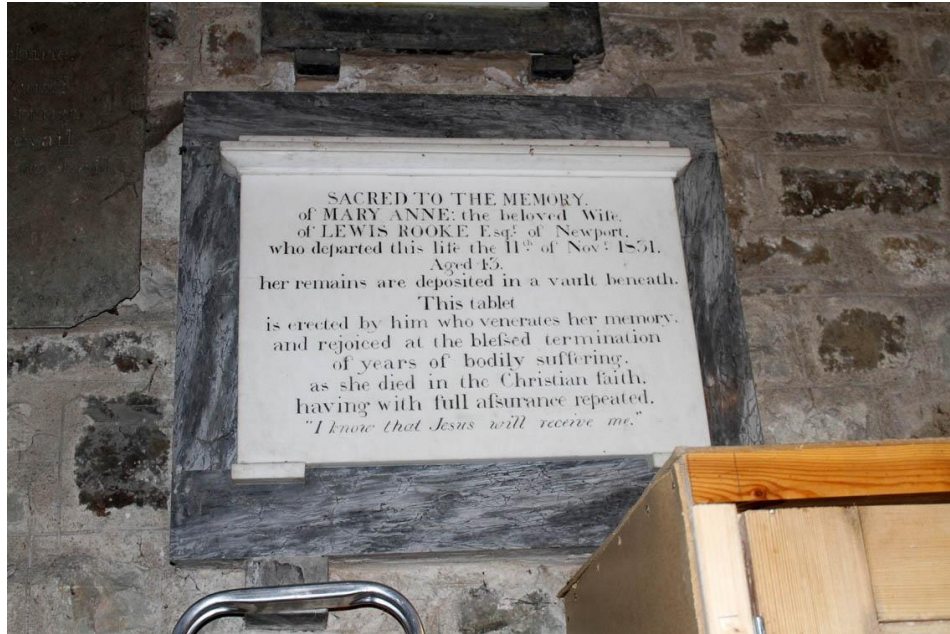
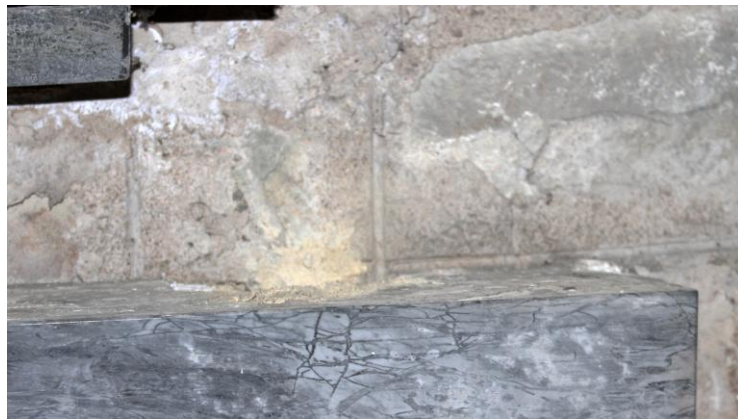
The monument was well supported on its built in stone corbels, but there were three corroded ferrous top fixings in a poor state.

Above: the Rooke monument after work and right, a new fixing bedded into the top of the plaque

An access platform was erected to give access to the monument. The top fixings were then progressively drilled out and removed, and replaced with two flat bar stainless steel fixings set in to the wall in polyester resin. Hole in the top surface of the monument were filled with lime mortar.
