# ST WULFRAM'S CHURCH, GRANTHAM (G8261)

Treatment Report for Internal Monuments

14/02/2020

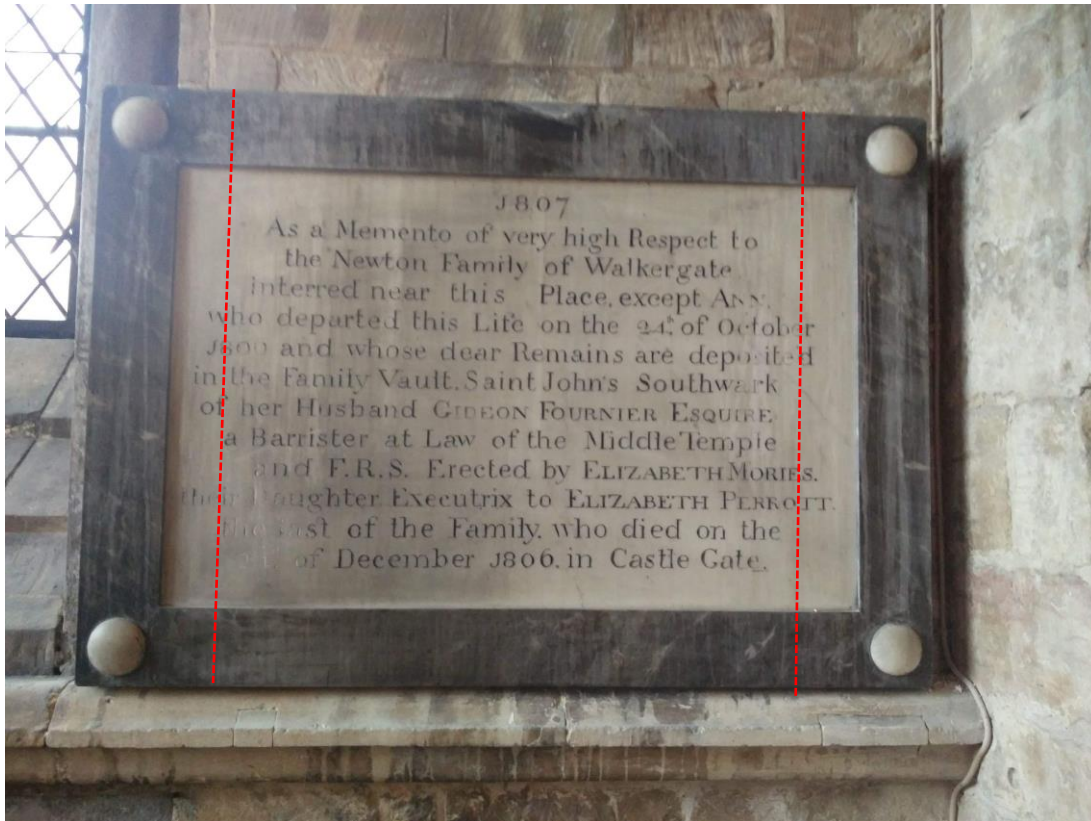
This rectangular wall mounted monument consists of a light marble centre with a dark marble border. Within each corner of the border is a hemisphere of white marble. The central plaque is engraved with text commemorating the Newton Family of Walkergate. The engravings are painted in a water-soluble paint. There are two ferrous iron pins running vertically within either side of the monument (see fig. 1).

**Figure 1: Pre-treatment condition of Newton family memorial. Diagram shows placement of iron pins.**

- An ammonium carbonate poultice in a 10% concentration was applied to the dark marble border and left for 45 minutes before removal.
- The poultice was removed with de-ionised water and *Flash Magic Eraser* sponges.
- The lettering in the plaque is painted with water soluble paint, therefore, the central plaque was cleaned with a solution of *Vulpex* and white spirits in a solution of 1:5.
- The dark marble border was treated with renaissance wax.
- Two ferrous metal cramps were treated with *Jenolite* and painted with black Dulux metal paint.
- The plaster on the sides of the monument were re-pointed with casting plaster.
- Lettering on the central plaque was touched up with an acrylic paint colour matched to the original colour.

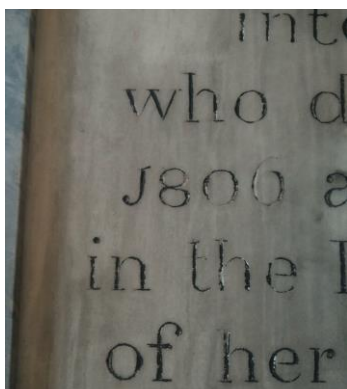
**Figure 2: Pre-treatment condition of Newton family memorial lettering.**

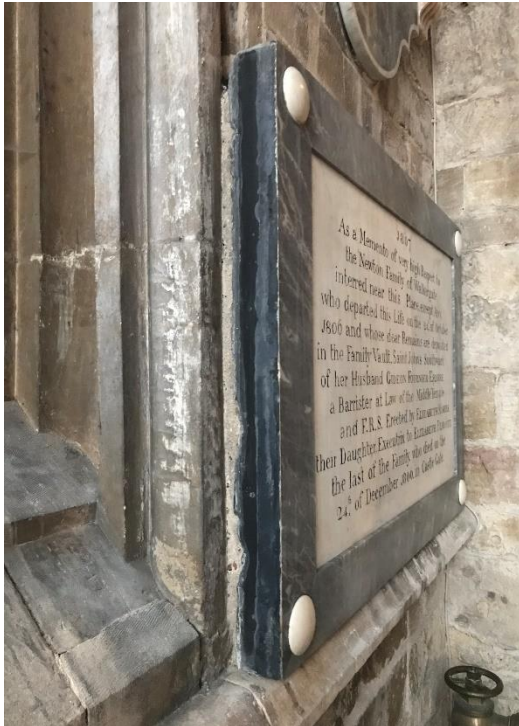
**Figure 3: Plaster repairs to the side of the Newton monument.**

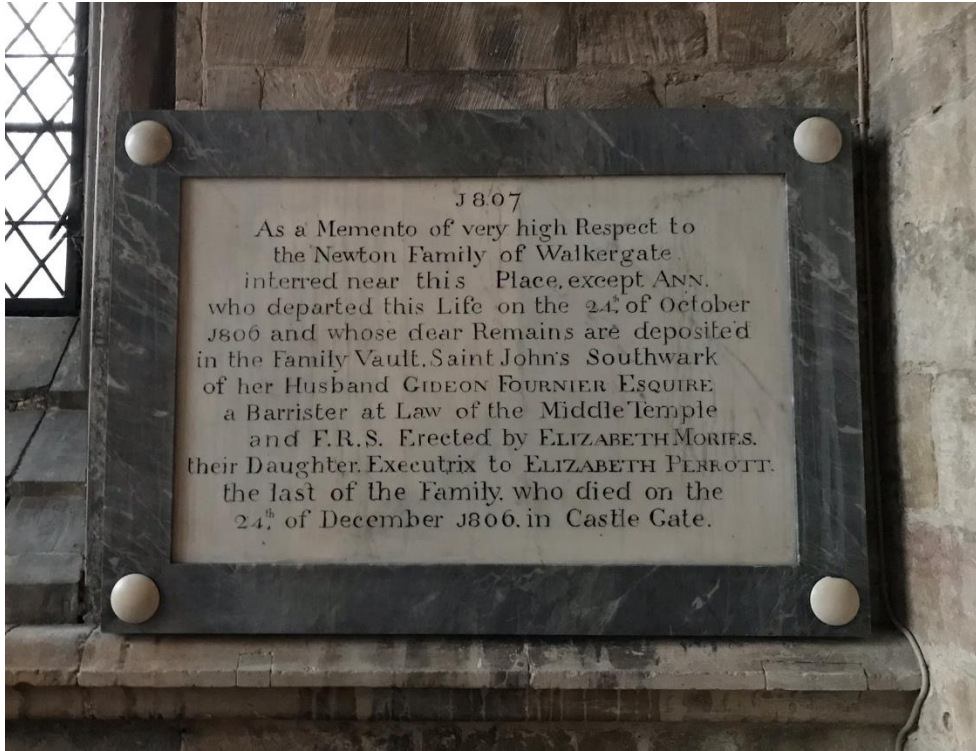
Figure 4: Monument to the Newton Family after treatment.

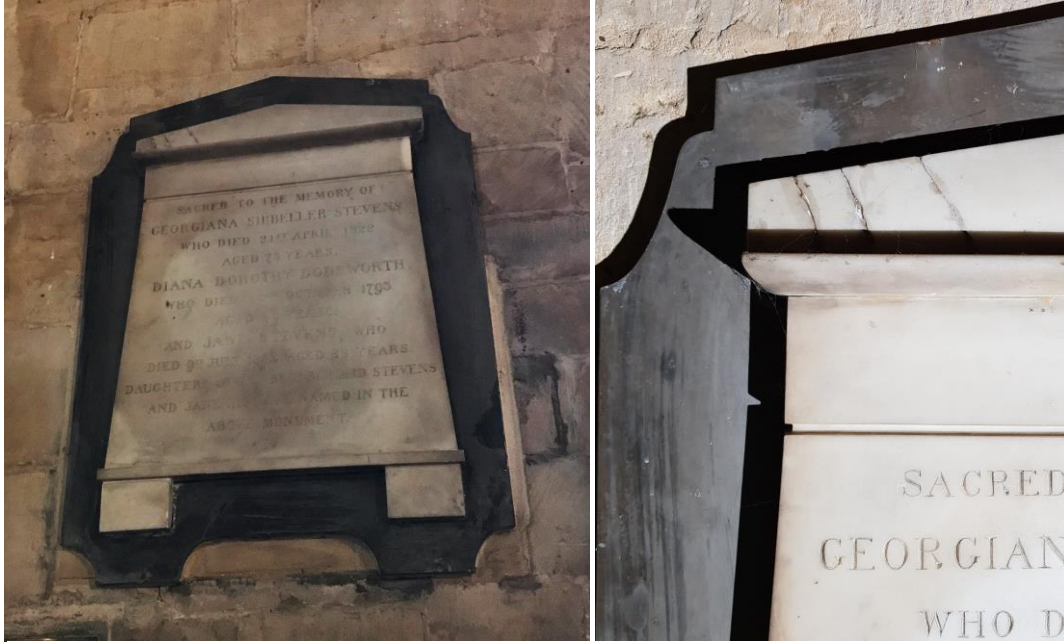
**Figure 5: Pre-treatment condition of the monument to Georgiana Sibbeller Stevens.**

This monument consists of a dark stone surround with a white marble plaque, topped with a pediment. The dark surround is coated in a fine layer of varnish that has become detached in some areas. The engraving in the centre has lost its original paint infill.

- An ammonium carbonate poultice in a 10% concentration and 2% EDTA was applied to the dark marble border and left for 45 minutes before removal.
- During this process the glue stains evident at the top of the monument (see fig.) were also removed.
- The monument was then steam cleaned with a DOFF steam cleaner to remove the poultice.
- The dark marble border was treated with renaissance wax mixed with black pigment.
- The lettering was entirely repainted with colour matched acrylic paint.
- There were slight rust stains to the base of the white marble plaque that were touched up with Jenolite.

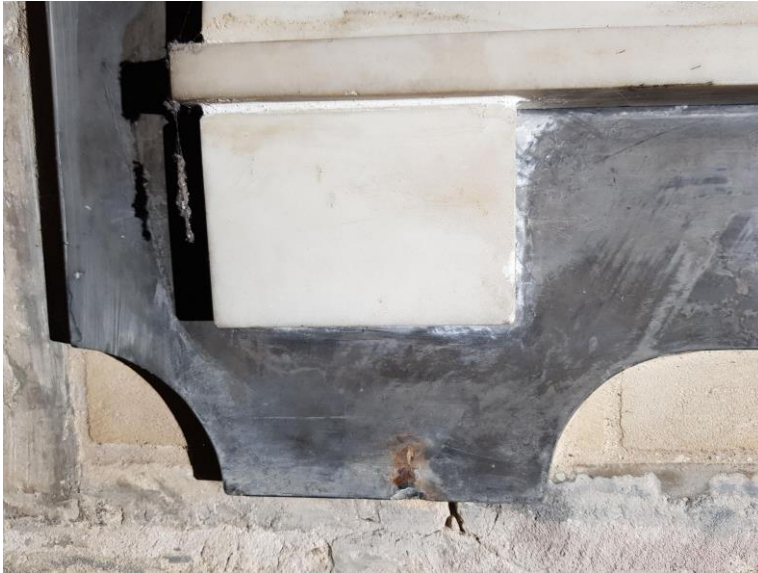
**Figure 6: Rust stains on the monument to Georgiana Sibbeller Stevens.**

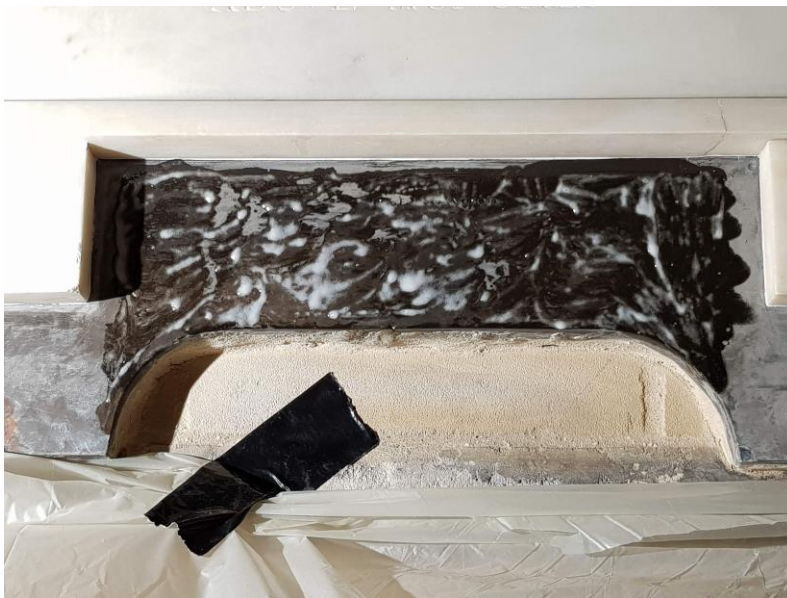
**Figure 7: Image showing the poultice that was used on the black marble border.**

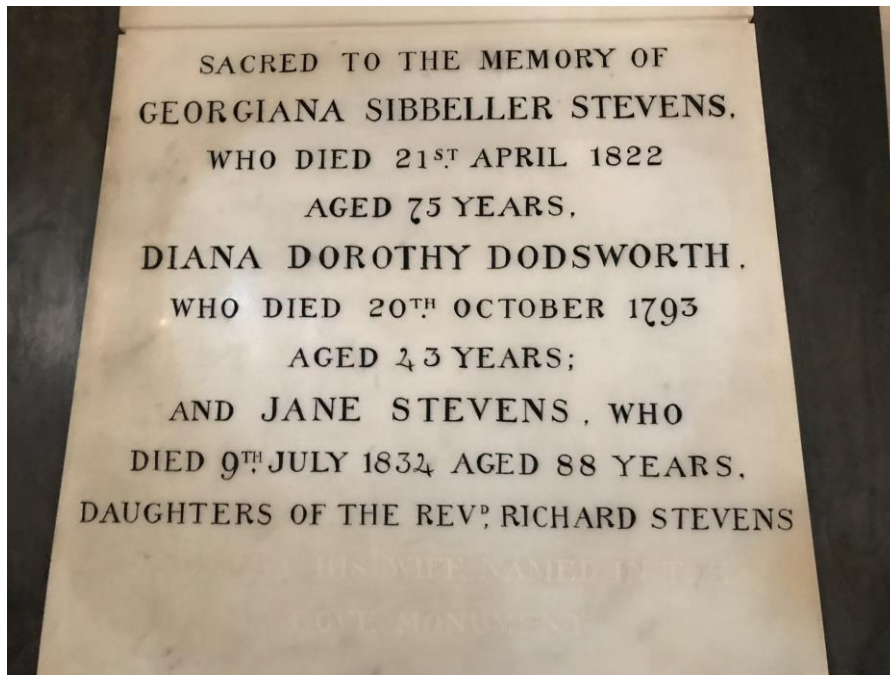
**Figure 8: Image of the monument to Georgiana Sibbeller Stevens after treatment.**

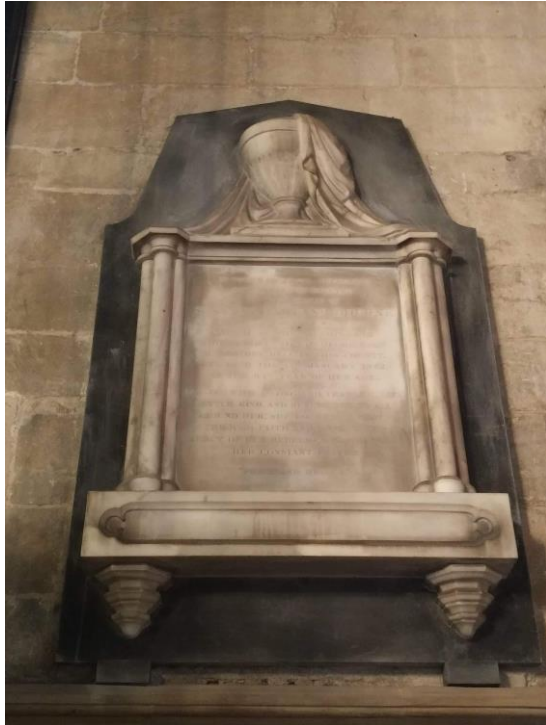
**Figure 9: Monument to Susanna Rowland Bourne.**

This wall mounted monument, situated close to the west doors, consists of a dark marble surround and a white marble monument. The ornate white marble monument is decorated with two columns flanking the central inscription, while an urn shrouded in fabric sits at the top. The engraving has lost its original paint infill.

- An ammonia carbonate poultice in a 10% concentration and 2% EDTA was applied and left for 18 hours.
- This poultice was not sufficient to remove all of the surface dirt so an additional ammonia carbonate poultice of 15% was applied for half an hour.
- These were removed with de-ionised water and steam cleaned.
- The remaining dirt was removed with sponges and brushes in combination with solution of white spirits and vulpex.
- The lettering was repainted with acrylic paint, colour 'Paynes black'.

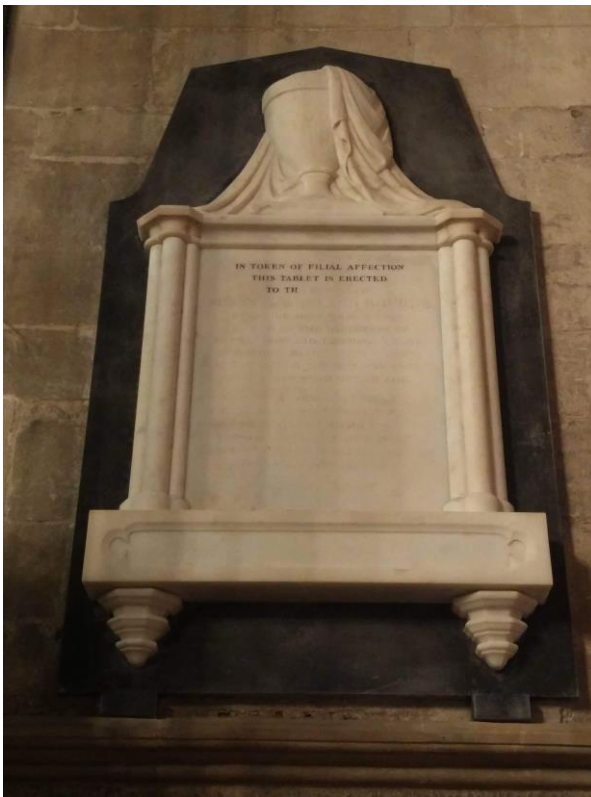
**Figure 10: Image showing the re-painting of lettering.**

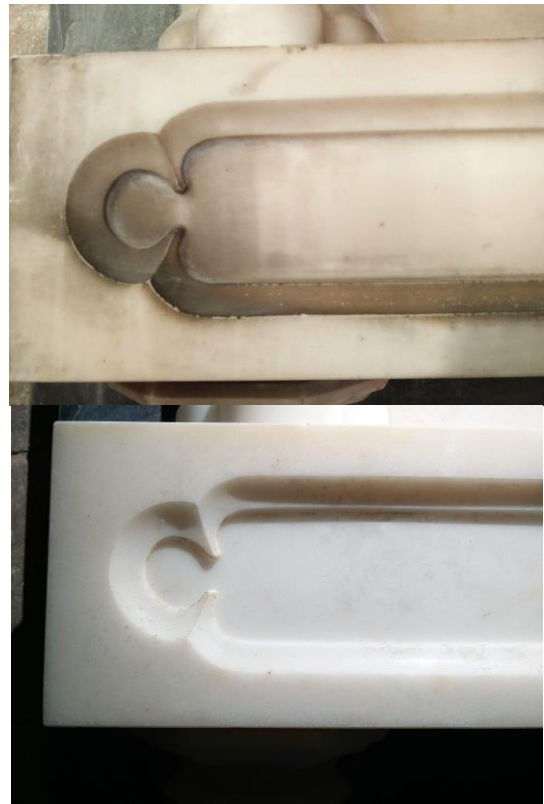
**Figure 11: White marble before and after cleaning.**

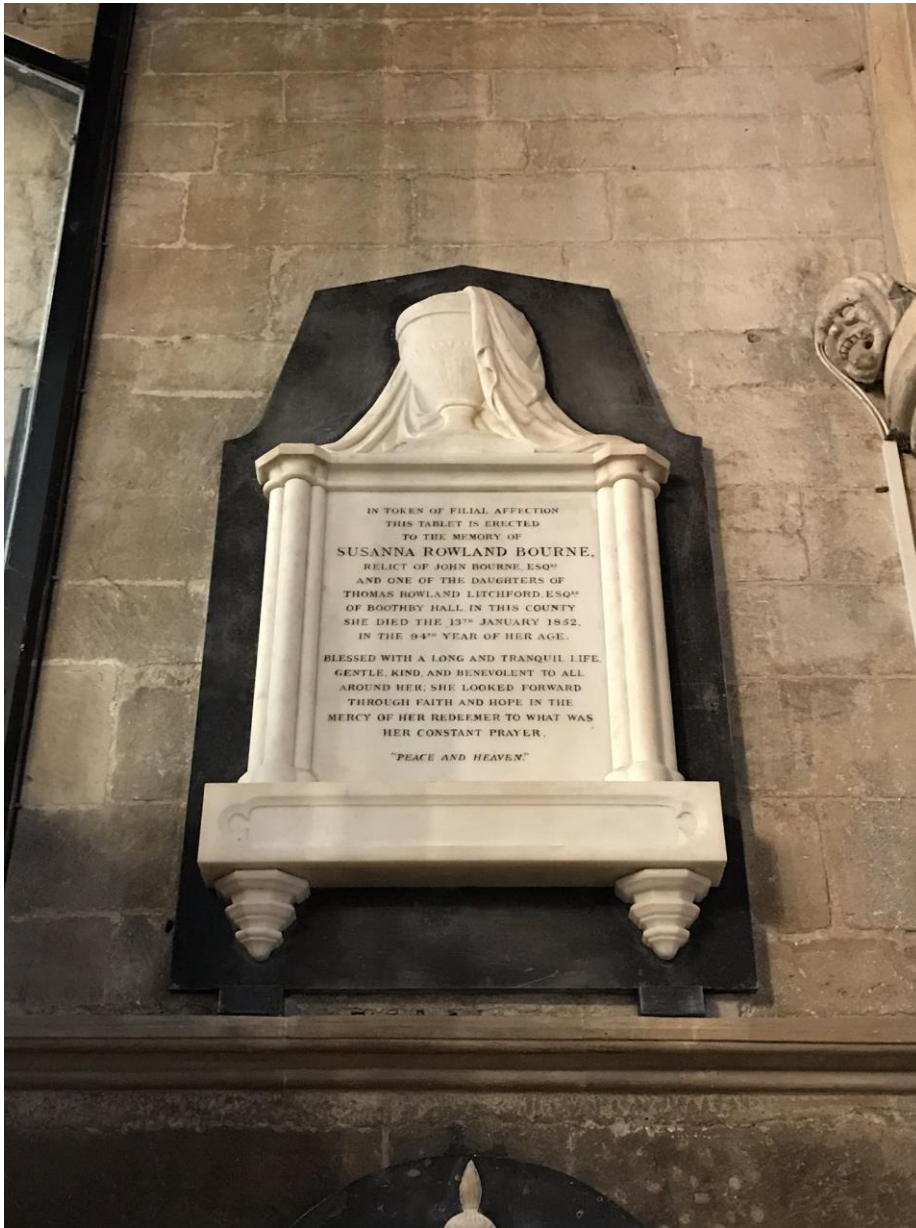
**Figure 12: Post treatment condition of the monument to Susanna Rowland Bourne.**

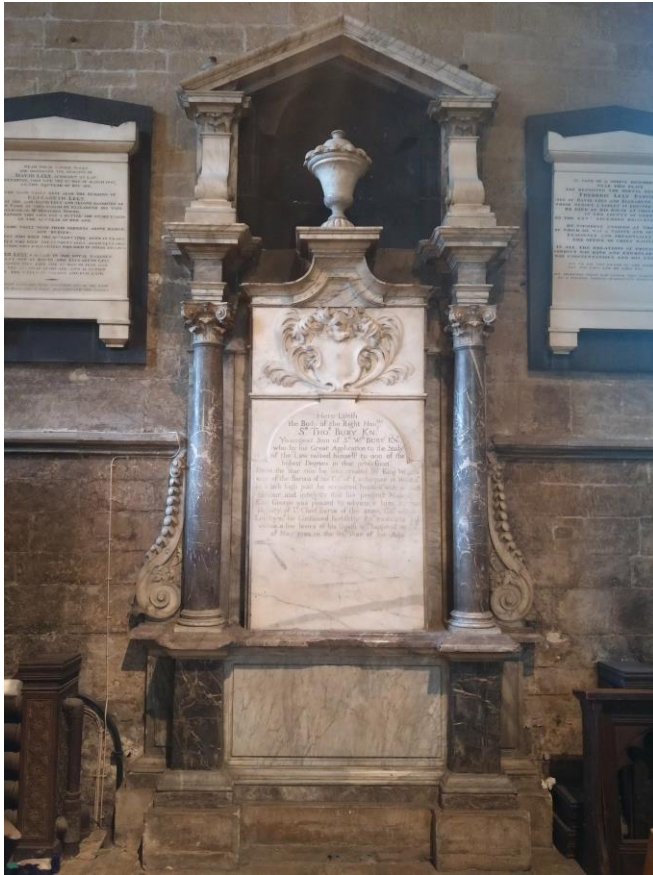
**Figure 13: Monument to Thomas Bury.**

This baroque standing monument consists of a white marble plaque with decoration and a dark marble background to the upper section. This dark marble was coated in a layer of varnish and the whole monument was flecked with cementitious deposits. The two marble pillars flanking the monument are constructed from a grey marble with pink and purple hued veins. The monument is topped by a pediment and below this is a decorative white marble urn. It was suggested that this monument may need dismantling in the Skillington's report produced in January 2017, but after further investigation, it was concluded that this would not be necessary.

- An ammonia carbonate poultice in a 10% concentration was applied to the monument for 12-18 hours.
- The poultice was removed with de-ionised water and a Flash 'Magic eraser' sponge.
- The varnish on the black marble was removed with the poultice.
- Renaissance wax was mixed with a black pigment and applied to the black marble.
- Repointing to the monument was carried out using fine casting plaster and then colour washed with acrylic paint to distress the colour and make the repair less obvious.
- The shield and lettering were cleaned with a steam cleaner.
- The cementitious deposits on the monument were carefully removed with a scalpel.

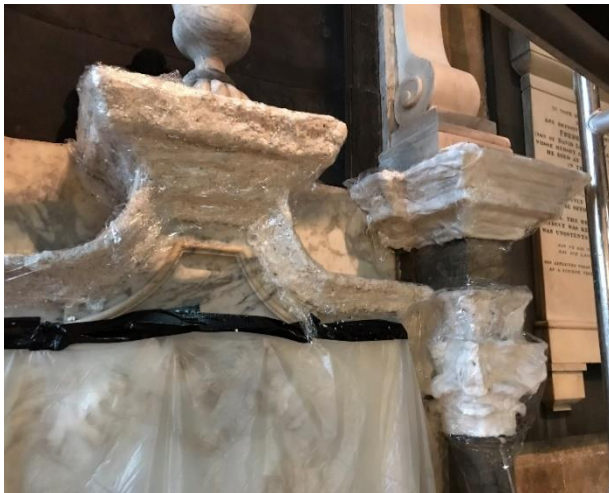
**Figure 14: Image of the application of the poultice pack to the Thomas Bury monument.**

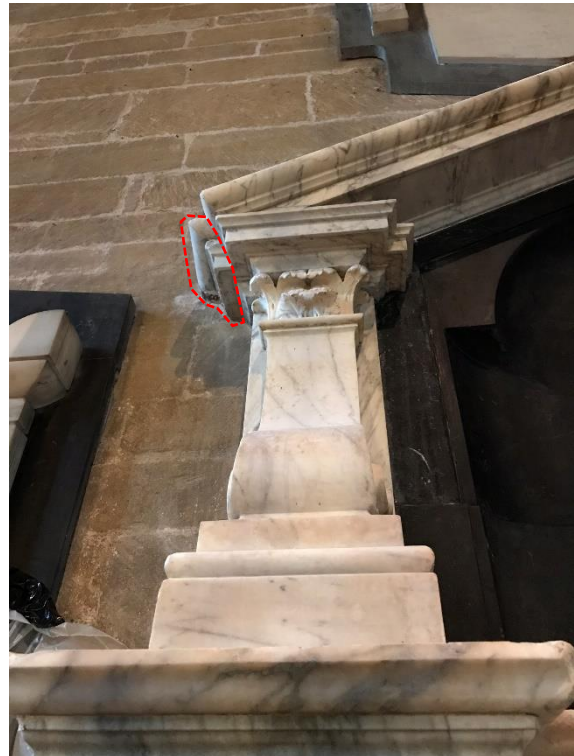
**Figure 15: Section of repair with fine casting plaster.**

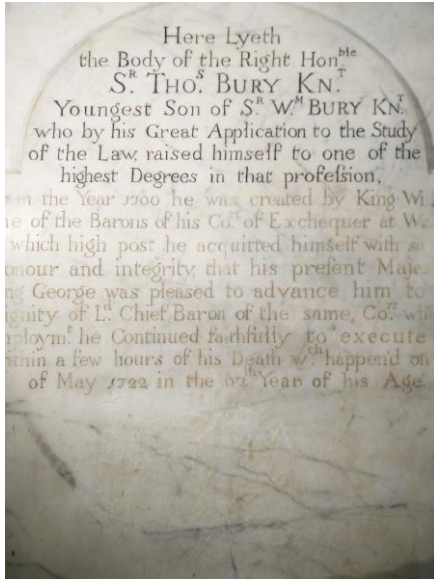
**Figure 16: Image showing the repainting of lettering.**

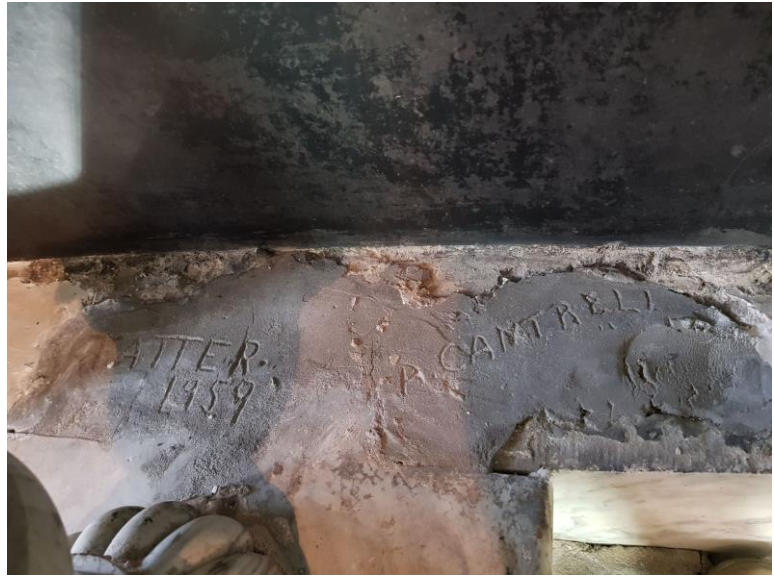
**Figure 17: Image showing engravings found in cement during treatment.**

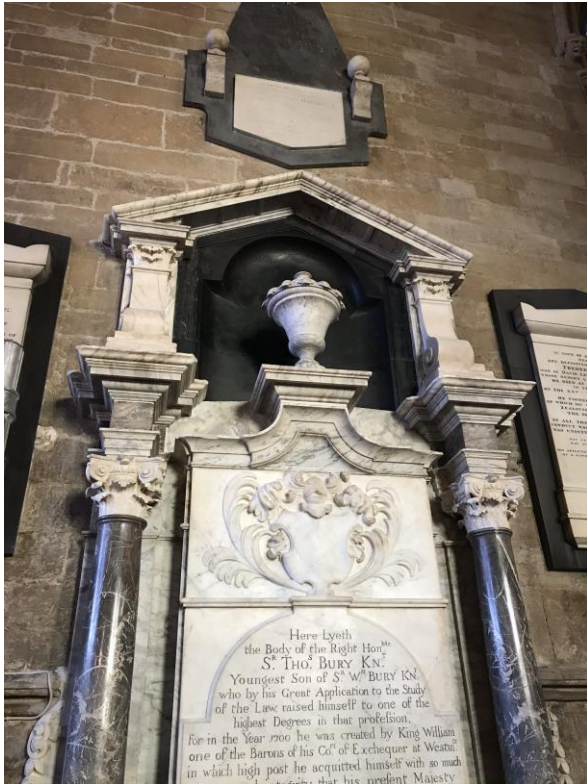
**Figure 18: Post treatment condition of the Bury monument.**

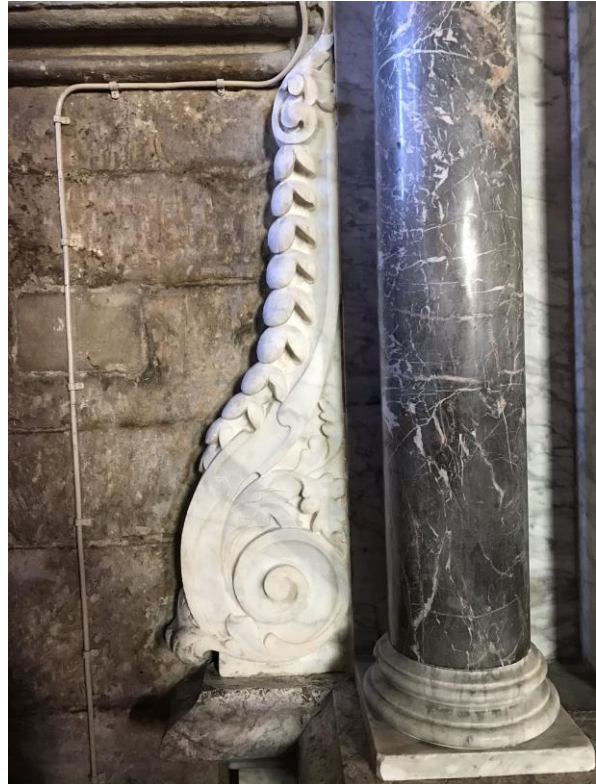
**Figure 19: Post treatment condition of the decorative scrolls on the Bury monument.**

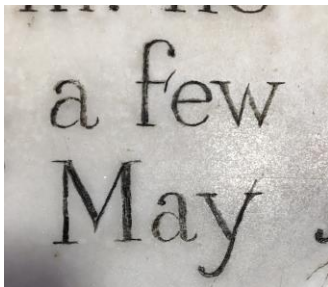
**Figure 20: Image of the condition of lettering**

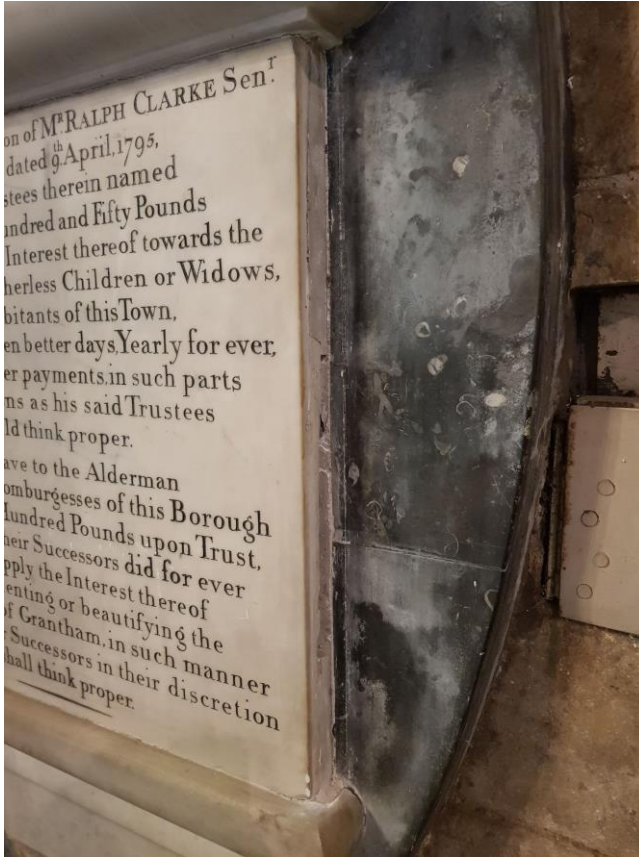
**Figure 21: Pre-treatment condition of the monument to Charles Clarke.**

This oval wall mounted monument is situated on the west wall of the Nave and consists of a white marble plaque, urn, cornice and apron set against a dark marble background. The inscription on the plaque is infilled with black paint.

- There were many concerning open joints on the monument, so it was first dismantled to survey its structural integrity.
- This was done by removing the plaque from the face of the monument and the four bolts that held it together were assessed.
- The bolts were treated with Jenolite to inhibit rust
- The left handle of the urn at the top of the monument was loose and was re-fixed with glue and casting plaster.
- Once reconstructed, the loose joints were repointed with casting plaster
- The lettering was retouched with colour matched black acrylic paint
- The varnish was removed from the black background with a poultice
- Wax with a black pigment was applied to the black background

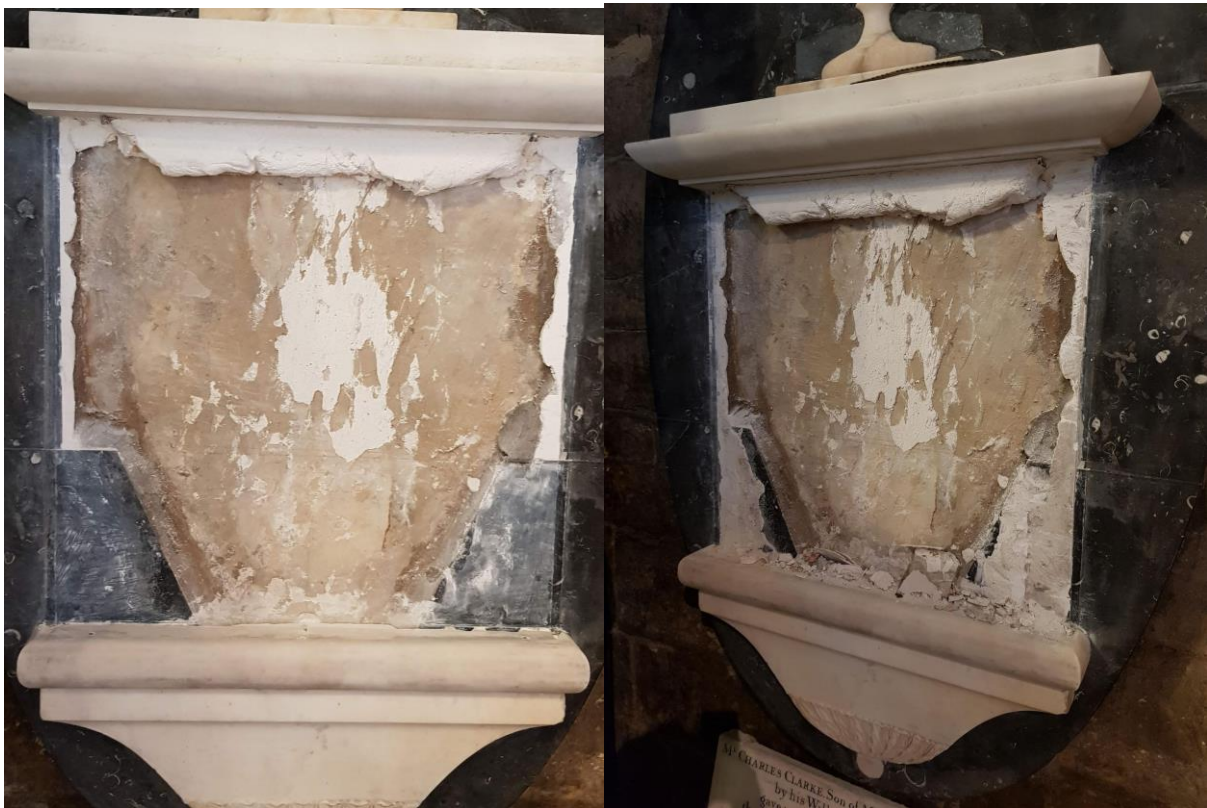
**Figure 22: Image showing the deconstruction of the Clarke monument.**

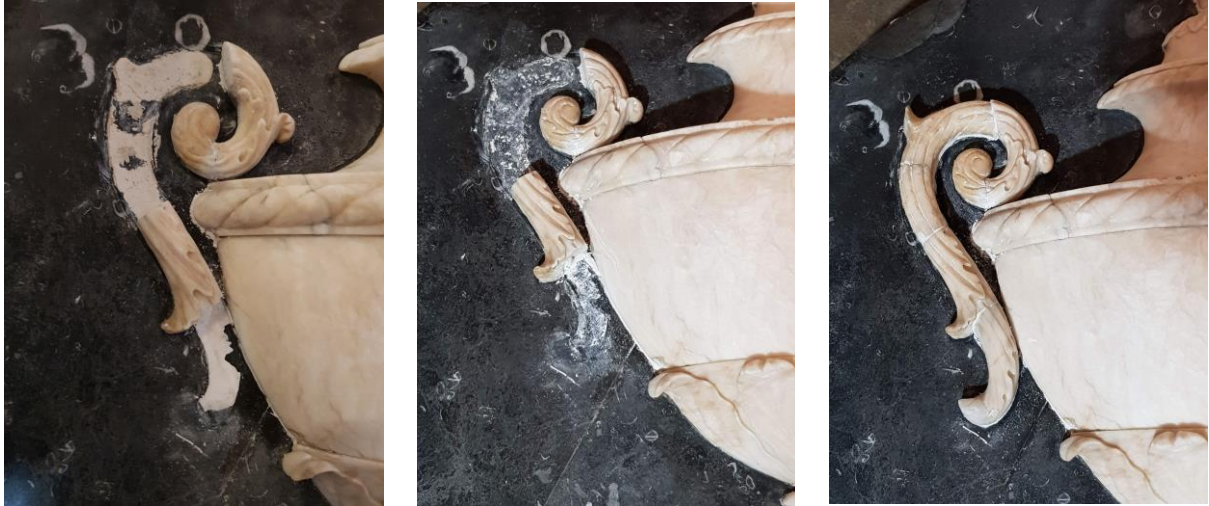
**Figure 23: Images showing the stages of repair for the urn handle.**

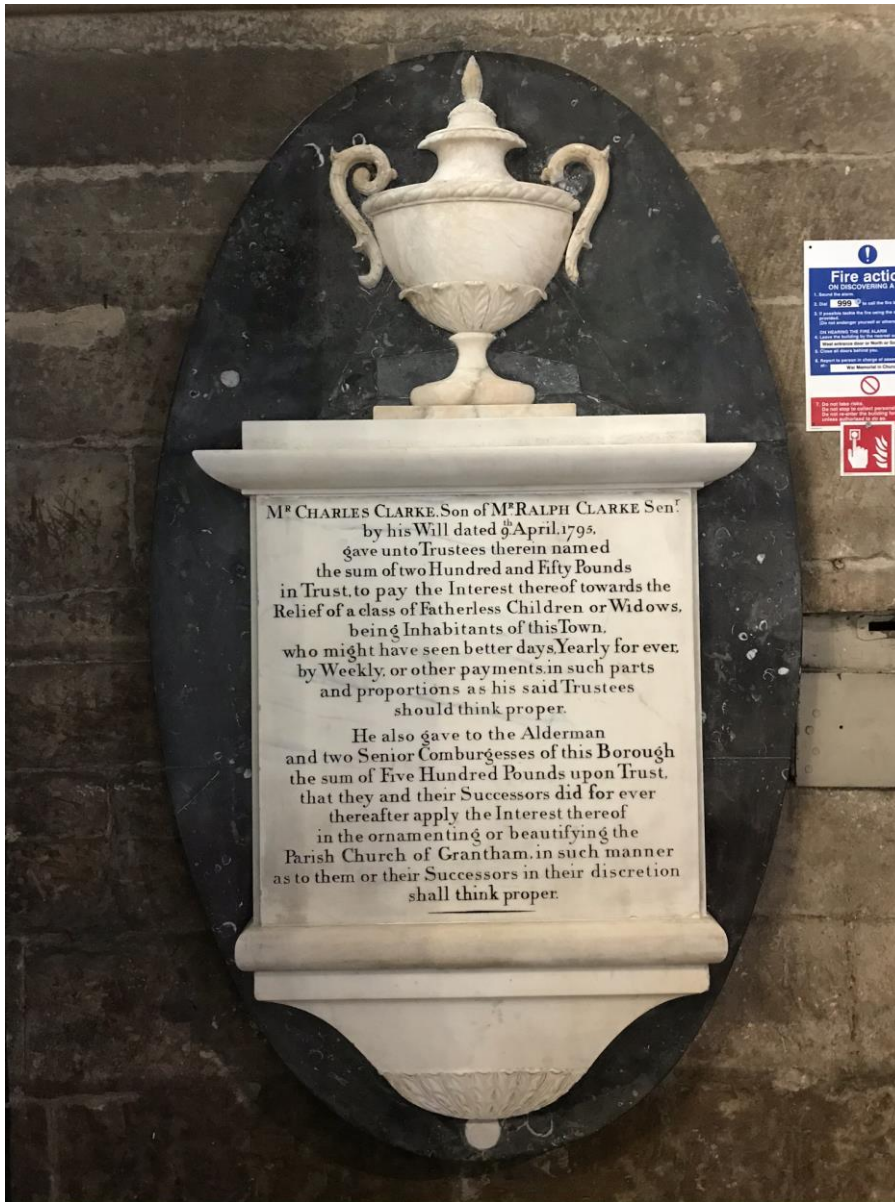
Figure 24: Post treatment condition of the Clarke monument.

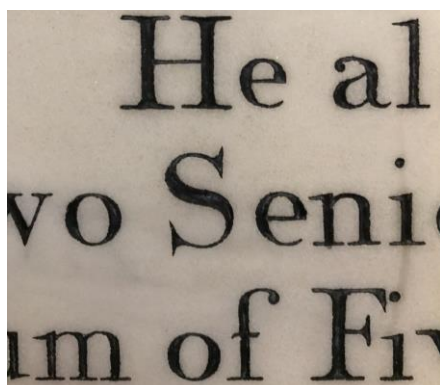
Figure 25: Lettering on the Clarke monument post treatment.
