# SKILLINGTONS

## St Mary's church Kirkby Fleetham, North Yorkshire

**A record of conservation carried out to the  
monument of William Smelt Esq (d.1755) during  
January 2020**

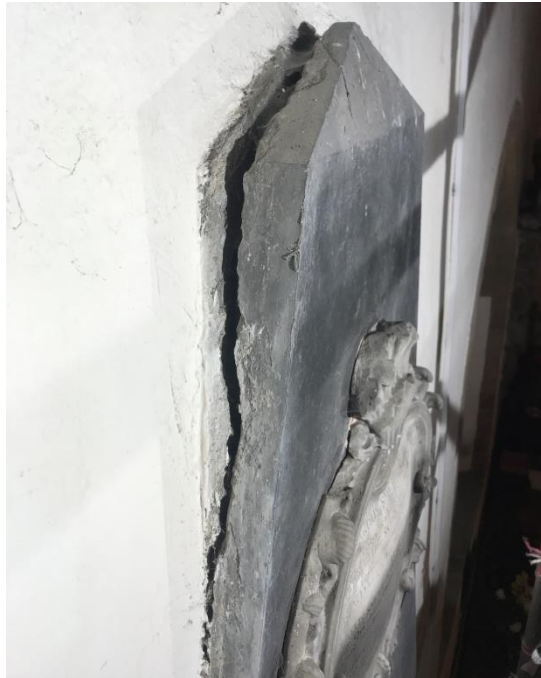
1. Once access was gained to the top of the monument via a mobile tower scaffold it was evident the top of the obelisk was not secure and there was a large gap between the marble and the wall. It was decided it would be safest to remove this section and the cartouche before carrying out works to the rest of the monument.

*Plate 2: The gap between the upper section of the obelisk and the wall.*

- The section of obelisk and the cartouche were reset using 316 marine grade stainless steel fixings and Hilti HY epoxy resin. No fixings were found to support the section of black marble; it appeared to be reliant on the cartouche to hold it in place. The section was bedded on a thin layer of plaster of Paris. To ensure it was secure cramps were added to the top edge which extend into the wall behind to give extra support. The original fixings for the cartouche hooked behind the lower section of black marble, these were replaced and extended to fix into the wall behind to offer greater security.

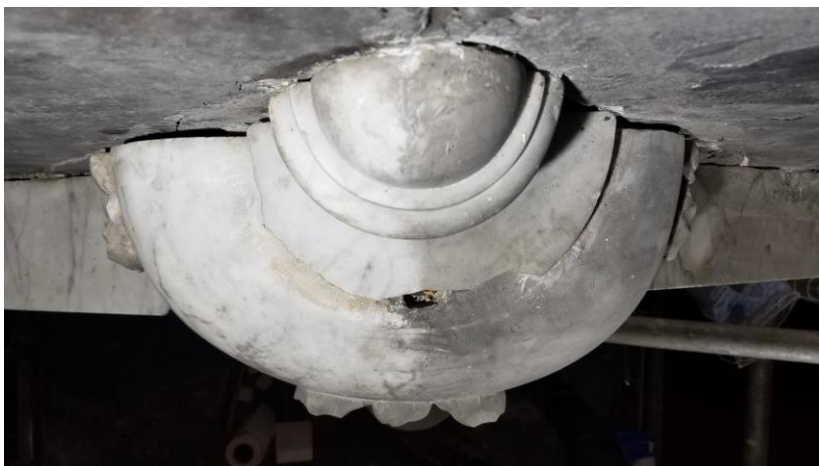
*Plate 3: The urn during cleaning*

2. The monument was then given a general clean using soft brushes to remove loose dirt into the nozzle of a vacuum cleaner.
3. Trials were carried out to determine the best method of cleaning. The whole monument was cleaned using melamine sponge moistened with deionised water. Cotton wool swabs were also used especially around the lettering to the cartouche and the inscription panel. The white and grey marble elements were then cleaned further using a 2% Ammonium Carbonate poultice applied on acid free tissue paper for a dwell time of thirty minutes. In some areas two applications were necessary such as the corbels. There was a surface coating on the corbels which had discoloured making them appear black which required two applications to soften enough to fully remove.

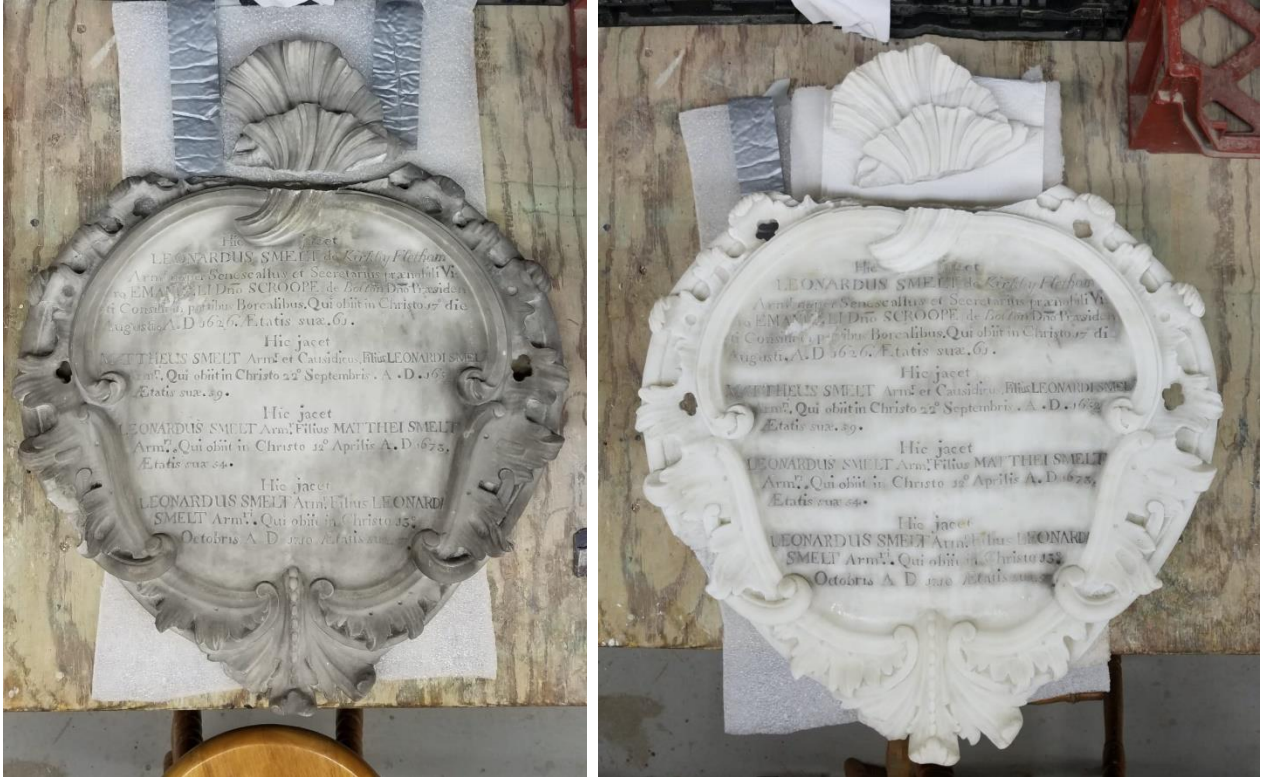
- The upper section of the obelisk and the cartouche were cleaned while dismantled. The decorative element on the top of the cartouche had been previously repaired in plaster which was deteriorating. This was removed and pinned back into place using a small stainless steel dowel set in polyester resin.

*Plates 4& 5: The cartouche before and during cleaning*

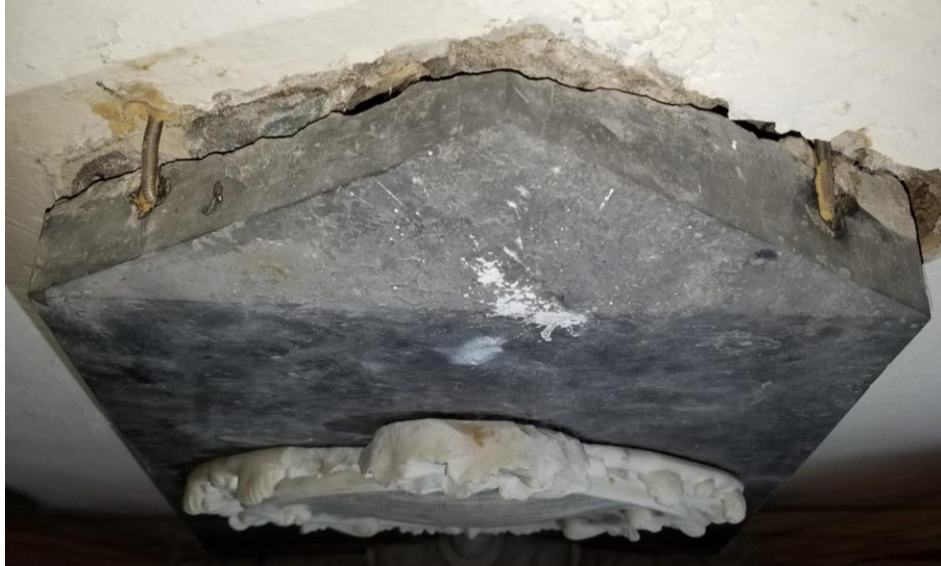
*Plate 6: Fixings holding the top section of the obelisk into the wall*

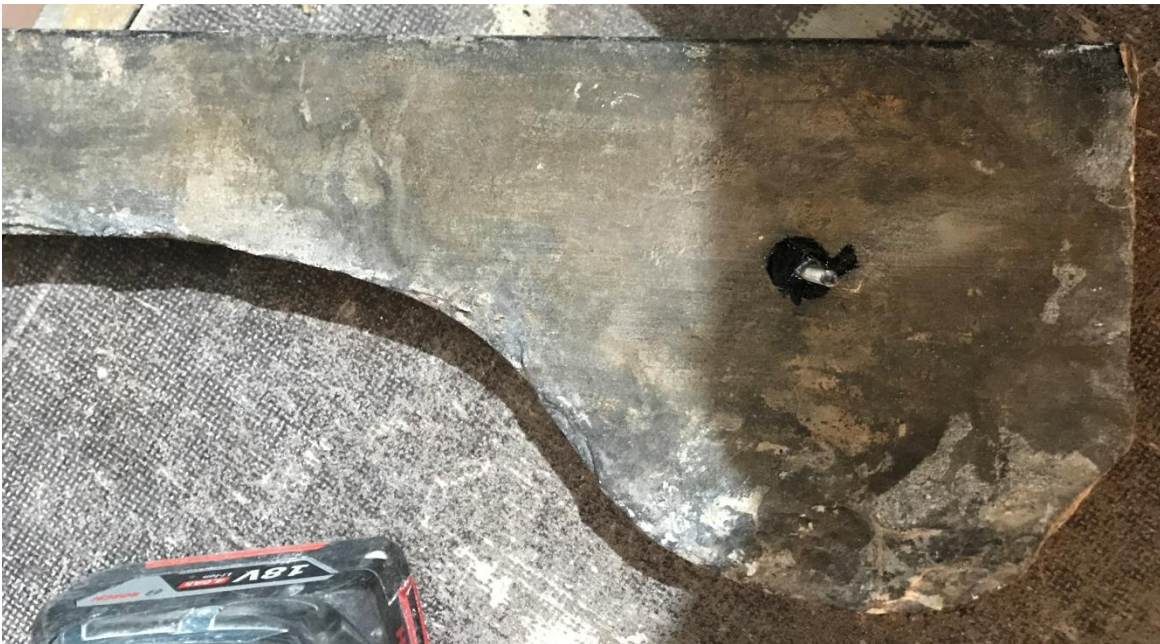
*Plate 7: Supporting dowel to the back of the scroll bracket*

6. The right-hand scroll bracket was reset using a similar method. A small stainless steel dowel was added as there had previously been no fixings holding it in place.

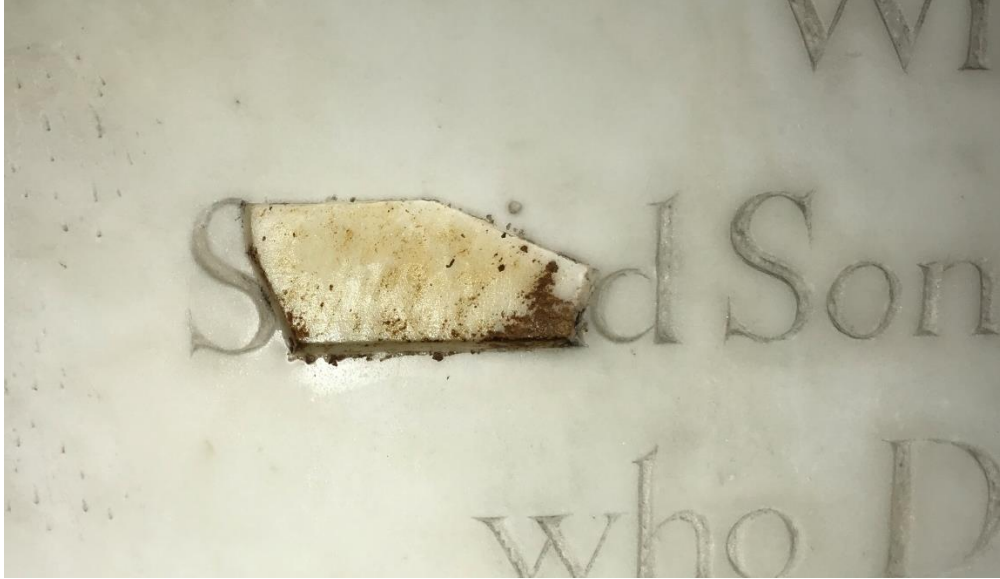
*Plate 8: Indent where lettering was replaced showing old adhesive residue*

7. A small slip of marble on the inscription panel, possibly where a correction was made, was loose, it was cleaned of old adhesive and re-adhered using polyester resin.

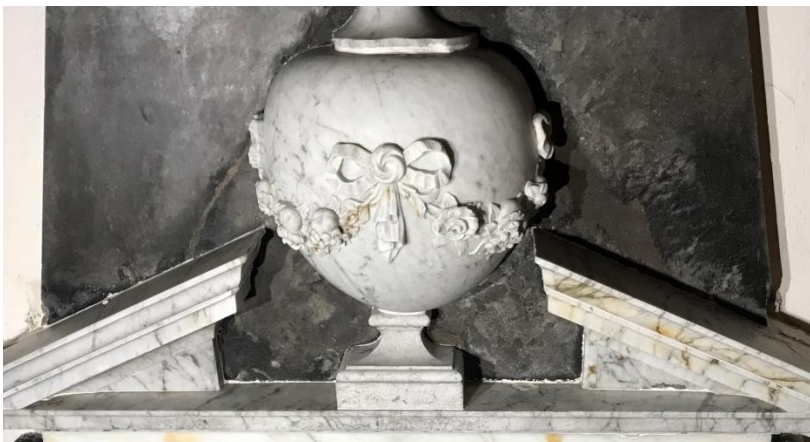
*Plate 9: The urn with lid repointed and cramp treated*

9. It was not possible to extract the iron cramp exposed in the top of the urn, instead the metal work was cleaned using wire wool to remove loose corrosion and then stabilised using Hammerite Kurust rust inhibitor then painted using Hammerite metal paint to protect it from corroding further. This was also done to the other exposed iron fixings including the one to the right side of the surbase which had caused a section of the marble to spall off. The metal work was treated and the loose section of marble was readhered in place using polyester resin. The urn lid was secured using plaster of Paris.

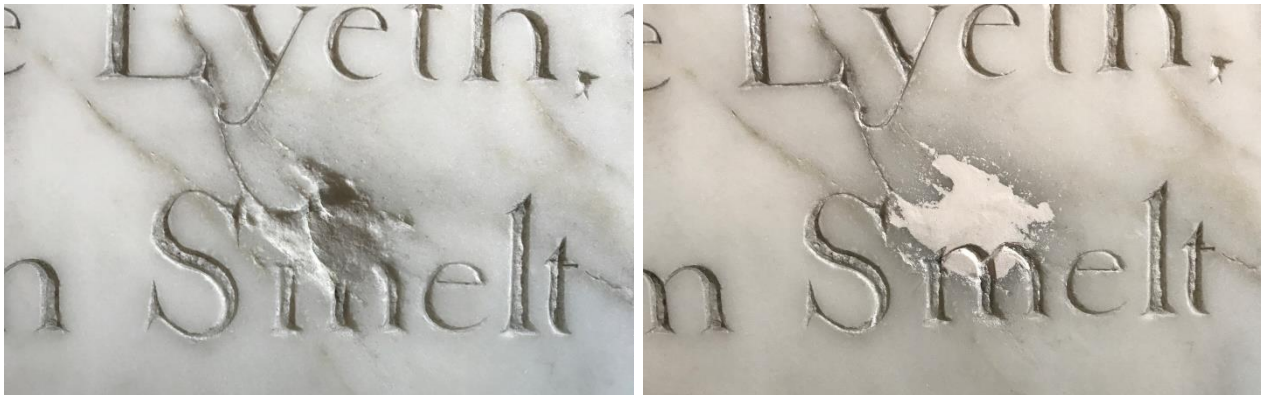
*Plates 10&11: Lettering before and during repair*

11. There were losses to some of the letters including the 'm' in 'Smelt', these were filled using casting plaster and carved into shape to improve the legibility of the inscription. These were toned in using artists' acrylics.

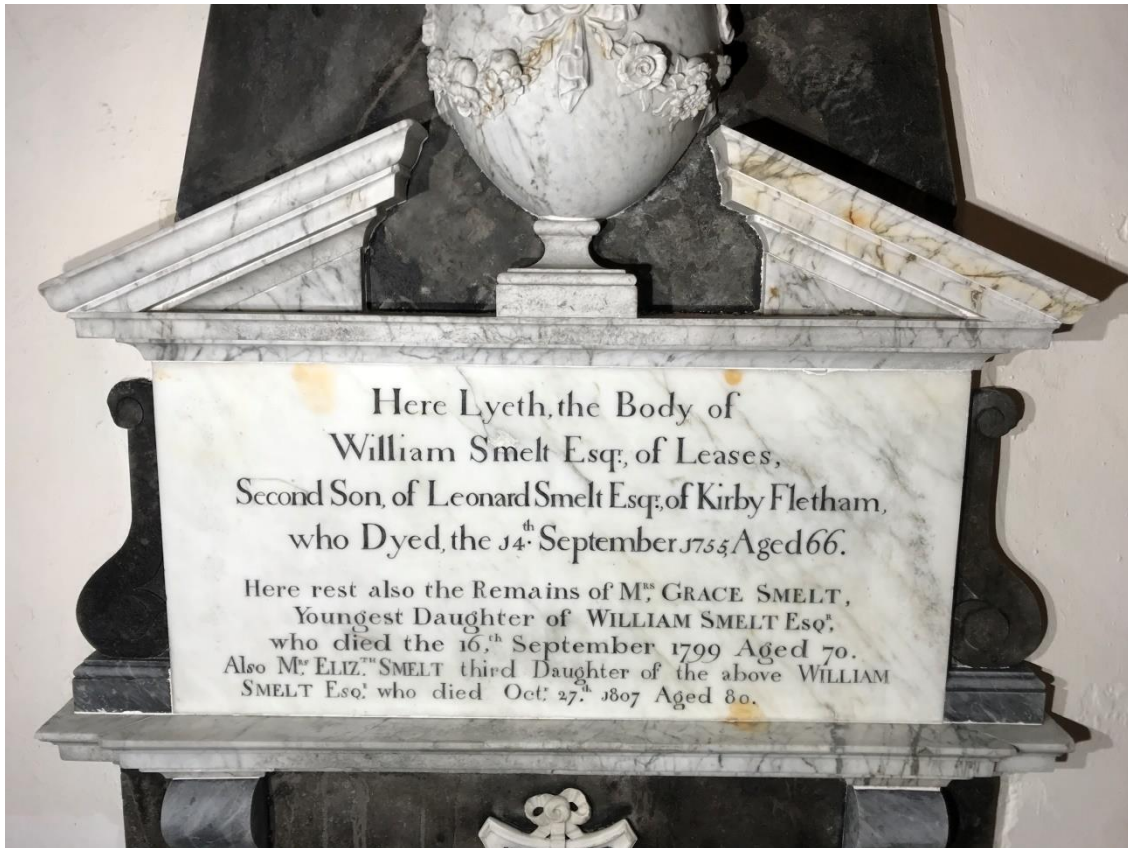
12. The lettering to the cartouche was mostly intact; the small losses were toned in using artists' acrylics. The paint in the lettering to the inscription panel was almost entirely lost. The lettering was repainted, again, using artists' acrylics to match the colour of the original paint being carefully to ensure the original paint was retained.

*Plate 12: The inscription panel after relettering*

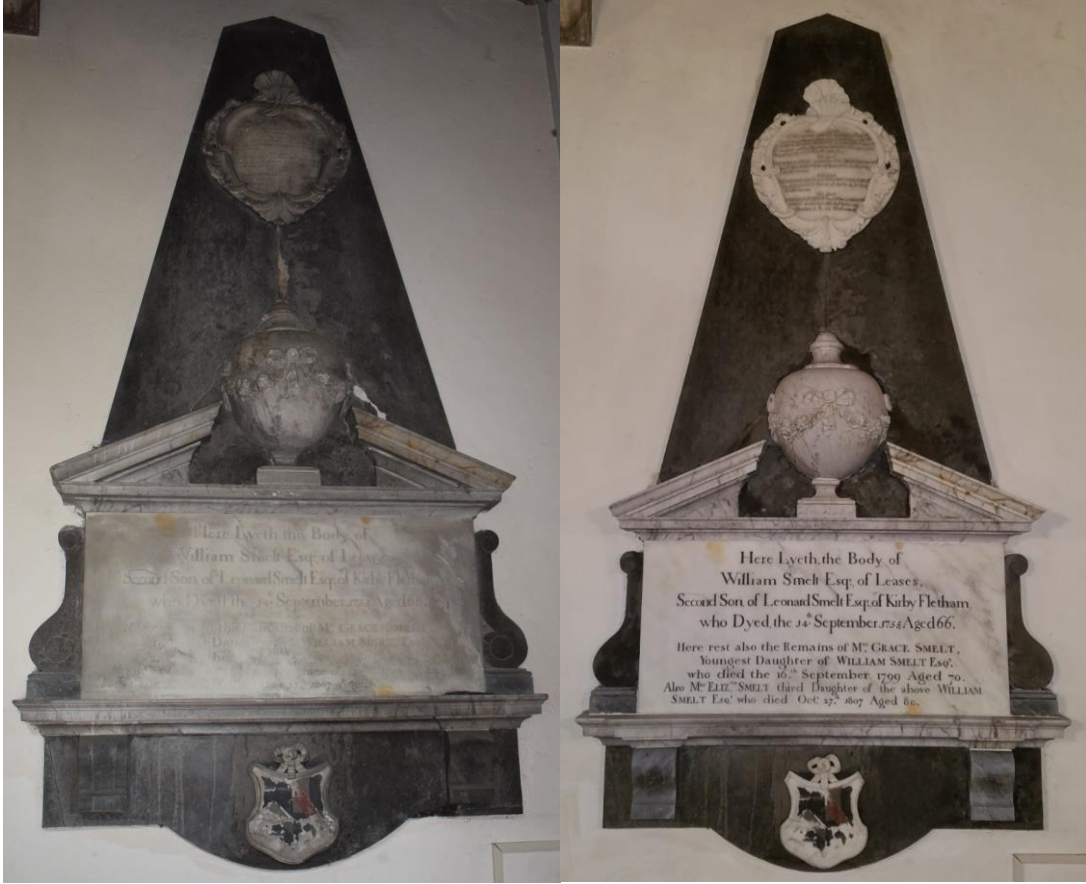
*Plates 13&14: The monument before and after conservation*

13. Loose and missing pointing was replaced using plaster of Paris, where this appeared obtrusive the joint lines were toned in using artists' acrylics.
14. The entire monument was given a protective coating of Cosmoloid H80 microcrystalline wax buffed to a uniform finish using a soft cloth.

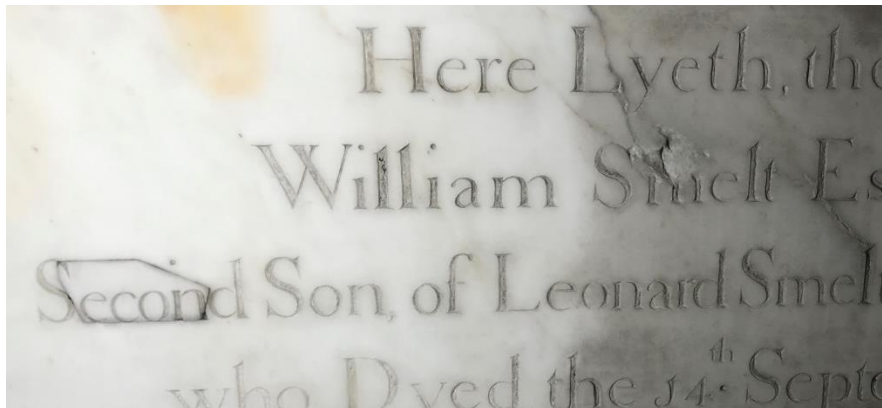
1. There appears to have been a correction made to the inscription tablet. William is described as the 'second son'; however, the letters 'econ' are on a small slip of marble which had been adhered into place. It is possible it originally read 'third' as the 'd' has not been altered and there is a tittle above the area where an 'i' would fit.

*Plate 15: The insert during cleaning of the inscription panel*

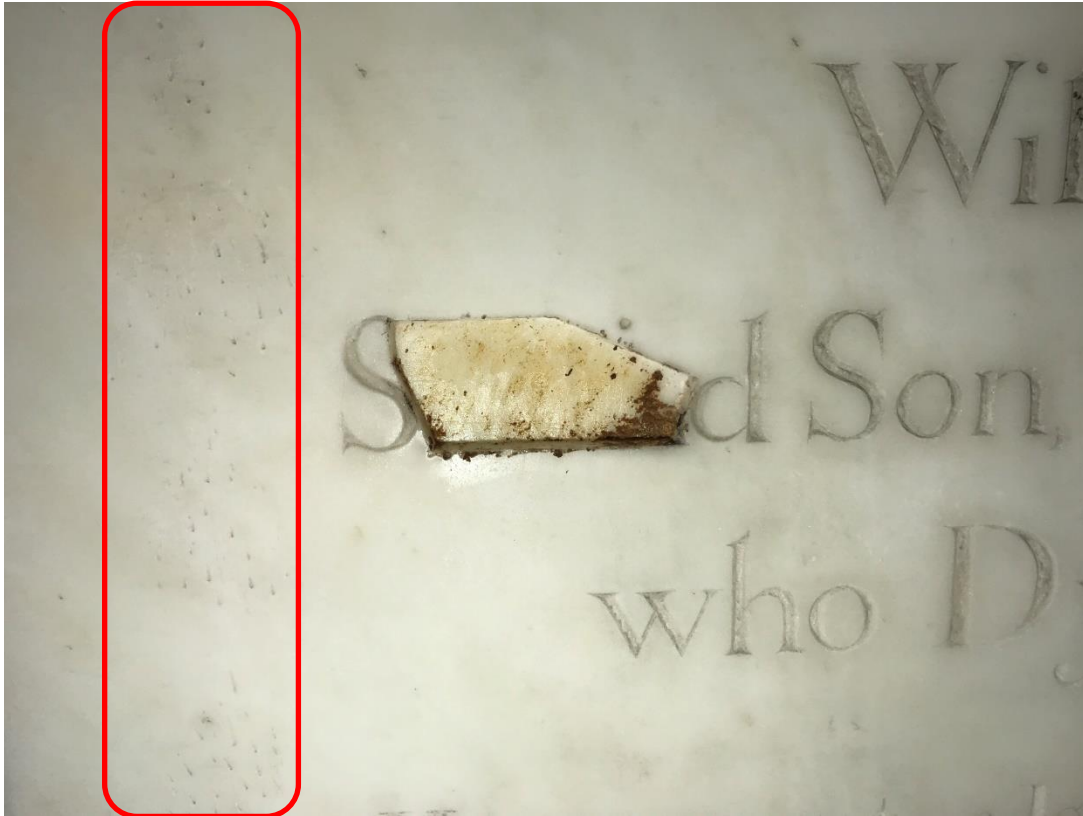
2. There appear to be some decorative elements missing from the inscription panel, either side of the lettering. There is a pattern of keying on the marble which from the shape may possibly have been a ribbon a flower decoration. It is less evident on the right hand side as the marble is damaged but there is a similar outline.

*Plate 16: The keying visible to the left of the lettering*
