CHURCH OF ST BRENDAN

BRENDON

**REPORT ON THE CONDITION OF THE BELLS,
BELL-FRAME AND FITTINGS**

Inspection carried out on Wednesday 27th April 2016, on behalf of the Devon Church Bell Restoration Fund, by Ian Smith and Ian Campbell (Trustees of the Fund and Bells & Belfries Advisors to the Guild of Devonshire Ringers); met and accompanied periodically by Tony Piper (ringer from Lynton). This report also makes reference to the findings of Prebendary John Scott, former Bells Advisor to the Diocese of Exeter, from his visit in December 1987.

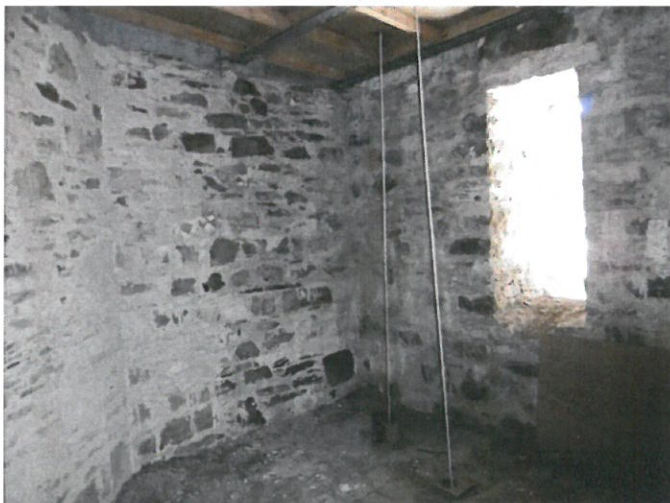
The **Intermediate Chamber** is reached from the access door below by 17 steps in the tower stairway. It measures 10 feet 7 inches N/S by 10 feet 8 inches E/W and is 9 feet 1 inch in height. As in the chamber below the NE corner is angled to accommodate the stairway. The walls are of rough stone. The N, W and E walls are all unpierced. The S wall is pierced centrally by a window opening with slate louvre slats, the slats being sufficiently

widely spaced to allow the ingress of birds, as is evidenced by a significant amount of bird nesting material on the floor of the chamber. It would be prudent to cover the window opening, and also the light opening in the stairway, with a robust mesh to prevent this.

The Intermediate Chamber

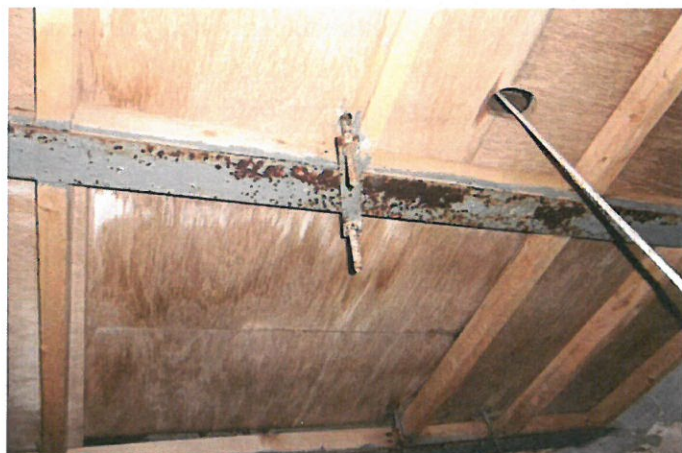
The ceiling of the chamber is supported by four rolled steel joists (RSJs) running E/W across the tower. These are not galvanised and are now corroding significantly. They should be thoroughly rubbed down and painted, firstly with a zinc-rich primer, eg “Galvafrid”, and then with either a machine enamel or good quality exterior gloss paint, paying particular attention to where they go into the walls. The three most northerly RSJs are each provided with three clamps securing the bell-frame above. These clamps consist of U-bolts passing over the frame cills and through straps below the RSJs. Being out of reach we could not

determine how tight the nuts were. These should be further investigated and tightened if necessary. The ceiling itself consists of lengths of timber and sections of ply inserted into the channels of the RSJs.

Corroded RSJs in the Intermediate Chamber Ceiling

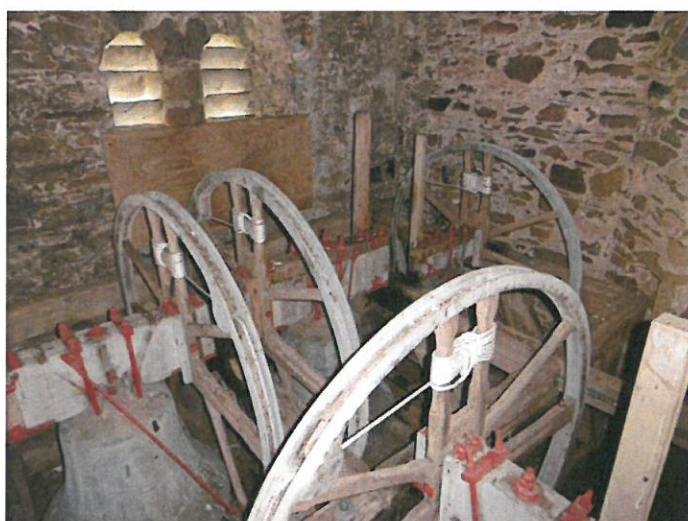
The W, S and E walls are each pierced centrally by arched twin-light louvres enclosed with slate slats. We noticed that one slat in the N side of the E louvre is broken. With approximately 4 inches between the louvre slats and no mesh covering, there is nothing to prevent the ingress of birds, nesting material in the chamber and bird excrement on the bell fittings being testament to this. We suspect that at one time the louvres were covered with $\frac{3}{4}$ inch chicken wire, a small portion of this remaining near the E louvre. We would strongly recommend that the louvres be covered with either heavy duty or stainless steel weldmesh with mesh size of $\frac{3}{4}$ inch (20 mm). To exclude the elements it would also be wise to cover the mesh internally with "Galebreaker" fabric. While excluding rain it would still allow

adequate ventilation to the chamber. The W louvre is partially boarded with $\frac{3}{8}$ inch ply. The lower section is still in place, though the upper section has fallen away. Even if this is to be replaced we would still recommend the installation of weldmesh over this louvre.

The Bell Chamber

1. Secure the tower against bird ingress and weather by installing a robust mesh covering immediately inside the louvre slats with a layer of "Galebreaker" fabric inside that.
2. Carry out urgent repairs in order to stabilise the bell-frame, particularly that section housing the second bell. We would suggest bracketing the two joints marked "A" and "B" on the frame diagram as per the diagram below.

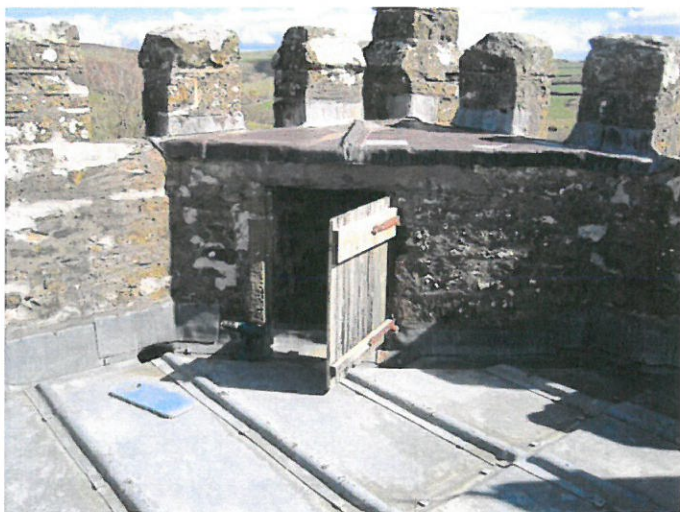
The **Roof** was originally supported by five oak beams running E/W. Having decayed significantly these are now in turn supported by four 9 inch by 3 inch softwood joists running N/S, the two central ones being supported by steel hangers with the others being built into the

tower walls. The N end of the most westerly joist is slightly water damaged. Externally the roof is conventionally lead covered and is in good condition with no significant debris interfering with the drainage of water.

The Tower Roof

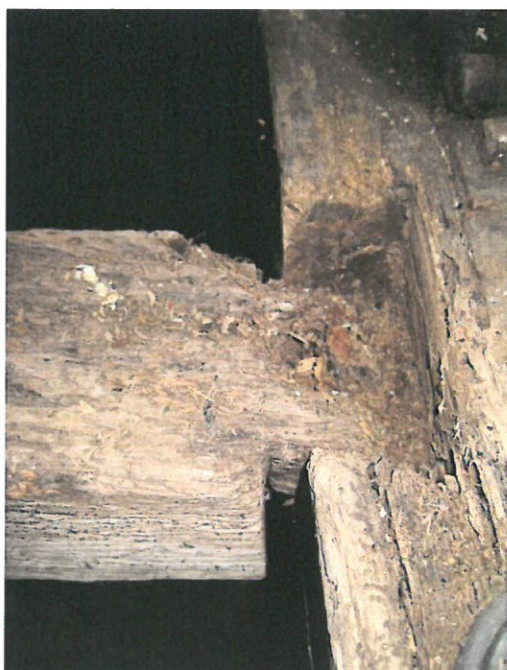
When Stokes rehung the bells in 1904 the frame was apparently even by then significantly decayed, and, in an attempt to stabilize it, he inserted 12 vertical tie-bolts from cills to heads and two horizontal tie-bolts from head to head and cill to cill across the N end of the pit for

the second bell. Sadly since then the ravages of the Exmoor weather have taken further toll on the frame. The timbers have deteriorated even more, particularly at the joints. The joint marked "A" on the frame diagram (see Appendix) has now completely failed and that marked "B" is rapidly heading that way, such that the section of frame housing the second bell is moving totally independently of the rest of the frame. The base of the frame between the treble and second bells (ie. immediately below joint "B") is in quite poor condition and it is not clear how well the clamps holding it to the RSJs below are operating.

Seriously Decayed Frame Joint "A"

We cannot but conclude that the bell-frame has reached the end of its life and the only long term remedy would be to have it completely replaced. In the short term it may be possible to buy a few more years by inserting $\frac{1}{4}$ inch steel brackets around the failed or failing joints.

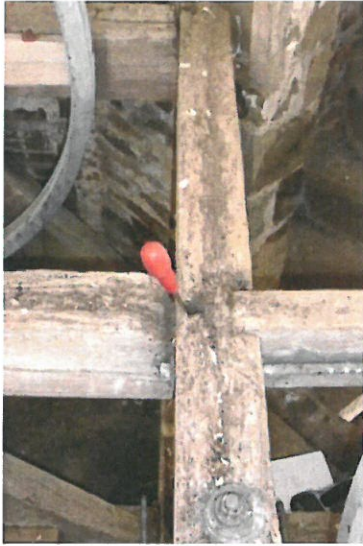
Decayed Joint "B"

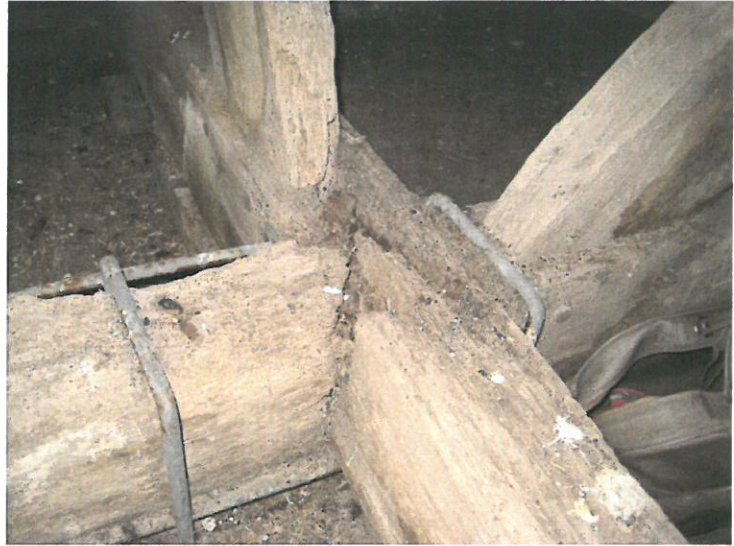
Decayed Cills below Joint "B", showing clamps to RSJs below

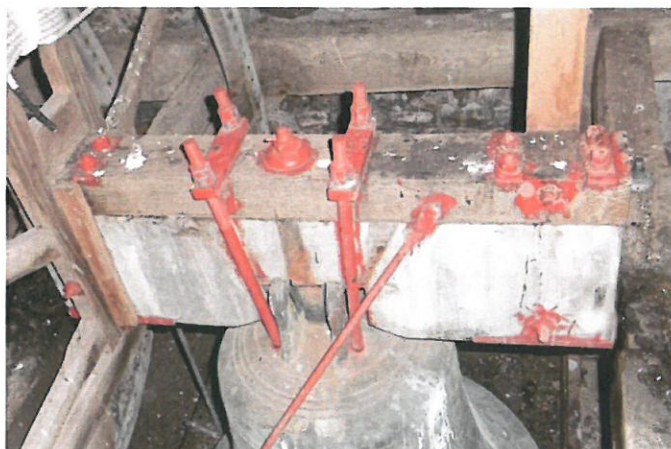
The **Headstocks** are of elm and are in quite reasonable condition, those of the treble and tenor having been repaired by the insertion of an extra section of timber along their tops. There is some evidence of former worm attack in the treble headstock. The bells are each hung from their headstocks by means of four long bell bolts through the crown of the bell and through straps across the tops of the headstocks where they are secured with a nut and lock-nut. These have been painted and are in good condition. We attempted to tighten them, but most of the bolts spun. We would suggest soaking them with a penetrating oil and tightening while a second person secures the head of the bolts under the bell, taking care to tighten the

The Repaired Headstock of the Tenor

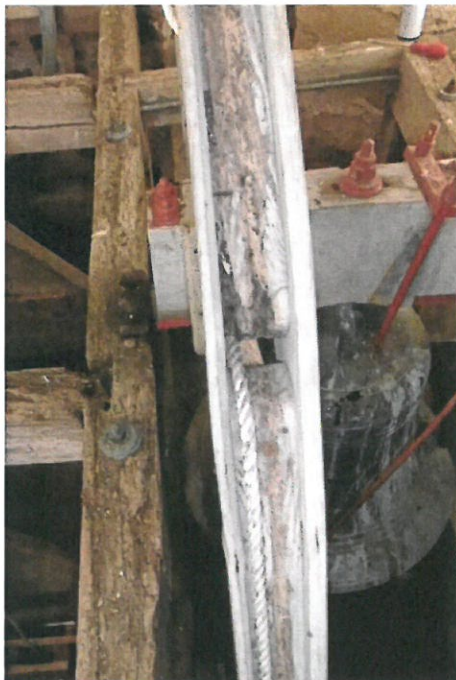
The **Wheels** are all in usable condition. That on the treble appears to have been refurbished and is quite robust; that on the second is not quite so firm and was a little loose on its

headstock. We tightened it as much as we could. There is considerable decay in the sole of this wheel around the garter hole; it clearly suffers from the weather being driven in through the S louvre. The wheels of the third and tenor are both in reasonable condition. The nails securing the shrouding to the soles of the wheel rims are all corroding and would benefit from being rubbed down and a dab of paint applied. The steel tongues joining the sections of shrouding are also corroding significantly and are causing some splitting of the shrouding. This is a problem we frequently encounter with Stokes' wheels. All the wheels are provided with iron wheel stays which have been painted.

Decay around the Garter Hole of the Second Wheel

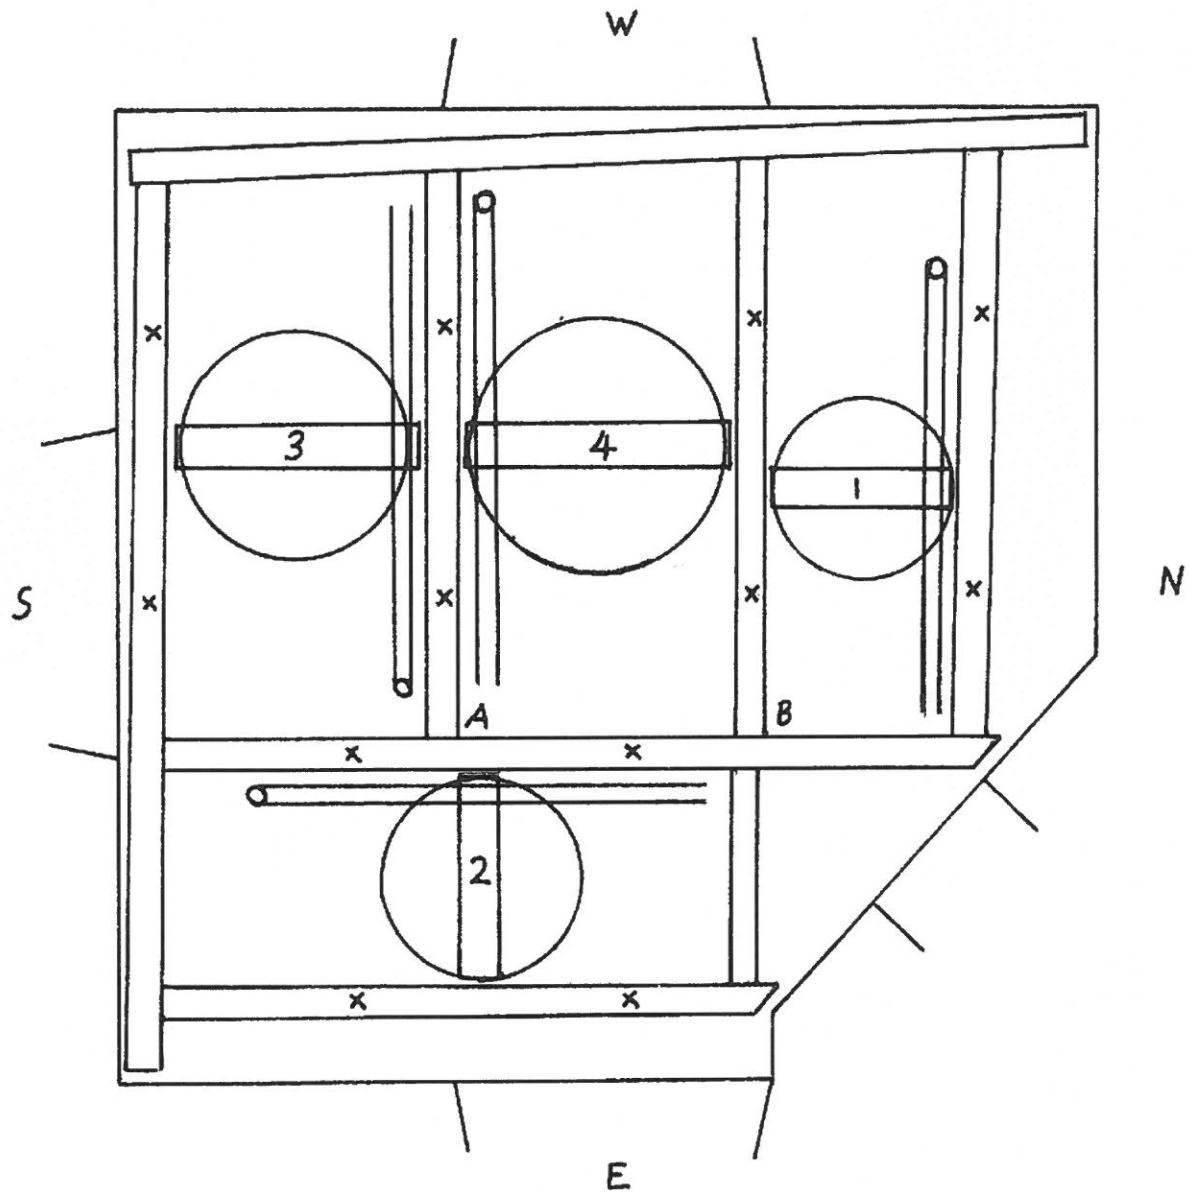
BELL-FRAME LAYOUT AT BRENDON

A and B indicate the most seriously decayed joints.
