Report and Register
for a
Renovation or Demolition Survey
St Andrews Church
Radstock
Holcombe
BA3 5ES

Executive Summary

The survey was undertaken on
12 June 2018

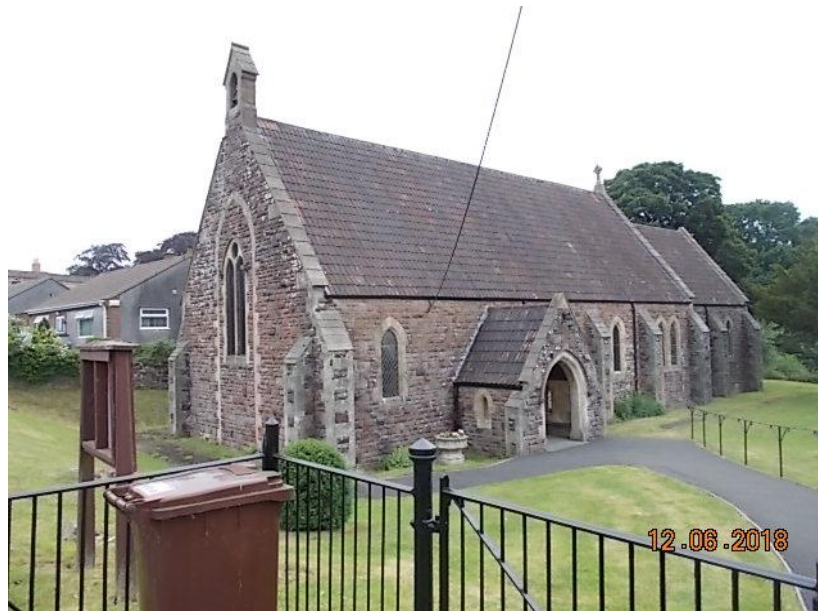
Dscn2184

No asbestos containing materials were identified

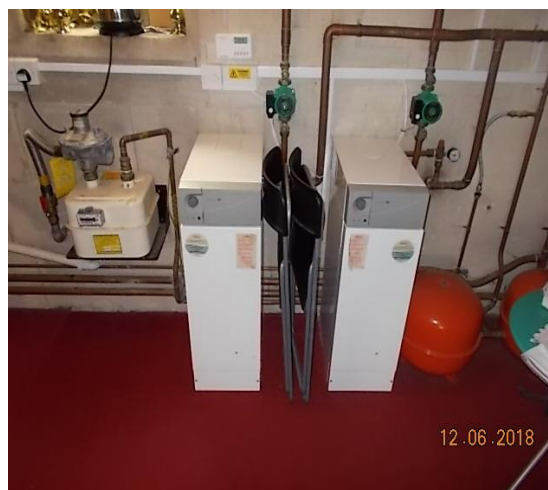
Photo Dscn2188

The boilers have not been dismantled to check for asbestos gaskets etc as this is outside the scope of the survey.

In these circumstances it is normal to describe the boilers as a no access element of the report, which assumes a high risk automatically.

Asbestos rope, paper and insulating board may be found inside any of the above equipment. Twin skinned stainless steel flues may contain asbestos based insulation; jointing materials may also contain asbestos.

Location: Existing Potterton kingfisher central heating boilers. To remain.

Level of Identification: This material has been presumed to contain asbestos since access was not possible.

Risk assessment of the Asbestos Containing Material only		Score
Product Type:	Unknown, no access	3
Damage /Deterioration:	Unknown, no access	3
Surface treatment:	Unknown, no access	3
Asbestos type:	Unknown, (no access)	4
Total		13

The material risk assessment indicates an asbestos containing material that has a potential high risk of fibre release.

Risk from the asbestos containing material (from above):	Potential High Risk
Surveyors opinion of the accessibility of the material:	Difficult Accessibility
Surveyors opinion of Number and frequency of occupants:	Low Occupation

There is a low risk to health from this material in its location.

If the boilers are not dismantled there will be no possibility of fibre release. A competent plumber should be able to identify gaskets and rope that may contain asbestos when the boilers are being serviced.

Any suspect materials should be sampled and analysed at an independent laboratory.

This equipment will be inspected during periodic maintenance by corgi-registered engineers. As such they will have received asbestos awareness training and will advise on the status of the product within.

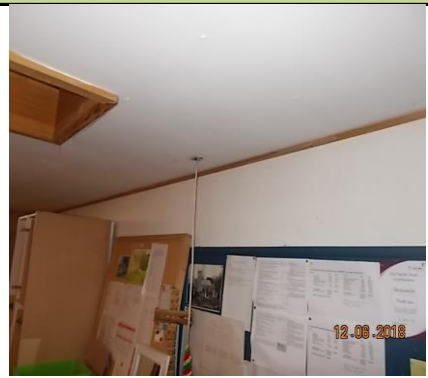
Location Wall board	Dscn2185	Material Reference 1 Neg
Material description Fire resistant board asbestos free

Sample number, if sampled 1		
Analysis result, or, surveyors opinion if 'look alike' A Material Sampled and analysed showing no asbestos

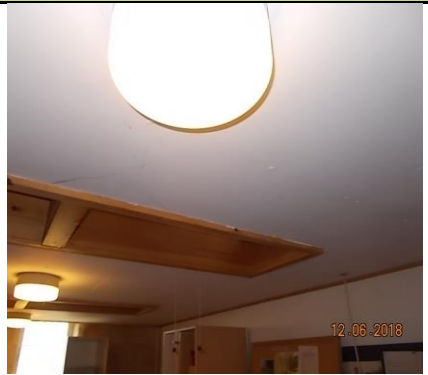
Location Ceiling board	Dscn2186	Material Reference 2 Neg
Material description Fire resistant board asbestos free

Sample number, if sampled 2		
Analysis result, or, surveyors opinion if 'look alike' A Material Sampled and analysed showing no asbestos

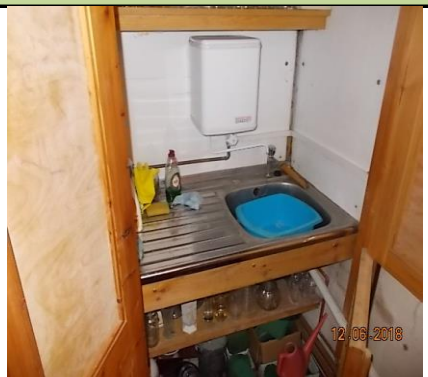
Location Beneath stainless steel sink pad	Dscn2187	Material Reference 3 La
Material description Modern asbestos free sink pad.

Sample number, if sampled N/a		
Analysis result, or, surveyors opinion if 'look alike' A look alike material that does not contain asbestos

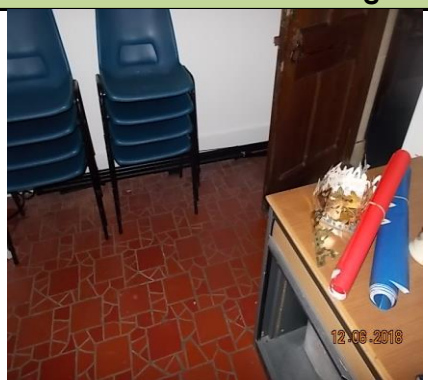
Location Vestry. Floor covering.	Dscn2190	Material Reference 5 Neg
Material description Asbestos free vinyl floor covering

Sample number, if sampled 5		
Analysis result, or, surveyors opinion if 'look alike' A Material Sampled and analysed showing no asbestos

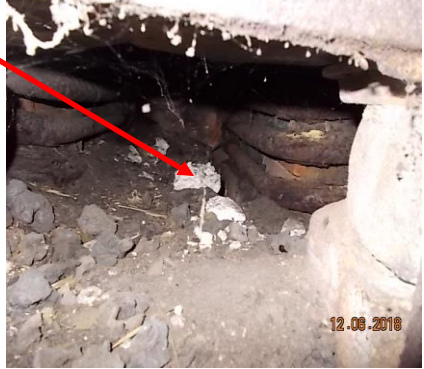
The boiler room is beneath the vestry with solid walls and a cast concrete ceiling. A redundant solid fuel boiler remains. the powdery white material within the boiler has been sampled with analysis showing no asbestos content.

<p>Location Boiler room within boiler</p>	<p>Dscn2192</p>	<p>Material Reference 6 Neg</p>
<p>Material description Asbestos free lagging type material.</p>

<p>Sample number, if sampled 6</p>		
<p>Analysis result, or, surveyors opinion if 'look alike' A Material Sampled and analysed showing no asbestos</p>

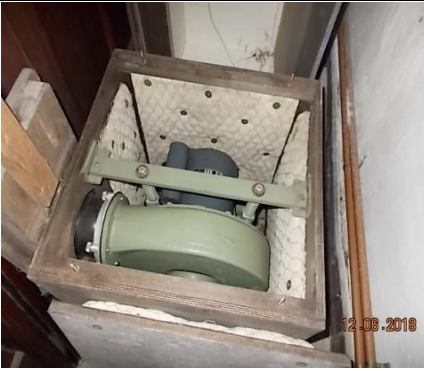
The original bellows organ is retained. The blower box has been inspected and found to be clear of asbestos.

<p>Location Organ Blower Box</p>	<p>Dscn</p>	<p>Material Reference 7 La</p>
<p>Material description Replacement non asbestos lining</p>

<p>Sample number, if sampled N/A</p>		
<p>Analysis result, or, surveyors opinion if 'look alike' A look alike material that does not contain asbestos</p>
