**SKILLINGTONS**

[www.skillingtons.co.uk](http://www.skillingtons.co.uk)

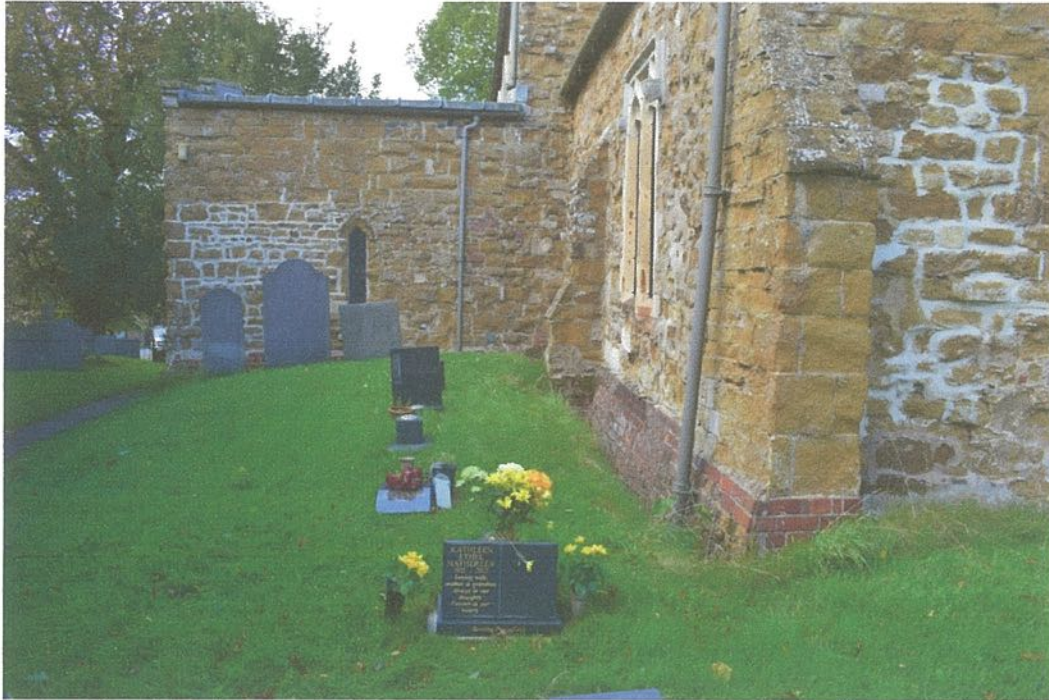
Plate 4: View of the east wall of the south transept, looking along the south wall of the chancel.

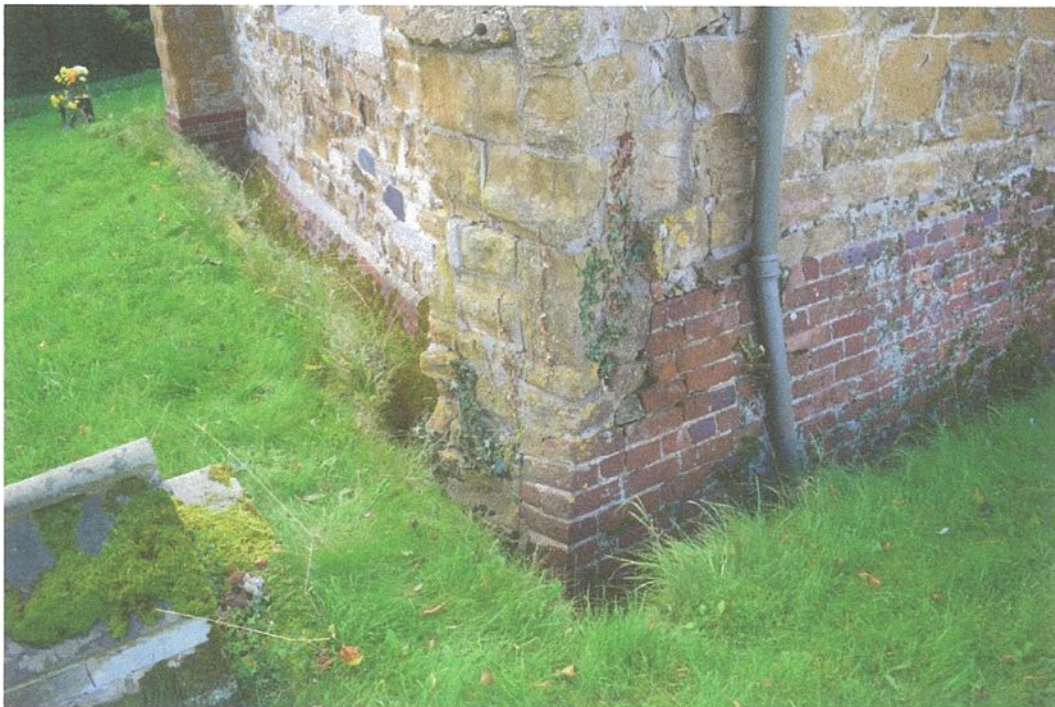
Plate 5: Detail of the channel at the north-east corner of the chancel.

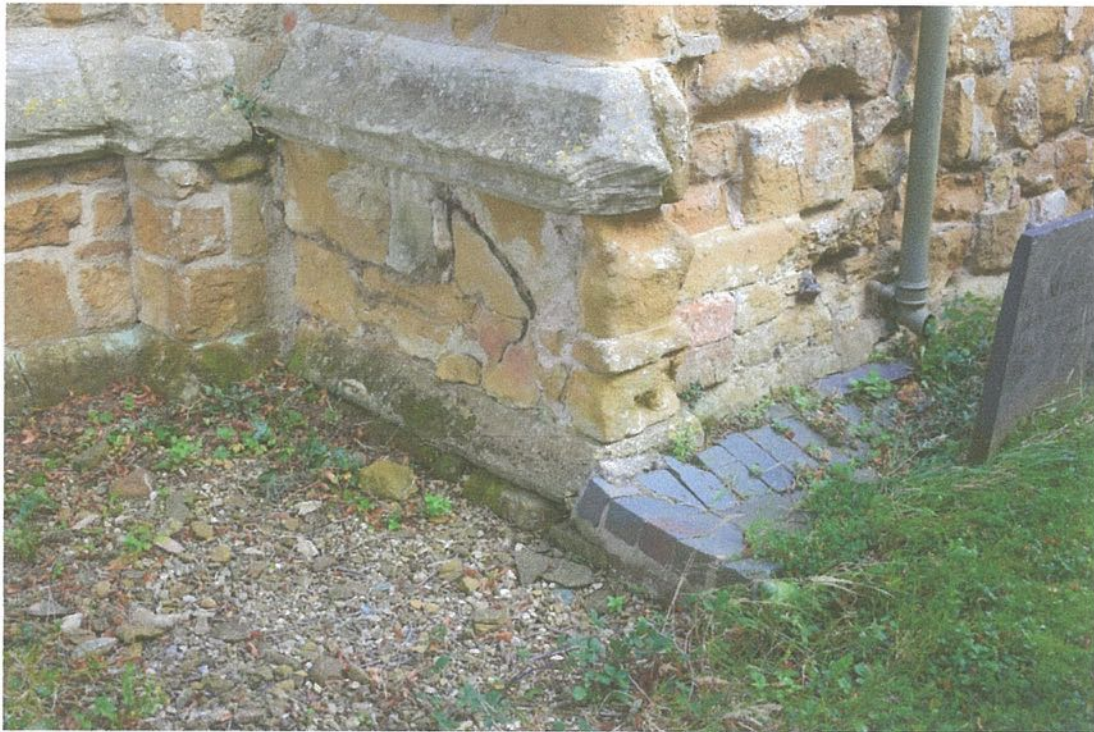
Plate 7: The south-west corner of the nave where the brick drainage channel meets the gravel. The very poor condition of the channel is clear. The limestone weatherings are basically sound. The ironstone visible can be conserved by localised repair, re-pointing and consolidation with mortars as described.

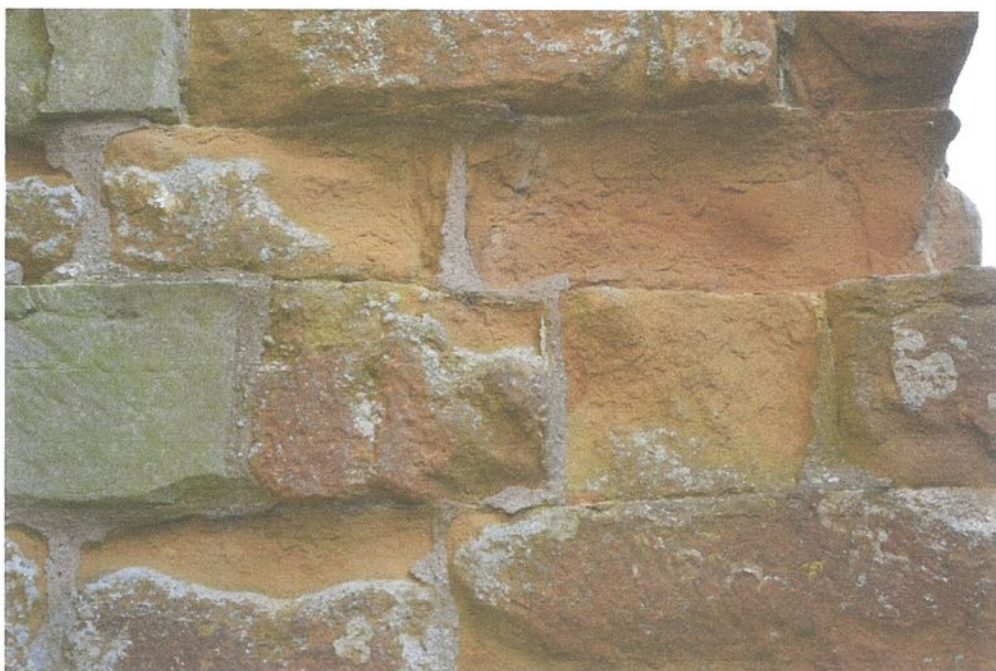
Plate 8: An area of weathered ironstone. The heavily weathered quoin with stones above and below surviving to almost full face is a rare case for replacing a stone complete.

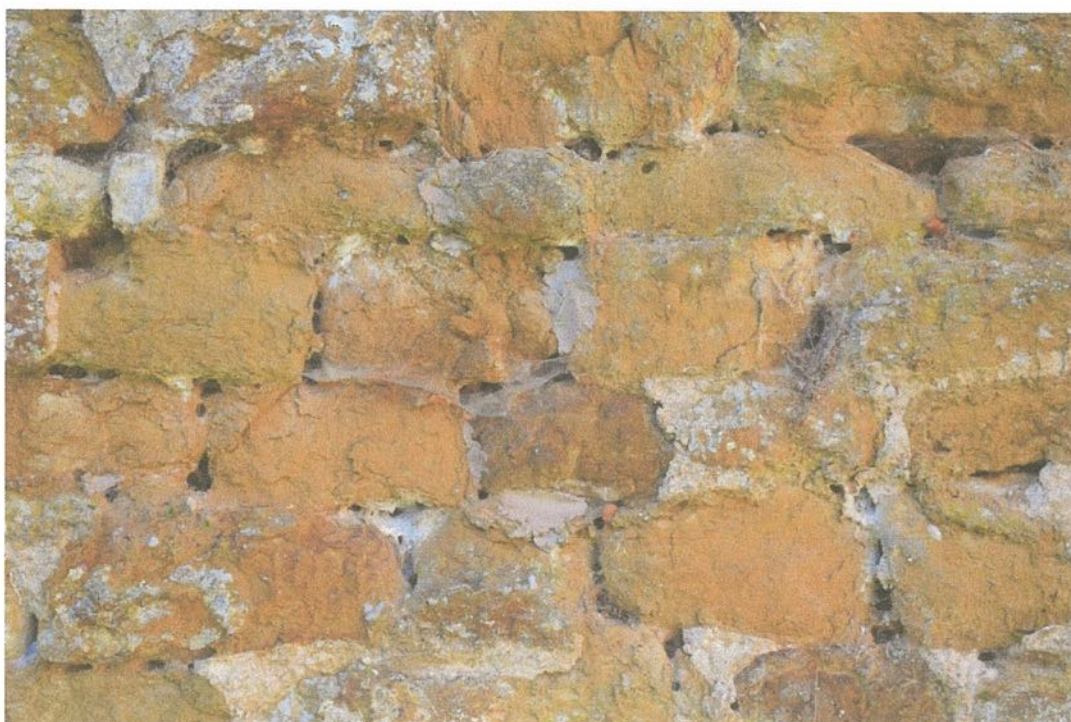
Plate 10: An area of stonework affected by masonry bees with quite deep and large pockets in the mortar, and lots of old patch repairs in cement. Although in principle it would be nice to be able to accept and accommodate the bees, here they are starting to cause structural problems. The voids here need grouting and filling, and the joints re-pointing in lime mortar. None of the stones visible in this photograph need replacing.

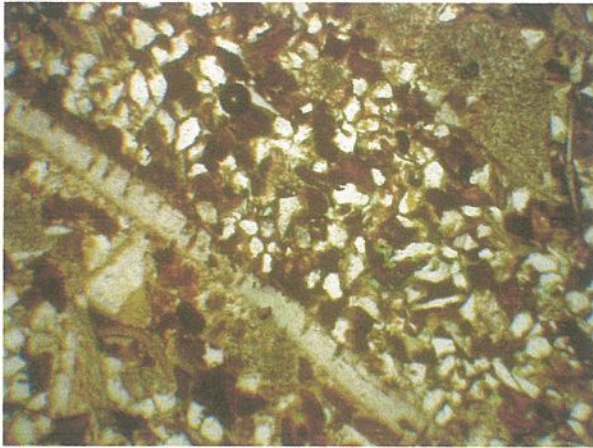
Figure 2. Photomicrograph of the stone from the church. Small clear quartz grains and larger, more mottled, shell fragments, are enclosed in reddish-brown limonite. Width of the photograph is 2.16 mm.

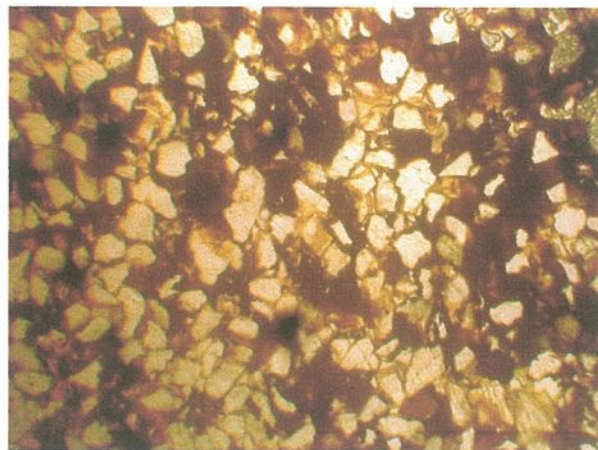
Figure 3. Photomicrograph of a sample of ferruginous sandstone from Harlestone quarry. The stone consists of quartz clasts bound with iron minerals such as limonite. Width of the field of view is 2.16 mm.
