# ST JOHN'S CHURCH

CHURCH LANE, GRIMSTON, LEICESTERSHIRE LE14 3BZ

## Asbestos Management/Refurbishment Survey

Report Date: 5th April 2018

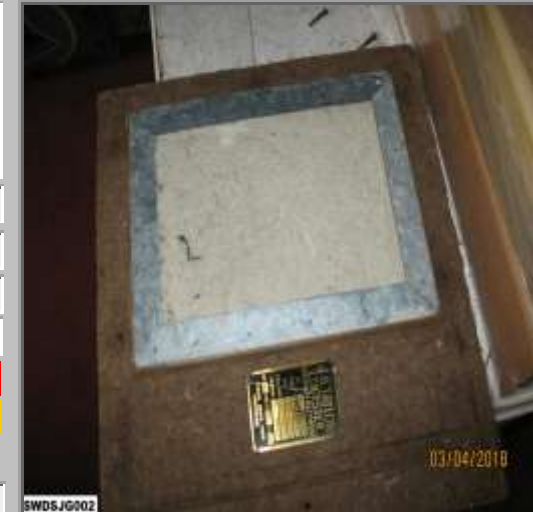
**Comments**  
 Insulation to panel in Organ Blower Box lid  
 Asbestos confirmed in sample taken  
 Recommendation to replace insulation before more deterioration takes place  
 This insulation is a licensed product and any removal of this product should be carried out by a licensed contractor under controlled asbestos conditions and the material disposed of under Hazardous Waste Consignment note.

Product Type	<input type="text" value="Insulation, Sprayed Coatings,"/>	Control Options	<input type="text" value="Remove"/>
Extent of Damage	<input type="text" value="Low Damage"/>	Control Timescale	<input type="text" value="3 months"/>
Surface Treatment	<input type="text" value="Unsealed lagging/sprays"/>	Management Options	<input type="text" value="Re-Inspect"/>
Asbestos Type	<input type="text" value="Amosite (Brown)"/>	Management Timescale	<input type="text" value="12 months"/>
		Estimated Cost	<input type="text" value="£0.00"/>
		Action Completed	<input type="text"/>
		Review Date	<input type="text" value="01-May-19"/>

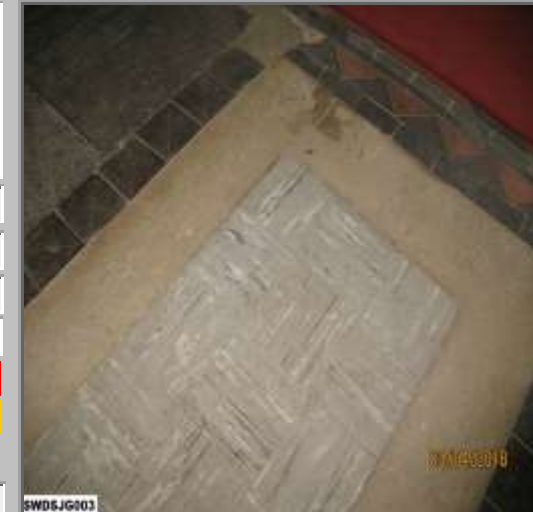
Product Type	<input type="text" value="Asbestos Composites"/>	Control Options	<input type="text" value="Monitor"/>
Extent of Damage	<input type="text" value="Good condition"/>	Control Timescale	<input type="text" value="3 months"/>
Surface Treatment	<input type="text" value="Composites"/>	Management Options	<input type="text" value="Re-Inspect"/>
Asbestos Type	<input type="text" value="Chrysotile (White)"/>	Management Timescale	<input type="text" value="12 months"/>
Material Assessment Score:	<input type="text" value="2"/>	Estimated Cost	<input type="text" value="£0.00"/>
Priority Assessment Score:	<input type="text" value="2"/>	Action Completed	<input type="text" value=""/>
		Review Date	<input type="text" value="01-May-19"/>
