# Report on an Archaeological Watching Brief at the Church of St. John the Baptist, Grimston, Leicestershire

Prepared for: Midlands Stonemasonry

Report Number: 023/2019

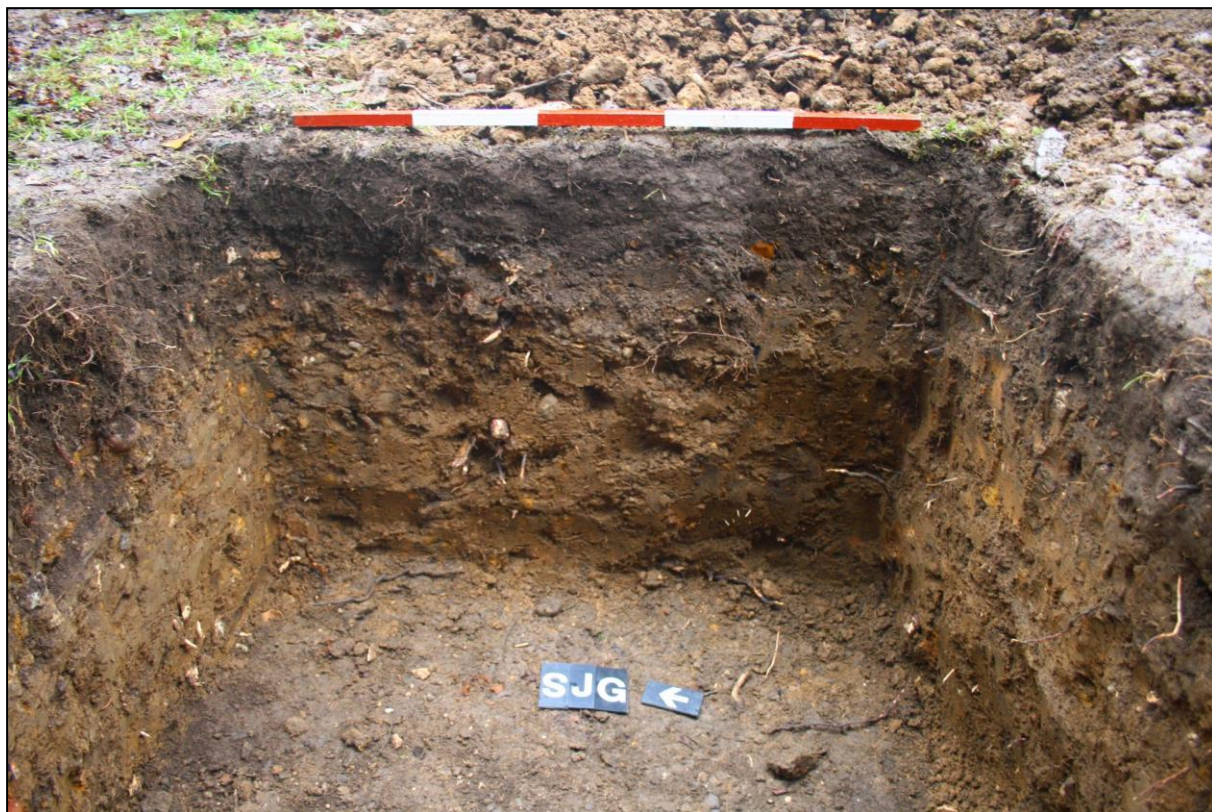
Plate 1: West-facing section of the soakaway pit. Scale: 1 x 1m.

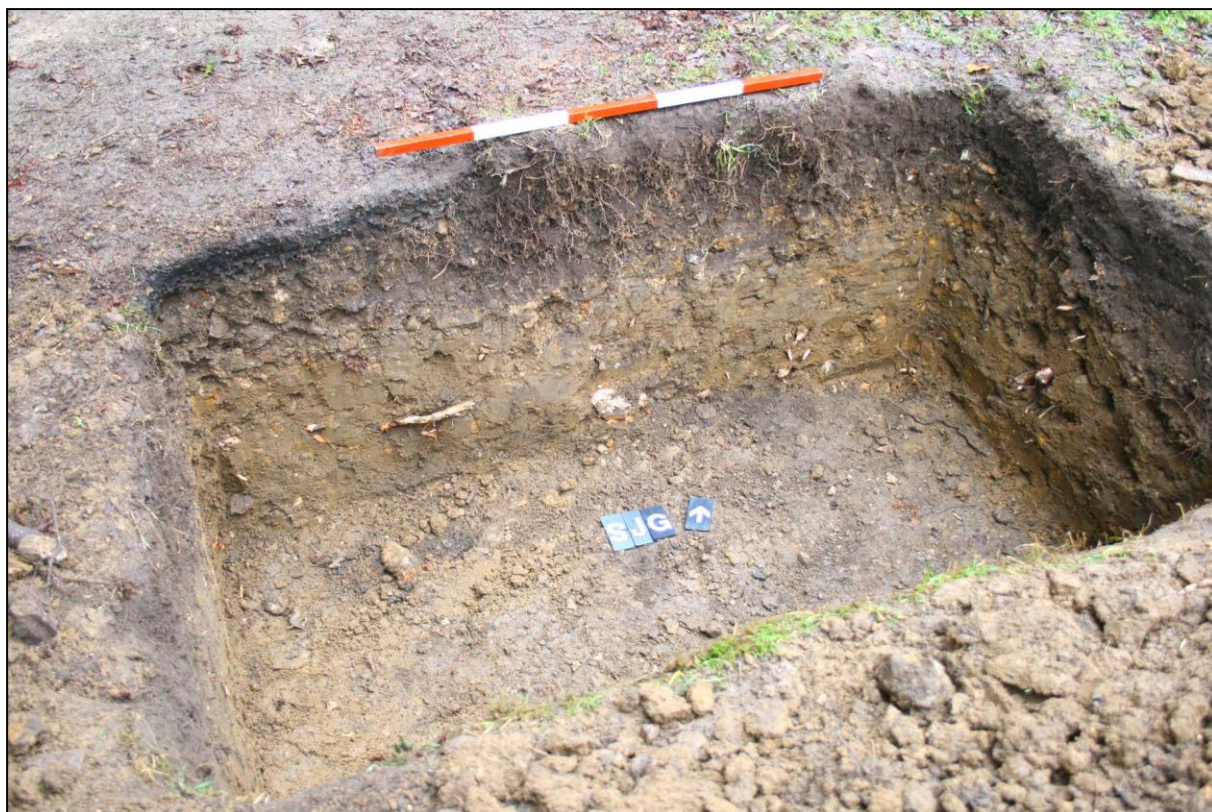
- 6.2.3 Within the soakaway to the north, principally visible in the south-facing section but also partially seen in the west and east-facing sections were layers associated with the construction of the footpath. Directly above the disturbed subsoil layer (0004) was a firm, dark yellowish brown foundation layer consisting of coarse sand and stone, (0002). In the northwest of the soakaway only, this was seen to be overlaid by the modern hardcore footpath, running approximately northeast by southwest across the southern part of the site. For the majority of the north-facing section and partly visible in the west-facing section, (0002) was sealed by the topsoil and turf, (0001) that was seen to be c. 0.12 – 0.22m thick and extended across the site.

Plate 2: Oblique view of the south-facing section of the soakaway pit. Scale: 1 x 1m.

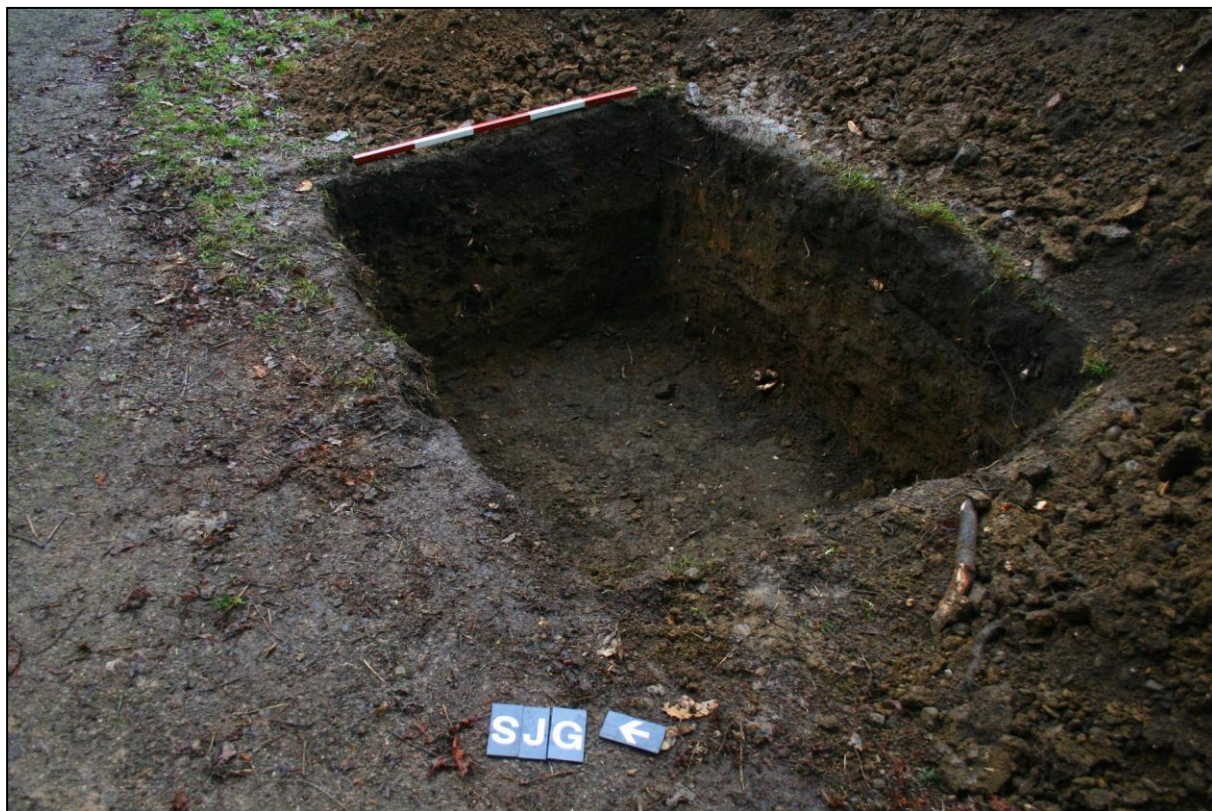
Plate 3: Oblique post-ex view of the soakaway pit. Scale: 1 x 1m.

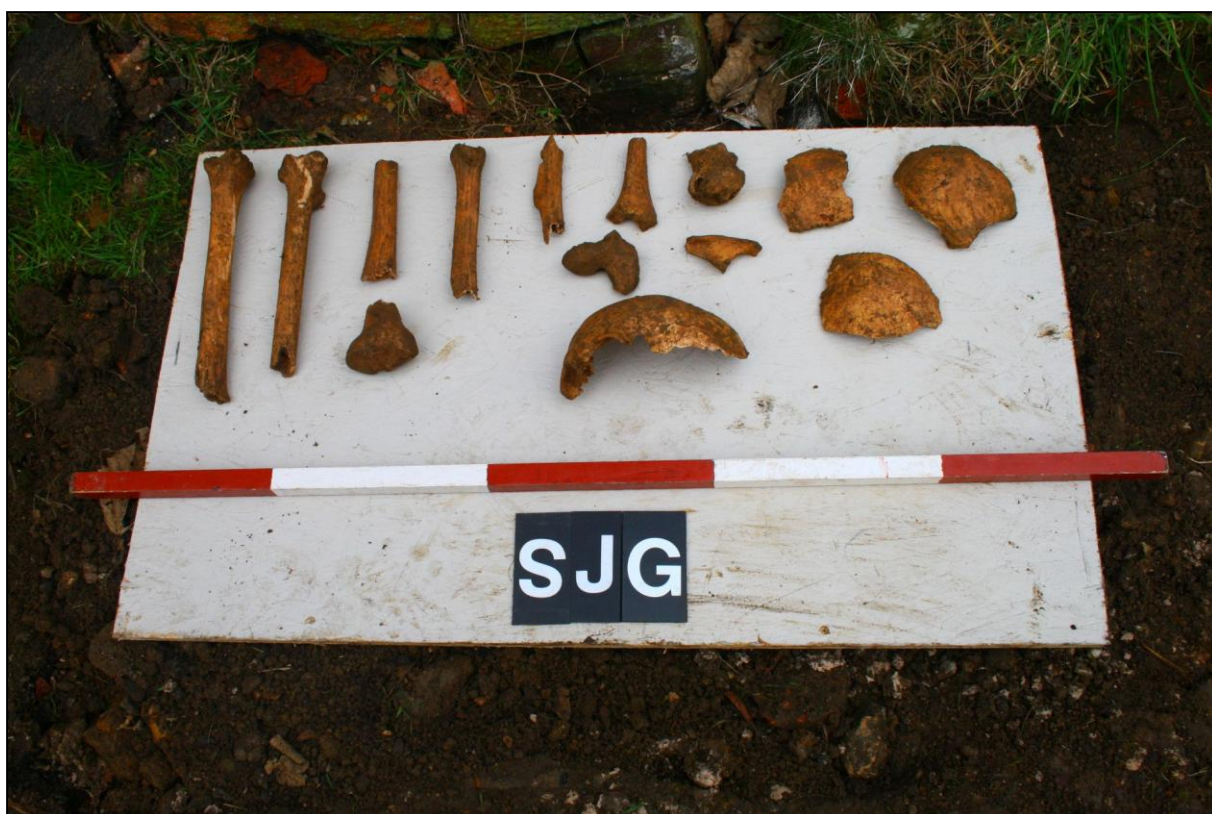
- 6.2.2 In the base of the soakaway was a layer of disturbed subsoil (0003), consisting of friable mid yellowish brown clayey silt seen to contain moderate inclusions of ceramic brick material (CBM) fragments. This had a thickness of up to 0.76m, being not fully excavated. A number of disarticulated bones were recovered from this context and subsequently reburied within the soakaway (Plates 4 - 5).

- 7.1 A number of disarticulated human remains were recovered from the disturbed subsoil, (0003) within the soakaway. Most of these comprised fragments of long bones, with a much smaller amount of cranial fragments, including a partially intact skull (Plates 4 – 5). These disarticulated remains are remnants of earlier phases of churchyard use for burial, and were collected together and reburied within the soakaway.

Plate 4: Disarticulated bones from the soakaway pit, c. 0.50 – 0.80m from the surface. Scale: 1 x 1m.

- 7.2 The increasing frequency of disarticulated remains suggests that burials could remain in-situ at a greater depth. Given the location of the soakaway opposite the main entrance porch this could be considered as extremely likely. In order to avoid unnecessary disturbance of probable in-situ human remains, it was agreed that the soakaway might be extended in length rather than depth to respect any burials.

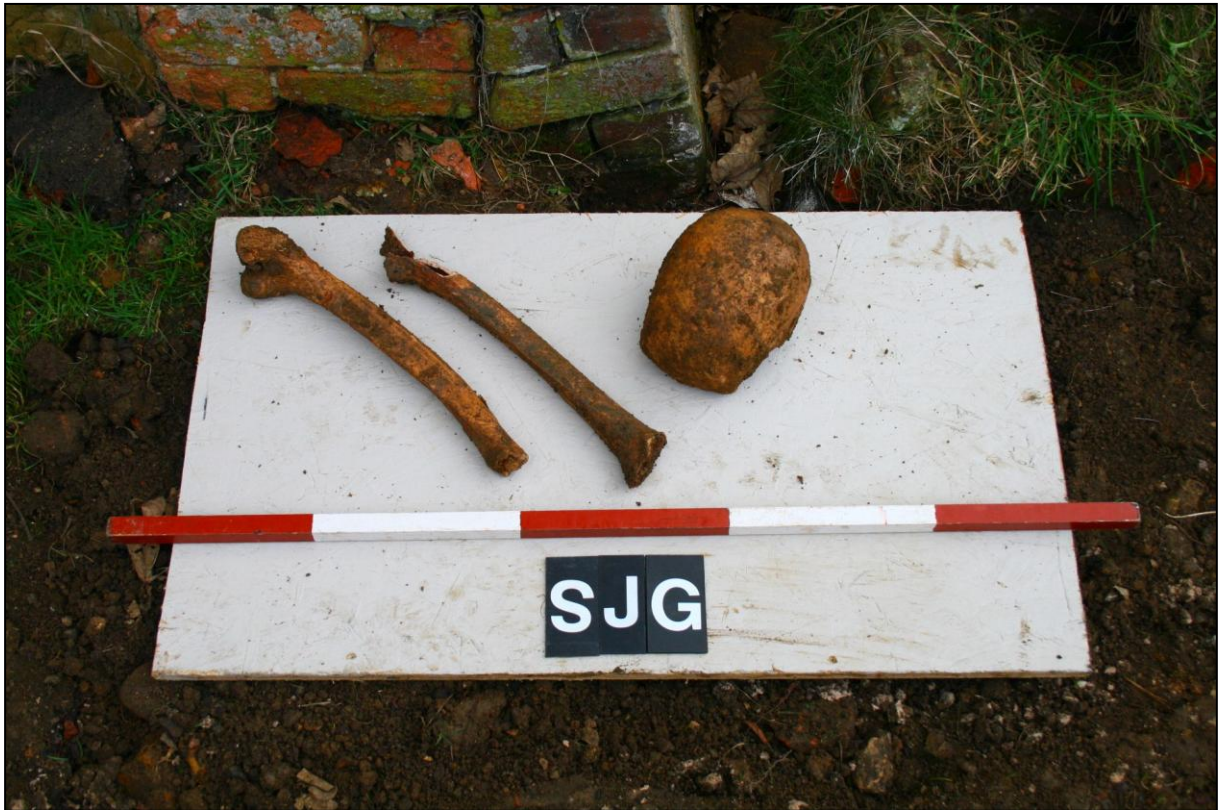
Plate 5: Disarticulated bones from the soakaway pit, c. 0.80 – 0.90m. Scale: 1 x 1m.

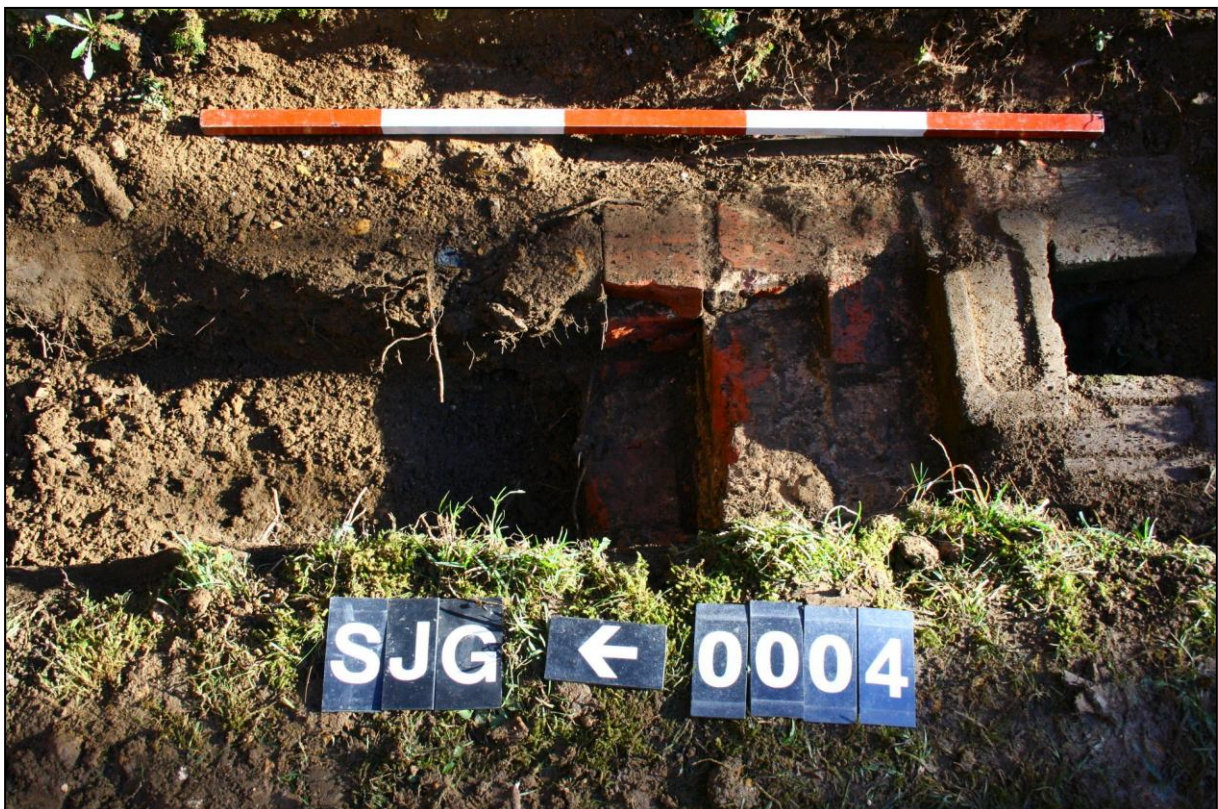
- 6.4 **Brick structure [0004]. Figures 2 and 3 (Dr#1 and 2); Plates: 6 – 7.**
- 6.4.1 Excavation of a section of the north by south drain run immediately parallel to the southern projecting transept revealed the remains of a brick structure [0004] truncated by a modern drain. This was comprised of four courses of reddish orange bricks c. 0.18 x 0.12 x 0.06m and parts of which were seen to be bonded with patches of cement/mortar. The eastern edge of the bricks appeared to directly abut the foundation/lower stone course of the church, and removal of a single course suggested that the feature did not continue into the east facing section of the trench, however this is not clear. A 0.12 – 0.08m deep sondage was excavated by the north facing elevation which showed the

- 7.3 Excavation of the drain runs did not run deeper than the topsoil, (0001) with one section revealing an interface between the topsoil and a layer of modern backfill/made ground (0005) (Plate 9). Immediately adjacent to the east facing elevation of the southern transept, a small brick structure [0004] was revealed, probably truncated by a later drain (Figures 2 and 3; Plates 6 and 7).

- 7.4 Interpretation of [0004] is difficult given the limitations of the excavation. It is possible that the feature constitute the remains of what must have been a small wall considering the shallow depth and its location within the topsoil. However, a wall aligned east-west would obstruct the main entrance porch, whilst a north-south alignment would immediately encounter the footpath. The latter is at least possible if [0004] predates the section of the path that continues to the northeast beyond the entrance porch. It is also possible that [0004] is the remains of an earlier drain, but this is based purely by its situation and later truncation by the current drain. The feature could alternatively be the remains of the lower course of a structural support, such as a brick buttress of the sort still extant on the north side of the church (Plate 8). Given the collapse of the northern transept, it is possible that steps were taken to support the southern transept, later removed when deemed to be no longer necessary. These interpretations remain speculative owing to the confines of the excavated area.

Plate 6: Plan view of brick structure [0004]. Modern drain on the extreme right. Scale: 1 x 1m.

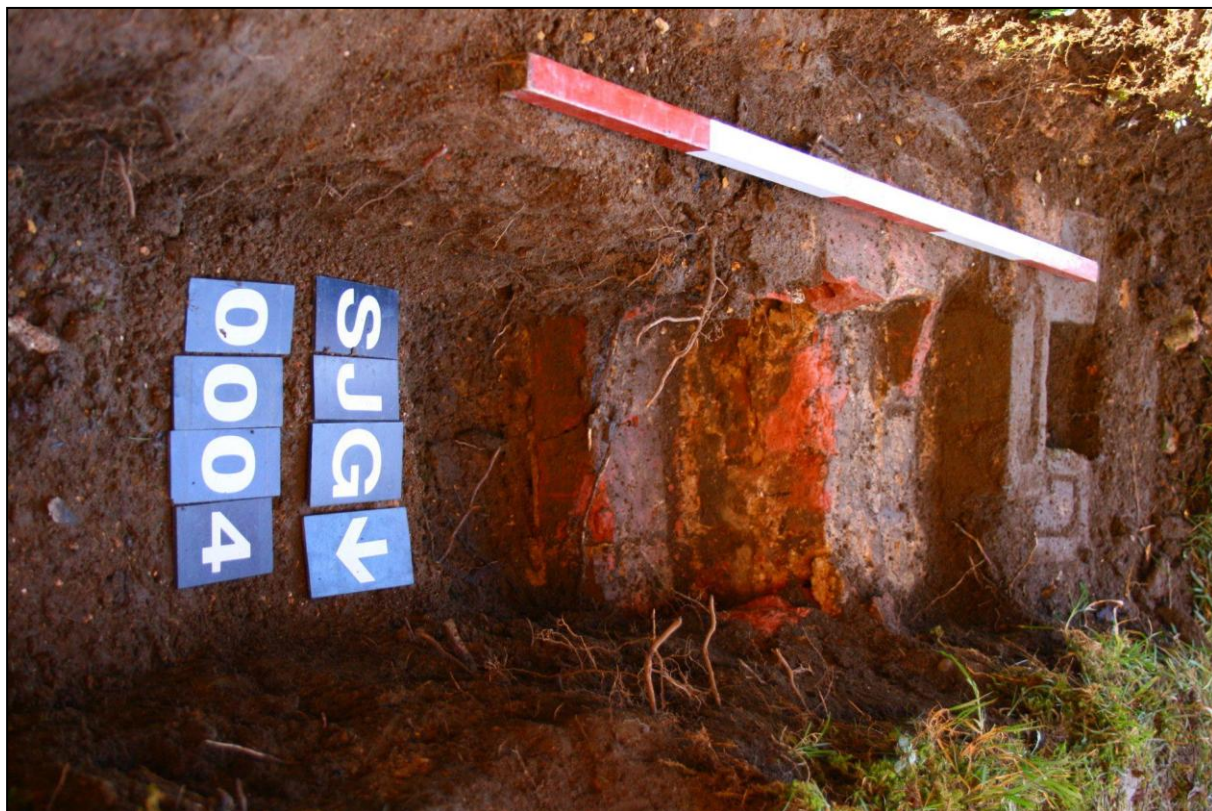
structure to be within the topsoil (0001) and to have no further courses, giving the structure maximum dimensions of 0.46m x c.0.40m x 0.32m. See section 7.4 for a discussion and possible interpretations of this feature.

Plate 7: North-facing elevation of [0004]. Scale: 1 x 1m

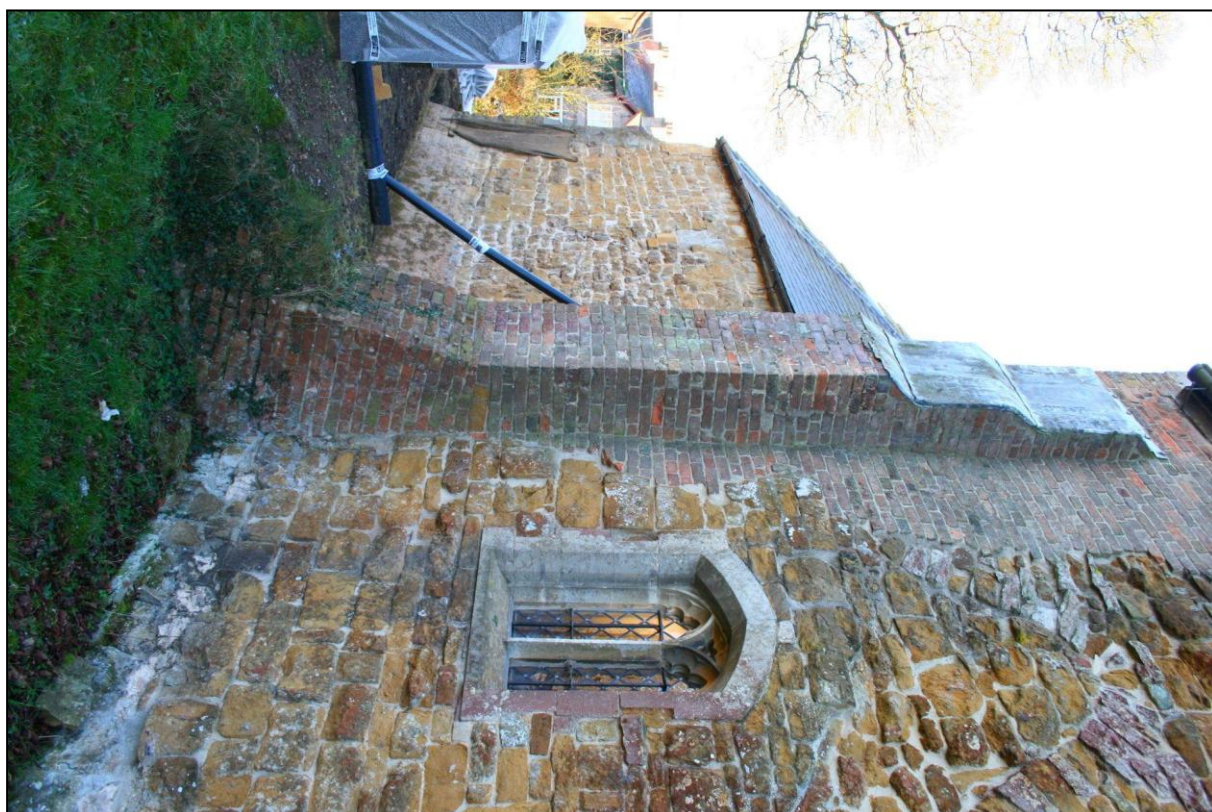
Plate 8: Brick buttress extant on the north side of the church. [0004] was possibly a similar structure.

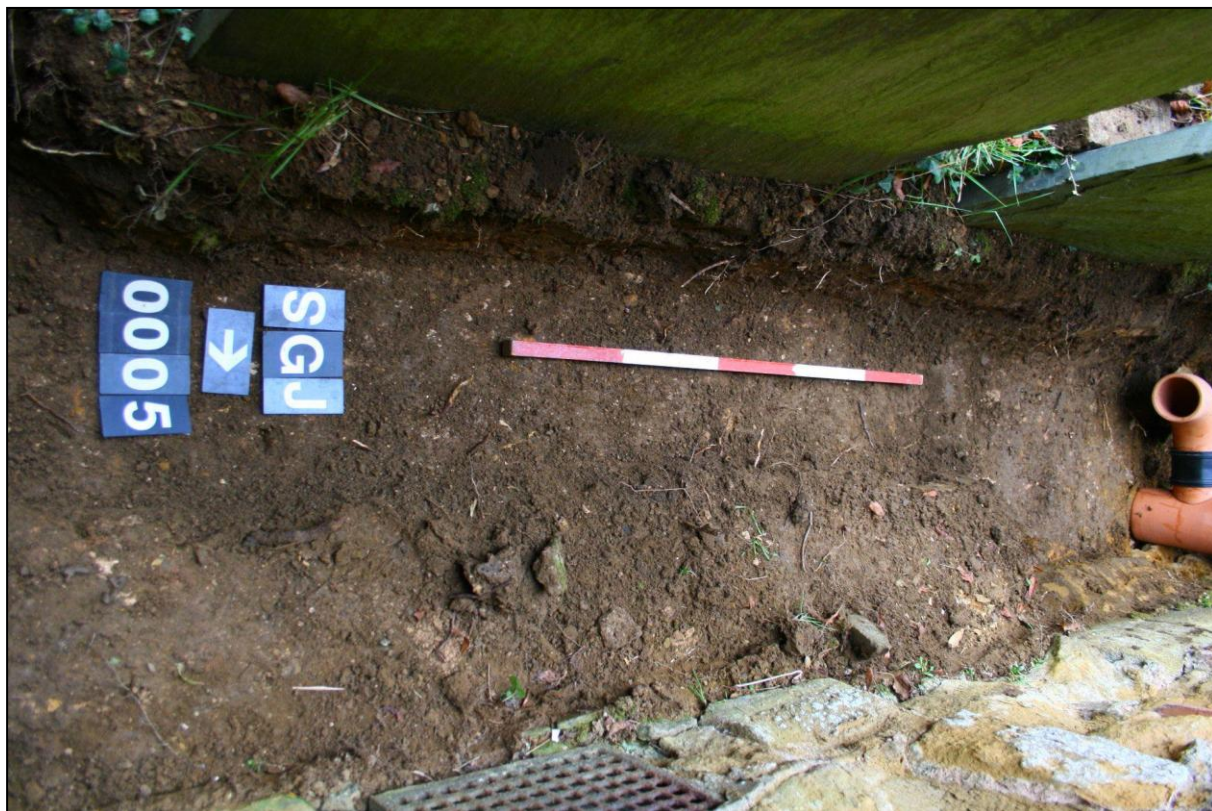
Plate 9: Excavated east-west drain run adjacent to entrance porch showing backfill layer (0005). Scale: 1 x 1m.

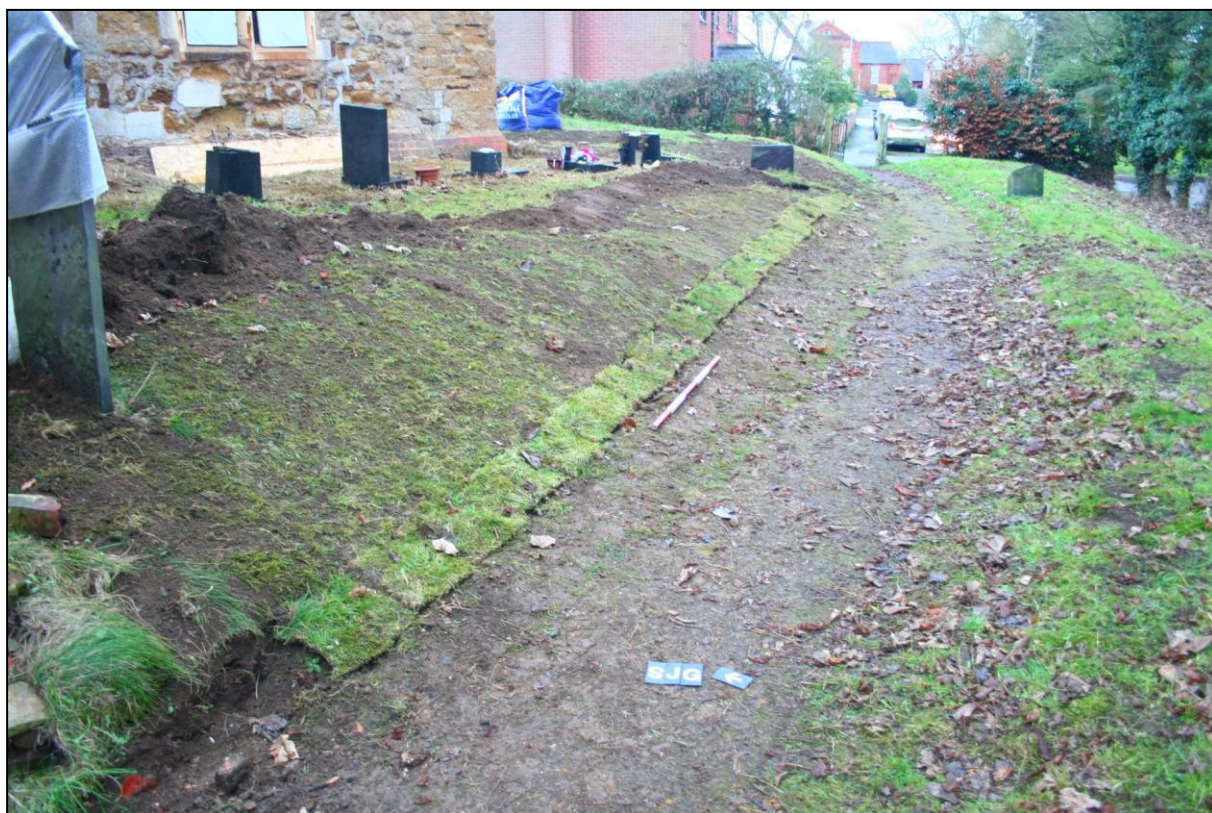
Plate 10: Completed east – west drain run. Scale: 1 x 1m.

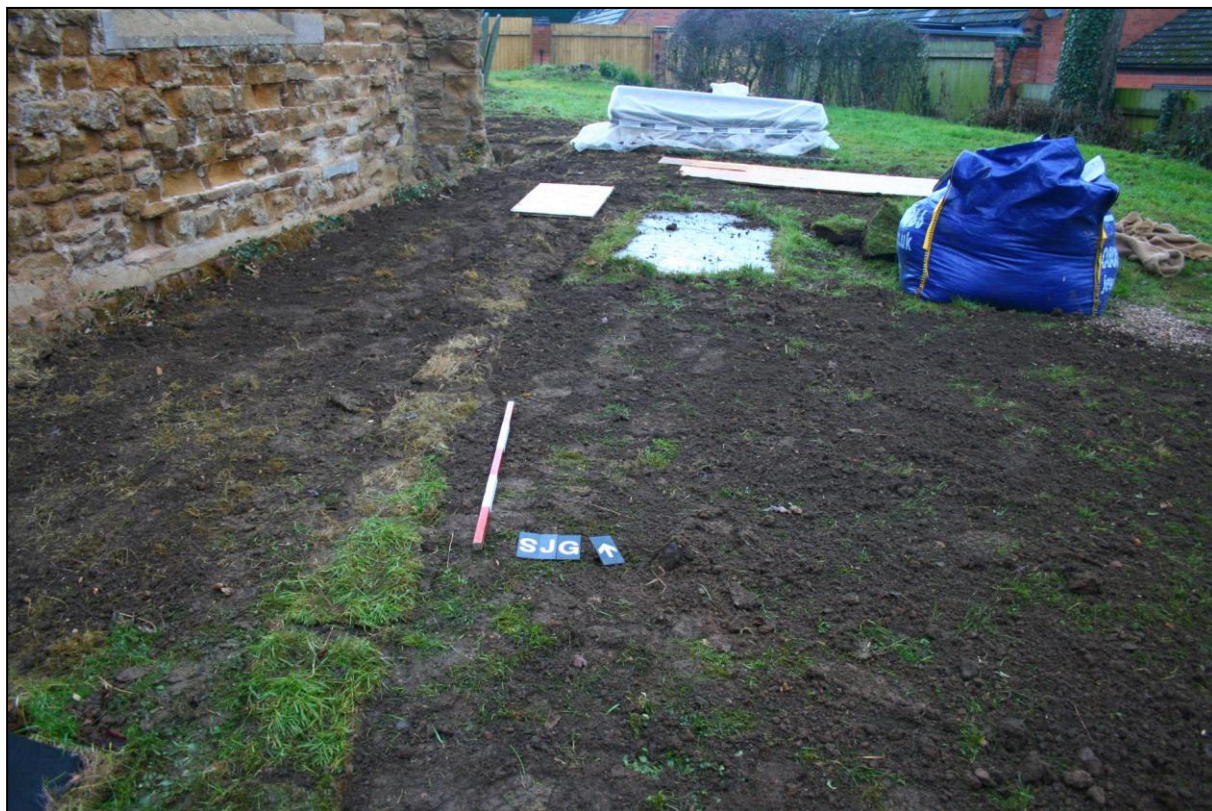
Plate 11: Completed north – south section of drain run. Scale: 1 x 1m.

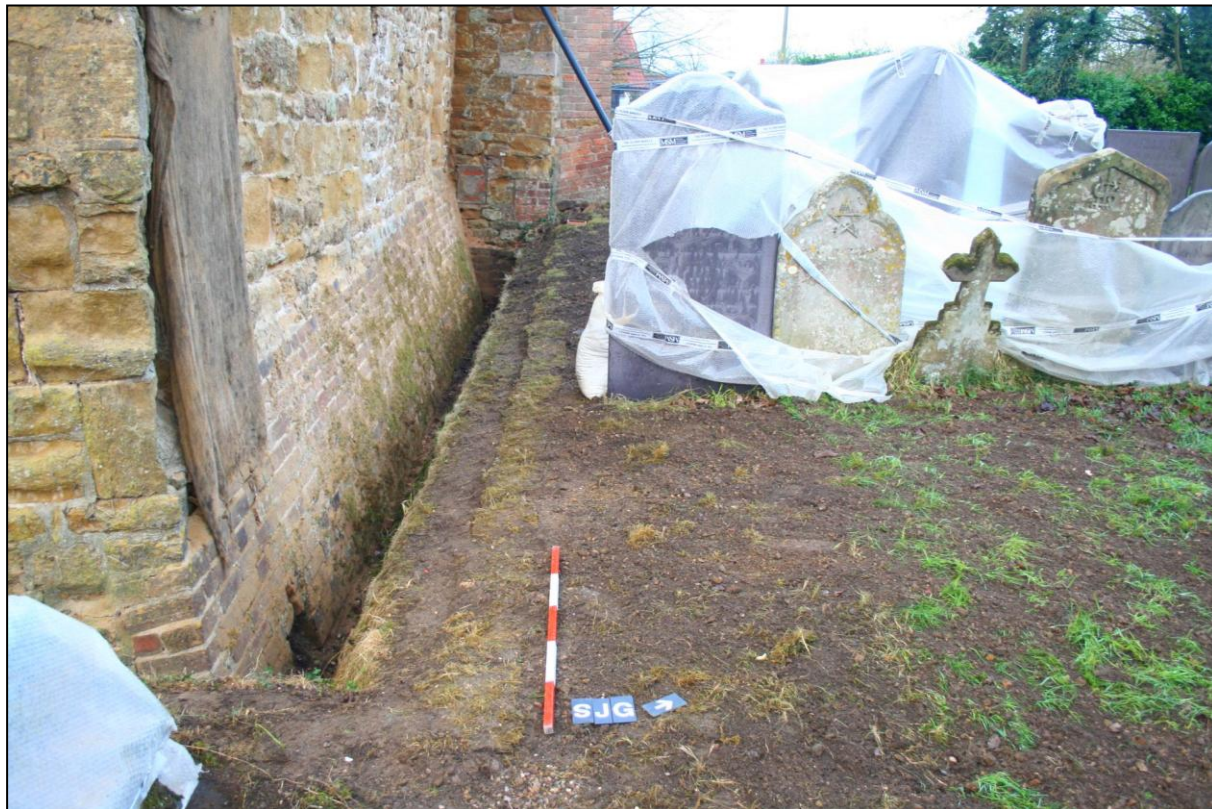
Plate 12: Completed east – west section of drain run. Scale: 1 x 1m.
