# Energy Audit Report for St. James Mission Church

Site Address	St. James Mission Church, Turton, BL7 0PW
Church Code	624388
Author	Tim Mawby Graduate Consultant
Date	21 <sup>st</sup> January 2020
Version	1.0

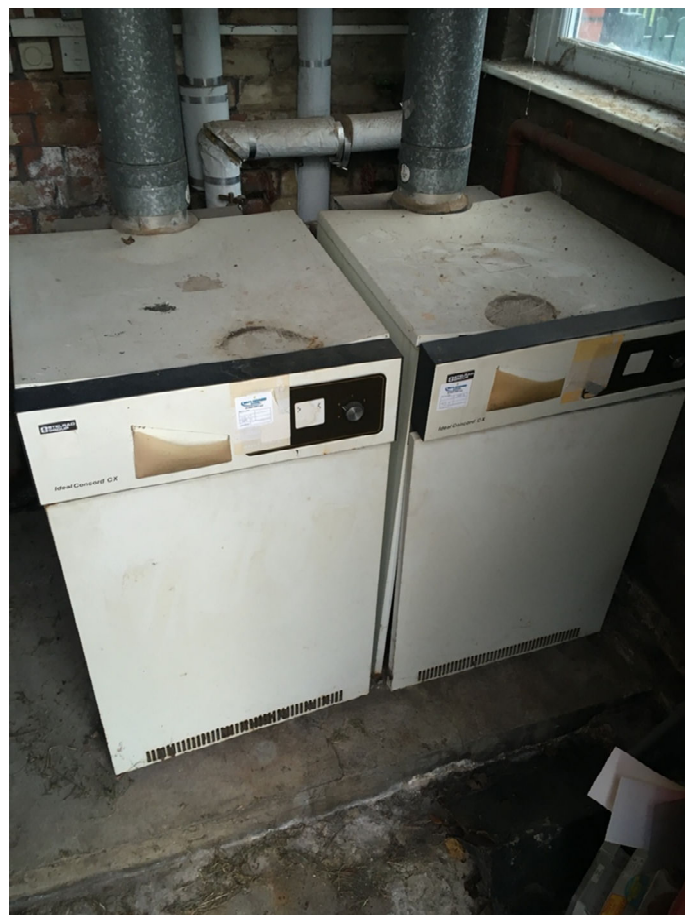
**Photograph 2: Church Boilers**

Heating is provided by 2no. Ideal Concord CX gas fired boilers (installed approximately 30 years ago) located in the basement plant room. One of these boilers serves the ground floor school club, whilst the other serves the first-floor church. Both systems are controlled manually, therefore, it is recommended that timers are installed to reduce the risk of accidentally leaving the systems on whilst the corresponding space is unoccupied. Based on the age of the boilers, it is assumed that the efficiency of the units may have dropped to as little as 60%. As such, it is recommended that the boilers are replaced with high efficiency gas condensing boilers.

It is recommended that the existing gas boilers be replaced with modern alternatives. Additionally, the client may consider exploring the possibility of installing air to water heat pump heating systems in order to move towards the goal of decarbonising energy consumption.

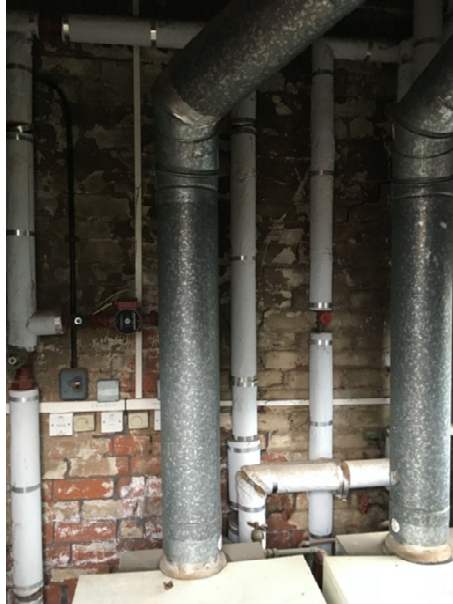
**Photograph 3: Heating System Pipework**

The heating systems' pipework is in good repair, with well-maintained insulating lagging in good condition. As such, no recommendations have been made in this area.

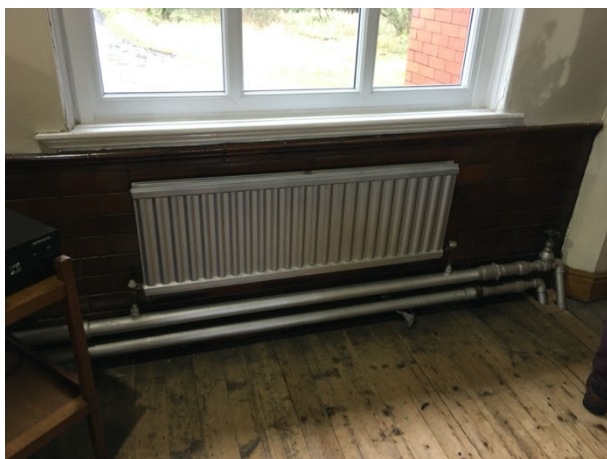
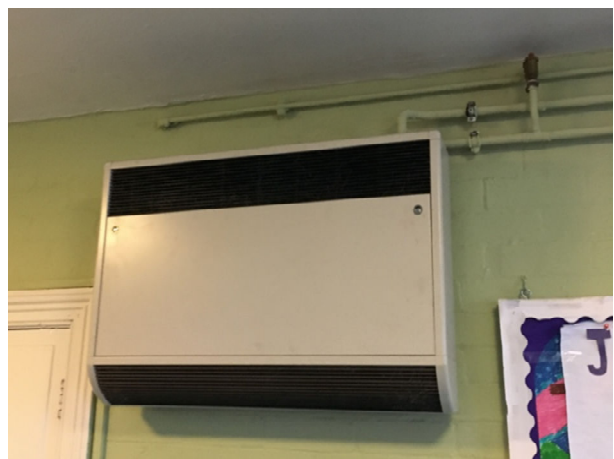
**Photographs 4 & 5: Radiator and Electric Curtain Heater**

Heating to the church is provided via 10no. iron radiators supplied by heating pipes fixed to the walls. There is also a Redring Sunspot 2.25 electric curtain heater situated above the main entrance. Heating to the ground floor school club is provided by 2no. wall-mounted cased-radiators, as well as 2no. wall-mounted gas storage heaters. There are also 2no. cased-radiators in WC areas and another in the school club storeroom.

A range of portable plug-in heaters are also present throughout the building and are used to provide additional heating to the smaller rooms when required. This can be an ineffective, inefficient and poorly controlled means of providing space heating, and can easily be left on when unoccupied. It is recommended that a more permanent heating solution be provided to these spaces if and when heating upgrades are undertaken.

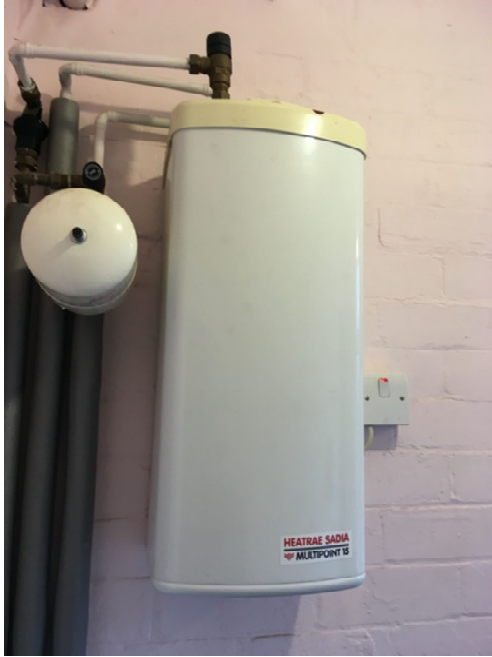
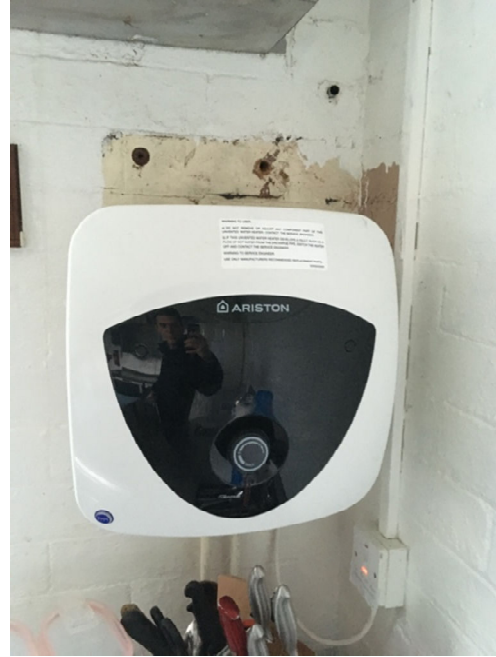
**Photographs 6 & 7: Water Heaters**

Hot water is provided to the WCs via a Heatrae Sadia Multipoint 15 electric water heater. An Ariston electric water heater provides hot water to the kitchen. Hot water consumption is considered to be minimal.

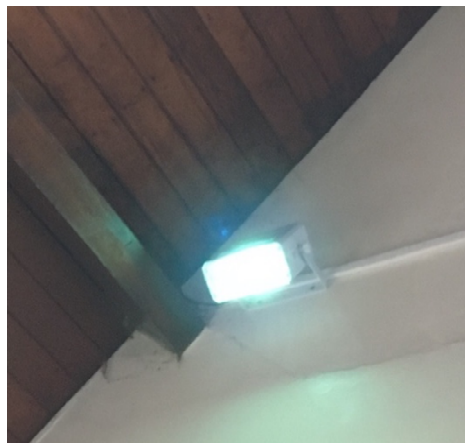
**Photograph 8: Metal Halide Floodlights**

- ▲ 14no. 250W metal halide floodlights – recommended to be replaced with 90W LED alternatives.

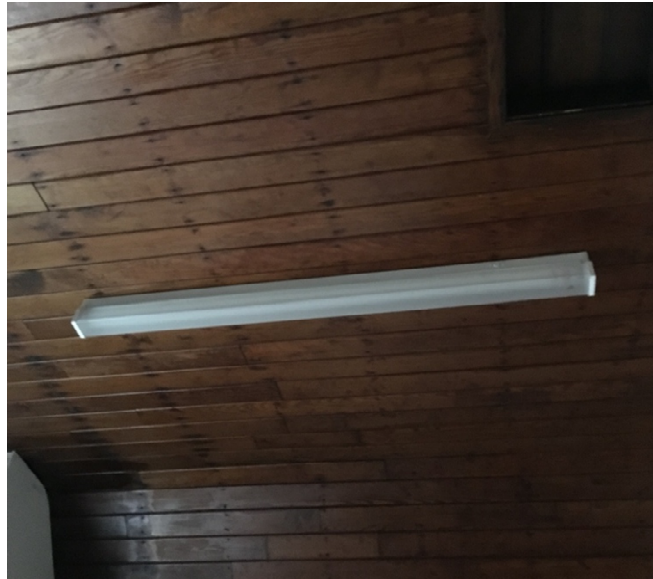
**Photograph 9: Fluorescent Tubes**

- ▲ 2no. 58W T8 Fluorescent tubes – recommended to be replaced with 22W LED alternatives.

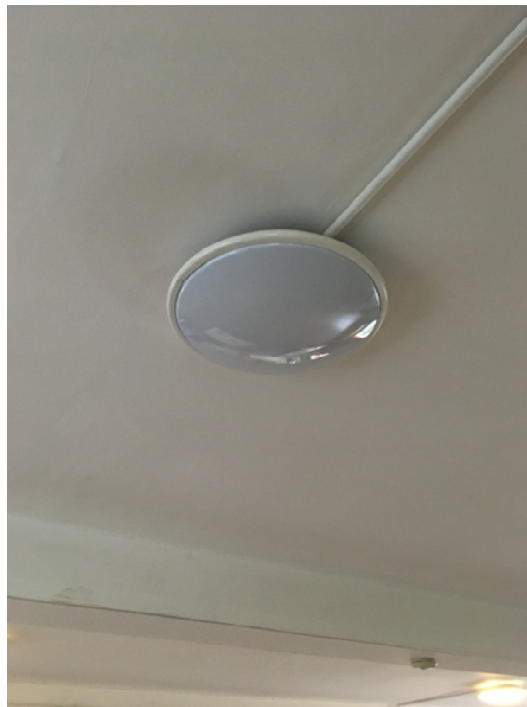
**Photograph 10: Compact Fluorescent Lamps**

- ▲ 10no. 36W compact fluorescent lamps – recommended to be replaced with 7.5W LED alternatives.

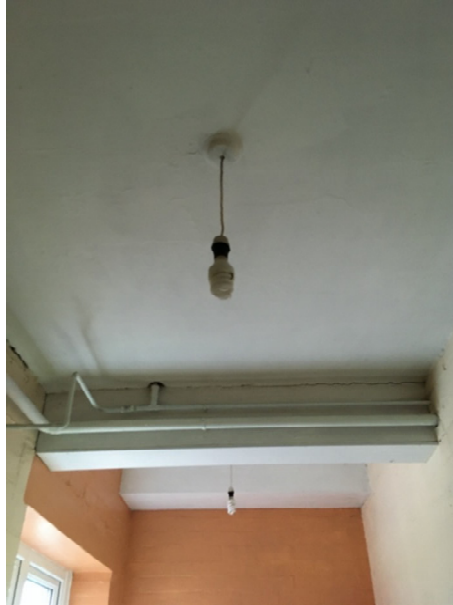
**Photograph 11: Fluorescent Pendant Lamps**

- ▲ 4no. 20W fluorescent pendant lamps – recommended to be replaced with 3.5W LED alternatives.
