# Energy Audit and Survey Report

## Christ Church, Ashford

Ashford Town Parish PCC

An energy survey of the Christ Church, Ashford, Beaver Road, TN23 7SR was completed on the 9<sup>th</sup> January 2020 by Dr. Paul Hamley. Paul is an energy auditor with experience of advising churches and small businesses. He is part of the Diocesan Environment Officers Energy Group developing advice for the Church of England and authored the "Assessing Energy Use in Churches" report for Historic England. He is a CIBSE Associate member and a Chartered Scientist, with experience of the faculty process gained from chairing the building committee of a Grade I listed church.

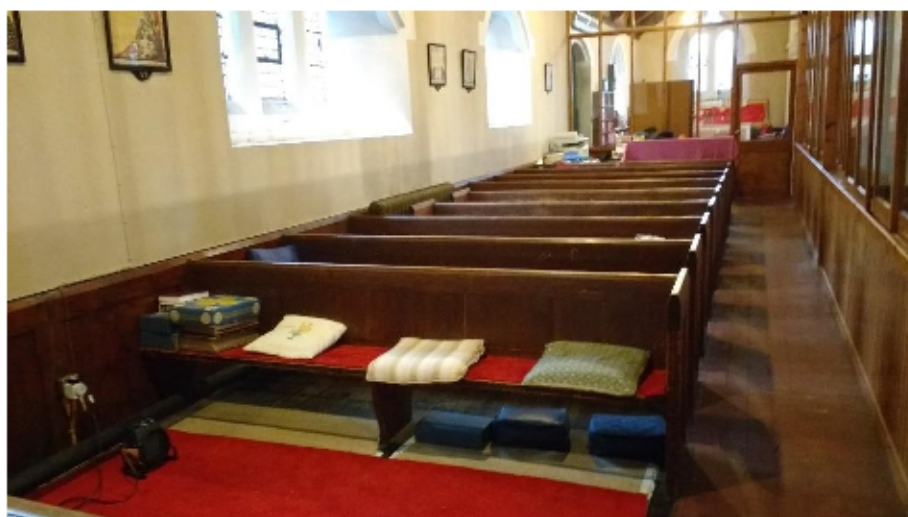
Seating in the south aisle chapel, separated by glass screens.

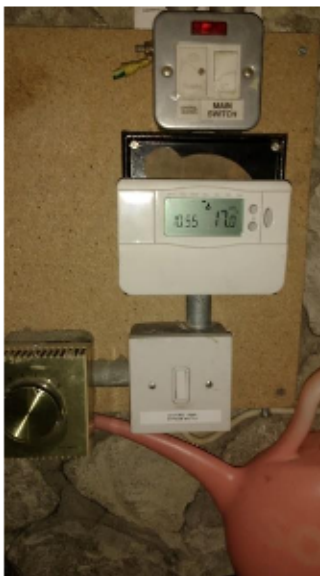
Controls are located opposite the boiler

Experiments in the Diocese of Lichfield at over 50 churches have established that hot water radiator heating can be optimised by being switched off 45 minutes before the end of the service.

Purchasing of a temperature datalogger will allow the time for the church to heat (in different weather conditions) to be understood, as well as the time to switch off to be optimised. This would require someone with a computer to plug in the device and download the readings.

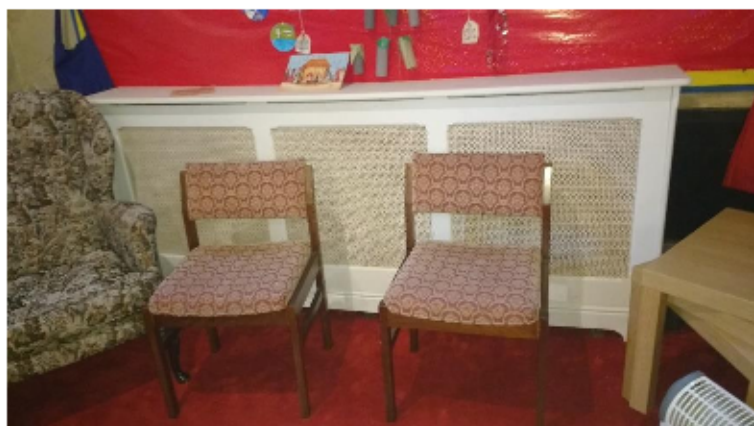
This radiator is unable to radiate and has limited ability to convect. The presence of a portable electric heater, bottom right, suggests that this seating area is not considered warm enough. The audit took place on a Thursday morning, when the church was open for coffee and cake. At 10:00, when the heating had been on for three hours, temperatures were: Floor 14.0-14.5°C, ceiling 14.8°C, north wall 12.6°C, pews 13.9-14.5°C, font 13.2°C, radiators 53, 54°C.

If it is possible to remove the wooden cover temporarily and experiment with the seating arrangement, this area could be made warmer.

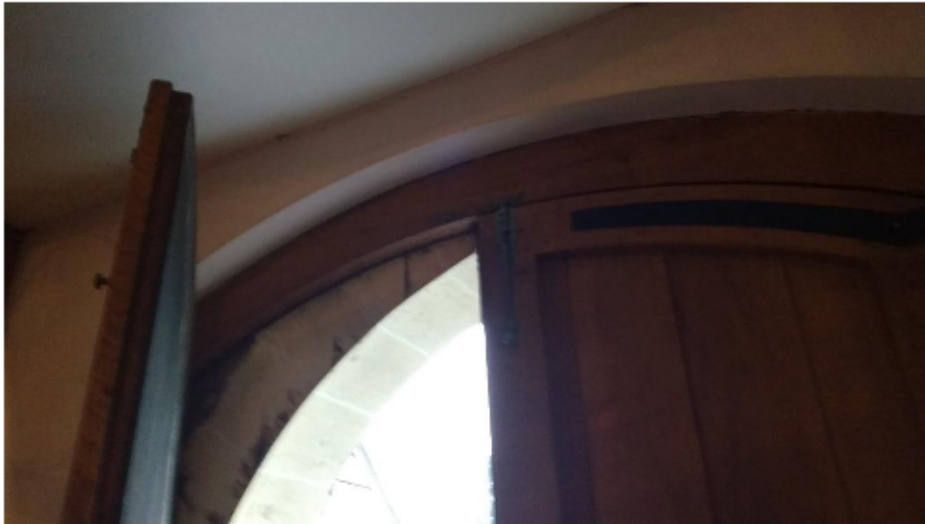
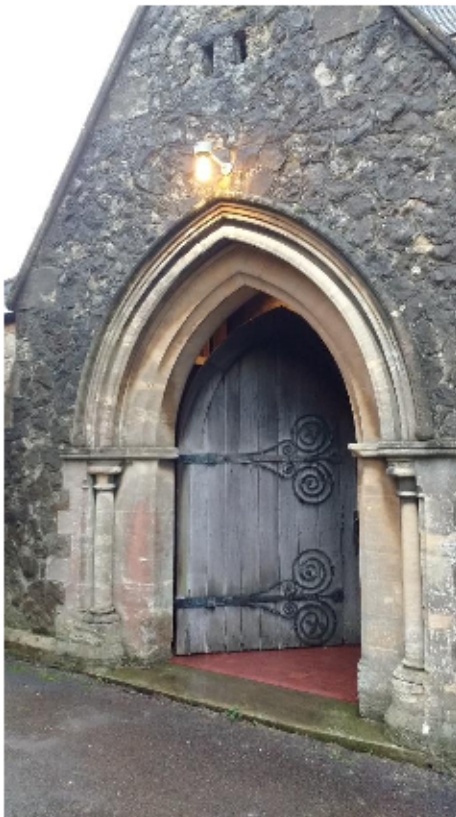
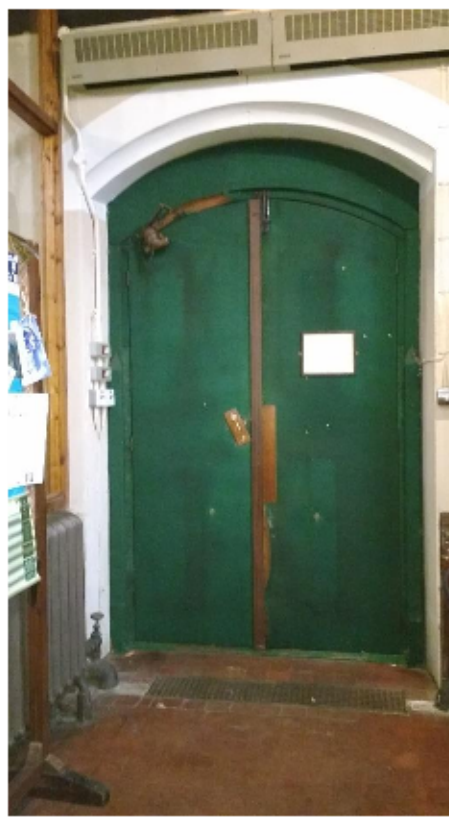
The tower and porch doors both close against stone with the wooden door set into a substantial recess, (see below) which offers the opportunity for some form of draught exclusion to be added, either between door and stonework, or door and wooden frame.

The porch door leads to inner doors which are covered with a mix of felt and leather strips around the edges – this system appears to fill the gaps but probably needs some maintenance to keep weather tight.

South porch doors, external and internal (right)

Where a timber door closes against a timber frame it is recommended that draught proofing is fitted. A product called QuattroSeal (see link below) is often used in heritage environments to provide appropriate draught proofing.

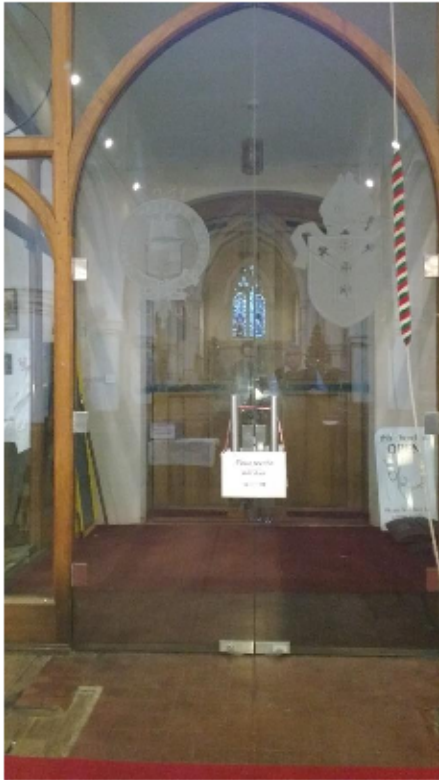
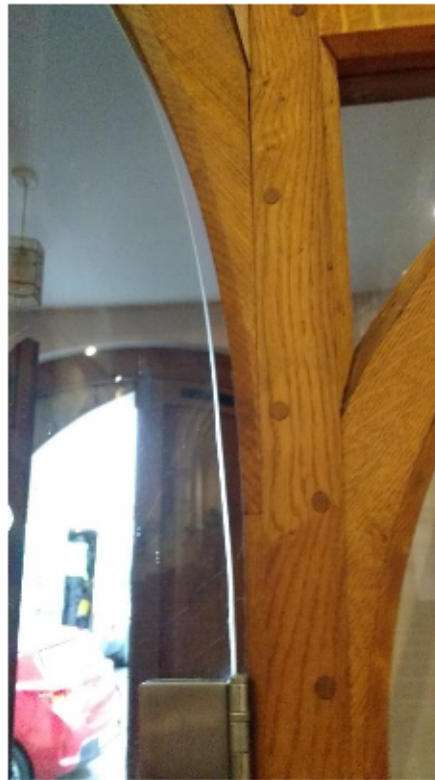
The inner glass doors to the tower cannot easily be made airtight due to their shape and the clearances provided. Other simple measures such as using a small fridge magnet painted black over the large keyhole or the use of 'sausage dog' type draught excluders at the base of little used doors can prove to be very effective. Doors should be reviewed in daylight and gaps where the light shines through sealed or filled in whatever the most appropriate way is for the specific door.

West tower internal glass doors, these would be very difficult to make airtight.

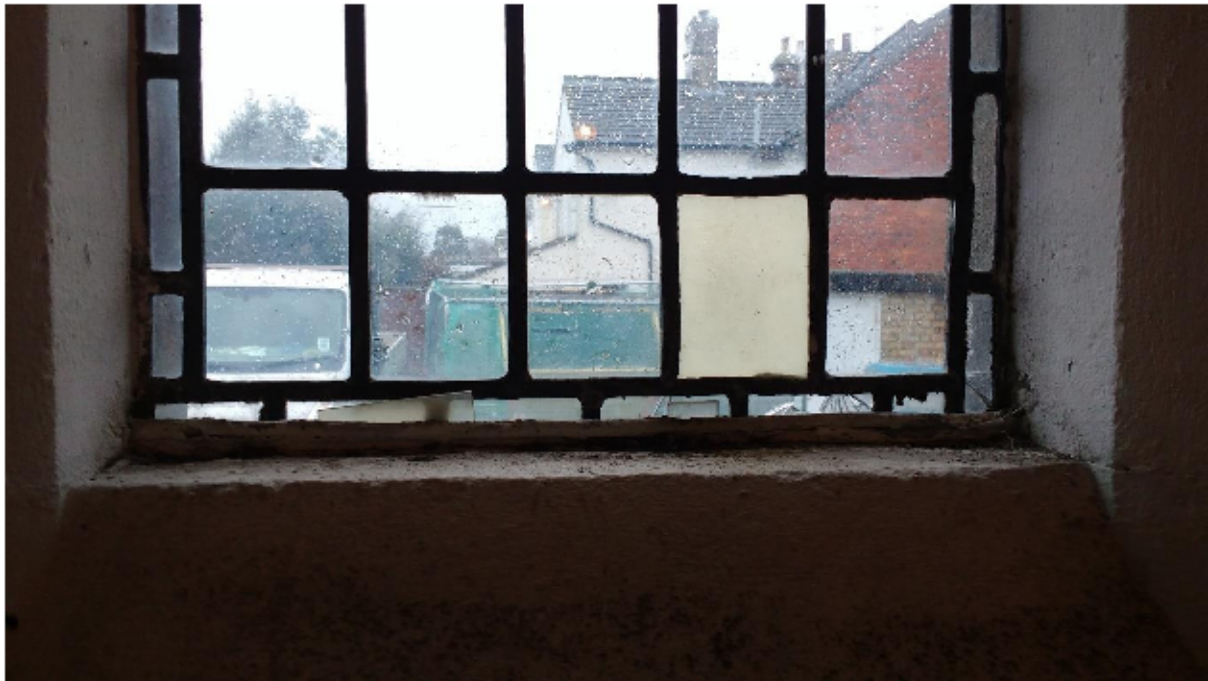
There are several windows in a poor state of repair where damage, probably from corrosion has distorted the framework to the extent that large gaps are appearing in the window structure.

This will lead to significant loss of heat from the building, with constant draughts, and to ingress of rain and moisture causing further problems.

If there are draughts caused by small cracks or hopper windows not shutting correctly, a temporary solution is to use black plasticine to fill gaps. However, many of the areas of damage are too great for this to work, Care should be exercised where there is already broken glass, as seen below.

**It is recommended that the PCC release money for window repairs.**

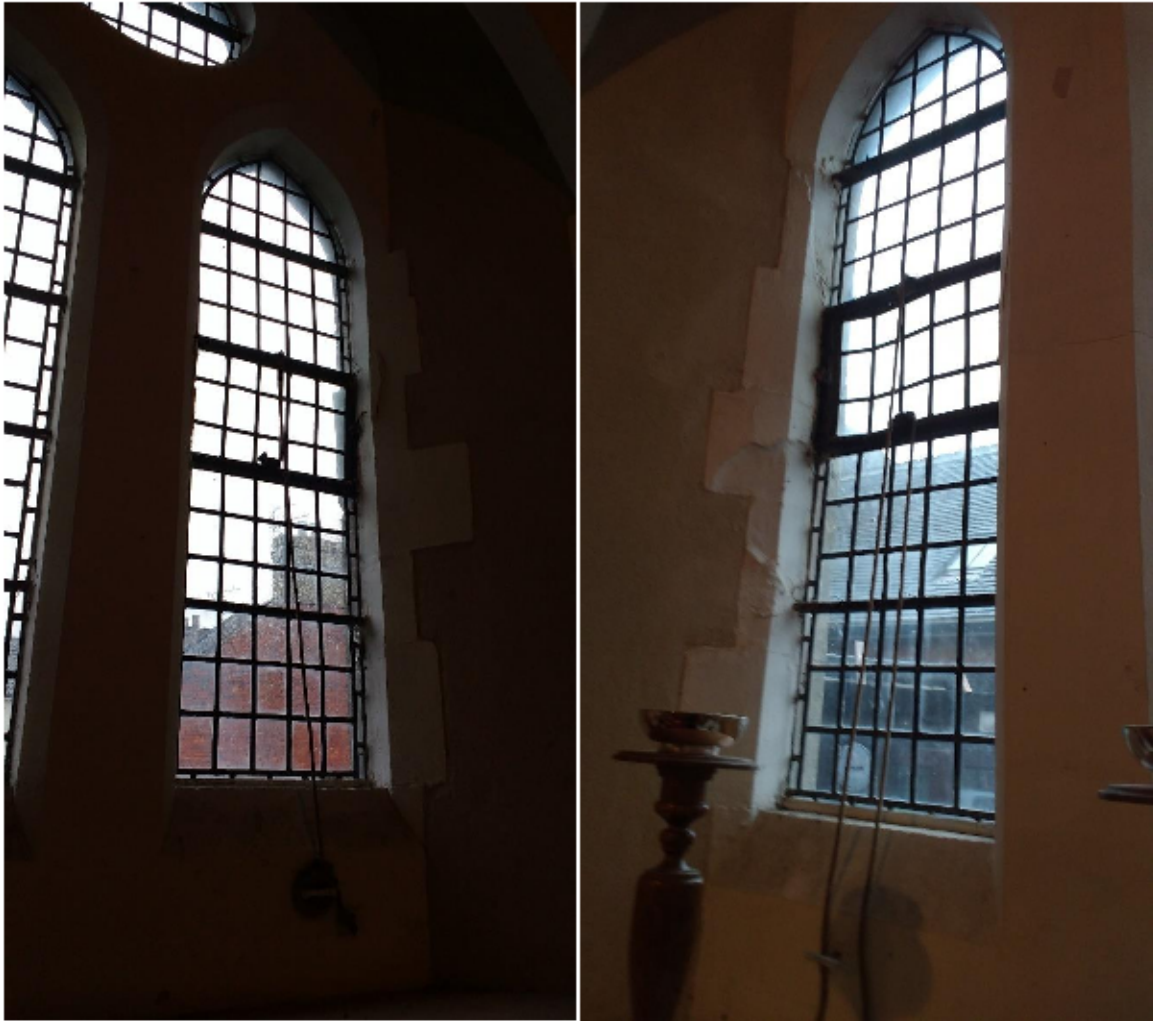
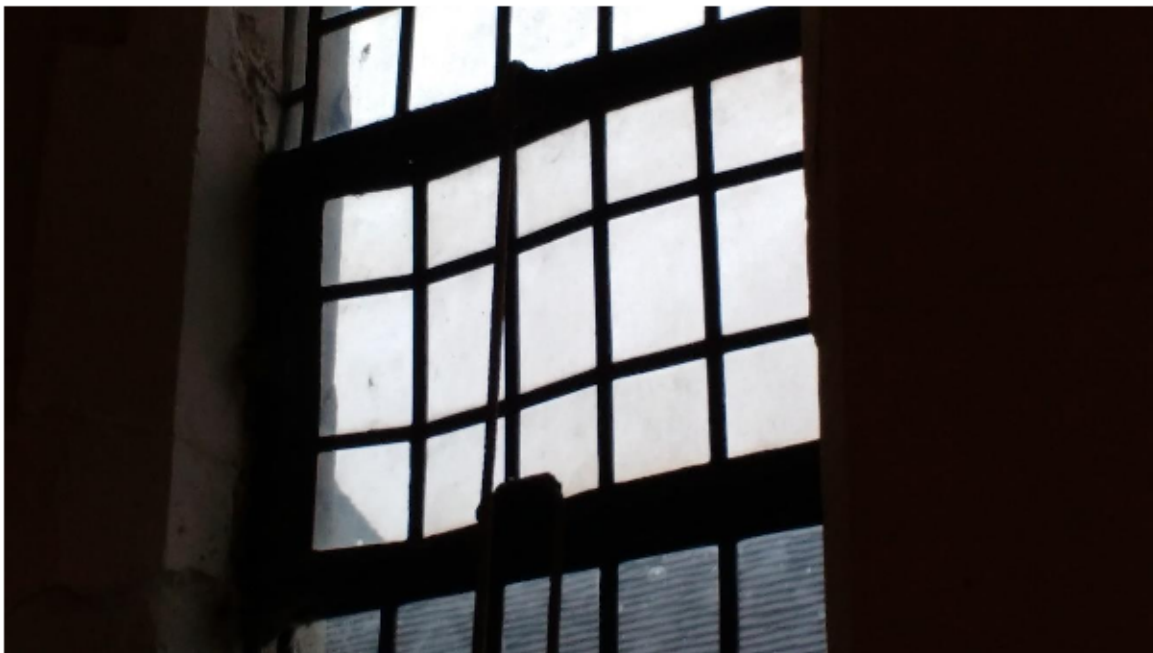
Many of the windows are in a poor state of repair, with cracked, broken or missing glass at the edges, ironwork which has corroded and deformed due to rust jacking leading to severe deformation, opening sections which will not shut. This is leading to draughts and ingress of moisture and rain which will cause further deterioration to the windows themselves and other fabric. The worst sections are approaching a state where large gaps will open.

**If this is not addressed it could lead to a chain reaction of decay.**

Actioning these repairs now will enable them to be carried out over the spring / summer to weatherproof the building before next autumn.

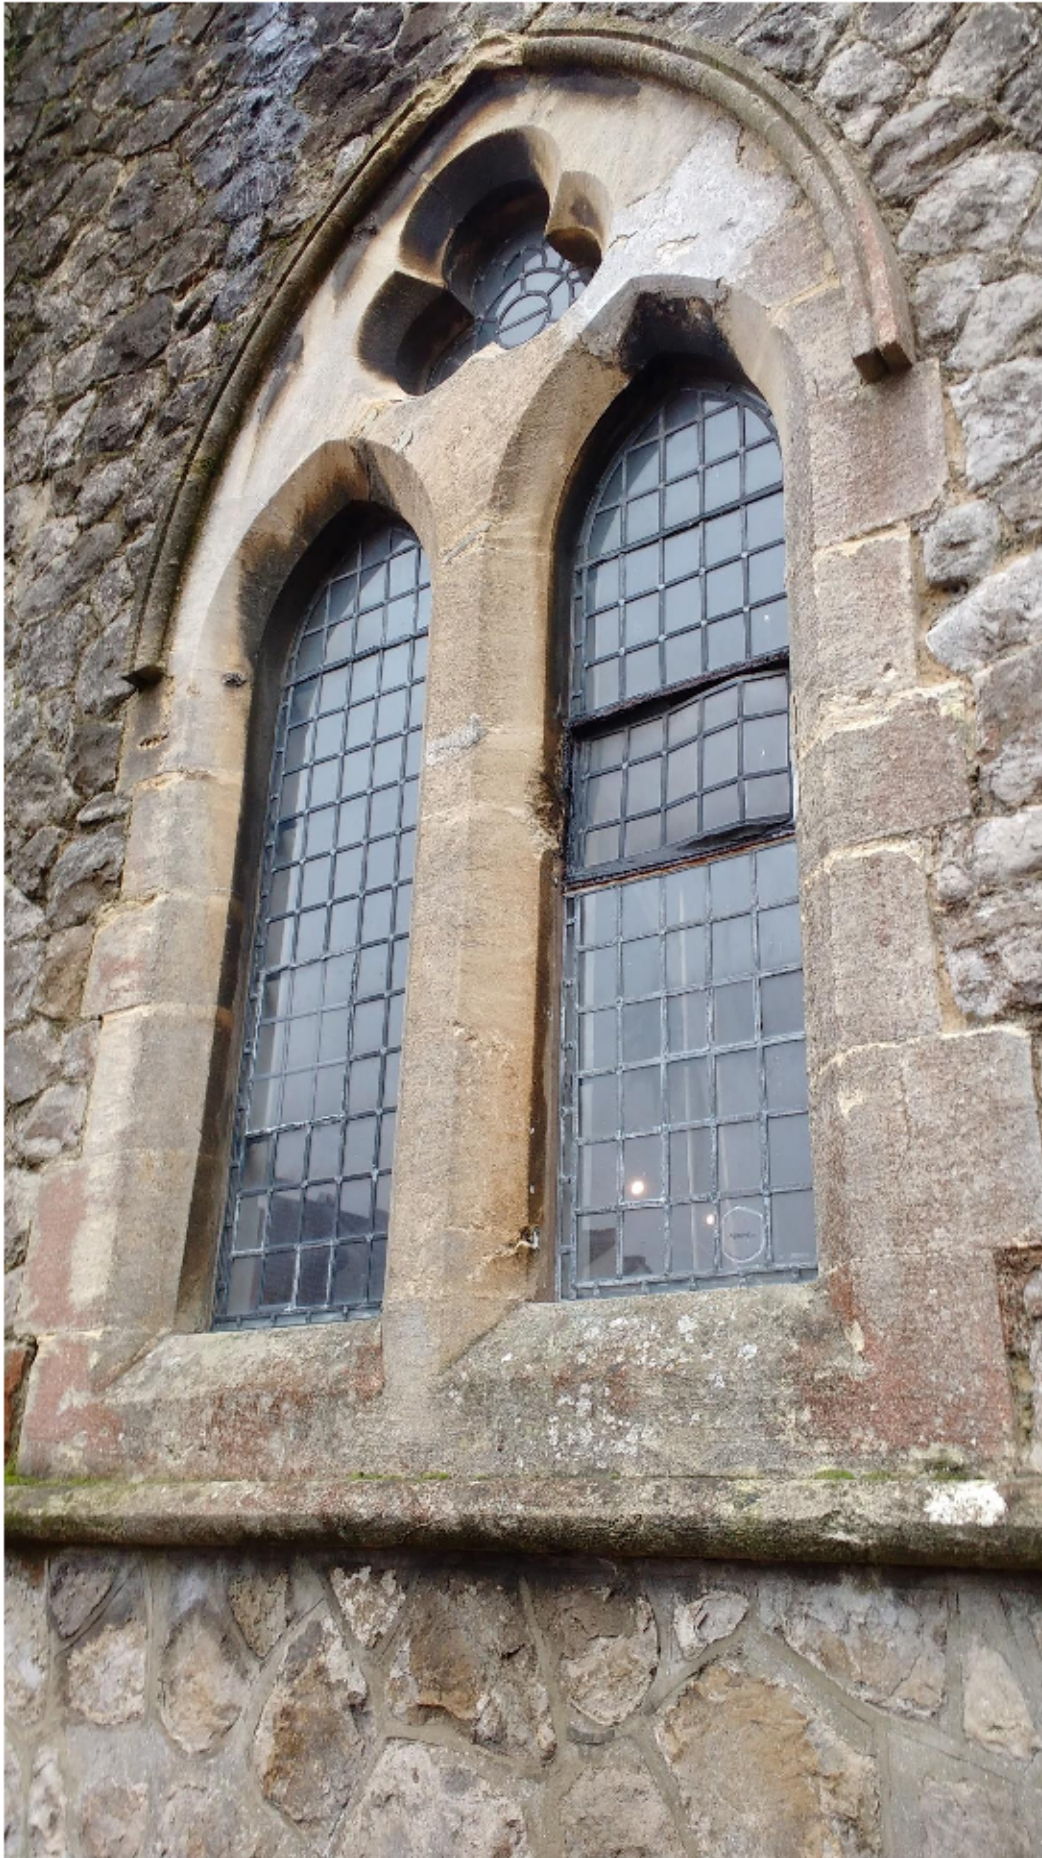
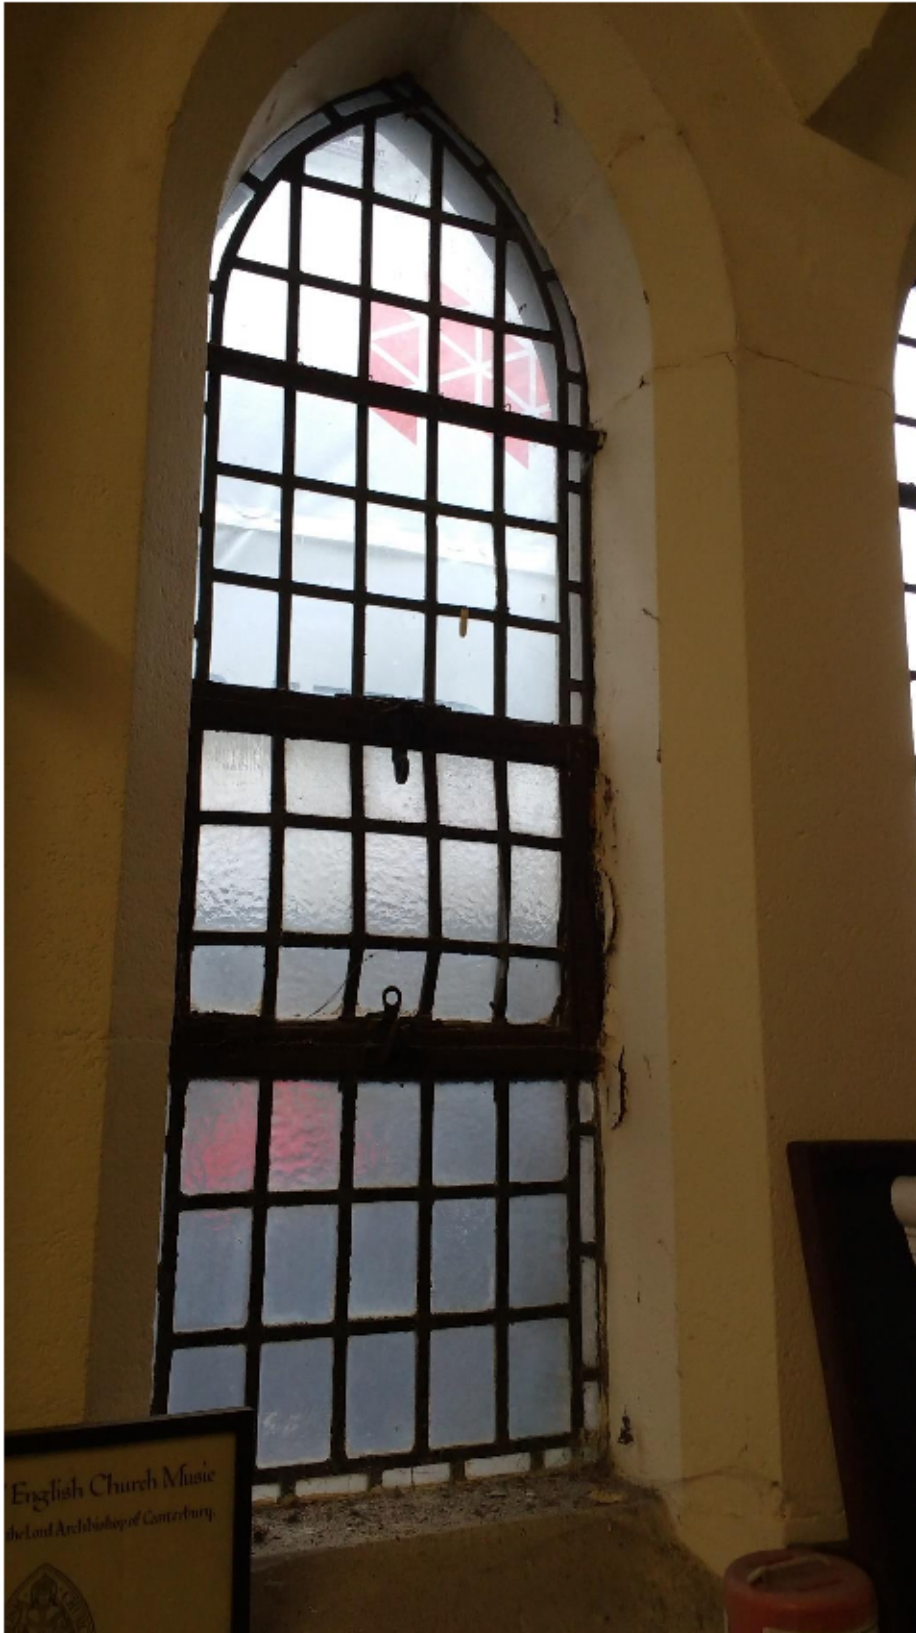
Above, possibly in vestry
