DOCUMENTATION  
OF  
CONSERVATION

ST WULFRAM'S CHURCH, GRANTHAM

Location: St Wulfram's Church, Grantham  
Window location: South aisle of NAVE  
Windows: Elizabeth Bradley window by Clayton and Bell

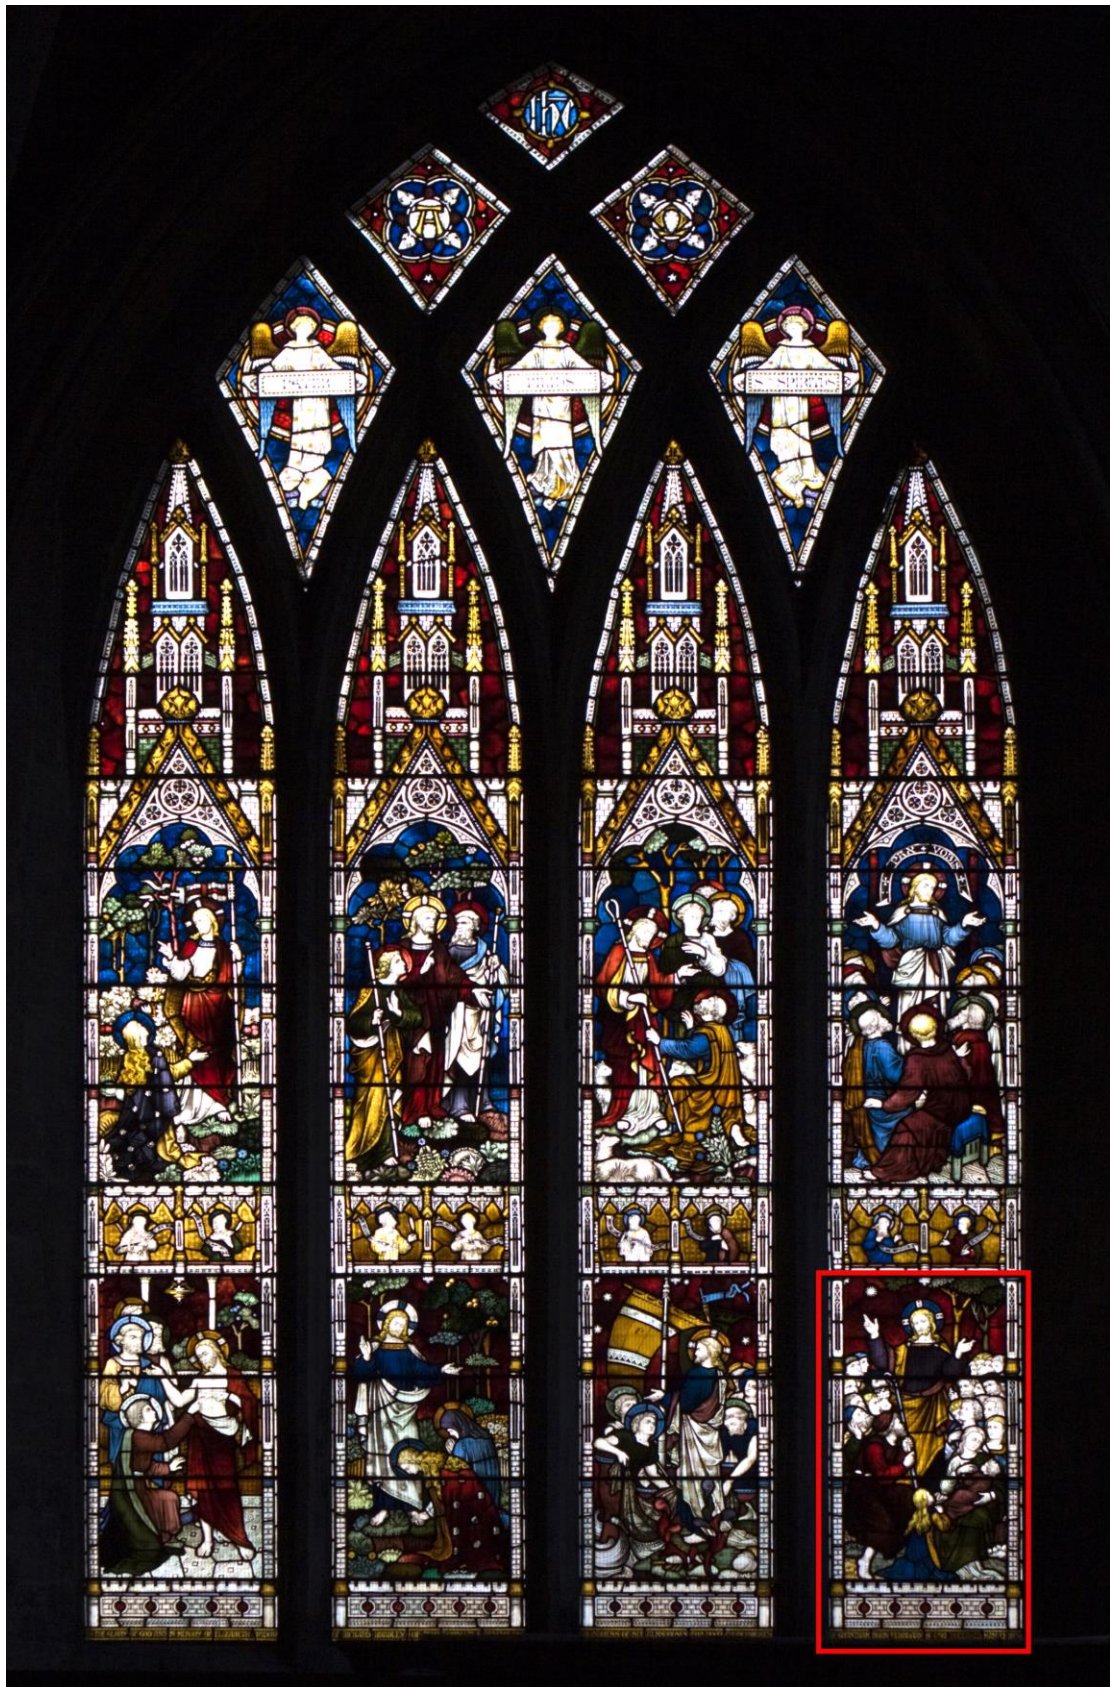
PLATE 2

Damaged panel 1d

Panel before Conservation

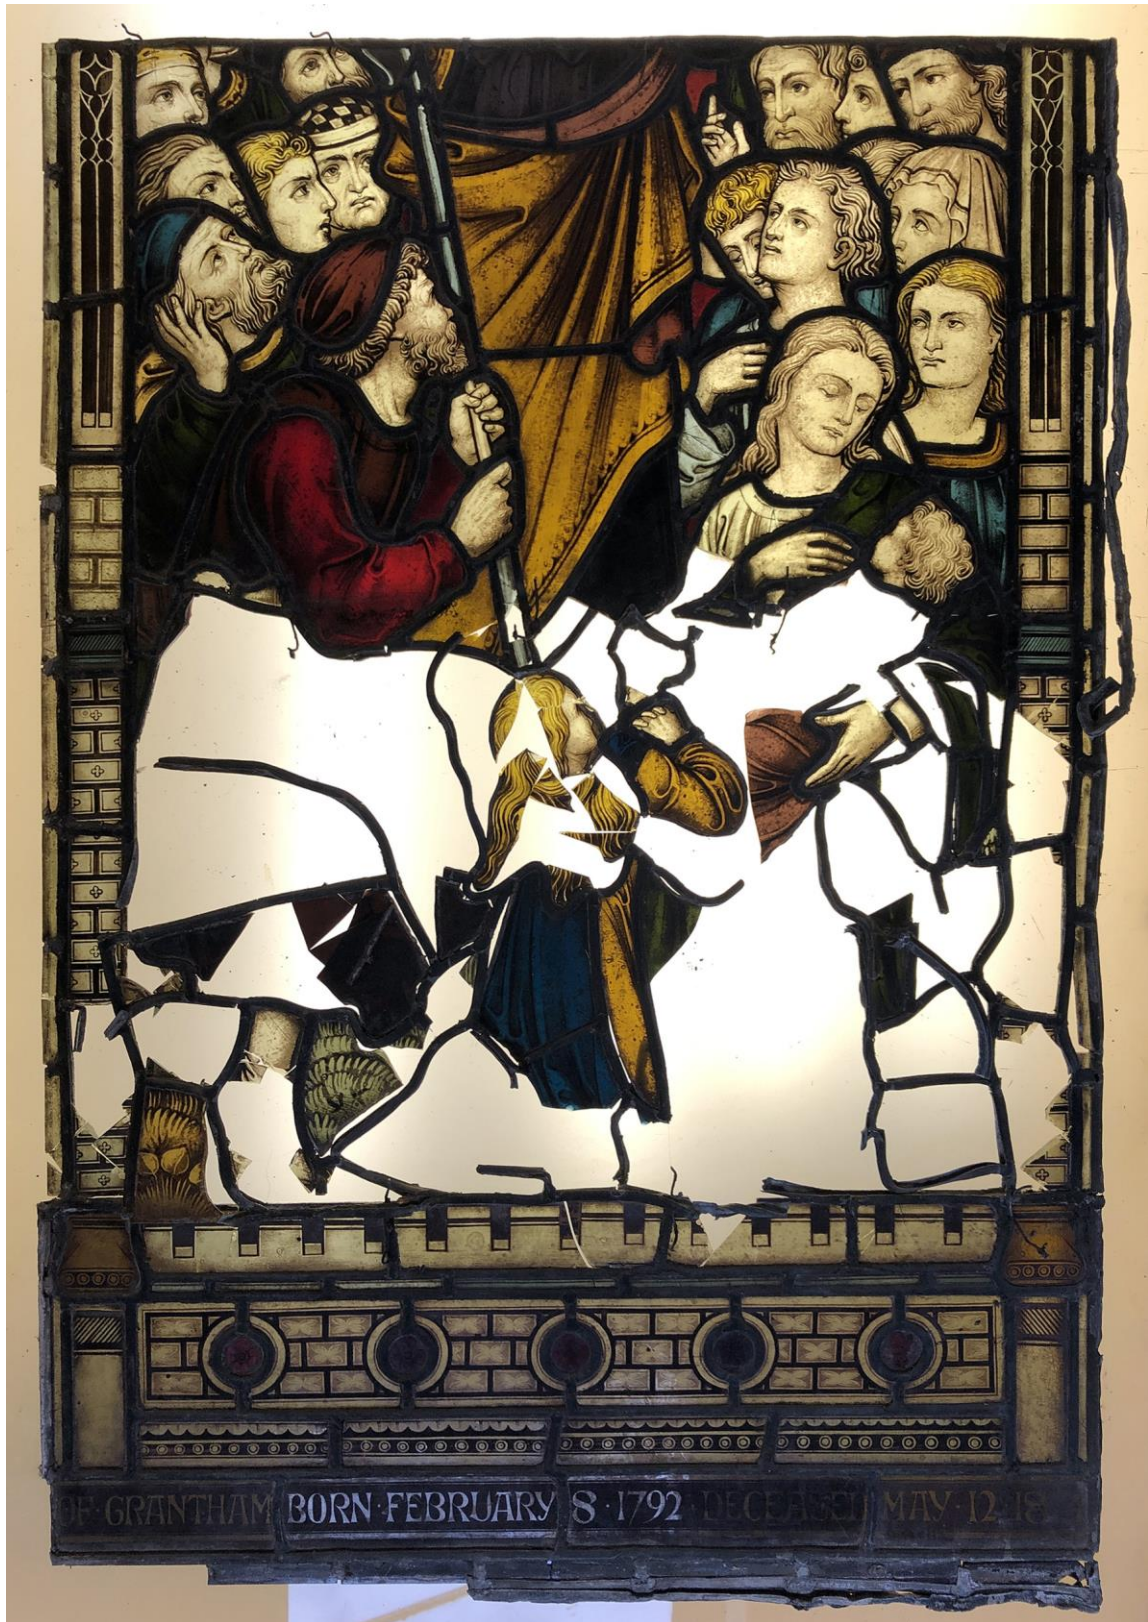
PLATE 3

Damaged panel 1d removed from stonework

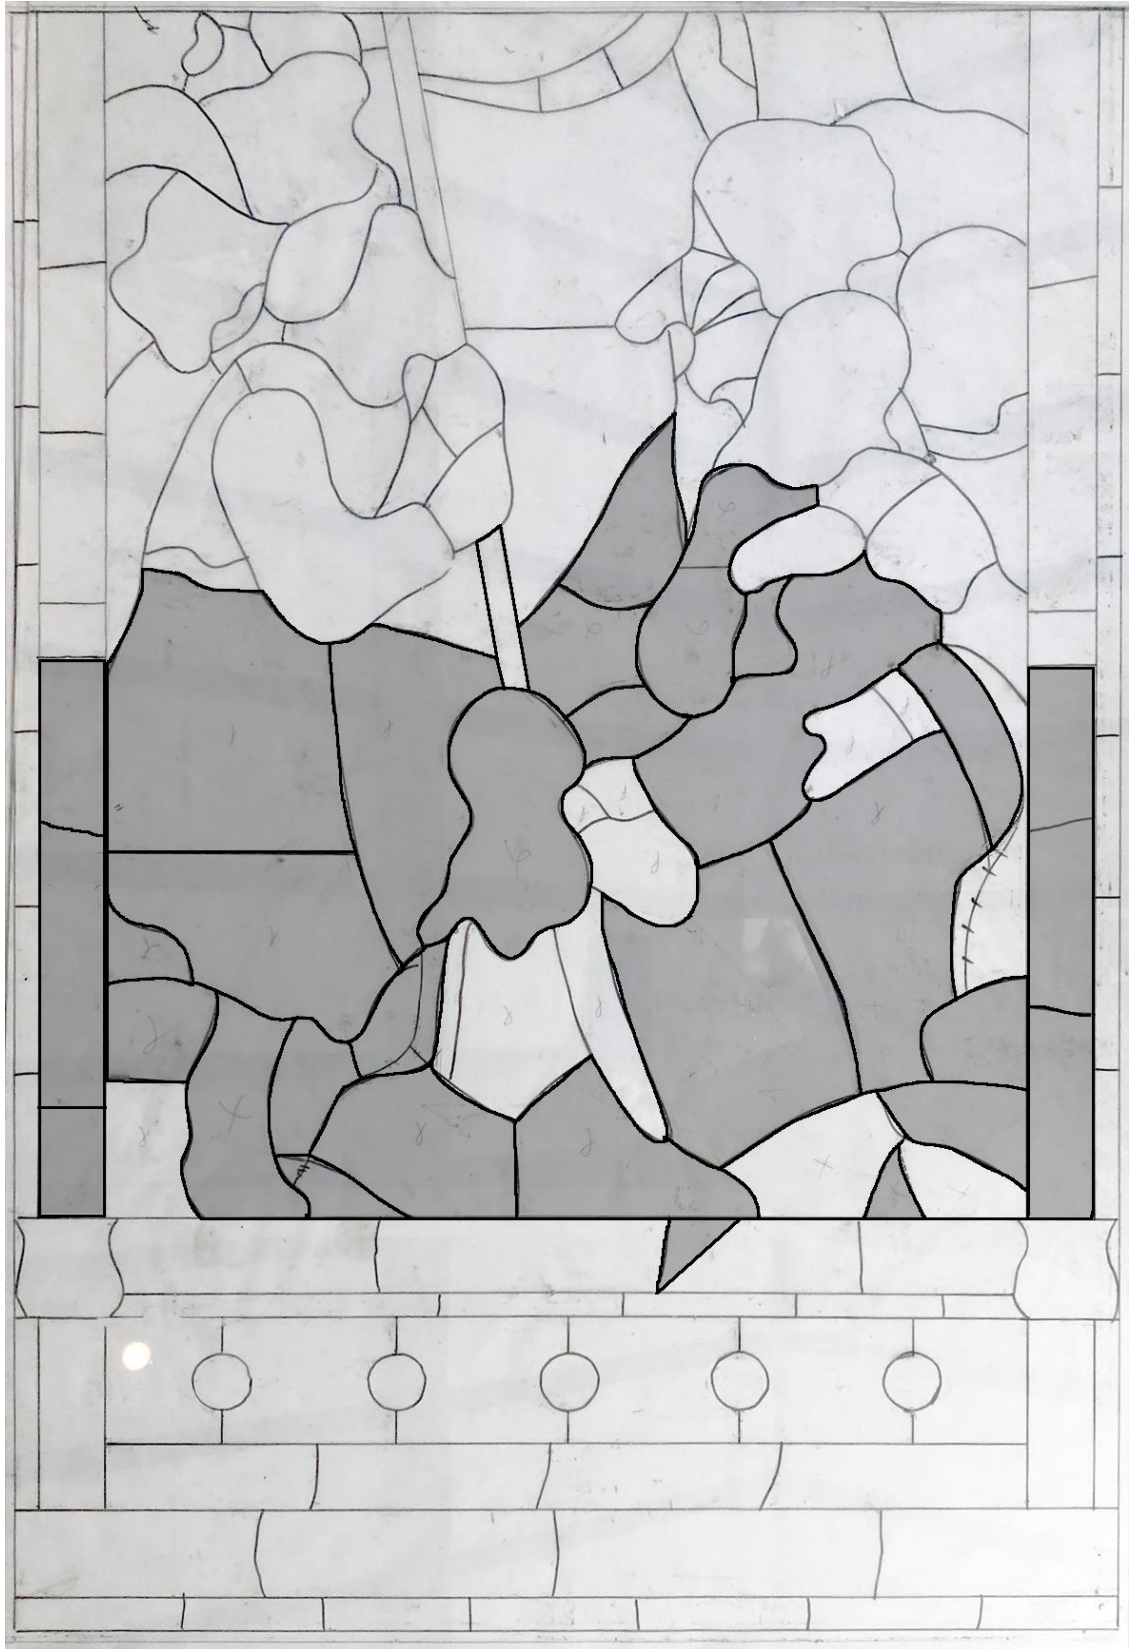
PLATE 4

Missing areas to be repainted

Sections of damaged painted glass which could not be edge bonded and re-used were replaced with new painted insertions. These insertions were edge dated as an historic reference. (see PLATES 4, 5 & 6)

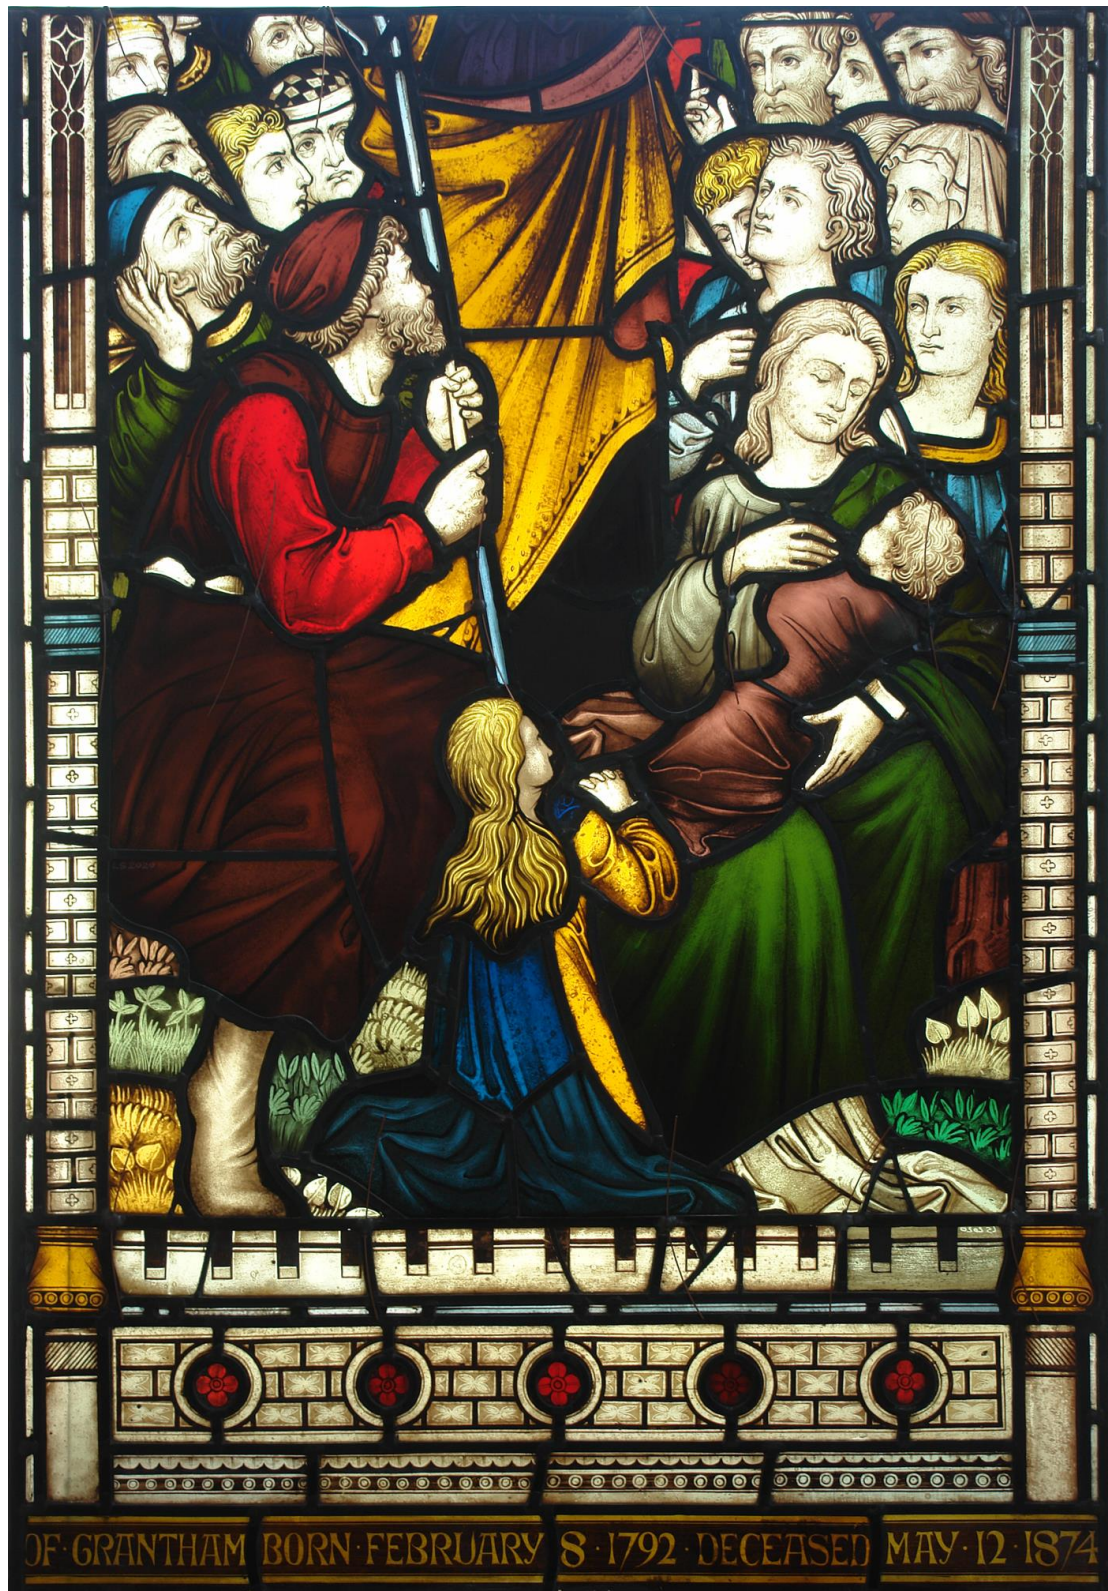
PLATE 5

Panel releaded and repainted

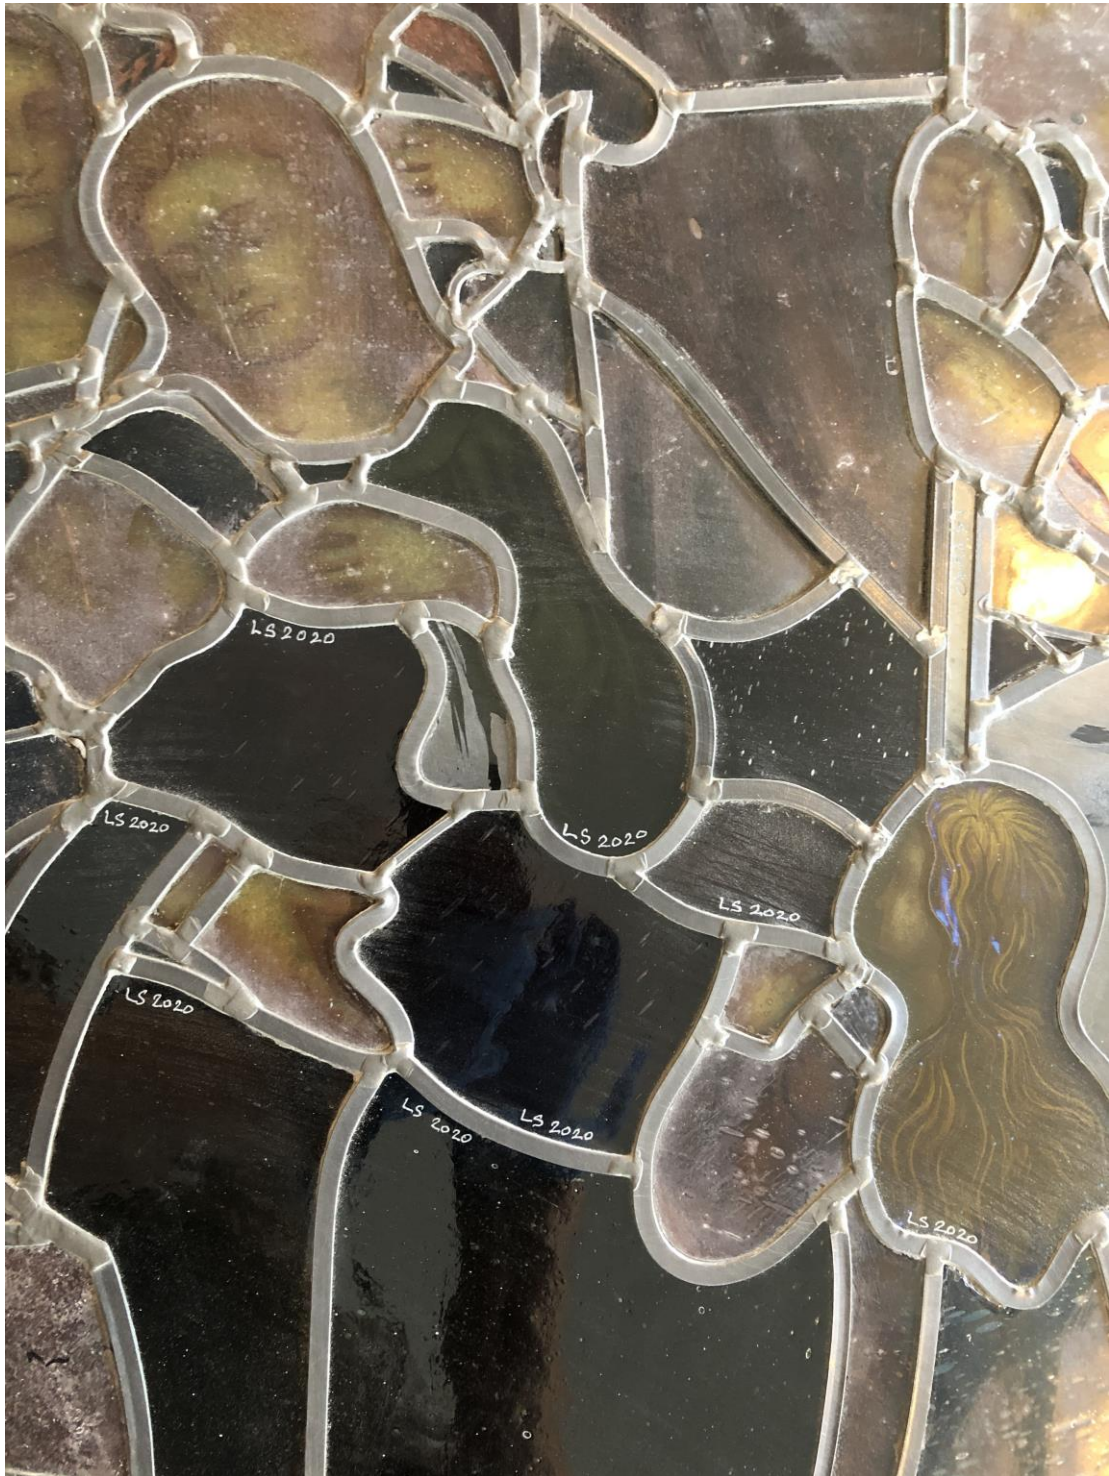
PLATE 6

Etched dates of work "LS 2020" = Limelight Studios 2020

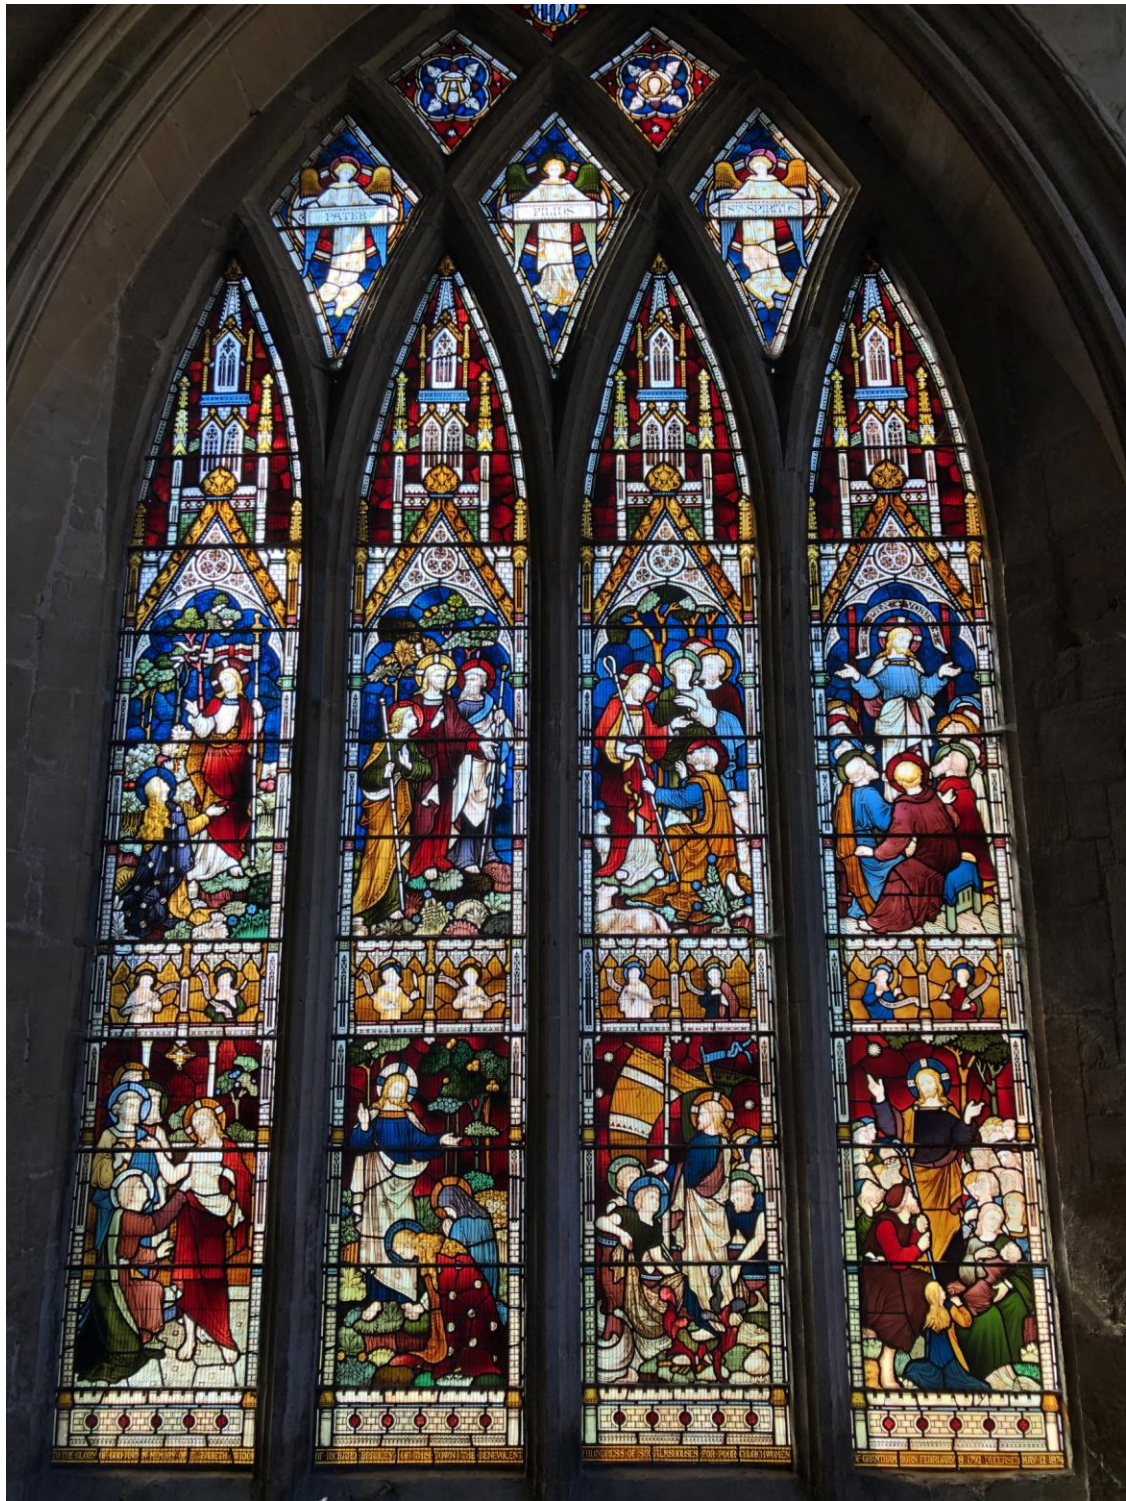
PLATE 7

Completed panel reglazed in position

Panels were installed into existing stone apertures using lime putty to match colour of surrounding masonry.

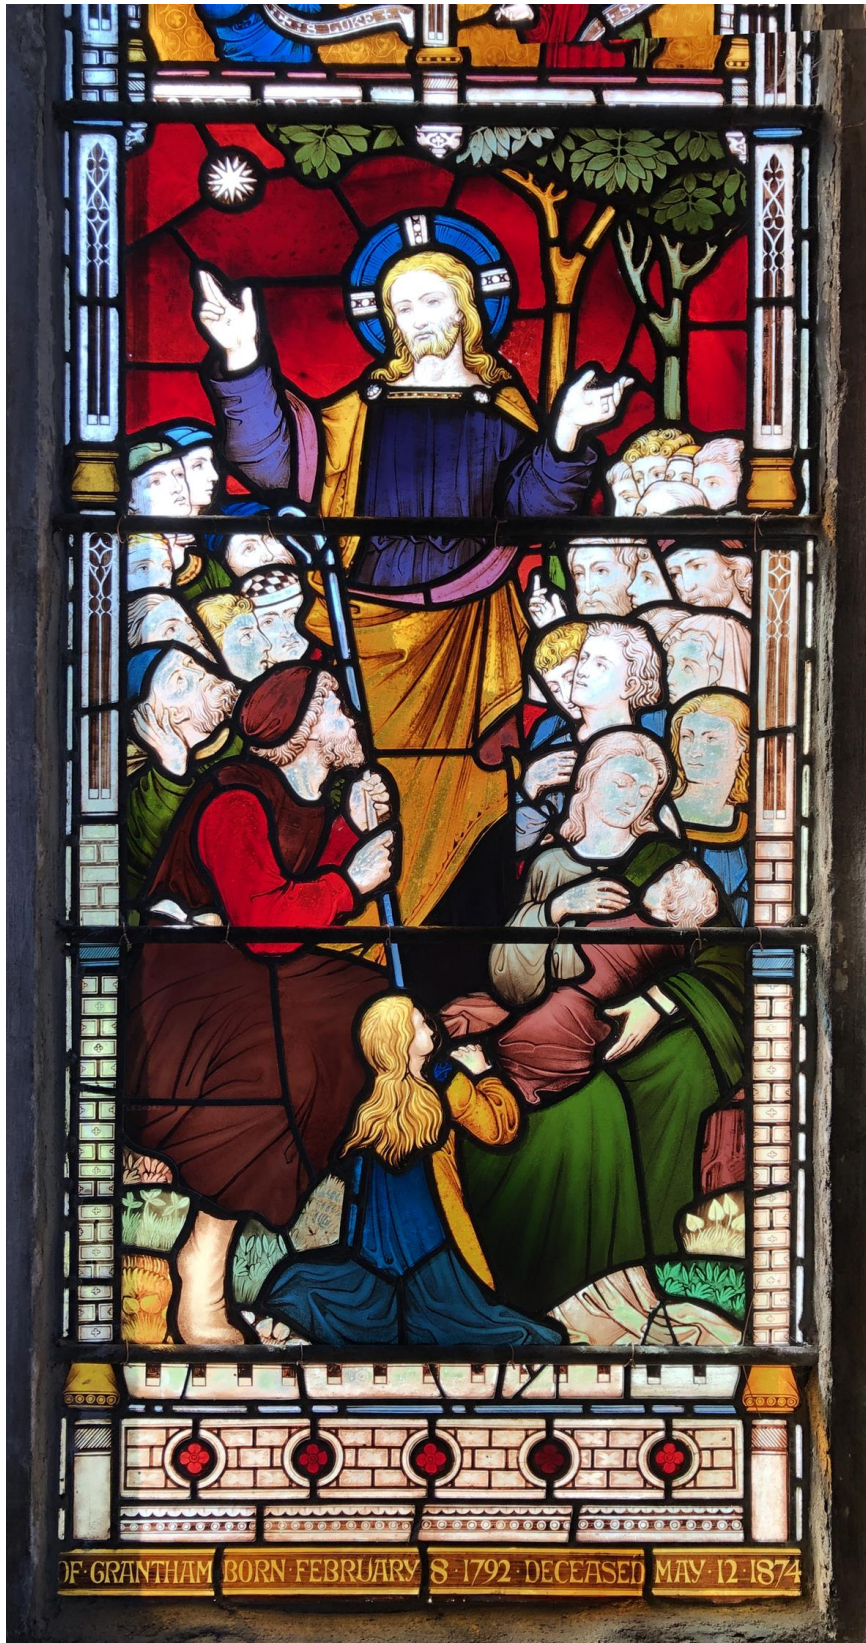
PLATE 8

Detail of completed conservation panel.
