**ST GILES PARISH CHURCH, STANTON ST QUINTON, WILTSHIRE:
STANDING BUILDING SURVEY ON MAIN DOORWAY
WITHIN THE SOUTH PORCH**

May 2019

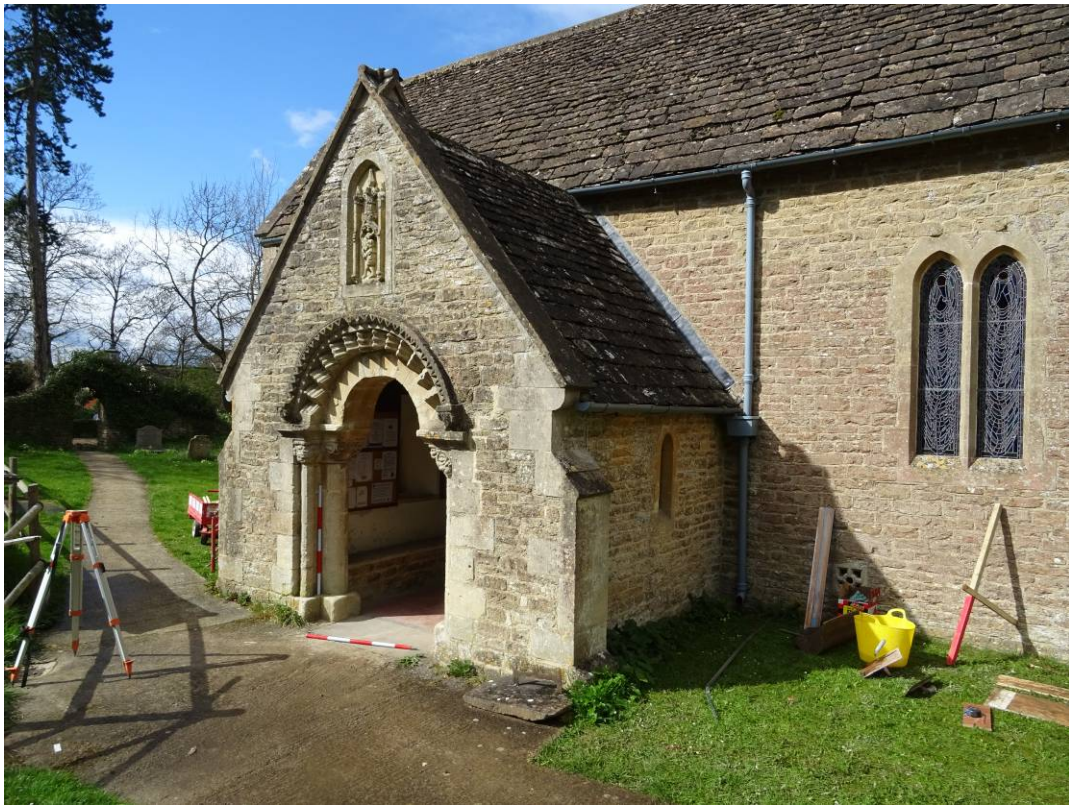
Plate 1. South porch dating to the 19th century abuts the medieval fabric of the southern elevation

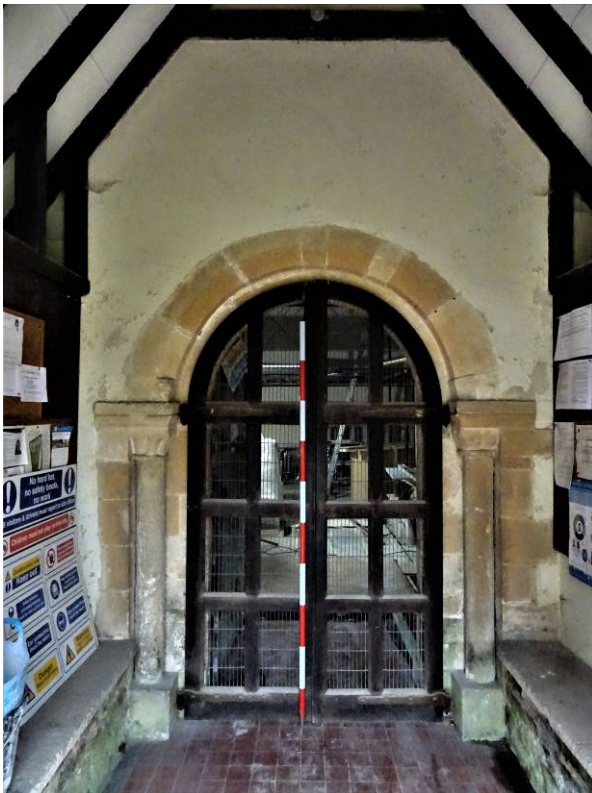
Plate 2. General view of the gated door access into the nave from the porch entrance

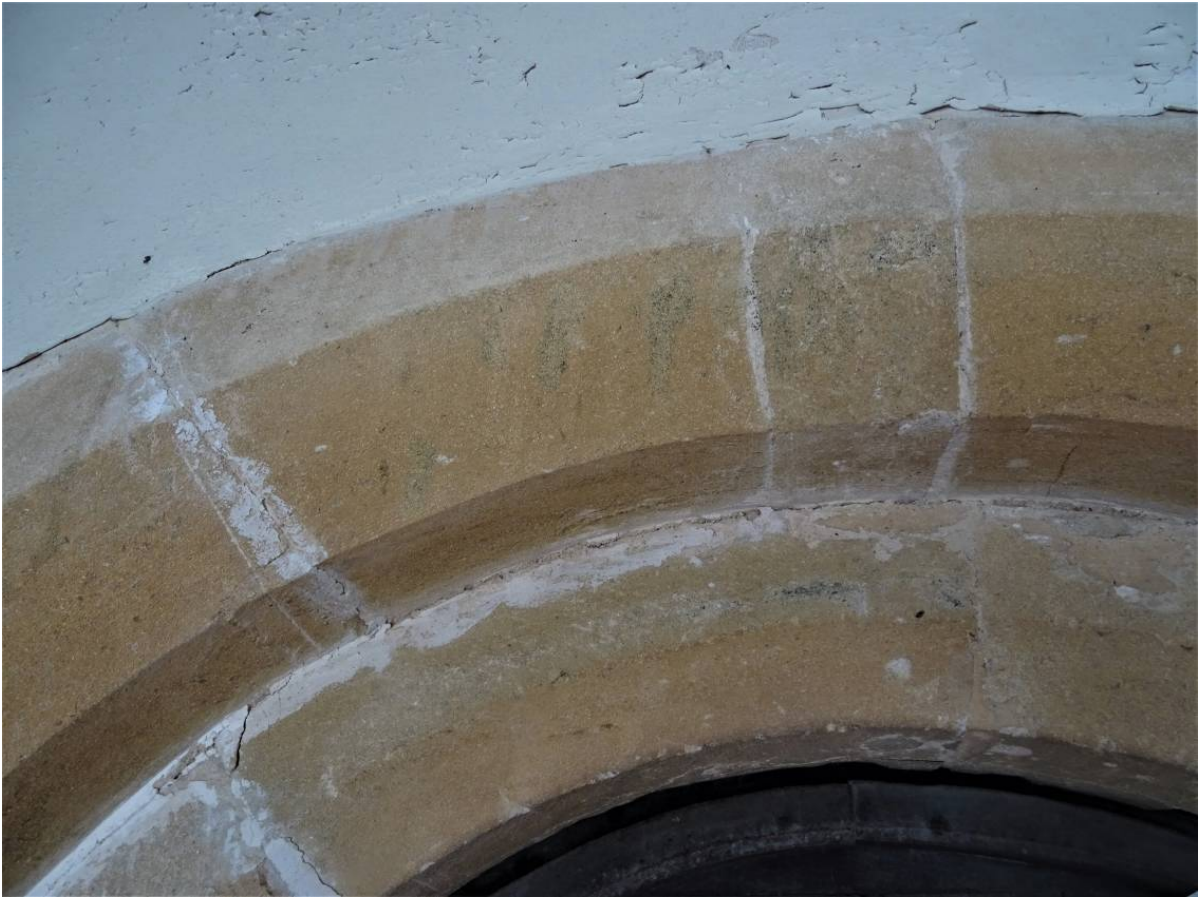
Plate 4. Detail of the dressed stone forming the arch

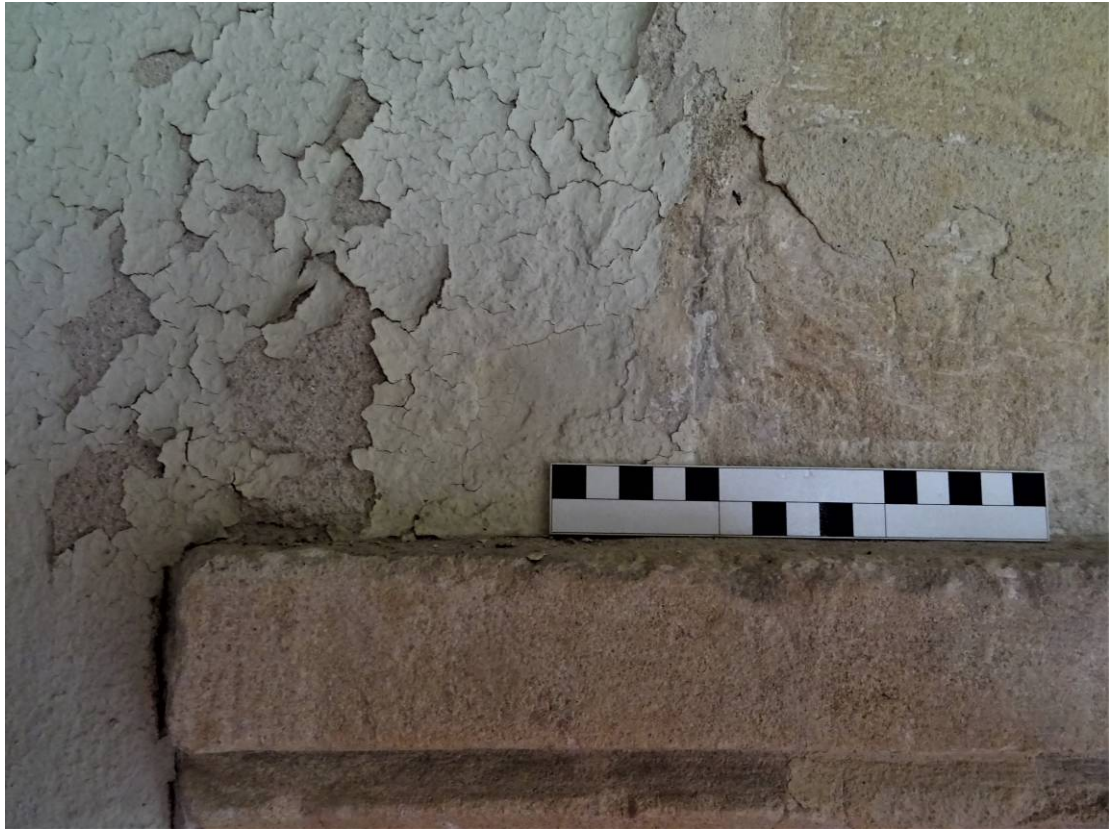
the nave was enlarged. The render surrounding the casement shows clear evidence (either side) of the layering of paint (lime-wash) (**Plates 8 and 9**). The lower section of the door casement is considered much earlier. This assumption is based on the weathering and geology of the stone plinths, columns and pediments on which the arch rest upon. Another piece of evidence is the 16th/17th century style cross that is engraved on the lower section of the column on the western section of the casement (**Plate 10**).

Plate 8. Flaking lime-wash from around the upper section of the door casement

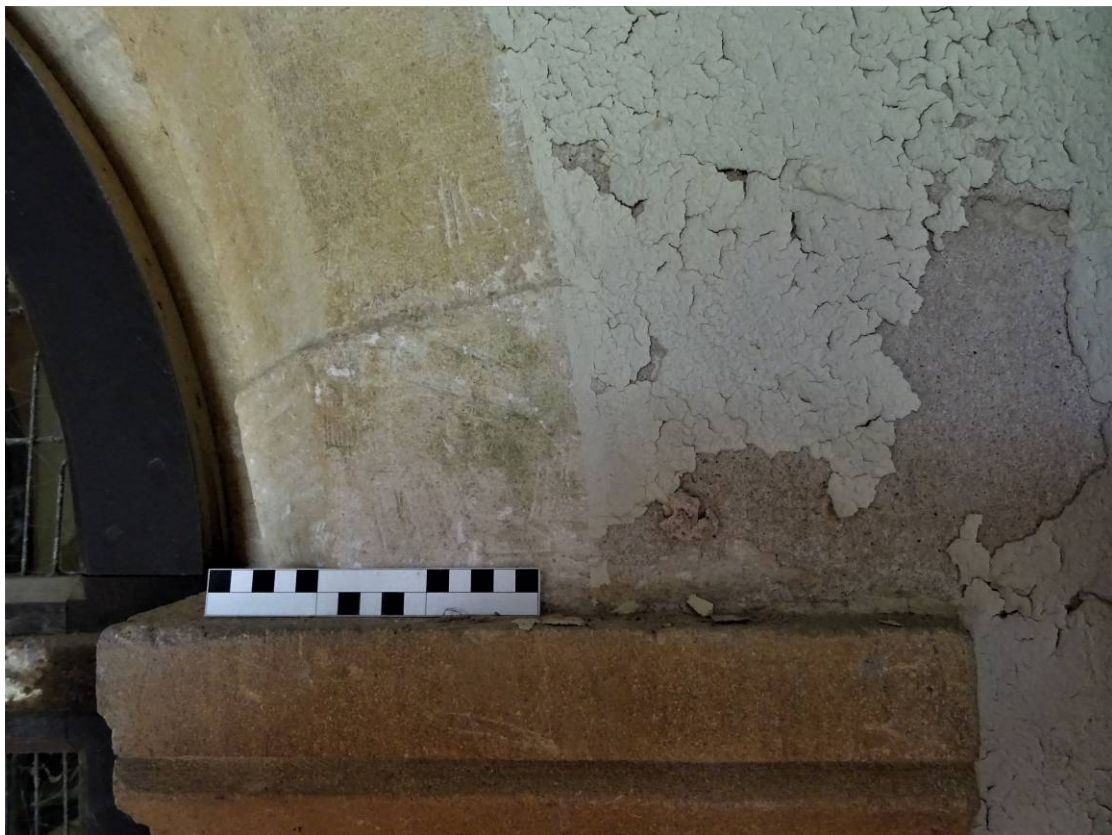
Plate 9. Flaking lime-wash from around the eastern upper section of the door casement

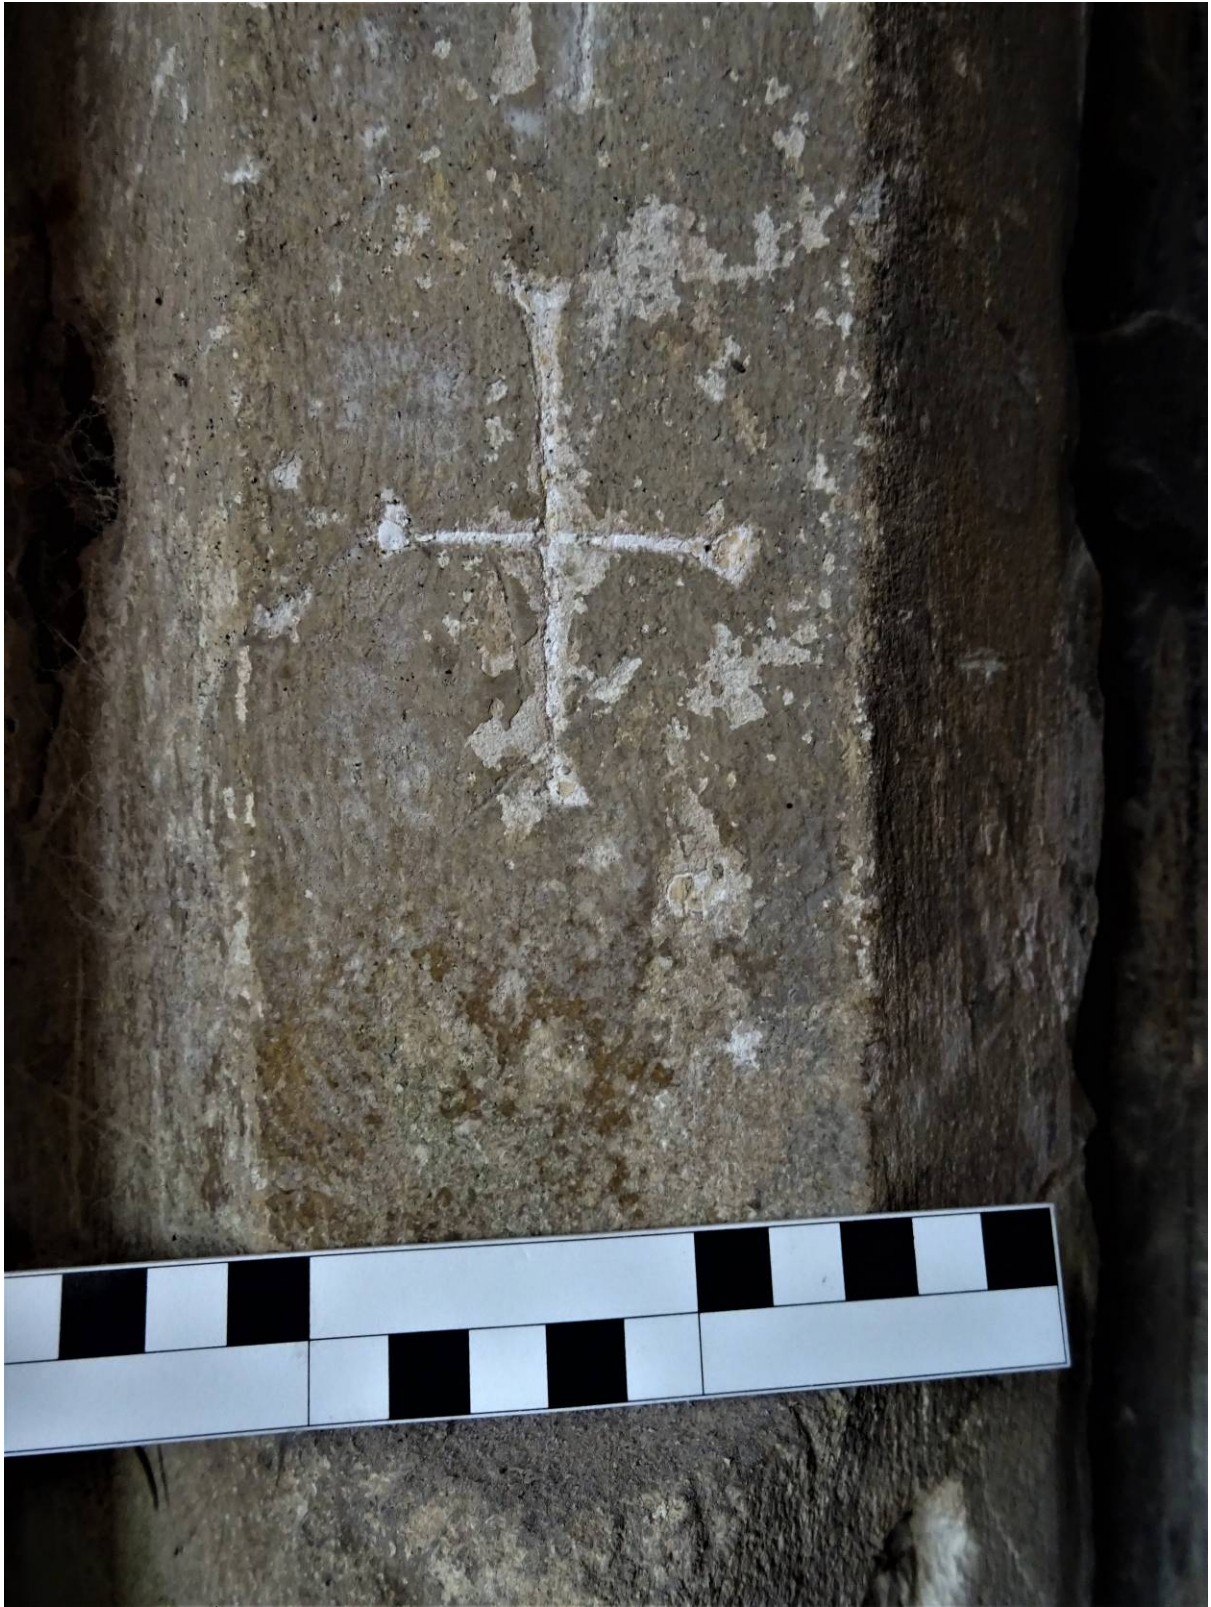
Plate 10. 17th century style inscribed cross located on the lower section of the western casement

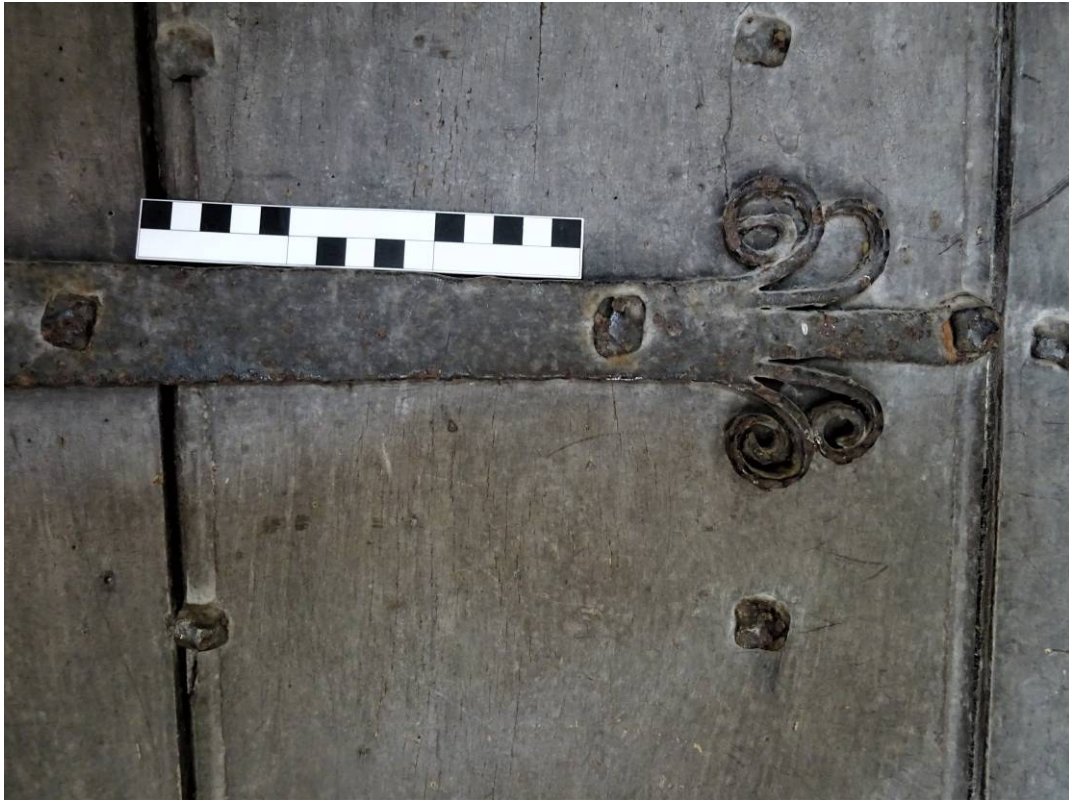
Using Alcock and Hall's guide to 16th, 17th and 18th century [house] fixtures and fittings (1994), one can gauge an approximate date for the timber door (see **Plates 11 to 13**). The strap hinge, drop handle and the two lock plates indicate a probable mid-17th century date. Similar fitting exist on the nave-side of the door (**Plate 13**).

Plate 11. Mid-17th century strap hinge

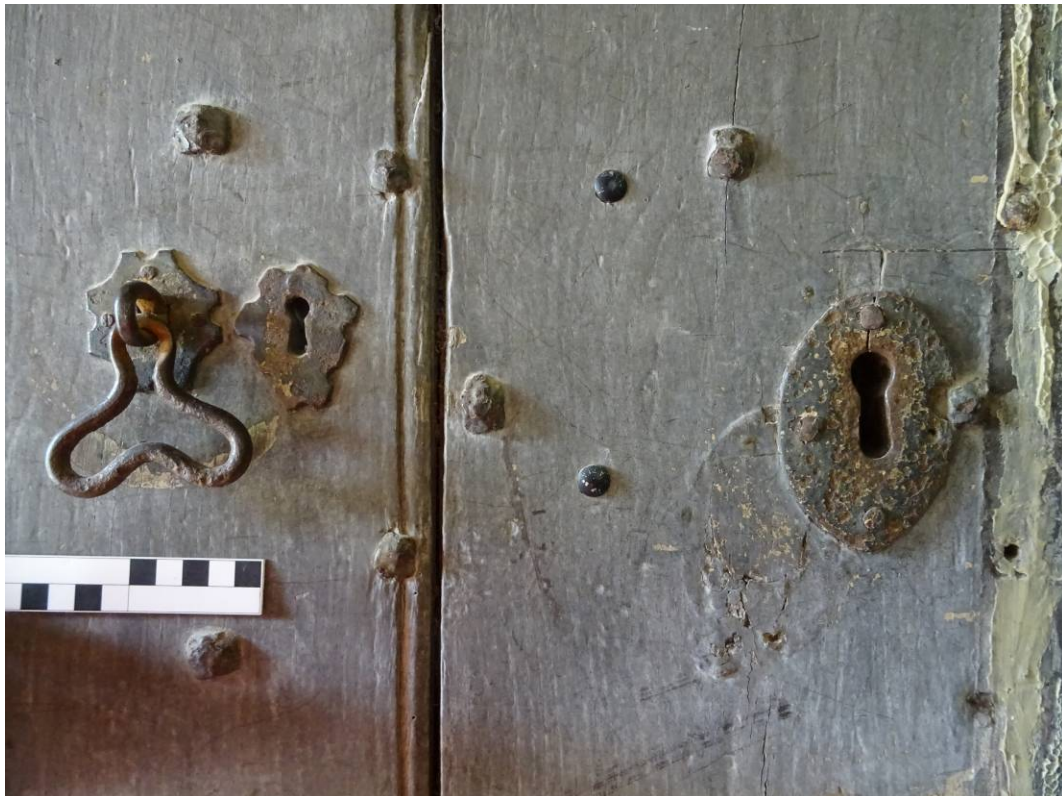
Plate 12. Mid- to Late 17th century drop handle and lock-plates incorporated into the door

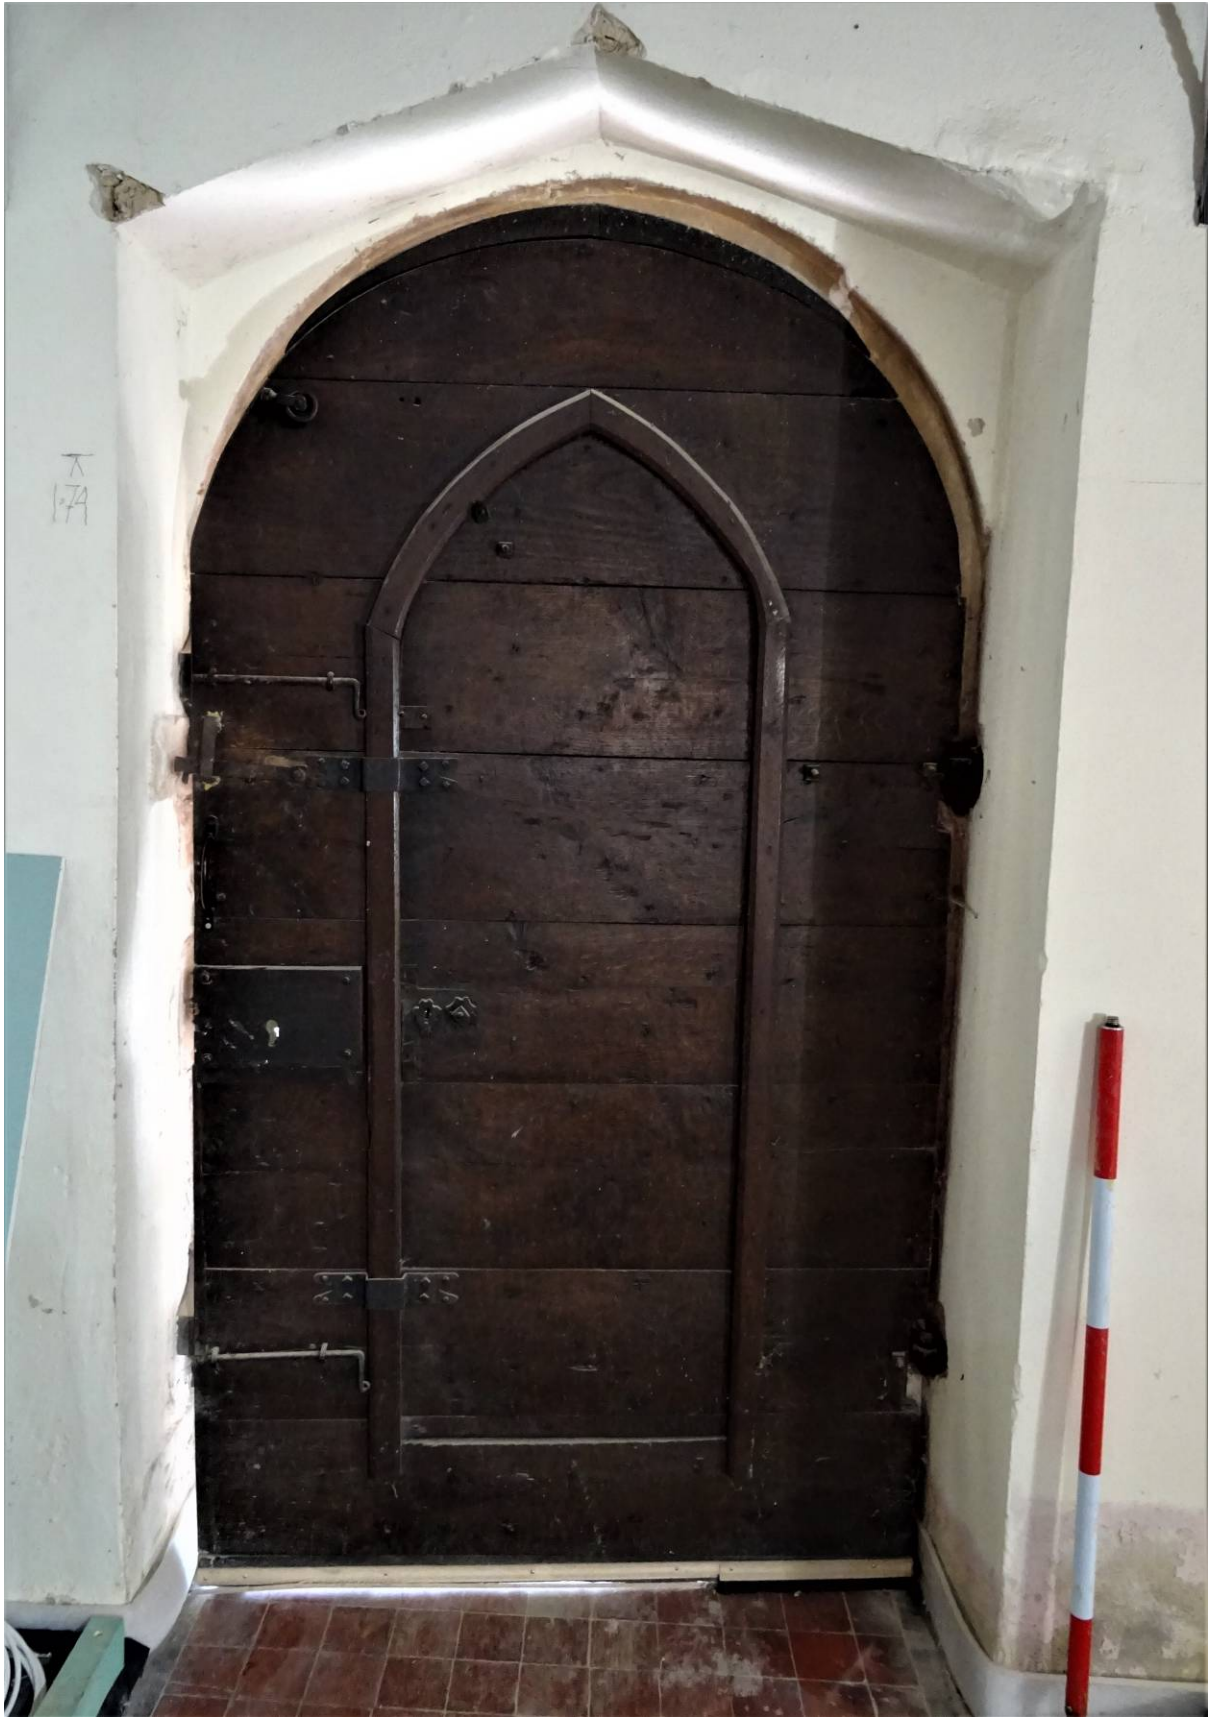
The nave-side door casement, which included a set of long and short quoins was rendered-over prior the remedial work (**Plate 13**). Only the upper section of the doorway was affected by the current work programme. Prior to the removal of render, the upper section of the nave-side door contained two diagonal moulded sections that converged centrally (**Plate 13**). This feature was considered by the author to be 19th century in date and replicates a 16th century 'Tudor' door opening style. Exposed, following the removal of lime-washed render around the door opening was the upper section of the east and west sections of the stone door casement (long and short quoins) and the exposure of a late-medieval squared arch, constructed in the Tudor style and supporting shoulder stone lintels either side (**Plate 14**). This unexpected feature showed signs of structural movement. Clearly visible was the keystone and the voussoir either side.

Plate 13. Reverse door face – image taken from the nave

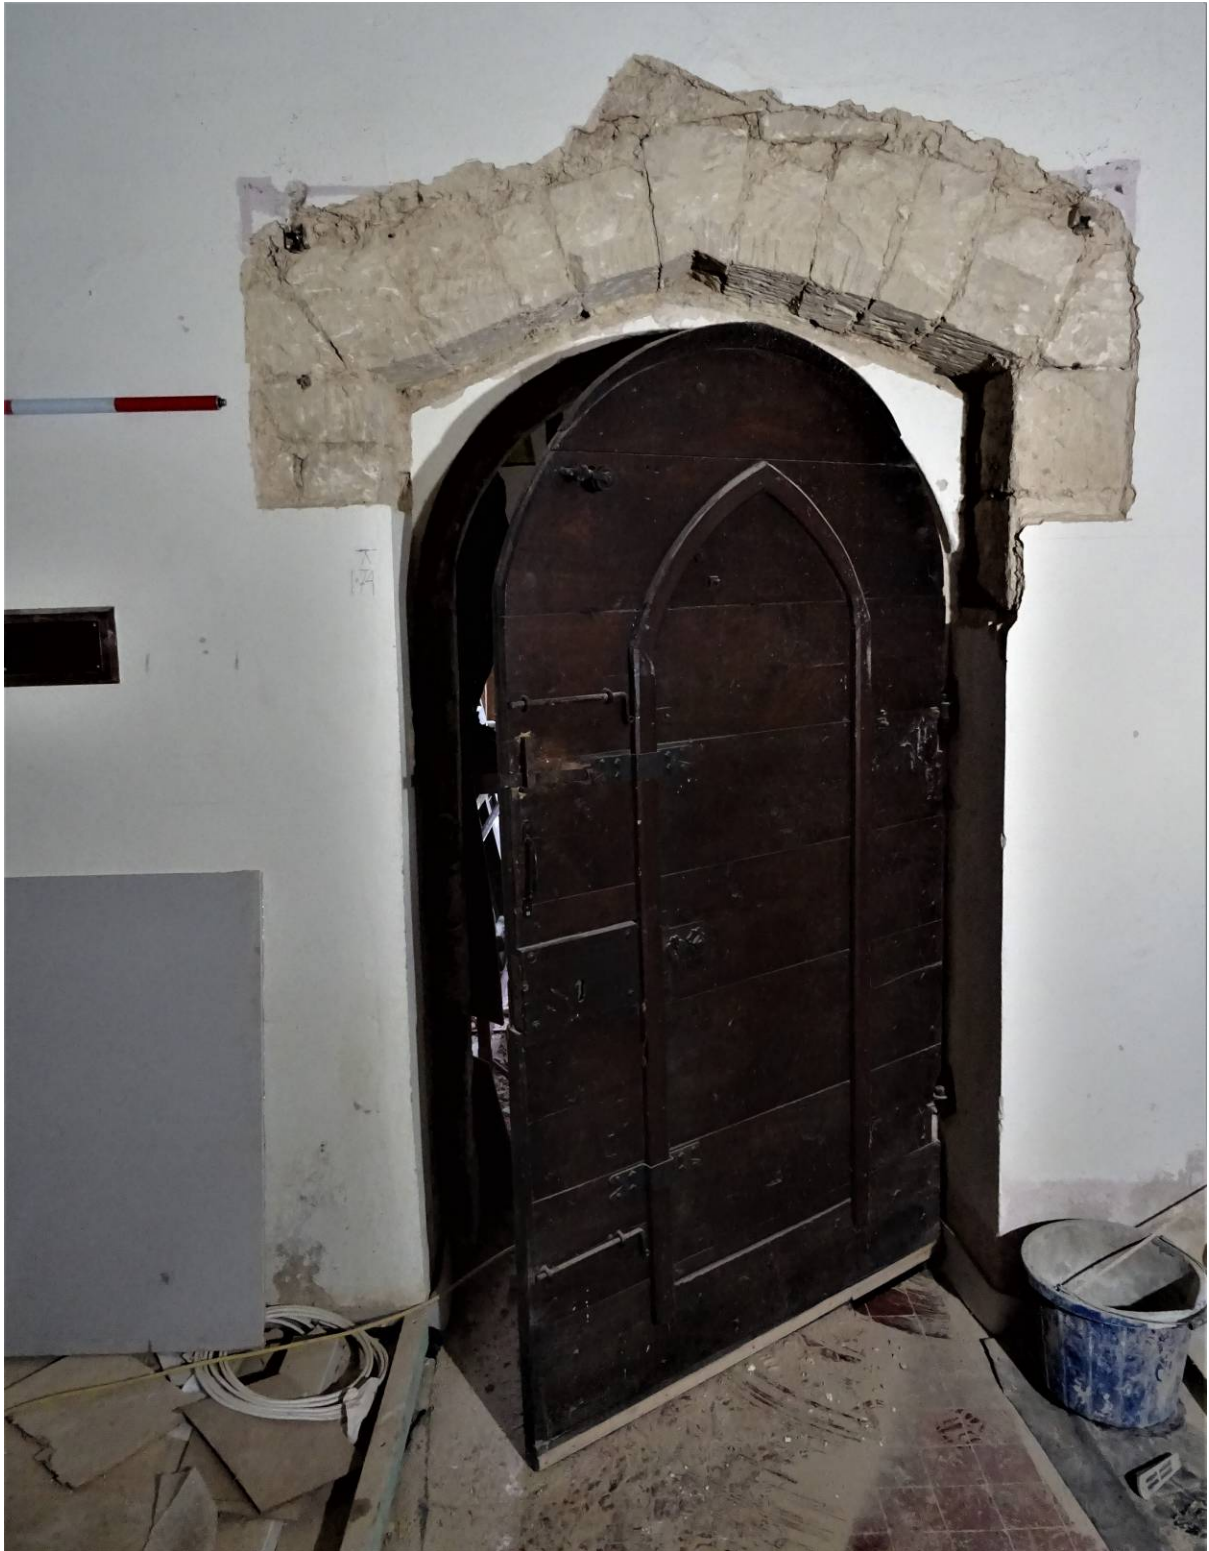
Plate 14. Exposed perpendicular arch, exposed during render removal

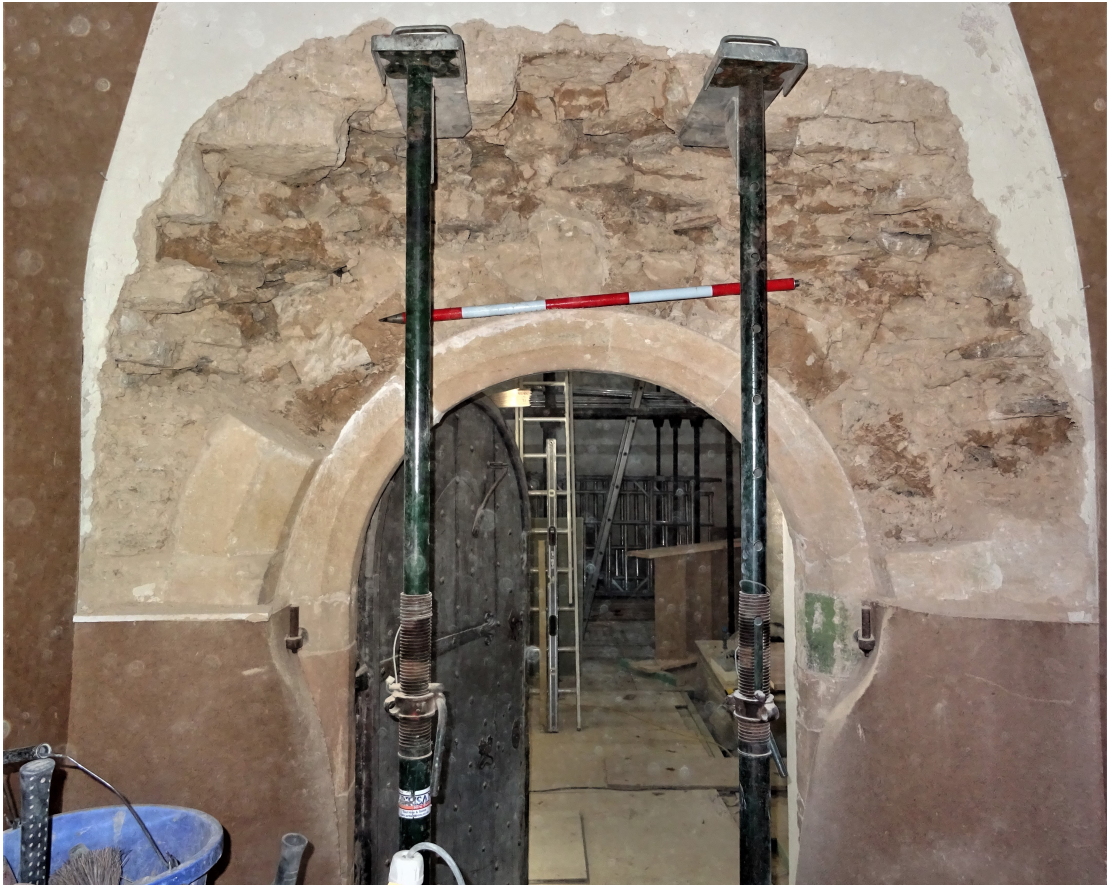
Construction work to initially remove the upper section of the casement revealed a large section of the walling that surrounds it. The arch (prior to removal) was supported by two adjustable acro-jacks (**Plate 15**). Removed was all plasterwork, loose stone (forming part of the casement construction) and the 19th century moulded arch (**Plate 16**). Following removal from the door casement, the arch sections were carefully laid in sequential order within the nave awaiting later reinsertion.

Plate 15. Removed render exposing the rubble stonework, view from the porch

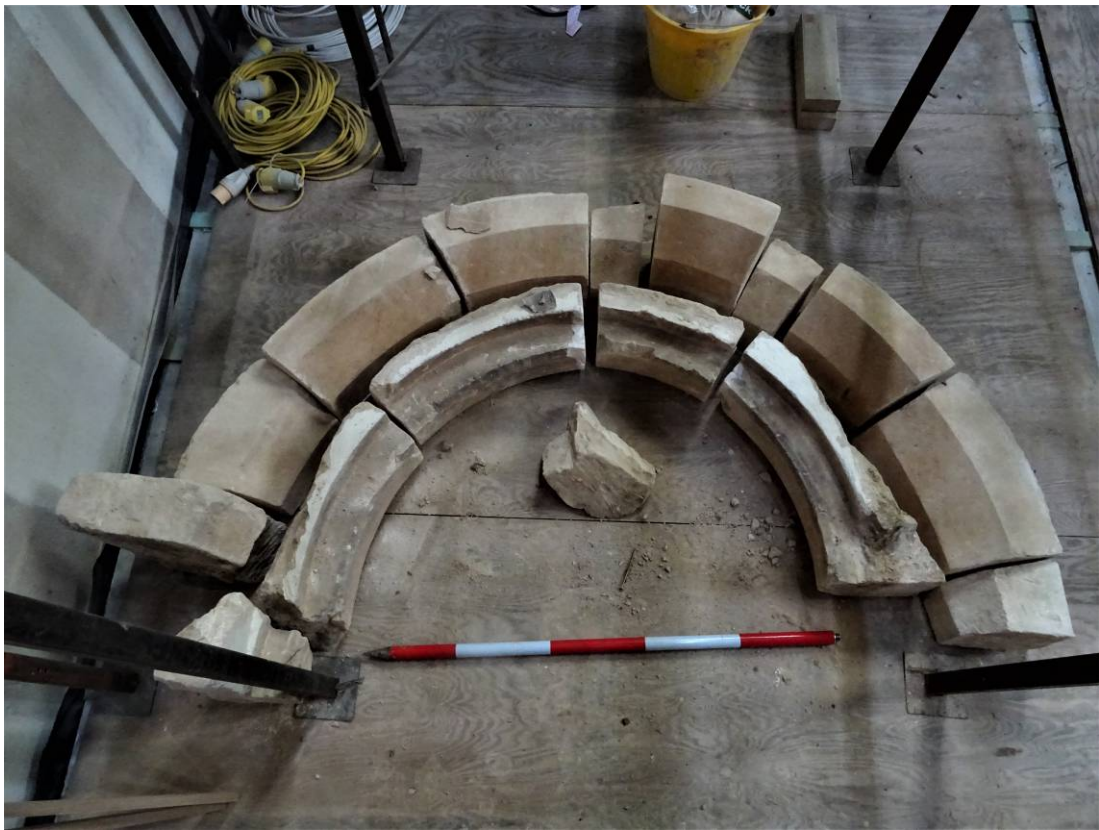
Plate 16. Removal of the arch from the porch-end elevation

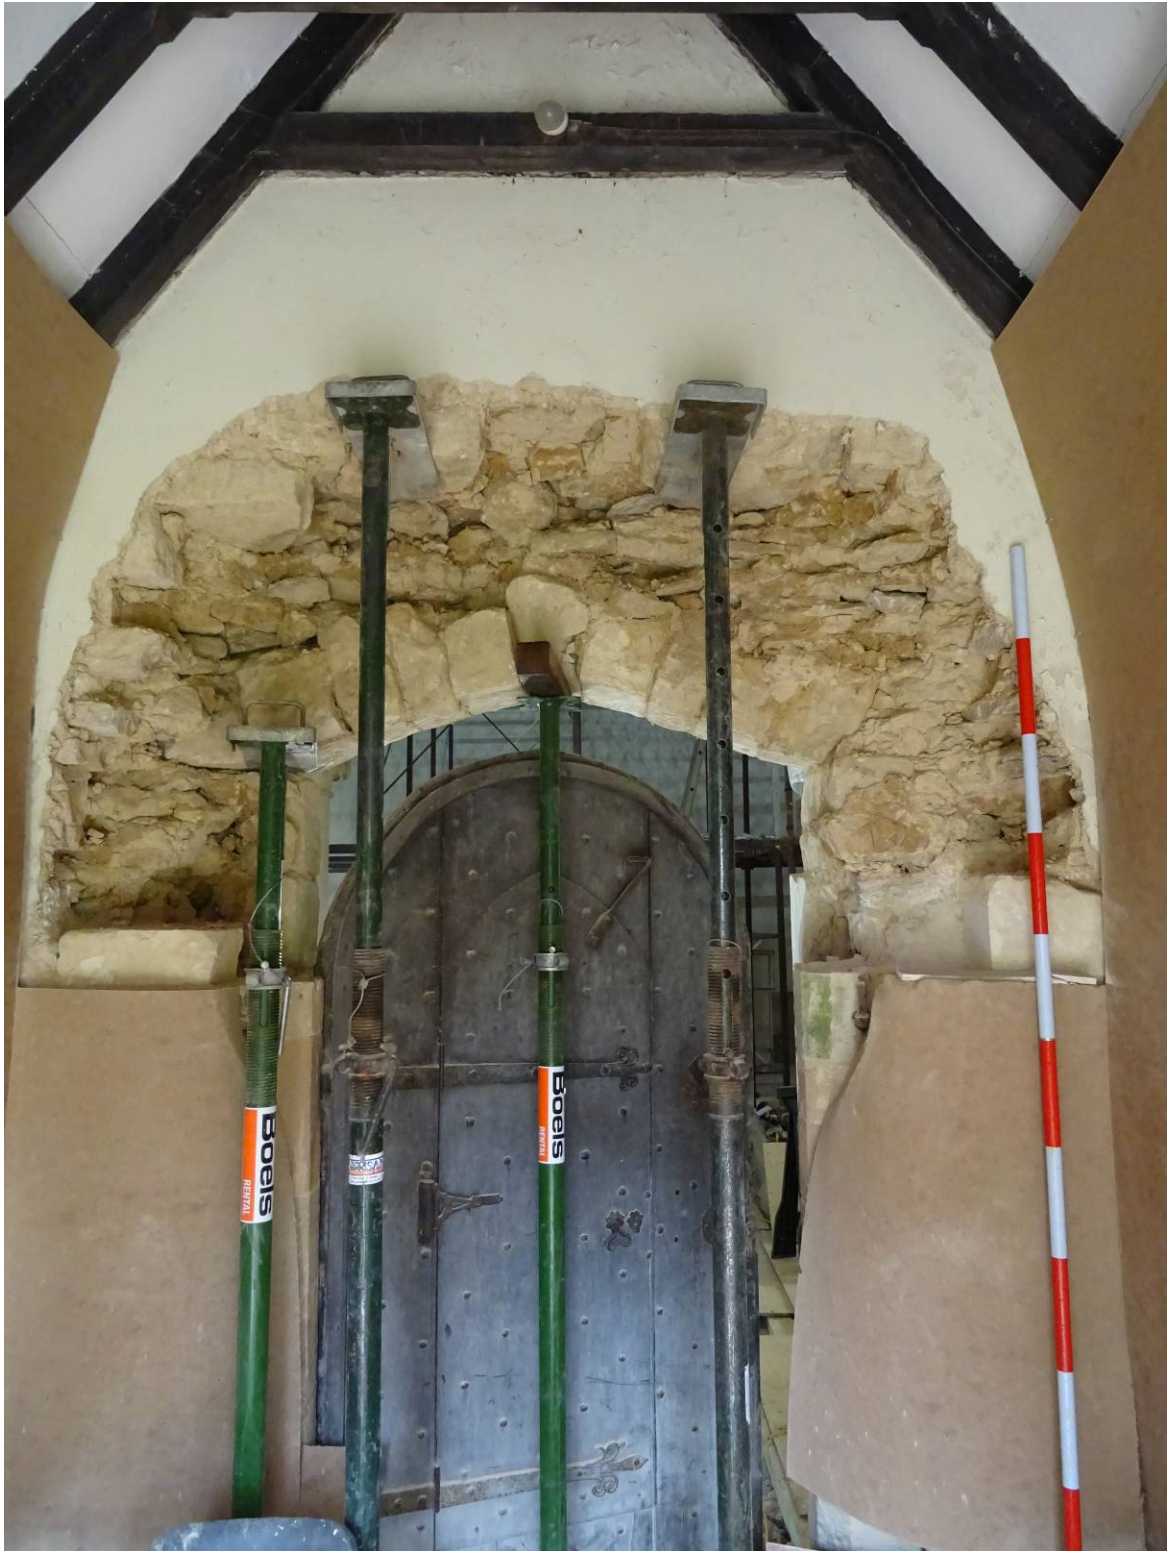
Based on the results of the historic building survey, the removal of render either side of the door casement revealed the remnants of an earlier door opening including the internal long and short quoins of the casement and a late medieval segmental arch, designed in the Tudor style.

Plate 17. Removal of render to expose rubble surface and perpendicular pseudo-four-centred arch
