St. Cyr's Church

**Stinchcombe,
Gloucestershire.**

Report on the Conservation of six Churchyard Monuments.

October 2019.

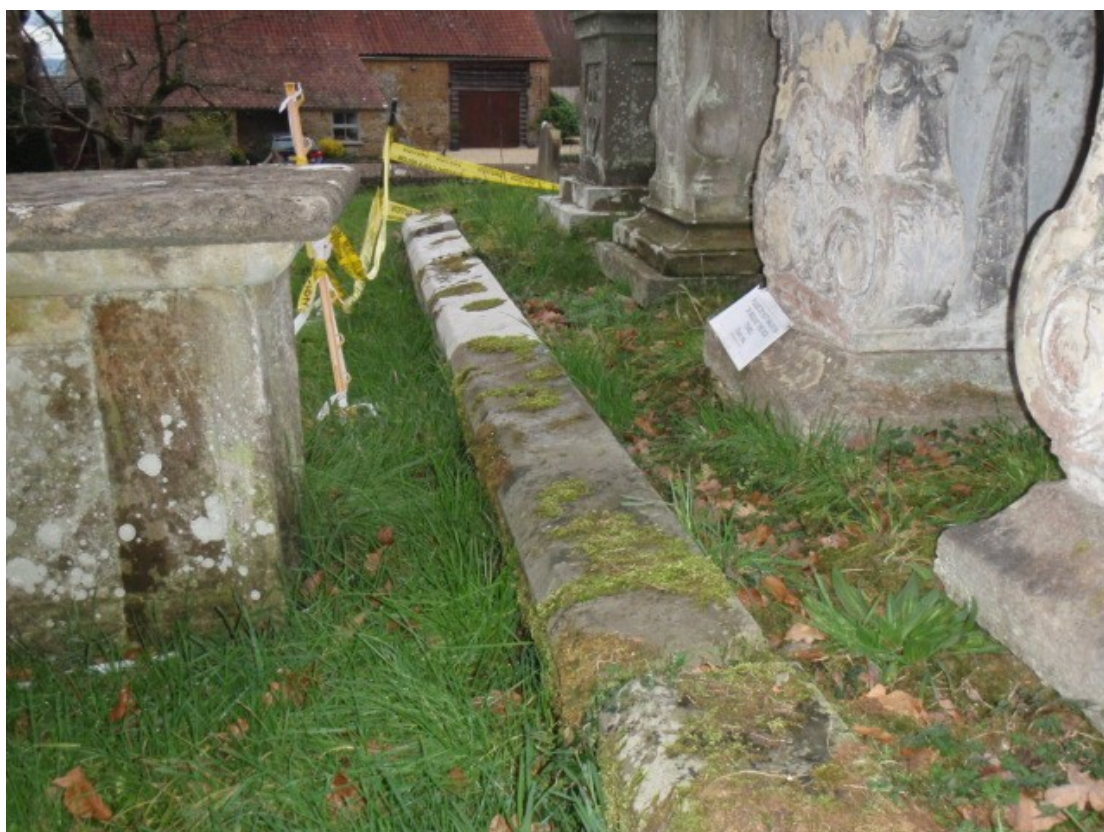
The two stones forming the edging have rotated and slid towards the west, and are no longer resting on their brick foundation (-also the west wall of the series of burial chambers). This is probably due to a combination of subsidence, and growth of tree roots between the east edge of the edging stones and the west ends of the paving slabs around the monuments.

The plinth stone is subsiding towards the west.

The two sandstone edging slabs were lifted using an overhead gantry, running bogie, chain-hoist and lifting straps. Soil on the E side of the stones was removed, sufficient to be able to move them back into their correct positions. This revealed the original foundation of hard, shelly limestone rubble bedded in lime mortar, still in good condition. Also uncovered were W (head) ends of the brick-lined burial shafts under the John Marbett 1879 and Thomas Marbett 1731 monuments. The stones were rebedded in their original positions. A lime mortar of sand, con-mix and NHL5 hydraulic lime was used.

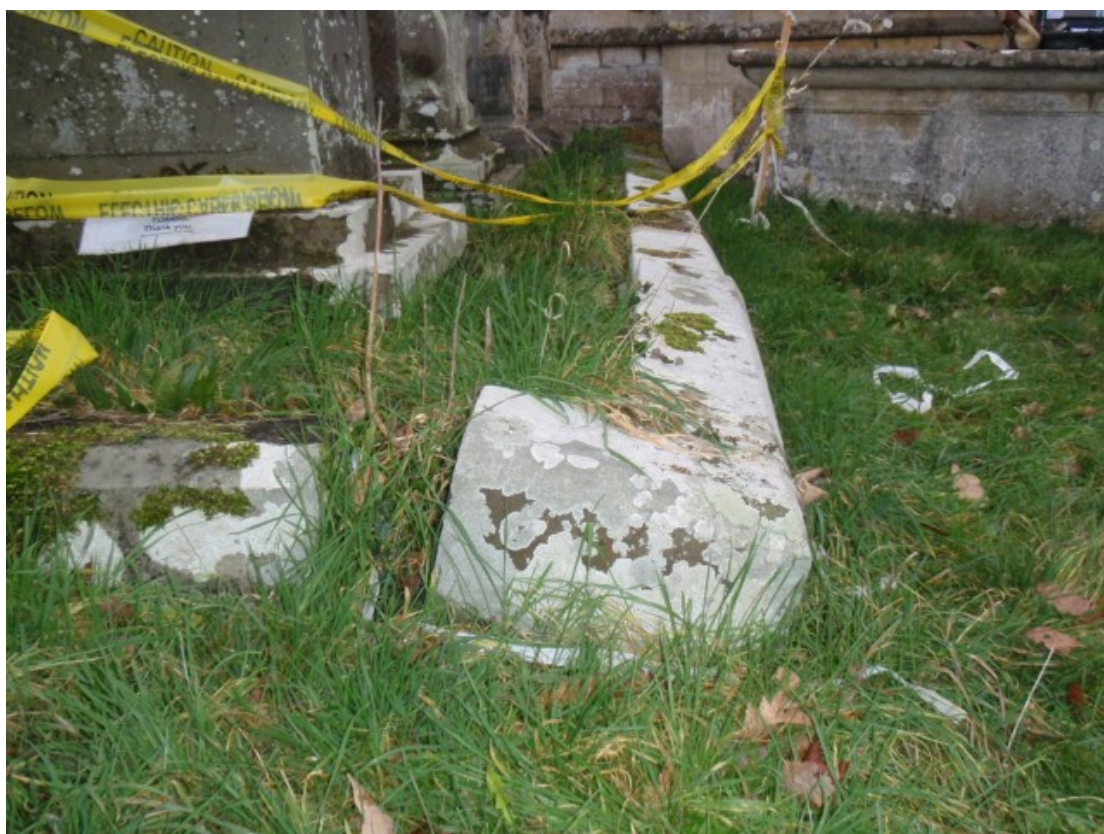
The north-west plinth stone, rotated due to subsidence.

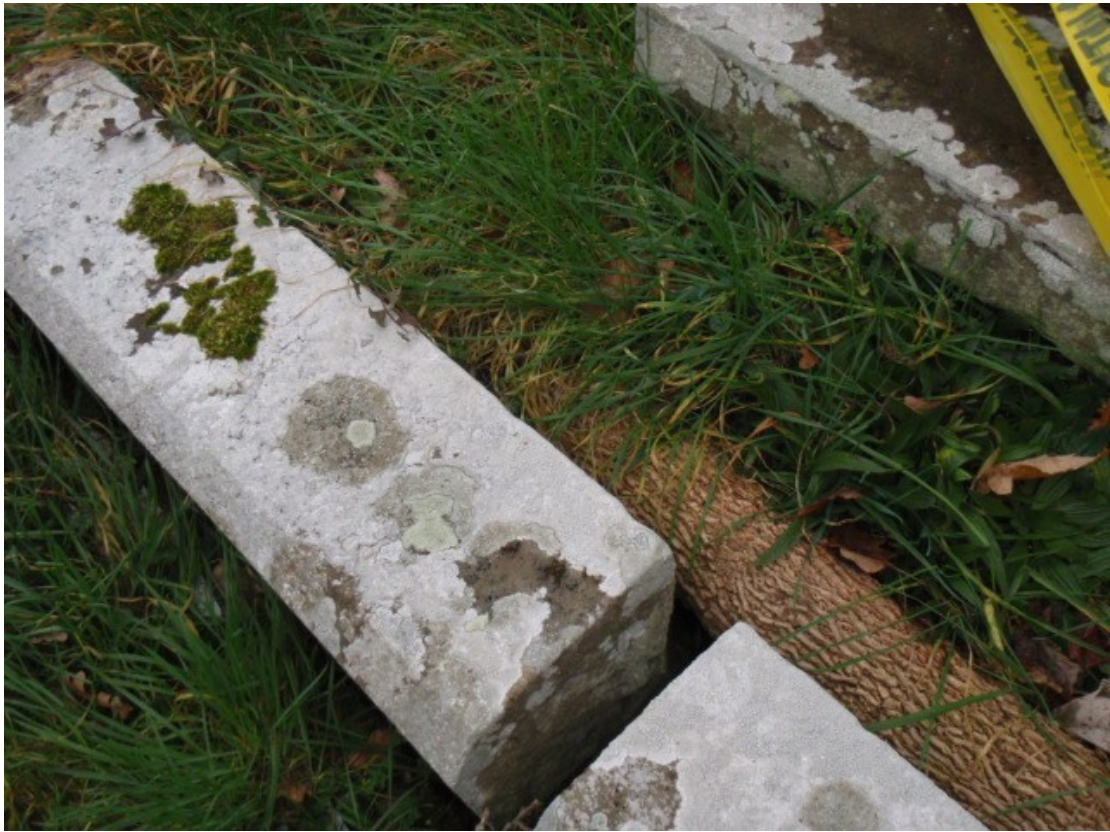
This movement has opened a gap approximately 200 mm wide at the north end of the edging. Looking through this, it is possible to see the west wall of the burial chamber beneath the John Marbett 1879 monument, and part of the interior.

The gap, exposing the interior of the burial chamber, temporarily filled by a log.

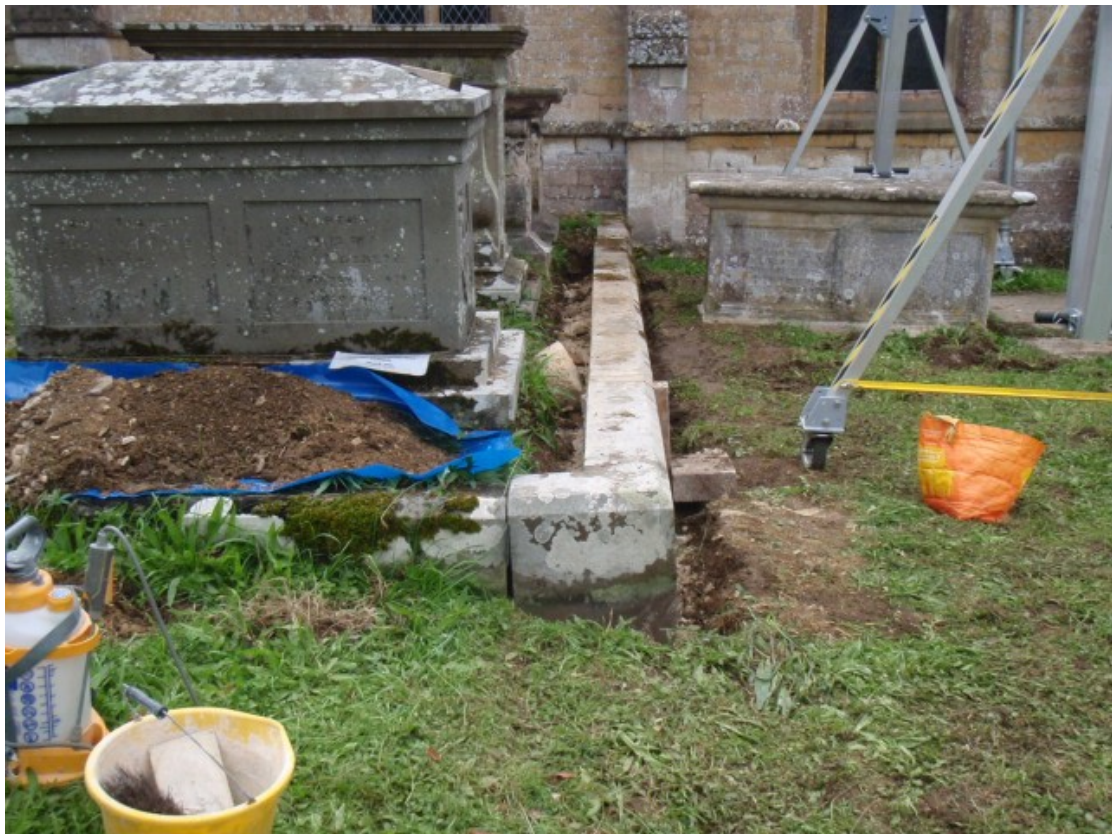
The north-west plinth stone after repositioning.

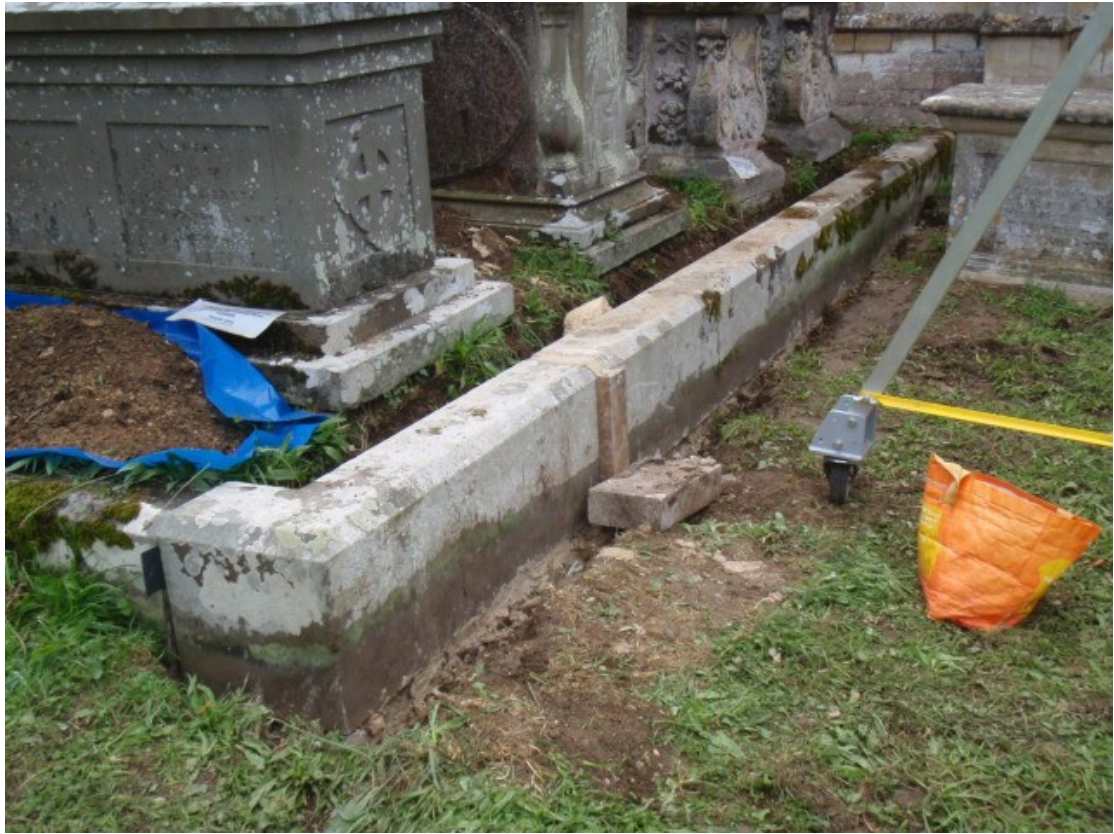
The stones rebbeded on lime concrete.

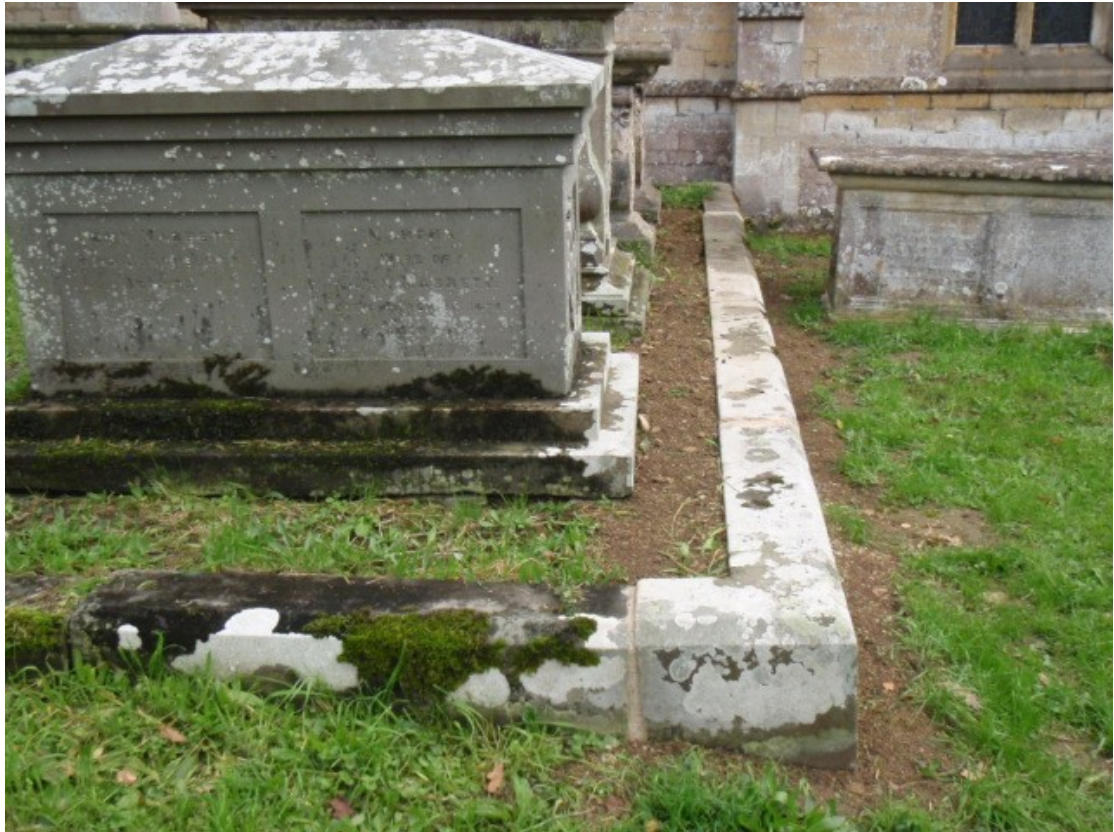
The works completed, from the N, with joints pointed and soil reinstated.

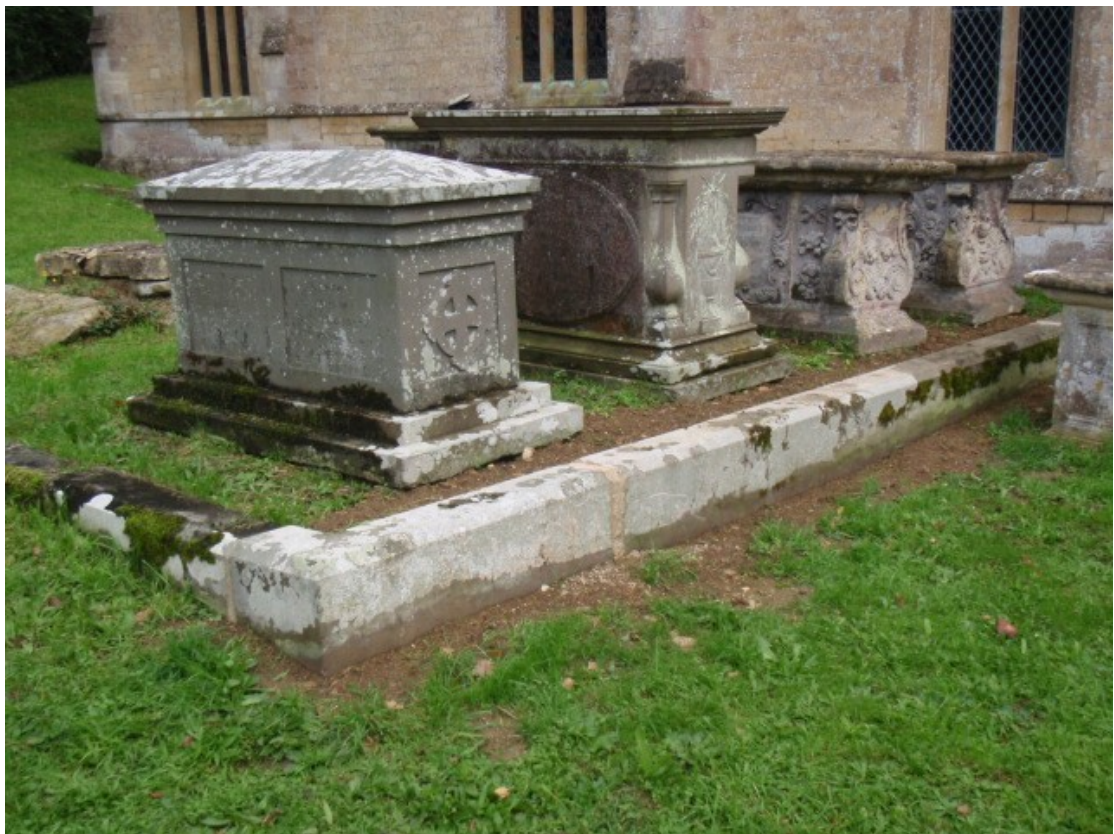
The completed works, viewed from the NW.

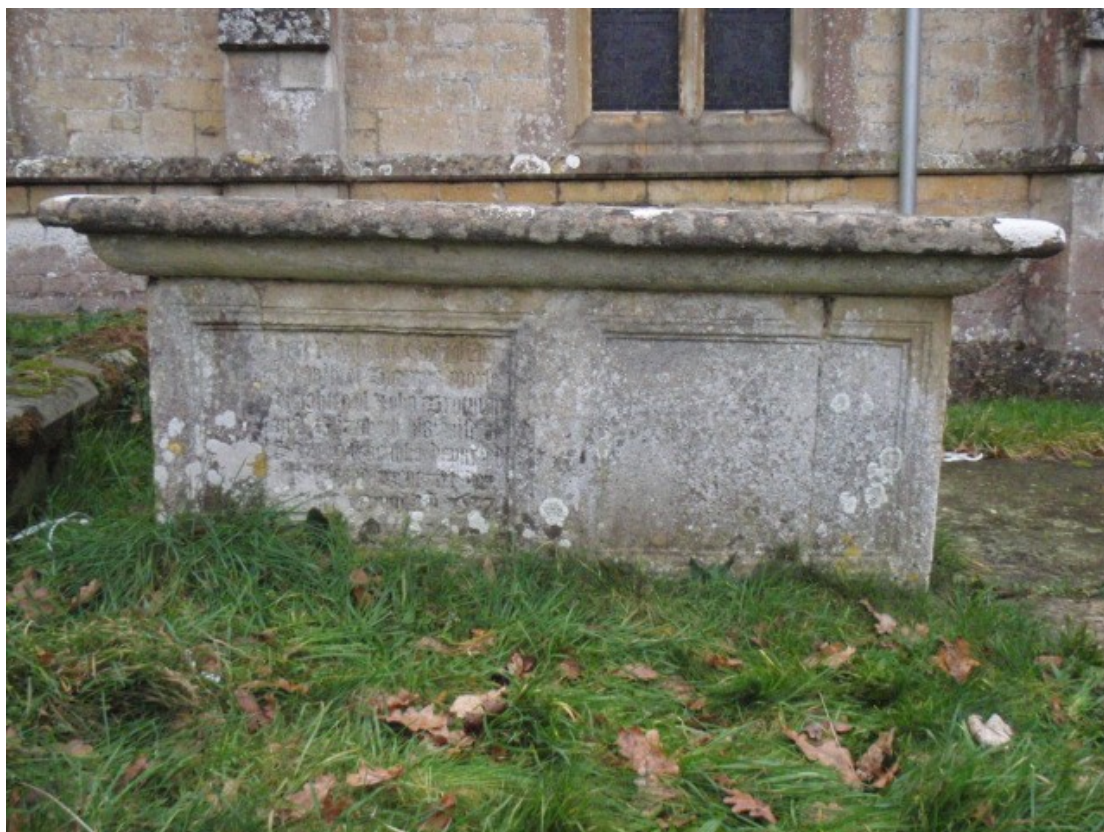
The limestone is in sound condition, with moderate weathering of the surface and some growth of lichens. Some of the lime mortar in joints between the stones has weathered back, potentially allowing more water to enter. The plinth below the side and end panels is now largely buried, due to a rise in the ground level within the churchyard. There is no sign of iron cramps at the corners, and no signs of the damage they usually cause, and the lid has not been lifted or displaced.

North side, with inscription before conservation.

Open joints were repointed with lime mortar, (using 2 parts Frithend sand, 1 part Holme sand, 1 part Daglingworth stone dust and 2 parts NHL2 natural hydraulic lime). Earth and turf were trimmed back around the plinth on the E and N sides so that its edges are visible and no earth is in contact with the sides of the monument.

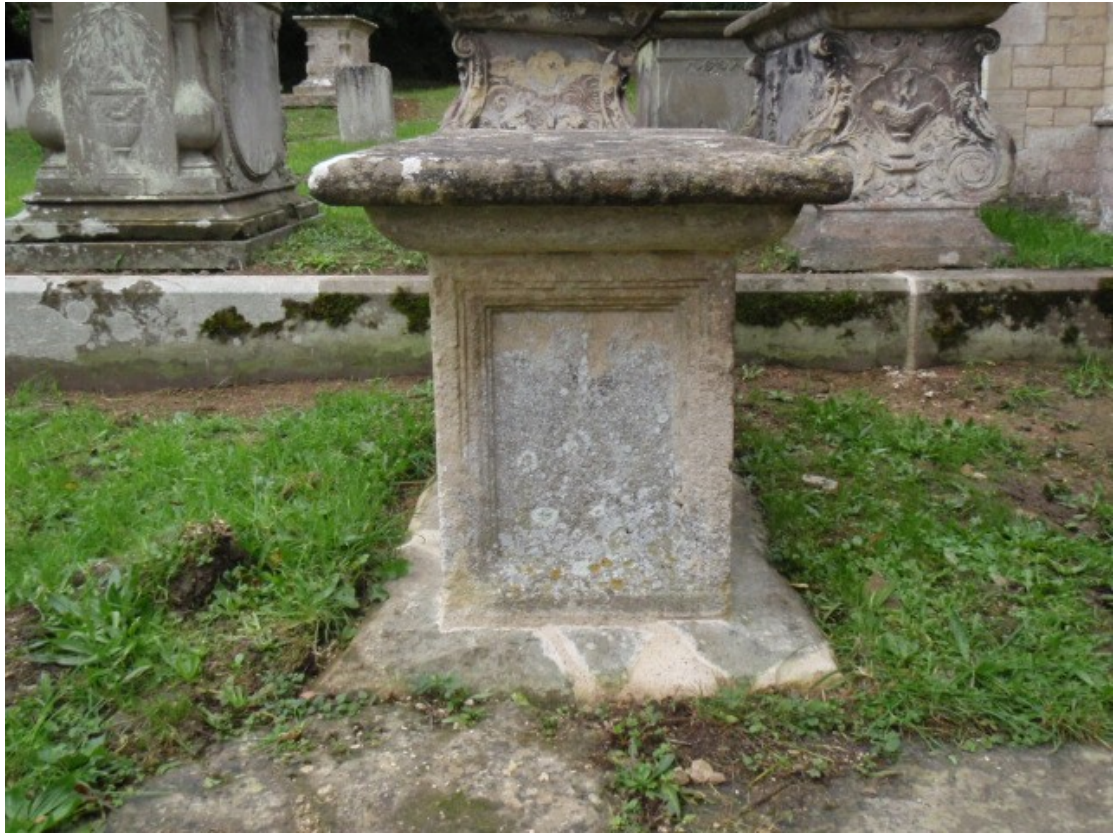
West end after conservation.

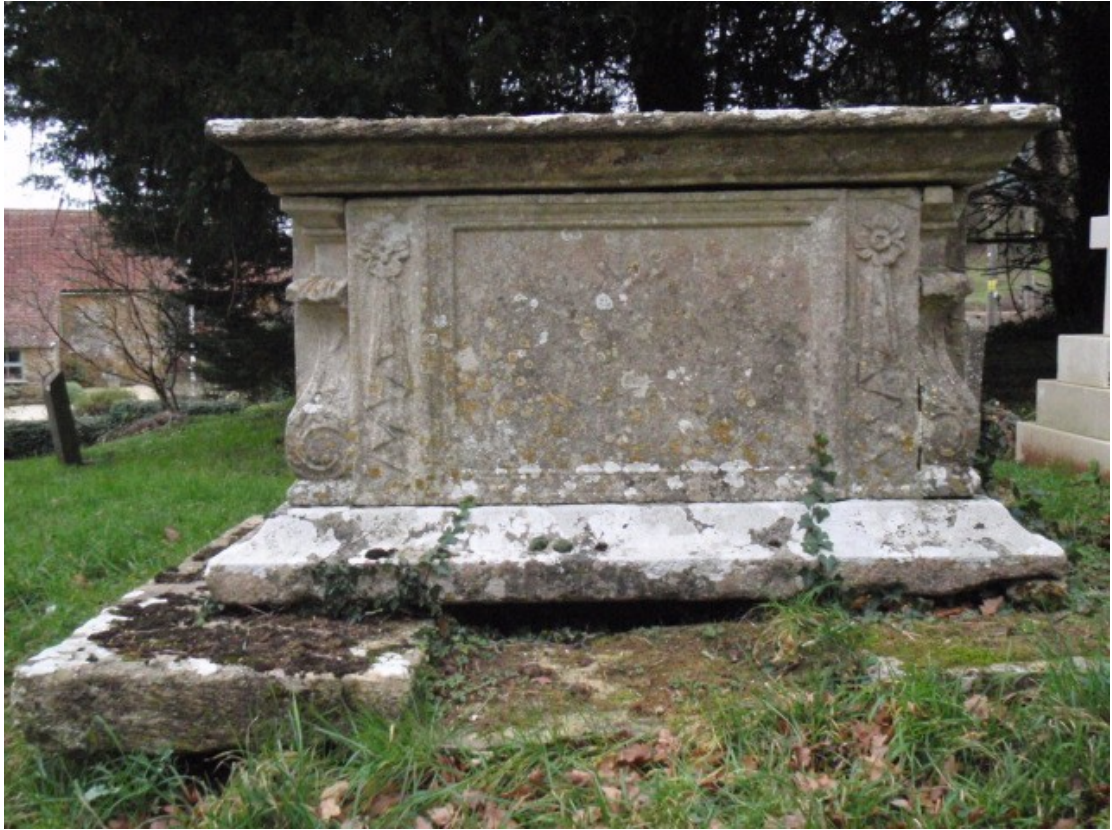
Individual stone elements are in sound though moderately weathered condition. Due to its construction with a one-piece plinth and thick end panels, the chest has remained in place despite movement in other parts of the monument. Iron cramps at each corner have rusted, expanded, and lifted the lid, and the cramp at the SE corner has also broken part of the stone away. Although the covering slabs (which cover the top of the burial chamber) at the E and W ends are wide enough to bridge right across and have stayed in position, the smaller ones used for the N and S sides have subsided outwards. Although the monument is not in a state of collapse, its long term stability is compromised.

South side before conservation.

The lid was lifted, rusting iron cramps removed, and replaced with stainless steel ones, before repositioning the lid on a bed of lime mortar. Open joints between the ends, sides and plinth were repointed. All ivy was removed, and the roots treated using a systemic root killer. The N and S side covering slabs were repositioned on firmer foundations made with concrete blocks and lime mortar. The very wide joint between the covering slabs and the plinth stone was repointed with a coarser mortar of 3 parts Ashton Keynes sand, 2 parts Frithend sand and 2 parts NHL 2 and Cotswold stone roofing tiles, packed in deeply. This will prevent future recolonisation by ivy.

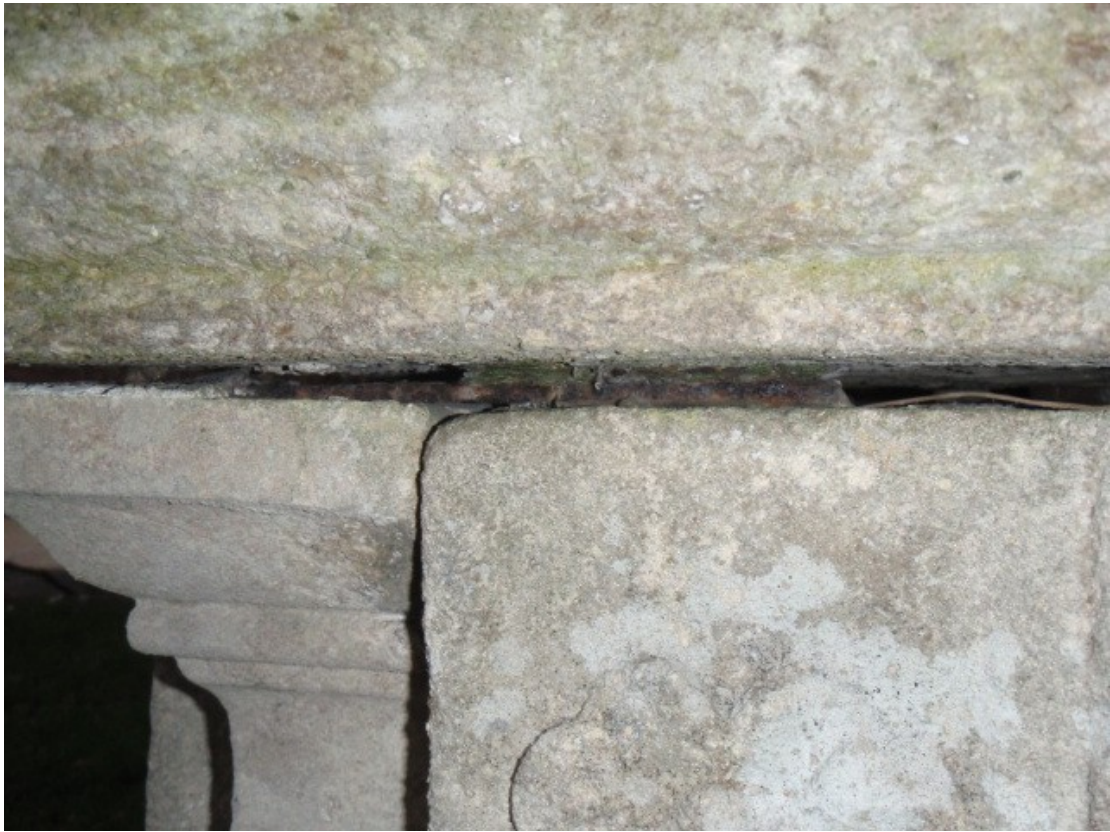
A rusting iron cramp lifting the lid at the south-west corner.

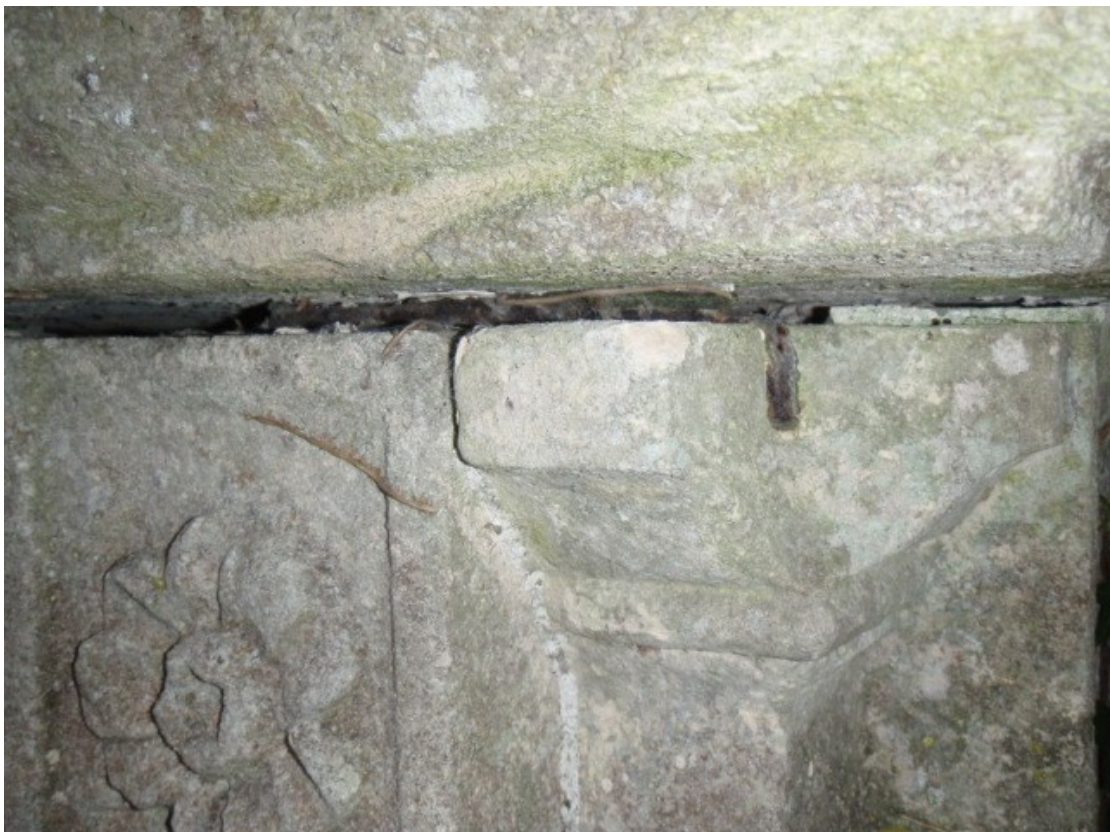
A similar cramp at the south-east corner. This one has also broken off the corner

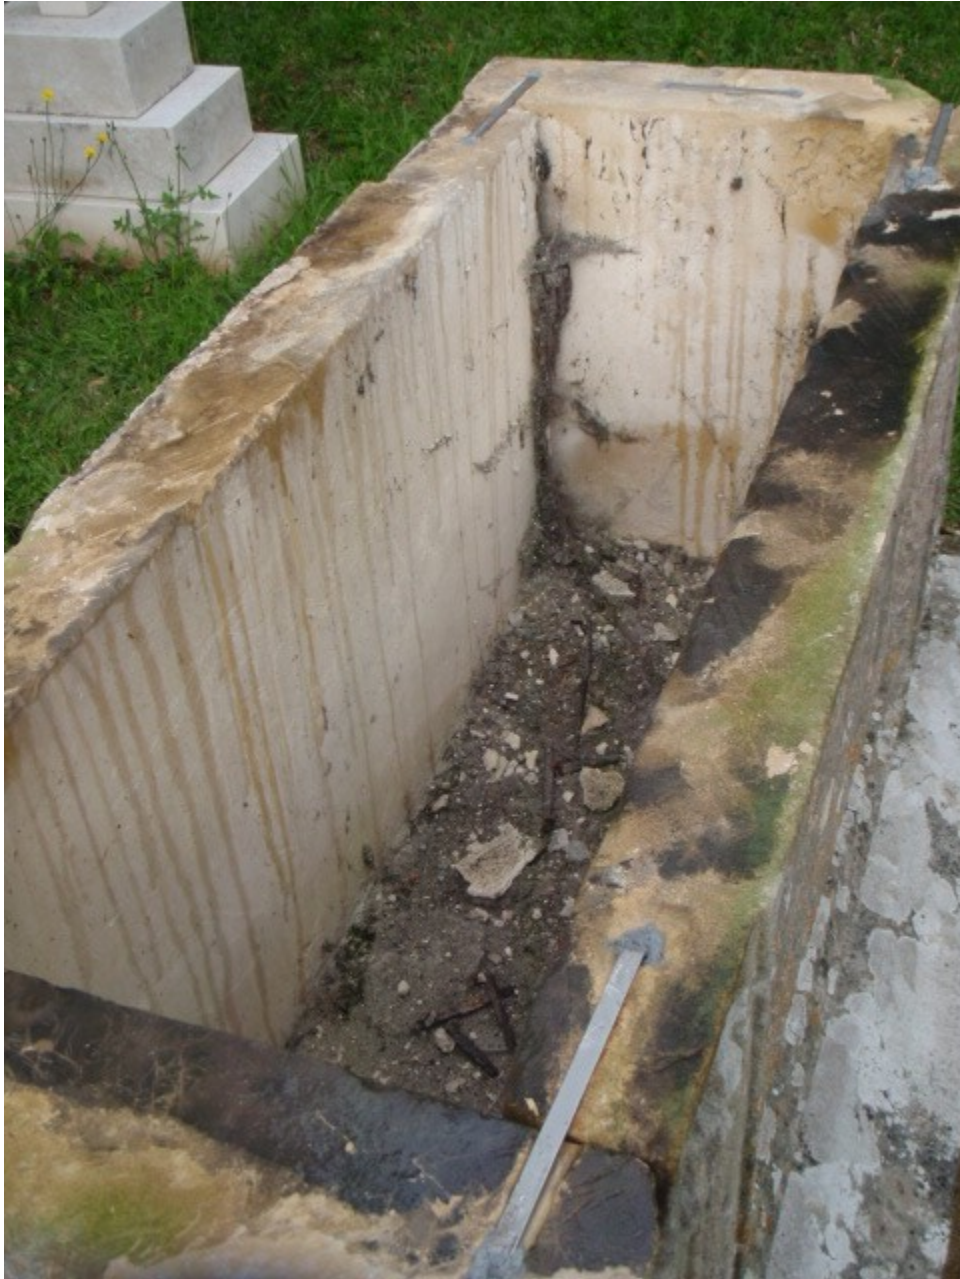
The lid was removed, and the iron cramps replaced by stainless steel ones.

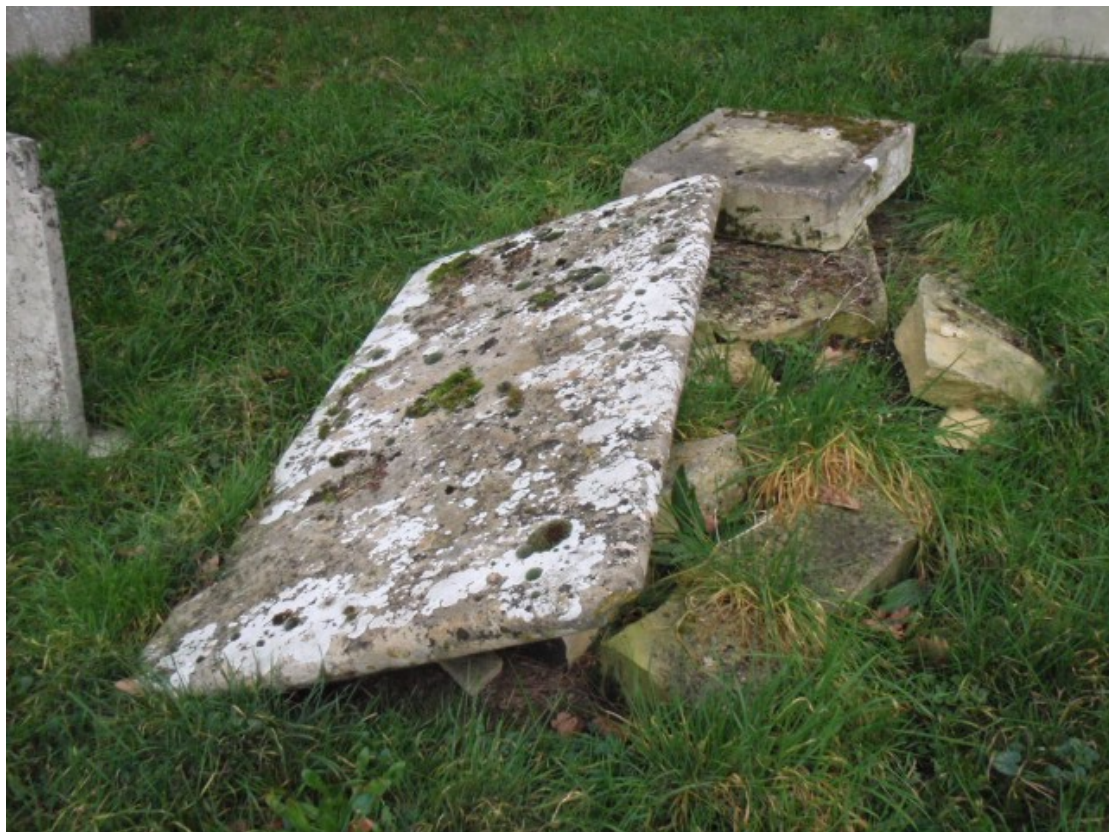
This monument has collapsed completely. The stone itself is moderately weathered, but the material is sound. Some components have broken on impact, due to point loadings, but these are “clean” breaks. All components are still present.

The completely collapsed monument, from the west.

The pile of stones was taken apart and all broken edges cleaned with water and a nylon scrubbing brush. After drying, the “jigsaw puzzle” was reassembled using polyester resin and stainless steel threaded dowels. The N, S and W panels were all broken into several pieces, particularly the N side, as this had been hit by the S side and the lid when the monument collapsed. It was reinforced by setting stainless steel flat bars into slots cut with a small angle-grinder using polyester epoxy resin.

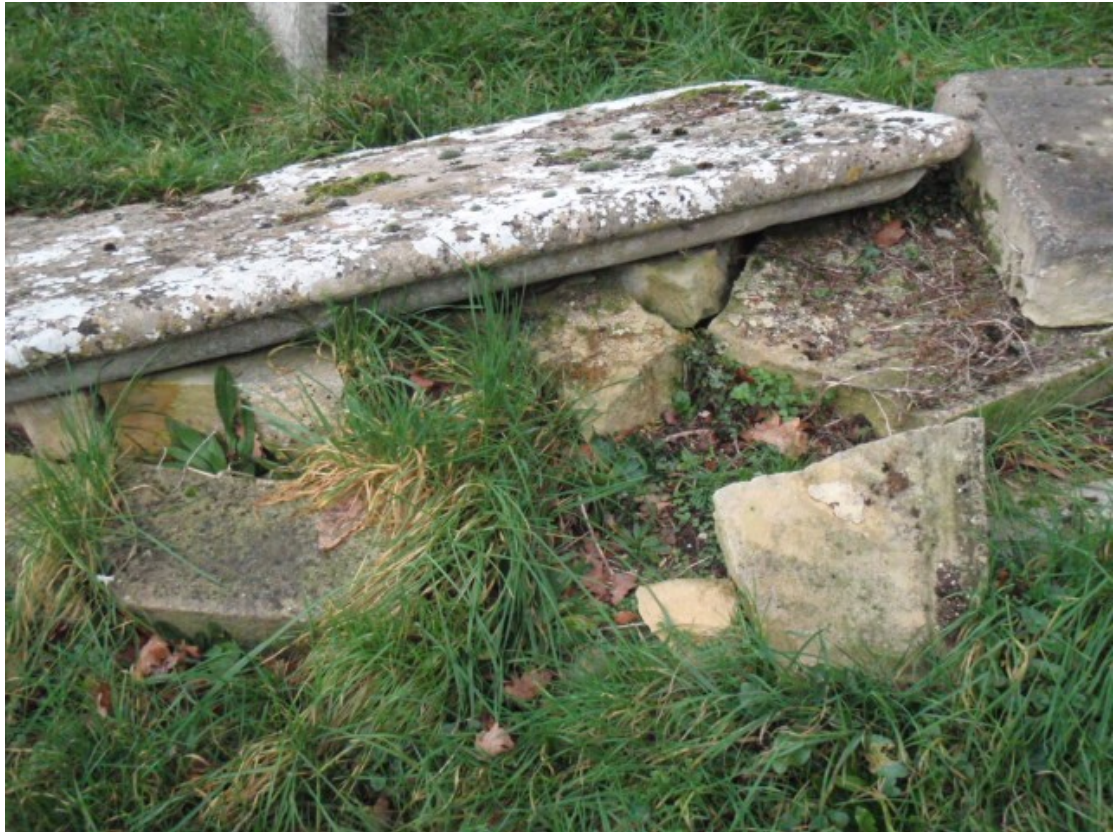
Broken pieces of the north and south side panels lie under the lid.

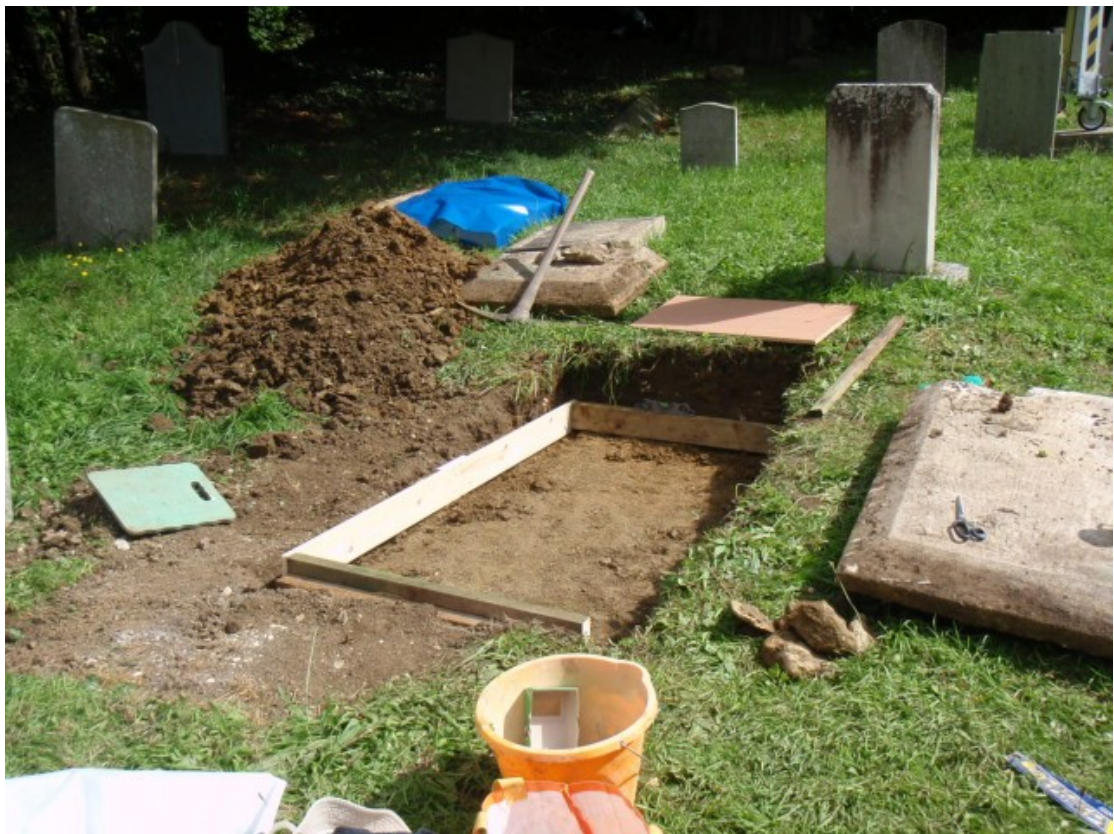
After lifting out the plinth stone, the area was prepared for a limecrete foundation.

Removal of the plinth created a rectangular hole. This was made more regular, lined with a geotextile membrane and filled with lime concrete made with 3 parts continuity mix to 1 part NHL 5 hydraulic lime.

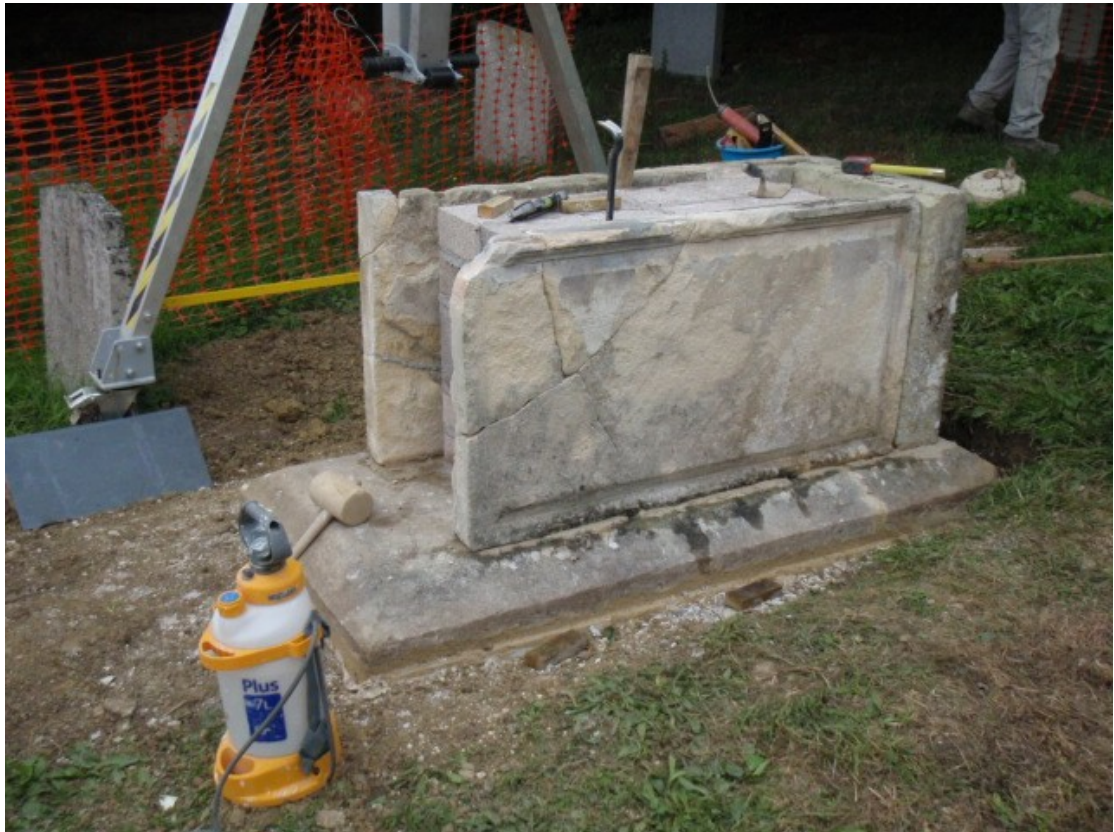
The repaired side and end panels were rebuilt around a blockwork core.

After re-bedding the plinth, a lightweight concrete block core was built up to the same height as the side and end panels. These were then rebuilt around it. Slates were added above the concrete core, so that it is slightly higher than the stonework.

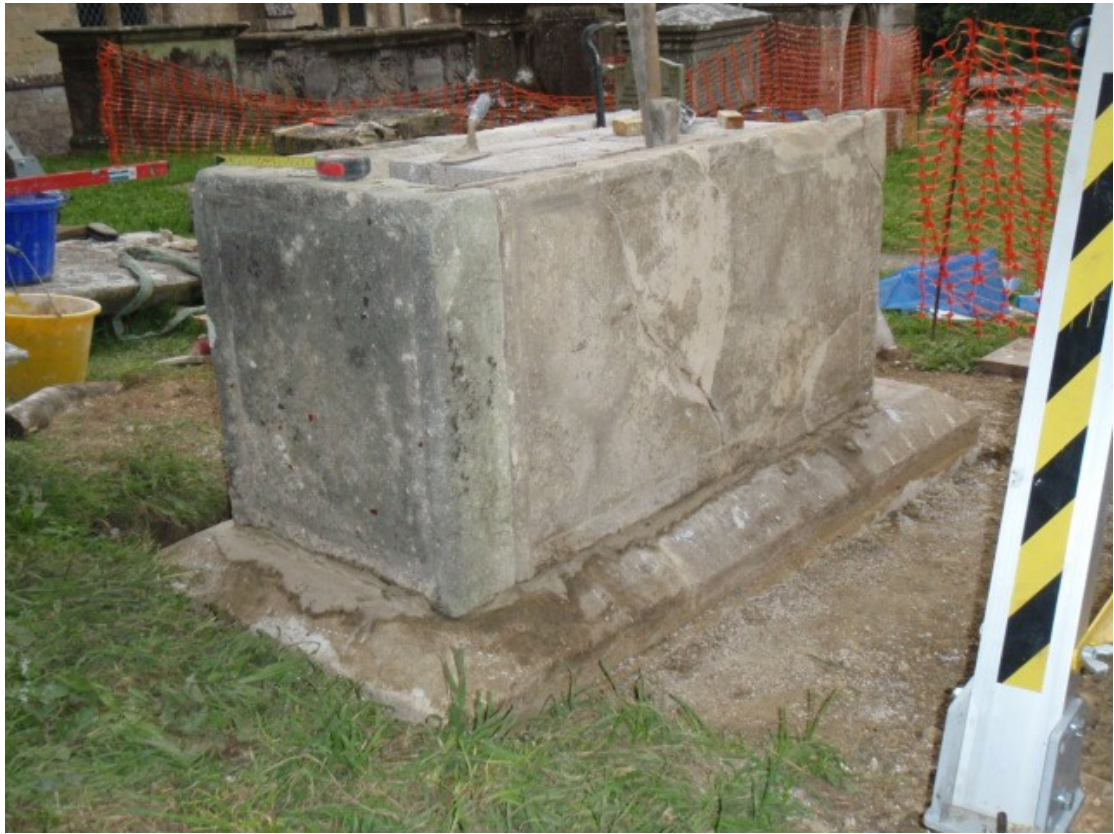
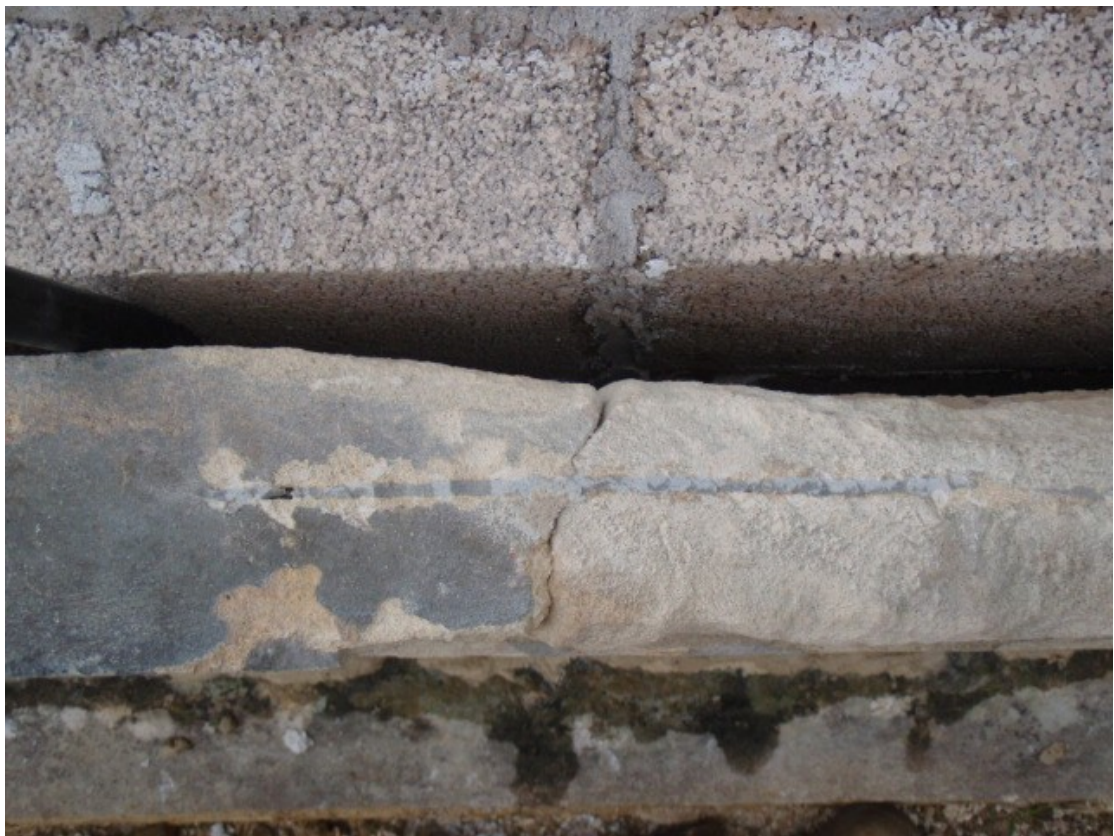
Detail showing stainless steel reinforcement/repair.

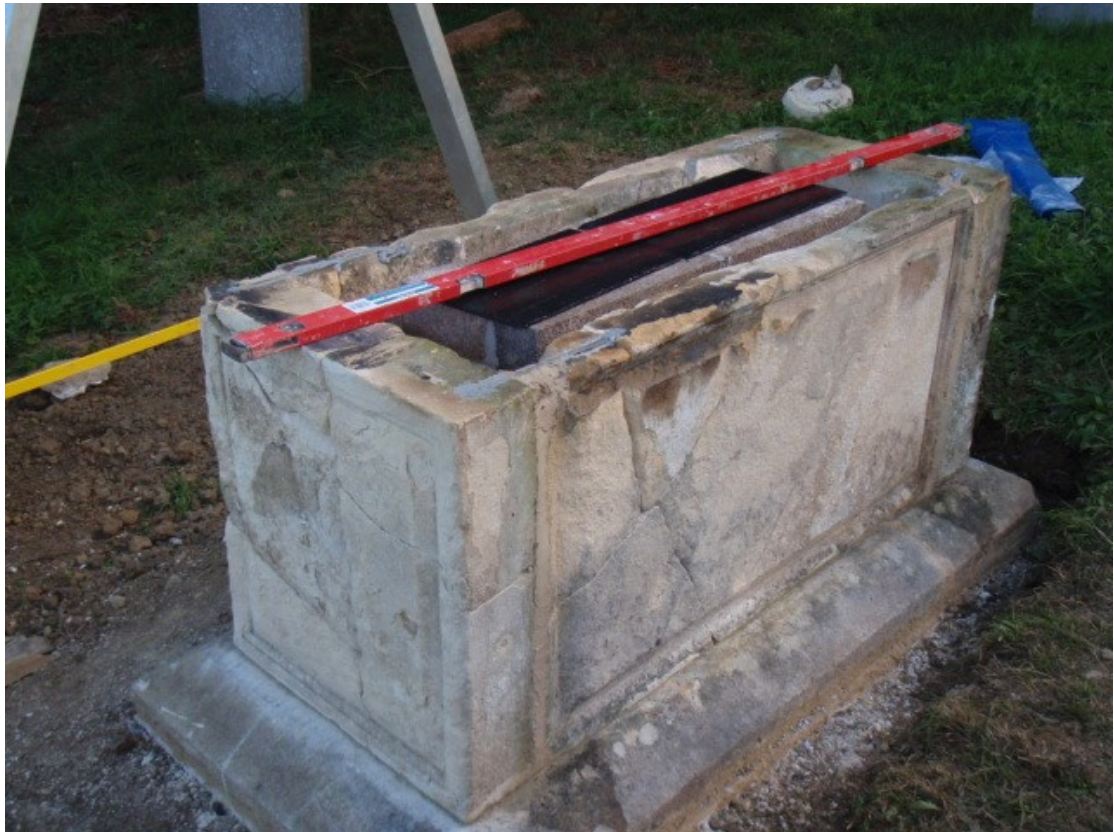
Slates were added to raise the top of the core above the sides.

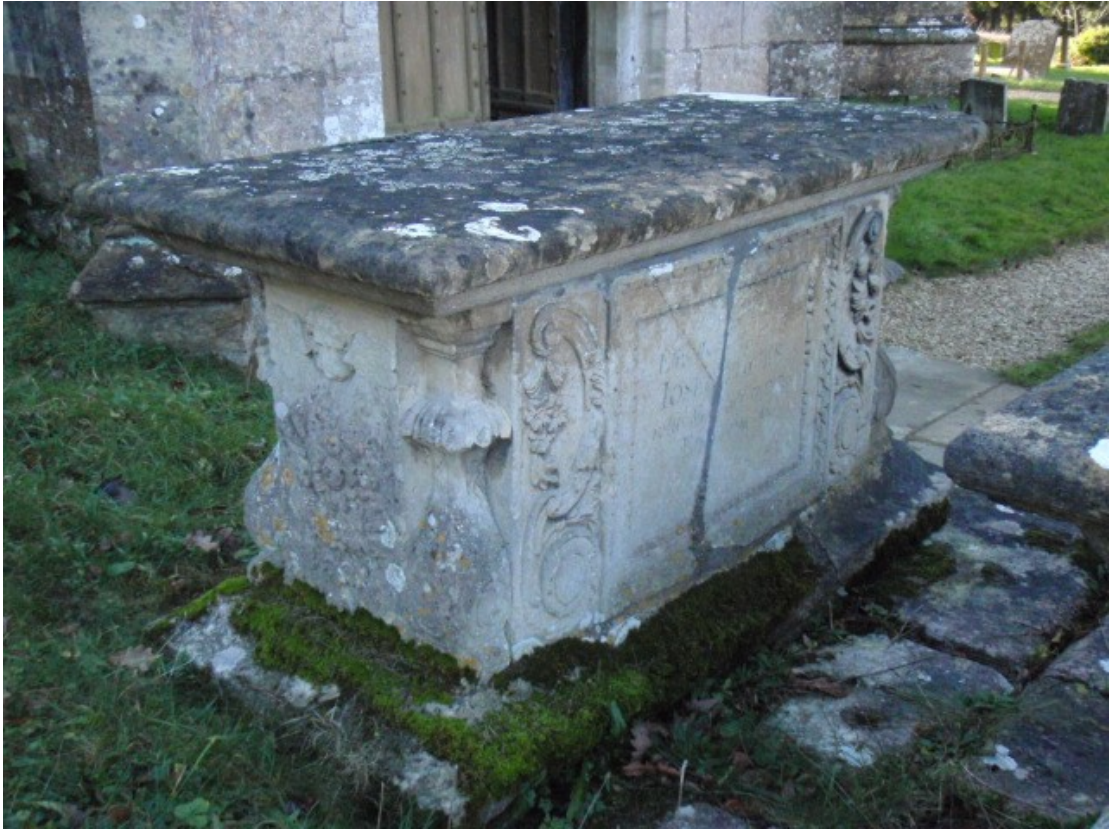
The limestone is in sound condition, with moderate weathering of the surface and some growth of lichens. Some of the lime mortar in joints between the stones has weathered back, potentially allowing more water to enter. Iron cramps present at the corners have rusted, expanded, and lifted the lid. The N side panel is broken, possibly by an iron cramp. The monument has been repaired previously using cement. The gap created by the lifting of the lid has been filled with cement-based mortar and slate wedges, but the iron cramps are still *in situ* and continue to lift the lid. The plinth has not moved on the covering slabs beneath, and is stable.

North side before conservation.

All cement pointing was removed. The lid was lifted, and rusting iron cramps removed and replaced with stainless steel ones, before repositioning the lid on a bed of lime mortar. The broken N side panel was removed without disturbing the S panel and ends, and repaired and reinforced by setting stainless steel flat bars into slots cut with a small angle-grinder using polyester epoxy resin. The break was repaired using a lime repair mortar mixed to match the stone for colour and texture. Open joints were repointed. The very wide joint between the covering slabs and the plinth stone was repointed with a coarser mortar of 3 parts Ashton Keynes sand, 2 parts Frithend sand and 2 parts NHL 2 and Cotswold stone roofing tiles, packed in deeply.

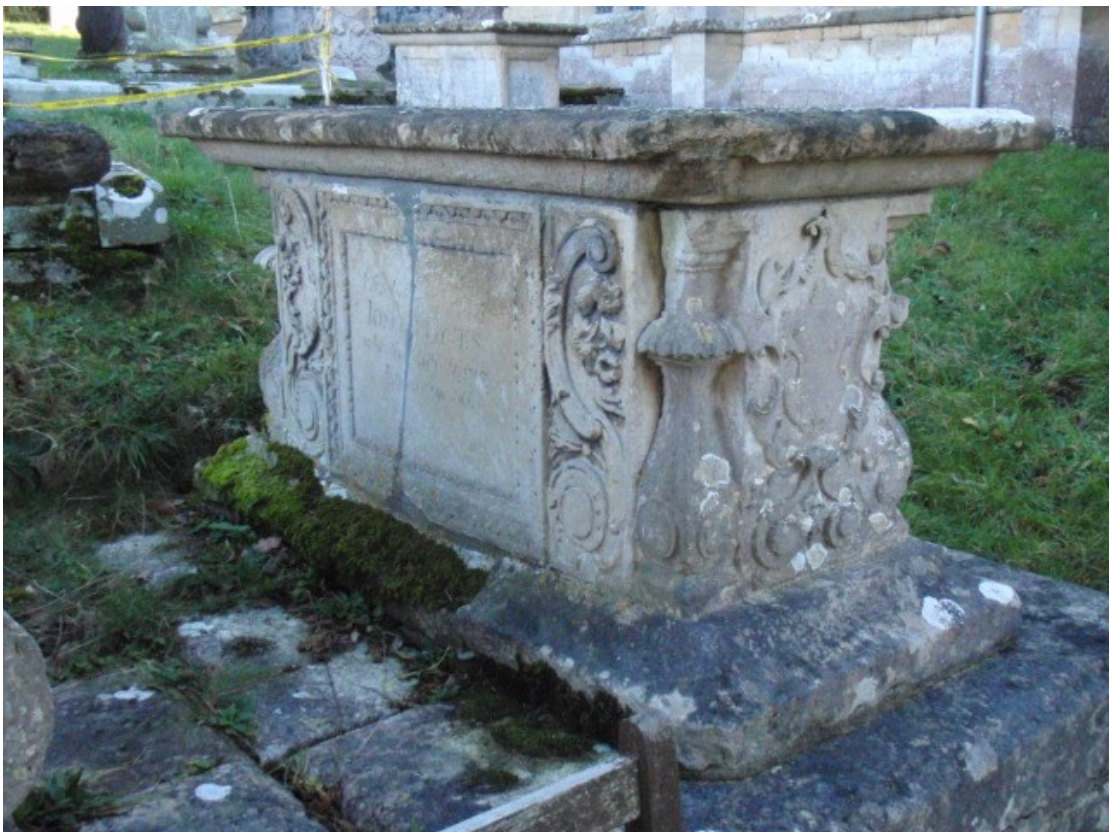
Note previous repairs carried out using Portland cement.
