St. Cyr's Church

**Stinchcombe,
Gloucestershire.**

Report on the Conservation of six Churchyard Monuments.

October 2019.

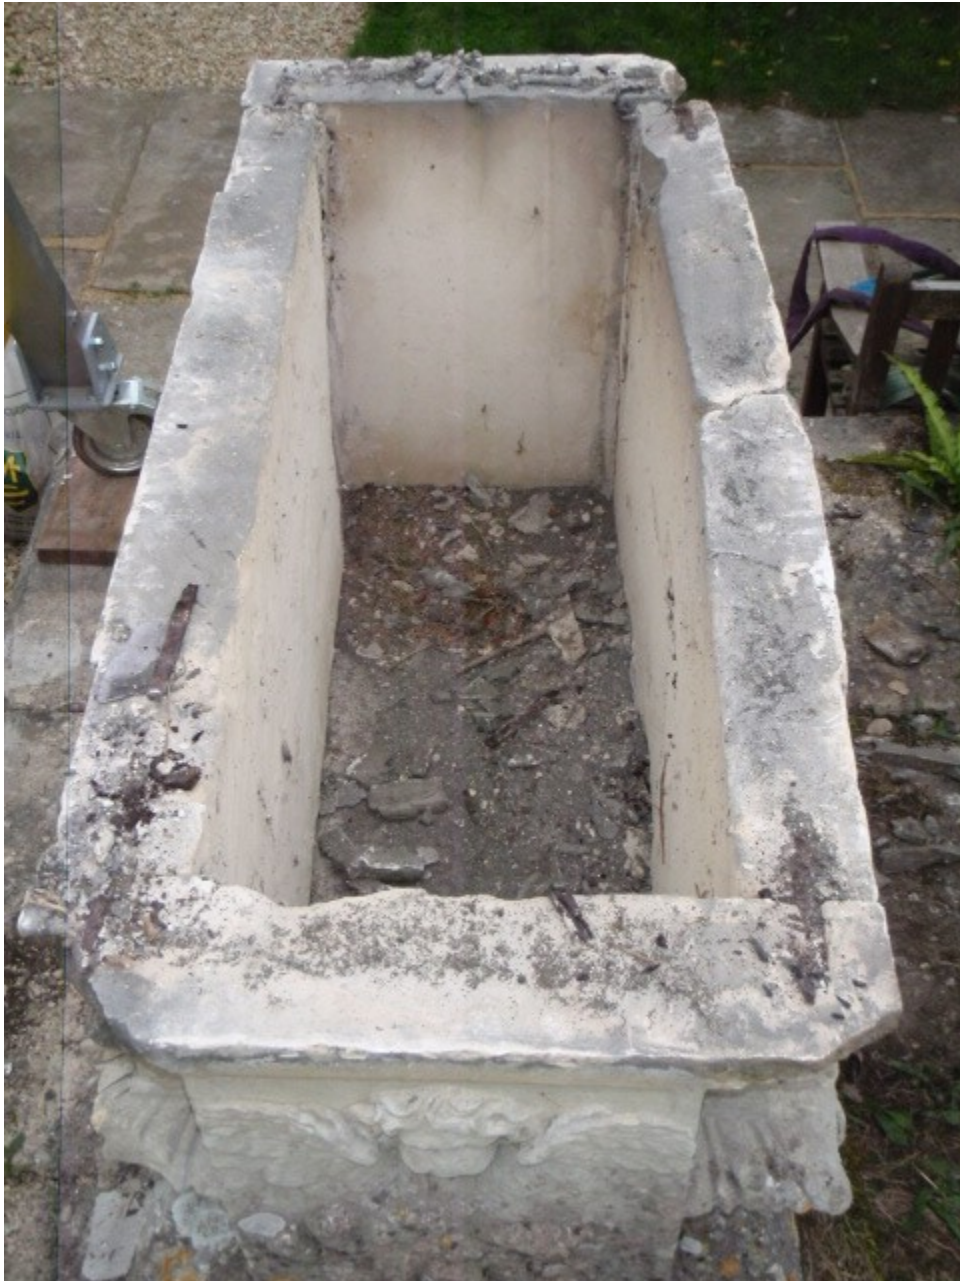
The lid was removed to enable replacement of rusted iron cramps.

All cement pointing was removed. The lid was lifted, and rusting iron cramps removed and replaced with stainless steel ones, before repositioning the lid on a bed of lime mortar. The broken N side panel was removed without disturbing the S panel and ends, and repaired and reinforced by setting stainless steel flat bars into slots cut with a small angle-grinder using polyester epoxy resin. The break was repaired using a lime repair mortar mixed to match the stone for colour and texture. Open joints were repointed. The very wide joint between the covering slabs and the plinth stone was repointed with a coarser mortar of 3 parts Ashton Keynes sand, 2 parts Frithend sand and 2 parts NHL 2 and Cotswold stone roofing tiles, packed in deeply.

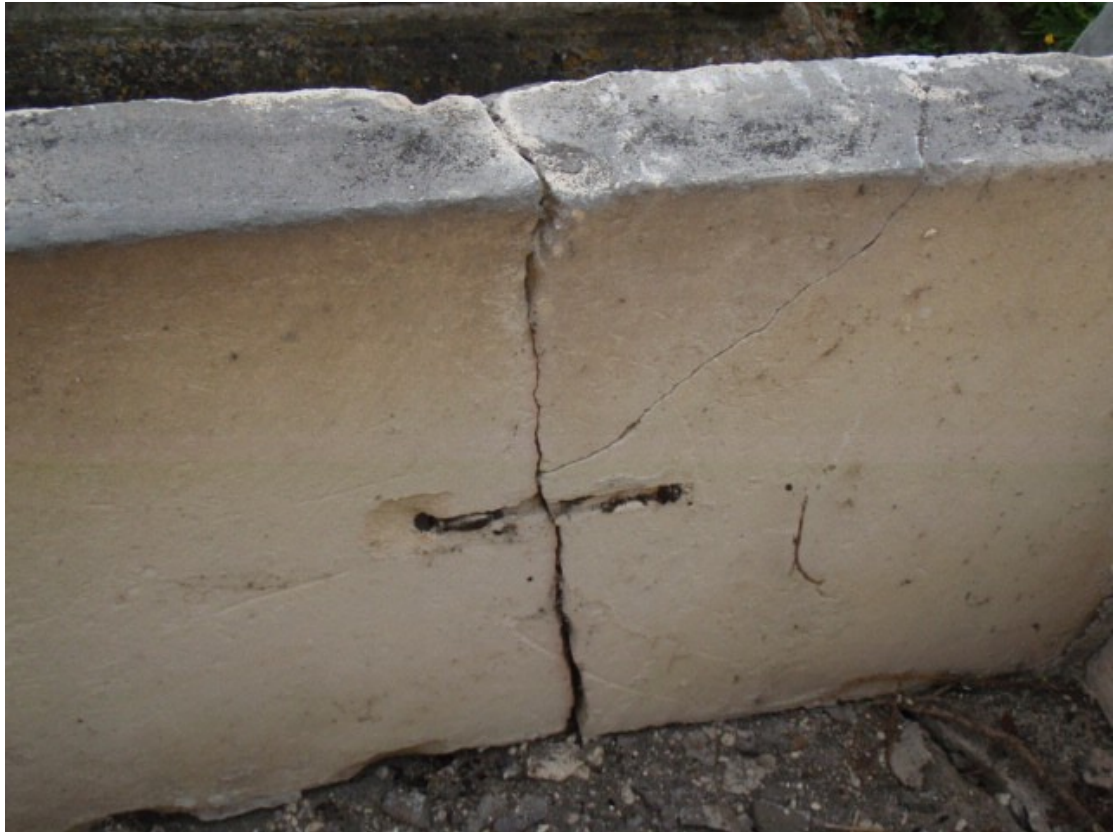
The north side panel, showing an iron cramp from a previous repair.

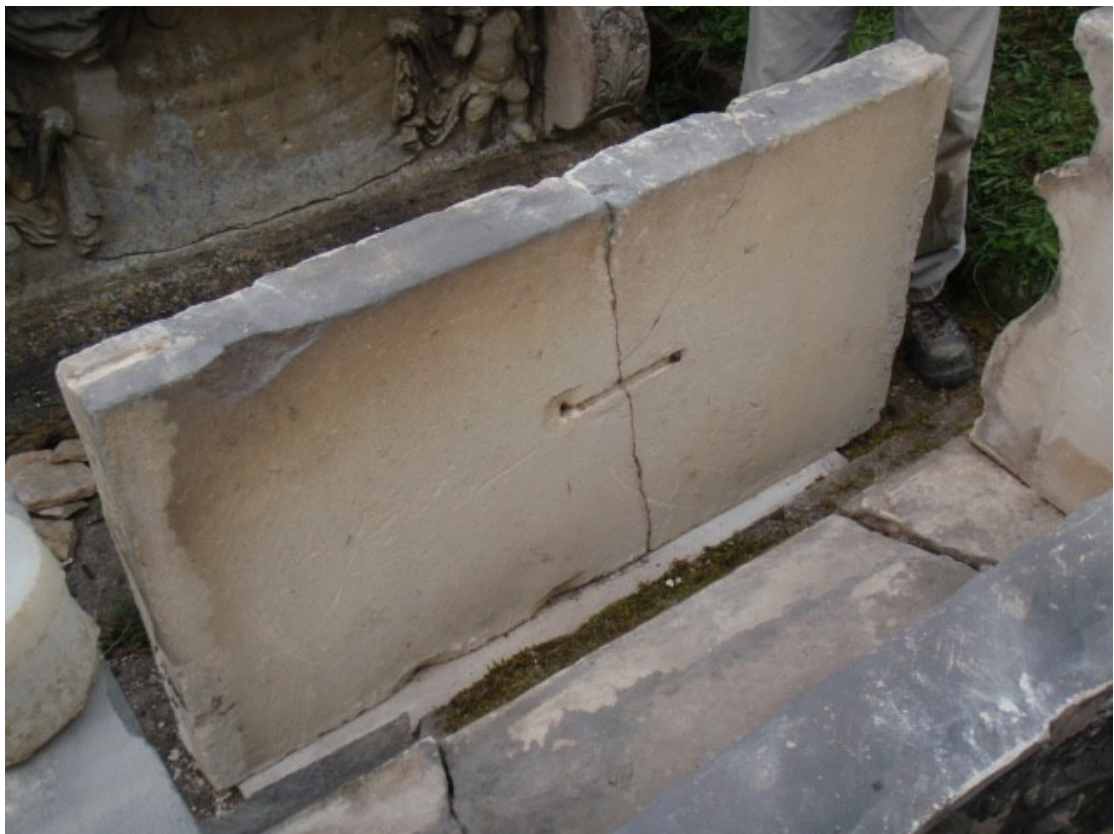
The north side panel after cleaning and realignment.

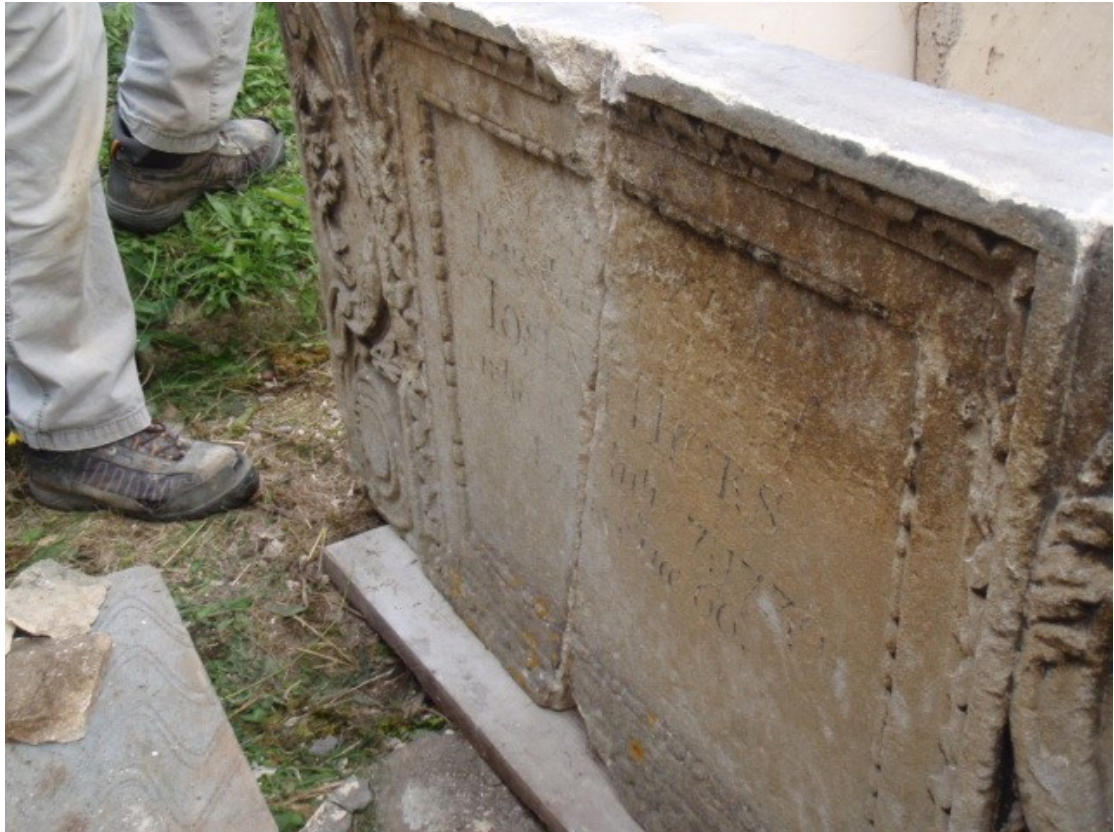
The north side panel pieces repositioned using polyester resin.

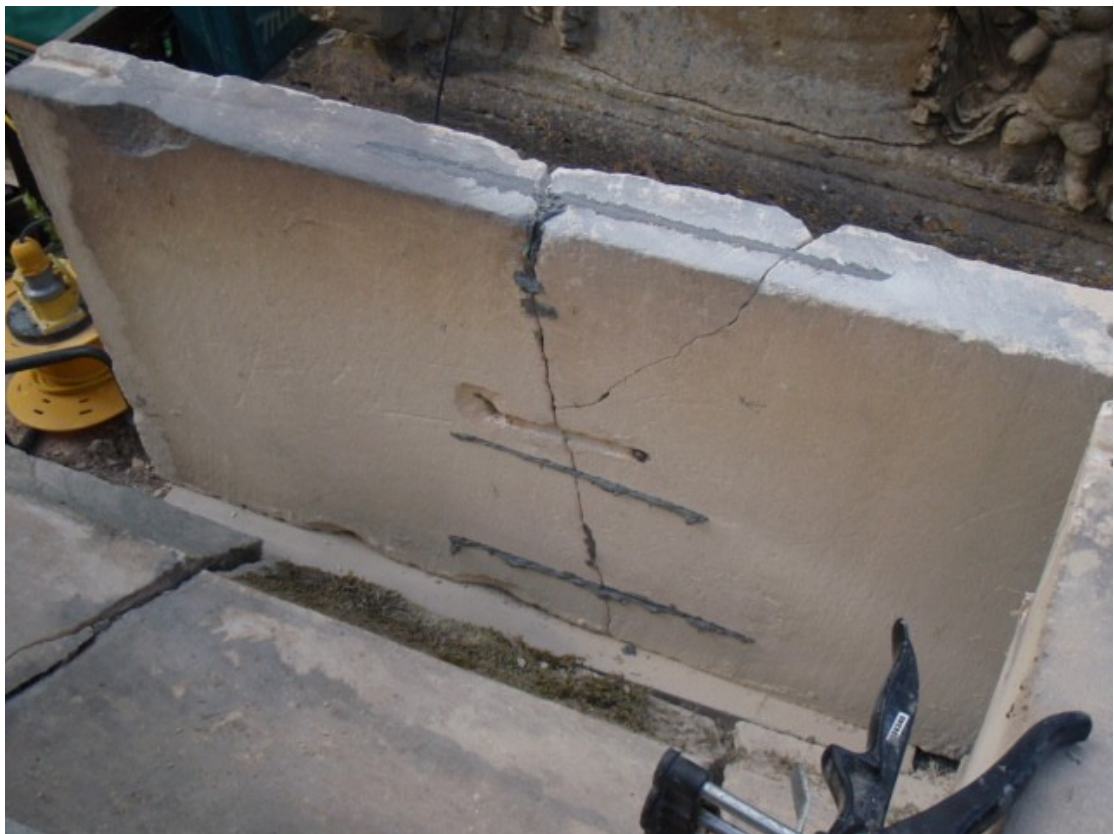
The broken panel was then reinforced using stainless steel bars set into slots.

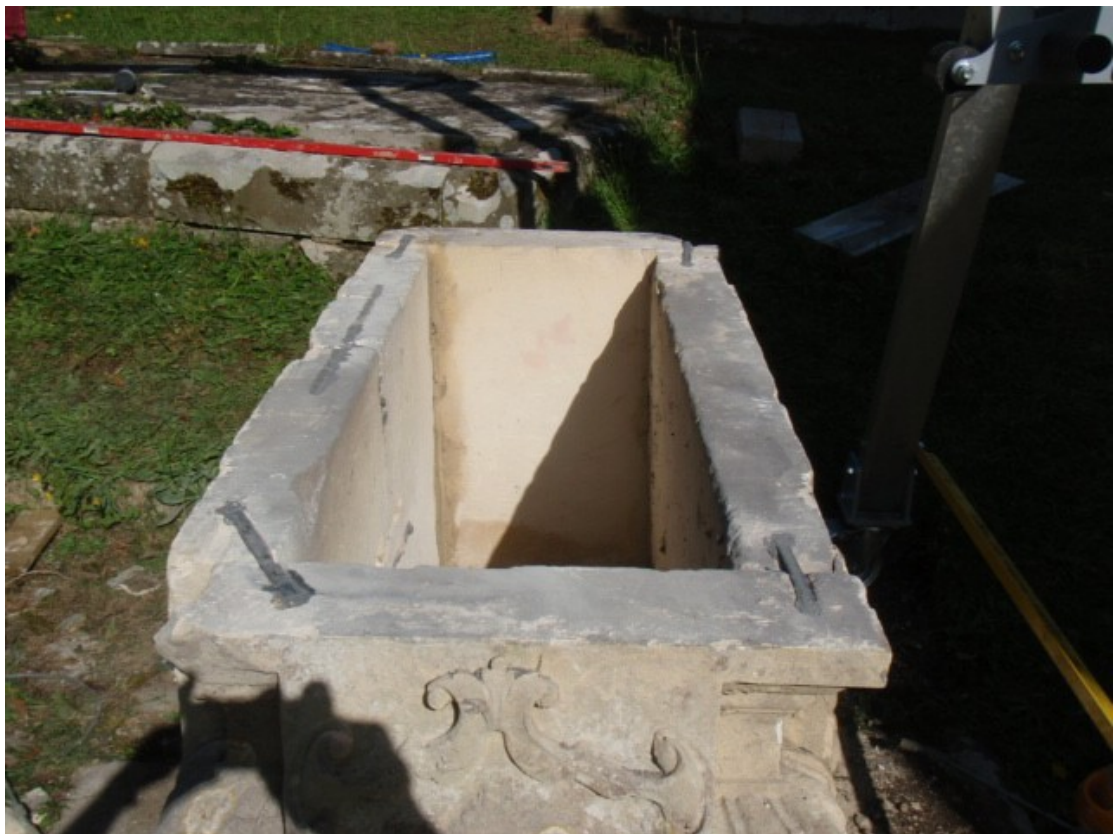
Rusted iron cramps were replaced by stainless steel ones.

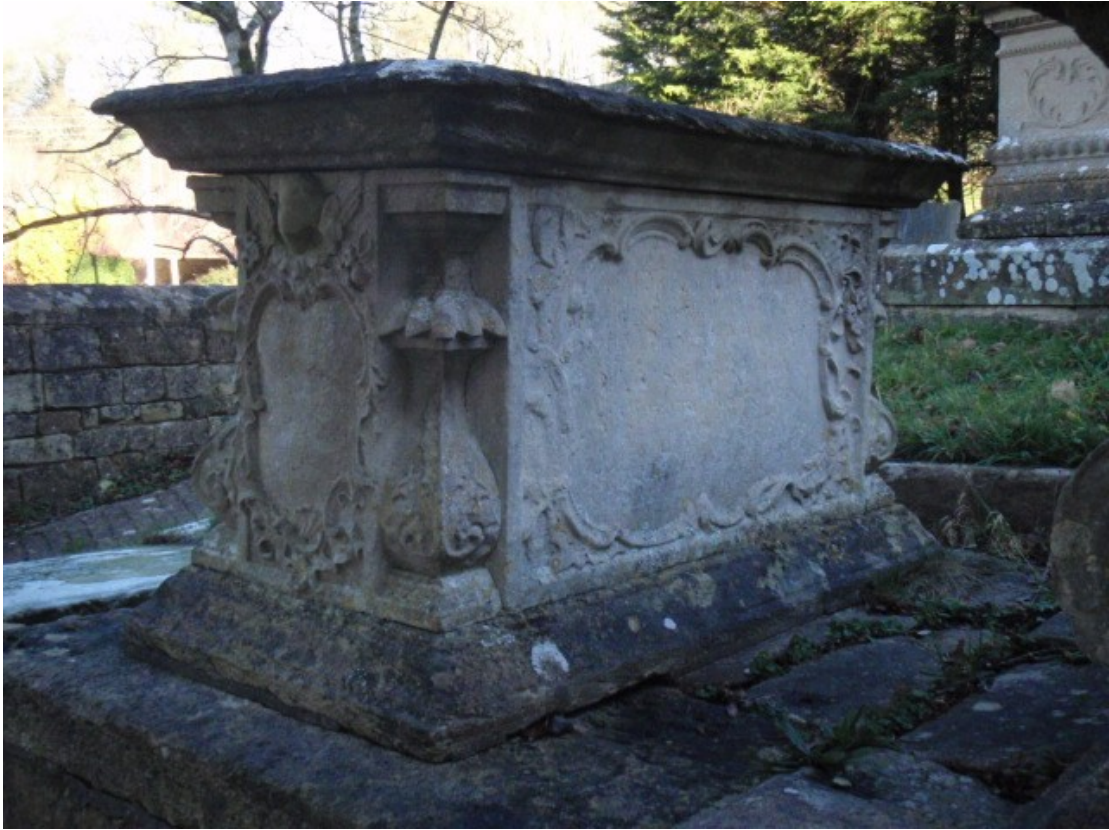
The limestone is in sound condition, with moderate weathering of the surface and some growth of lichens. Some of the lime mortar in joints between the stones has weathered back, potentially allowing more water to enter. Iron cramps present at the corners have rusted, expanded, and lifted the lid to a considerable degree. The lid is now unstable. The plinth has not moved on the covering slabs beneath, and is stable.

The south side before conservation.

The lid was lifted, and rusting iron cramps removed and replaced with stainless steel ones, before repositioning the lid on a bed of lime mortar. Open joints were repointed. The very wide joint between the covering slabs and the plinth stone was repointed with a coarser mortar of 3 parts Ashton Keynes sand, 2 parts Frithend sand and 2 parts NHL 2 and Cotswold stone roofing tiles, packed in deeply.

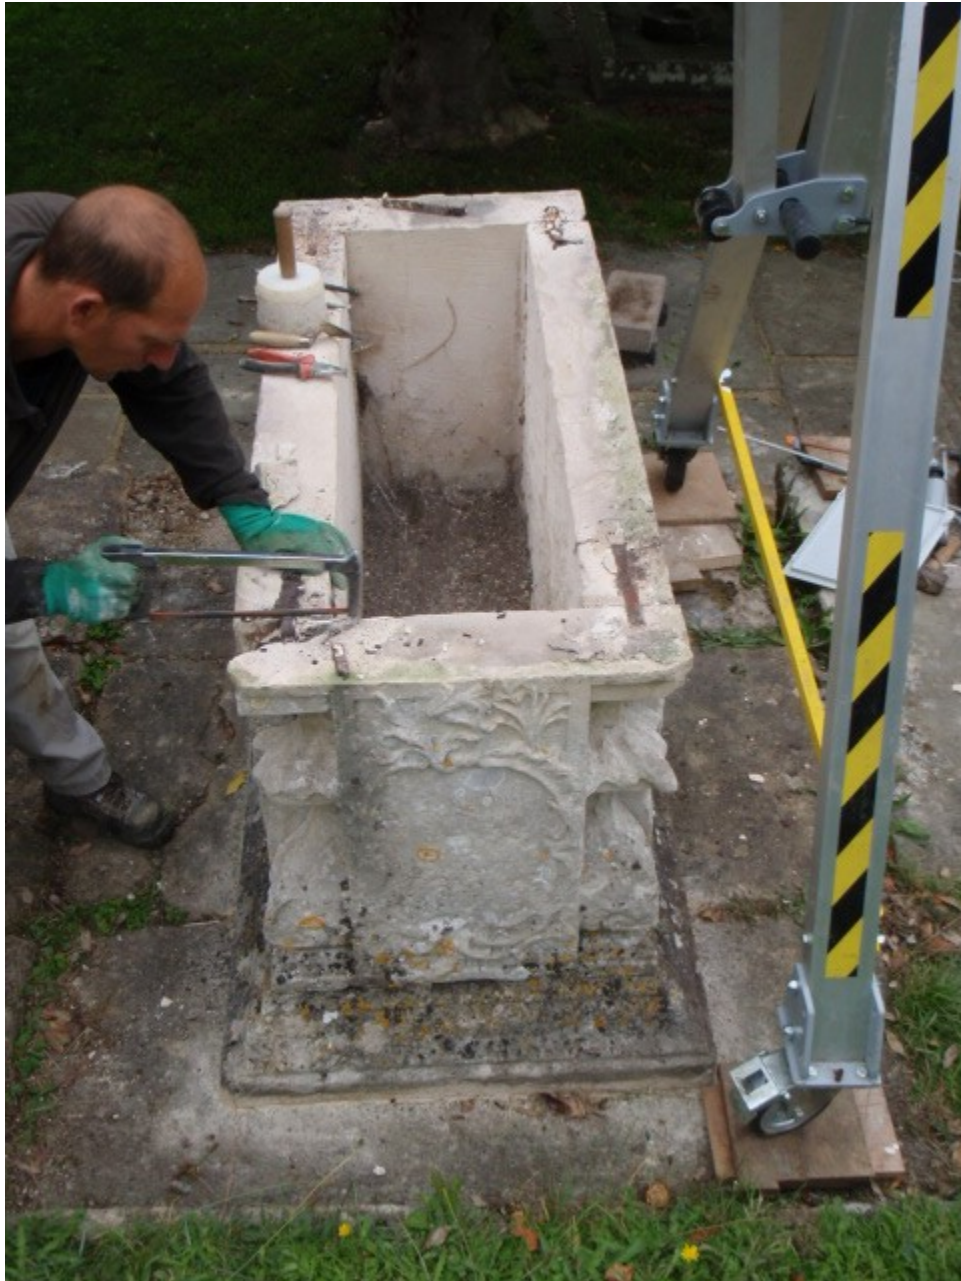
The top was removed using a lifting gantry, and the rusted iron cramps taken out.

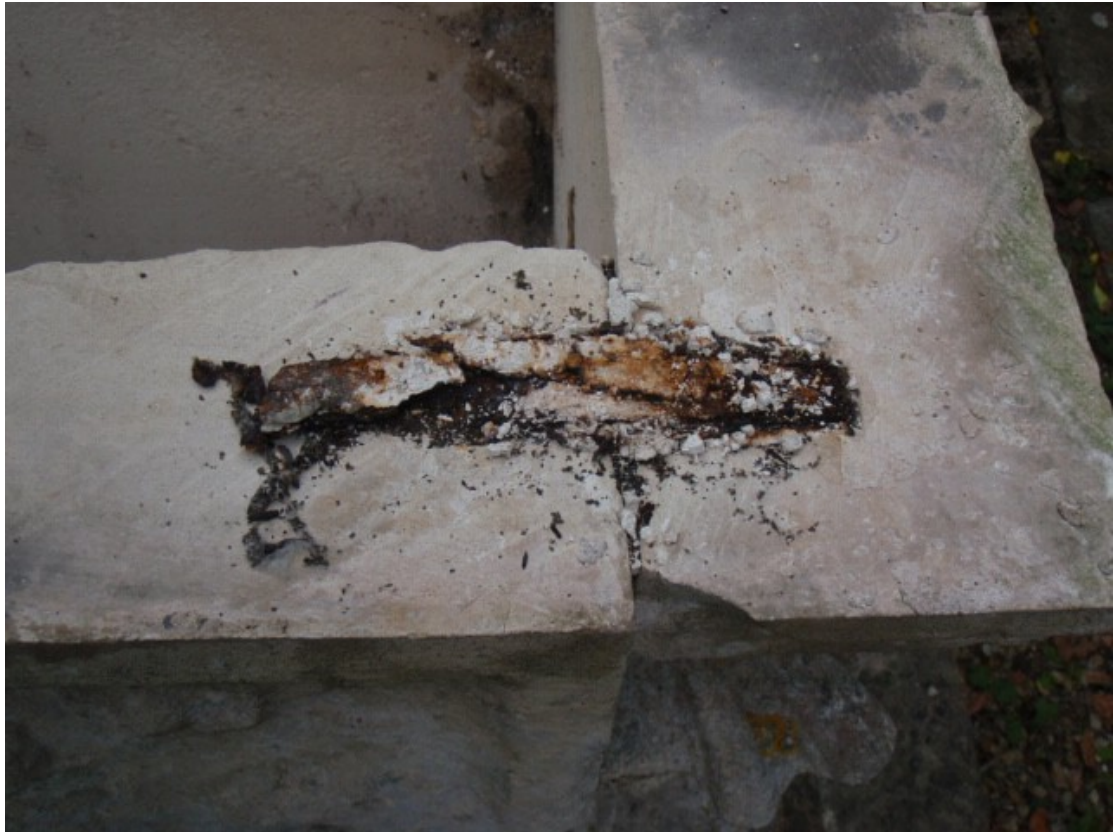
A rusting iron cramp.
