Inspecting Architects Report on Proposed New Central Heating Boiler The Church of the Ascension Hall Green

Issue date: June 2018
Prepared by: LZC
Checked by: CXT

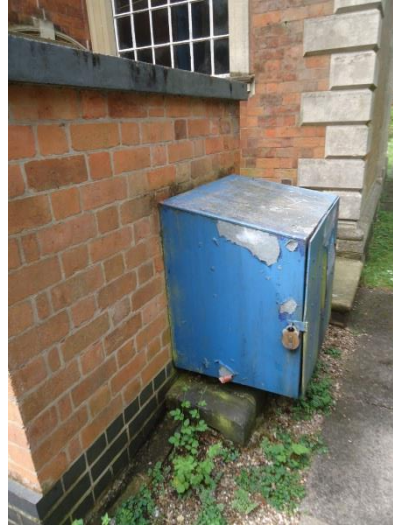
The Church of the Ascension, Hall Green is heated by means of a gas fired conventionally flued boiler located in a below ground boiler room beneath the vestry lobby on the South East corner of the church. The gas meter is located in a locked metal cabinet fixed to the outside face of the boiler room access stair wall.

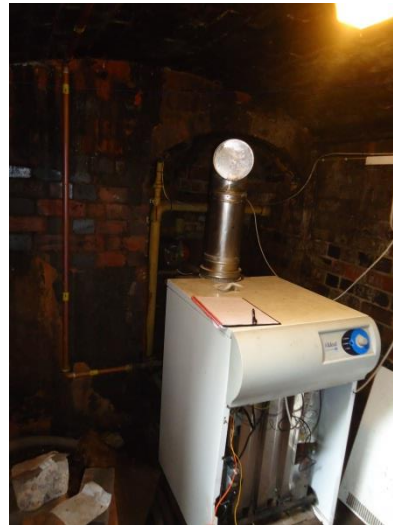
- The existing boiler is of some age and the church has been troubled with poor reliability during the heating season and the difficulty of getting spare parts for it.
- The below ground boiler room suffers from periodic flooding and is routinely very damp.
- The boiler plinth is very shallow and encourages flooding of the base of the boiler.

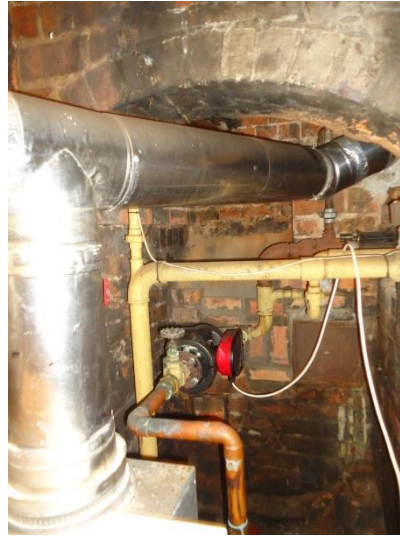
- d) Lack of headroom in the boiler room has caused the flue installation to be made with a 90 degree bend above the boiler outlet. While compliant when originally installed this bend should be 135 degrees under current regulations.
- e) It was noted that the boiler flue outlet was of 225mm diameter. The existing flue has been reduced to 175mm diameter suggesting that the brick flue may not accommodate the correct, design flue size.
- f) The heating pipework and radiators appear in fair condition and no leaks are reported. However one or two rusting joints are noted and parts of the cast iron pipework is buried beneath the aisle and chancel floors without duct access. The condition of those hidden parts is not known.

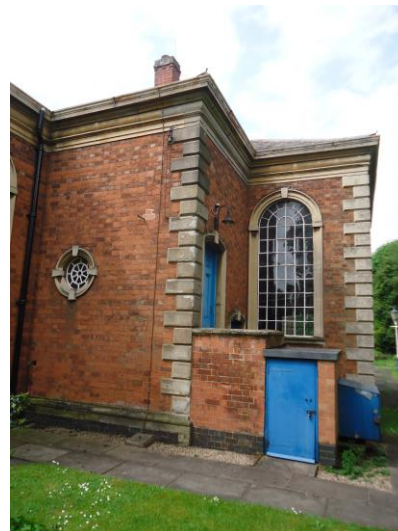
The use of a balanced flue boiler in this location is also discounted as the flue would discharge at low level and be prone to vandalism in this secluded part of the church.

A handrail should be installed to the access steps and boiler room ventilation improved to current regulations

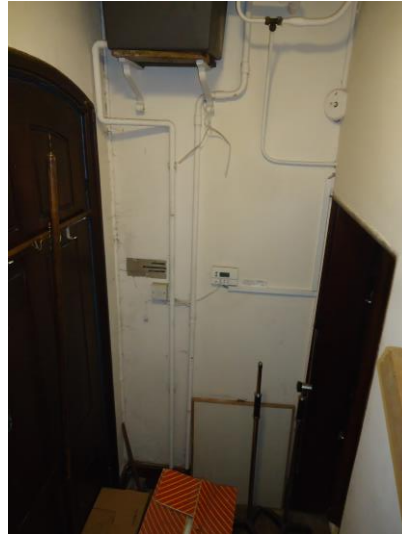
There is space to accommodate such a boiler on the East wall of the lobby. The necessary balance flue would exist through that wall.

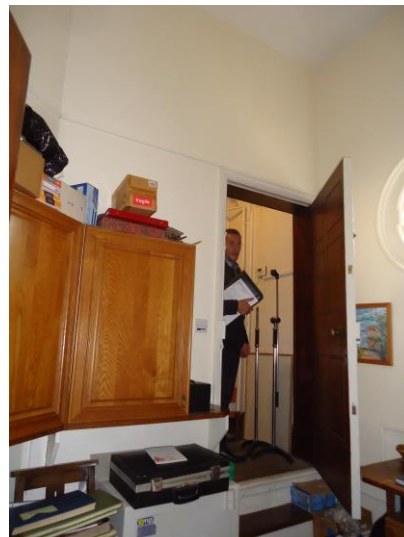
This would have the advantage of not compromising the space in the lobby but it is noted that pipework in this location may cause disruption to the memorial cupboards and their setting.

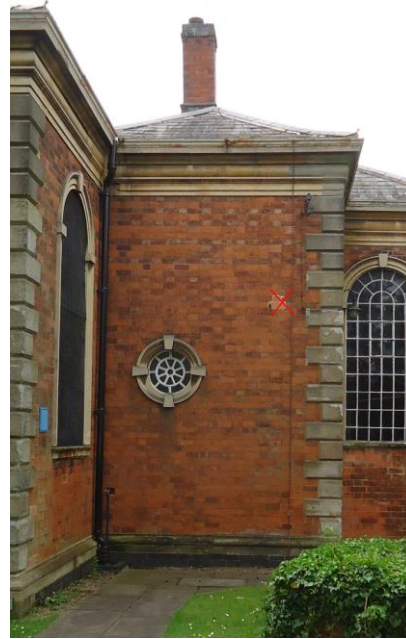
New flue marked X

The balanced flue will probably require Listed Building Consent. We recommend therefore that the external parts should be powder coated to match the facing brick colour. We also recommend that its installation be used to relocate the existing header tank immediately below it and to make good the poor quality pointing where the overflow pipe was installed.
