Energy Audit and Survey Report

St Alban's, Westbury Park

PCC of St Alban's

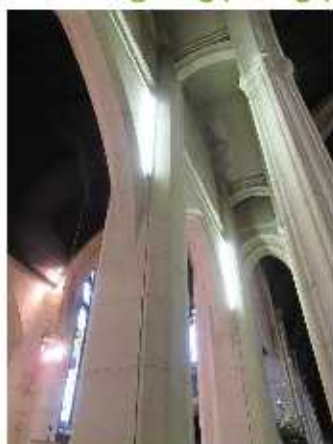
5.1 Lighting (fittings)

The lighting makes up a relatively small overall energy load within the building. A lighting up-grade to the main nave lights took place in the last 6 months and they are now LED spot lights.

However there still remains the number of other lamps which were not replaced, and can be up-graded to much more efficient lamps. There are a number of T12 fluorescent tube fittings, such as in the vestry, choir room, choir stalls and organ loft. These fittings are widely available on the market and it is suggested that the complete fitting (not just the lamp) is replaced. Any new LED fitting would have a much longer life and hence reduce the need to replace the

It is recommended that all of the fittings, scheduled in Appendix 1, are changed for LED.

If all the lights were changed the total capital cost (supplied and fitted) would be £1,409. The annual cost saving would be £122 resulting in a payback of around 11 years. Many of the lights could be self-installed and therefore cost much less than the supply and fit cost above.

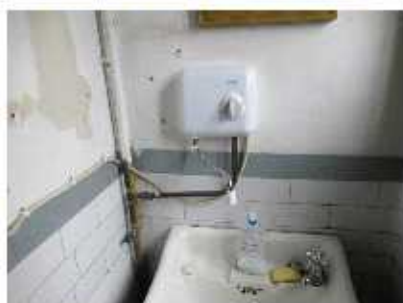
5.3 Timed Fused Spurs

There are a number of electric point of use water heater in the toilet and vestry to provide hot water for hand washing. This only needs to heat the water to the required temperature when the building is in occupation but at the moment this heater is directly wired in without any form of time control and therefore maintains its set temperature 24/7.

It is recommended that the heaters are fitted with a 24 hour/7 day timeclock to replace the fused spur switch. An example of such a unit would be a TimeGuard FST77. They should be set up with times to match the times that the building is occupied and this will prevent the standing losses from the unit wasting energy during periods when the building is not occupied.

Such units can be purchased at any electrical wholesaler and fitted by your existing electrician or any NICEIC registered electrical contractor.

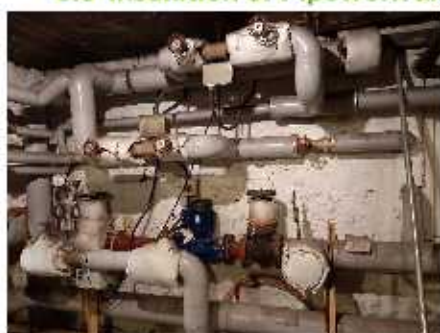
6.3 Insulation of Pipework and Fittings

The pipework within the plant room has the majority of its straight lengths insulated and a number of the more complex shaped pipework fittings, such as valves, have been insulated. However, some of the specialist jackets have been removed and not replaced. These exposed areas of pipework contribute significantly to wasted heat loss from the system and make the plant room unnecessarily warm. The exposed hot surfaces also represent a health and safety risk of burns for those working in the area.

It is recommended that these areas of exposed pipework and fittings are insulated with bespoke made flexible insulation jackets. These wrap around the various elements but can be removed and then replaced for any servicing activities.

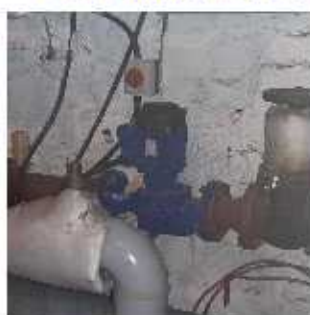
6.4 Variable Speed Drives

The existing pumps within the building are fixed speed units meaning that they are either running at full power or they are off. In varying conditions, the pumps and fan motors will only need to operate at part power and can consume less energy in doing so.

It is recommended that the pumps are changed to variable speed drive units which can automatically vary the power they use depending on the conditions at that particular moment in time, for example, how much heat is required into the heating system or how much air is required into the building based on factors such as CO₂ levels.

The installation of variable speed units will require the removal of the existing pump and the installation of a new unit with integration back into the controls system. As such this should be carried out by a competent mechanical engineer.

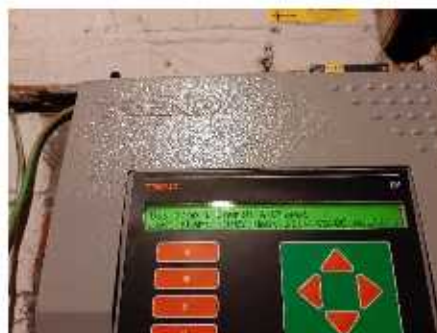
6.5 Controls

The buildings main heating, hot water and ventilation plant is controlled by a centralised building management system (BMS). This is a Trend system operated from a control panel located the boiler room.

A high level review of the settings within this control system highlighted a number of areas where the way in which it operates the building can be optimised to both reduce energy consumption and improve comfort. For example:

- The timings for heating the church are currently on from 8am Friday until 12pm Sunday. This should be reduced, and perhaps set to start at 12pm on Saturday until 12pm on Sunday.
- The control system has an optimised start/stop which is not being used correctly. This brings the heating on in time to be up to temperature for the time period selected, therefore, the boiler control is trying to get the church up to temperature for 8am on Friday morning.
- The time on the clock on the controller is incorrect, it was running 1hr 15 mins ahead of time at the time of the site visit.

It is likely that a more detailed forensic review of the control system settings and strategy will yield further opportunities for improvement.

It is therefore strongly recommended that a detailed control optimisation process is conducted, this can be run alongside and with the full support of any existing controls maintenance company that may be used, or as a separate independent exercise.

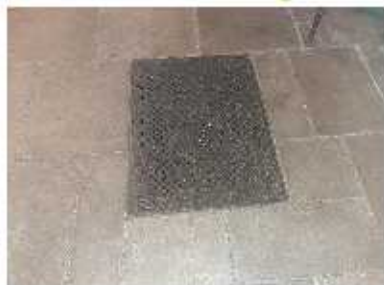
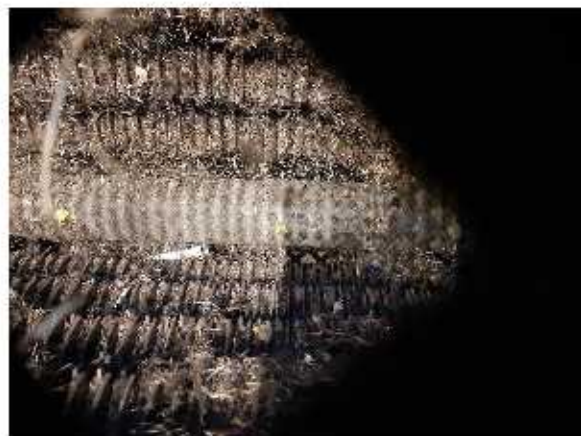
6.6 Clean Heating Floor Grills

The main heat emitters to the church nave is via floor grills. Looking through them, the pipes are very dirty and covered in a lot of dust. This will be providing a nice layer of insulation over the pipes and making them less effective at heating the air

It is recommended that the grills are cleaned regularly to enable them to be as efficient as possible.

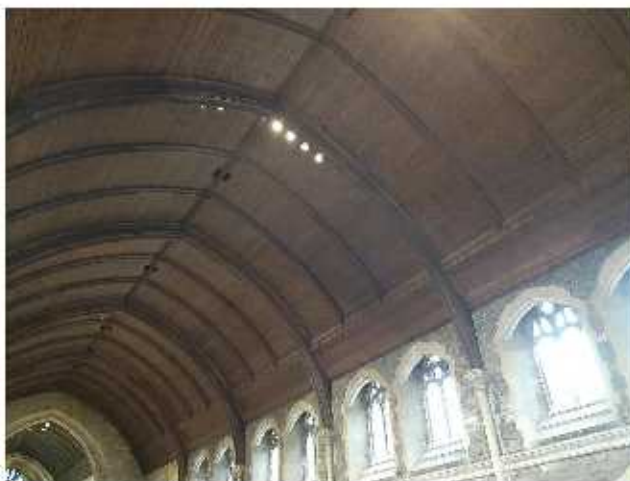
7.1 Roof Insulation

The loft void above the ceiling was not inspected as part of this audit, however it was reported that there is little or no insulation present. In all cases where there is 100mm or less of insulation within accessible roof spaces it is recommended that insulation be added to prevent heat loss and create a more comfortable environment for the occupants of the building.

The ceiling/roof of a building is the largest contributing area to heat loss from a building as heat rises. The insulation of such spaces can therefore have a dramatic impact on both the efficiency of the heating system and the temperature of the space below. Insulation measures such as this also need to be combined with control measures such as TRV's or room sensors to ensure that the space does not overheat because of the additional insulation.

A free survey and quotation for the supply and installation of insulation to the loft spaces can be arranged through ESOS Energy Ltd (contact Adrian Newton 0117 9309689, adrian@esos-energy.com).

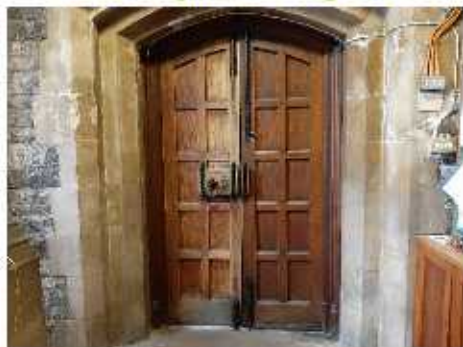
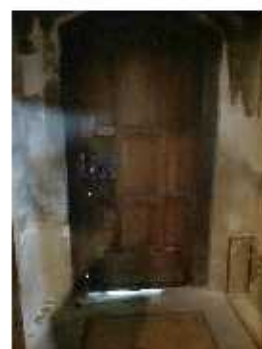
7.2 Draught Proofing to Doors

There are a number of external doors in the building. These have the original historic timber doors on them, but these do not close tightly against the stone surround and hence a large amount of cold air is coming into the church around the side and base of these doors.

Where a timber door closes against a timber frame it is recommended

that draught proofing is fitted. A product called QuattroSeal (see link below) is often used in heritage environments to provide appropriate draught proofing.

Other simple measures such as using a small fridge magnet painted black over the large keyhole or the use of 'sausage dog' type draught excluders at the base of little used doors, such as the side doors from the nave, can prove to be very effective. Doors should be reviewed in daylight and gaps where the light shines through sealed or filled in whatever the most appropriate way is for the specific door.
