Energy Audit and Survey Report

St Mary's Church, Buscot

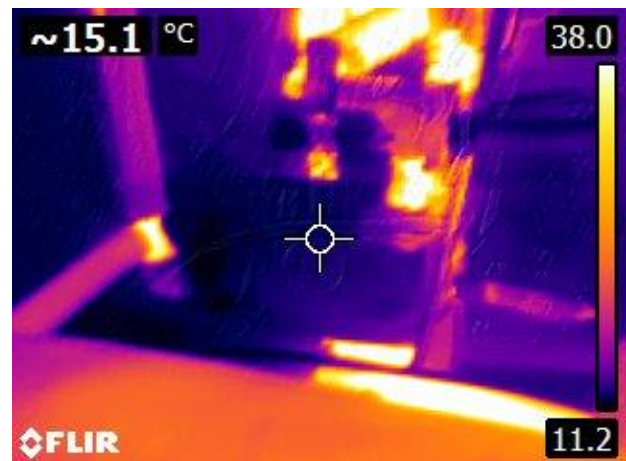
The pipework within the plant room has the majority of its straight lengths insulated but the more complex shaped pipework fittings, such as valves, have been left uninsulated. These exposed areas of pipework contribute significantly to wasted heat loss from the system and make the plant room unnecessarily warm. The exposed hot surfaces also represent a health and safety risk of burns for those working in the area.

Photo 1 - Heating pipework - light colours highlight high heat loss

It is recommended that these areas of exposed pipework and fittings are insulated with bespoke made flexible insulation jackets. These wrap around the various elements but can be removed and then replaced for any servicing activities.

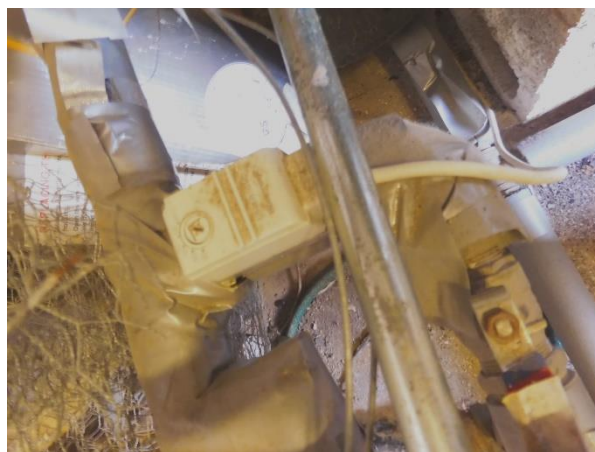
It was discovered on site that the flow temperatures within the pipework when the boiler was running were rather low. It is for this reason that the heating has to run on for so long before a service and will have impacted on the church's current decision to maintain a level of background heating within the church. Investigations on site suggest that the flow temperature of the boiler is currently being held back by the pipe sensor on the flow pipework. Even although this has been turned up the flow temperature is being limited to around 45°C to 55°C.

Photo 2 - Faulty pipework sensor next to boiler

It has therefore been concluded that this pipe stat may well be faulty and should be replaced. Replacement pipe stats can be purchased for around £30 and fitted by any competent heating engineer. This should then result in much higher flow temperatures within the system that will result in shorter and more effective warm up times and avoid the need for background heating.

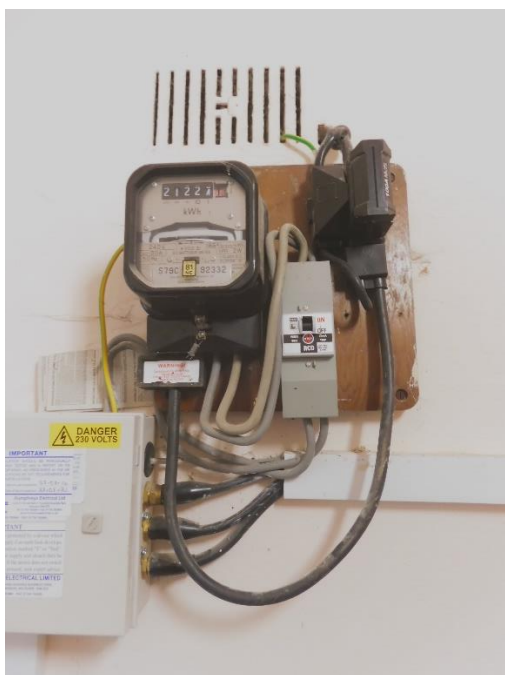
Given the need for all churches to decarbonise, the best step for this would be to move to electric heating within the church. This would require an upgrade of the currently 100A single phase electricity supply to the church to allow for the additional load of electric heating, which is discussed further below. The church would need to speak with the current electricity supplier, SSE to investigate this process but it would appear as if the upgrade may be relatively straight forward as there is a 3 phase power supply on the pole immediate behind the church from which the overhead supply into the church is supplied.

Photo 4 - Existing incoming 100A single phase supply

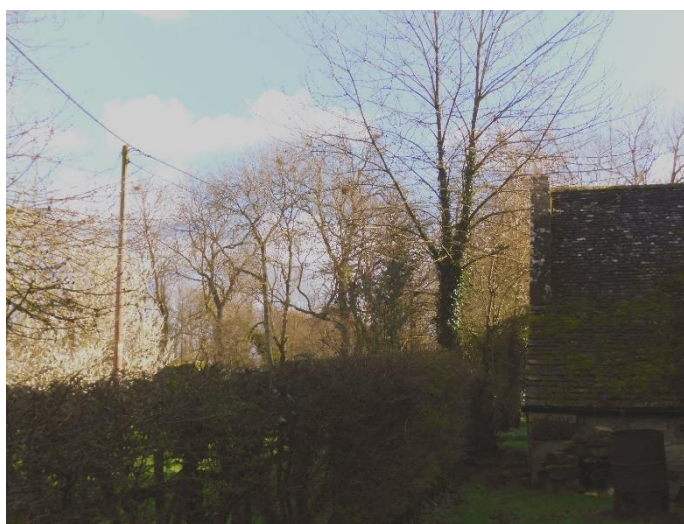
Photo 3 - Overhead 3 phase line behind church

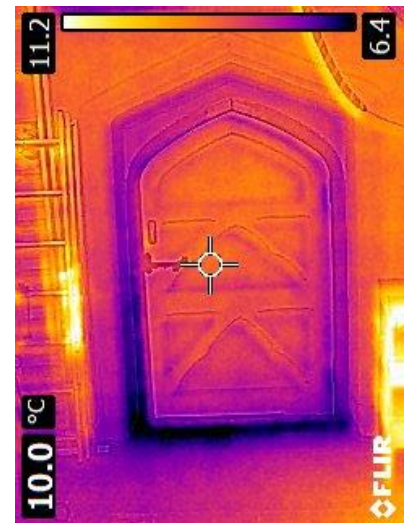
There are a number of external doors in the building. These have the original historic timber doors on them, but these do not close tightly against the stone surround and hence a large amount of cold air is coming into the church around the side and base of these doors.

Photo 7 - West door - dark area at base of door indicate cold air blowing in

It is recommended that draught proofing is fitted to all external doors. A product called QuattroSeal (see link below) is often used in heritage environments to provide appropriate draught proofing.

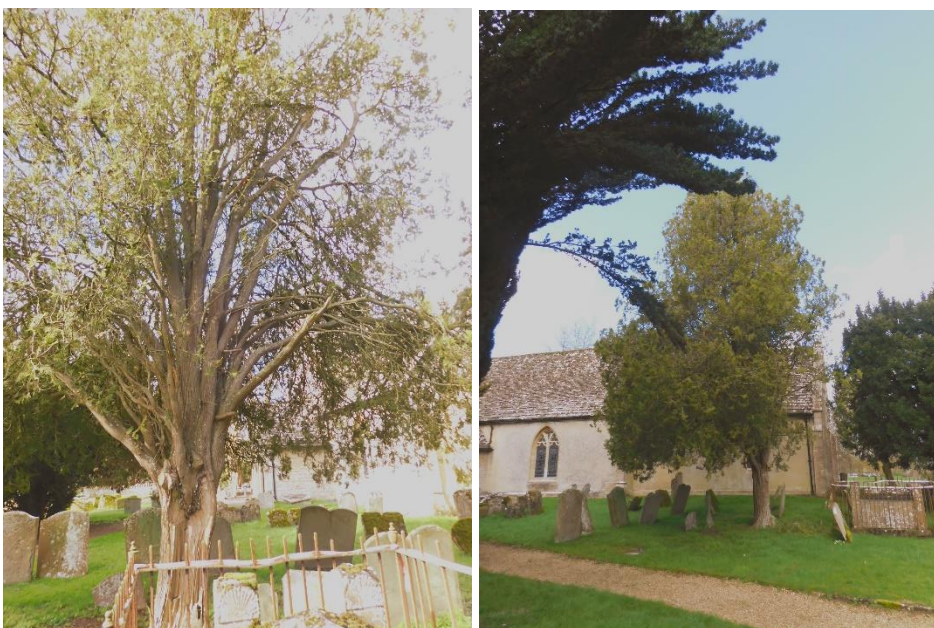
There is one tree within the church yard which provides significant shading on the south side of the church due to its proximity to the church and its evergreen nature. This shading is not helpful in that it does not allow for the church to benefit from solar heat gain and results in this section of the church being more damp. The tree itself appears to be in poor condition with a large section having previous split off and the remaining tree therefore appearing to be unbalanced.

Investigations should be made as to whether retaining this tree is a pragmatic solution in the long term or whether it should be removed and replace for multiple trees along the boundary of the church yard where they will have less adverse impact on the fabric of the building.
