Energy Audit and Survey Report St Mary's Church, White Waltham

DIOCESE OF OXFORD

Version Control

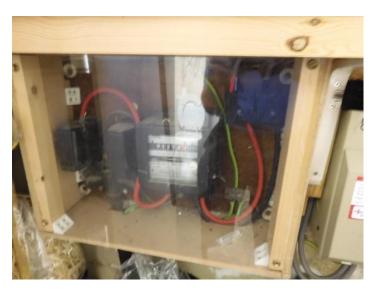
The oil use is not metered, and the electricity meter is an old-style meter so its usage profile is not logged. It is recommended that the church consider asking their suppliers to install smart electricity meter so that the usage can be monitored more closely and the patterns of usage reviewed against the times the building is used.

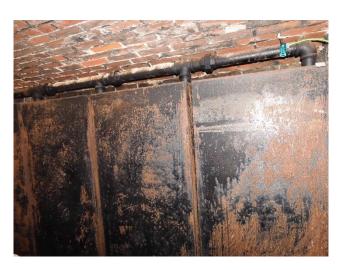
The current oil-fired boiler is at the end of its life and the current oil tank is a single skin metal tank which does not conform to the latest oil storage regulations. The cast iron radiators within the church provide some heat but not in the places where it is most required. To be able to reach comfortable levels within the church the heating is likely to have to be turned on for many hours in advance which is inefficient and costly. The continued use of oil, which is a highly polluting fossil fuel, in a low carbon future is also highly undesirable and does not align to one part of the churches mission to be good stewards of creation.

Having reviewed the heating arrangements and usage of the church it is recommended that is considered converting to a direct electrical form for heating and abandoning the old oil system.

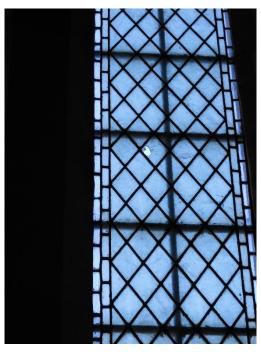
It was noted during the audit that there were a number of places where the glazing within the leaded windows had broken. This is allowing cold air to easily enter into the building and will be resulting in cold draughts.

It is recommended that the windows are reviewed and repaired by a suitable specialist to makes sure that all glass is intact and all joints are well sealed.

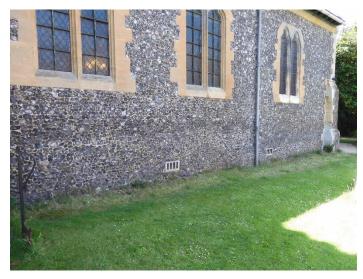
There are air vents to the low level of the external walls. These are required to provide ventilation to the timber within the floors, but they also provide a route for cold air to come into the building and result in a very uncomfortable cold draught rising up from the floor. This is especially prevalent on the north side when a cold wind blows in from this direction. To modulate the ingress of cold air in winter it is recommended that a temporary board is propped up against these vent holes on the outside. If this is

at a slight angle against the wall some air will still be able to get into ventilate the floor but the direct flow of cold air will be reduced.
