# St John the Baptist Hawkchurch Devon

Treatment Report Job Ref: 19253

July 2020

## Rob Smith Memorial Plaque

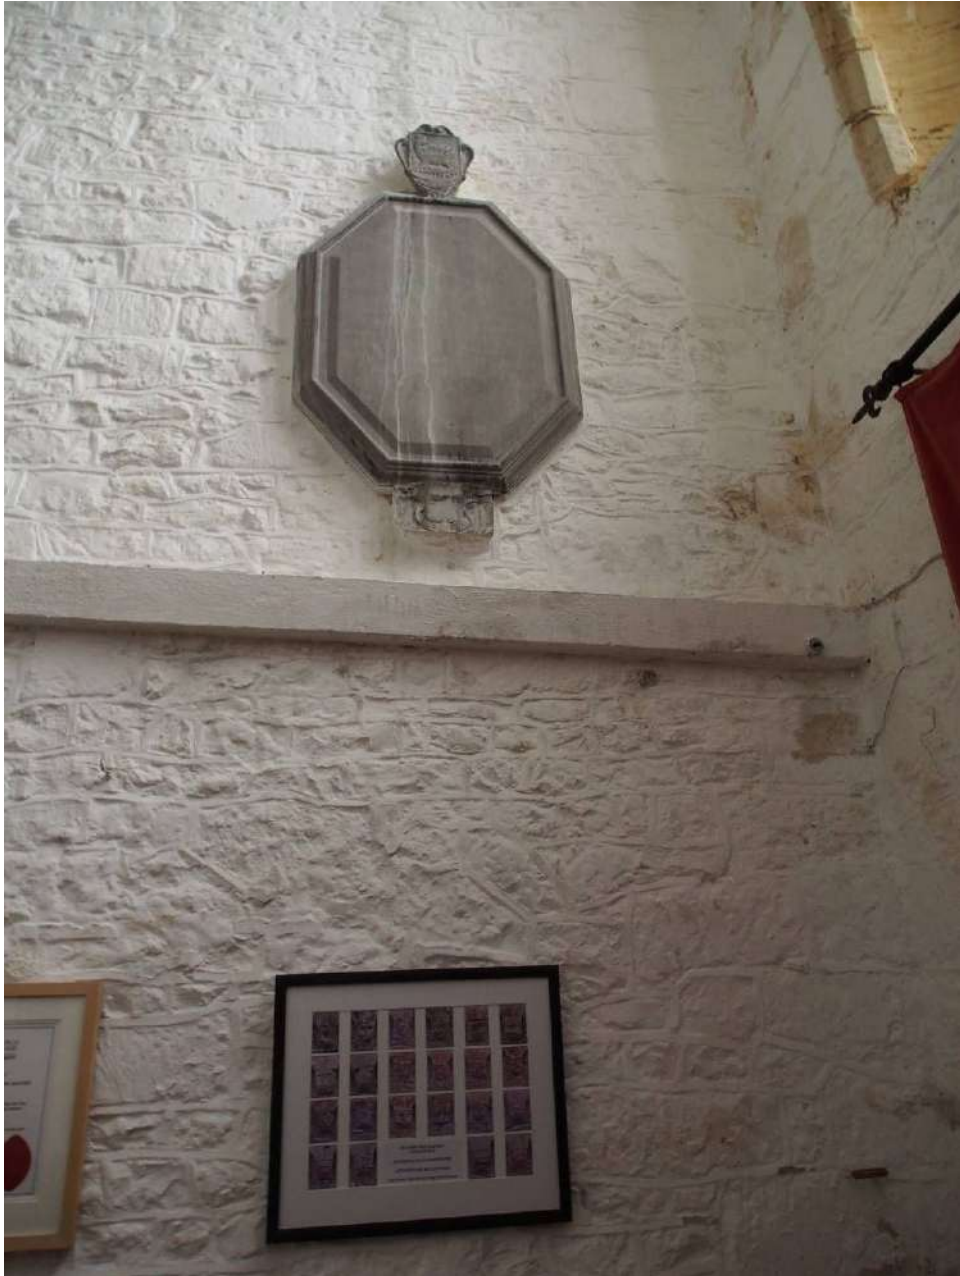
The plaque was taken down using a scaffold with a block and tackle and was transported to the Bath workshop for repair. Less than 5% of the highly polished surface remained amidst a general dull and lacklustre surface; an equal percentage of black lettering remained. Several vertical streaks caused by water ingress marred the face of the plaque.

*This image shows the plaque in its original location. Note the water streaks.*

The dull and matt surface persisted after two applications of buffed microcrystalline wax and the water streaks remained highly visible. The only way to remove the streaks was to restore the highly polished surface using marble polish and oxalic acid. Wax was then applied with the addition of Lamp Black pigment to restore the original colour. Two coats of pigmented wax were applied and buffed to a high polish with a rotating mechanical wool pad. This process greatly reduced the water streaks and restored depth and lustre to the stone. The incised lettering was then painted-in with black acrylic paint before the plaque received a final wax coat. The corbel stone surface and lettering were treated in the same way.

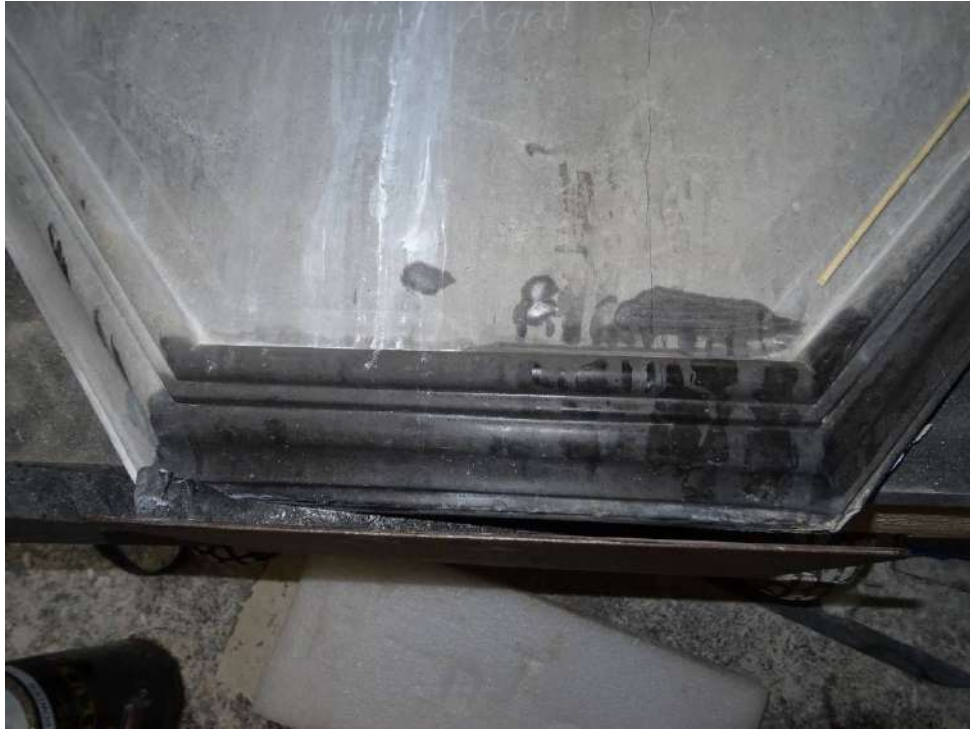
*This image shows some of the few remaining fragments of polished stone surface.*

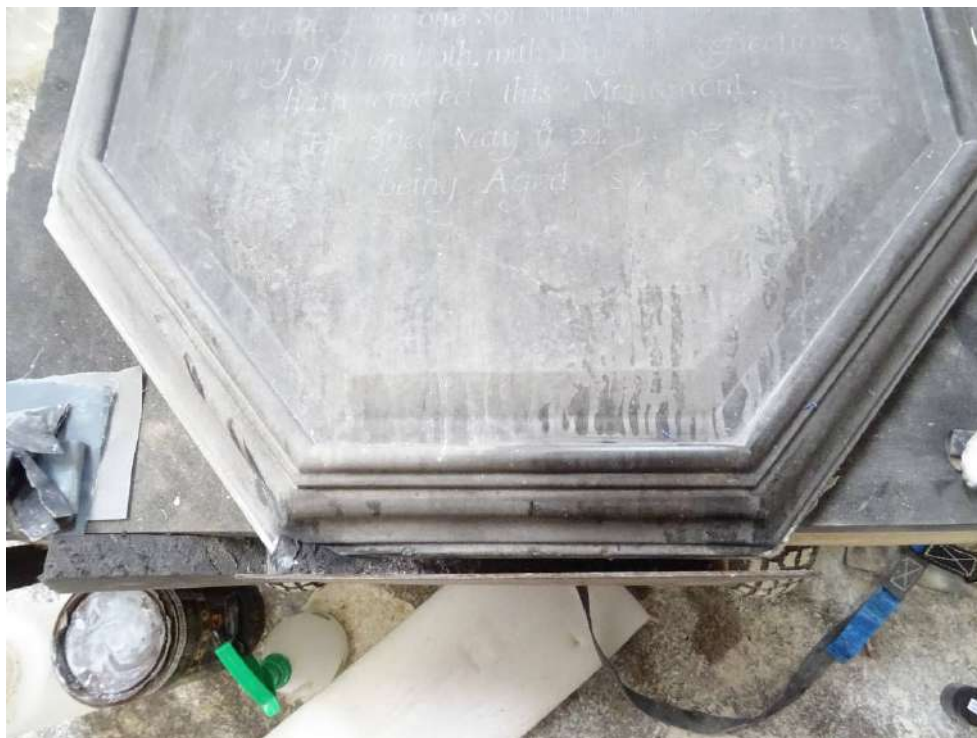
*The water streaks have etched into the surface leaving lighter coloured stone.*

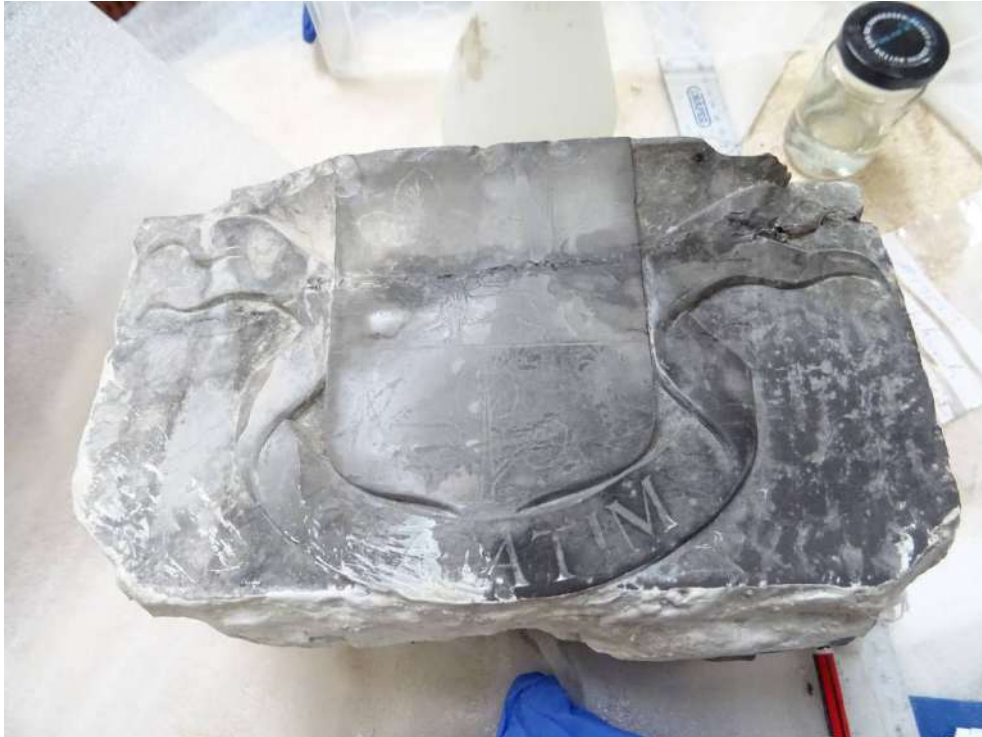
*This image shows the corbel after cleaning the right hand side*

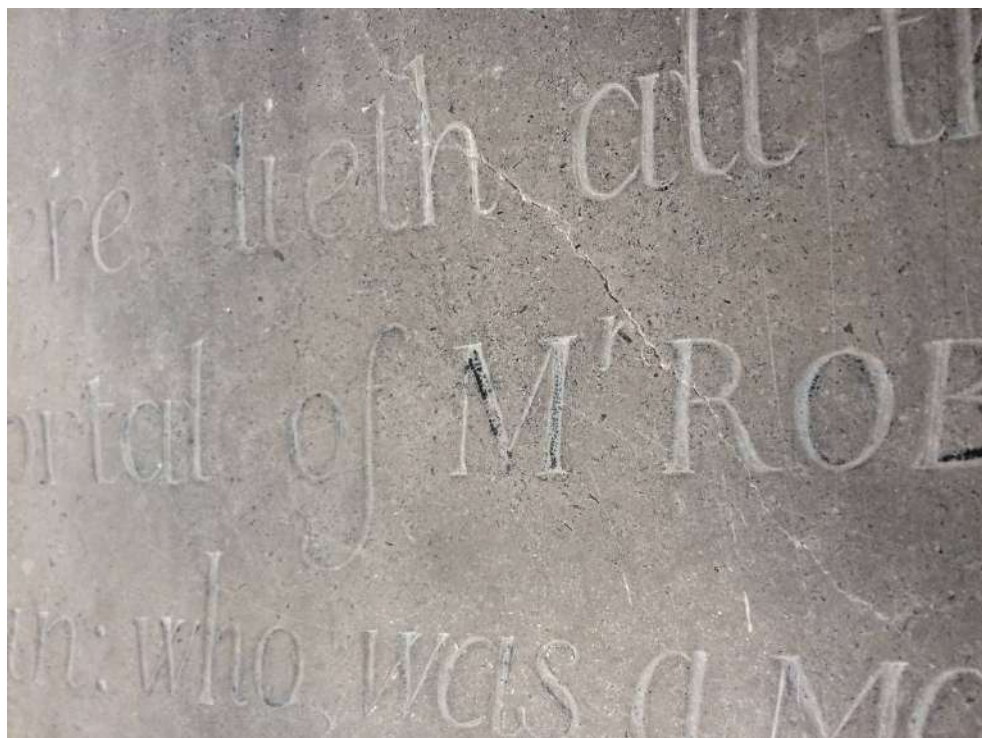
*This image shows some remaining black paint within the incised lettering. The diagonal line is a natural shake that has not developed into a structural weakness.*

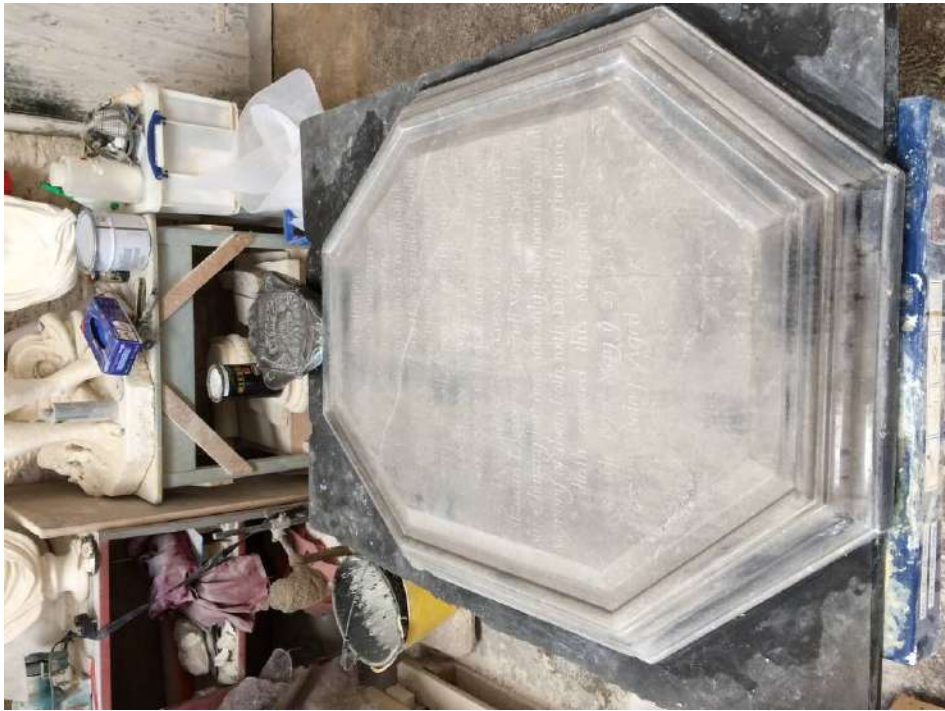
*Plaque after restoring the polished surface.*

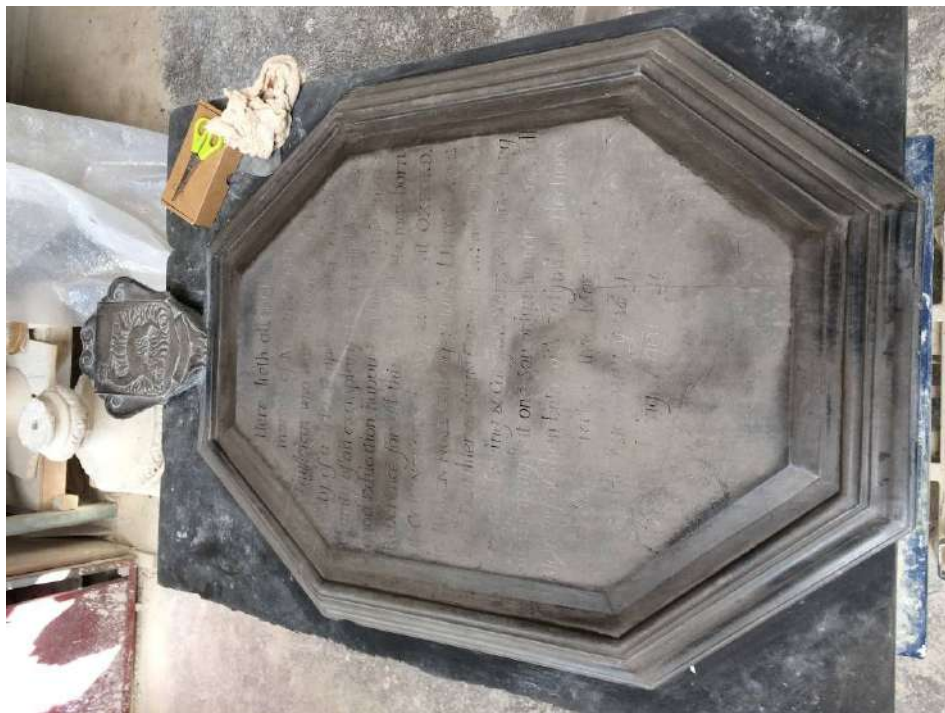
*Plaque following waxing with pigmented microcrystalline wax. The original lettering is now more visible.*

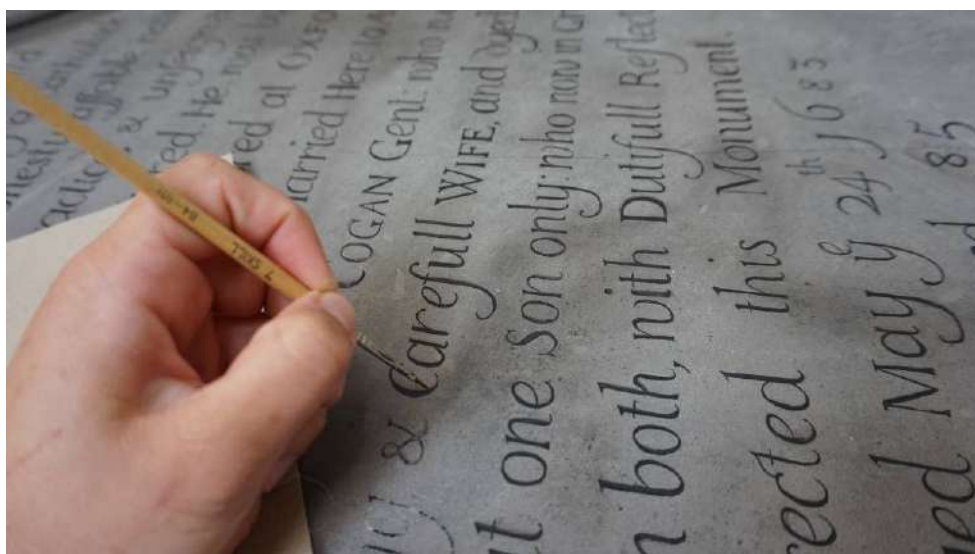
*Retouching the lettering.*

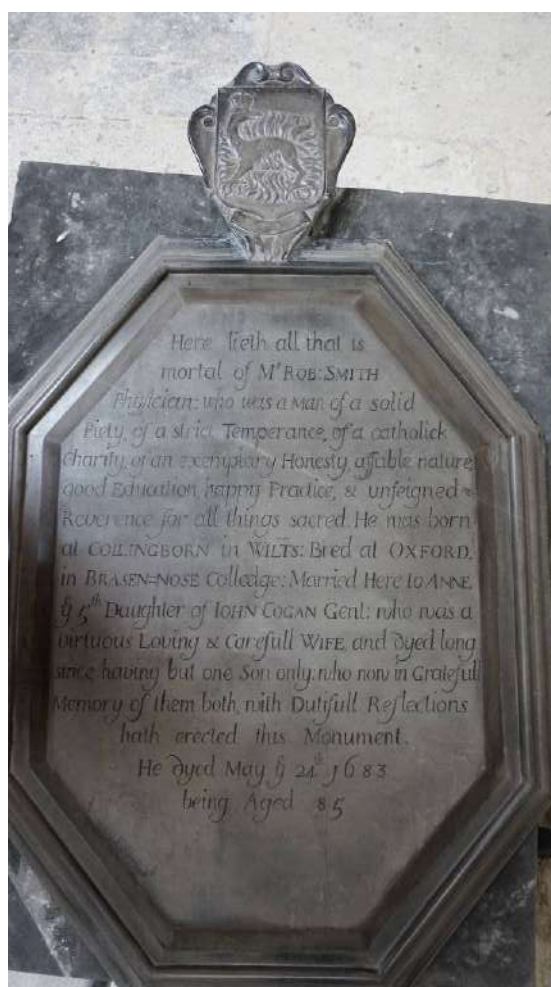
*Plaque on completion of treatment.*

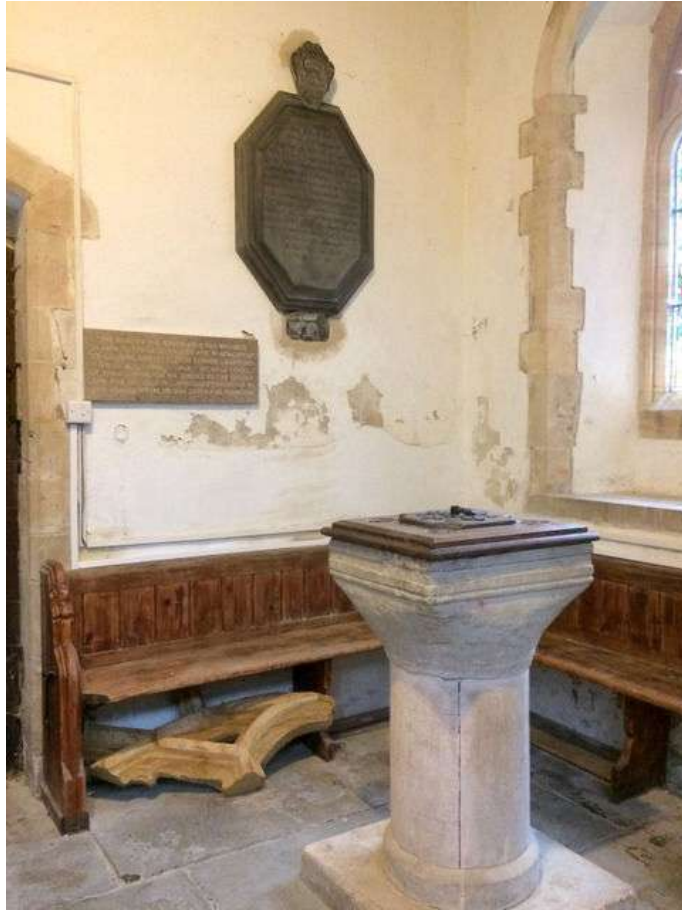
*Plaque in its new location on the south wall.*

was set in fast setting Prompt Natural cement. The plaque rests on the corbel and is secured at the top with a stainless steel flat bar restraining cramp set into the wall with polyester resin.

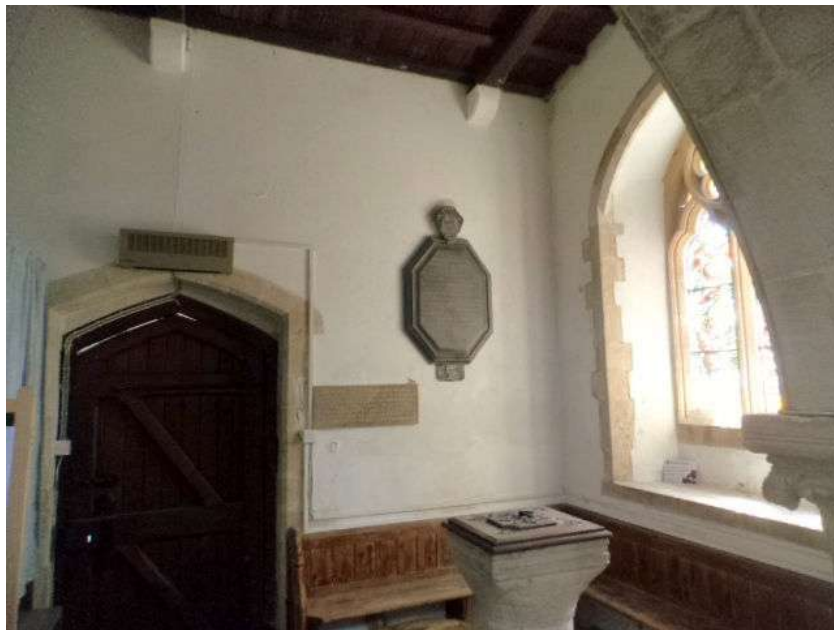
*Following painting of the surround*

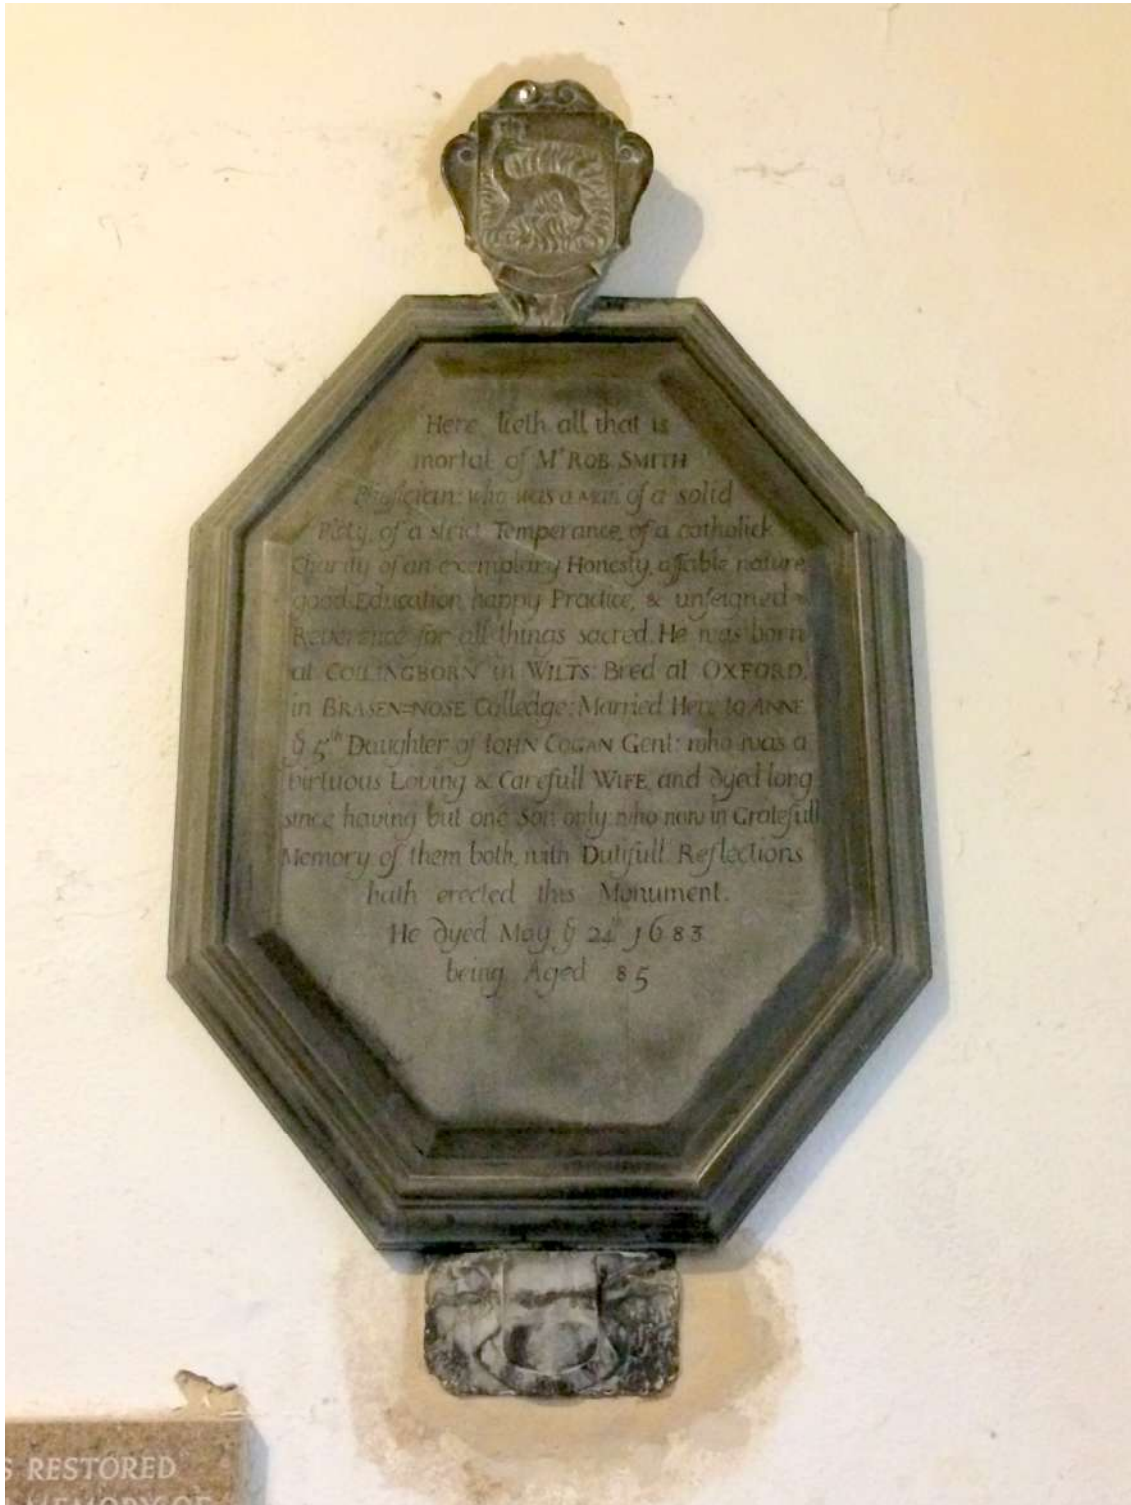
*Prior to repainting the surround*
