<b>CONDITION REPORT</b>		<b>April 2019</b>	<b>JOB NUMBER</b>	19253
<b>DATE OF INSPECTION</b>				
<b>PROPERTY</b>	St. John the Baptist, Hawkchurch

<b>LOCATION</b>	Bell tower, ground level			
<b>OBJECT</b>	memorial			
<b>MATERIALS</b>	Purbeck limestone (probably)			
<b>DIMENSIONS LxWxH</b>	750mm x 90mm x 1250mm high. Set 2.6m from ground level			
<b>DESCRIPTION OF OBJECT</b>	An octagonal wall mounted cartouche with fine incised lettering. The small shield above is integral to the main body of the memorial, however the decorative corbel it sits on is not. The corbel below is decorated with a shield bearing three leaf motifs and a lion, all in very fine incised carving. Neither the lettering or the decoration appears to have been painted.			
<b>Condition – surface</b> COND. CODE  C	The central octagonal cartouche is in fair condition although the lettering is difficult to read. Water damage is evident across the surface and there is further discolouration to the lower moulding. There is a fine pale line across the upper section from the top left-hand corner, however this appears to be nothing more than a natural feature of the stone.  The corbel has a horizontal crack and is very disc

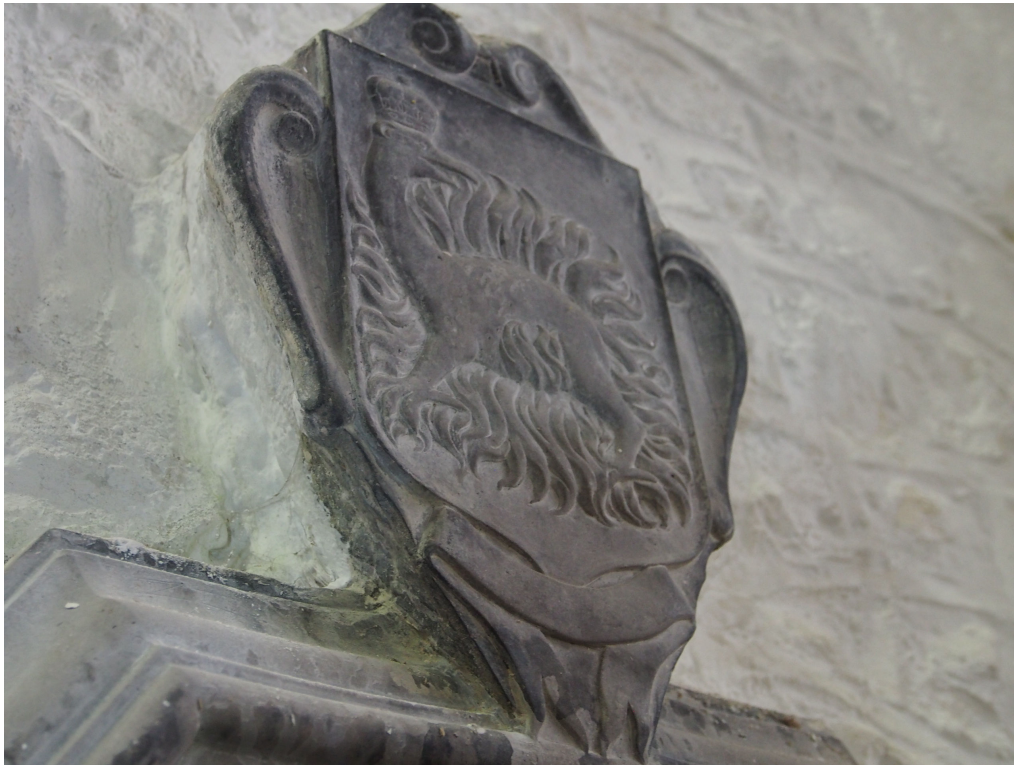
*The top shield to the memorial*

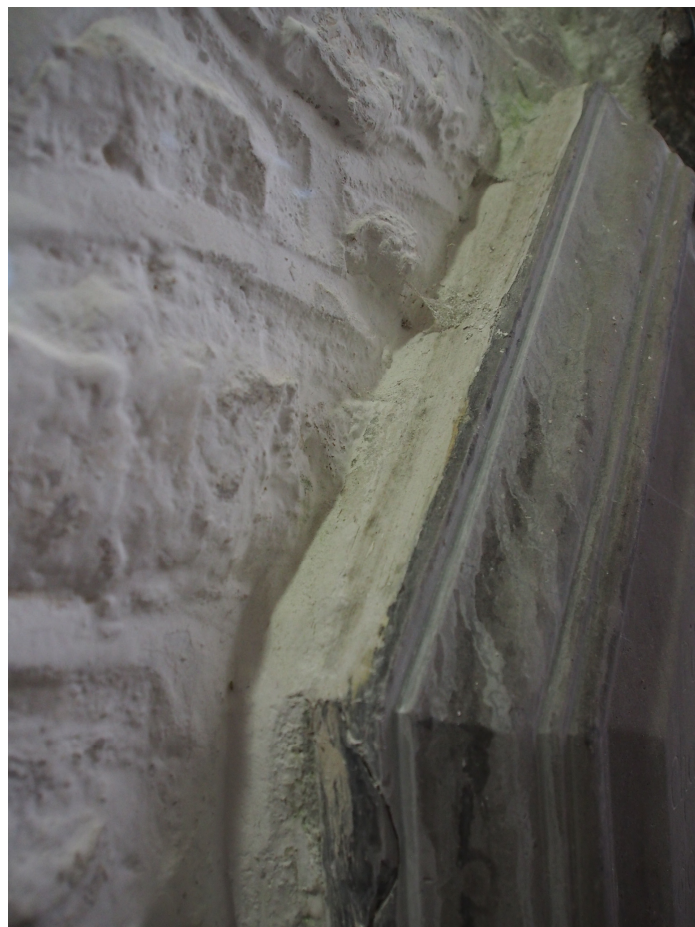
*The backing material is thick but there are no signs of fixings*

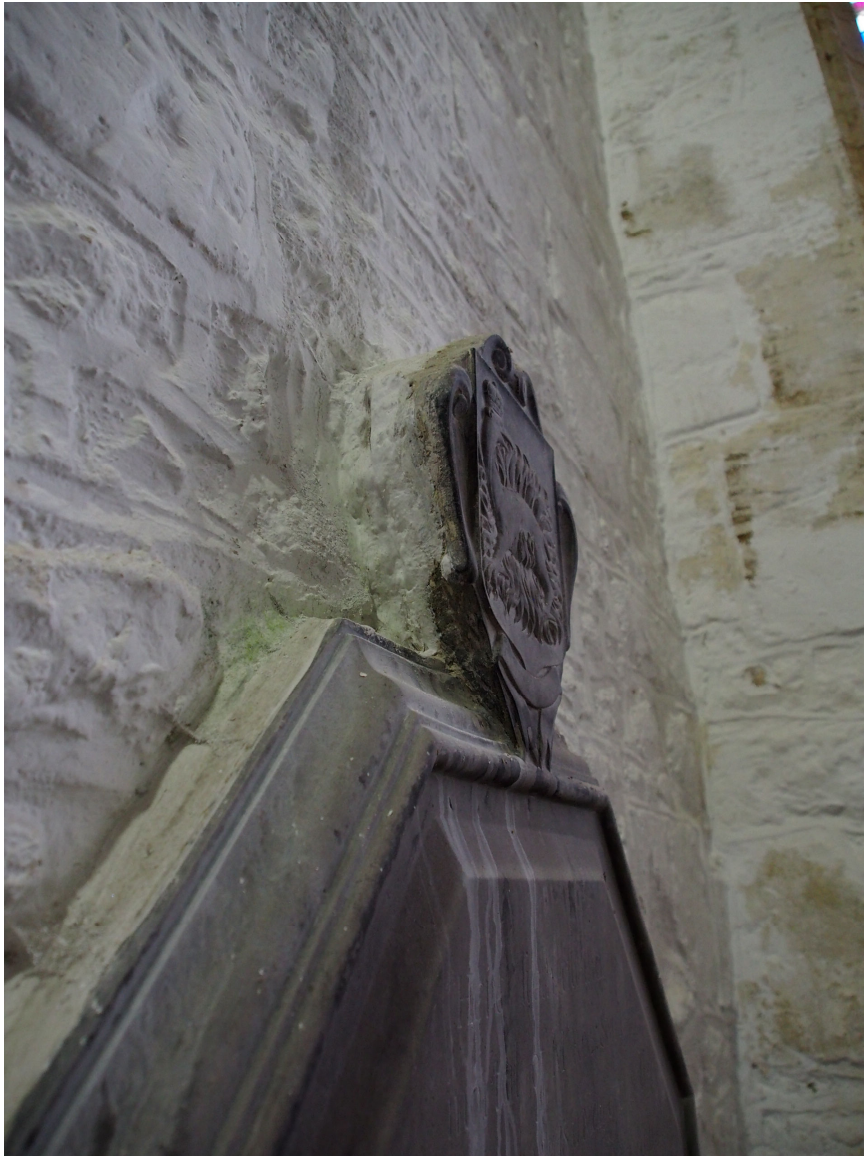
*Streaking and biological growth is apparent on the memorial*

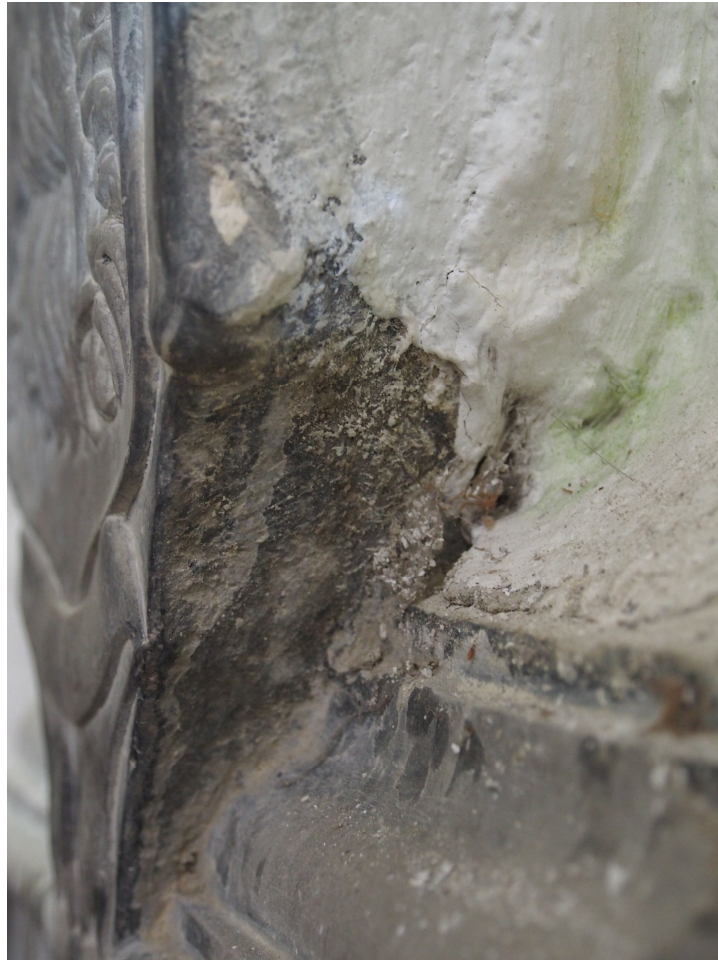
*Detail of the junction between the memorial and the wall – the stonework is quite thick*

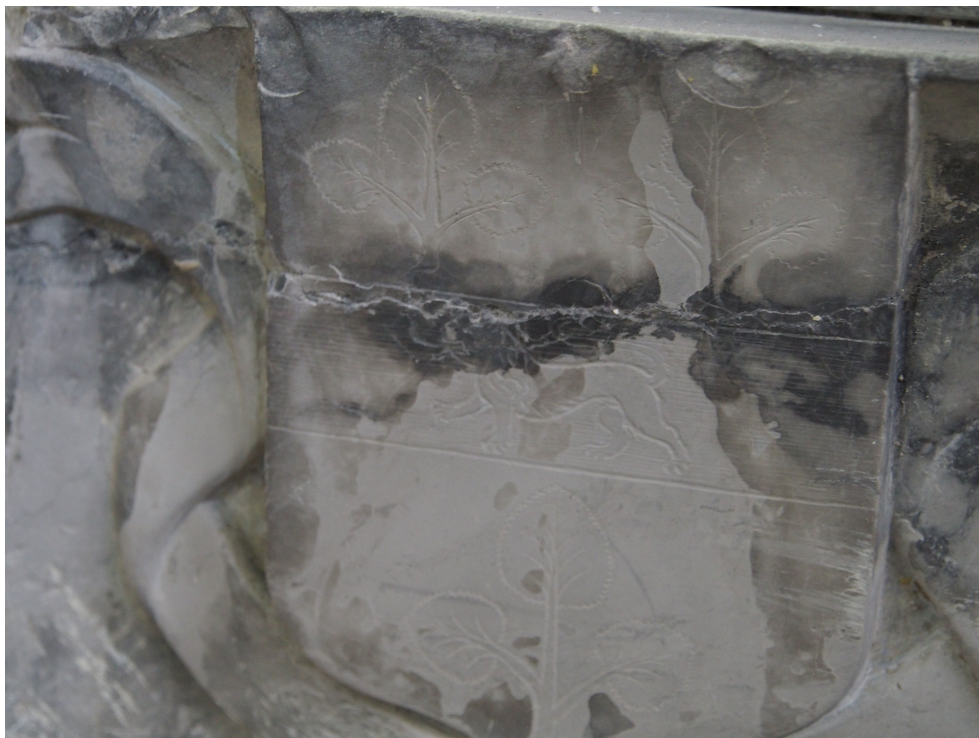
<b>Condition – Structure</b> COND. CODE  ii	The memorial is stable and well-secured to the wall. The horizontal crack across the corbel is of some concern, but otherwise the object is structurally sound.

*Lower shield/corbel showing staining*

Treatment Priority Code	Recommended Treatment
2	<p>A small kitchen unit is being inserted beneath the monument, and this is the ideal opportunity for re-mounting it on the opposite wall. This plan finds favour for the following reasons –</p> <ul style="list-style-type: none"> <li>• It gives the opportunity to address the cracking and staining</li> <li>• It allows for removing the memorial from a possible source of water ingress</li> <li>• It allows for the memorial to be positioned at a lower height enabling the inscription to be read.</li> </ul> <p>A tower scaffold will need to be erected to the object to enable access, and cutting out of the wall plaster/limewash will help to establish the fixing mechanism. It is assumed that the central octagonal cartouche is set on the lower stone corbel, but there is no indication of visible restraints into the wall.</p> <p>The lower corbel should be carefully faced up using eltoline tissue and an appropriate facing material, to prevent losses. It may be prudent to inject a consolidant into the delaminations prior to removal from the wall.</p> <p>The upper section of the memorial can be cut out from the wall and lifted down, secured with padding onto a pallet and removed to a workshop</p> <p>The corbel will likely need to be cut out of the wall, and some replacement stone infill will be required.</p> <p>We have not allowed for redecoration/limewashing</p> <p>Once the memorial is safely removed from the wall it should be taken to our workshop for further works.</p> <p>Further repairs should be carried out to the corbel – this may required a hidden dowel fixing, and some attempt made to remove the discolouration.</p> <p>The memorial cartouche should be gently cleaned to reduce the impact of the water streak. Close inspection of the lettering should be made to establish the presence of any inpainting. It may be than a decision could be made to inpaint a subtly darker colour to help enhance the inscription, as fading and streaking from water ingress has affected the plaque. The exact scope of works can only be firmed up following removal.</p> <p>Following the works to insert the new kitchenette at the church, the memorial can be returned as follows:</p> <ul style="list-style-type: none"> <li>• Erect tower scaffold</li> <li>• Cut out section of wall to fit corbel</li> <li>• Insert supporting stainless steel brackets to take the weight of the cartouche (preferable to resting the entire memorial on the corbel)</li> <li>• Restrain the cartouche from above by stainless steel brackets</li> <li>• Repoint</li> </ul> <p>Costs – Please see Estimate for costs including budget costs for repairs to memorial</p>
