INSPECTION REPORT
ON THE CONDITION OF
ST LUKE'S CHURCH SPIRE, HEYWOOD
2019

In November 2019, a close visual and tactile inspection of the Spire, external and internal was completed by Skyline technicians.

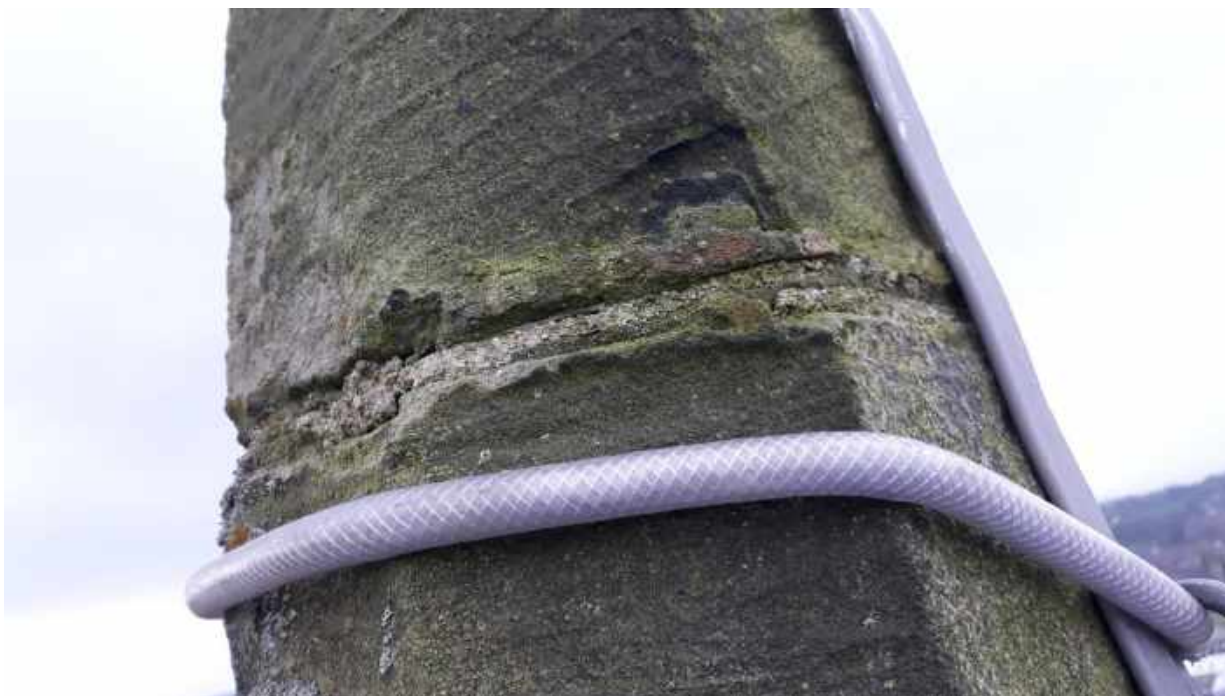
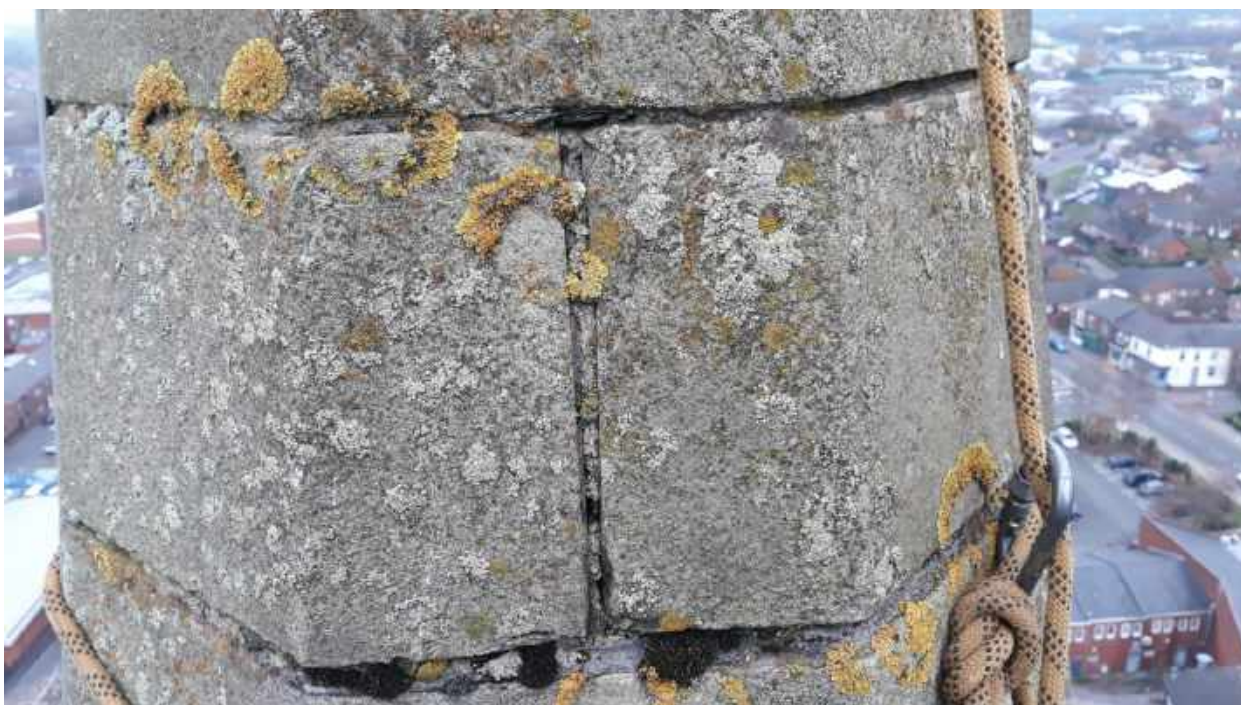
Pointing to the spire is badly degraded on the South, SW and West faces. The SE and NW in slightly better condition and the East NE and North are generally in much better condition.

Pointing West face

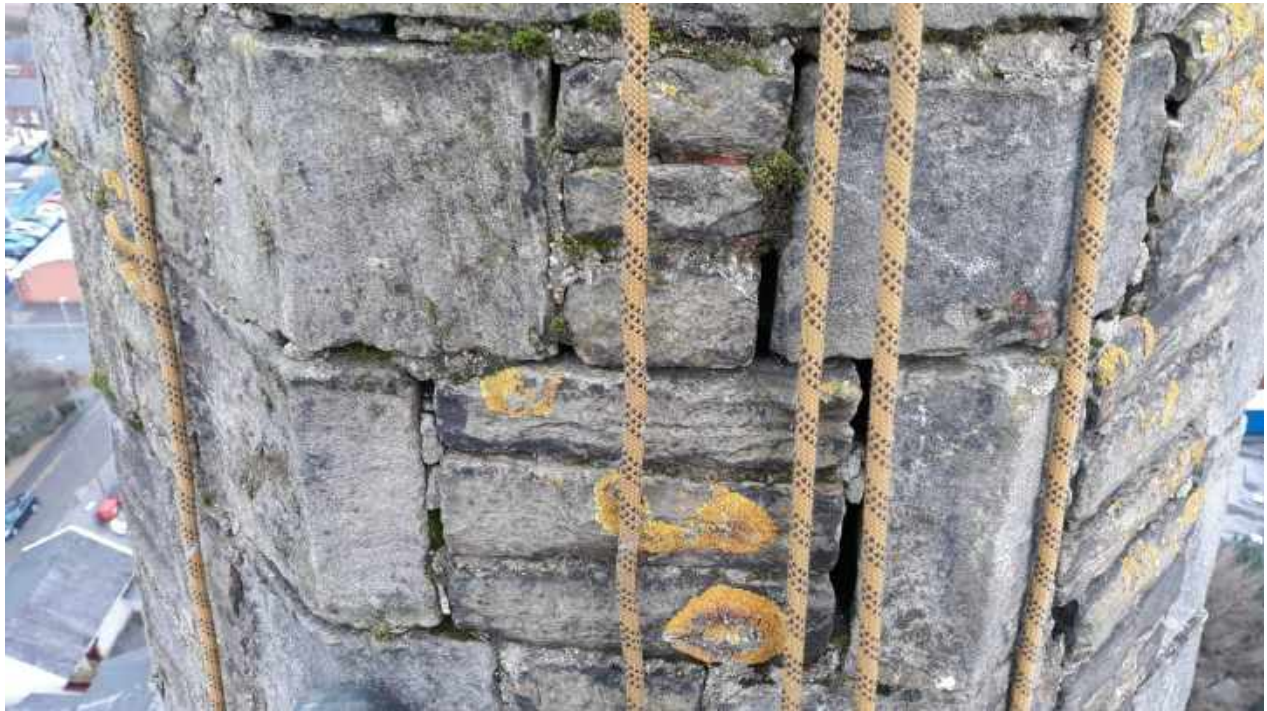
Pointing West face

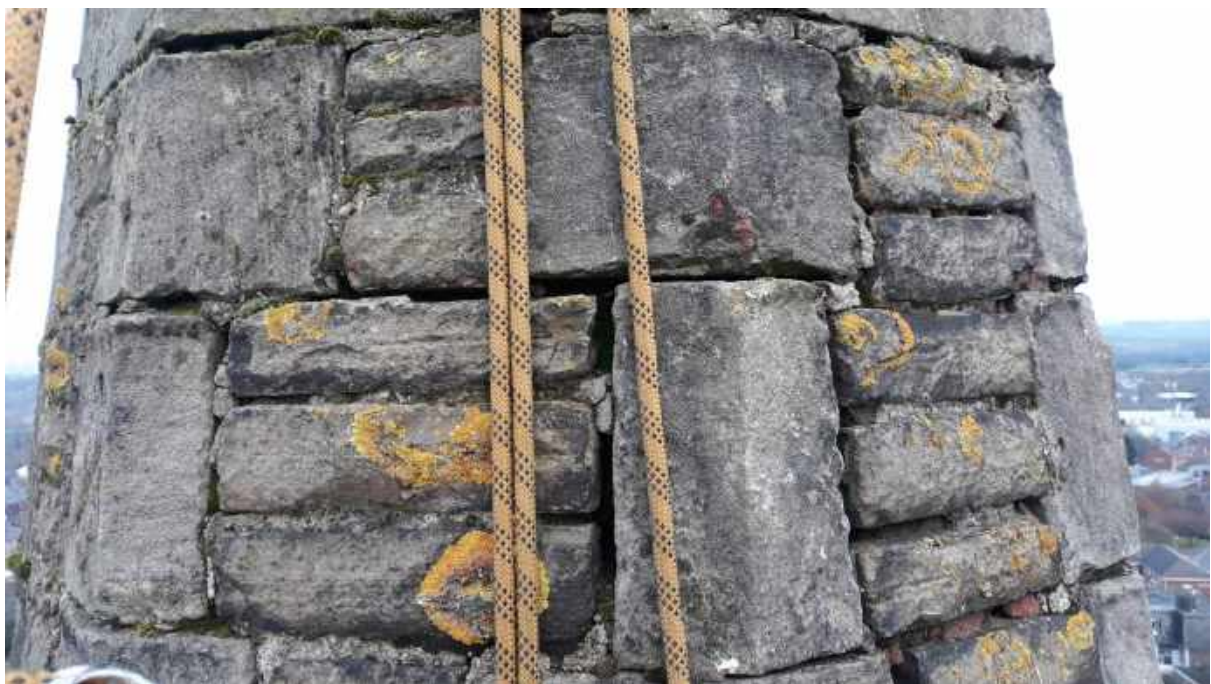
Pointing South West face

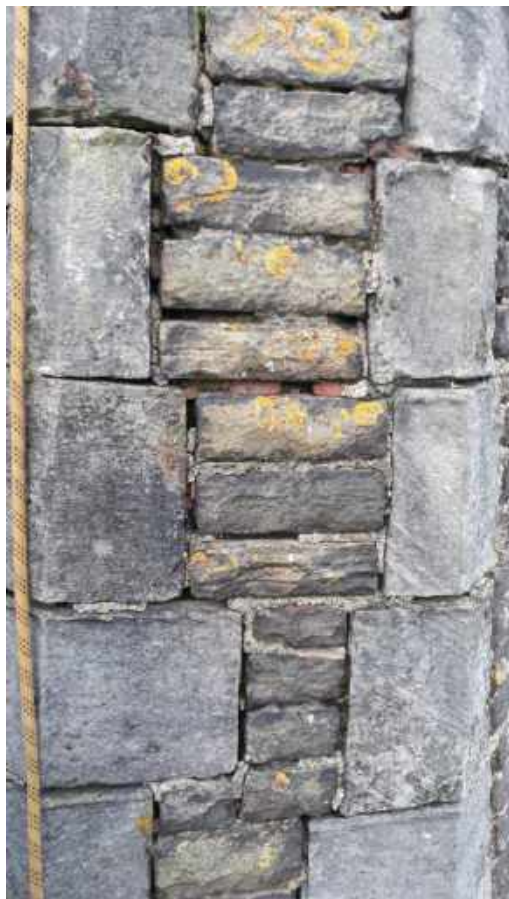
Pointing South face

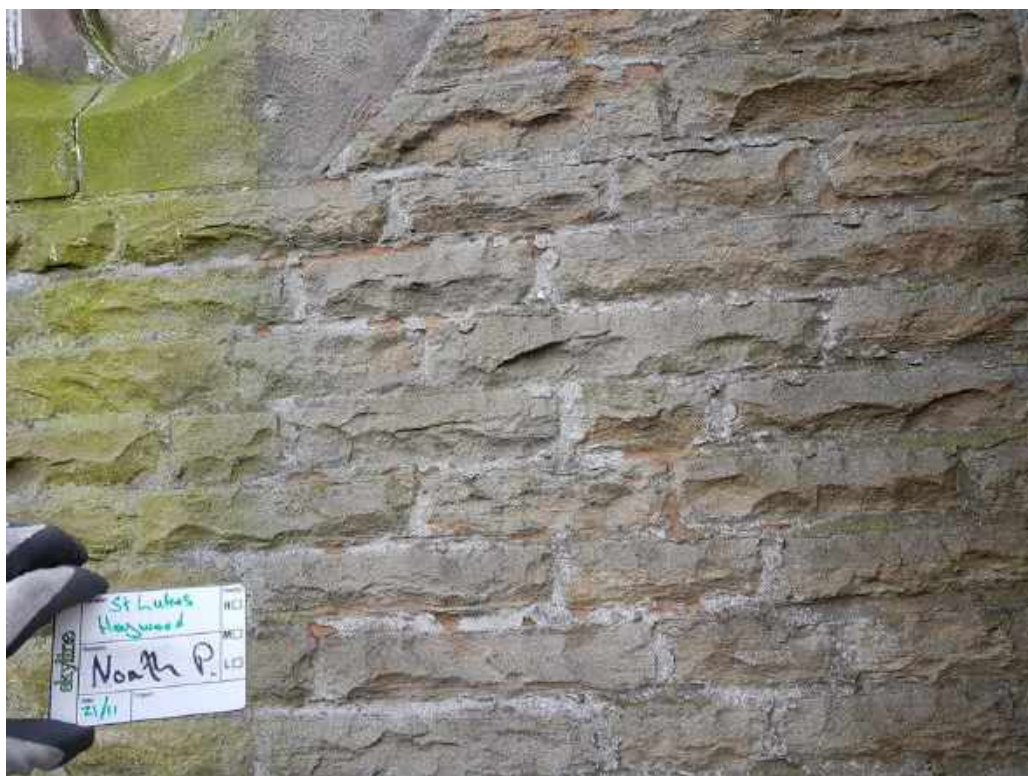
Pointing North face tower

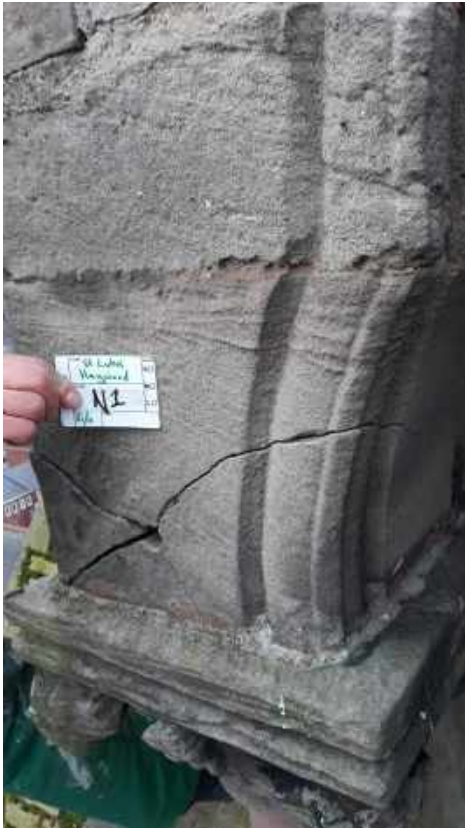
Head					
Code	Description of defect	Height	Width	Depth	Photo ?
	North Face				
N1	Stone cracked, multi directional. Ferrous scaffolding fixing	550	<5		P
N2	Stone cracked, horizontal. Ferrous scaffolding fixing	,2	400		P
N3	Stone cracked, removed. Ferrous scaffolding fixings	220	150		P
N4	Stone missing, degraded	60	600	50	P
N5	Stone missing, degraded	60	600	50	P
N6	Stone tracery, diagonal crack	130	HL		
N7	Stone eroded / missing	150	60	<60	P
N8	Stone sill surface shaling	250	900	<10	
N9	Stone string course cracked / degraded	200	500		P
N10	Clock light rust				P
N11	Stone surround to clock-face degraded	50	150	<10	
N12	Stone gablet to buttress cracked	450	<2		P
N13	Stone gablet to buttress cracked	400	<1		
	North West face				
NW1	Stone quoin cracked, ferrous scaffolding fixing				
	East Face				
E1	Stone diagonal crack lucarne gable	70	1		
E2	Stone quoin cracked, lucarne gable	<10	500		P
E3	Lucarne jamb spalled, ferrous scaffolding fixing	200	150	<50

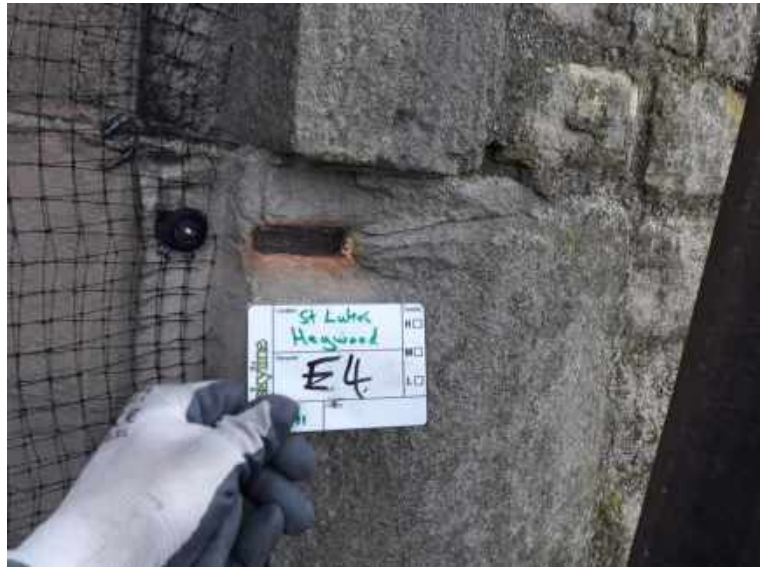
E4	Lucarne jamb spalled, ferrous scaffolding fixing	150	150	<40	
E5	Netting failed				
E6	Vertical crack in stone	120	HL		
E7	Stone moulding surface degraded	200	400	<5	
E8	Stone Quatrefoil cracked, ferrous scaffolding fixings	200	1		P
E9	Stone Quatrefoil cracked, ferrous scaffolding fixings	200	1		
E10	Stone tracery cracked	450	<1		P
E11	Timber louvre missing				
E12	Stone jamb degraded	40	350		
E13	Netting failed				
E14	Timber strap loose	600	50		
E15	Stone sills cracked	950	<2		
E16	Stone gablet eroded				
E17	Stone Clock surround surface shaling	250	50	<5	
E18	Stone Clock surround degraded	400	70	<30	
E19	Stone string moulding degraded	75	700	<60	P
E20	Stone string moulding surface degraded	75	600	<12	
E21	Stone string moulding surface degraded	75	500	<10	
E22	Stone string moulding surface degraded				
E23	Stone string moulding surface degraded	75	350	<12	
E24	Stone hood moulding degraded	75	450	<10

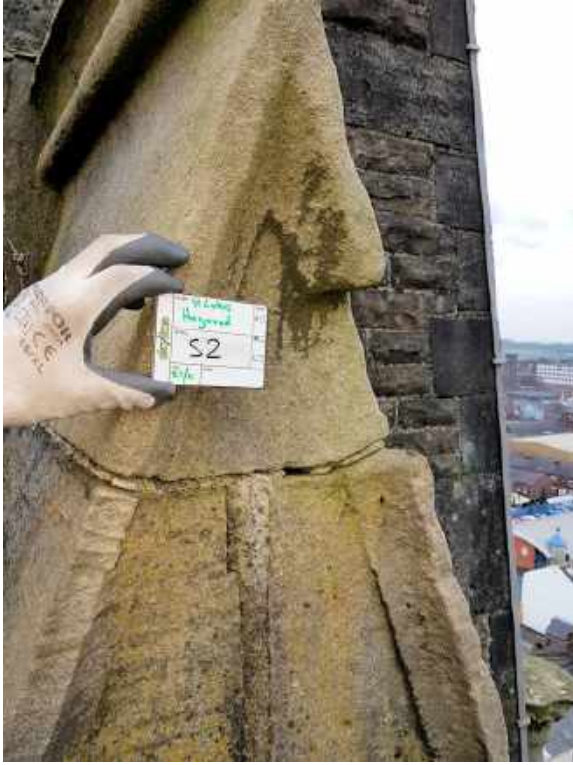
E25	Glass cracked	60			
E26	Stone tracery cracked	130	HL		
E27	Stone mullion cracked	120	<1		
	South Face				
S1	Small tree, removed				
S2	Stone coping to lucarne gable missing	150	70	70	
S3	Buttress capstone displaced by tree	30			
S4	Dentil corbels surface shaling	6			
S5	Stone mullion and capital degraded	<40			
S6	Stone cracked, rusting glazing bars				
S7	Stone moulding degraded	75	650	<20	
S8	Stone moulding degraded	75	500	<20	
S9	RWP fixing loose / failed				
	South West				
Sw1	Stone quoins cracked ferrous scaffolding fixings				
Sw2	Stone quoins cracked, ferrous scaffolding fixings				
	West				
W1	Ferrous fixings in Lucarne face, diagonal crack	<1	550		P
W1	Ferrous fixing in lucarne face, cracks	0.5	400		P
W2	Jackdaw debris behind lucarne netting				
W3	Ferrous scaffolding fixing. Stone cracked	2	300		
W4	Tracery cracked	150	<5		P
W5	Stone string moulding cracked / degraded	100	250		
W6	Stone quoin cracked	250	<20		P

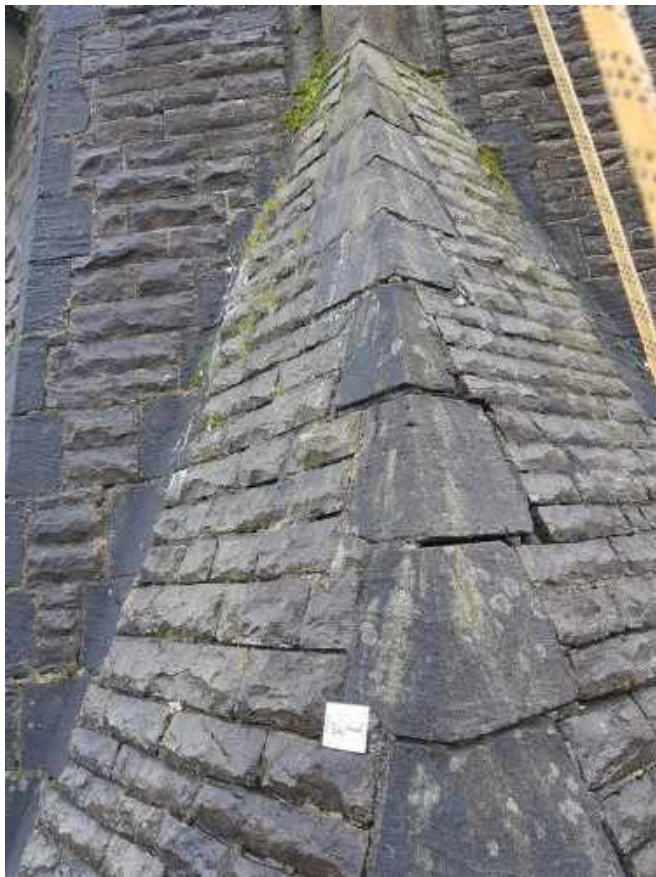
The broaches on the West corners of the tower are in poor condition.

SW broach

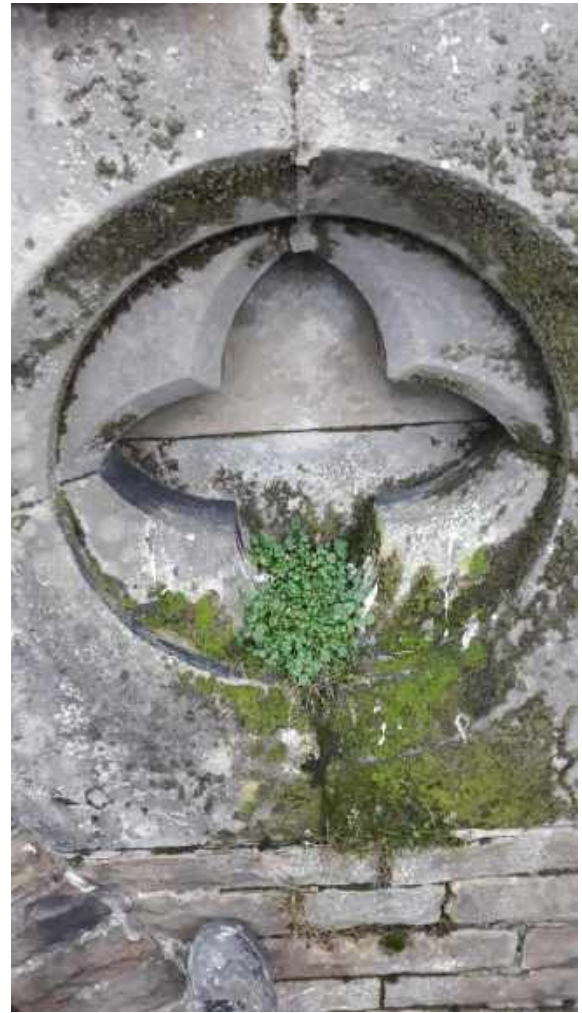
West Vegetation

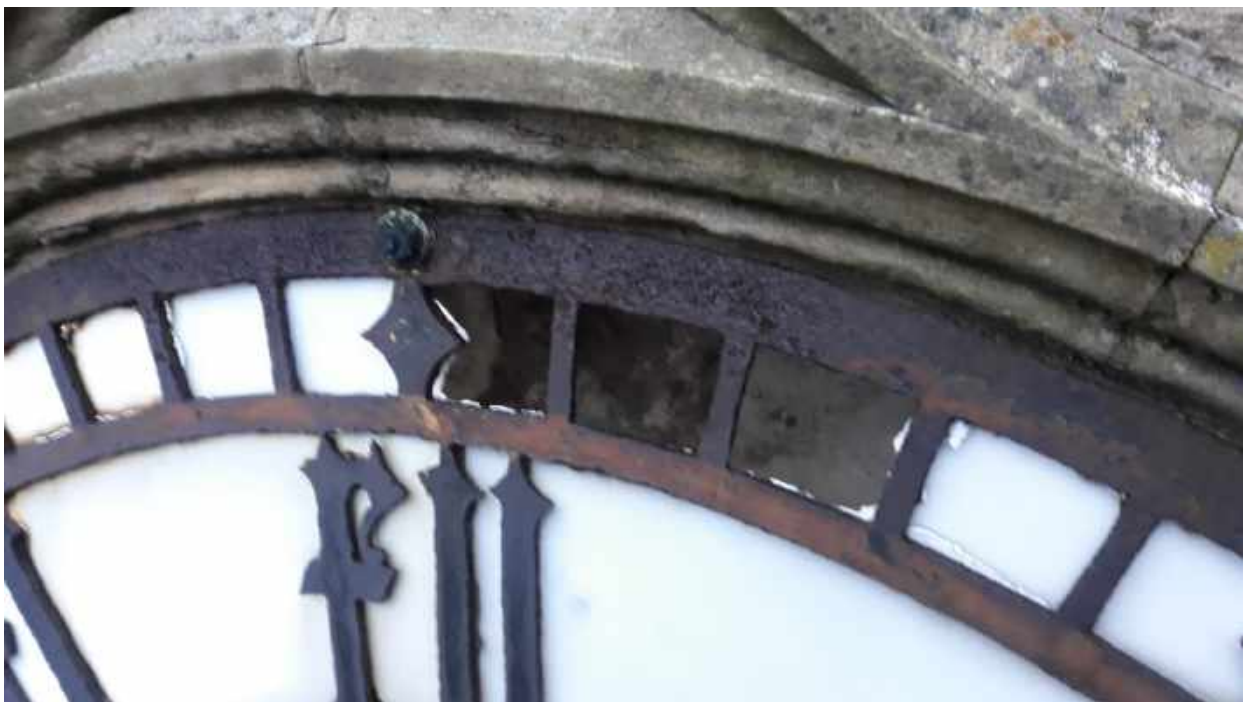
W7	Clock face glass broken				P

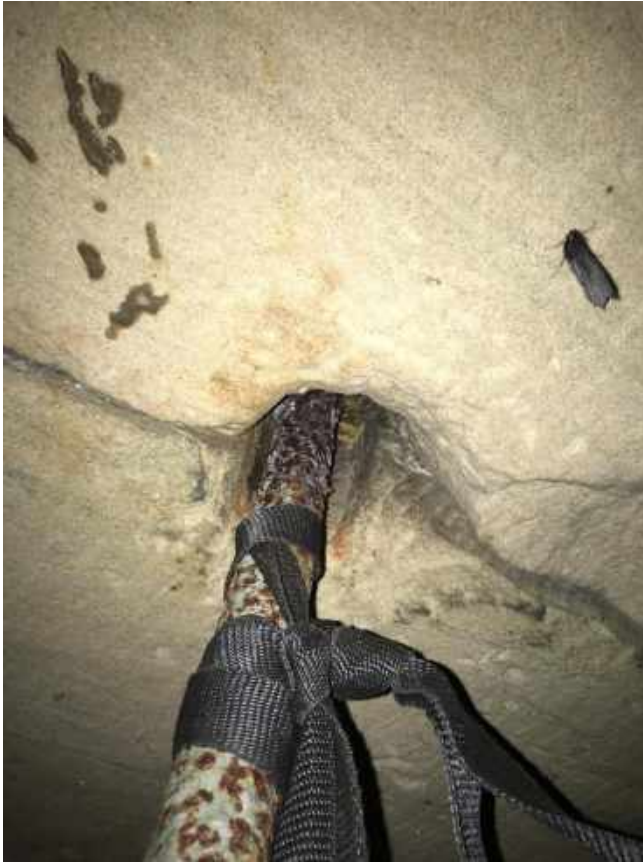
The soffit is formed by two large stone slabs, the holding down rod enters the soffit into a loose fitting hole. The holding down rod is approximately 30mm dia. and well rusted. The HD rod runs to the holding down beam approximately 7.5m below, there are 2no. couplings within its length. At the mid-point two heavy timber boards are clamped around the rod and embedded into the walls of the spire, they are approximately 300 x 100 x 2300. (We think these boards are to prevent the holding down rod from oscillating) The top faces of the boards have some wet rot, a sharp probe penetrated 25mm. The main holding down beam is a ferrous RS Channel, this is in good condition. No cracks or bed lift was visible at the point of entry to the embedded ends of the beam, approximate size 90 x 230 x 3200. The holding down rod is in tension.

Soffit

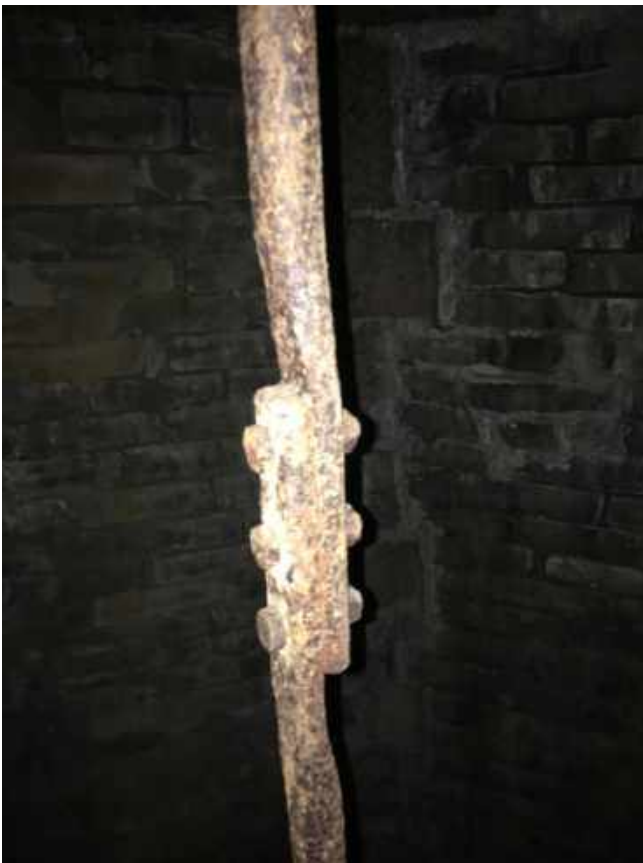
Holding down rod forged lap joint

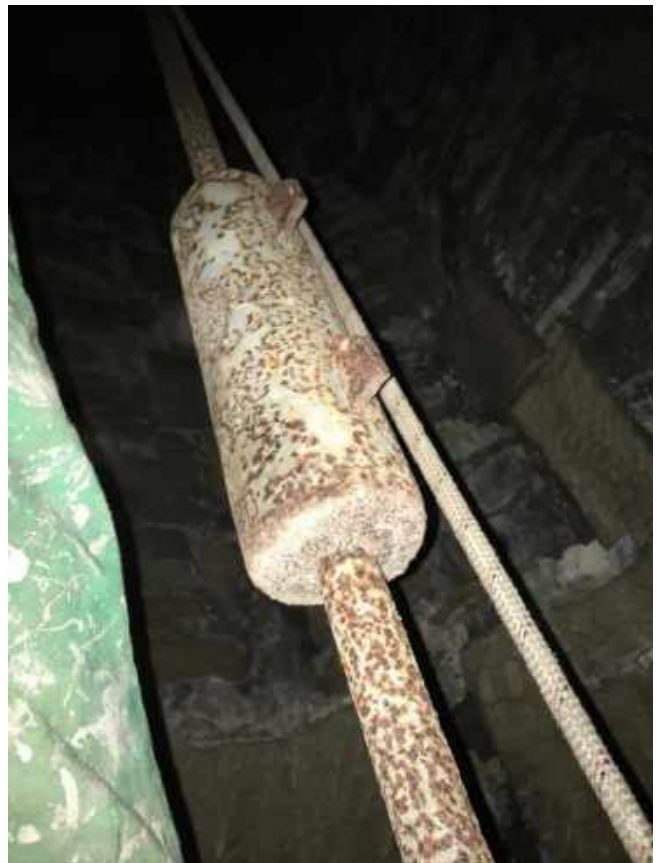
Holding down rod coupling

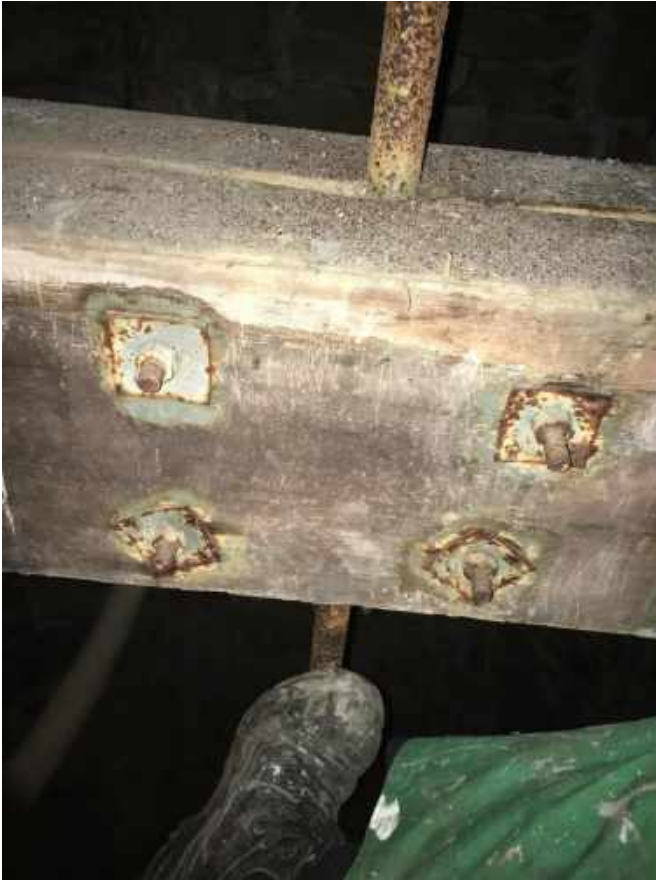
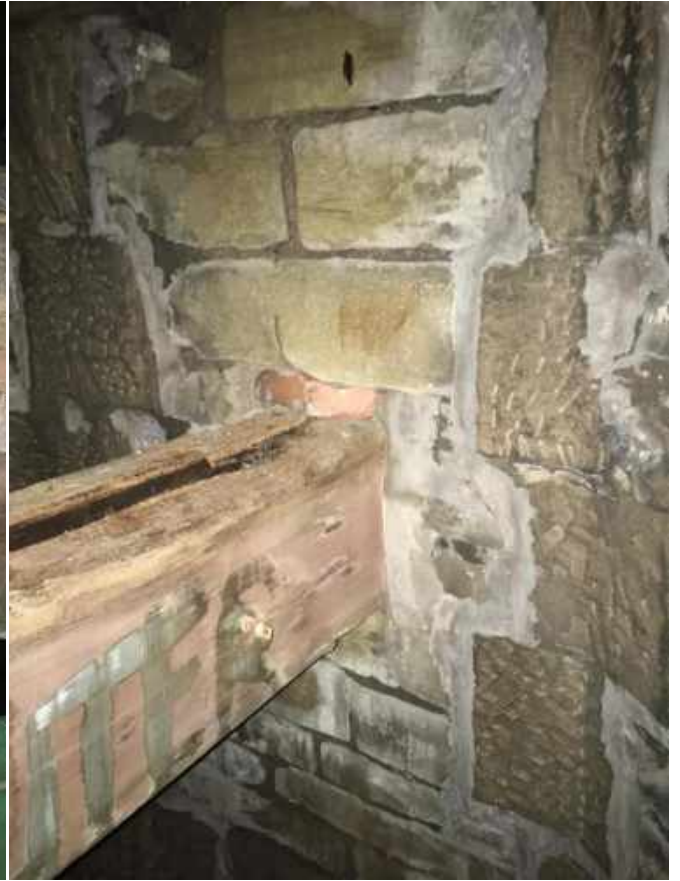
Boards clamped around HD rod

Wet rot to top of boards

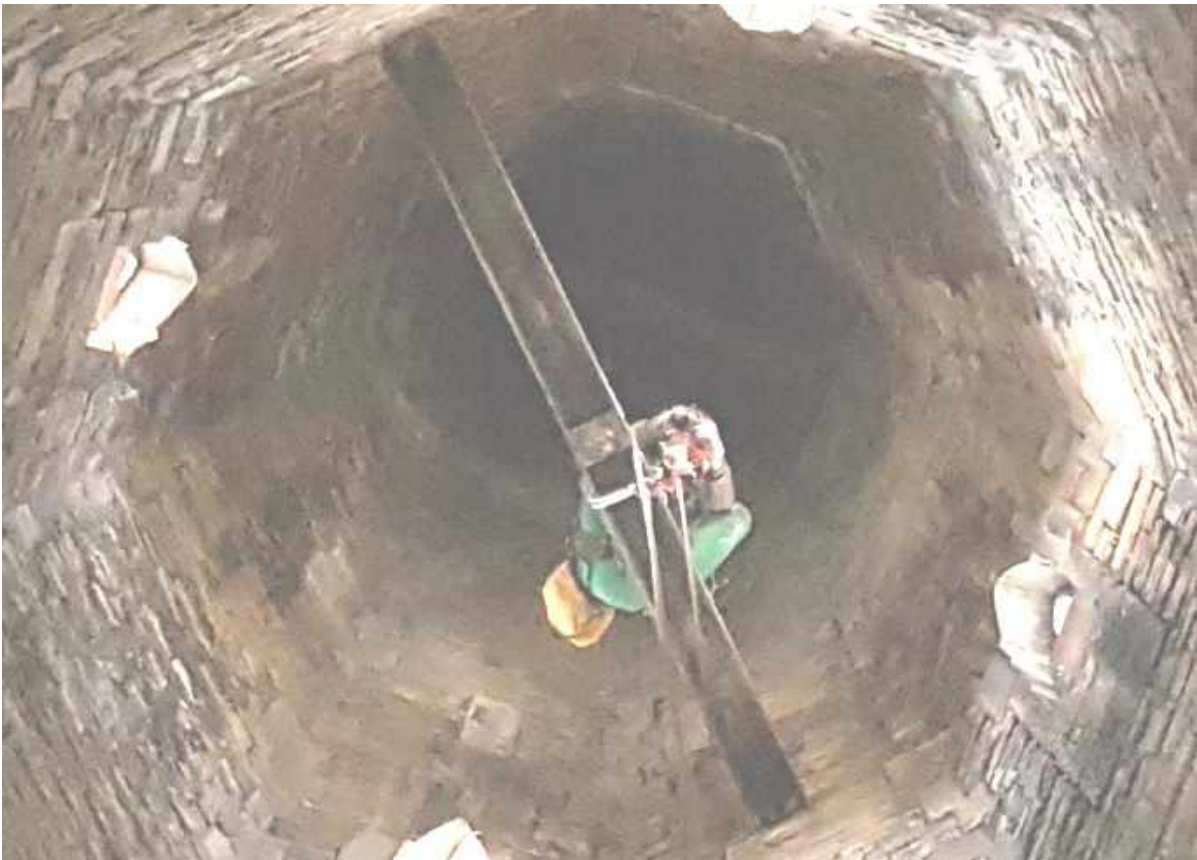
Holding down beam

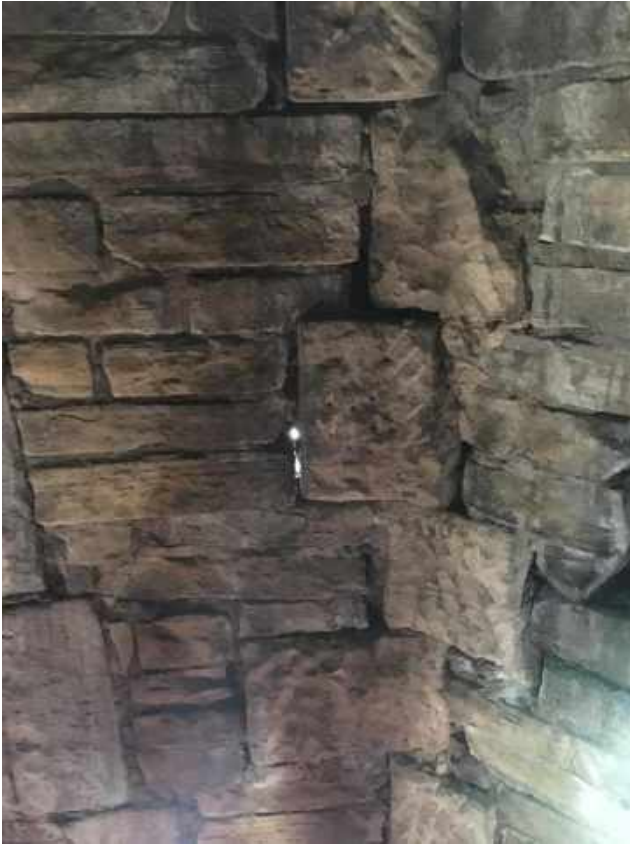
The stonework to this upper internal section of the spire has degraded / missing mortar and is sometimes open jointed, particularly around the quoins. The condition of the mortar improves at about 2m below the upper lucarne vents.

Open joints

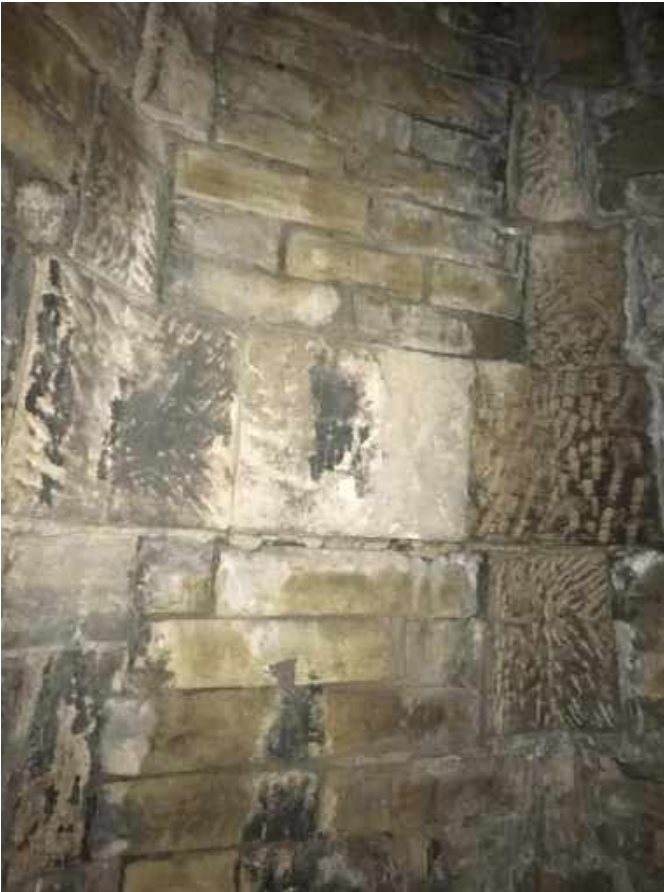
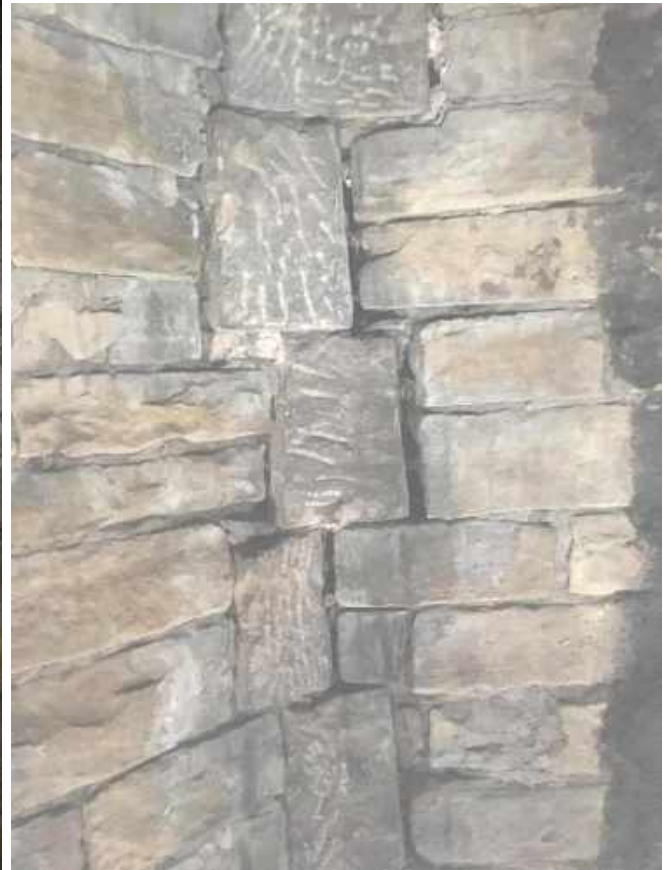
Pointing

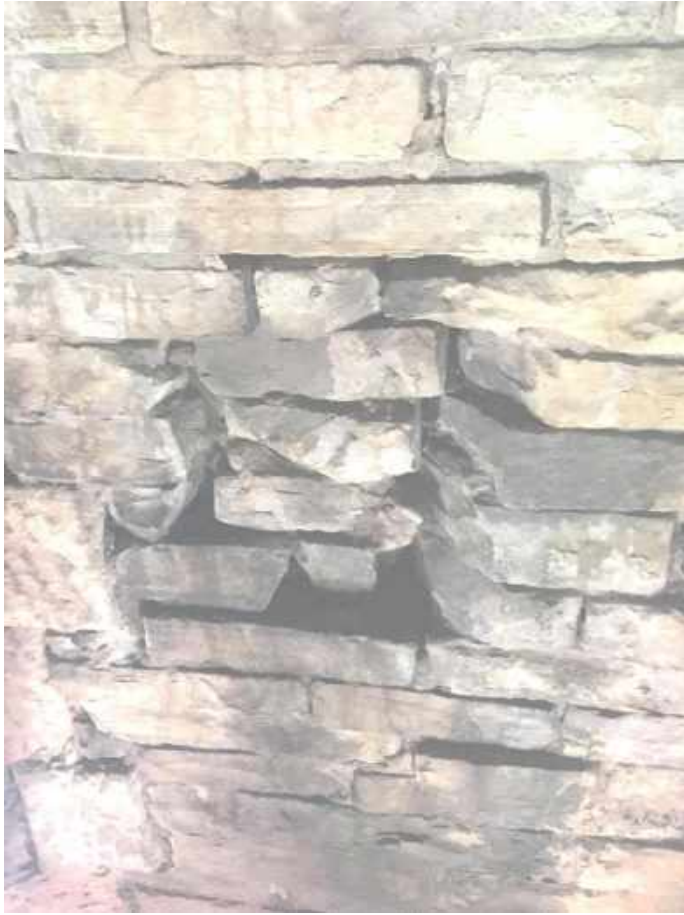
Pointing

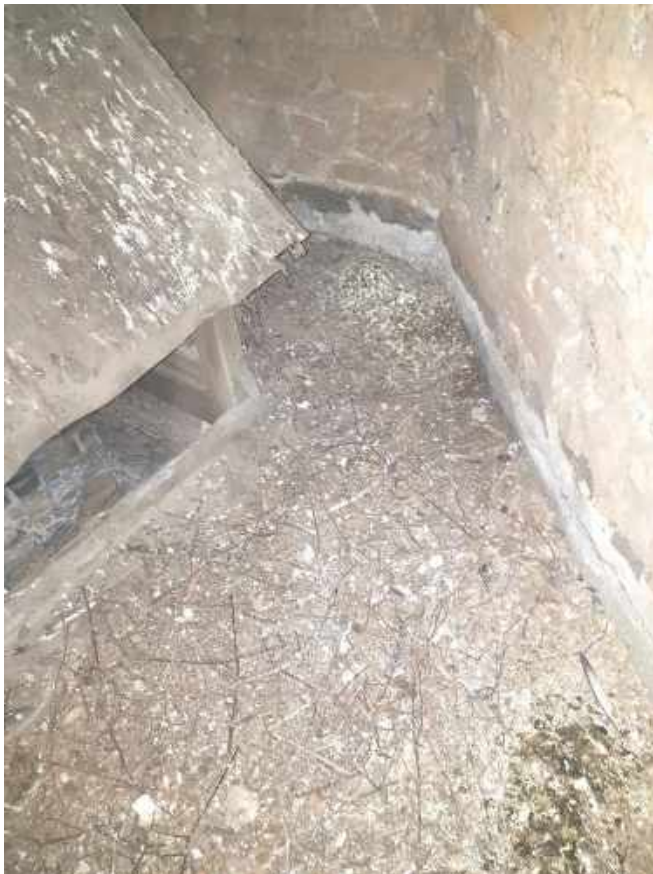
This floor is supported by timber beams, the beams are embedded and we found no signs of rot at the point of entry. The framework which supports the internal roof is simple but still intact. The internal roof has failed. There are pigeons inside the spire and this top 4th floor is covered in pigeon detritus and excrement.

4th floor pigeon detritus

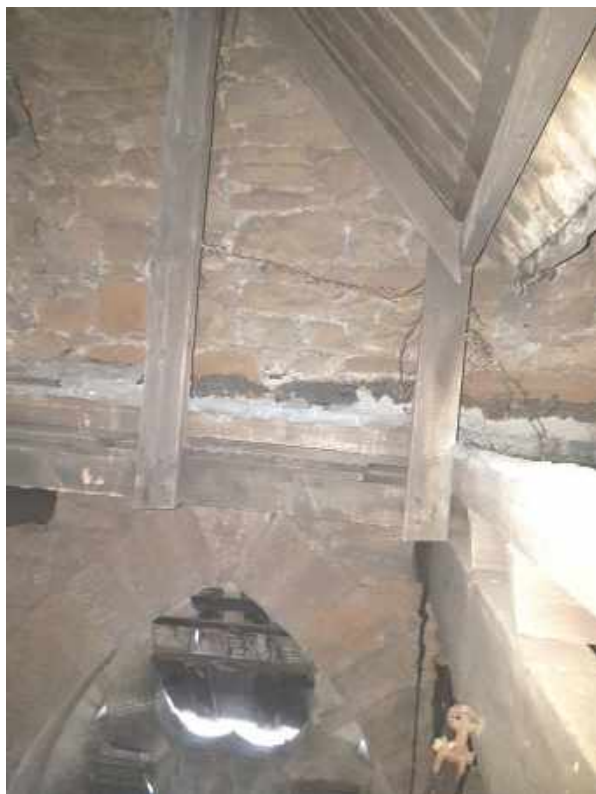
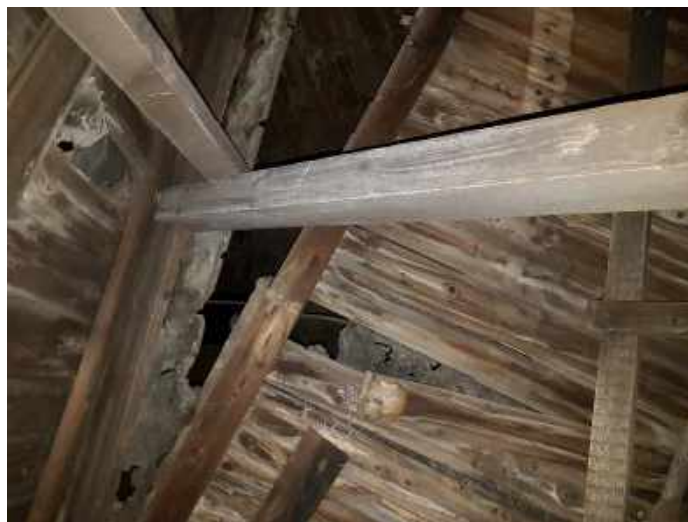
Internal roof and frame

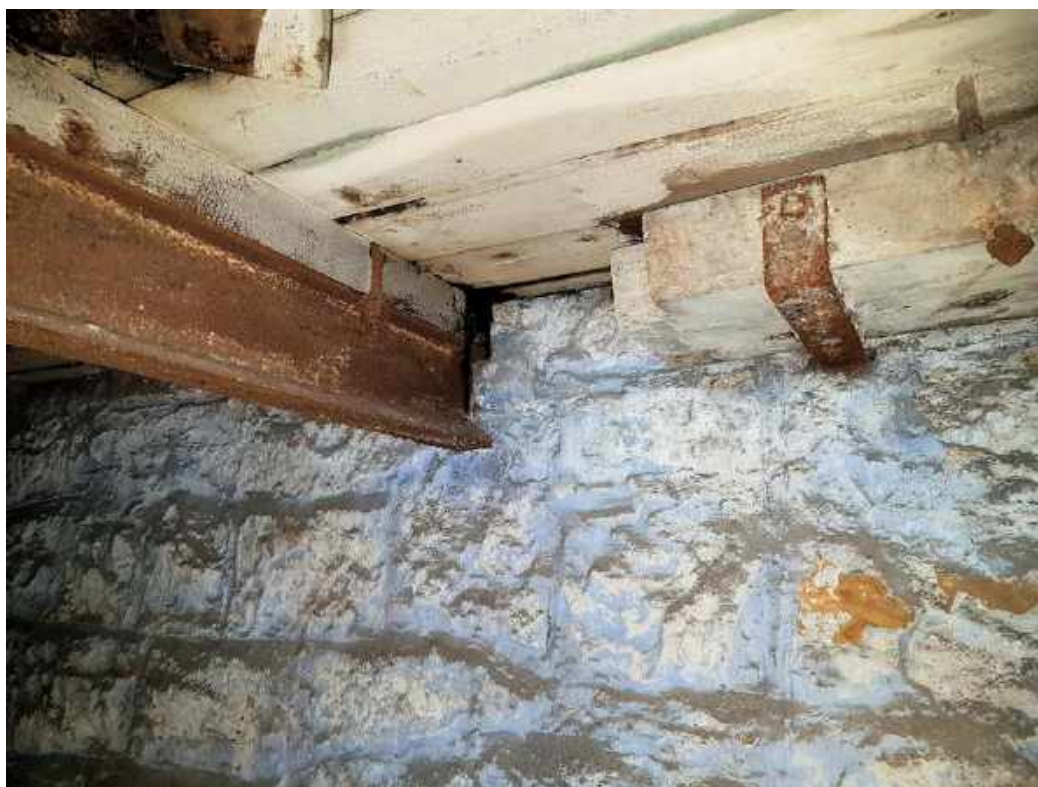
The angle iron which supports the third floor is well rusted but currently intact. The angle iron is in places embedded but often supported by embedded heavy steel folded plates, these appear to be in good condition and no bed lift or cracks were visible around this ironwork.

3rd floor supports

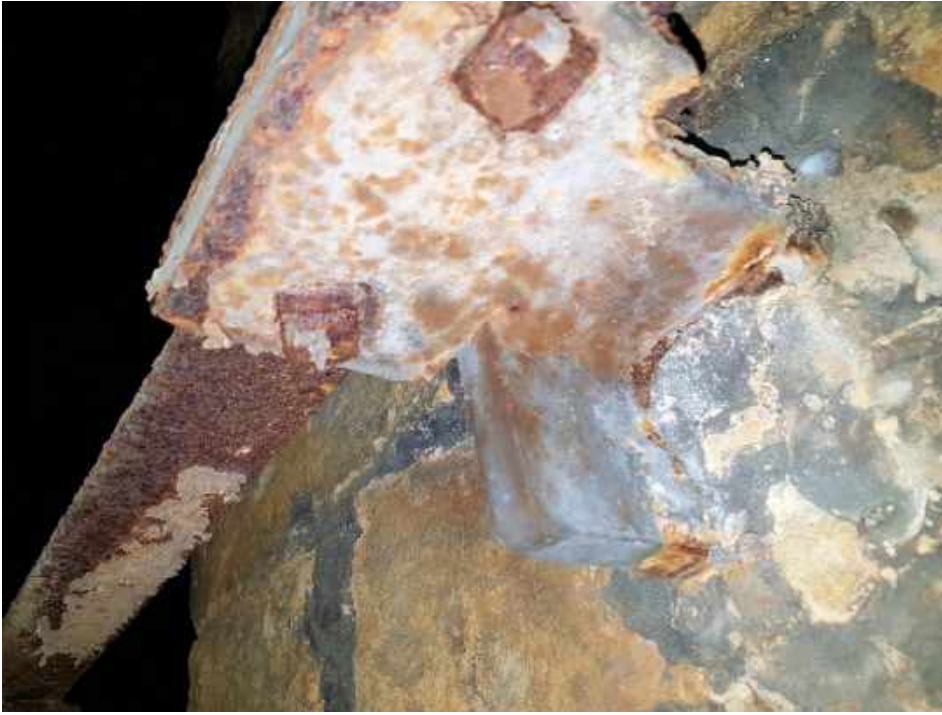
3rd floor supports

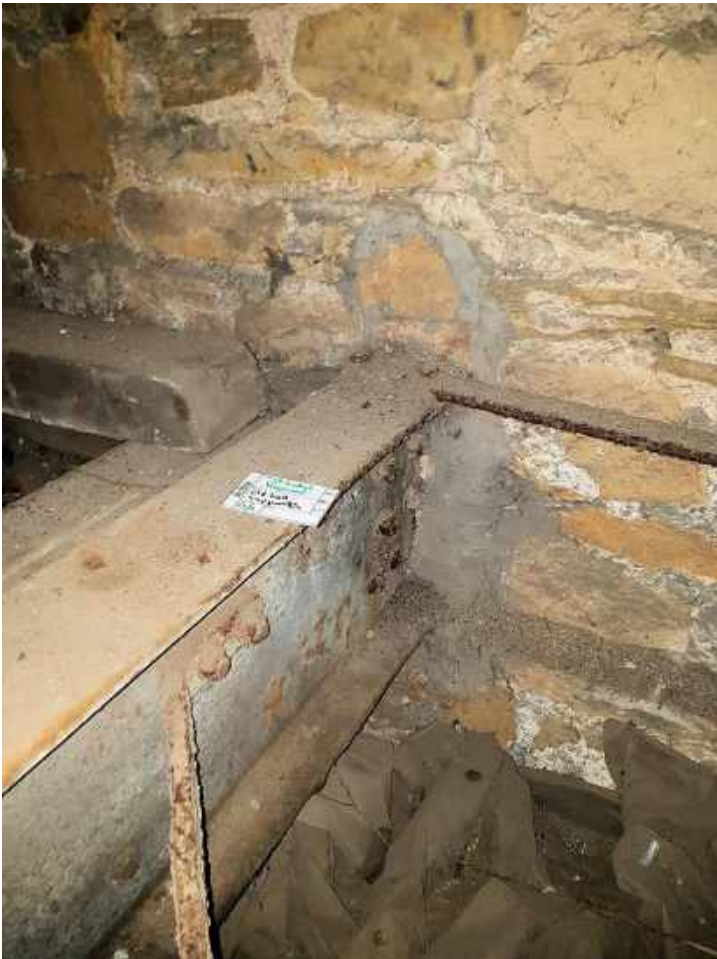
The embedded ends of the frame have been re-pointed, no cracking was seen in the new mortar.

Old bell frame RSJ

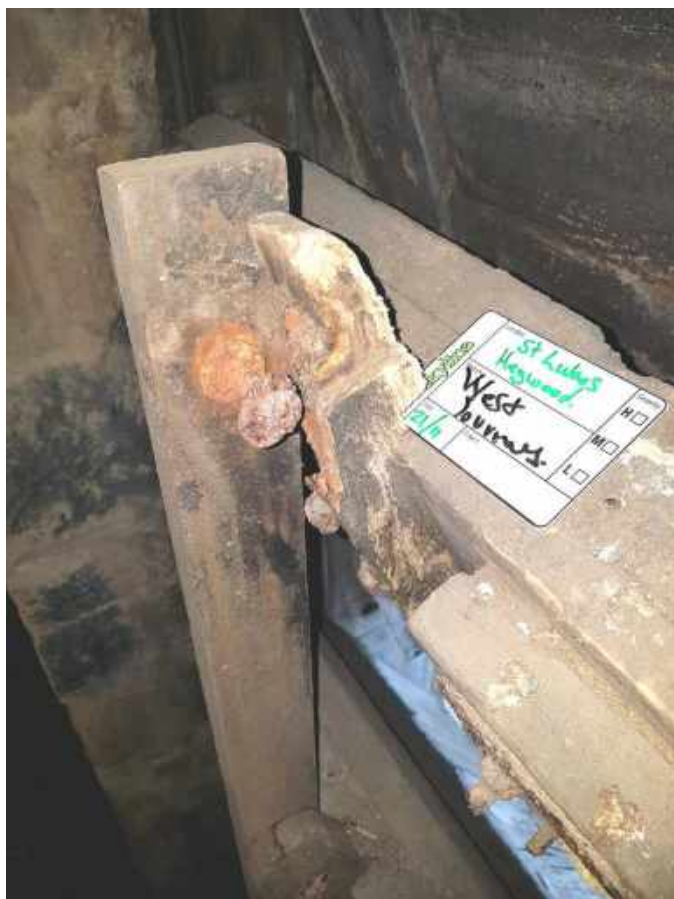
The timber louvres are generally in good condition. Each louvre is mounted on a pivoting shaft, all the louvres within each belfry opening are linked by timber straps so they open and close in unison. It is a very nice system which is well designed and well made. A few of the linkages have failed but could be repaired. The anti-pigeon netting is fitted badly and impinges on the movement of the louvres.

West louvres

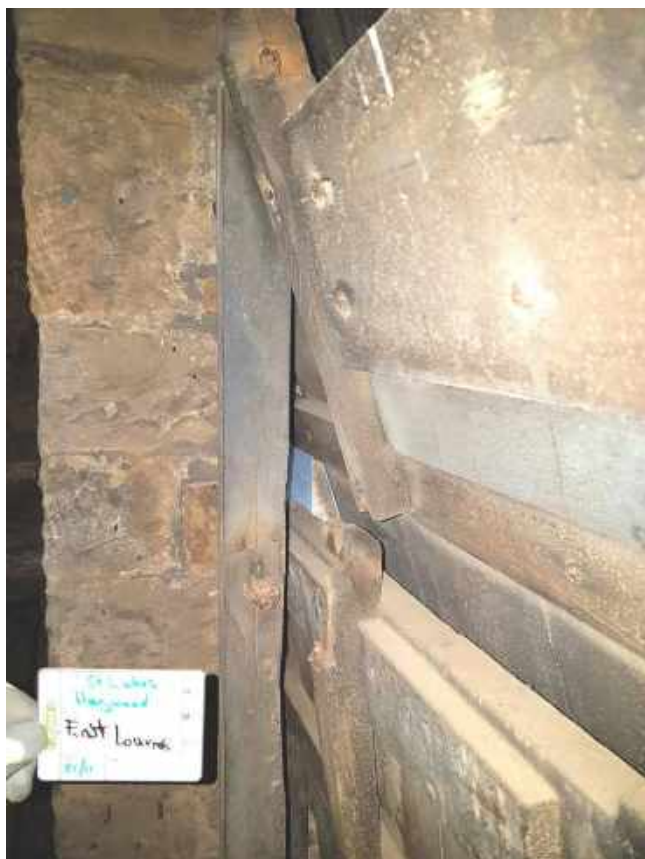
East louvres

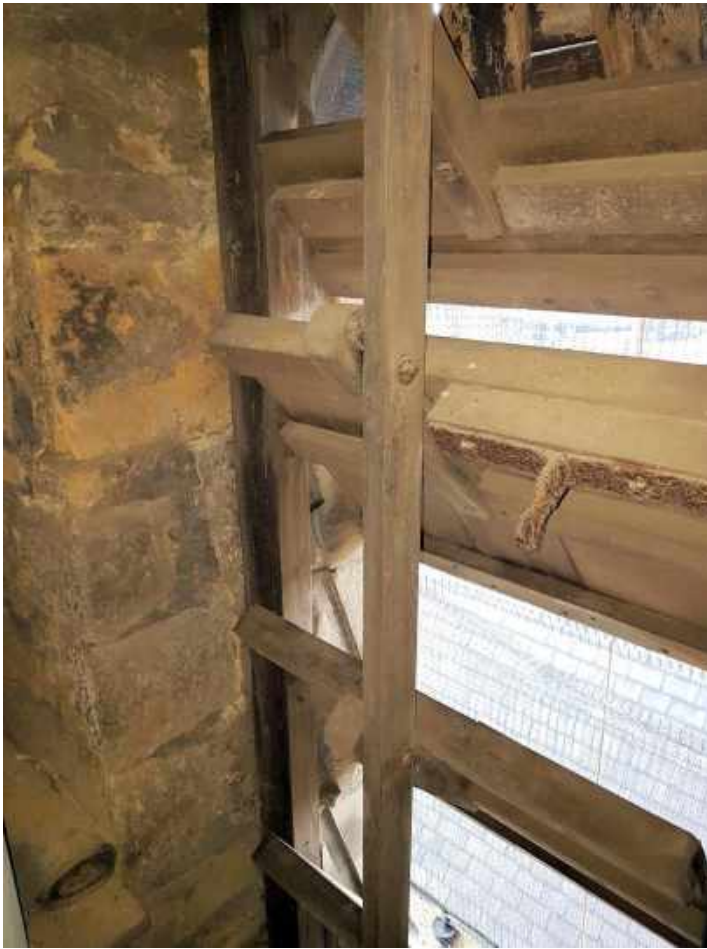
Louvres operating but impeded by netting
