St Andrew's Church, Stokeinteignhead, Devon (Diocese of Exeter)

Four churchyard Tombs

Report on Conservation and Repair

September 2020

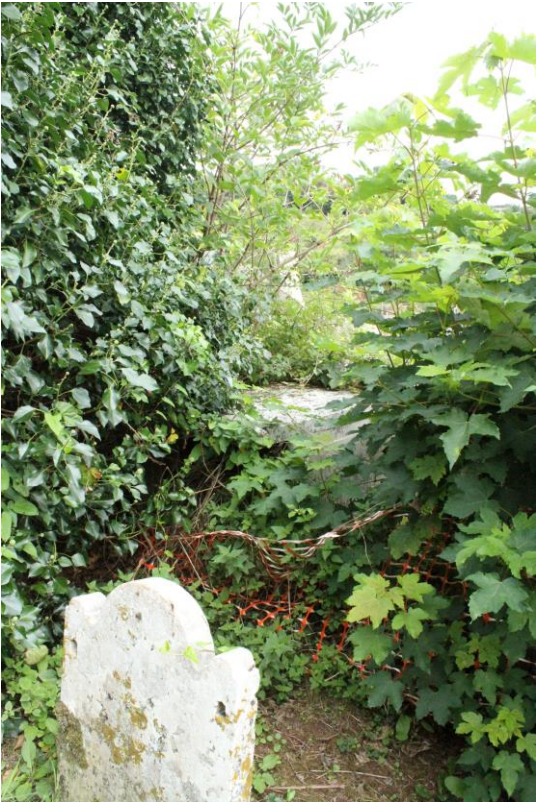
The Hunt monument (northernmost) was in slightly better condition, but was undermined not only by the secondary roots of the Sycamore but also by the intrusion of an elder bush and brambles to the north. The base was essentially sound due to the lead joggles. The upper parts of the structure however, had begun to come apart; roots had grown into the plinth joints and the iron had caused damage to the stone side panels. One end had fallen in and a corner pilaster was missing at the south west corner.

1-4. Views of vegetation affecting the tombs. 1 above; the Hunt virtually invisible in plant cover; 2 above right; brambles on the Roll tomb 3 right; Sycamore tree in the base of Elias Hore tomb 4 below; tombs covered in growth

Vegetation and large plants growing on or around the tombs was removed with suitable garden tools; the sycamore sapling was dug out and cut with a hatchet and pick, so that there was no possibility of its regrowth. The elder bush and all brambles and ferns were removed and their roots dug out, and where possible, soil was drawn back from the edges of the monuments. This was not possible on the west and north sides of the Hunt monument as this is built into the slope of the hill.

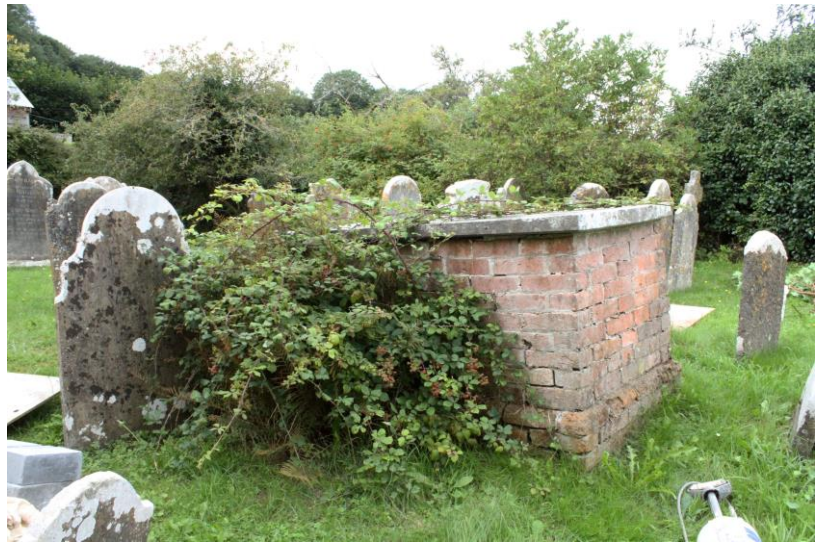
The Mary Roll monument was leaning distinctly to the south, due to the fall in the ground here. This lean did not, however, appear to threaten the structural integrity of the monument and it was considered sufficient to repoint the brick section and remove adjacent plant growth. This consisted of a collection of brambles and ferns growing along the southern edge of the monument.

The monument of Mary Roll did not require dismantling but raking out and re-pointing of failed mortar joints, together with a limited amount of brick replacement. First, all vegetation surrounding the tomb was removed and the roots dug out of the ground.

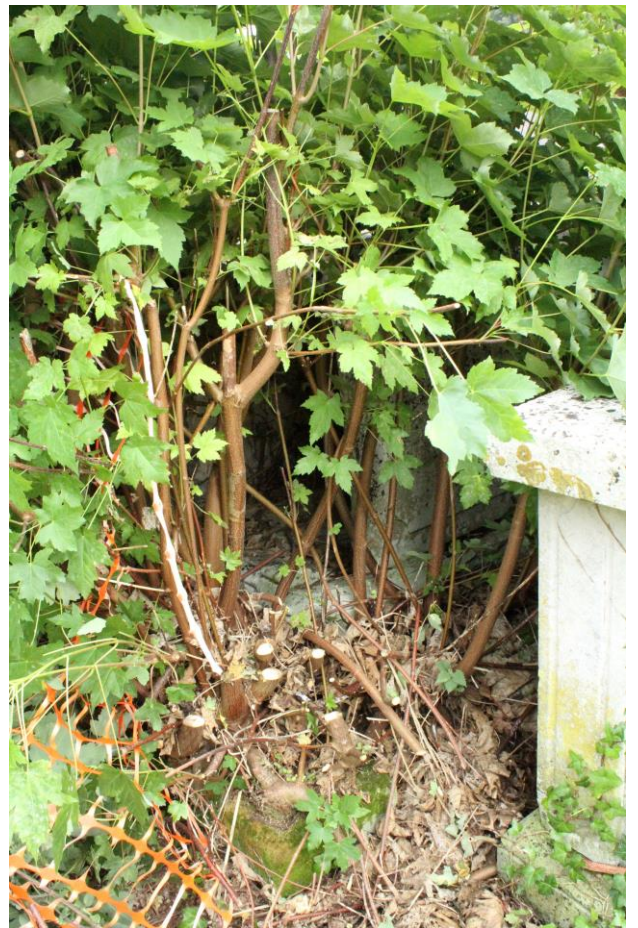
The monuments were in varying states of dilapidation. Worst was the Elias Hore monument, which had been severely undermined by the growth of a vigorous Sycamore tree at its west end. The roots of this were found to extend for several metres north south and east. The lack of lead joggles between the base stones had allowed the sycamore to displace and destabilise the base and therefore the whole monument. The corrosion of the iron fixings had further undermined the structural integrity of the monument and cause spalling of stone at the corners of plinth and panels. The western end panel had fallen in and the plinth here was damaged.

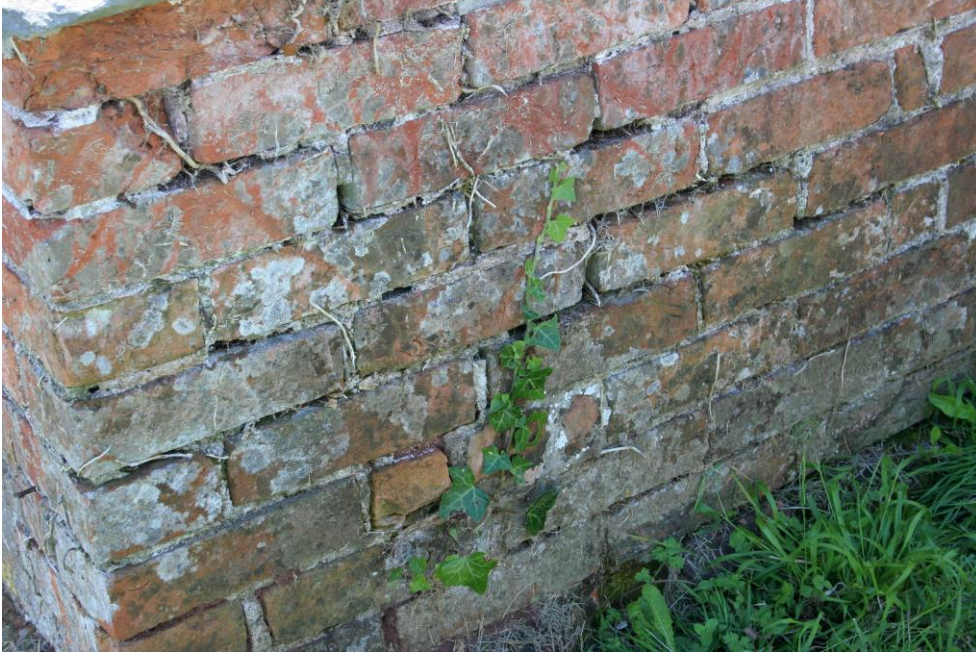
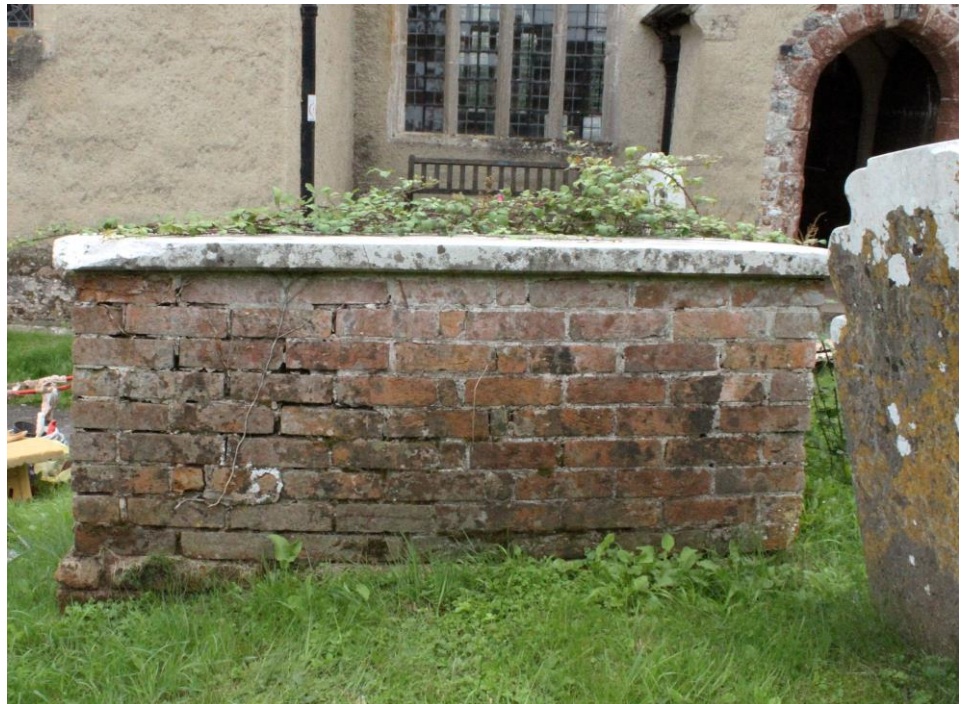
The Roll monument had clearly been repaired in the past, probably more than once, and there were some areas of cement-rich pointing. Some of these were stable and did not appear to be doing any damage; other areas of both cement and lime pointing had failed or been lost altogether. One or two bricks were shattered or damaged.

7 and 8. ivy growth and open joints affecting the Roll tomb

Failed joints were raked out using hand tools and re-pointed with hot mixed lime mortar in two coats. The top coat was matched as closely as possible to the original mortar, using a mix of

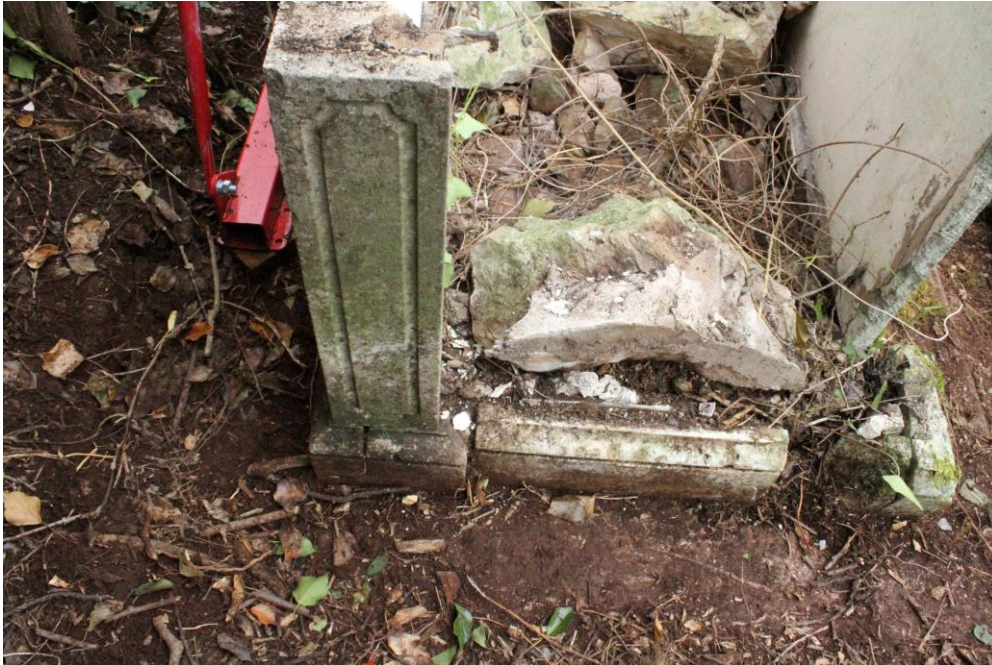
All the stone monuments were tied together with iron cramps when work began, at plinth and side panel level. The base courses of the Brockinton Hore monument and the Hunt monument were fixed together with very effective lead joggles, providing a very secure footing for the chest tomb proper. Internally the central Elias Hore monument had a cross wall of brick supporting the two long sides; the other two monuments had rough stone support blocks behind the side and end panels of decidedly dubious effectiveness.

9 and 10. Right; poor quality internal support system to the Hunt tomb; below, moss and open joints in the plinth and base

The three monuments were then rebuilt in the reverse sequence to their dismantling. Each was supported internally by a new structure of concrete blocks laid on a levelled sub-base of rubble and Prompt natural cement mortar. Each side and end panel was supported in this way.
