Report of Work under Archaeological Supervision and Control

St Nicholas' Church, West Lexham, Norfolk; removal of cement render from west tower, drainage and other improvements

NHER ENF 141561

Sarah Bates and Simon Underdown, Report no. 50
May 2020

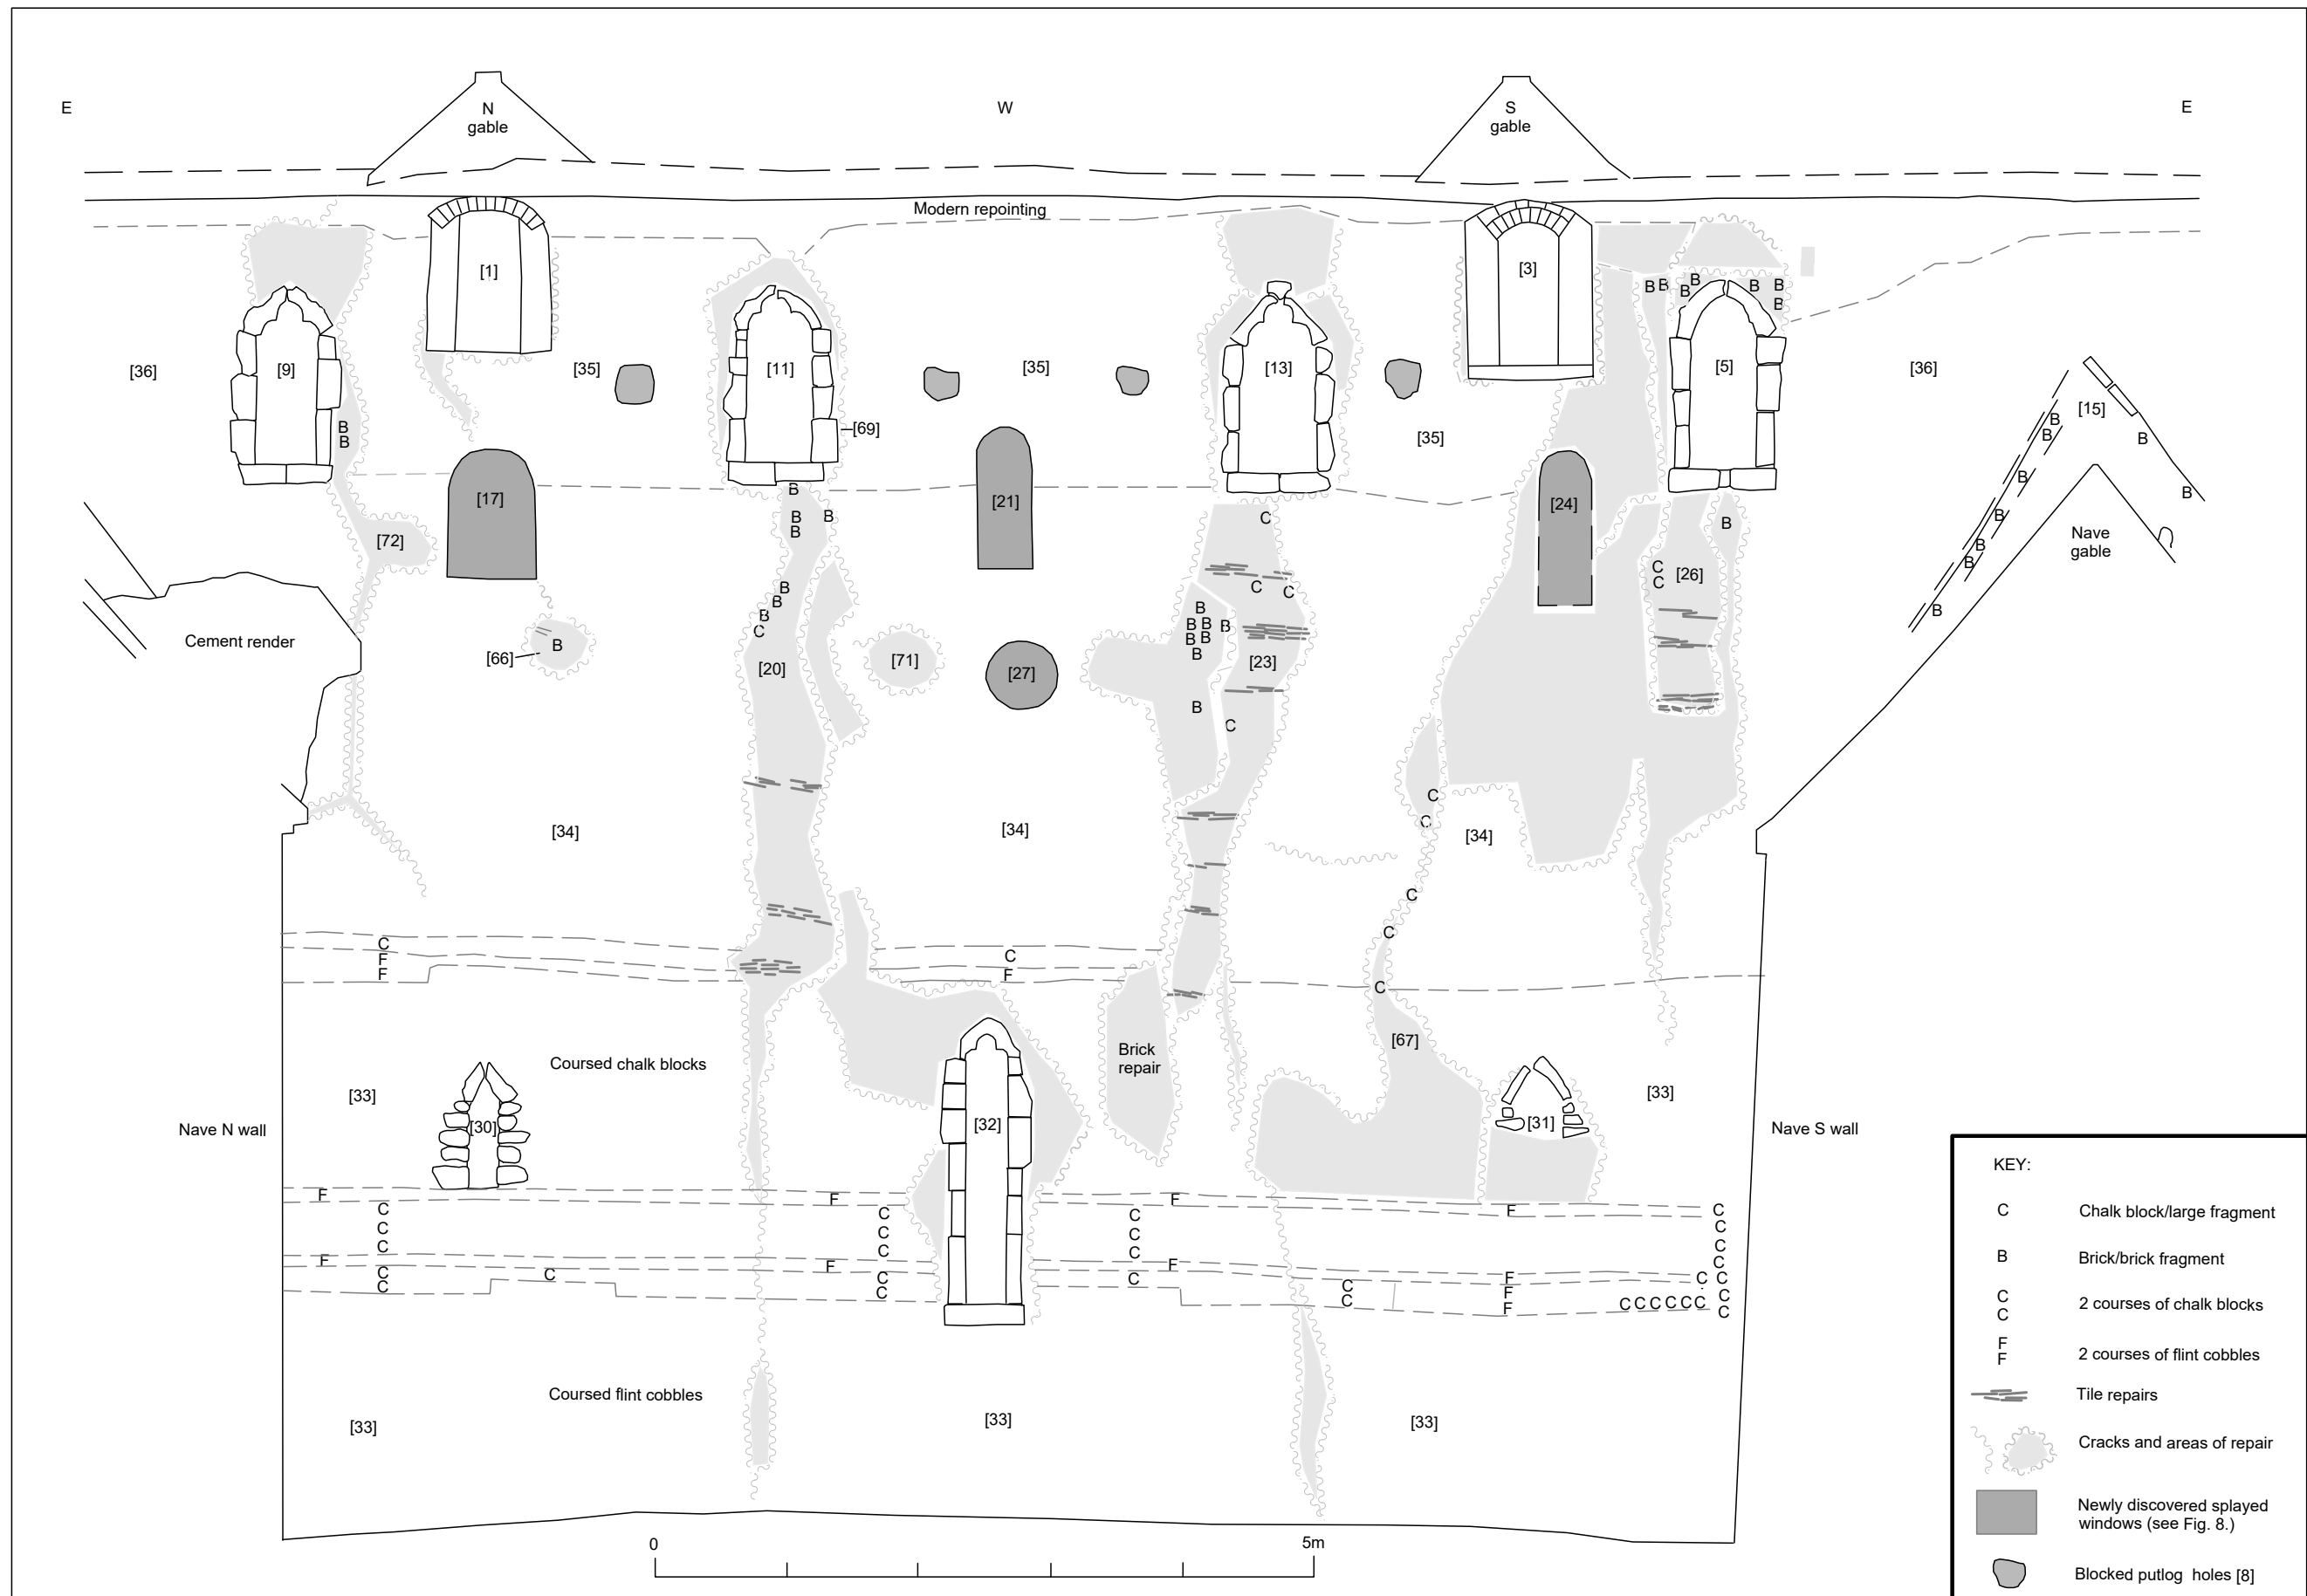
Fig. 7: ENF 141561, St Nicholas' Church, unwrapped elevation of west tower. Scale 1:50

Several significant previous repairs to the tower were revealed (Fig. 7). These included areas immediately surrounding the belfry openings and large irregular vertical areas [20] and [23] running down from beneath the two westernmost cusped belfry openings (Plate 33 shows [23]); the cracks in the tower wall in these areas were discernible to ground level. A similar, slightly smaller area [26] existed beneath the pointed south-eastern opening and a further repaired crack ran down the south side of the north-eastern opening [72] and continued below it almost as far as the bottom of the central

tower wall fabric [34]. There was also a crack emanating from below brick belfry opening [3] which, lower down, had been repaired in a narrow band which widened out into a larger area [67] to the west side of window [31] (Plate 26).

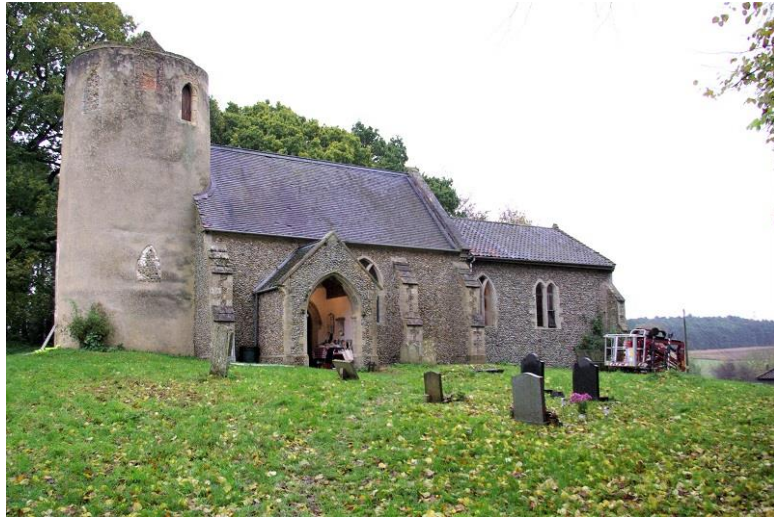
Plate 1: St Nicholas' Church, prior to work in 2018

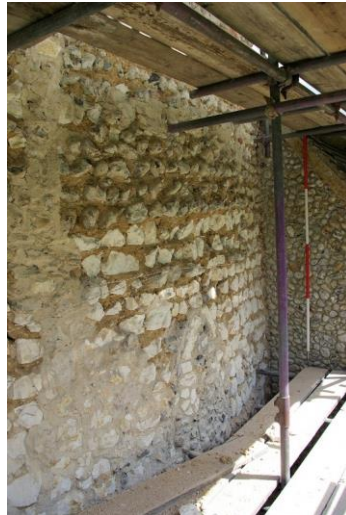
Plate 26: S side, lower stage [33], with [34] above, window [31] visible, looking E, 2m scale

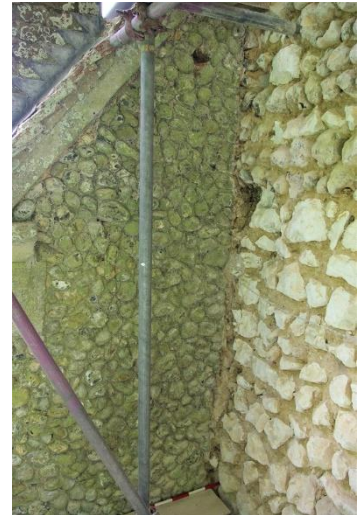
At its north lower side, the tower wall appeared to abut the surface of an 'original' nave wall (Plates 27 and 28). This latter, seen in a very small area between the coursed stones of the tower and the regular, but un-coursed, flint cobbles of the 19th-century nave wall, had a very similar mortar as the lower part of the tower but the two mortars were distinct in tone, the mortar of the tower being of a yellower tone and that of the nave slightly pinkish. As mentioned this was only observed in a small area but it does suggest that a small part, at least, of the former nave wall survived when the nave was rebuilt (this concurs with the artist's representation of south side of the tower of the partly demolished church (see above, *NHER and historic images of the church*)).

Plate 27: N side of tower abutting former nave wall, with Victorian flint wall, looking ESE. 0.5m scale

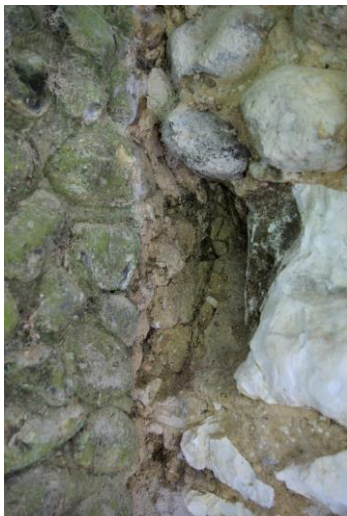
Plate 28: Tower abutting former nave wall (detail), Victorian wall to left, looking SE

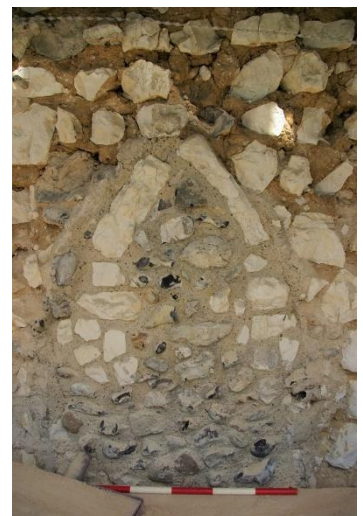
Window [31] at the south side of the tower was slightly wider and not as completely preserved; chalk blocks survived at the upper sides and two long blocks of chalk formed its triangular head (alike to window [30]) (Plate 30). The lower part of the window was lost; replaced by the later flint infill and repairs. Some blocks of chalk irregularly set at its west side were not in their original position and the original mortar of the window surround was not exposed, a gritty light greyish cream mortar bonded the flint blocking of the window and continued around the chalk blocks.

Plate 30: S side, window [31], looking S, 0.5m scale

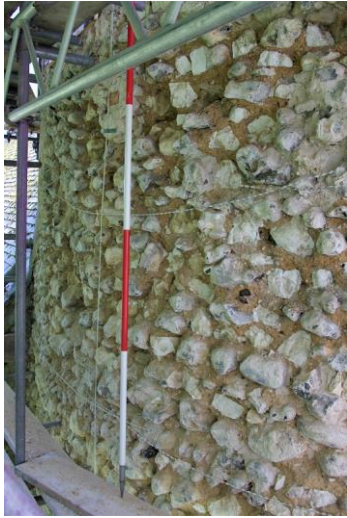
Plate 31: N side, central stage [34], infilled patch, [66] (top left, brick visible), looking ESE, 2m scale

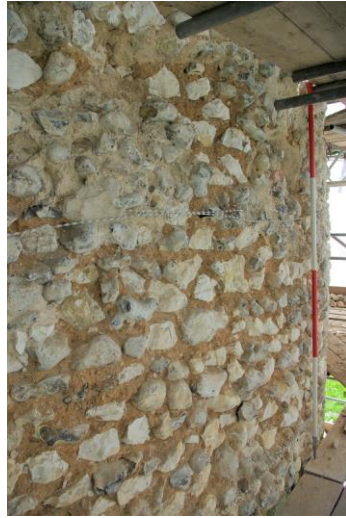
Various other smaller areas of repair or infilling were evident in [34]. They include several small circular areas in the central section of the tower on approximately the same level as the oculus; [71] just to its north (Plates 32 and 35), [66] (below and west of window [17] (visible top left in Plate 31), and a roughly circular area (not separately numbered) just south of the oculus and extending from the north side of large repaired area [23] (visible in Plate 33). These may be blocked former openings but this was not obvious during the recording work and is perhaps unlikely considering their position relative to the existing openings (but see below para. 7.0). They may possibly be infilled putlog holes although these would normally be smaller and squarish in shape like those [8] higher up (see below).

Plate 32: W side, central stage [34], infilled patch, [71] (top left), window [17] to left of 2m scale, looking S

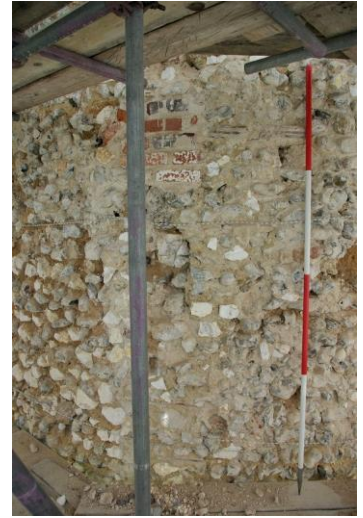
Plate 33: SW side, central stage, repair [23] with different wall fabric to either side, looking NE, 2m scale

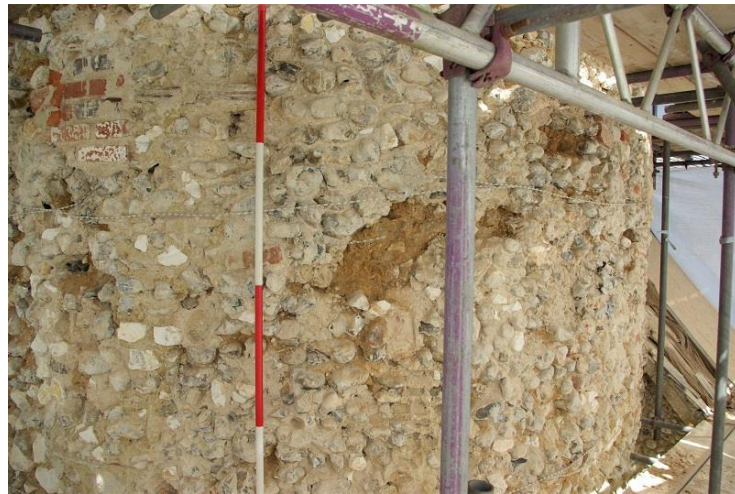
Plate 34: S side, central stage, wall exposed with on-going repairs in progress, looking E, 2m scale

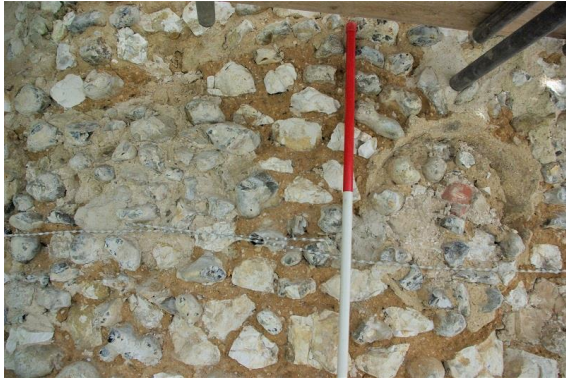
Plate 35: Window [27], with blocking (right), infilled area [71] (left), looking E, 1m scale

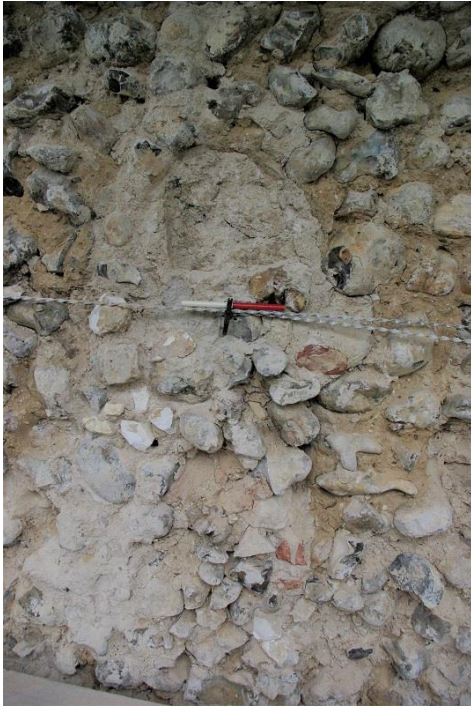
Evidence for a third semicircular-headed window [24] survived in the south wall of the tower but the window was far less well-preserved; it was not recorded by detailed drawing and conservation work was not possible as so little of its original fabric survived. The mortar render of its splayed upper part was, however, discernible (Plate 43). The former window appeared to be of similar size as that to its west [21], possibly slightly taller although this was unclear due to the nature of the blocking and, also, due to repairs to the wall in the area.

Plate 43: Window [24], blocked and with surrounding repairs, looking N, 0. 2m scale

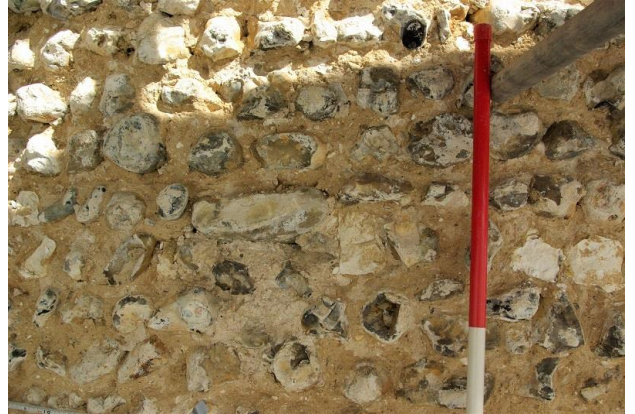
Plate 44: Blocked putlog hole ([8]), north of window [11], flint 'framing' at top and lighter mortar within, looking E 0.5m scale (red)

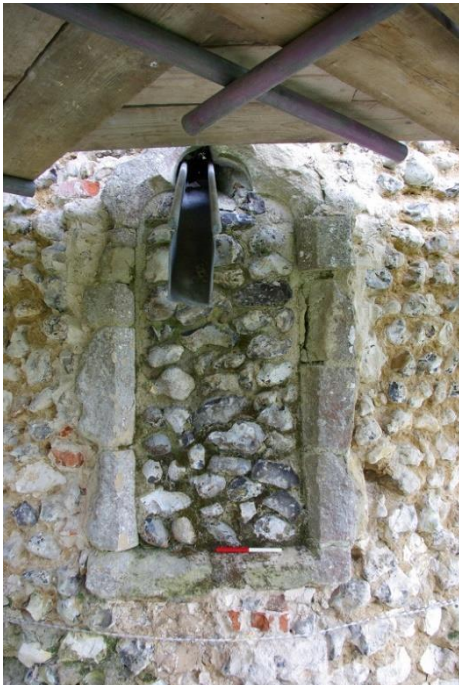
The belfry openings had been inserted into the early fabric of the upper tower [35]. Although most of the fabric around them had been obscured by later repairs (see below *Historic wall repairs*) it was possible to see in a few small areas, notably on the south side of the second stone above the sill of opening [11], that a slightly lighter coloured mortar than the gingery brown early mortar had been used to bond the fabric [69] immediately around the opening and the flints within that mortar are not quite lined up with the courses of the main tower fabric (Plate 45).

Plate 45: Cusped bell opening [11], looking SE, 0.2m scale

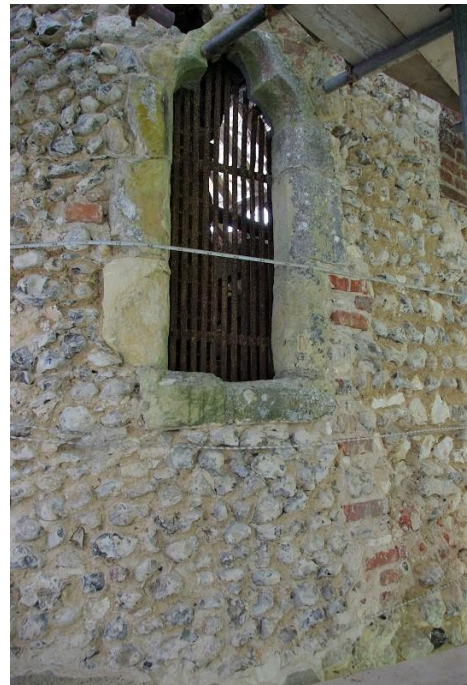
A large area of flintwork represented the rebuilding of the upper part of the tower from below and eastwards of the bell openings [9] and [5] and above the nave roof [36] (Fig. 7). The wall comprised flints (mostly 100 – 150mm, occasionally <200mm) with rare inclusions of broken brick (which were probably later inclusions). The mortar was very light whitish cream and slightly crumbly, and the flints were unevenly coursed giving this part of the tower wall a far more irregular appearance than the areas of undisturbed original wall to the west (see Plate 46).

Plate 46: Cusped bell opening [9] and repair [72], with wall fabric [35] (right) and [36] (below and left), looking SW

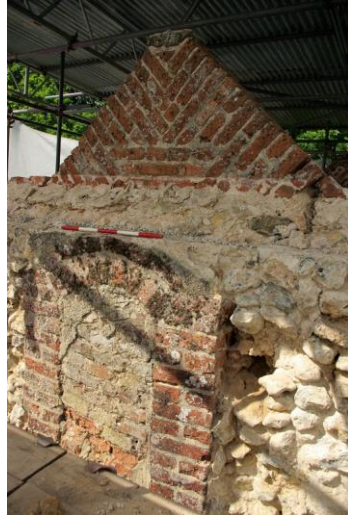
Plate 48: Bell opening [3] and S gable, looking NNW, 0.5m scale

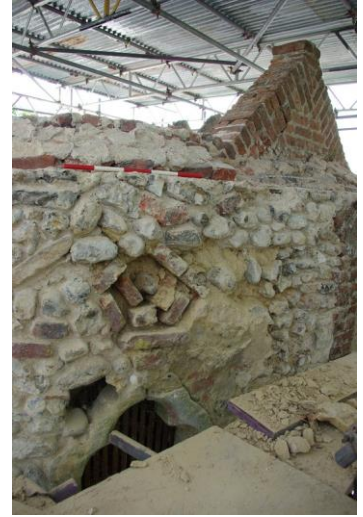
In the random rubble repair above the north-east belfry opening [11], a small pentagonal opening with sides formed of pieces of brick was uncovered at a late stage in the contractors work and, thus, is not shown in Fig. 7 but was within an area of repair shown there above opening [9]. It was infilled with a few fragments of brick and one or two flints [70]. It was positioned just above and slightly west of the smaller opening that had been used for rainwater drainage of the east roof slope of the tower (Plate 49). From the inside of the wall it could be seen that the blocked opening was positioned at

Plate 49: N gable and pentagonal opening [70] above cusped opening [9], looking SW, 0.5m scale
