DOCUMENTATION
OF
CONSERVATION

ST WULFRAM'S CHURCH, GRANTHAM

Location: St Wulfram's Church, Grantham
Window location: South aisle of NAVE
Windows: Quarry Leaded Glass lancets with tracery above
Description:

(A) CONDITION REPORT

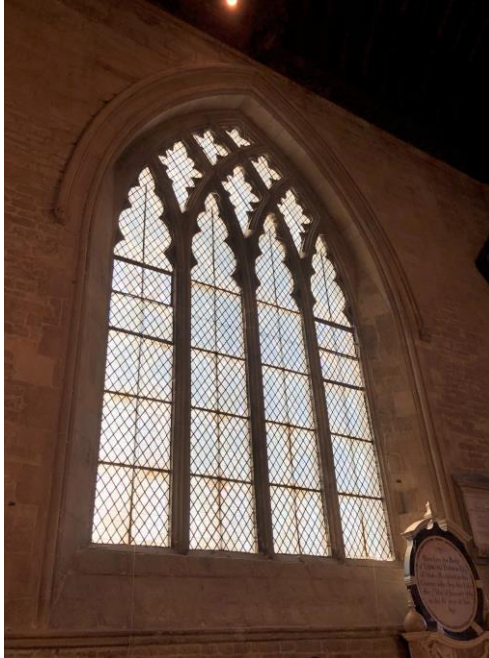
PLATE 1

Quarry glass leaded window south elevation

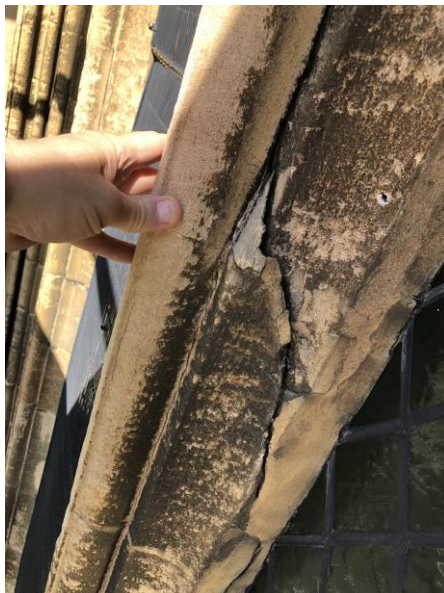
PLATE 2

The surrounding stonework to the jambs and mullions is in good condition, except for an area to one of the mullions and the inside area of the bottom stone sill which has suffered cracking (see PLATE 2). There is no evidence that corrosion of saddle bars has caused blowing of stonework. In addition, a feeble mix lime mortar has been used to fix the windows into the stone rebates.

Example of cracked mullion
