Saltmarsh *Paintings Conservation*

**Conservation treatment report for the
Royal Coat of Arms to George III**

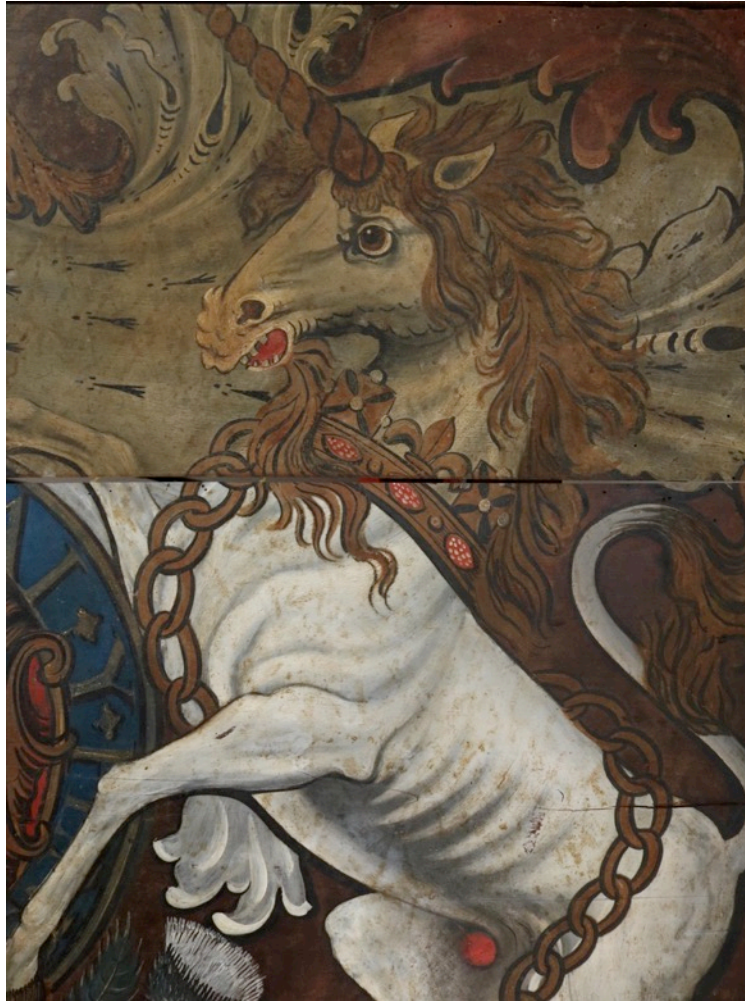
Plate 10 During varnish removal. The level of staining caused by the bat urine affecting the varnish and embedding it into the upper surface of the paint layer is visible. Some of the staining was removed by further cleaning. The most visible remnants were addressed with retouching

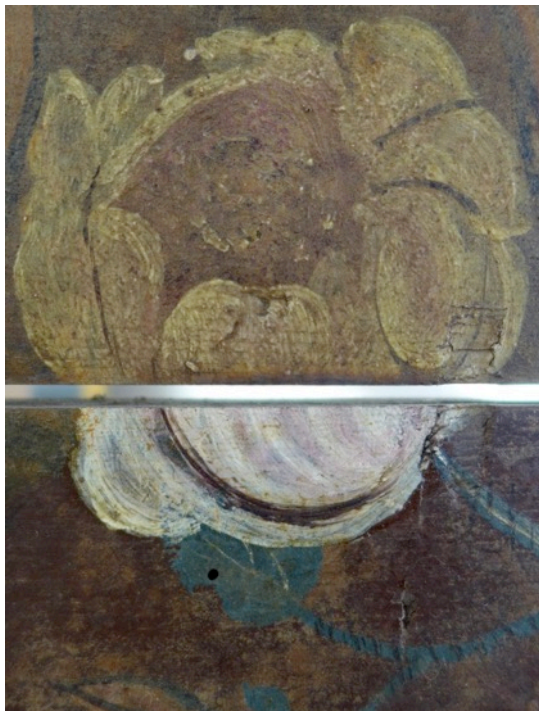
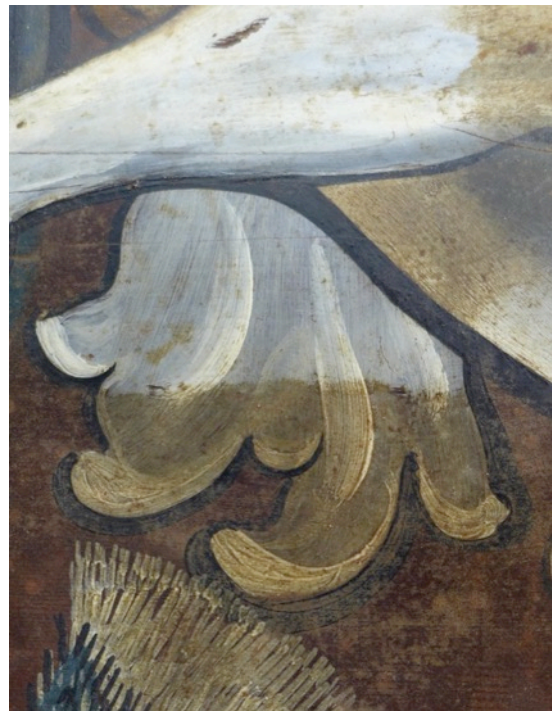
Plates 11 & 12 Details during varnish removal
