## St. Helen's church BILTON-IN-AINSTY North Yorkshire

**A record of conservation works carried out to four  
Anglo-Saxon cross fragments**

**January 2021**

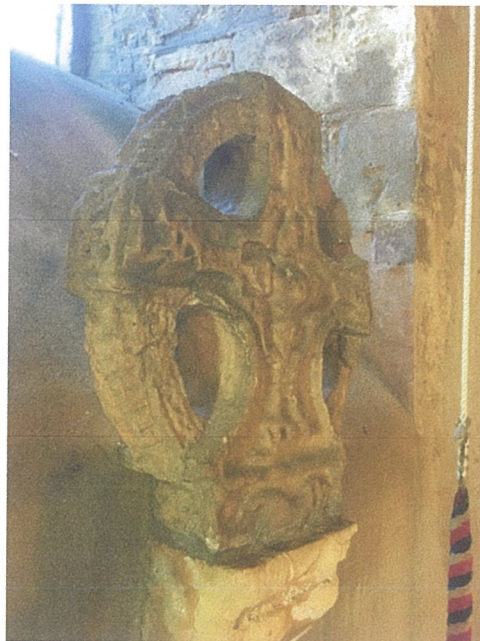
Plate 2: the Wheel head cross prior to removal.

- 2.3 The cross was bedded onto what appeared to be a very hard ordinary Portland cement mortar. The cement bed was approximately 15mm to 20mm in depth. Sharp tungsten chisels were firstly employed to begin removing cement from the arris of the cross base and the corbel to eliminate any damage during its extraction. Once this had been completed we began to remove the bedding cement. This proved to be quite difficult due to its hardness relative to the stone. It was felt that due to the thickness of the bedding it would be safe to use a non-percussive drill to chain drill along the bed. A long 6mm masonry drill bit was then utilised to create a series of holes along the front of the cement bed. Once this had been completed a flat cold chisel was punched into the mortar bed, joining up the holes until the cement bed finally 'broke'. The cross was removed from the corbel and placed into a bespoke packing crate and transported to our workshop for further works.

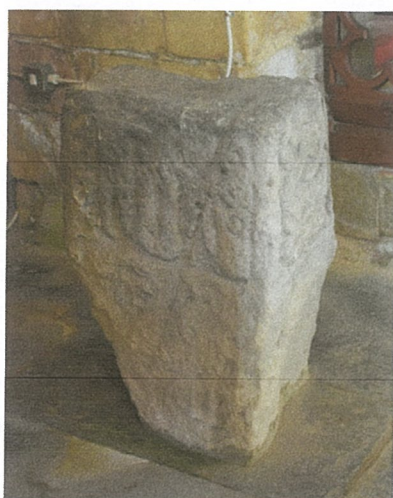
Plate 3: (top left) fragment 1

These photographs show the stones prior to their removal.

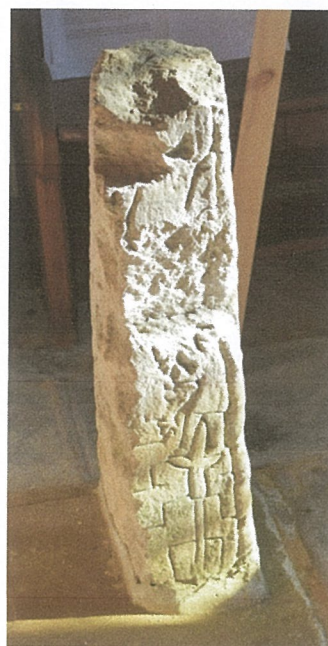
Plate 4: (left), fragment 2

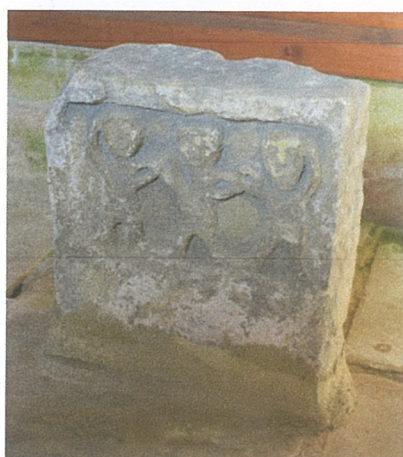
Plate 5: (above) fragment 3

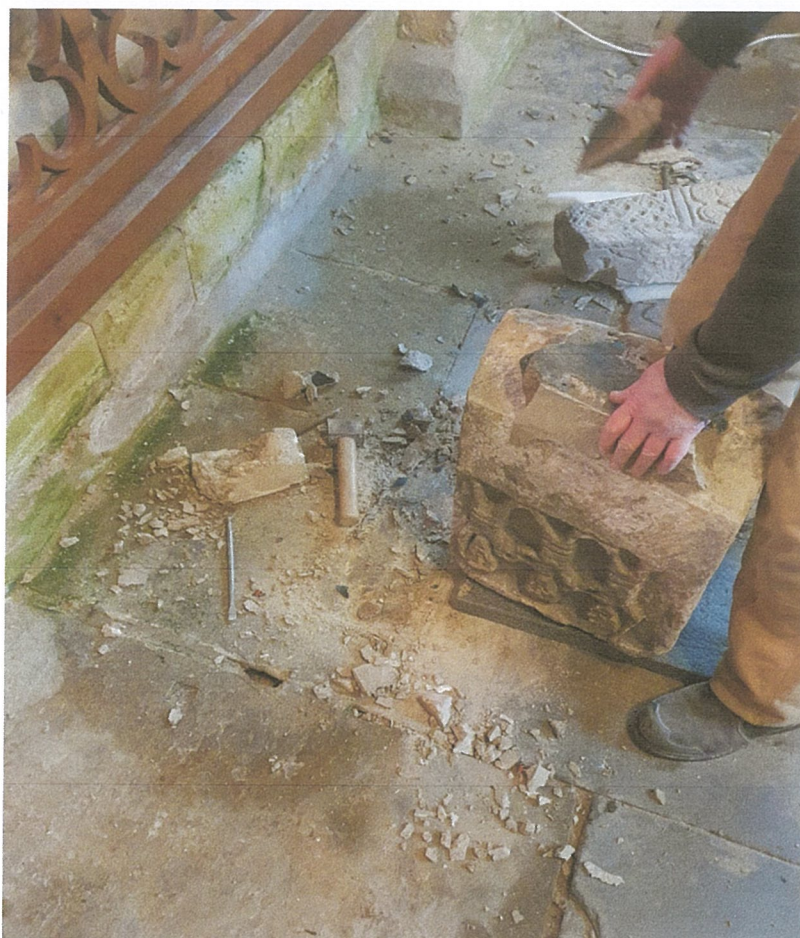
- 2.6 The three shaft fragments were set upon a very hard cement mortar, flaunching up around the sides, on the south aisle floor. Prior to work on these commencing the floor was swept and vacuumed and hardboard floor protection was placed around them and up to the location where they will be mounted.
- 2.7 Sharp tungsten chisels were firstly employed to begin removing cement from the arris of the cross base and the corbel to eliminate any damage during its extraction. Once this had been completed we began to remove the bedding cement. Flat cold chisels were then tapped into the mortar bed until the cement bed 'broke'. At this point all remaining cement on the flag floor and the underside of the cross fragments were removed. This was undertaken with sharp tungsten-tipped chisels.

Plate 6: During the process of removing the stone cross fragments from the flag floors.

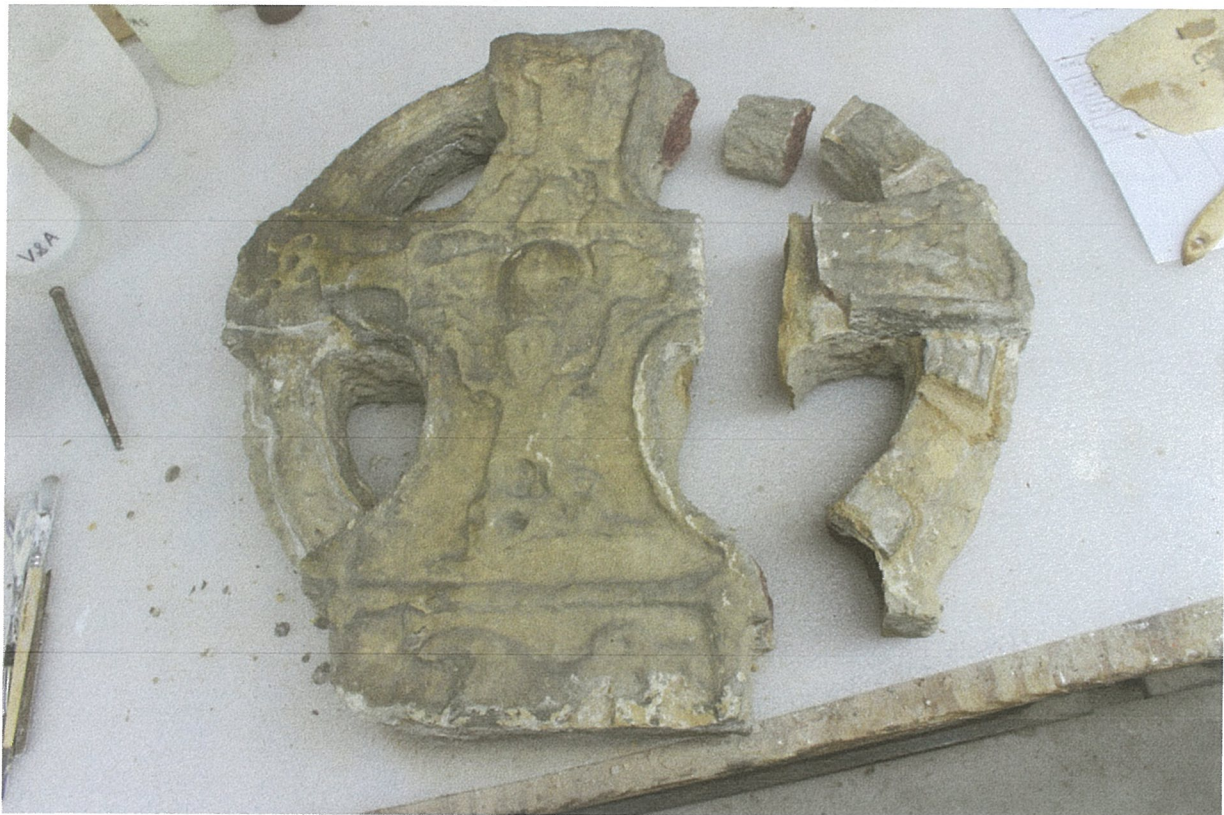
- 3.1 The wheel head cross was transported to our conservation workshop to receive further works. The cross was displaying numerous fractures and repairs on the right hand side from where it had been damaged. These repairs had been had taken the form of simply using a resin to bond the various elements together. In most cases the resin had discolored in UV light and was becoming brittle and failing (Plate 7). These elements were gently prized apart in readiness to be pinned back into place.

Plate 7: The Wheel head cross showing the right hand side disassembled

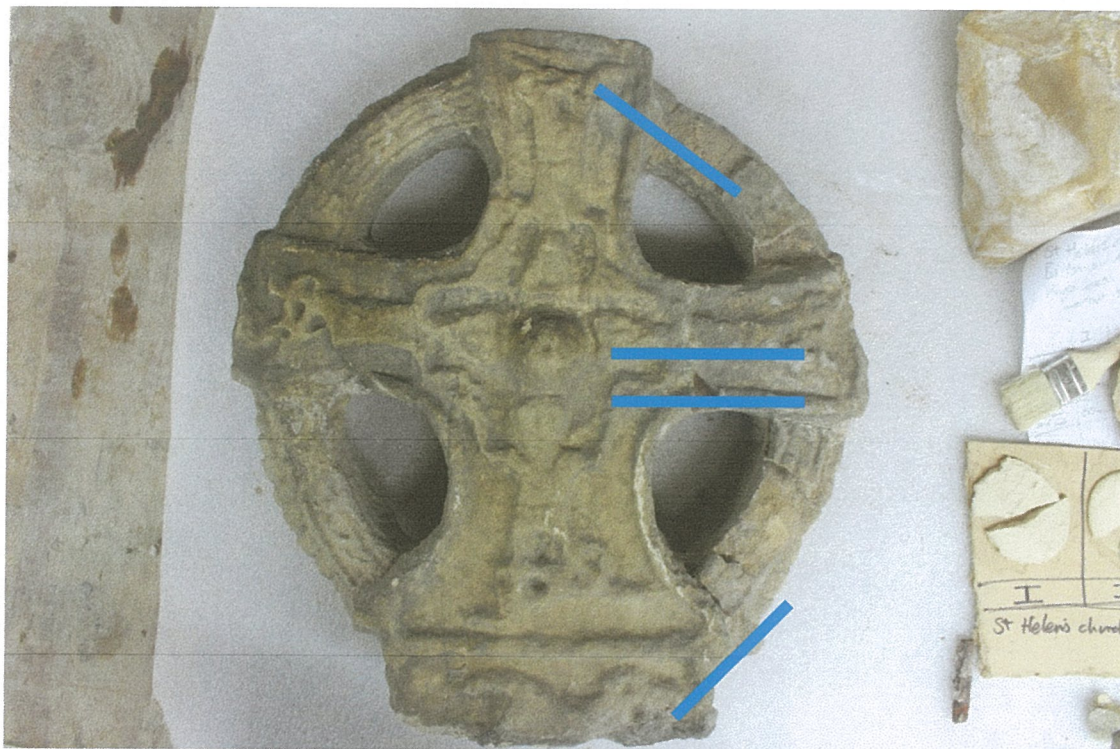
Plate 8: The Wheel cross now fixed together. The blue lines illustrate the locations of the stainless steel pins

- 3.2 Before a satisfactory repair could be undertaken the old resin was removed. This was softened with repeated applications of an acetone cotton wool poultice and eventually picked away with scalpels. Hidden dowels were used to repair the cross. Holes were drilled into the cross to accept threaded stainless steel dowels (316 grade). Four dowels were used, each having a diameter of 8mm. The holes were drilled out at 10mm and given a thorough clean to remove any dust. The dowels were set into *General* polyester resin and the fractured stone surfaces to be joined had a thin polyester resin layer applied. All elements were fixed at the

same time and a ratchet was placed around the circumference of the wheel and gently tightened. This ratchet remained in place until all of the resins had cured.

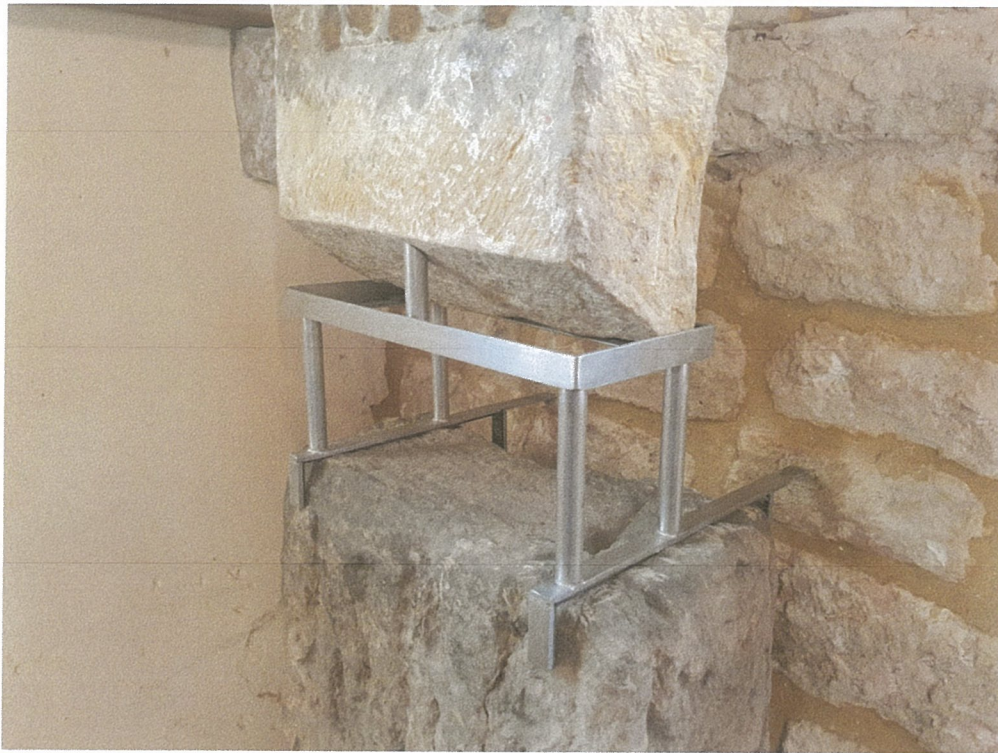
Plate 9: The frame for fragments 1 & 2. Note the additional support for fragment 2

- 5.2 The three stone fragments were to be mounted in the south aisle. Fragment 1 on a DPM (damp proof membrane) of code 4 lead sheet. The lead sheets wasa painted on both sides with black bitumen paint. This is to help prevent the oxidization of the lead. A stainless steel frame (316 grade) was designed and fabricated to sit on the top of fragment 1 and to then offer a cradle for fragment 2 to sit in. to offer support and stability to the top of fragment 2 two dog legged cramps were also fabricated. The frame and upper dog leg cramps were fixed into holes drilled into the wall which was cleaned of all debris. The steel projecting into the holes were given a fishtail detail and set into Hilti HY resin. Any areas of the steel frame or the restraining cramps that are in contact with each other had 3mm *Plasterzote* separating them. *Plasterzote* is a chemically inert closed cell foam. As a note fragment 2 was not flat on its underside but had a large, almost, 45° cut so would not sit in the designed frame without additional support. To aid in supporting this stone at the front a 25mm diameter stainless steel dowel was welded to the frame to carry out this function.

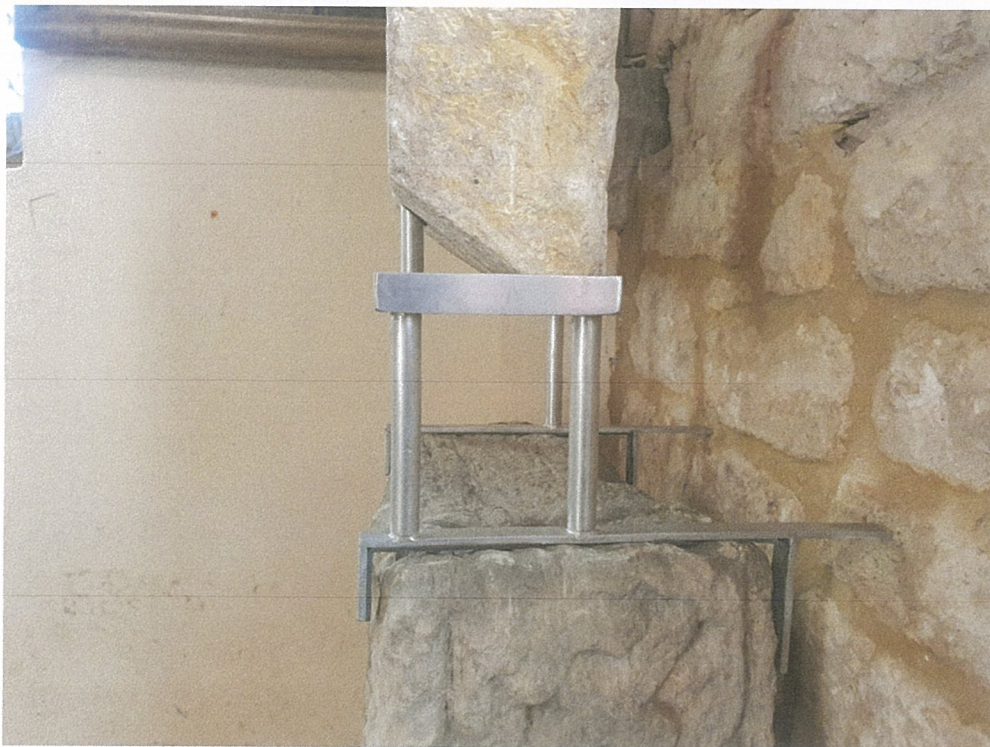
Plate 10: A side view of the frame

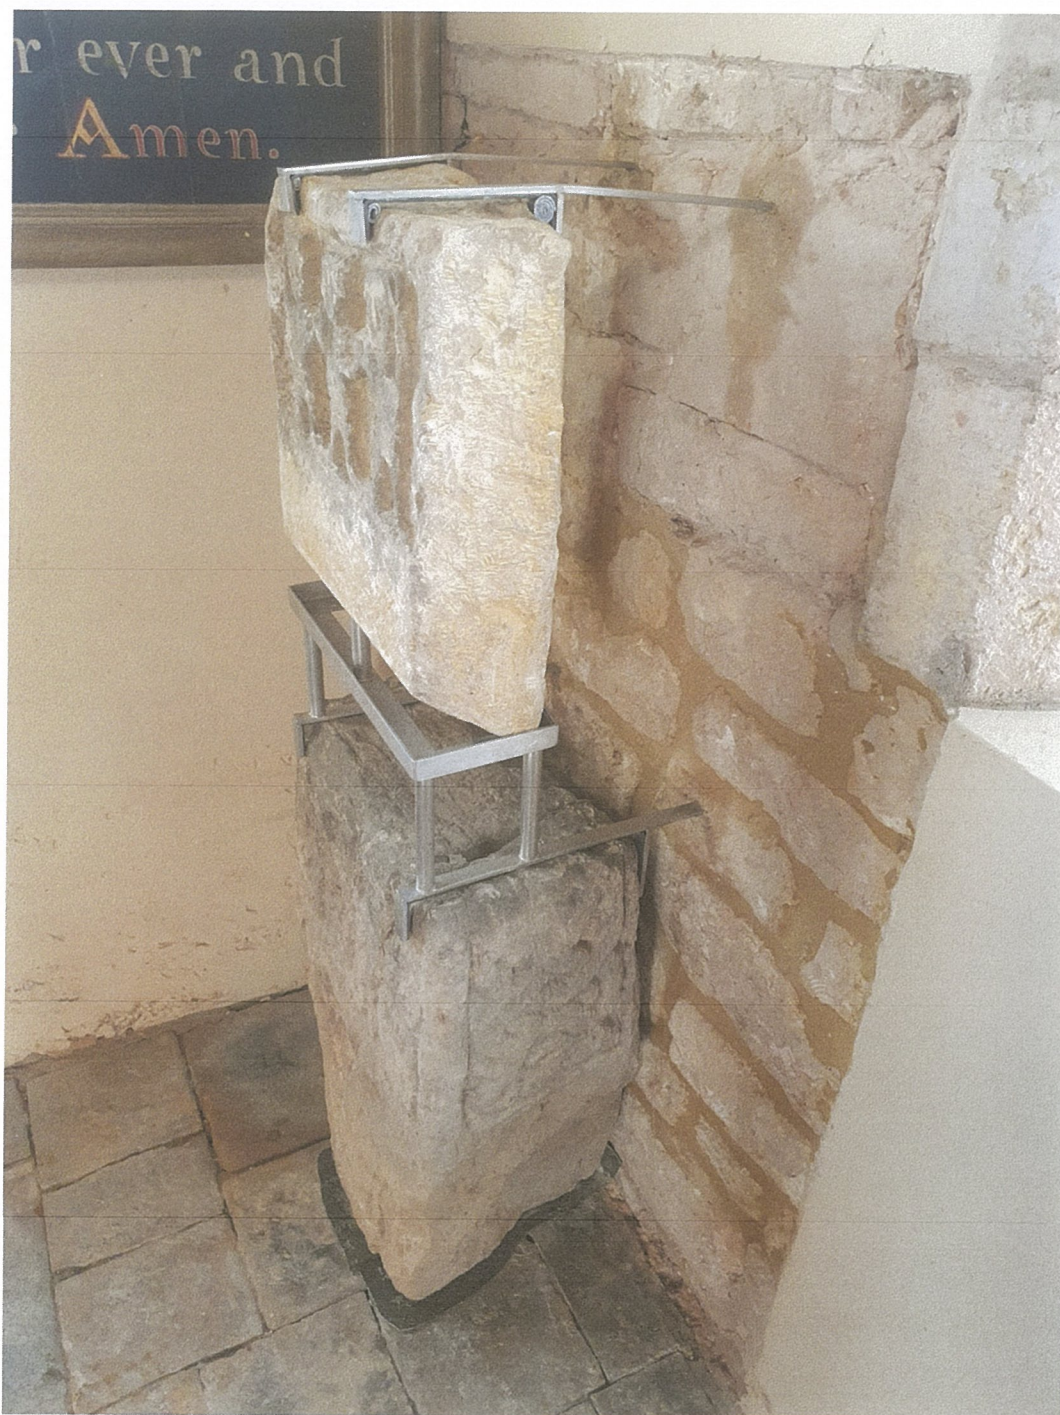
Plate 11: The completed arrangement for fragments 1 & 2

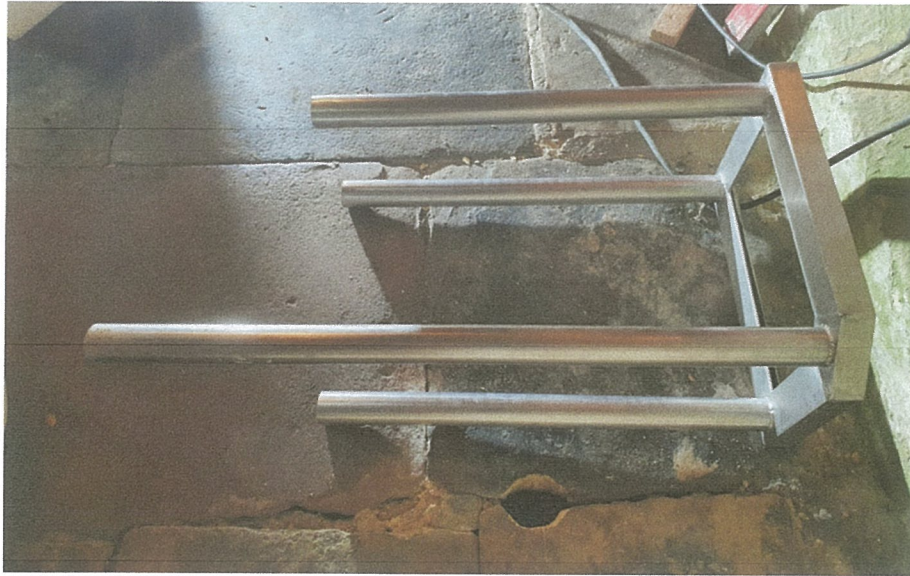
Plate 12: detail of the table for fragment 3

- 5.4 Fragment 3 had a table fabricated for it to sit on displaying the shaft fragment at an angle to make all sides available for viewing. The table has four legs as support with the foremost leg left longer and inserted in between the stone floor flag stones. This was fixed using epoxy resin. To hold the upper section of the shaft shaped stainless steel was manufactured and fixed into pre drilled holes and fixed with epoxy resin. The wheel head cross was sat on fabricated dog leg cramps with a further two cramps, holding and clamping, the top section. The steel projecting into the holes were given a fishtail detail and set into Hilti HY resin. Any areas of the steel frame or the restraining cramps that are in contact with each other had 3mm *plasterzote* separating them

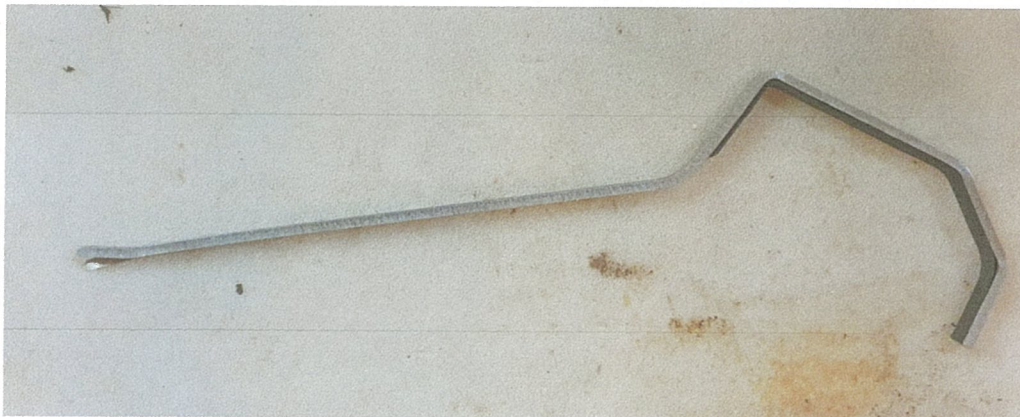
Plate 13: detail of one of the shaped restraining cramps for fragment 3

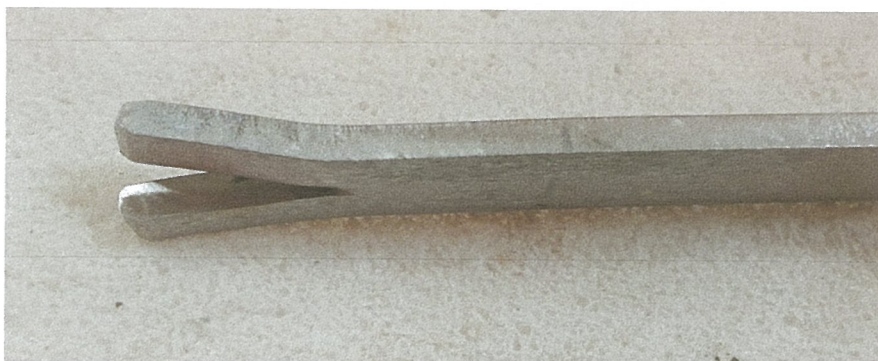
Plate 14: detail of the fishtail at the end of all restraining cramps fixed into wall

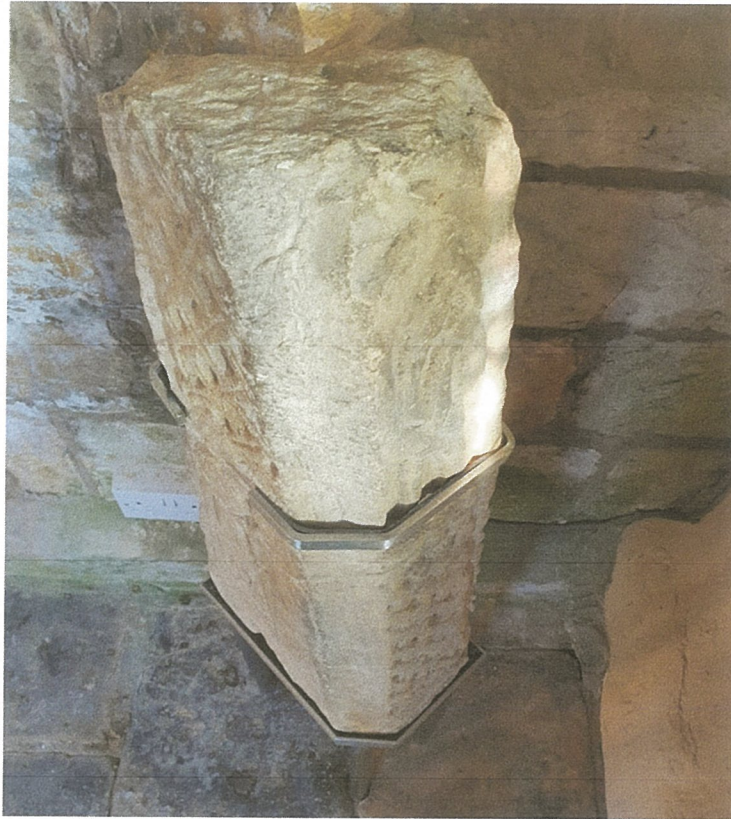
Plate 15: Fragment 3 in position on its table and with its restraints

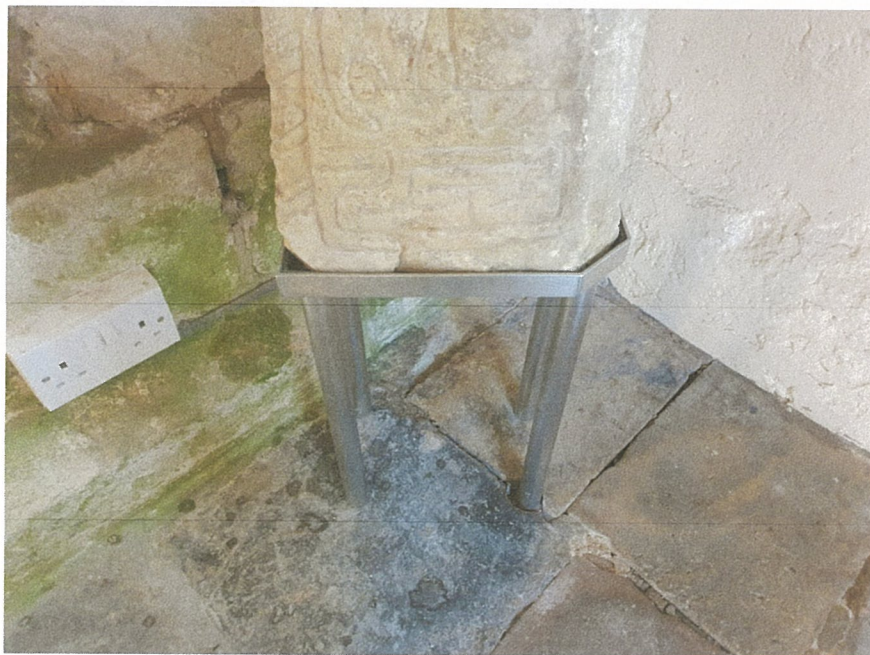
Plate 16: Fragment 3 in position on its table

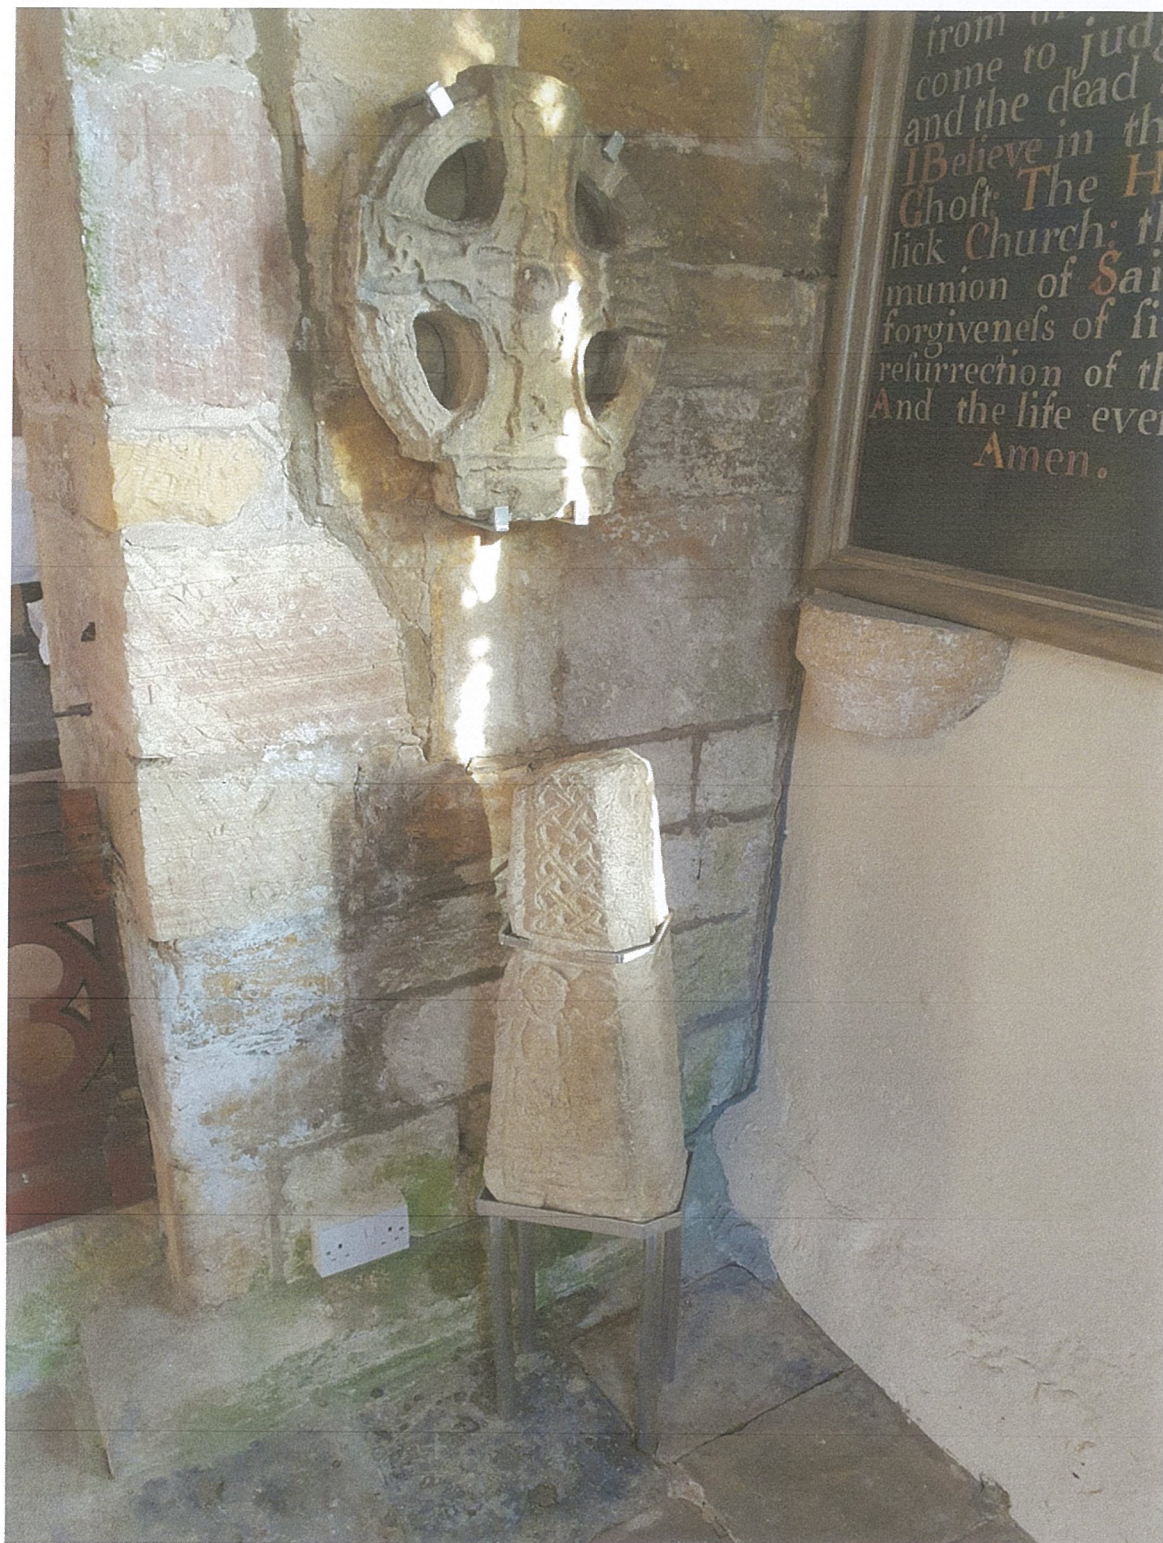
Plate 17: The completed arrangement of fragment 3 and the wheel head cross
