Quaife Woodlands

23rd January, 2018

Our Ref: AR/3734L/jq

Arboricultural Survey – Health, Condition and Risk Assessment at St Leonard's Church Streatham, Tooting Bec Gardens, London, SW16 1RB

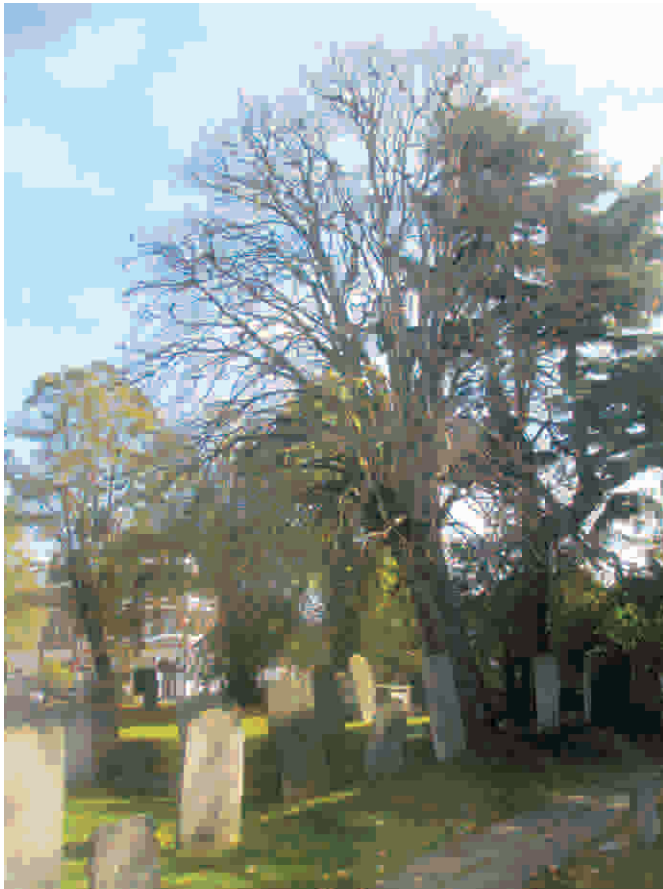
Photograph 1.
View of horse chestnut T20 showing the reduced shoot extension and that it was pollarded at about 4½ metres 15-20 years ago

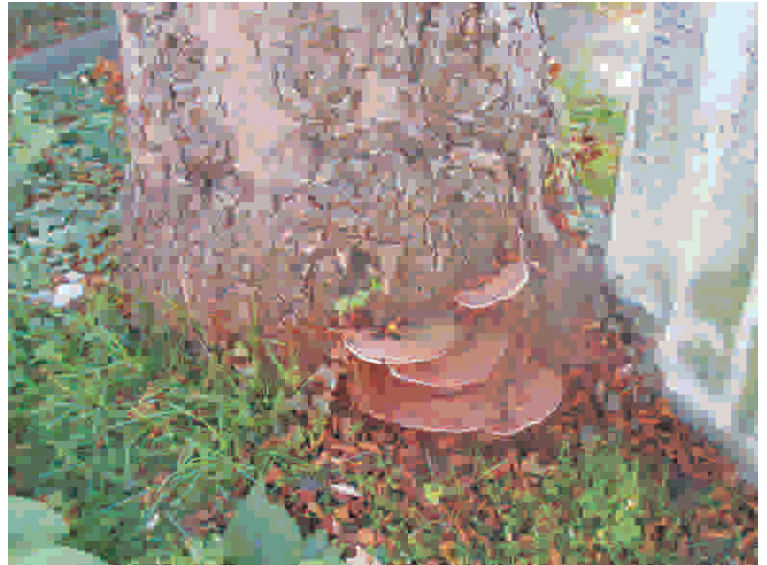
The only tree that requires urgent attention is the **horse chestnut T20**. This has advanced basal decay and there was a very distinct hollow-sounding resonance in the zone around the fungal brackets (photograph 2, Appendix C). These are brackets of the fungus *Ganoderma adspersum* which causes decay of the stem and roots. It can co-exist with a host tree for many years, but once the crown exhibits symptoms of stress (photograph 1, Appendix C) the structural integrity of the tree becomes compromised. This stress is likely to have been exacerbated by horse chestnut leaf miner which causes early leaf discolouration. There are fungal mushroom remnants, the species of which I could not identify (photograph 3, Appendix C), growing east of the tree's base which may be associated with the roots, and a surface fungus on the base (photograph 4, Appendix C) which appears to be saprophytic – feeds on dead tissue and not of itself harmful, but indicative of dysfunctional tissue. The tree should be removed and for obvious reasons it is better to do so while it remains sound enough to climb, as the tree will have to be sectionally dismantled because felling is out of the question in the churchyard.

Photograph 2.
Ganoderma fungal brackets at the base of T20

In conclusion, the only tree which presents a risk which needs attention is the horse chestnut T20. This risk is not imminent, but the tree should be removed without undue delay. None of the other trees presents any abnormal risk. I use term "abnormal risk" in relation to trees where the level of risk is acceptable. No tree is 100% "safe" but where there are no defects or characteristics that render the subject tree more likely to fail than any other, I describe it as presenting no abnormal risk.

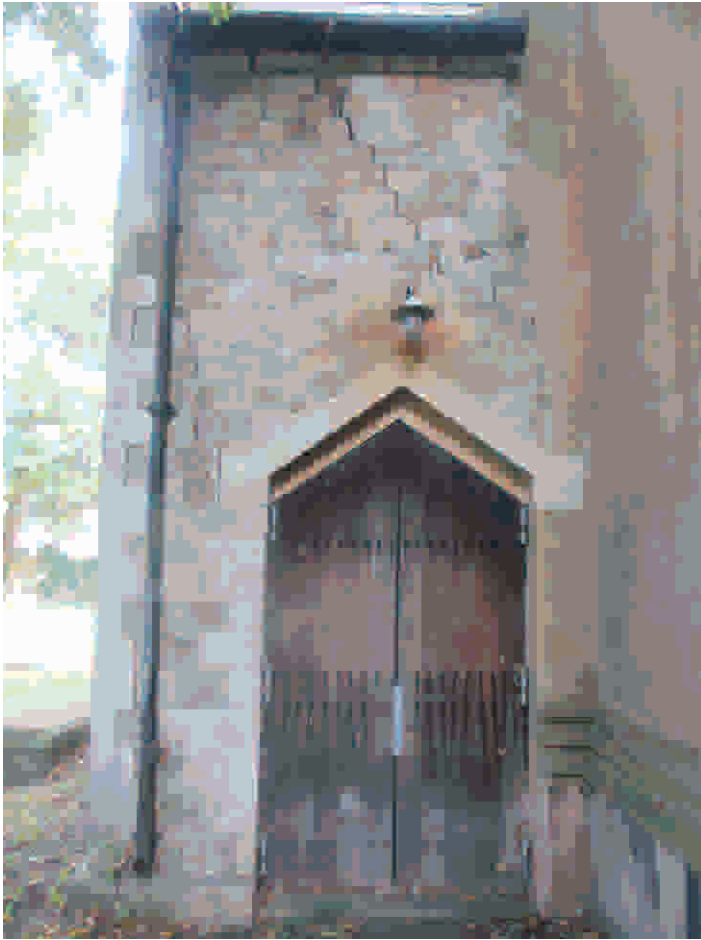
You are particularly concerned about the oak T1 on the north side of the church which may be causing damage to the north porch. I note from the British Geological Survey that the site is on London clay, which is a shrinkable soil, and therefore susceptible to drying from water uptake by trees

The North Porch has pronounced angled cracking on the south-western elevation (photograph 5, Appendix C) which is characteristic of rotational movement caused by the foundations sinking. The cracks widen in magnitude as they ascend. Interestingly on the north-eastern elevation has no cracks, or possibly the start of a very small crack – although it was not clear to me (photograph 6, Appendix C). This should be inspected by a structural surveyor. If it is found to be subsidence associated with the oak T1, the only way this influence can be removed is by installing a root barrier, or removing the tree. The other method, which is not favoured in the UK as insurers regard it as being unreliable, is to irrigate the soil to negate shrinkage. To discover whether the tree is the cause of the cracks should be monitored over a year to see if the variations of magnitude are seasonal – expanding in the summer and contracting in the winter.

Photograph 5.
View of the south-western elevation of the North Porch showing the cracking angled upwards to the west

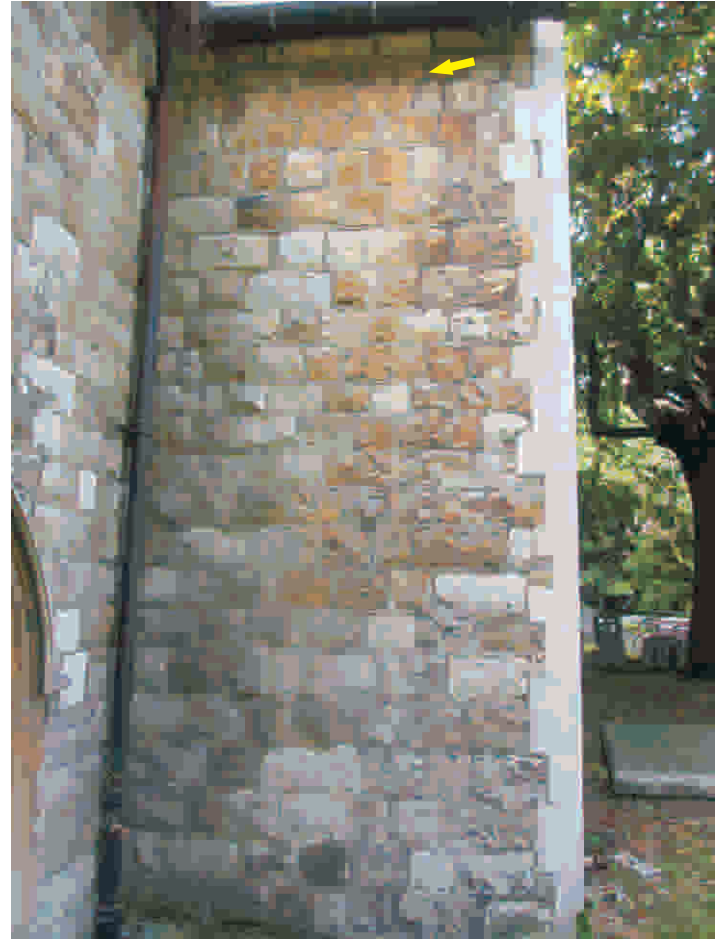
Photograph 6.
View of the north-eastern elevation of the North Porch with what could be a small crack (arrowed)

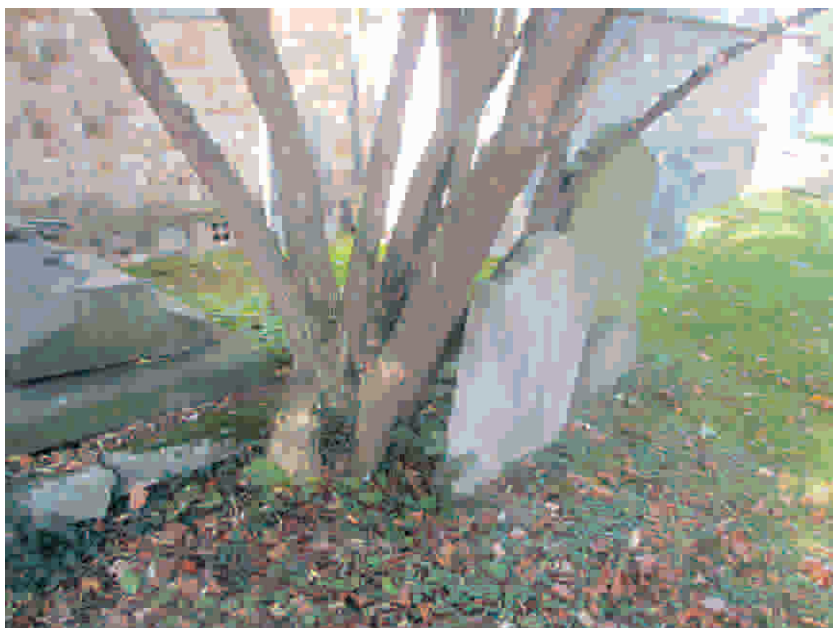
The **elder T23** (photograph 7, Appendix C) is dislodging a headstone and it should be removed.

T21	Variegated Holly		4	E			
T22	Holly		7.5	E	Forked into 2 at 0.3m, small Elms underneath		
T23	Elder		6.5	M	In contact with headstones – see Appendix C, photograph 7	Suggest removal	At next maintenance operation Minor work
T24	Yew	T7	9	E	Multi-stemmed, lean to east, ivy 15%		
T25	Elm		11	E	Suckers at base,		
T26	Yew	T6	11	E	Multi-stemmed at 5m		
T27	Yew		12	E	Forked x 2 at ground level, lean to south

Photograph 7.
View of elder T23 displacing a headstone
