St Mary's Church, Main Road, Longfield

Archaeological Watching Brief Summary Report

Project Code: WB SMCML20
 Planning Ref: N/A
 NGR: TQ 60332 69044 (centred)
 Archive No: 4515

August 2020

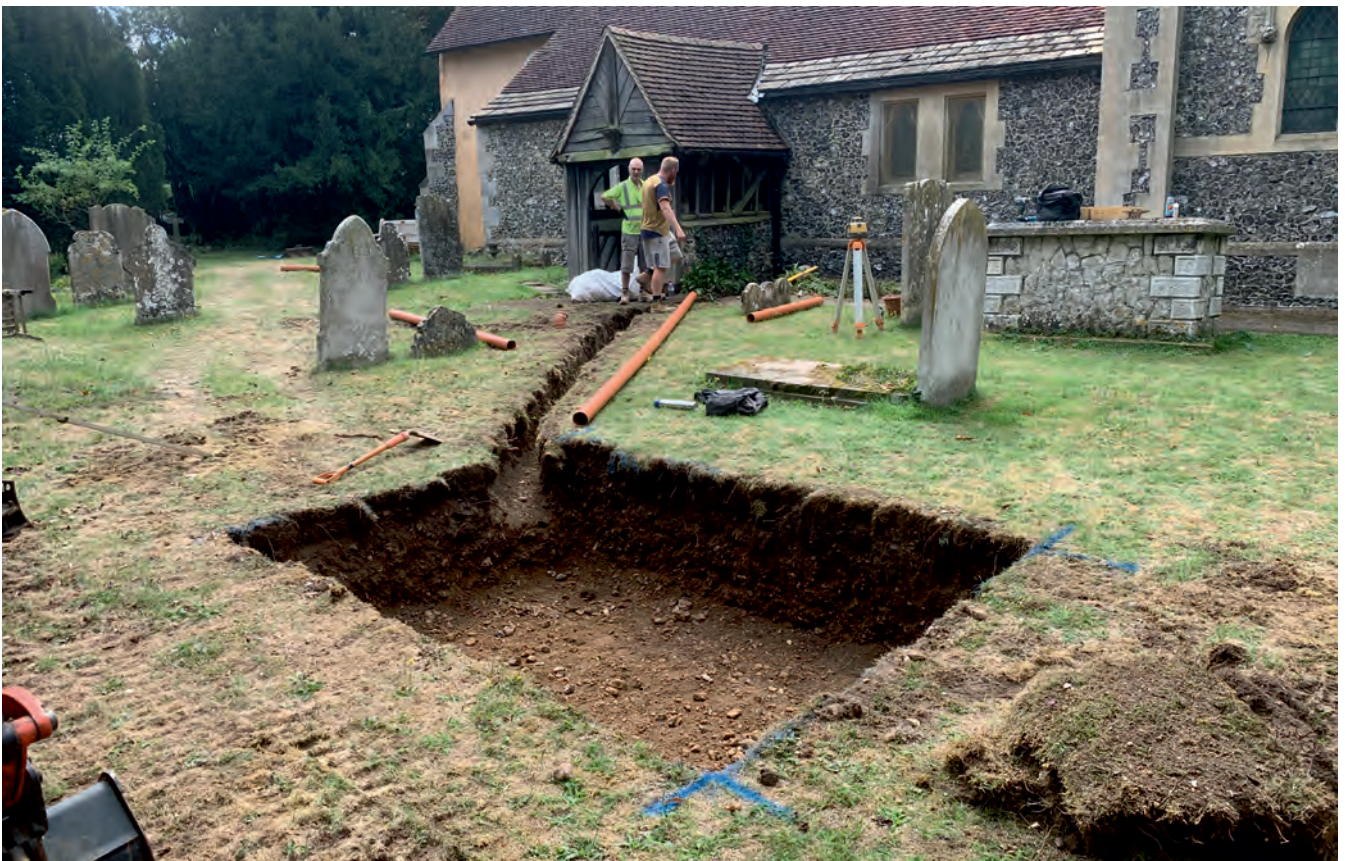
Plate 2. General view looking southeast across Soakaway position S1 and showing drainage trench DT1 within the northern portion of the churchyard.

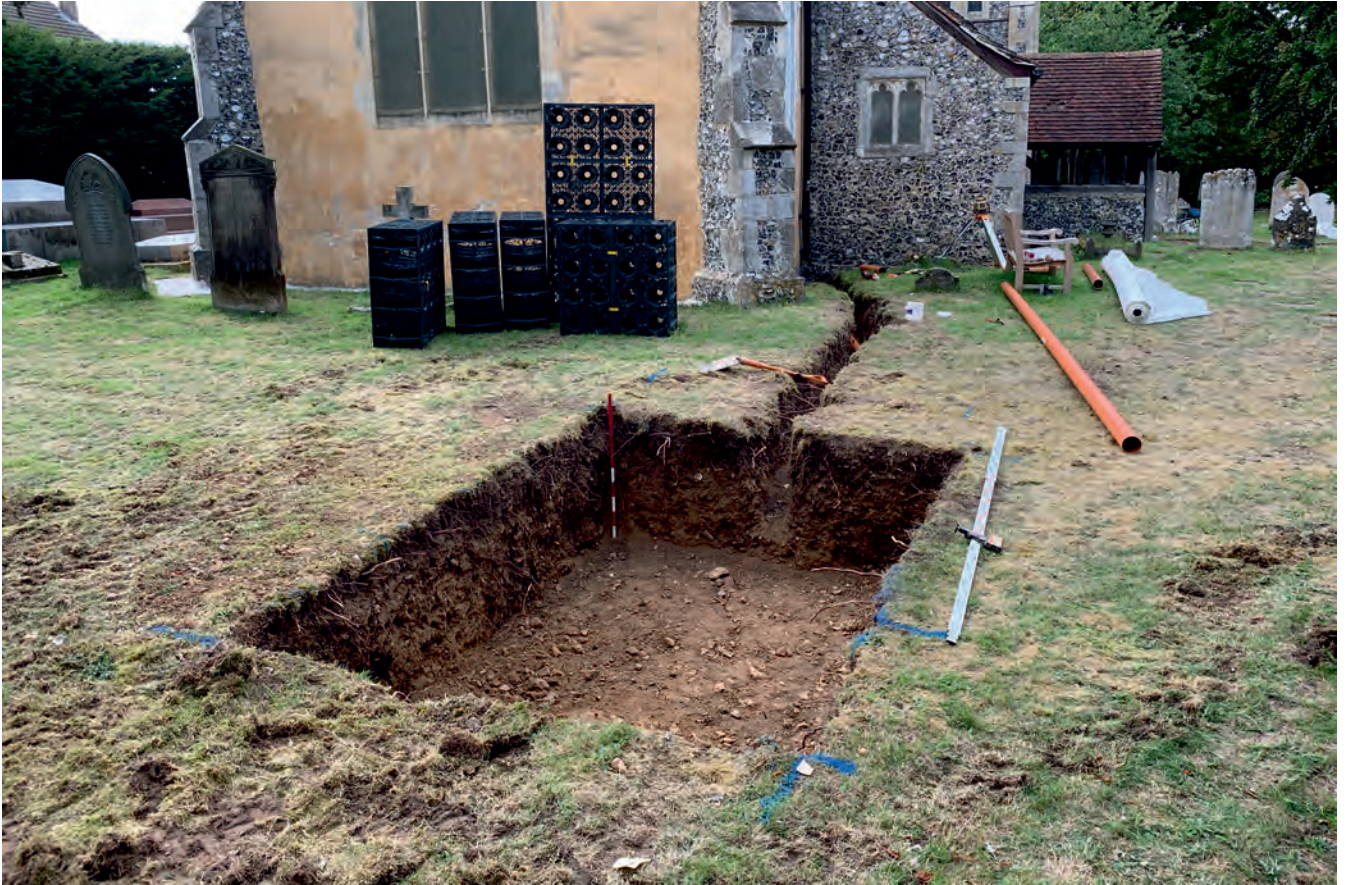
Plate 3. General view looking east showing soakaway position S2 and drainage trench DT2 in relation to the east end of the chancel.

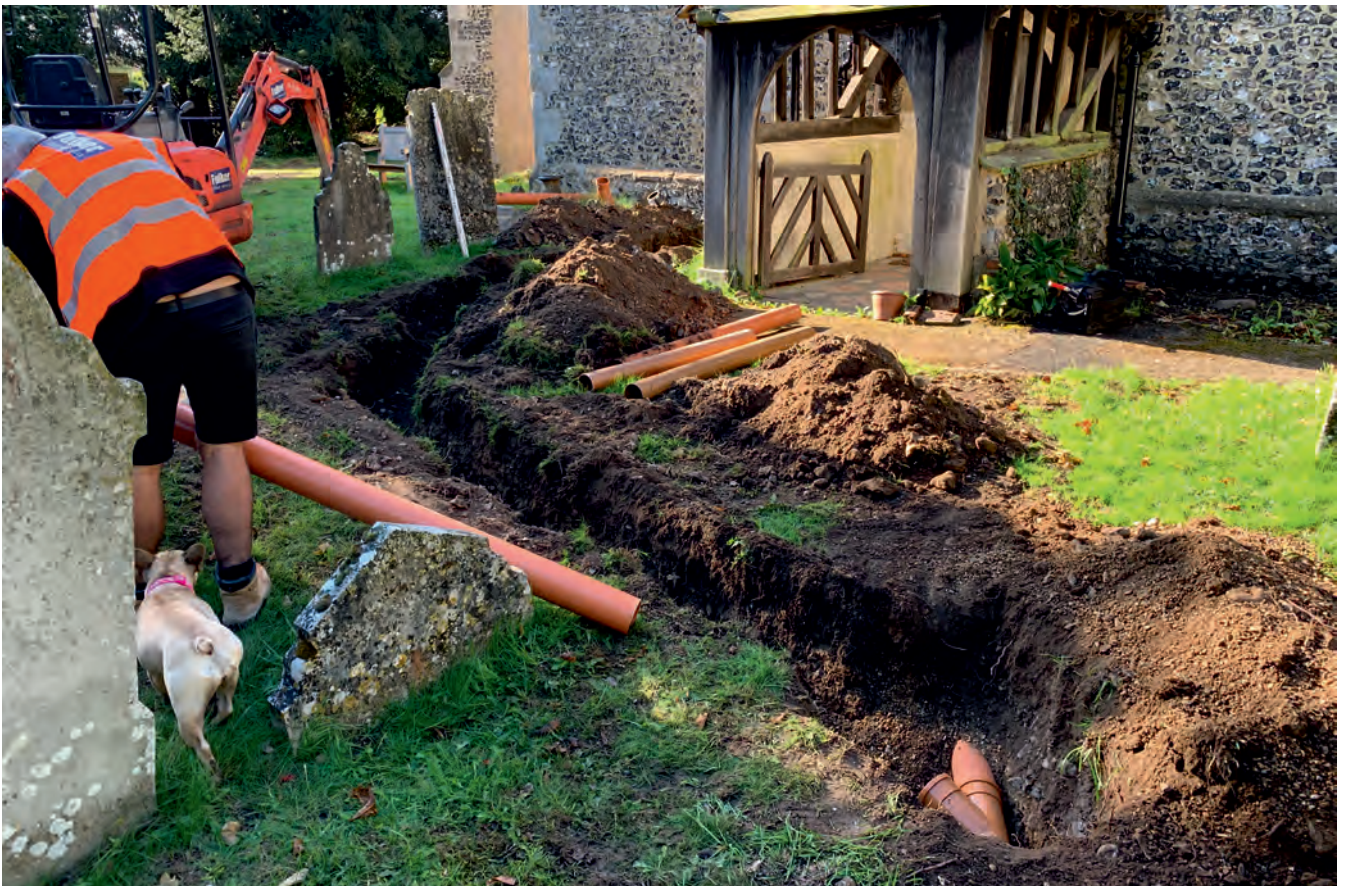
Plate 4. General view looking southeast showing drainage trench DT 3 in relation to the north porch.

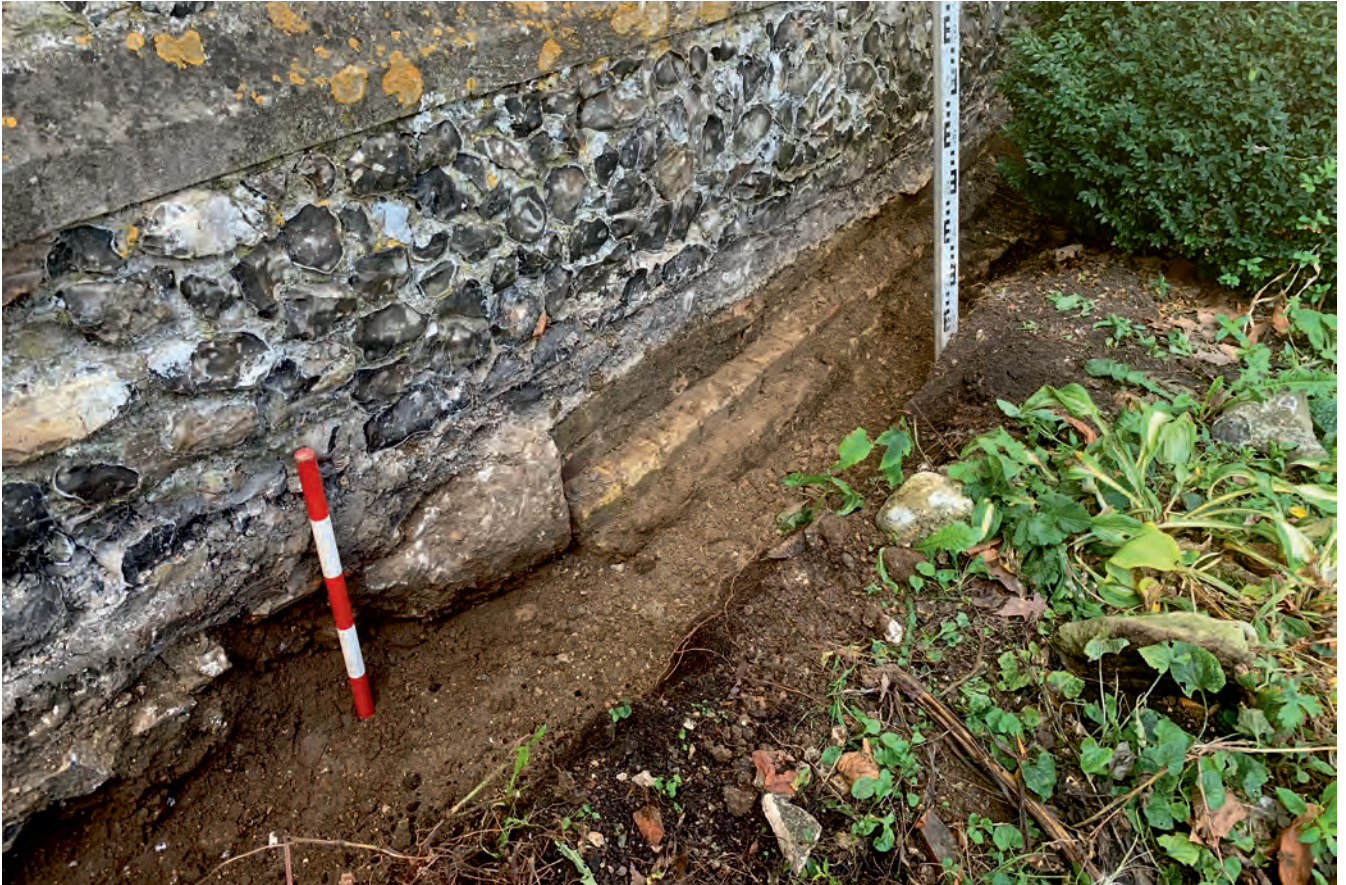
As the service trenching commenced, or extended, along the base of the church's walls, this provided an opportunity for the upper extent of the wall foundations to be briefly inspected. This examination would allow the constructional methodology, and the stone type usage to be noted, which can frequently be used to clarify period additions through the relationship of different period foundations. The most obvious one of these was encountered along the line of Drainage Trench DT1 where it extended along the base of the wall of the present north wall of the north aisle. Here, a clear separation in constructional techniques was identified illustrating the westward extension of the church in the latter part of the nineteenth century (c.1889). Whilst the foundation to the earlier thirteenth century north aisle, consisting of irregular flint rubble bonded with pale creamy white coarse sandy lime mortar, occupied the western 2.2m length of the exposed foundation, this ended in a large corner stone formed from a roughly hewn stone boulder. The westward extending remainder of the exposed foundation, with a prominent offset step, was formed in machine made yellow stock bricks bonded with hard cement-based mortar. Abutting the western face of the foundation corner boulder, this clearly revealed the abutment of the later extension of the church against the earlier western end of the nave and north aisle, a feature not visible in the standing walling above due to nineteenth century face knapped flint refacing.

Plate 5. View looking southwest along the line of drainage trench DT1 extending along the base of the north wall of the north aisle showing corner stone to medieval foundation abutted by brick foundation of later west tower and nave extension.

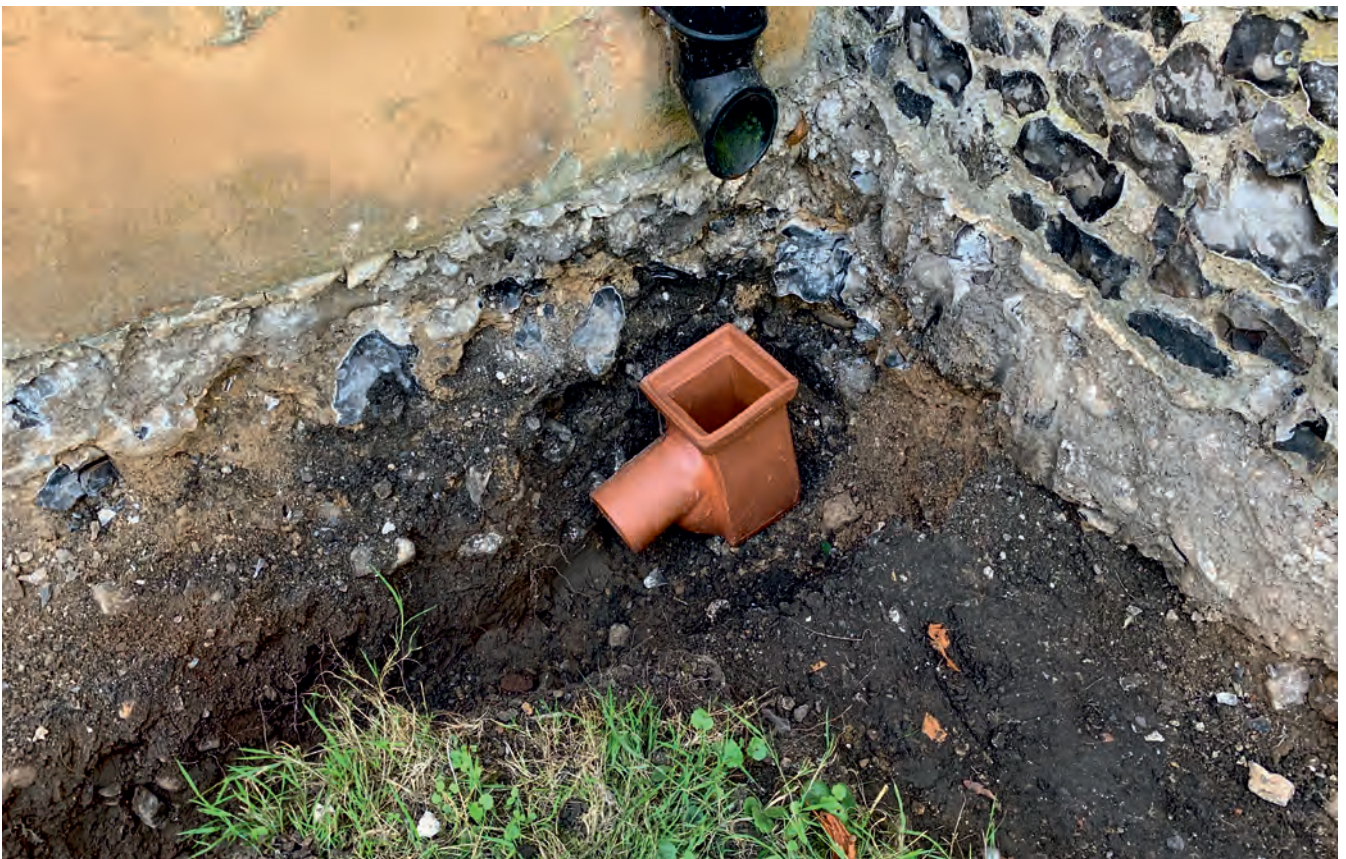
A similar foundation abutment was also noted at the junction of the east wall of the north aisle with the north wall of the chancel and the eastern side wall of the north porch with the north wall of the north aisle. With respects to the junction of the aisle with the chancel, here it was noted that the chancel wall foundation was formed of large unknapped irregular flints bonded with a firm – hard, mid – pale creamy

orange/brown coarse gritty lime mortar typical of the early Norman period. Examination of this junction revealed the external face of the earlier chancel foundation stepped towards the north by approximately 700mm before returning on its westward alignment. Clearly forming the projecting northeast corner to the earlier nave, this foundation contrasted with the foundation of the north aisle, which was formed of irregular flint rubble bonded with pale cream whist coarse sandy lime mortar. Closer inspection of the junction revealed the standing masonry of the earlier nave's northwest corner had been removed allowing the southern end of the north aisle's east wall to over sail the earlier foundation before connecting with the masonry of the earlier chancel's north wall. Though complicated in its description, this is not uncommon method of adding a later aisle onto the side of an earlier church, as the formation of an aisle required the removal of the earlier nave's north wall and the construction of an multiple arched arcade between the two. This enabled the reuse of the earlier nave's north wall foundation as a below ground 'sleeper foundation' to the new aisle arcade, whilst the former nave's north east corner removed and replaced with the eastern end wall of the new aisle.

Plate 6. View of the junction between the north aisle's east wall and the chancel's north wall exposed in drainage trench DT2 showing the junction of the two separate medieval period foundations.

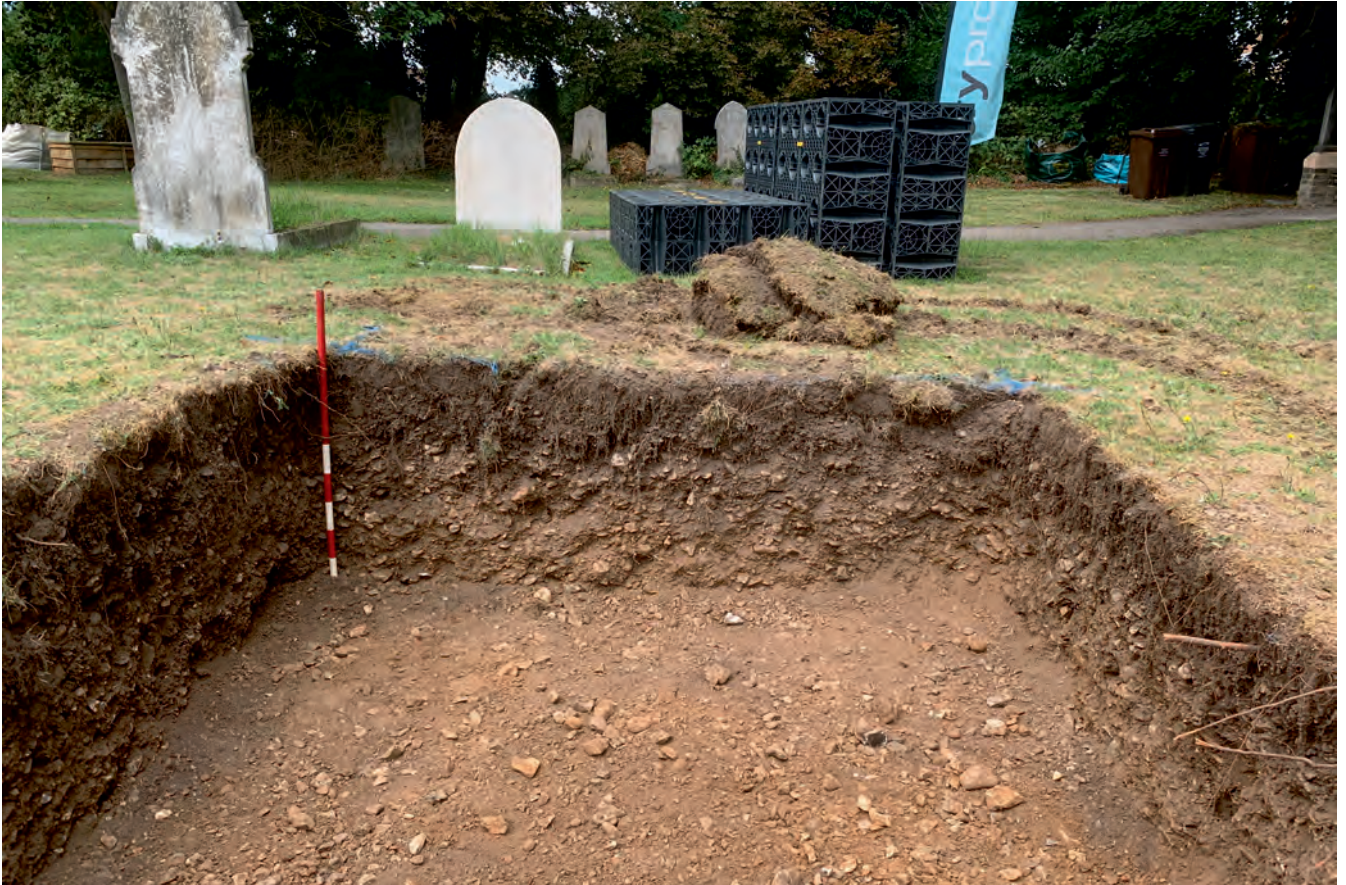
Plate 7. View looking west at the western section of soakaway position S1 showing graveyard deposits over natural gravel geology and sealed by topsoil.

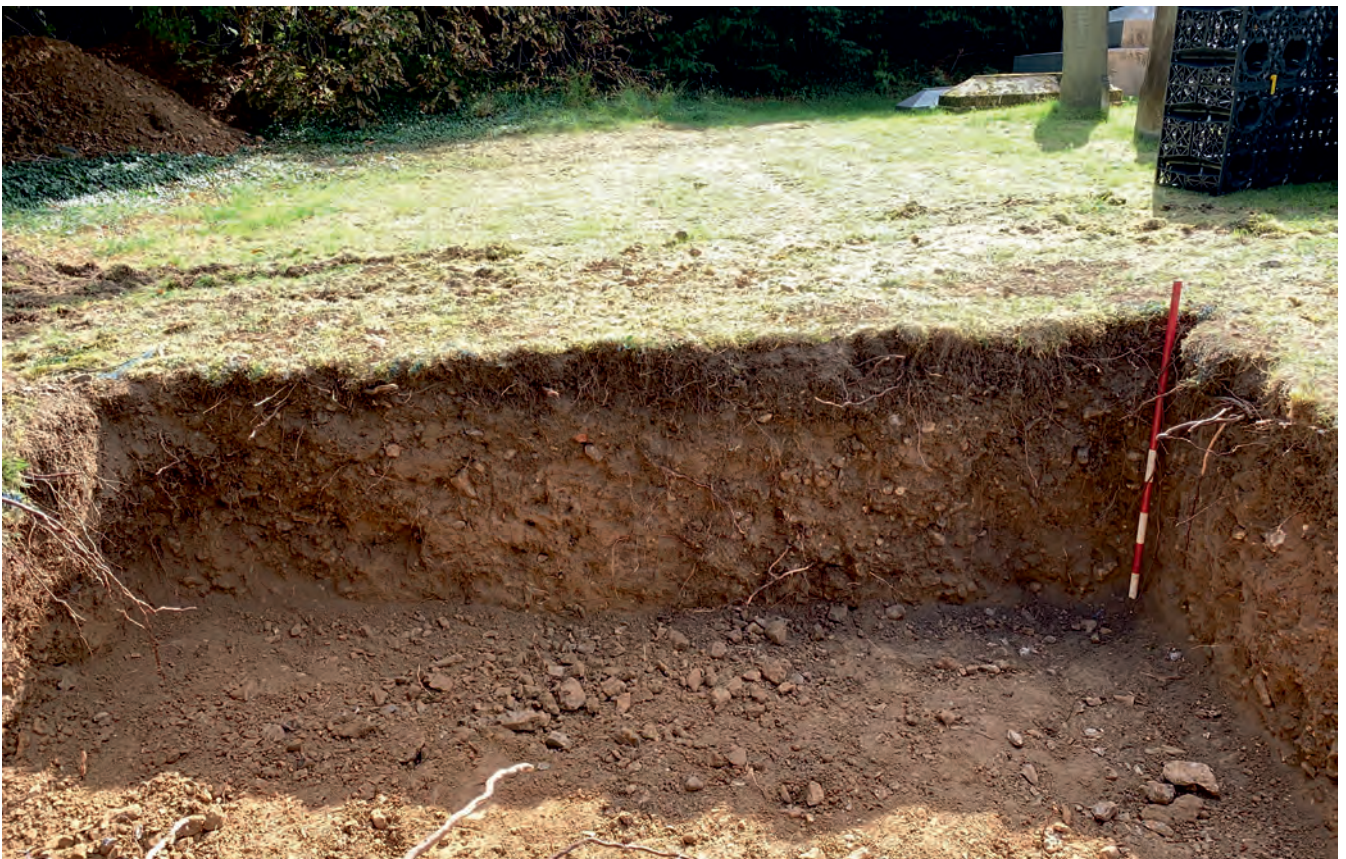
Plate 8. View looking south at the southern section of soakaway position S2 showing graveyard deposits over natural gravel geology and sealed by topsoil.
