St Winwaloe's  
East Portlemouth  
Rood Screen: Polychromy Report

©Eddie Sinclair ACR

October 2016

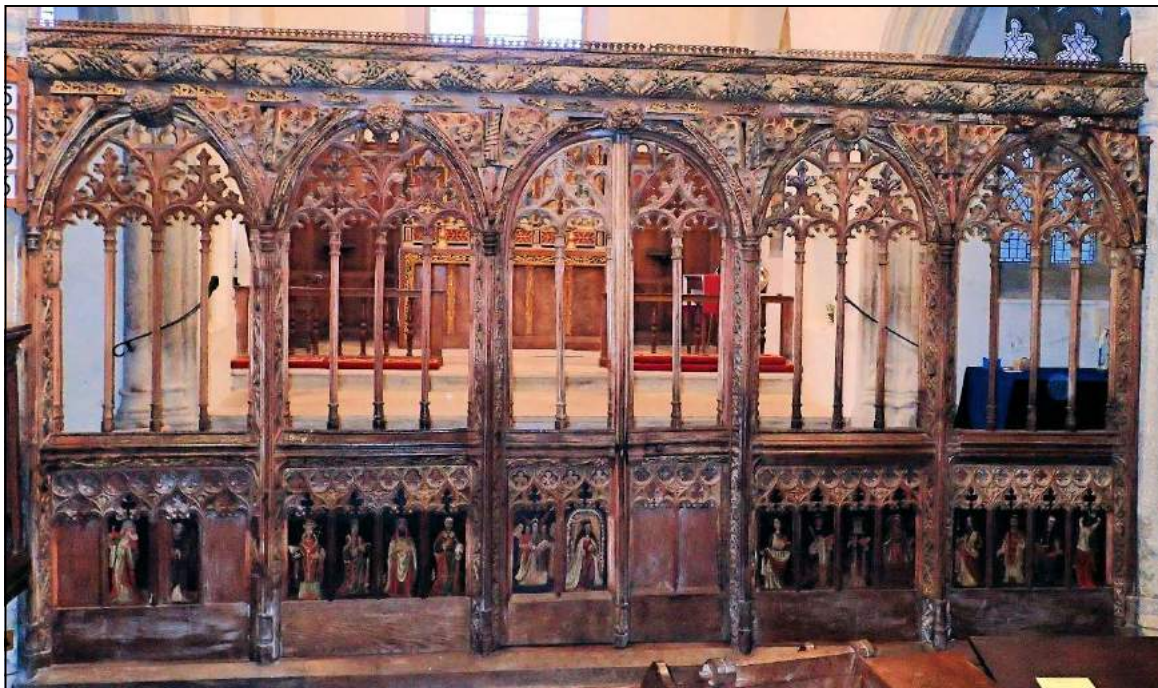
View of chancel screen west face. There is extensive original polychromy, alongside more recent replacement carving and surface coatings such as wax and a partial silver waxy coating.

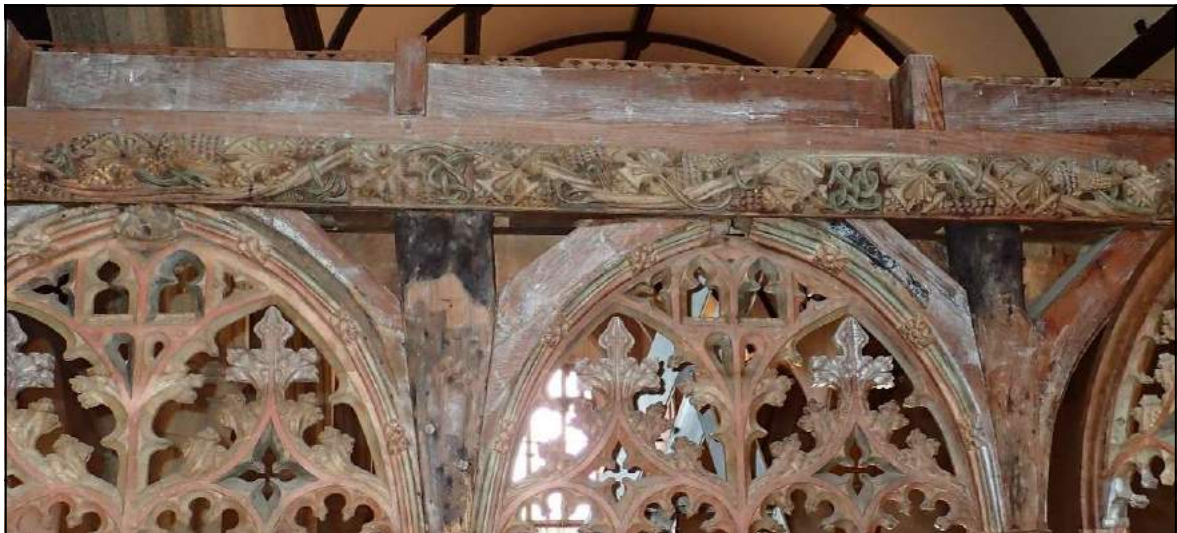
There is extensive polychromy on the east face above the dado. The paint here is dull, lack-lustre and dusty and there is evidence of a wax coating, as well as the silver coating noted on the west face.

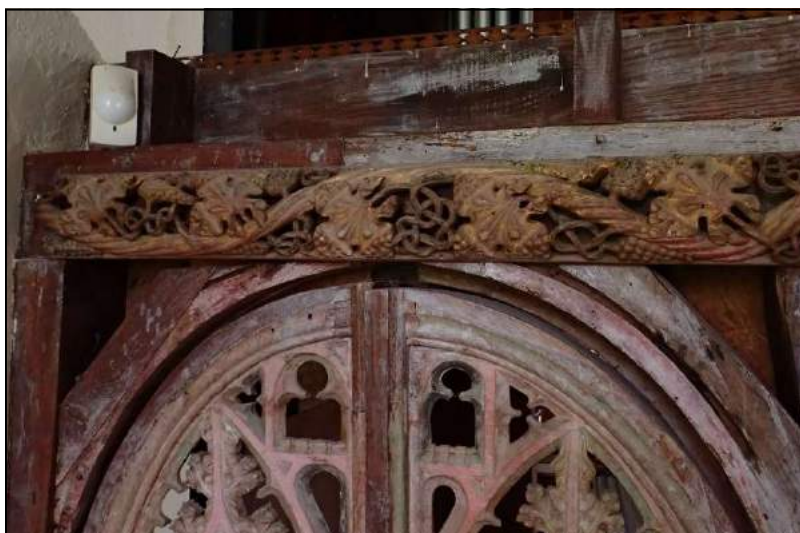
East face

Detail of east face cornice, showing ornate running ornament, originally from the west face. The white bloom is a degraded wax coating obscuring the paint.

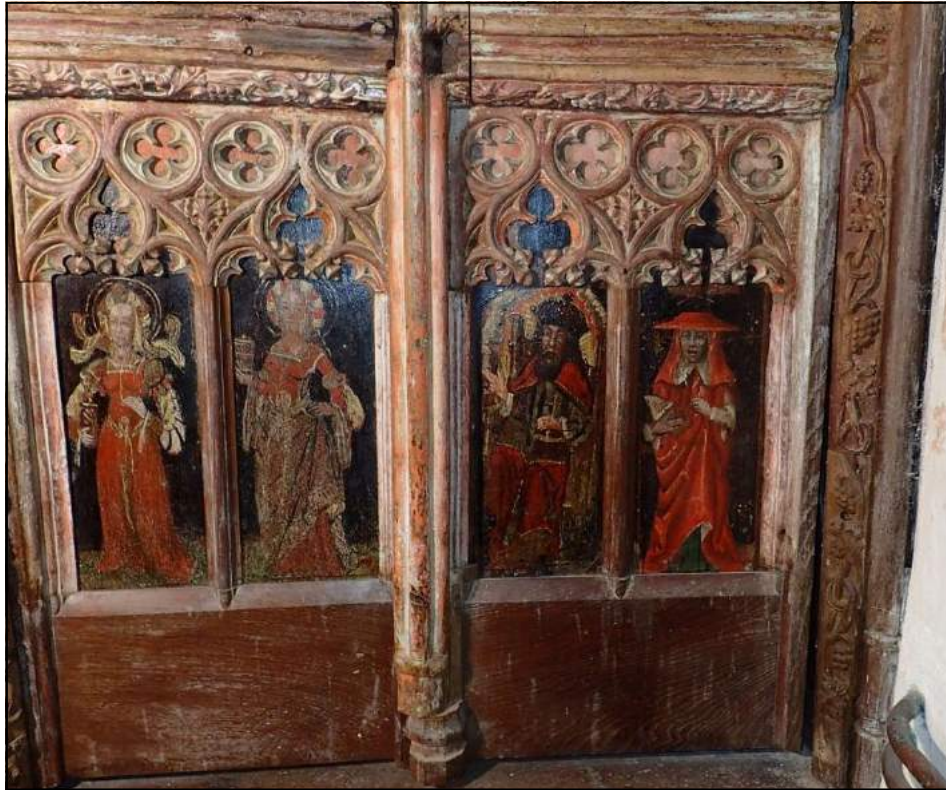
The south screen doors; these retain their original, extensively polychromed tracery

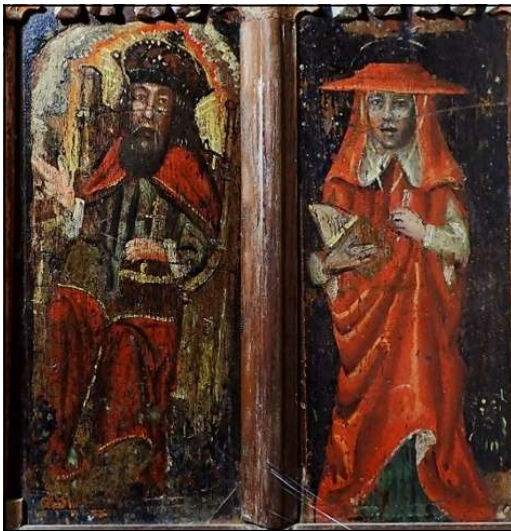
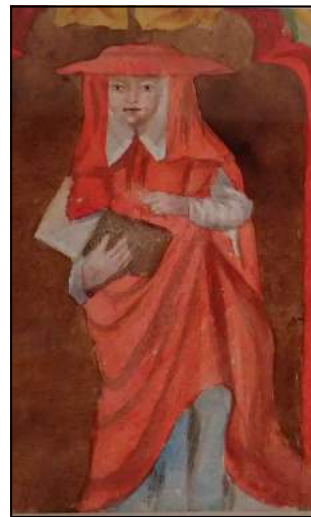
The two southern most panels (above right and detail below left) are not in their original location; it is a mystery why they have been positioned thus in the darkest corner of the screen where they are found today. The left figure clearly depicts Christ in a Coronation of the Virgin narrative scene and the right figure is St Jerome, shown as a cardinal.

The panel of Christ would have come originally from the central doors where it would have formed a focal point as part of a narrative with the Virgin Mary, flanked by angel present on the doors today. A photograph dated 1954 shows St Jerome on the south door, and possibly the figure of Christ in the adjoining panel as is also visible in photographs of 1909 and 1934. An early description of the screen refers to 'a general (and most wanton) shuffling of the panels'.

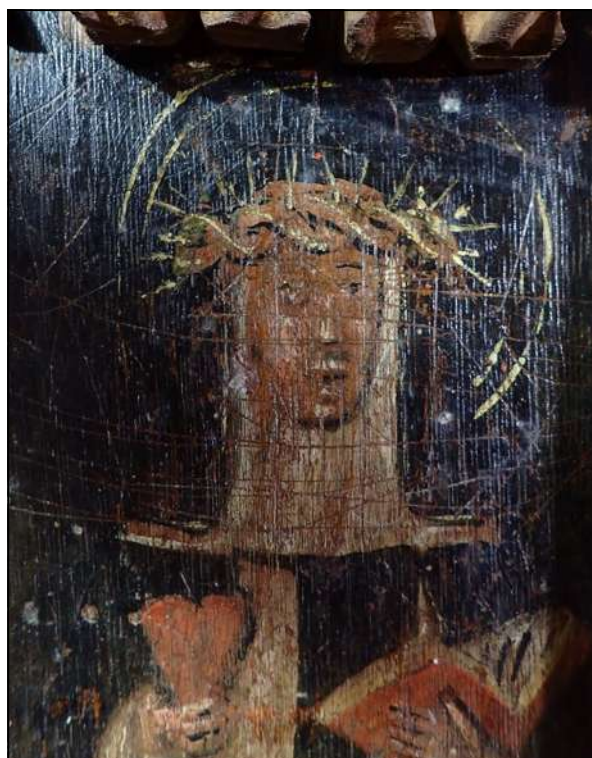
The figure panels display varying degrees of iconoclasm, where the faces or eyes have been scratched, although the damage is limited, compared to what is often found.

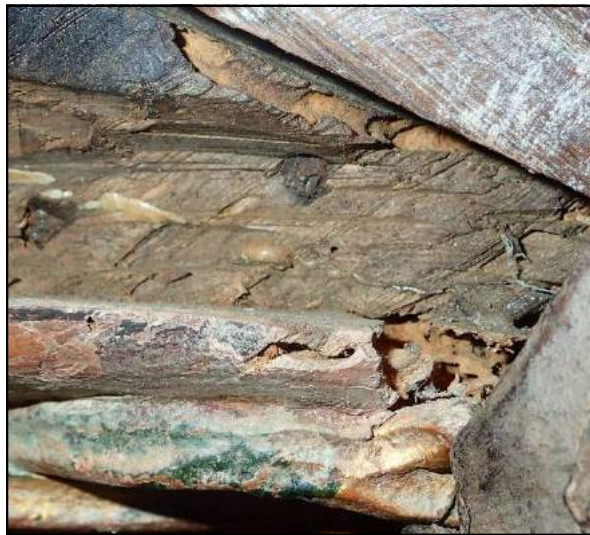
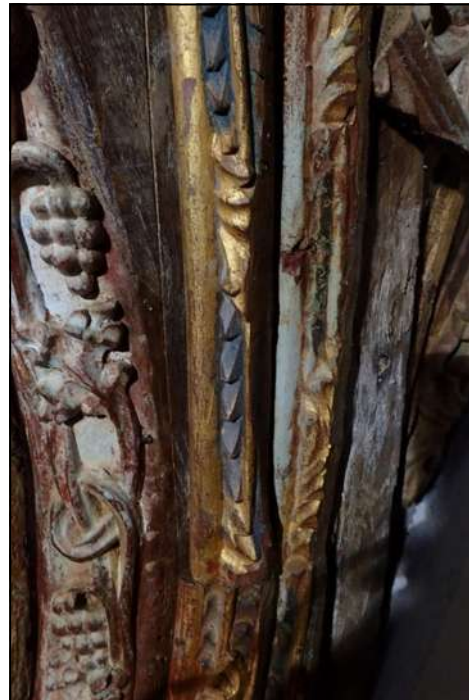
Death-watch beetle damage. Much of this is historic but there are signs of recent activity where the wood is crumbling and the surface of carving, sometimes with paint, is in danger of being lost.

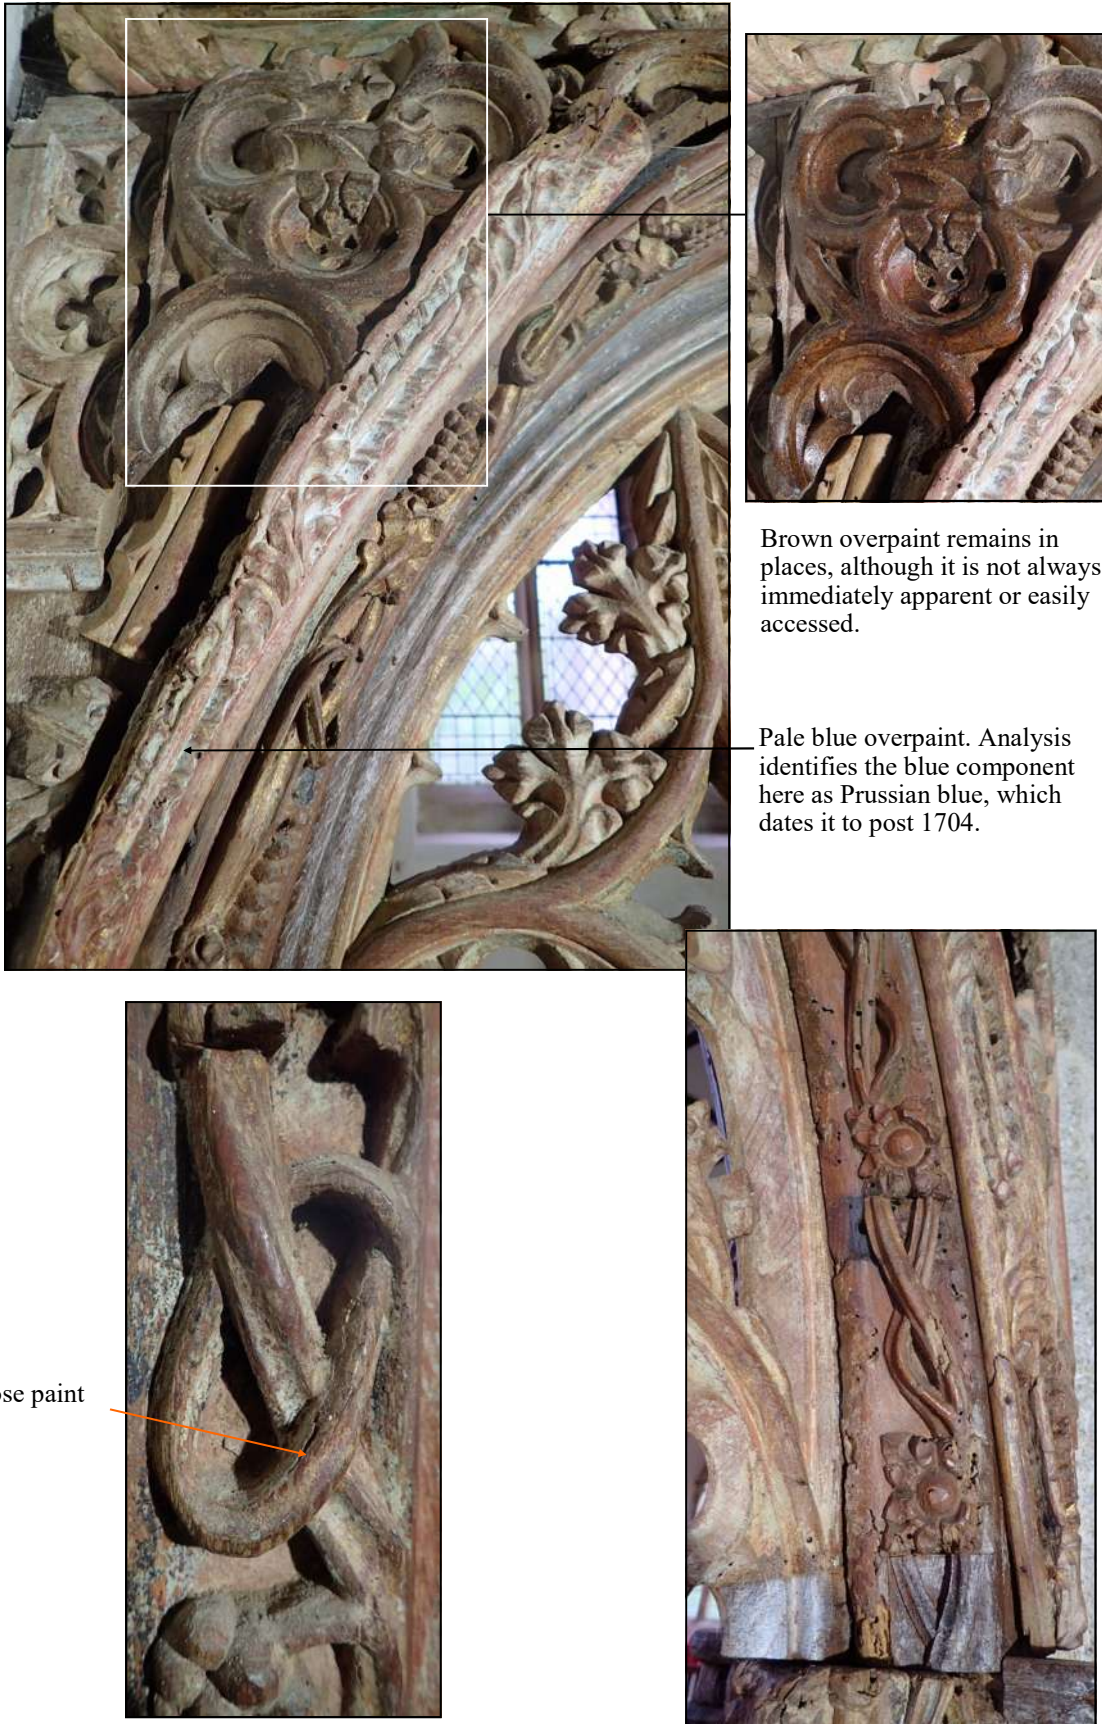
Areas of extensive original polychromy alongside sections with coating of wax or overpaint

Brown overpaint remains in places, although it is not always immediately apparent or easily accessed.

Pale blue overpaint. Analysis identifies the blue component here as Prussian blue, which dates it to post 1704.

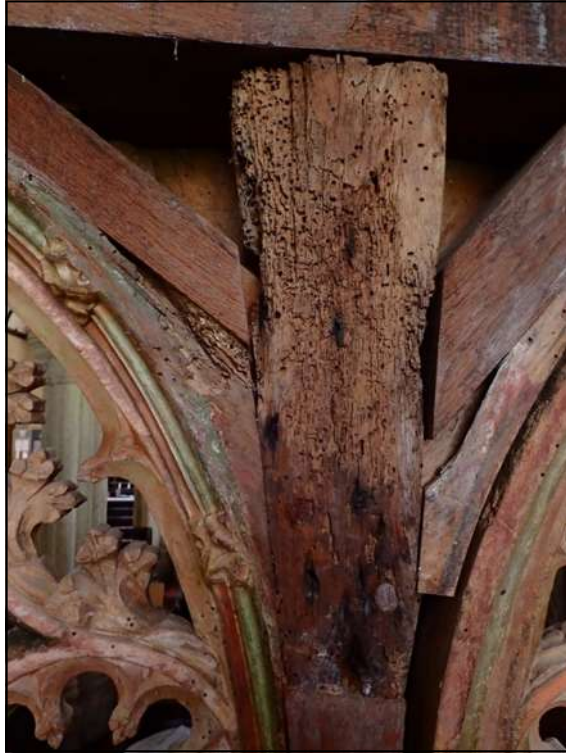
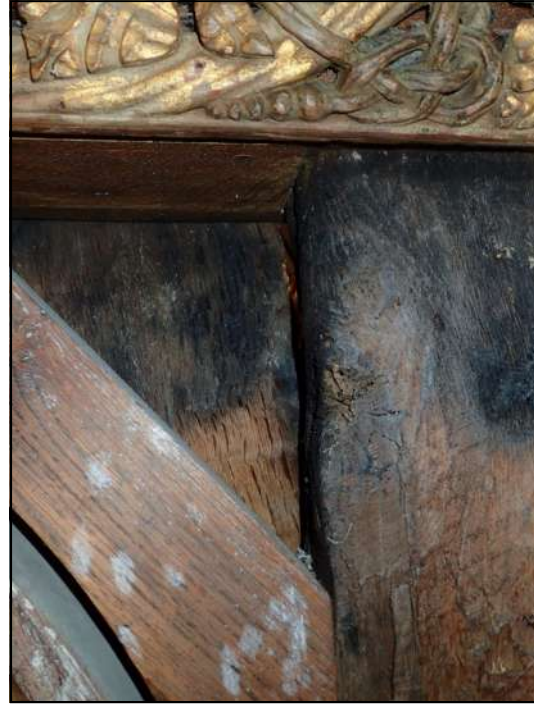
These images show original and replacement timber, pockets of death-watch beetle damage and evidence of caustic soda treatment.

The burn marks on some of the large timbers exposed on the east face of the screen have historically been described as Cromwellian attempts to set fire to the screen. New timbers were inserted where necessary, when the screen was restored, leaving much of the structure of the top of the screen exposed.

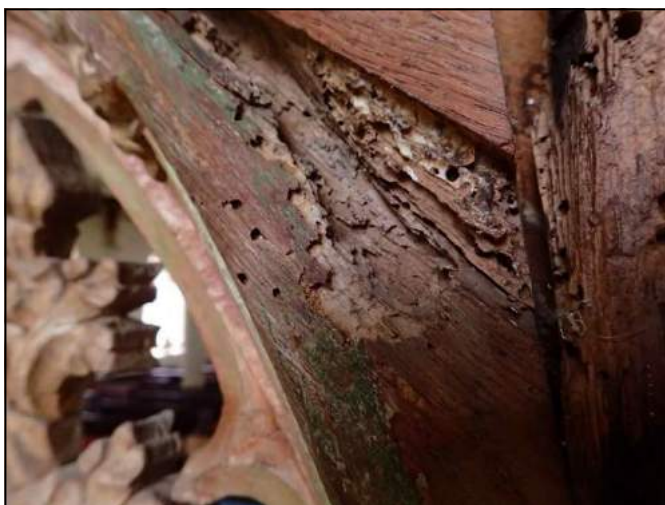
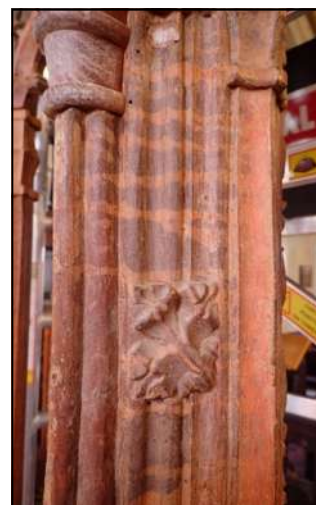
In places pronounced dribble marks, from the caustic soda treatment, can be seen from when the screen was dismantled and laid flat (see below right).

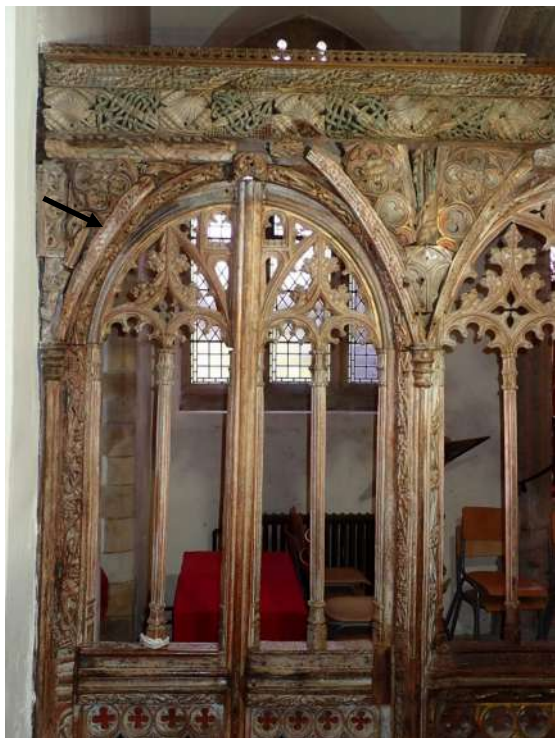
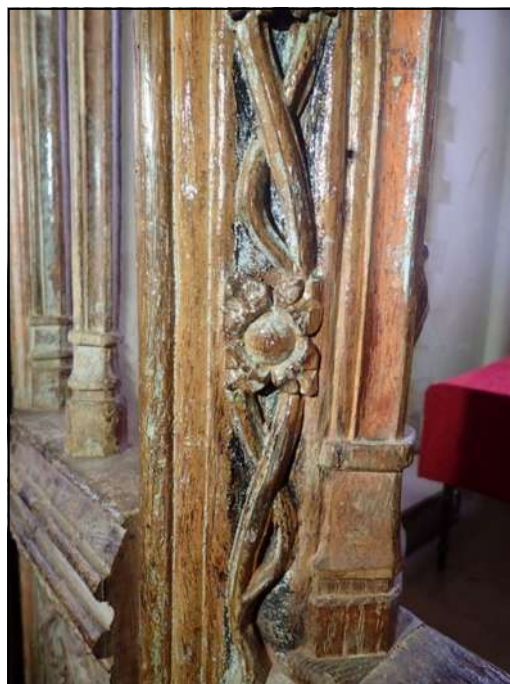
North screen arcade. Above left, view and location of sample 6 (see arrow). Above right, detail of carved post, north screen, showing pale blue overpaint which in places is flaking. The appearance of these surfaces would be considerably improved if the overpaint were removed.

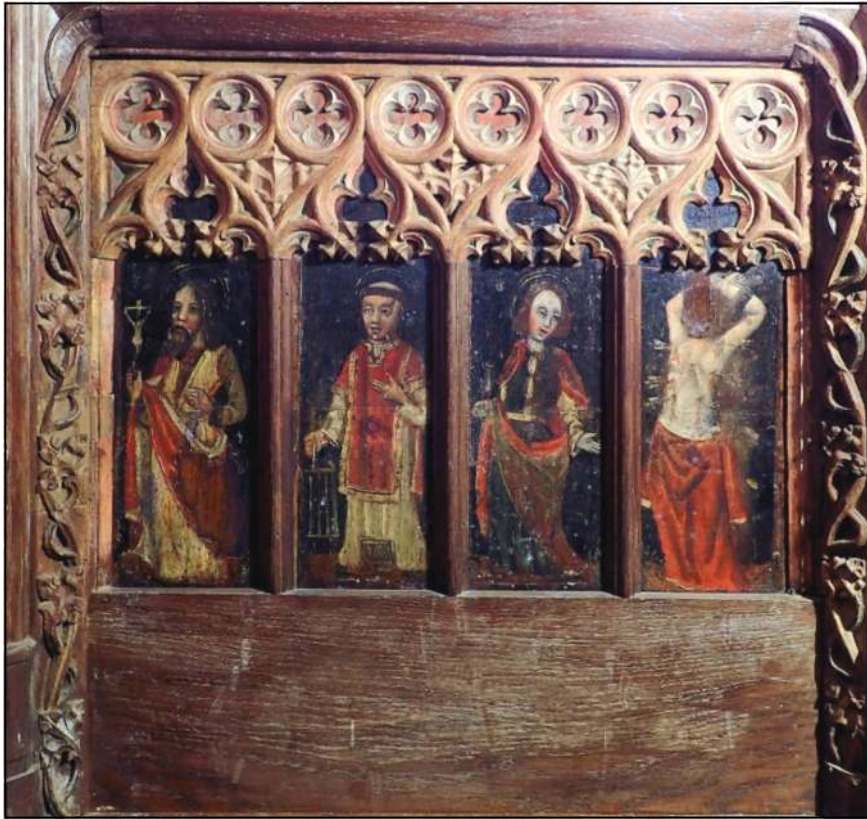
None of the East Portlemouth figure panels retain their lower tracery. Instead a plain heavy board spans the bottom of each bay. The tracery is missing in the earliest photographs and this may date from 1881 restoration. Rising damp historically usually means that the lower tracery displays various degrees of decay and beetle damage; presumably the condition of the tracery here was considered at this period to be beyond saving.

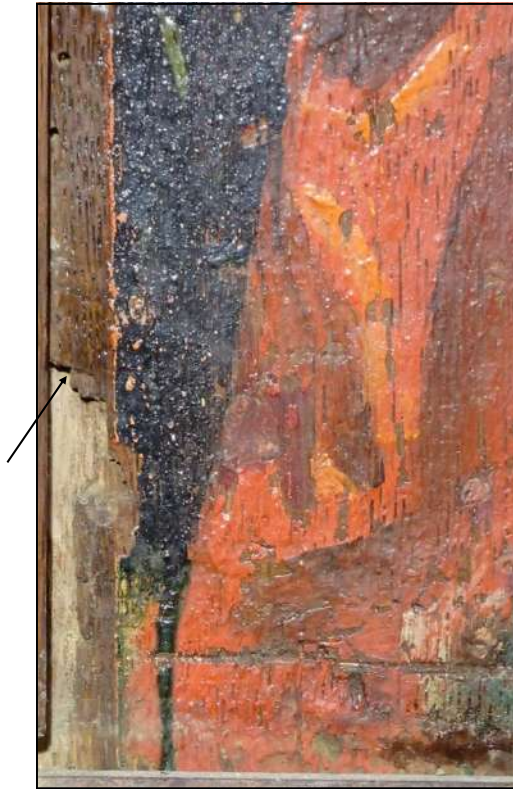
Arrow above indicates where the pared-back painted panel is separating from the backing board.

Of high priority would be to get the advice of Hugh Harrison, timber specialist.

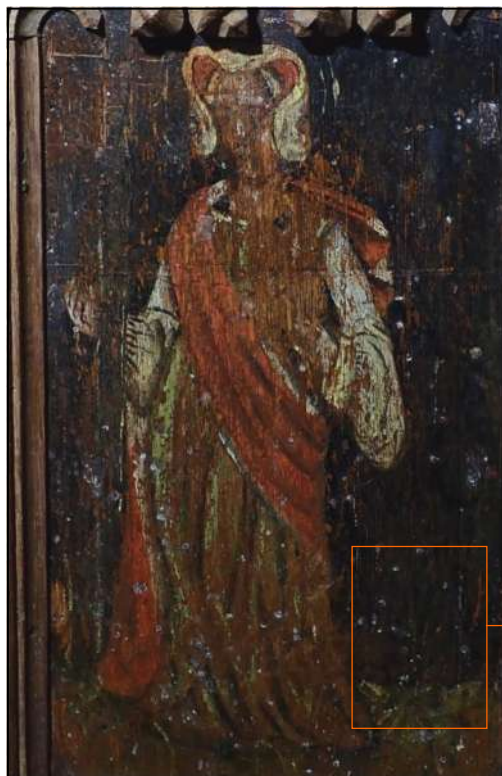
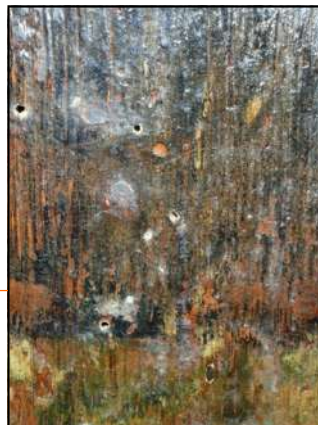
Details of active beetle attack on south screen figure panel.

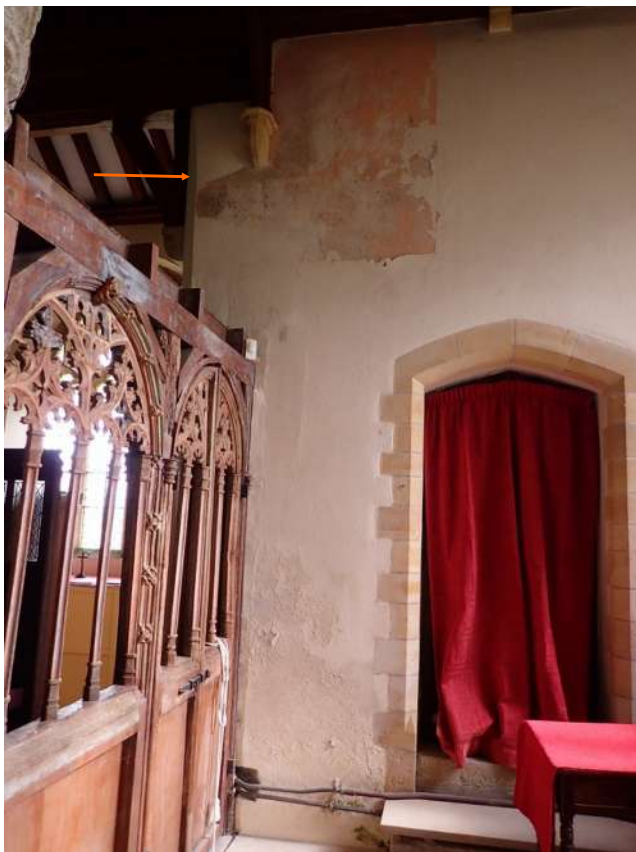
Regarding the issues highlighted on this page, there is an item in 2014 QI (4.04.14) which has been 'ticked', stating: 'Repair north transept ceiling plaster-work once the external repairs are completed'. QI 3.10.05

The north screen is set against the north wall W25, which butts on to the north transept, which has had various damp issues, some of which may have been addressed. Filled cracks in the render above window WN5, and noted in two QI reports, need monitoring. There is damp in the east end of the ceiling of the east wall of the north transept W24 which will be creating an environment detrimental to the screen.

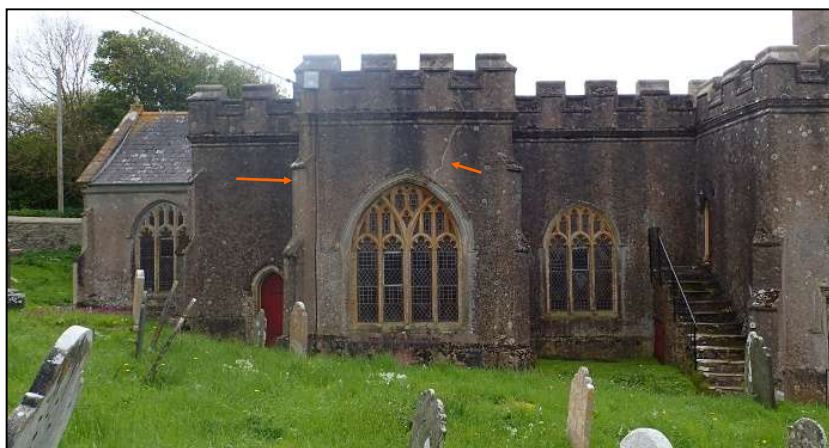
North side of church.

The crack on north transept wall W23, above window WN5, has been present through two QI inspections, but needs monitoring.

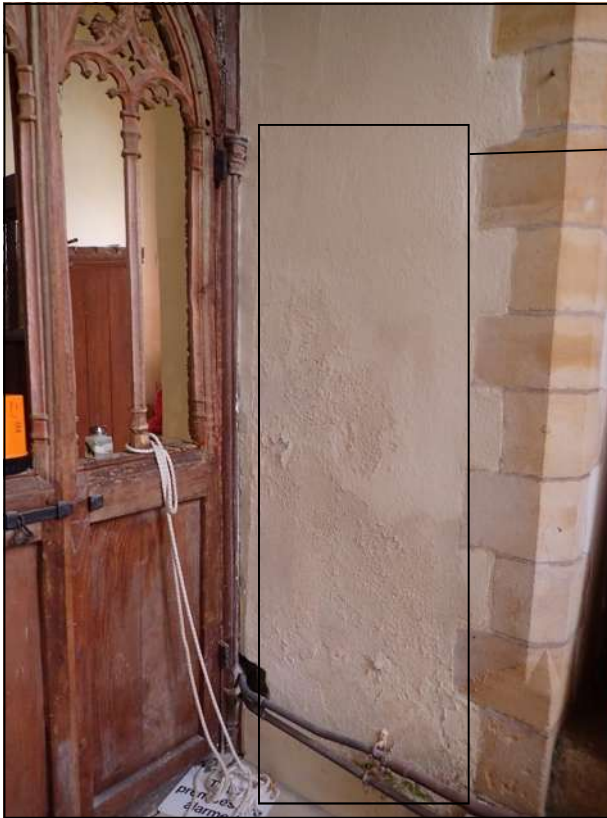
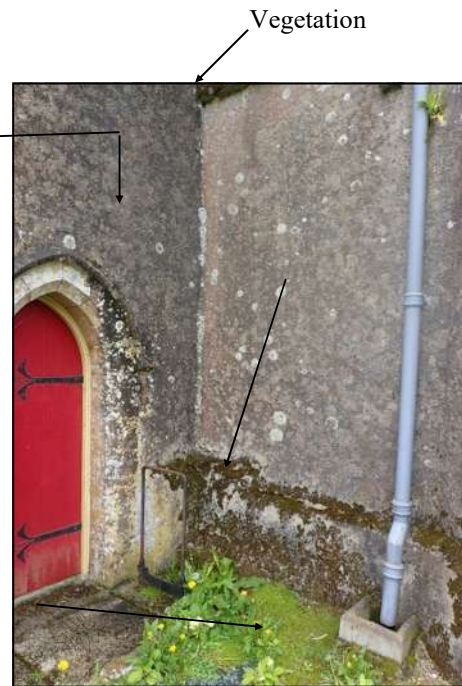
The 2014 Quinquennial Inspection noted that external gullies should be kept free of debris 'if they are not to affect the walls of the church as rainwater floods the adjoining ground rather than being conducted to the drainage system'.

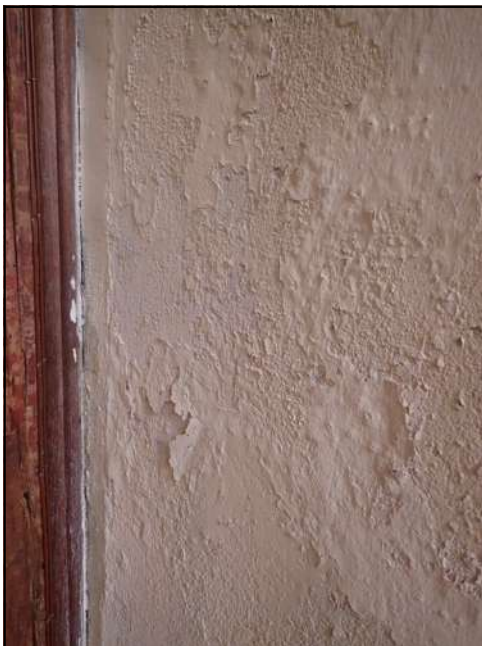
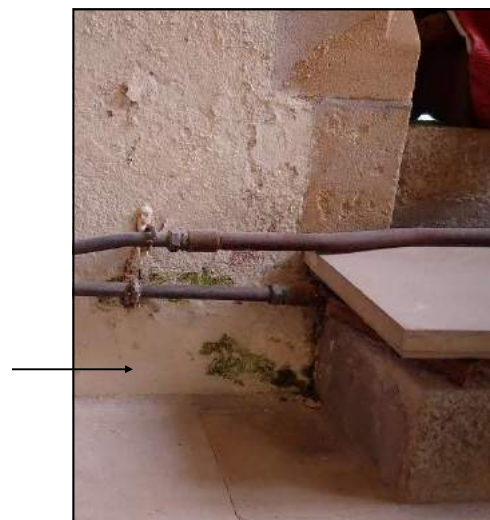
The walls adjacent to the aisle screens are damp and deposits of salts were in evidence on the peeling plaster, as well as moss at ground level.

The north wall butts on to wall W24, the east wall of north transept. The photograph above right, shows the exterior where these two walls meet, with moss along plinth and around gutter, and grass extending onto the wall.

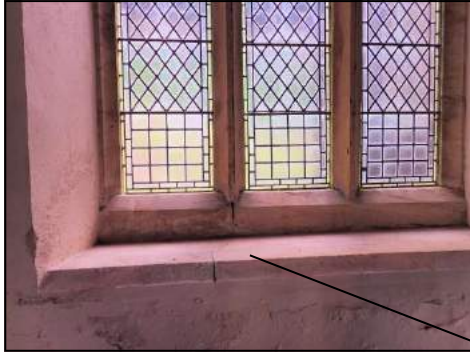
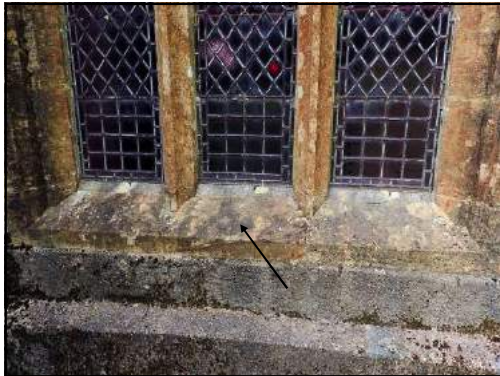
Cracks under window WS3 (above interior, below exterior) will be contributing to damp on this wall

The 2014 QI inspection had noted cracks in the exterior render, which were listed under 'Recommendations for further investigation'.

- Monitoring should also be a priority

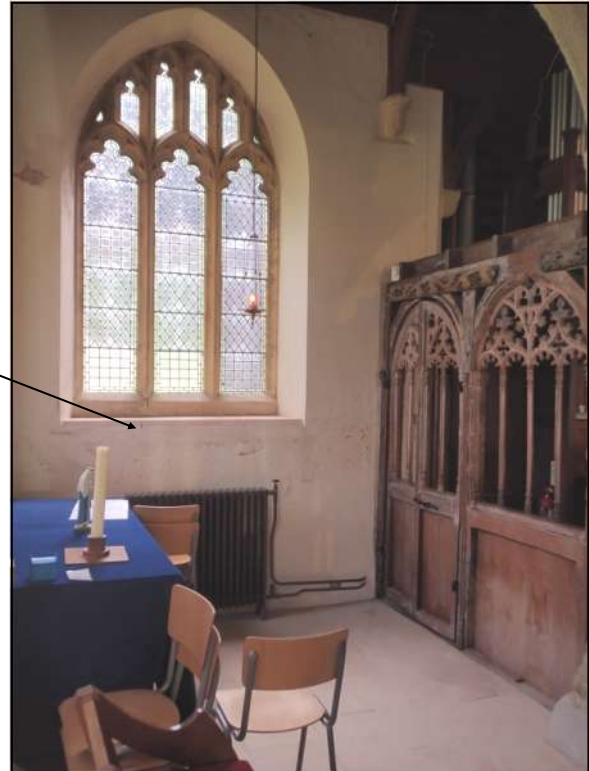
The walls at the south end of the screen are also suffering from the effects of damp and pockets of salts and peeling paint/plaster can be seen.

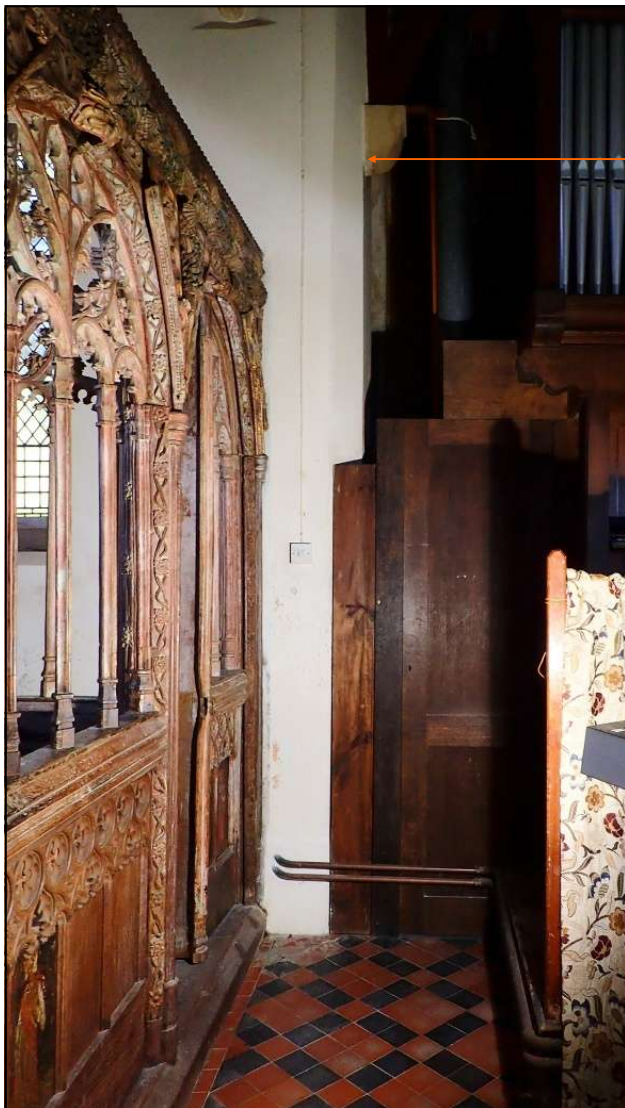
South side, view of corner where the south aisle wall W4, meets the east wall of the south transept, W5. The organ can be seen filling the south transept and access to inspect W5 is severely restricted.

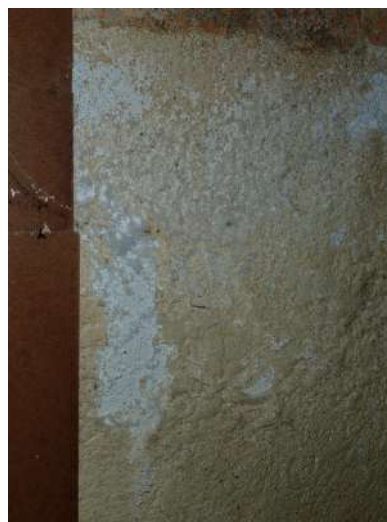
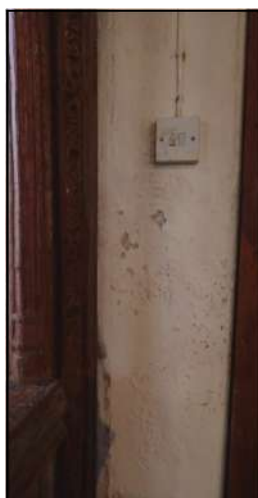
The window in the east wall has been blocked and dampness in the wall is causing adjacent paint to detach in sheets (see details above and below).

Detail of wall W4, south aisle wall, showing condition of plaster.

Issues highlighted in the 2014 QI on the exterior, related to blown render behind rainwater pipe RWP.7 on wall W5. This may have since received attention or it could be an ongoing issue. It is important to remove any vegetation here.

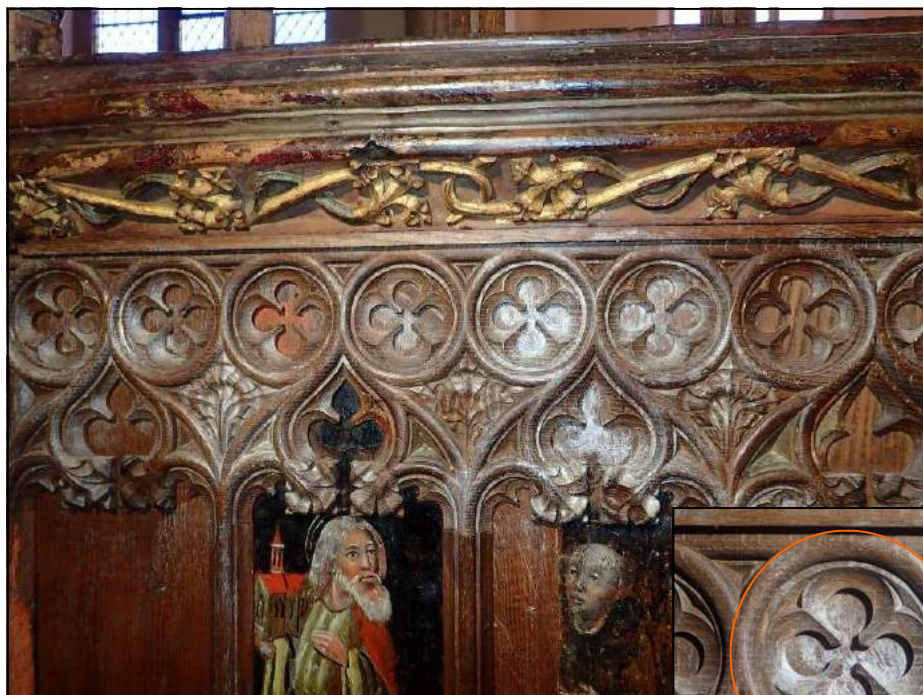
Large areas of replacement carving, probably from the 1960s intervention, have in many places been coated with a silver wax.

**Test 1** shows that this wax can be removed and allow the fine oak carving to again be clearly visible.

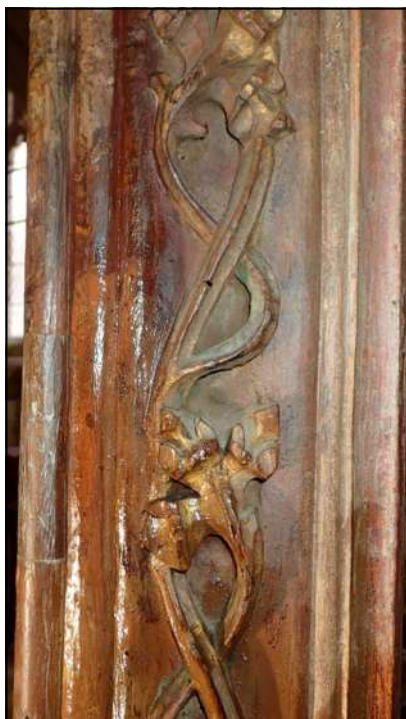
Left, north side foliate trail, wetting-out test: **Test 2**. The vibrancy of the paint is slightly muted probably due to a wax coating which has become opaque. Dust also clings to the wax.

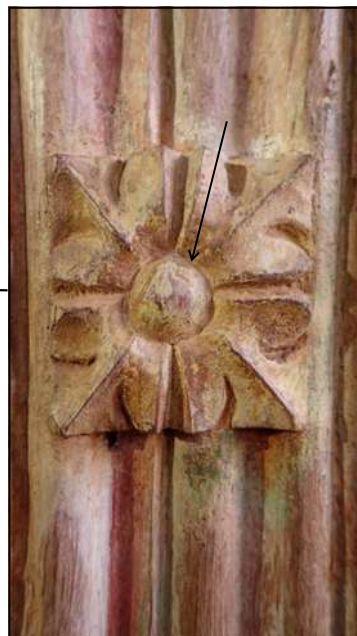
A considerable amount of colour survives here (see above and far left) though much of it appears muted or blanched. The paterae, of which one is shown above, are painted with lead tin yellow. This is often found on the east face of Devon screens, where it was used as a substitute for the gold on the west face.
