## **ST PETER'S CHURCH, REDCAR**

Replacement of the lead Chancel Aisle roofs with stainless steel.

simmonsherriff LLP  
Unit 10, 30-38 Dock Street  
Leds  
West yorkshire  
LS10 1 JF

March 2021

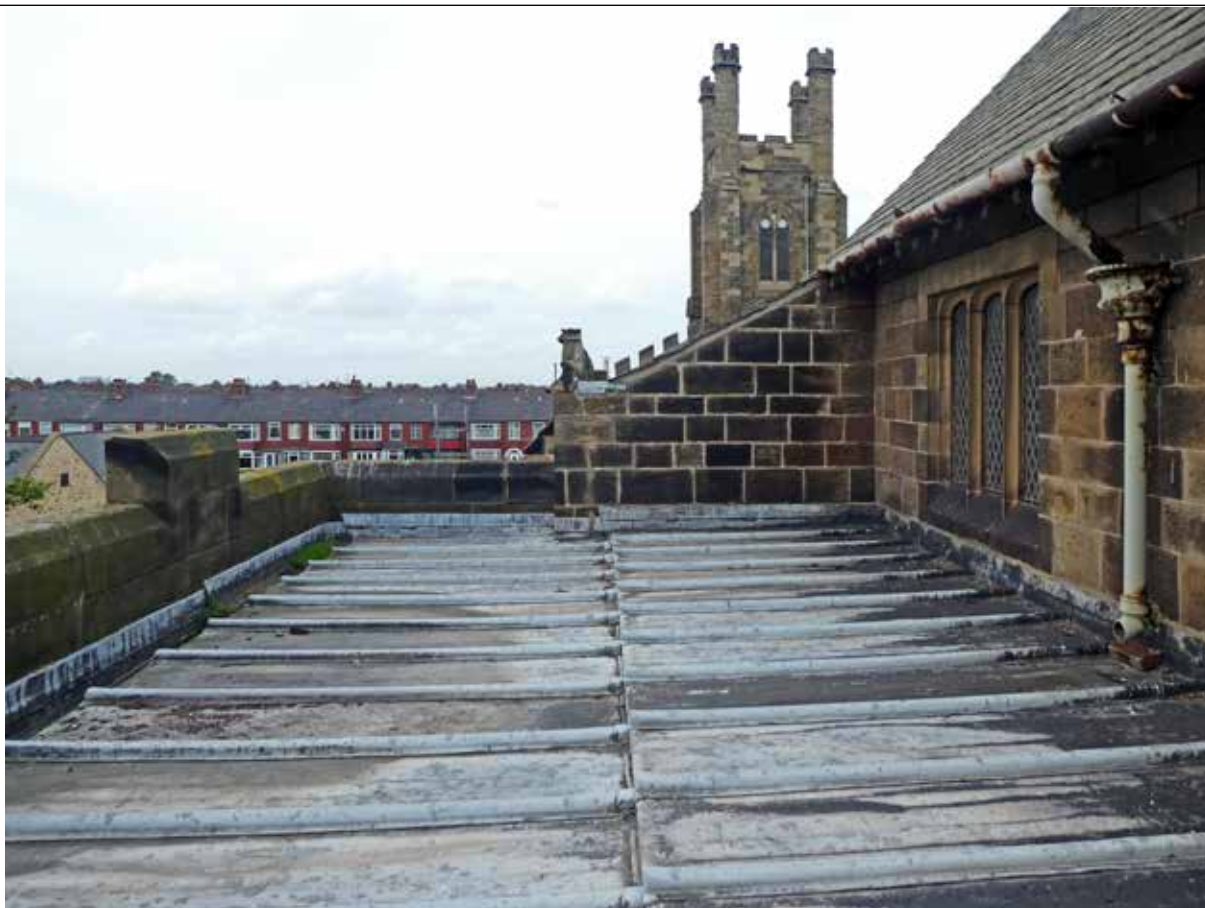
*The existing lead roof on north side of Chancel (looking west). The limited length of lead bays required a step to be formed resulting a very shallow pitch resulting in ponding of water, indicated by dark patches on the lower sections of roof. This photo was taken in 2019 before the cast iron gutter was taken down due to concerns over its condition and fixing.*

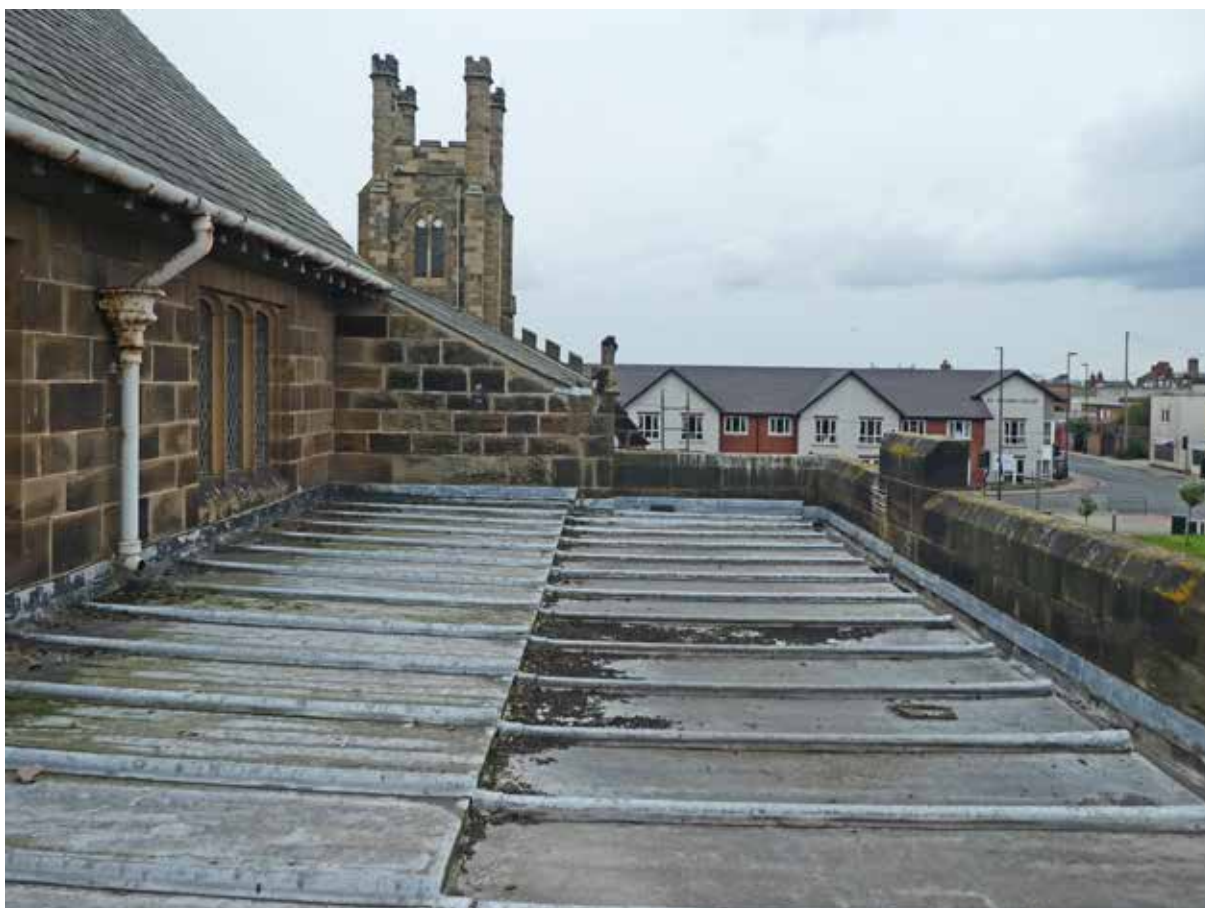
*The existing lead roof on south side of Chancel (looking west).*

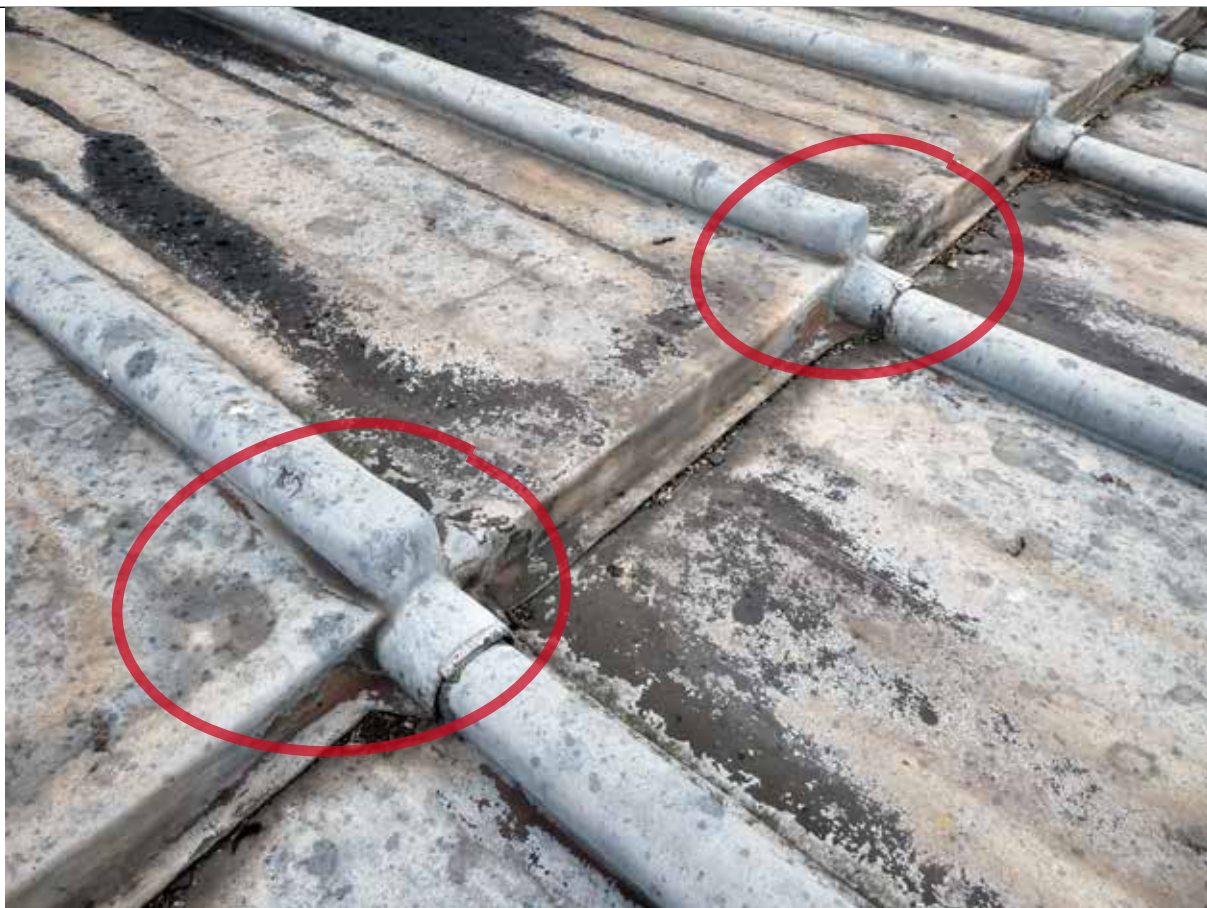
*Failures in the lead include splits at the bottom of the rolls (highlighted). These have been temporarily repaired with mastic in the past.*

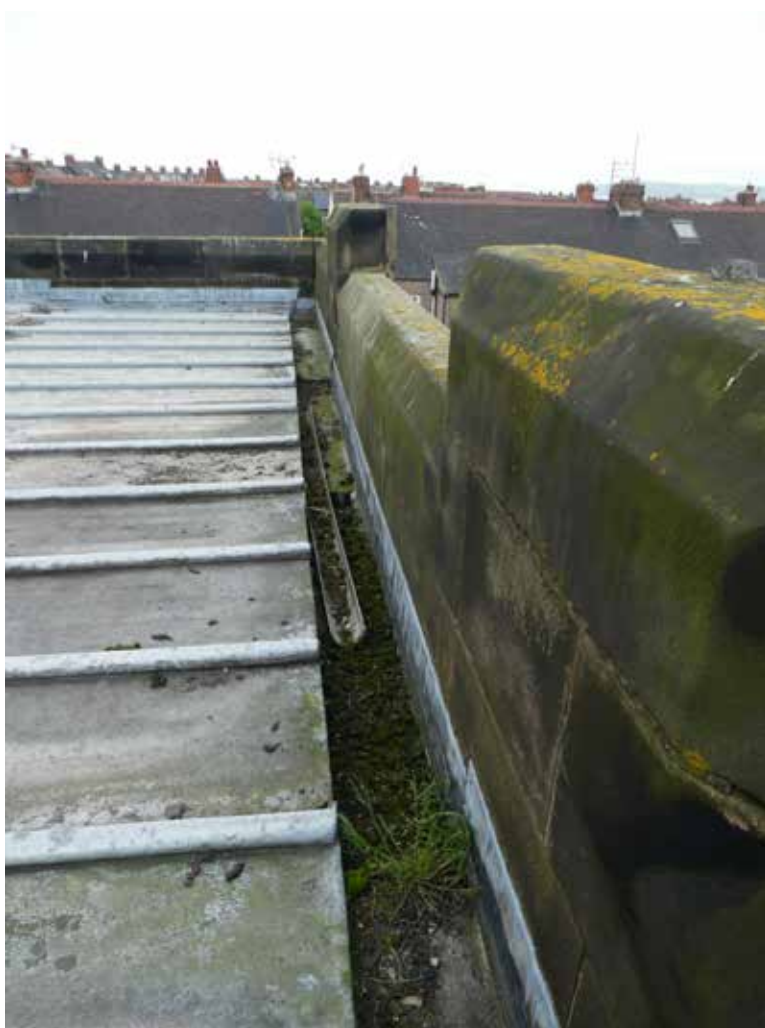
*Debris and growth in the north side parapet gutter.*

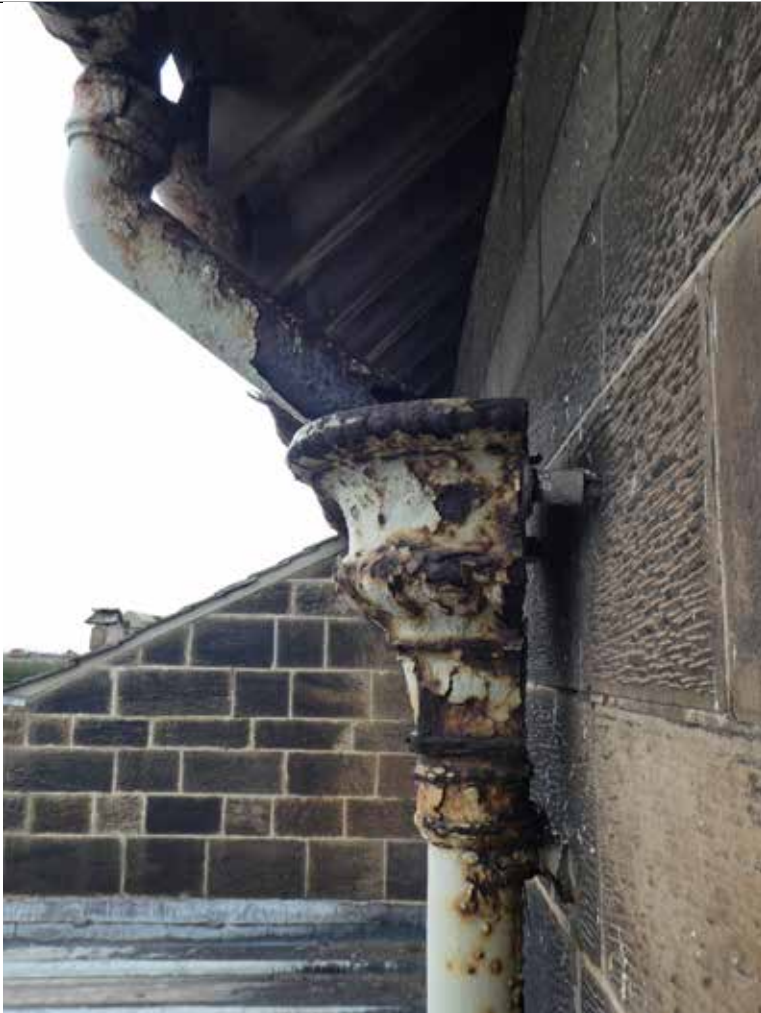
*Some sections of the existing rainwater goods at high level were in a poor condition. While the gutters were replaced with new cast iron, the existing hoppers and downpipes were salvaged and kept.*

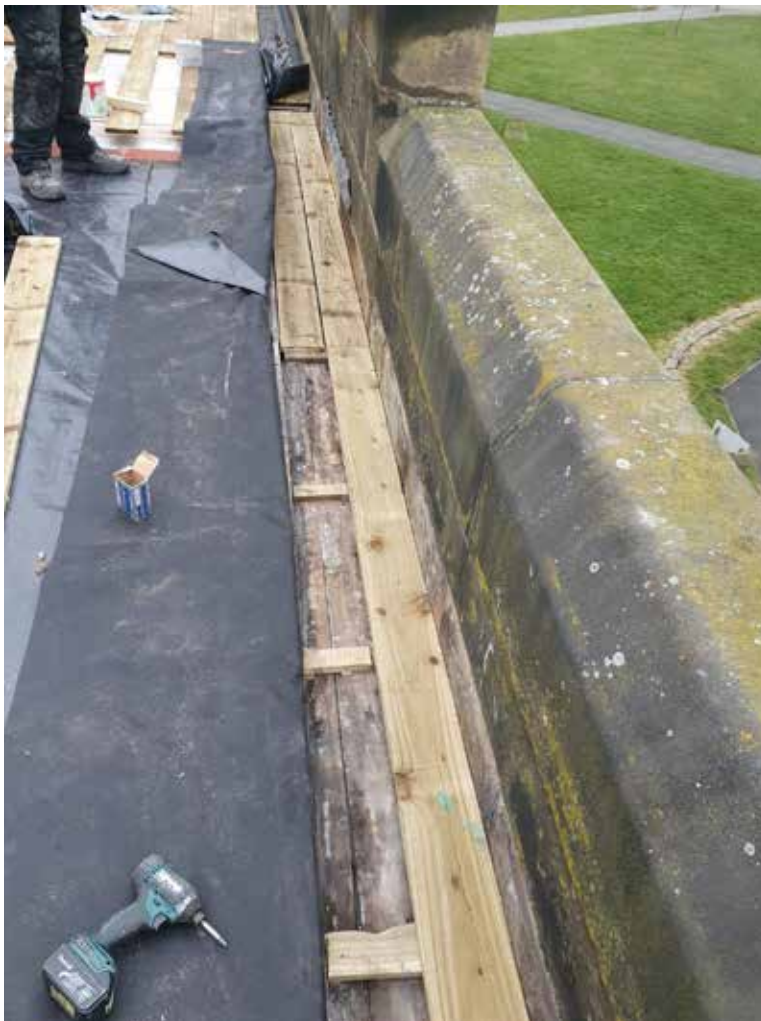
*Some of the existing boards under the parapet gutter were affected by rot. This shows the installation of new gutter boards.*

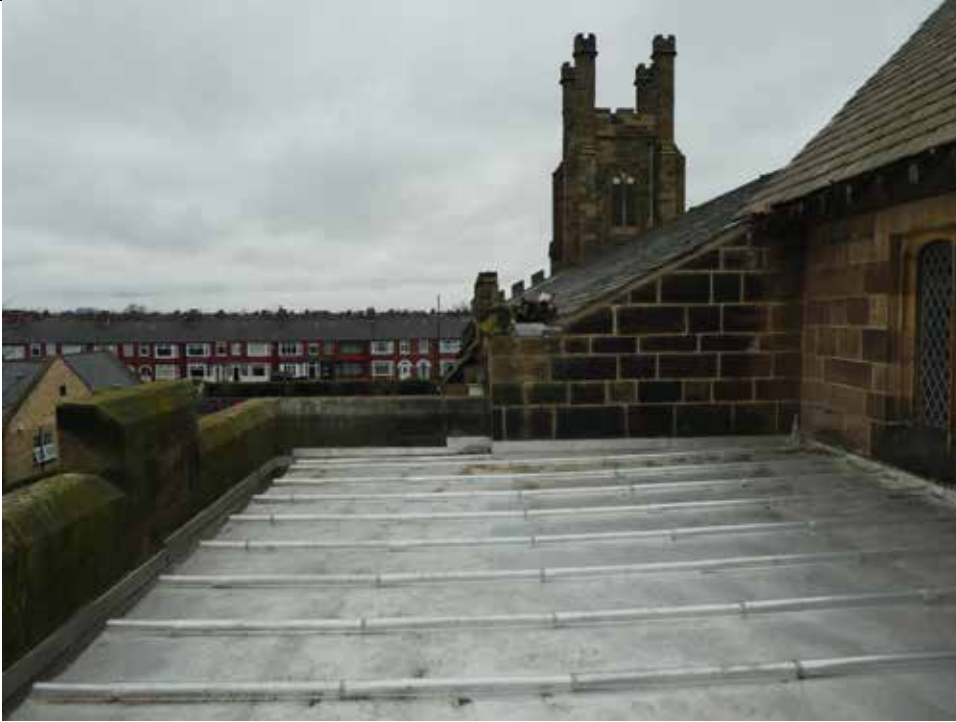
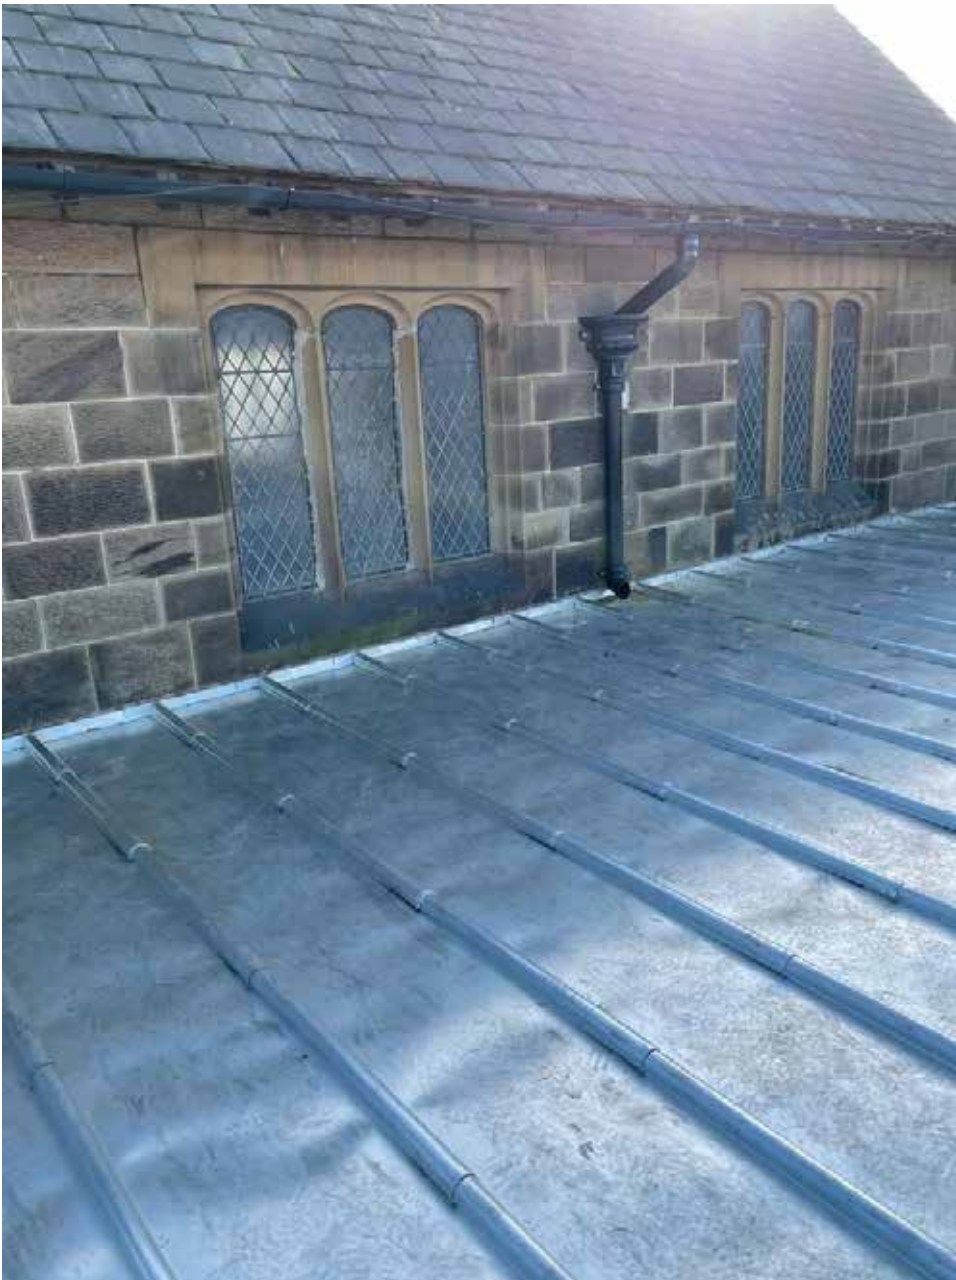
*Work complete.  
The thickness of the stainless  
steel (0.5mm) results in a slight  
undulation. This does not affect  
its performance in any way.*
